# Provision of Cremators at Wo Hop Shek Crematorium

Tree Survey Report

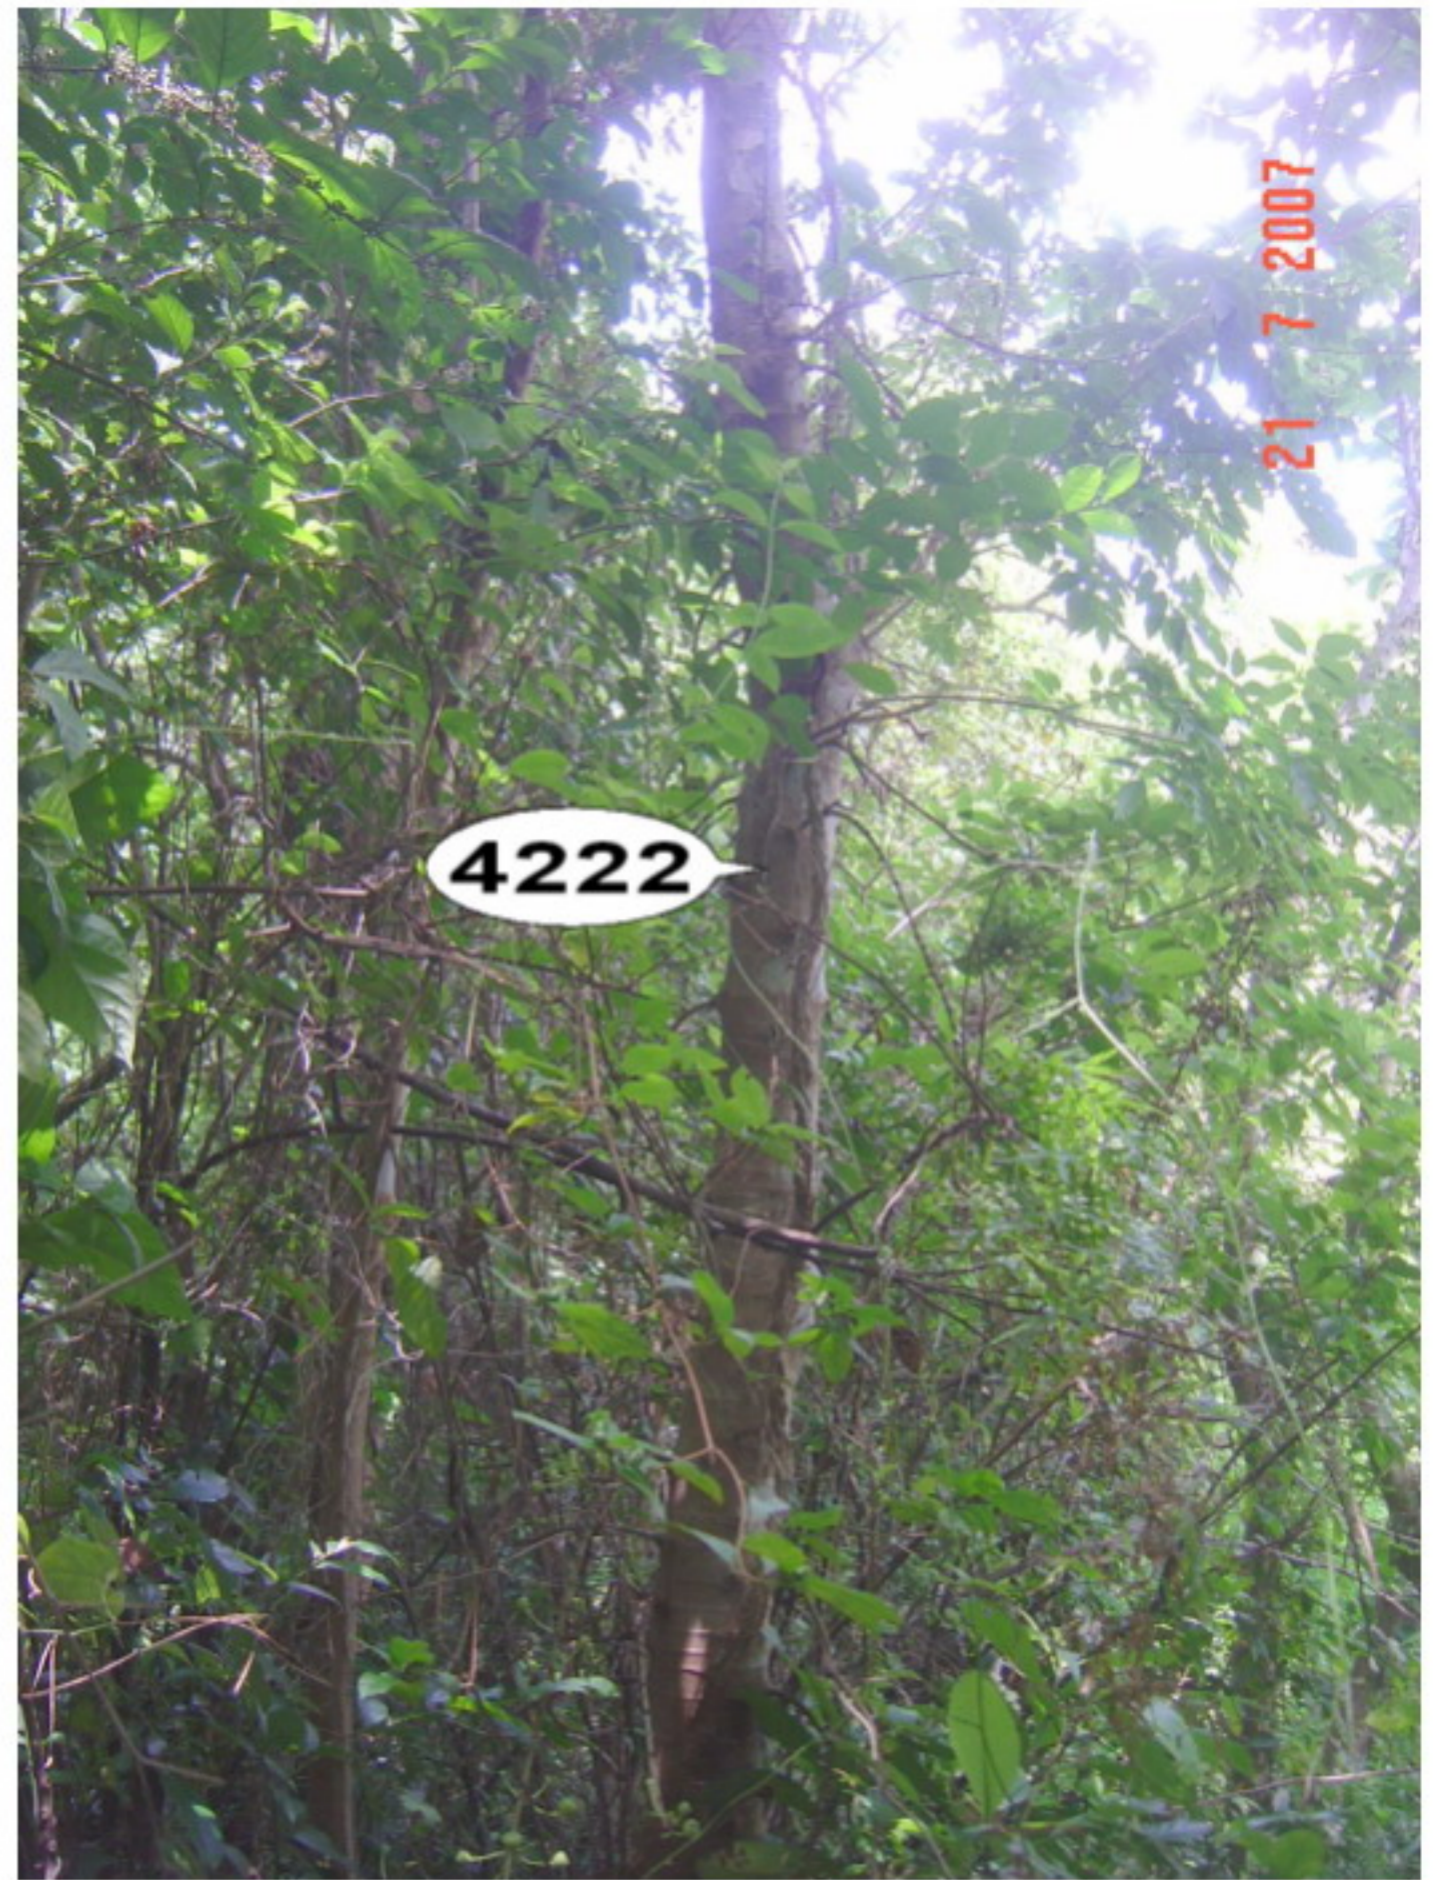
Tree 4222  
Poor health will lead to low transplantation survival rate.

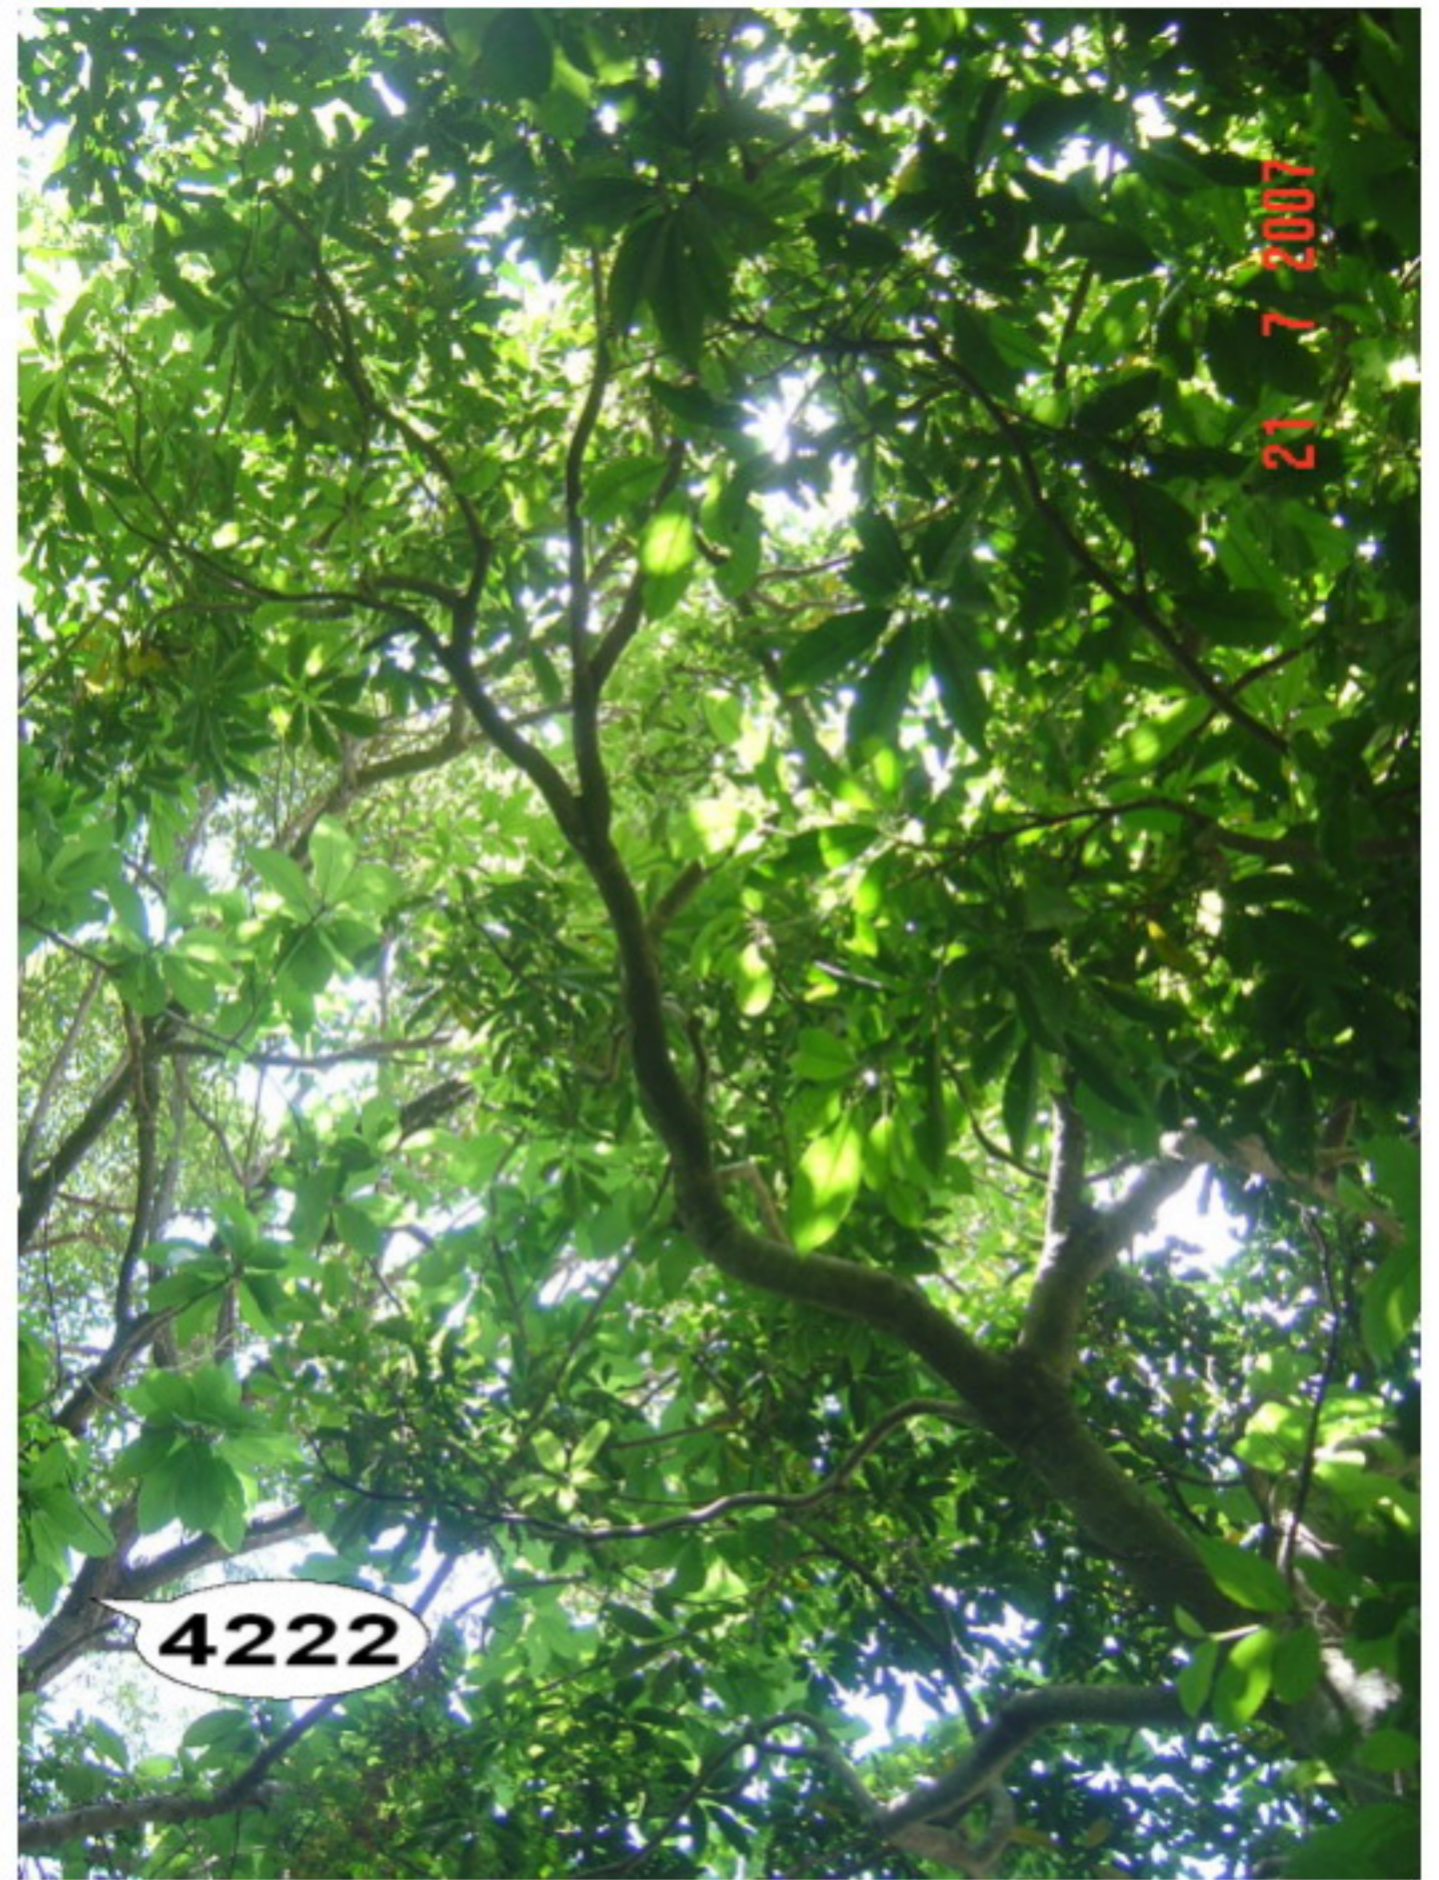
Tree 4222  
Poor health will lead to low transplantation survival rate.

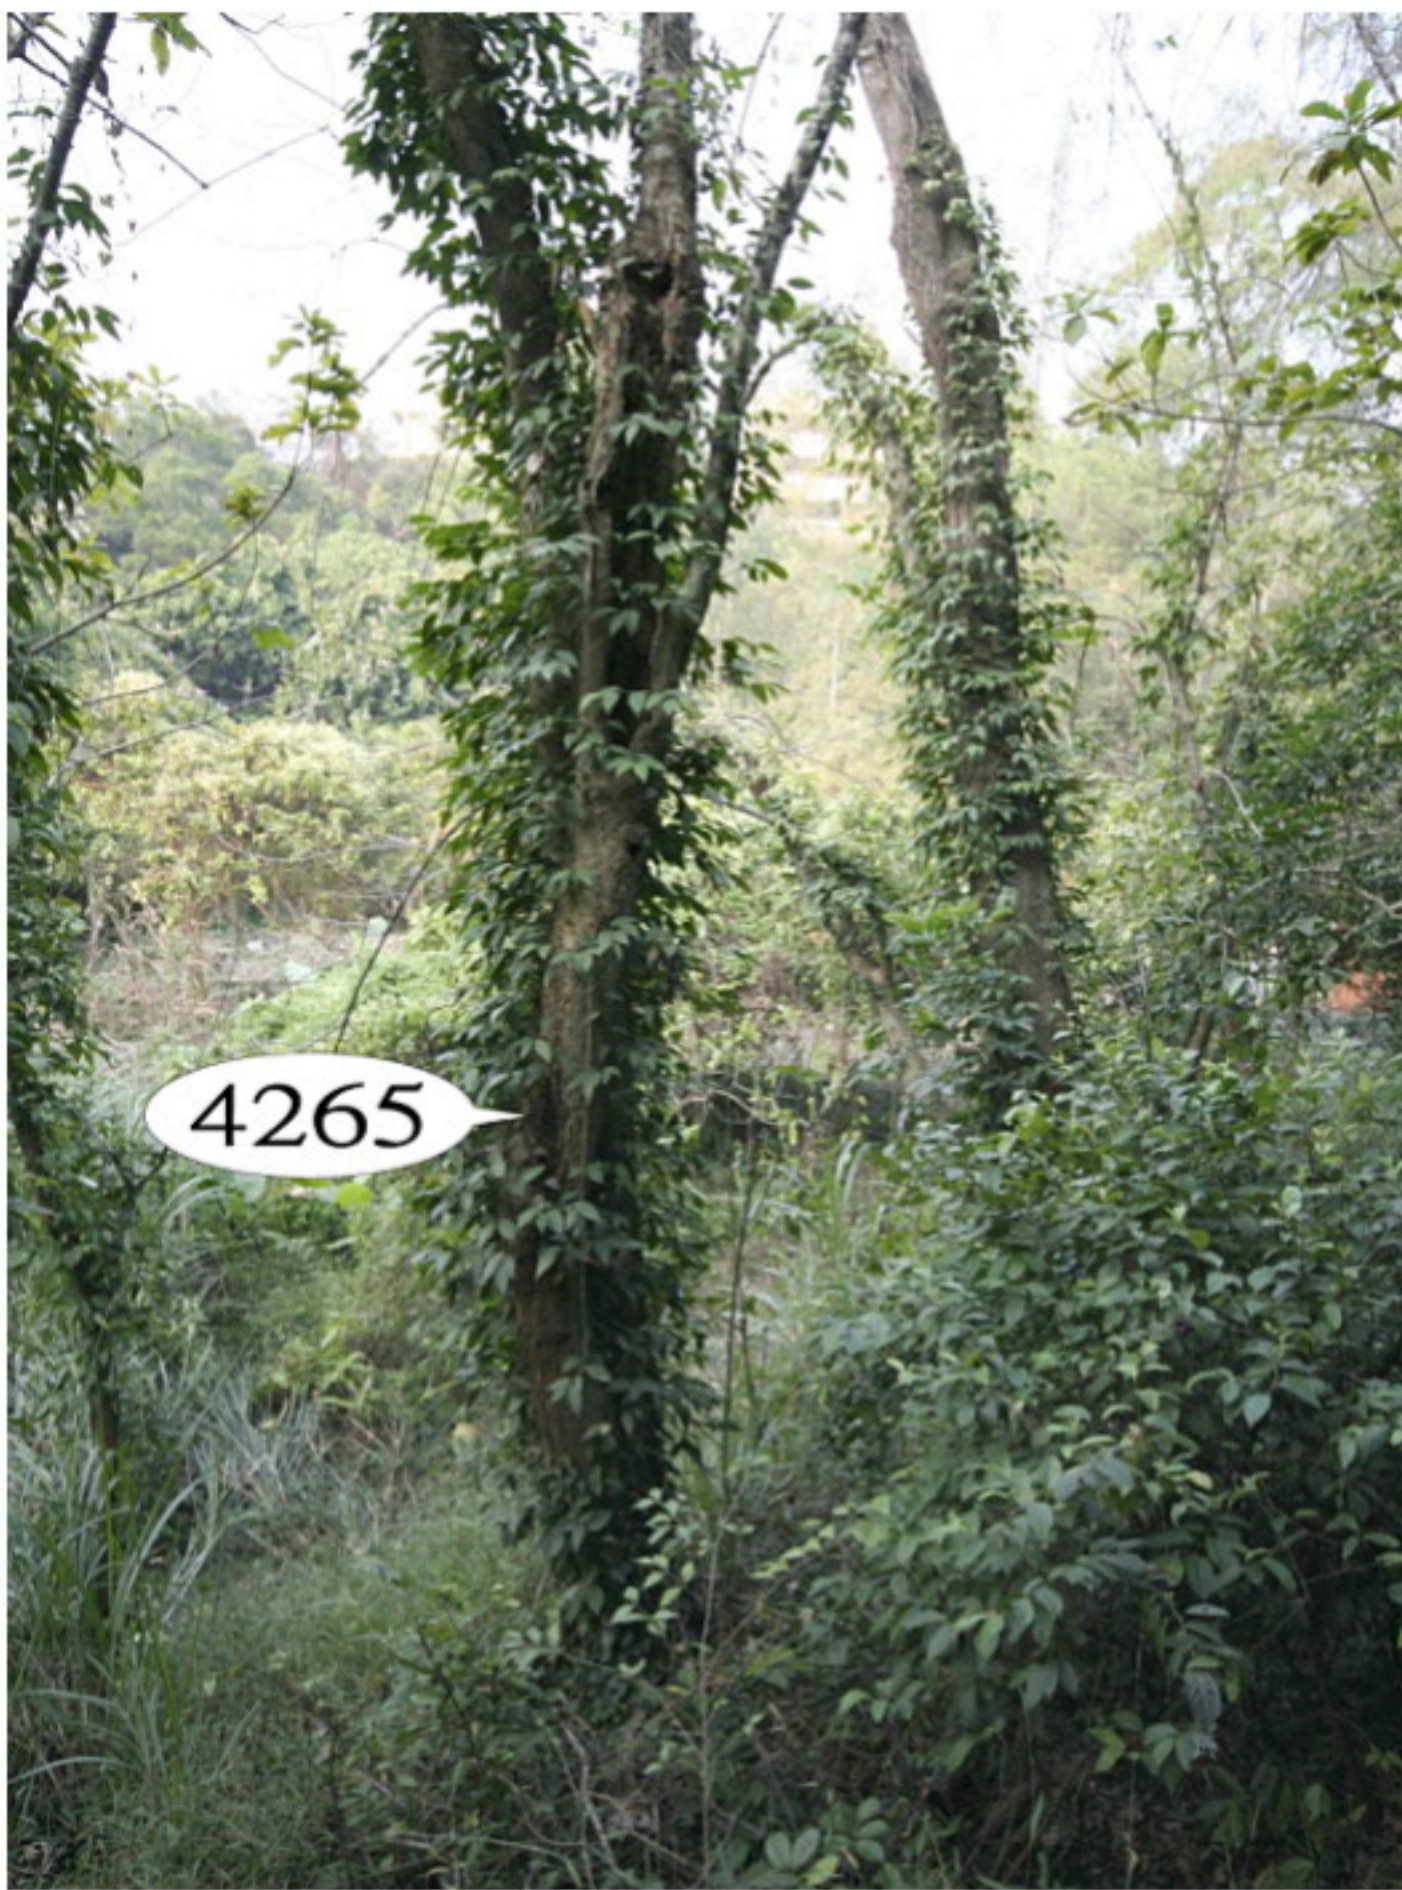
Tree 4265

Poor health lead to low transplantation survival rate. Vines, broken branches and cavity on trunk.

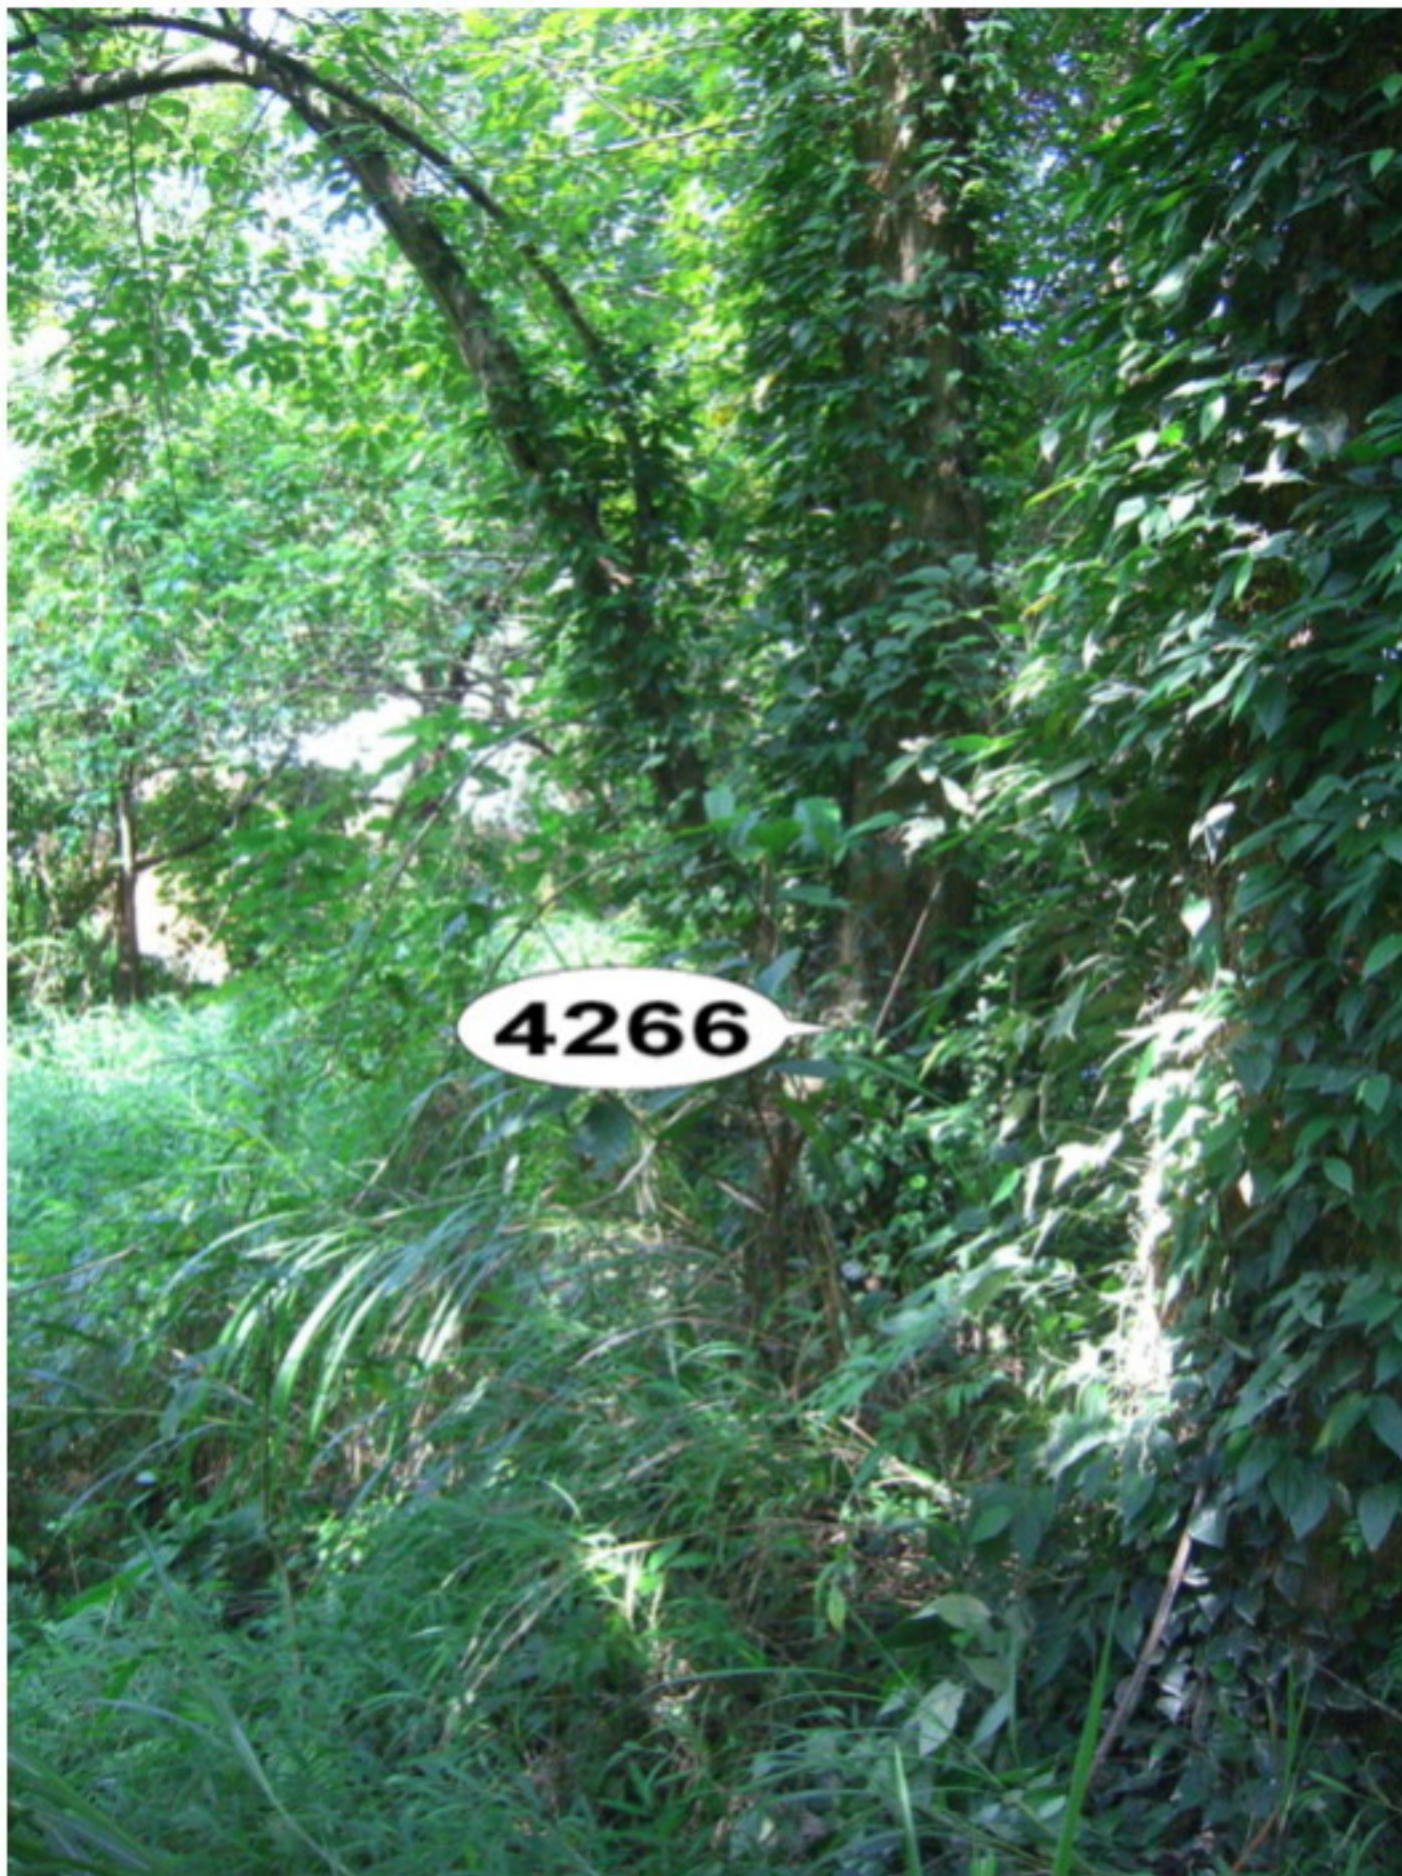
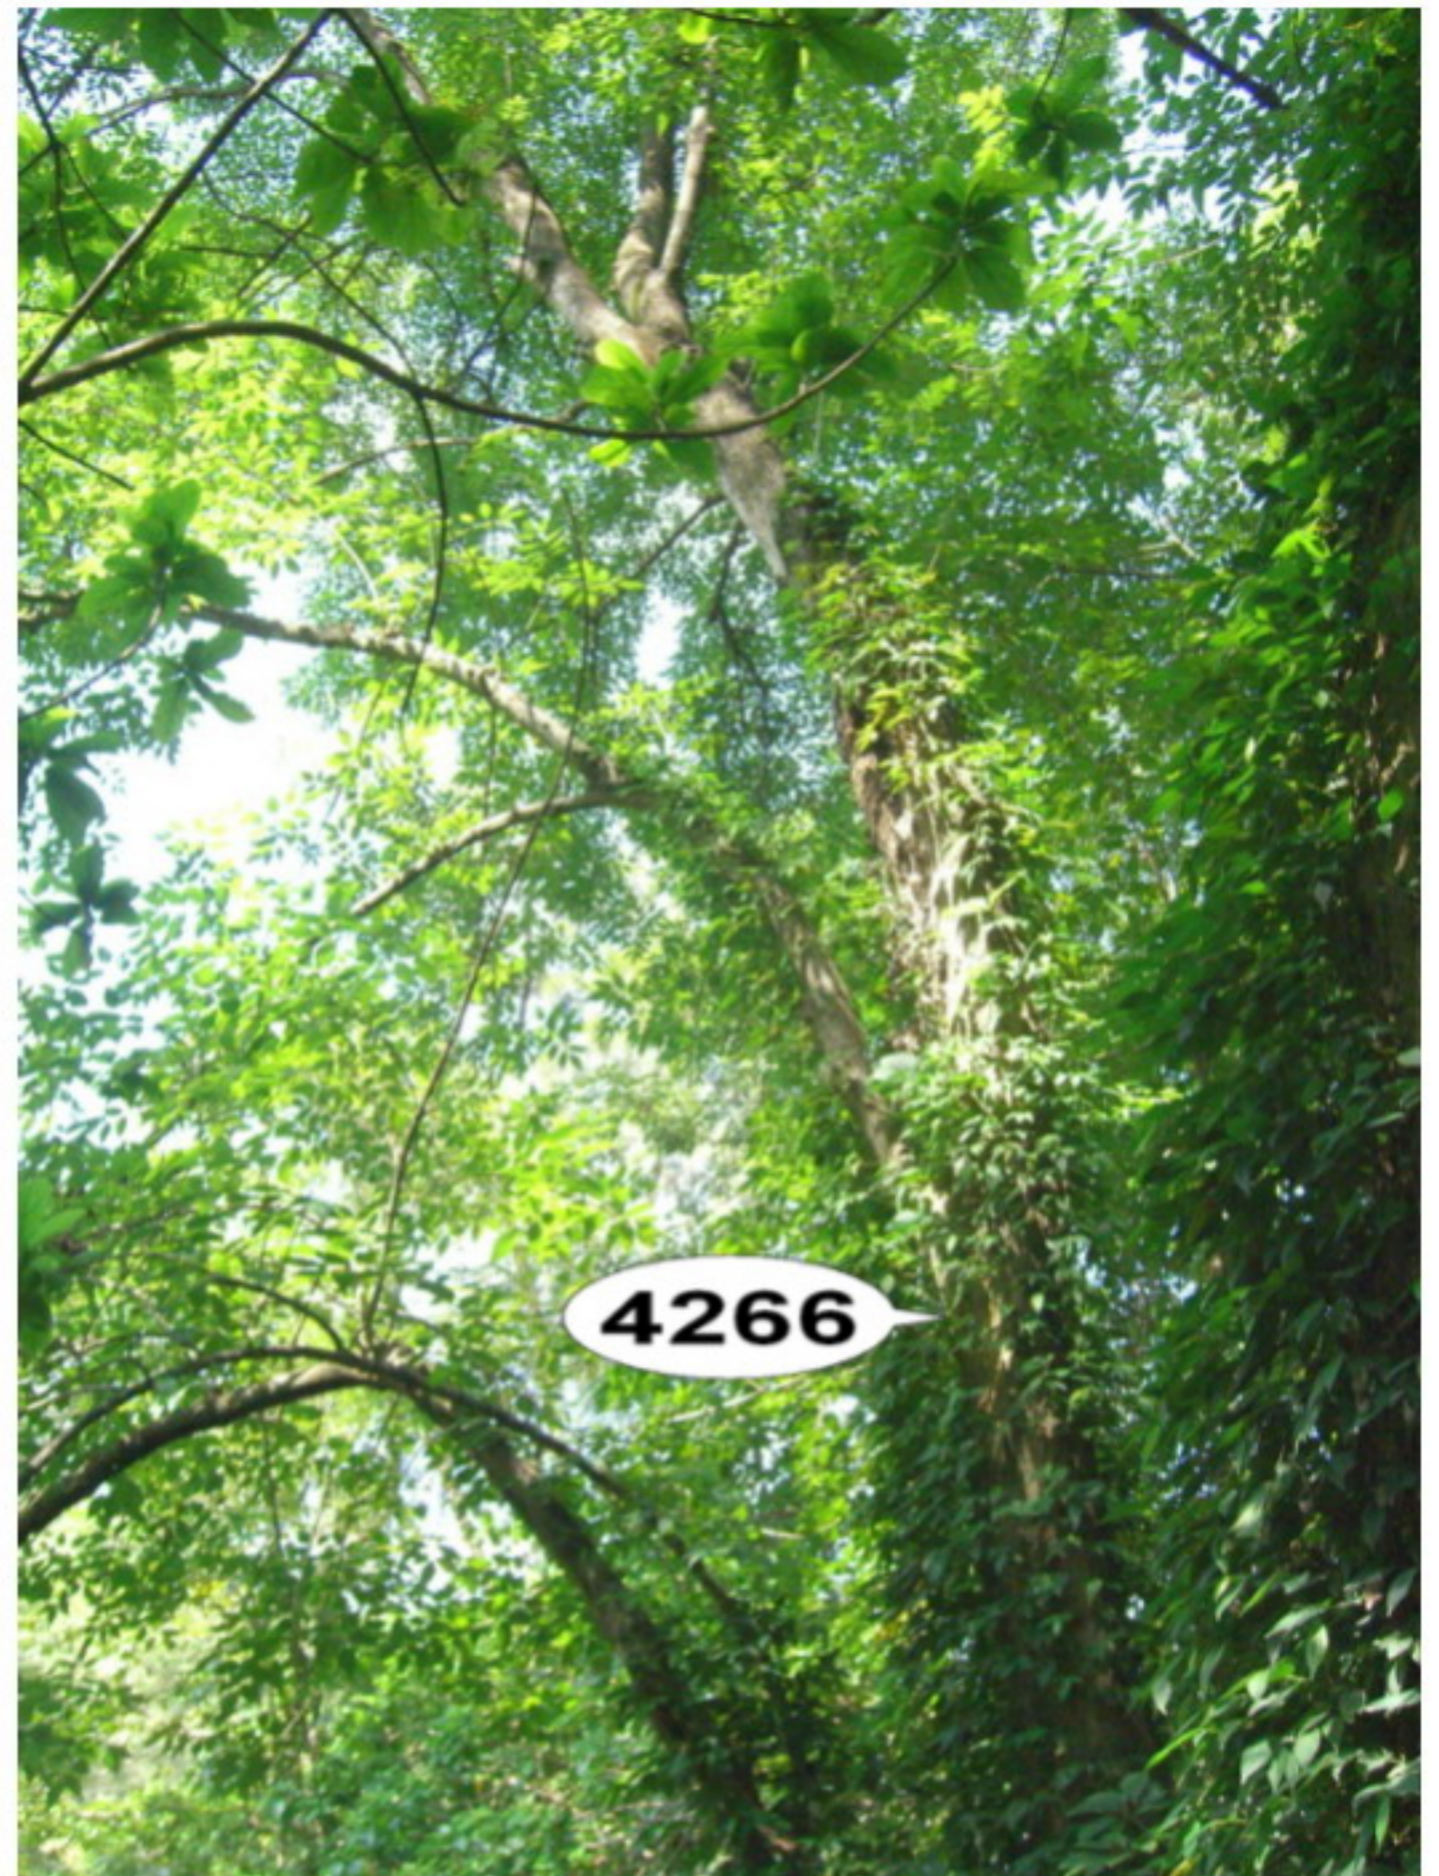
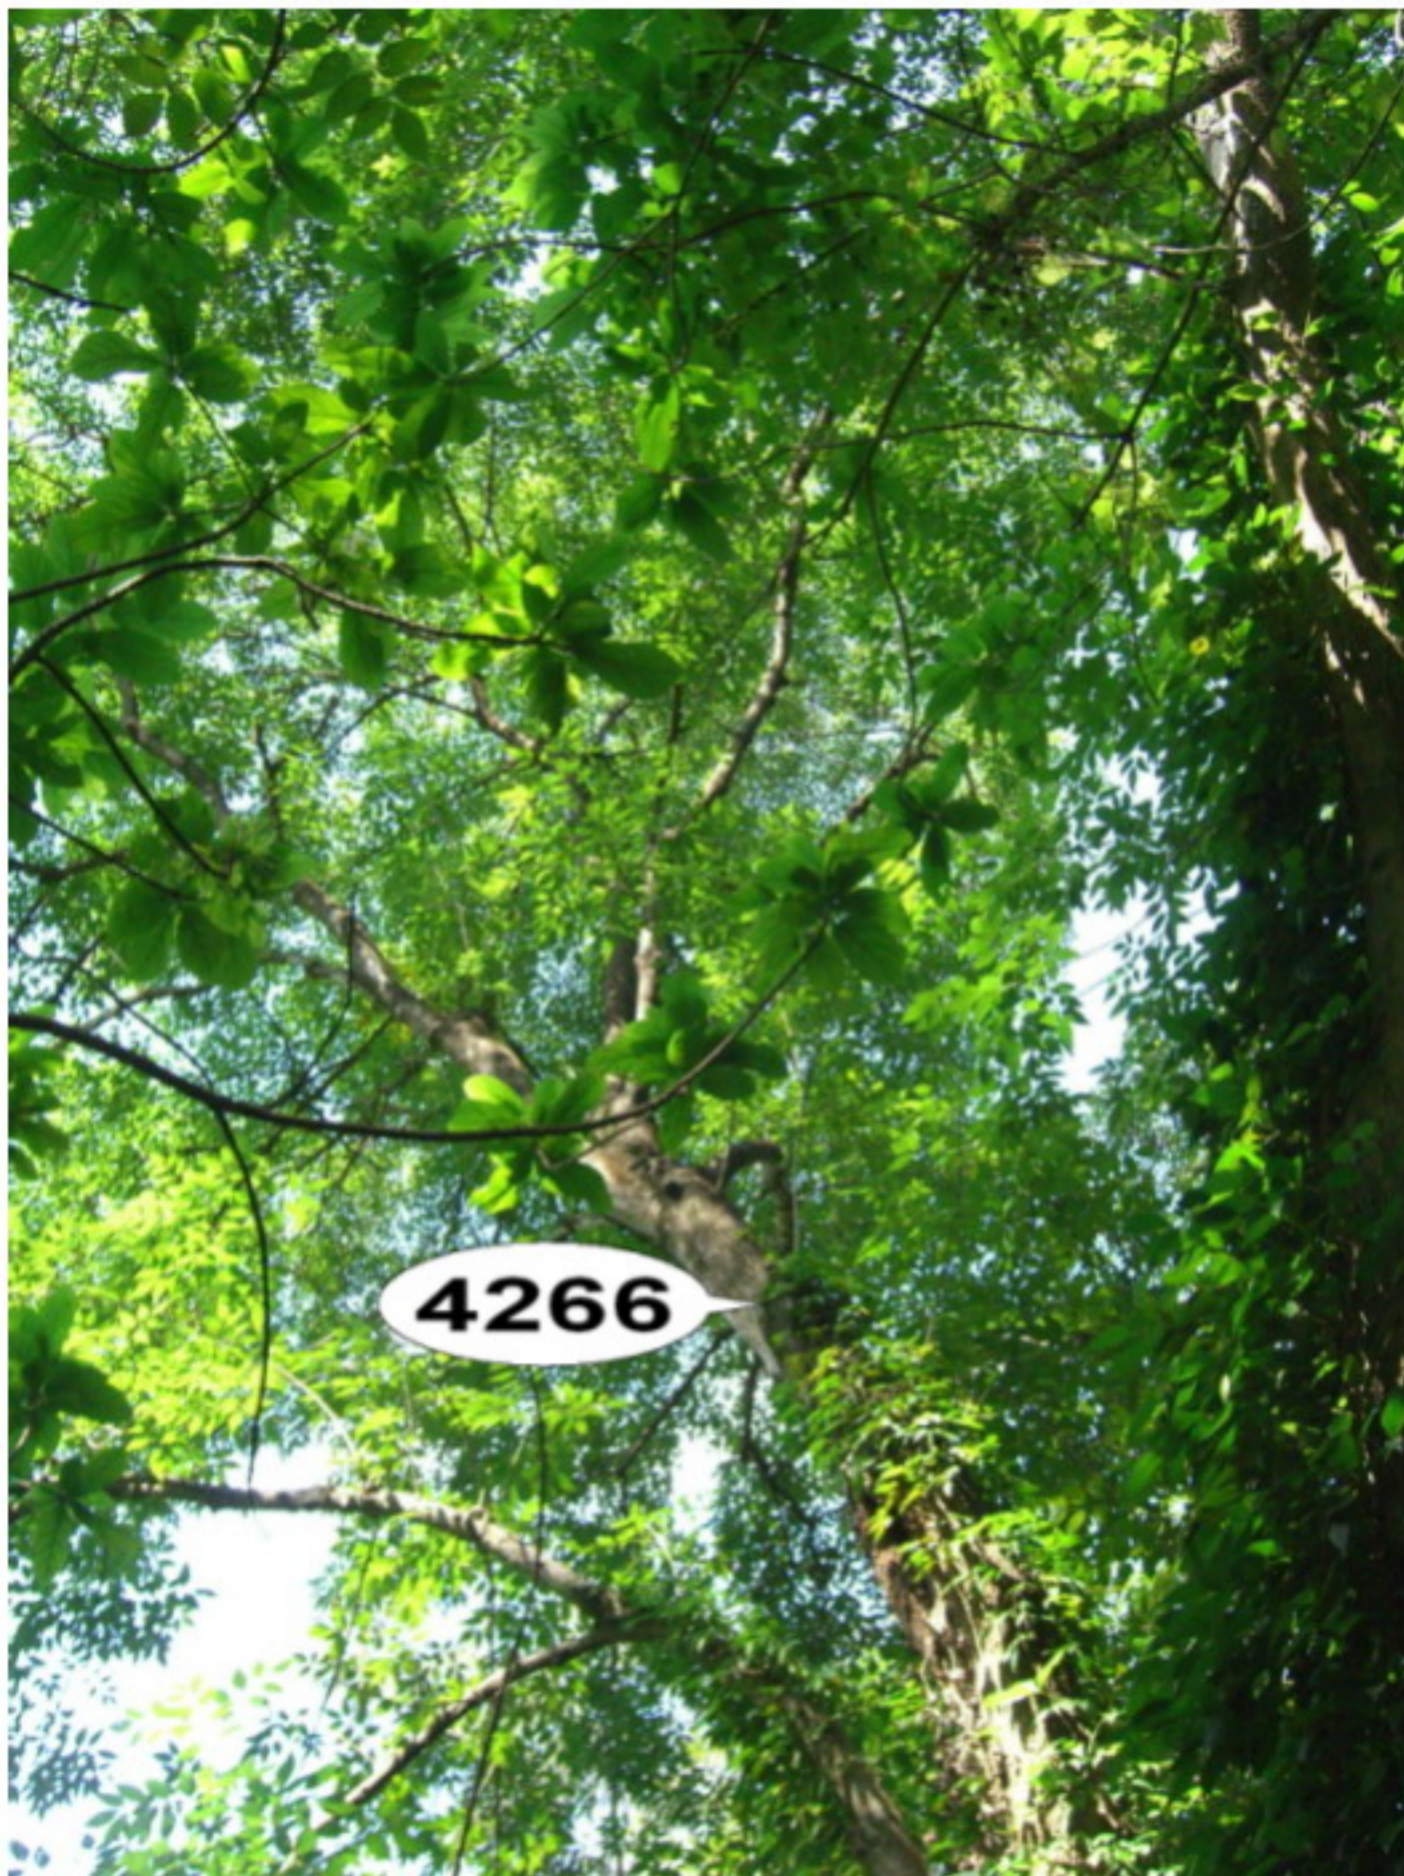
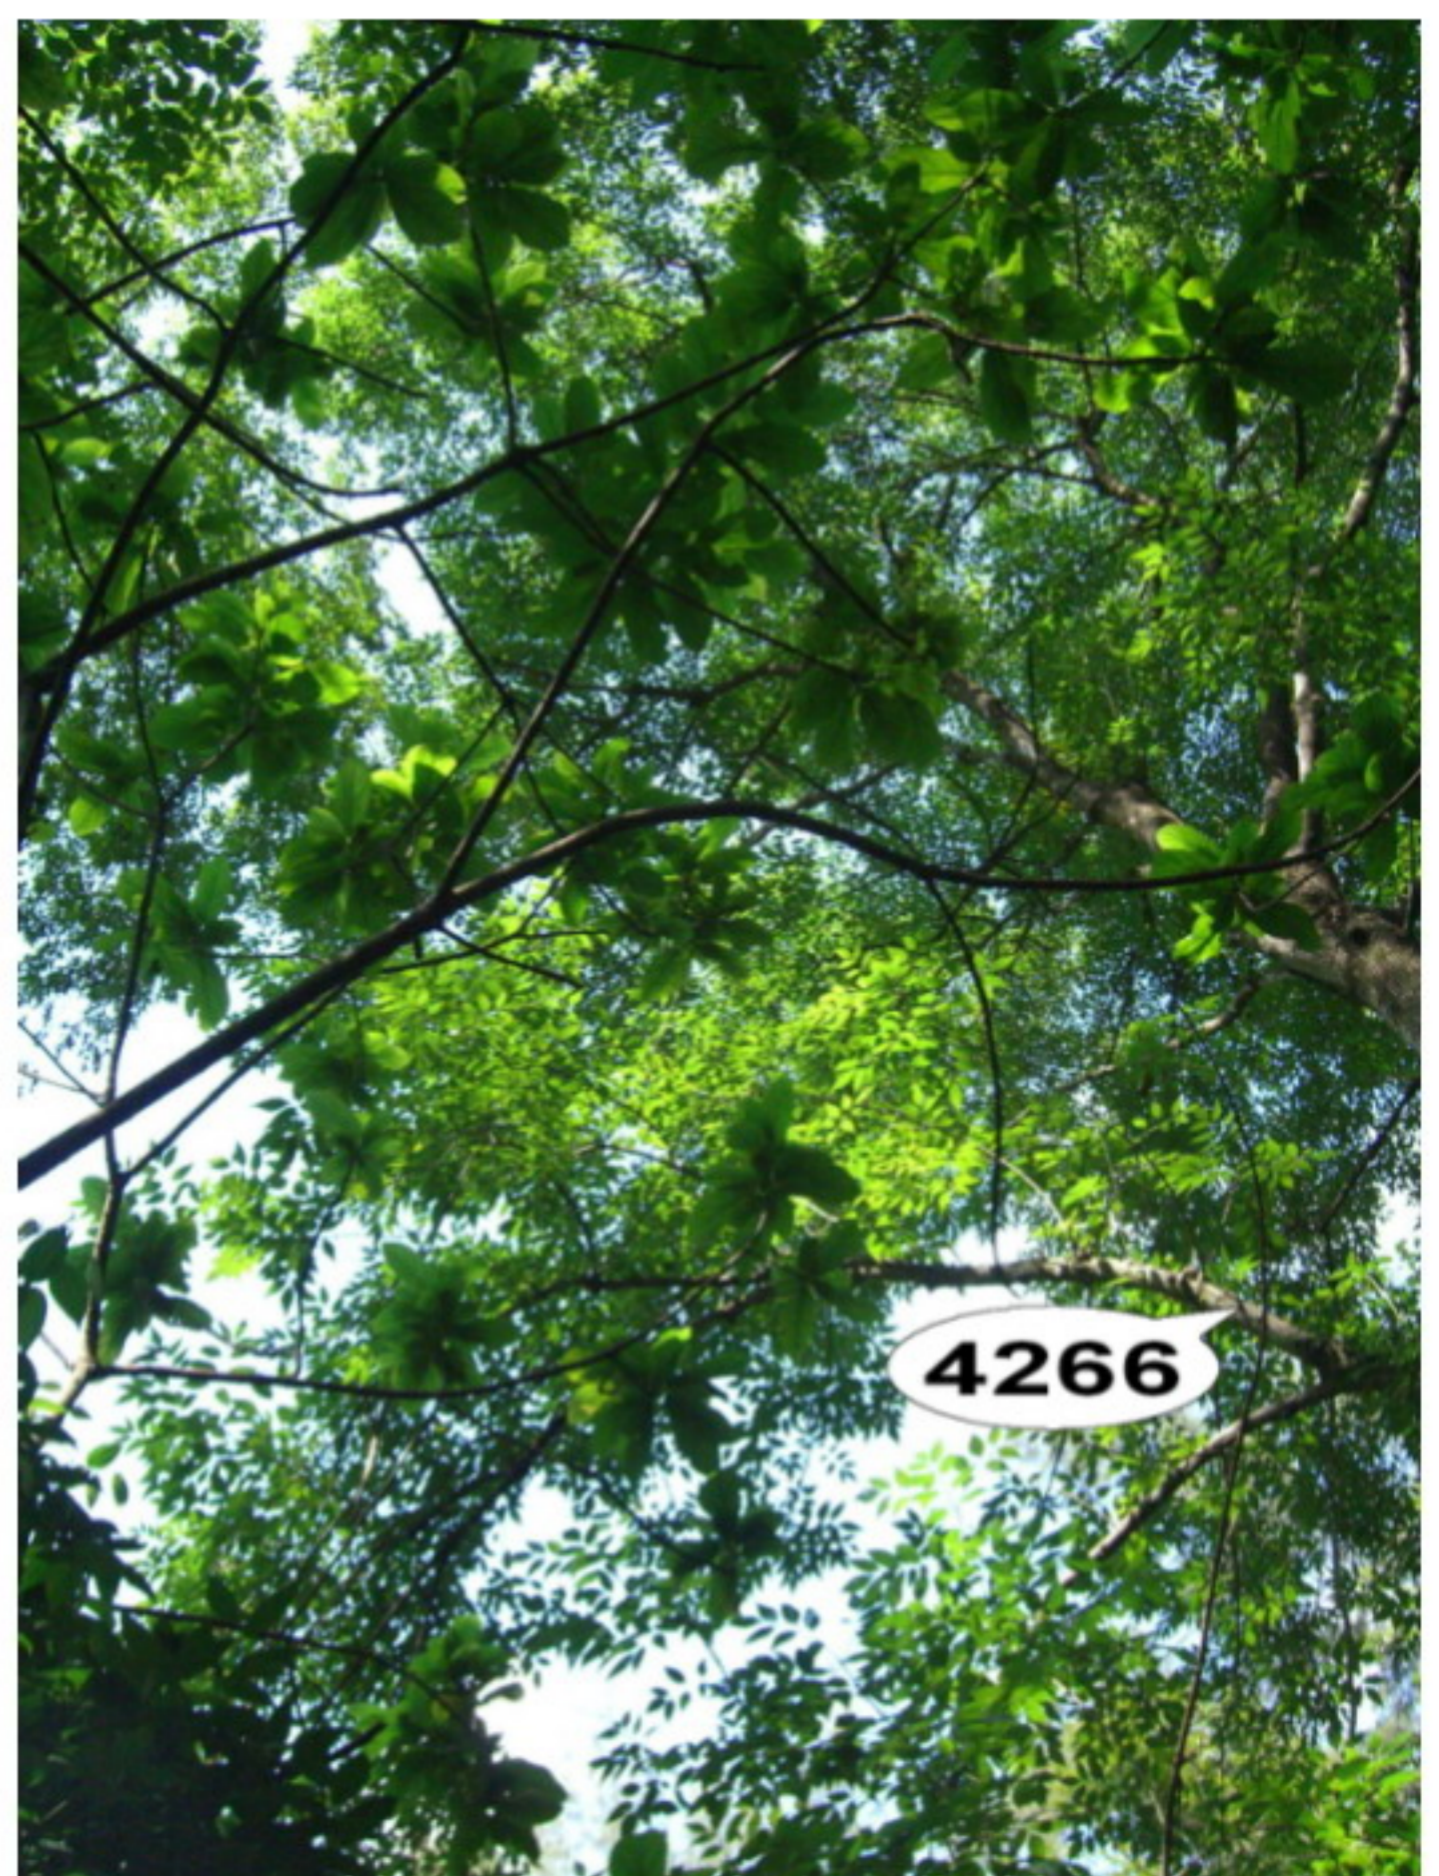
Tree 4266

Poor health lead to low transplantation survival rate. Termites attack was found on tree trunk.
