# Provision of Cremators at Wo Hop Shek Crematorium

Tree Survey Report

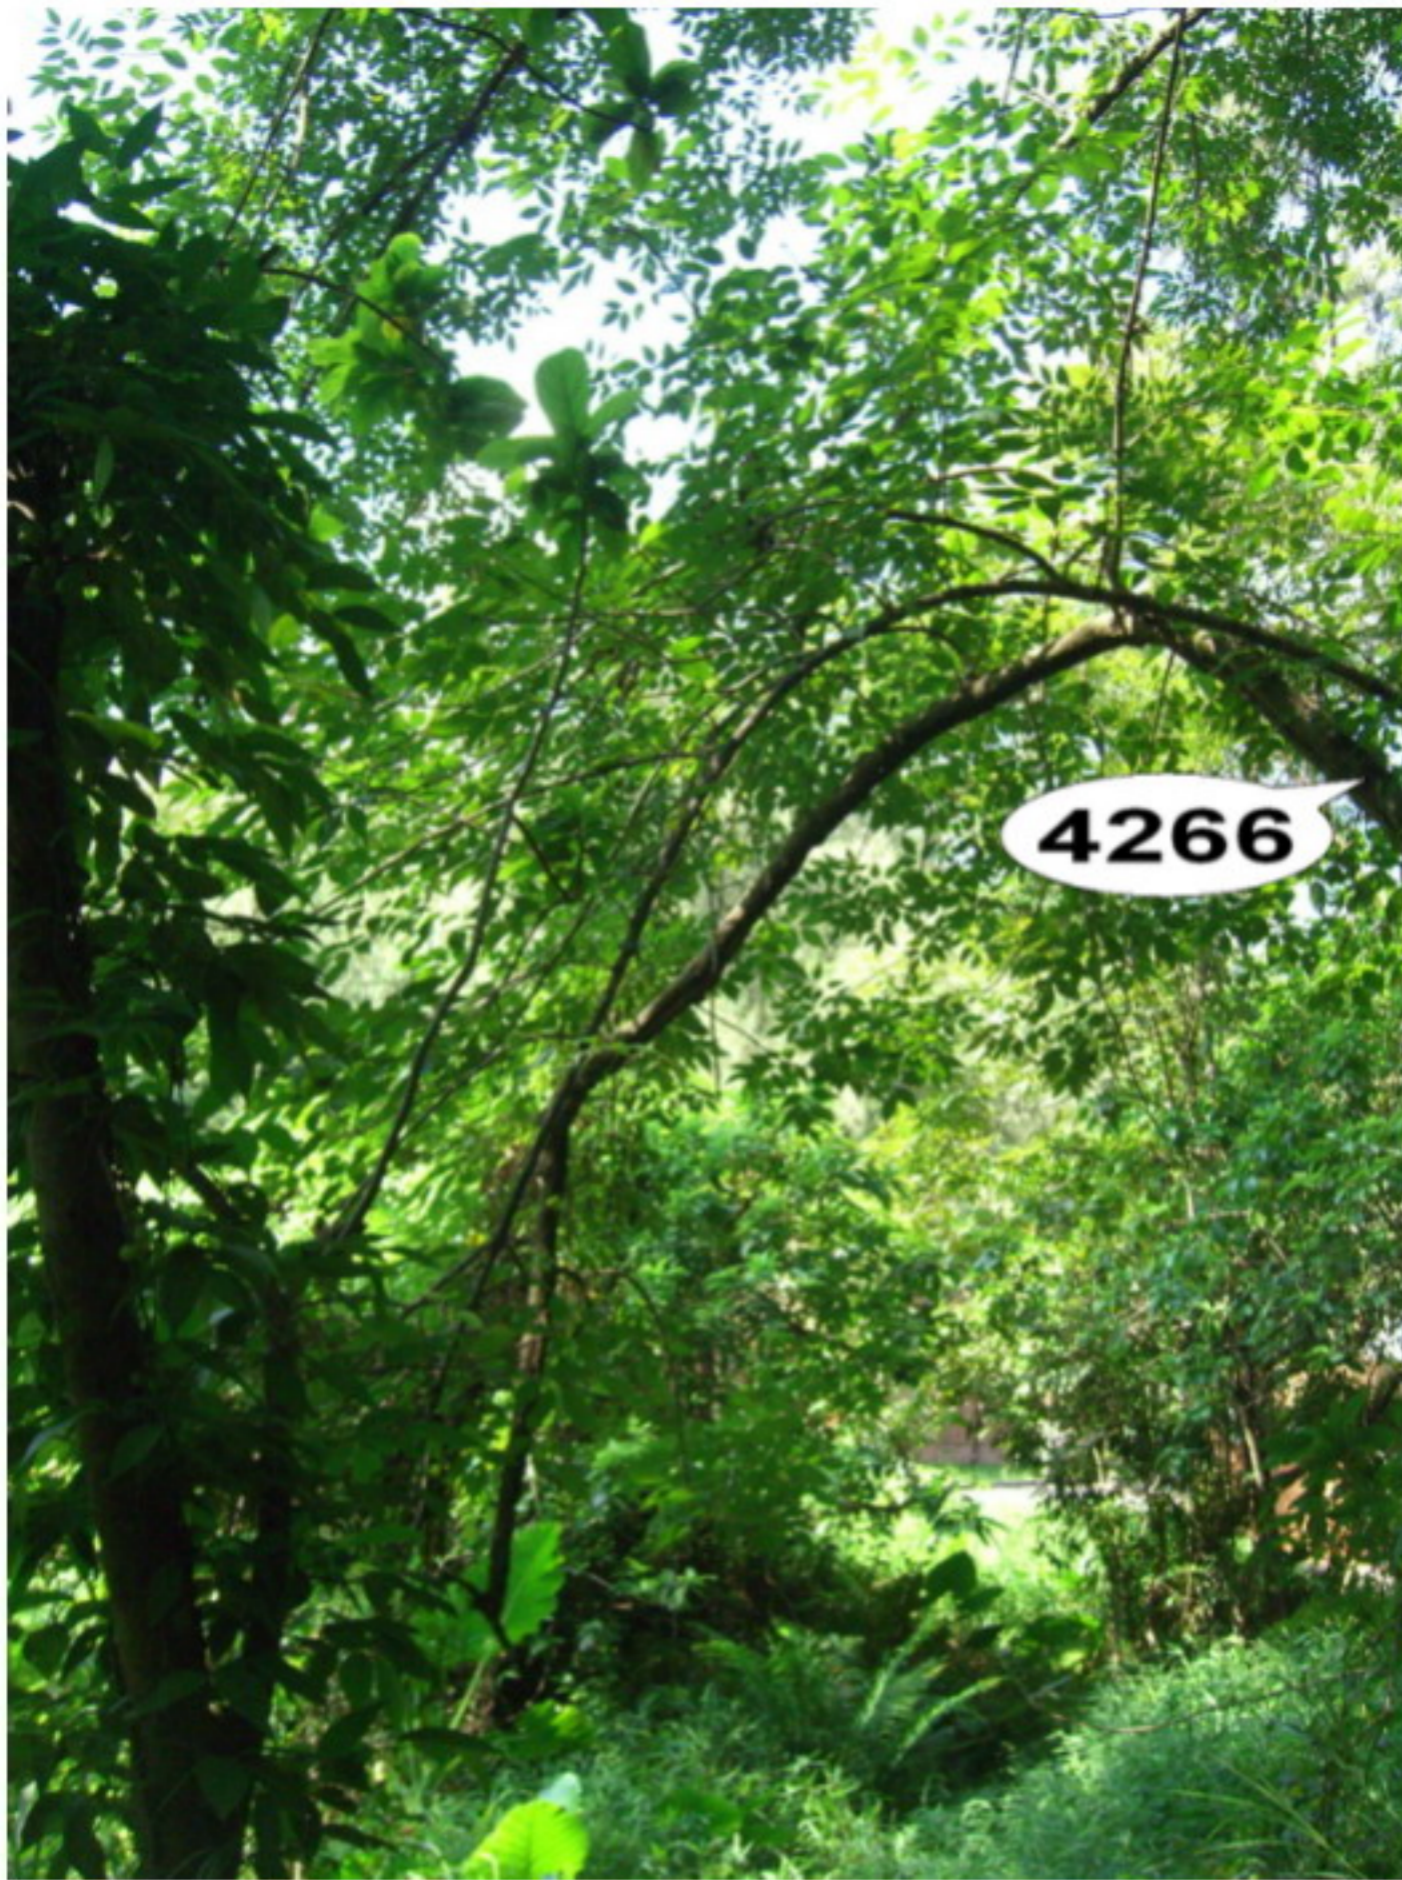
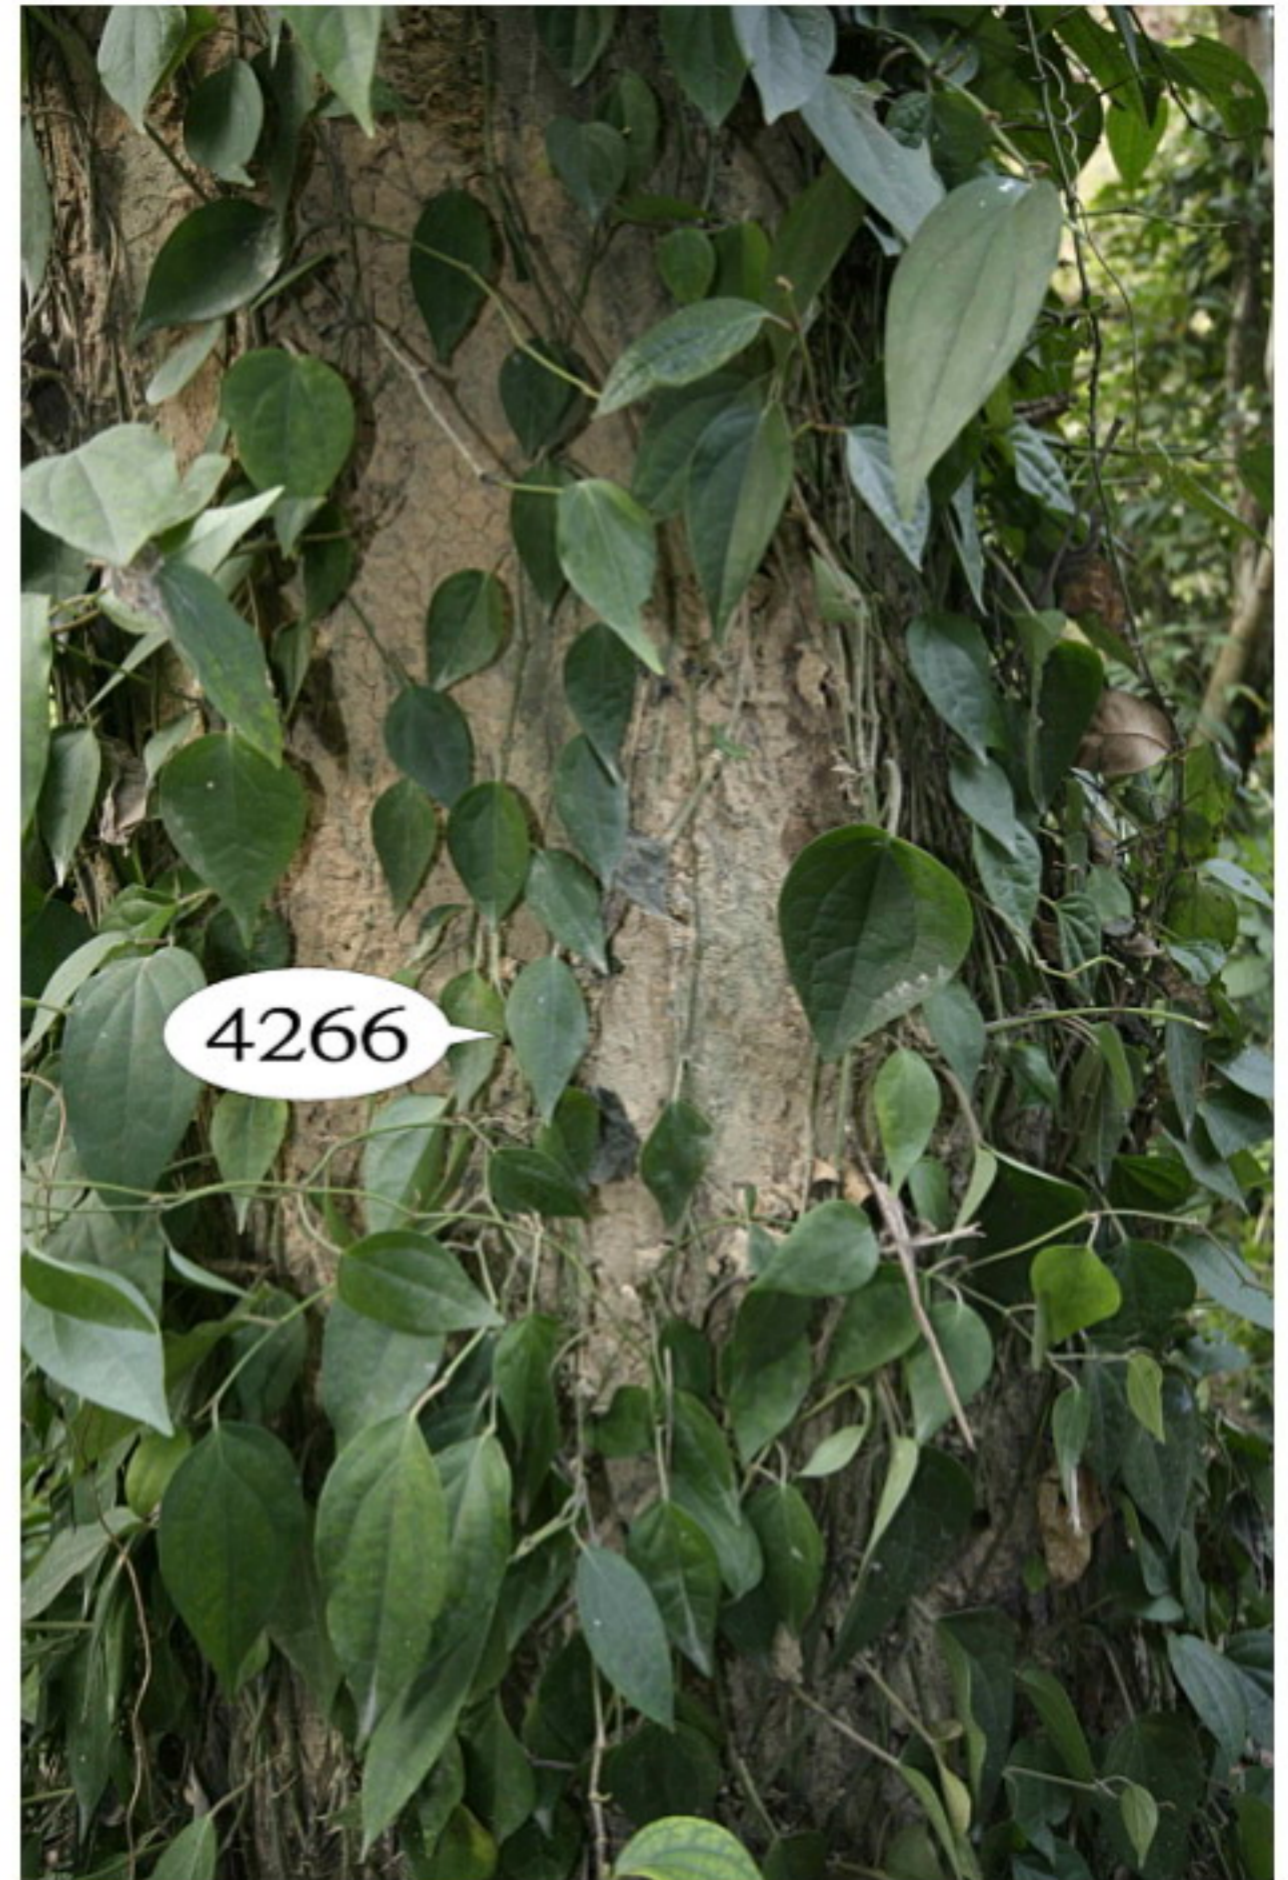
Tree 4266

Poor health lead to low transplantation survival rate. Termites attack was found on tree trunk.

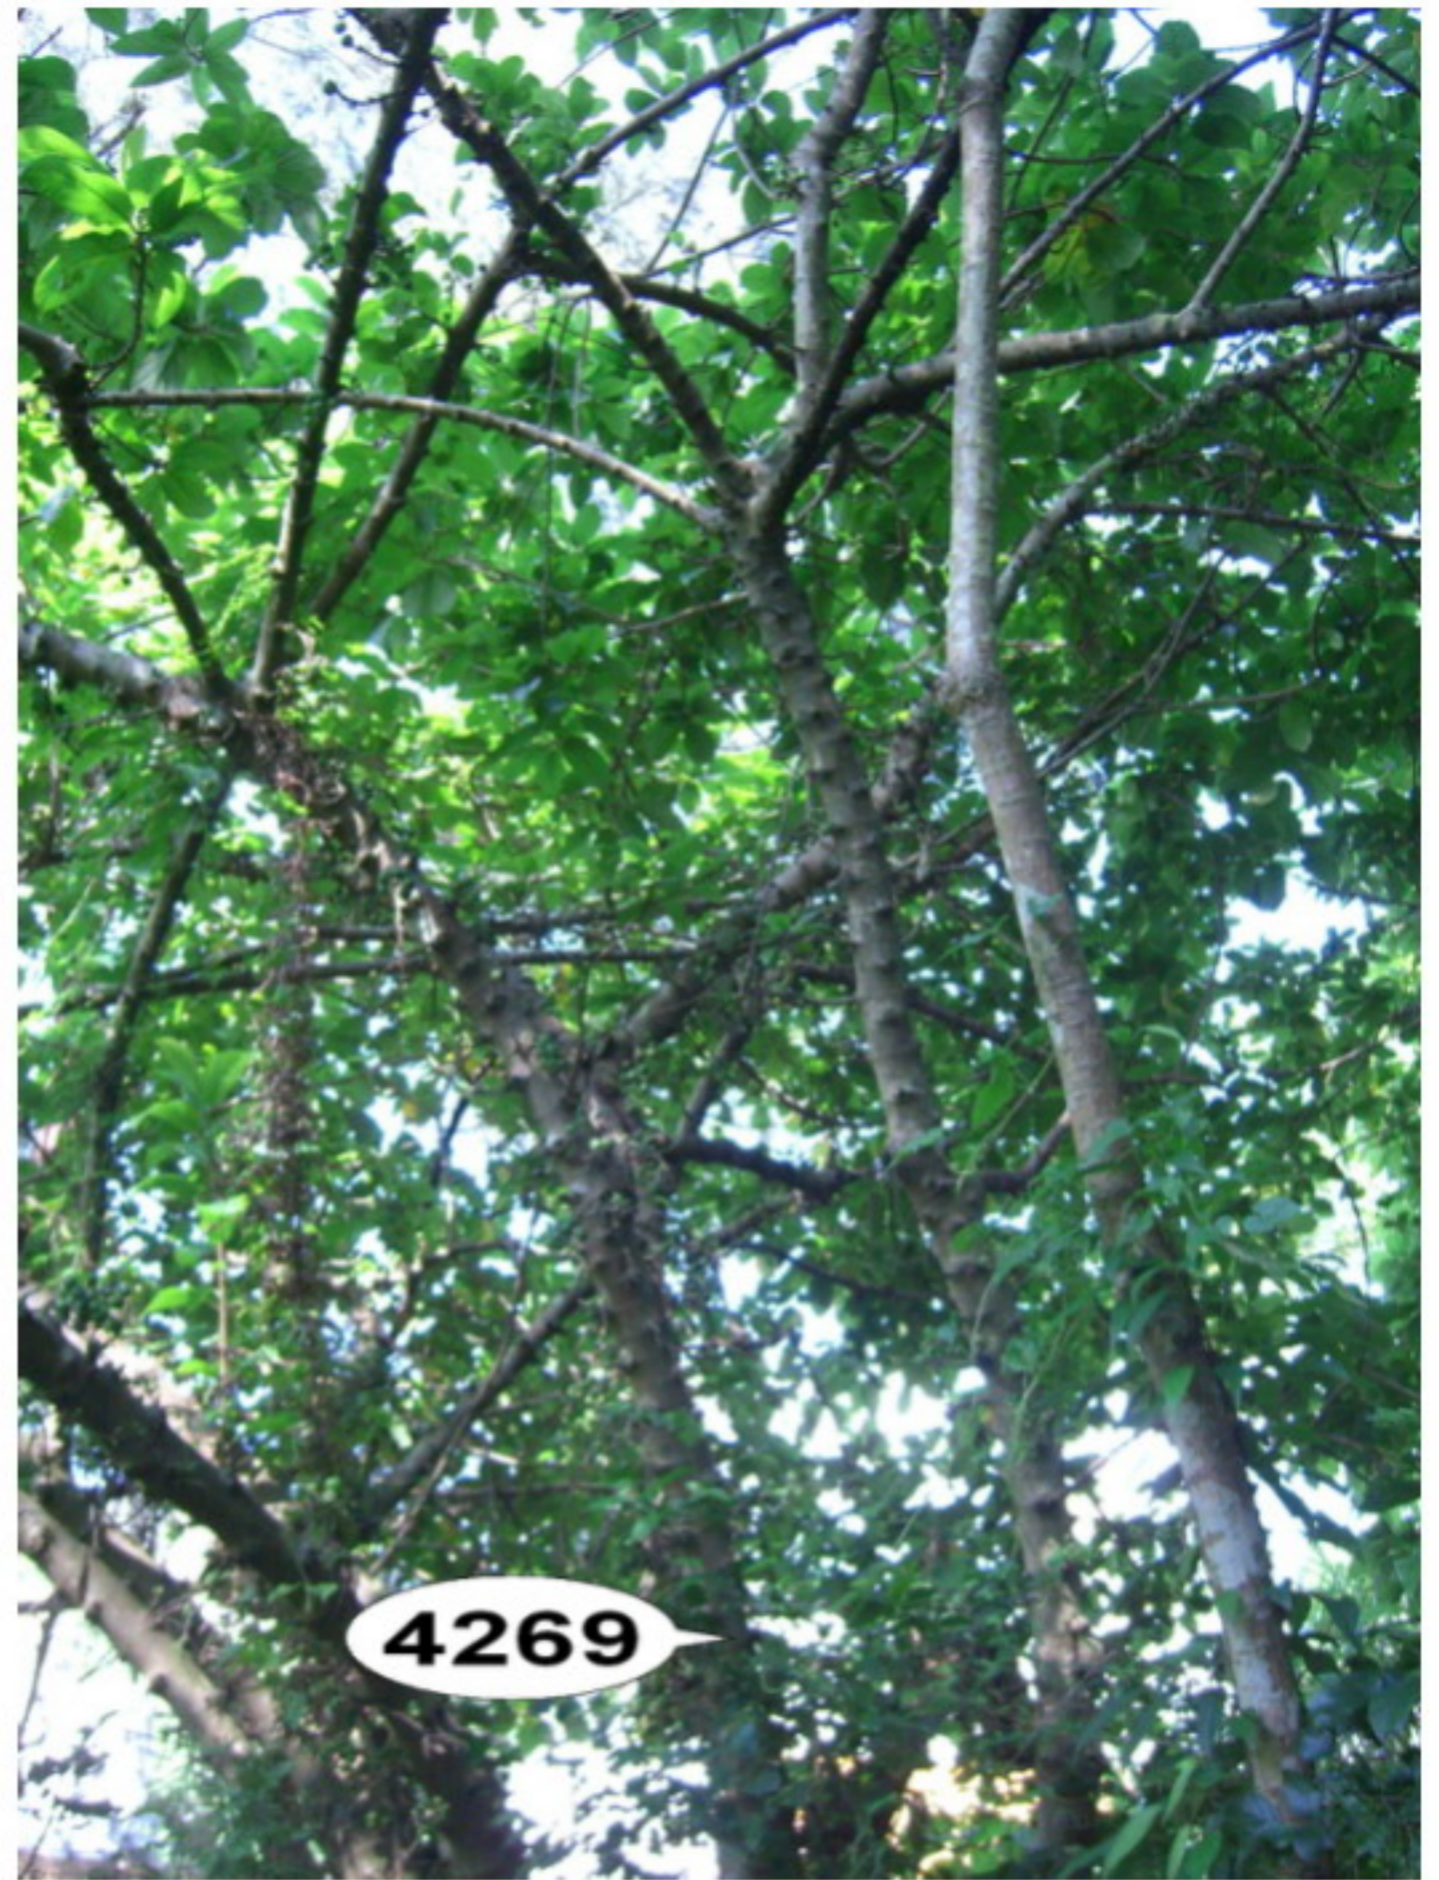
Tree 4269

Poor form which lead to low amenity value. Besides, the tree is unbalance. It may need heavy pruning after transplantation that will affect its transplantation survival rate. Moreover, the operation of the transplantation for poor form tree is also difficult.

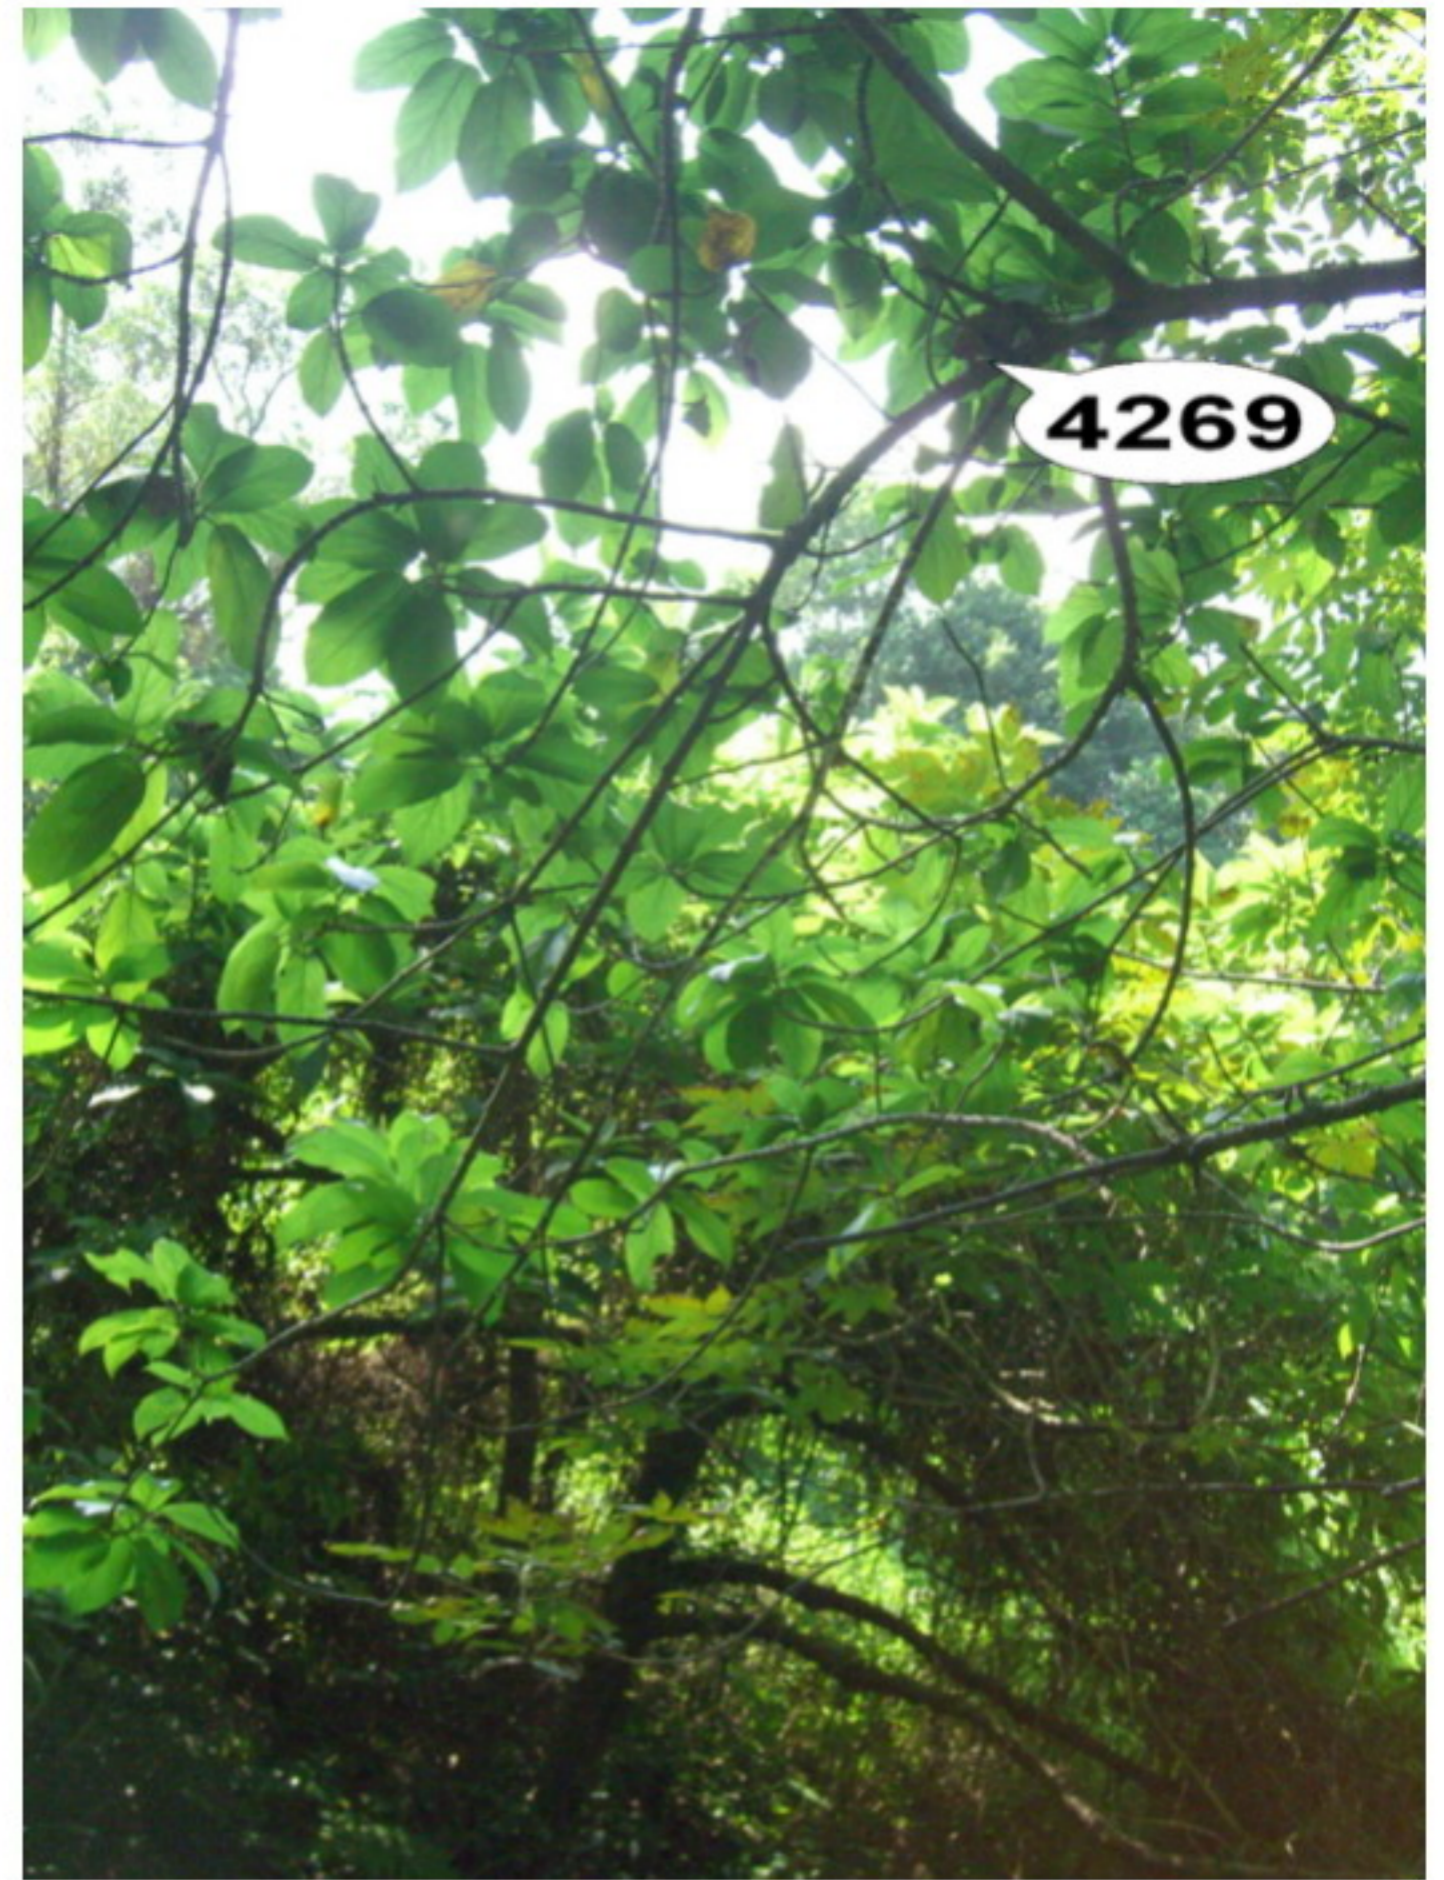
Tree 4269

Poor form which lead to low amenity value. Besides, the tree is unbalance. It may need heavy pruning after transplantation that will affect its transplantation survival rate. Moreover, the operation of the transplantation for poor form tree is also difficult.

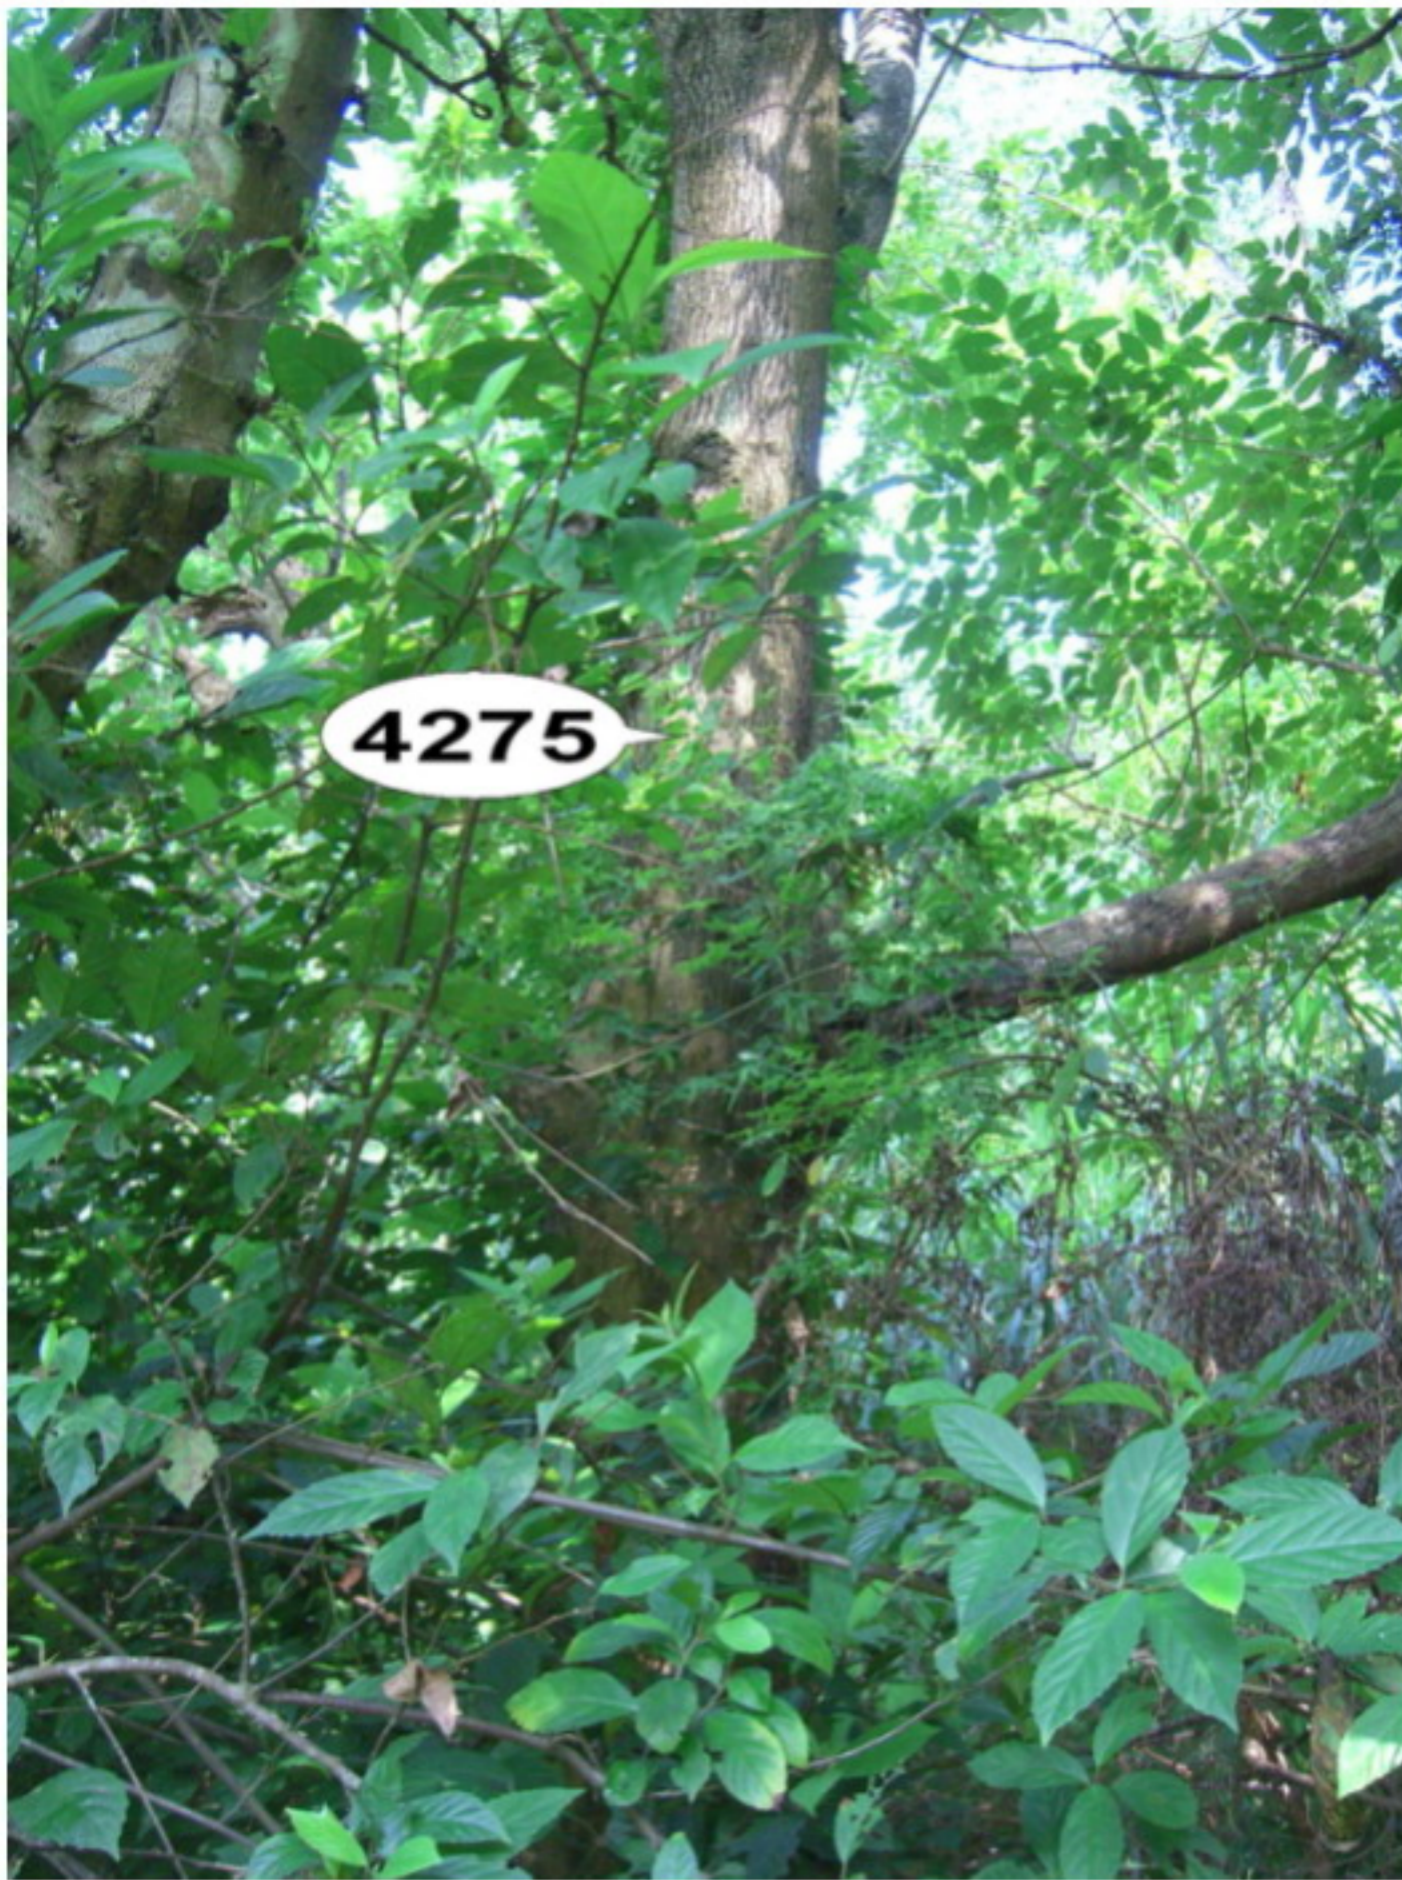
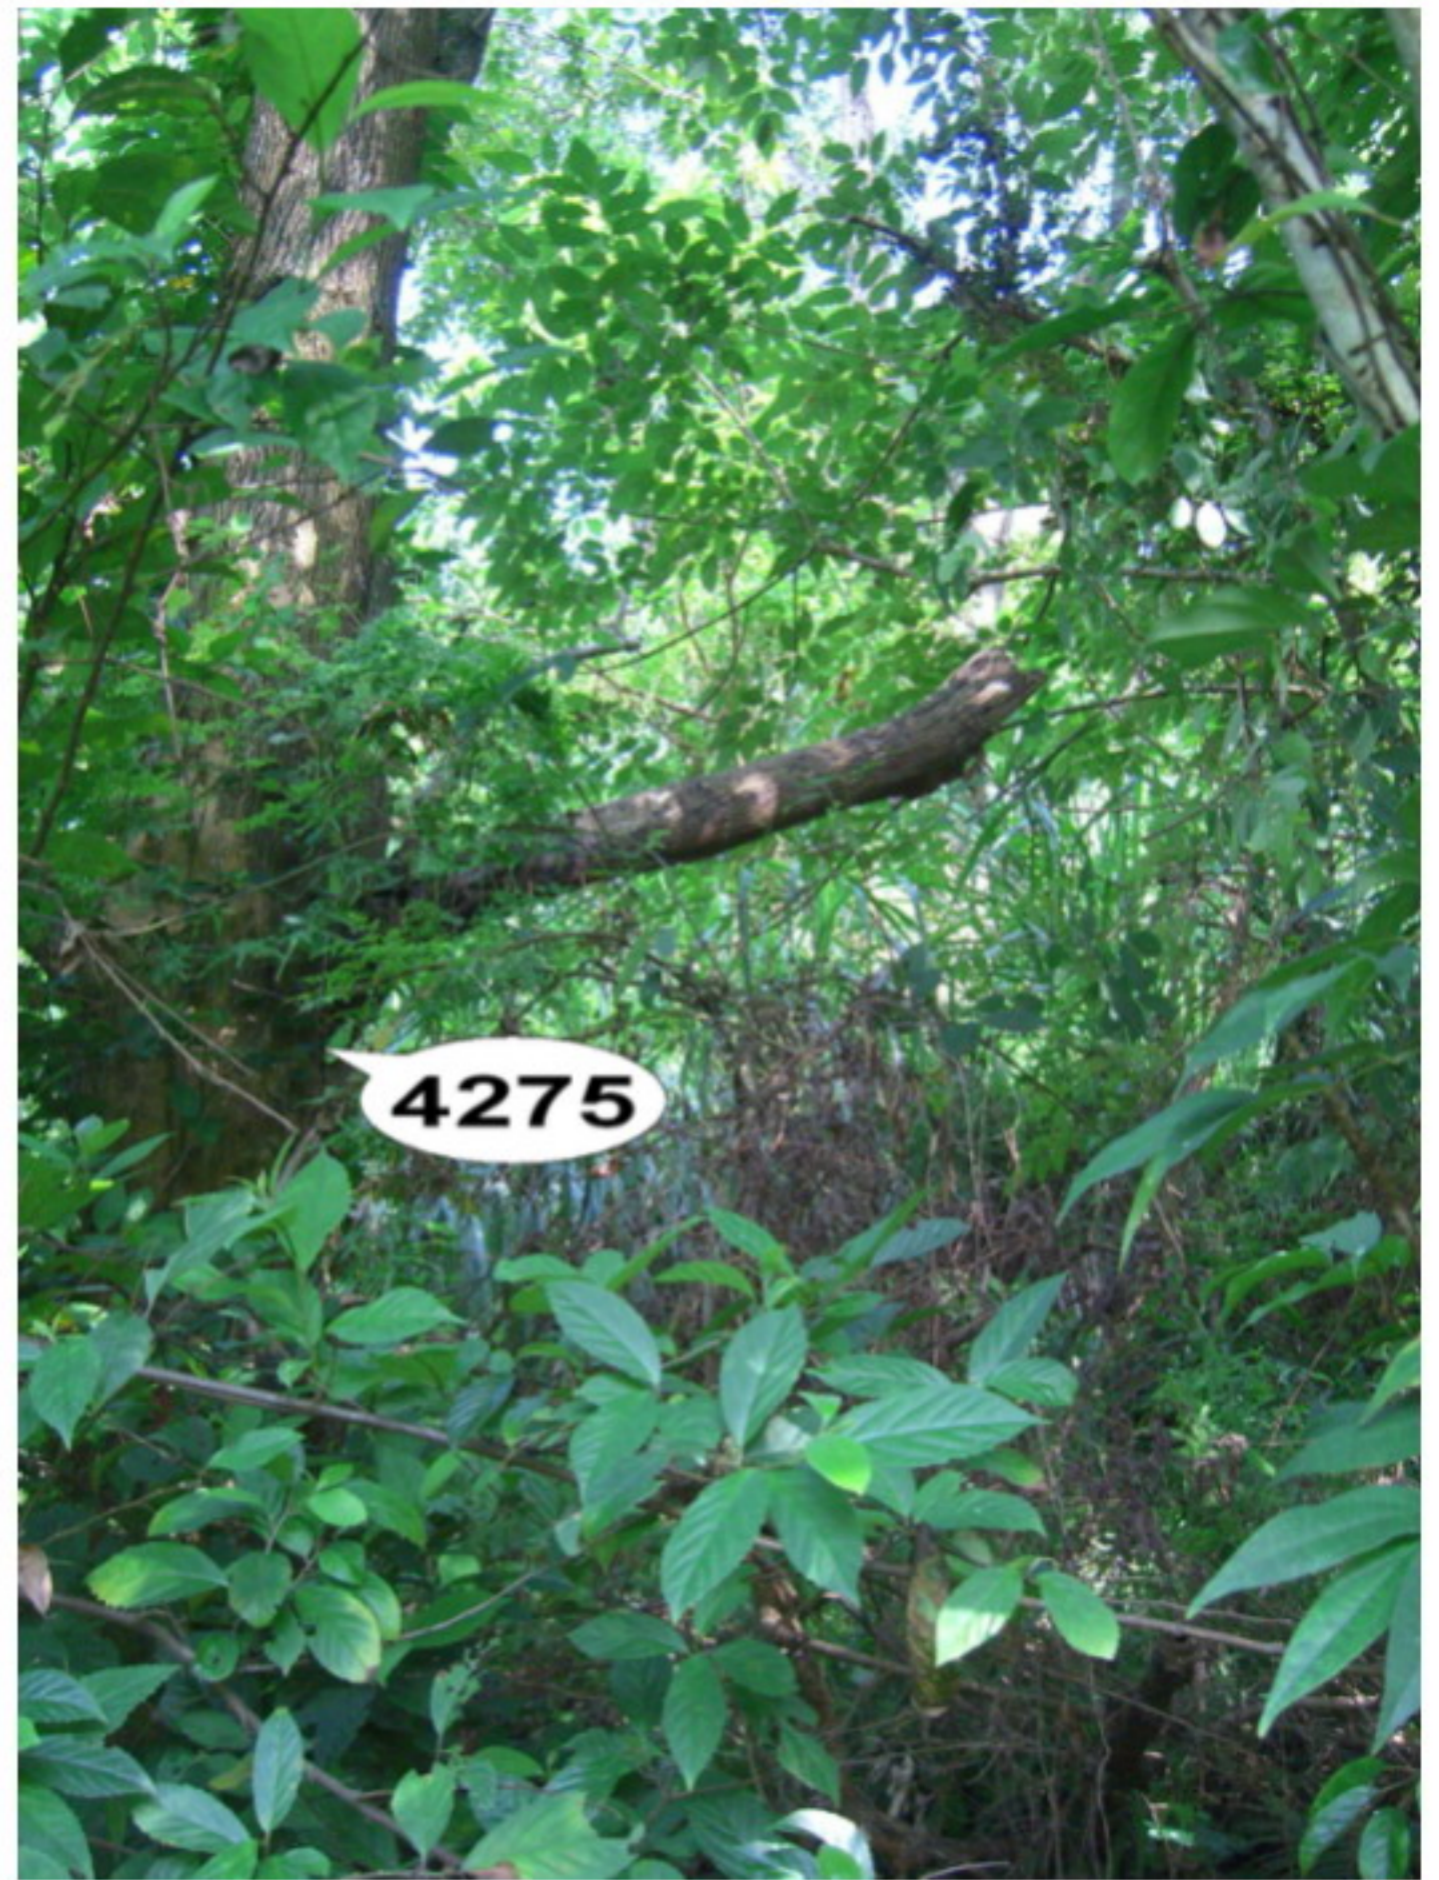
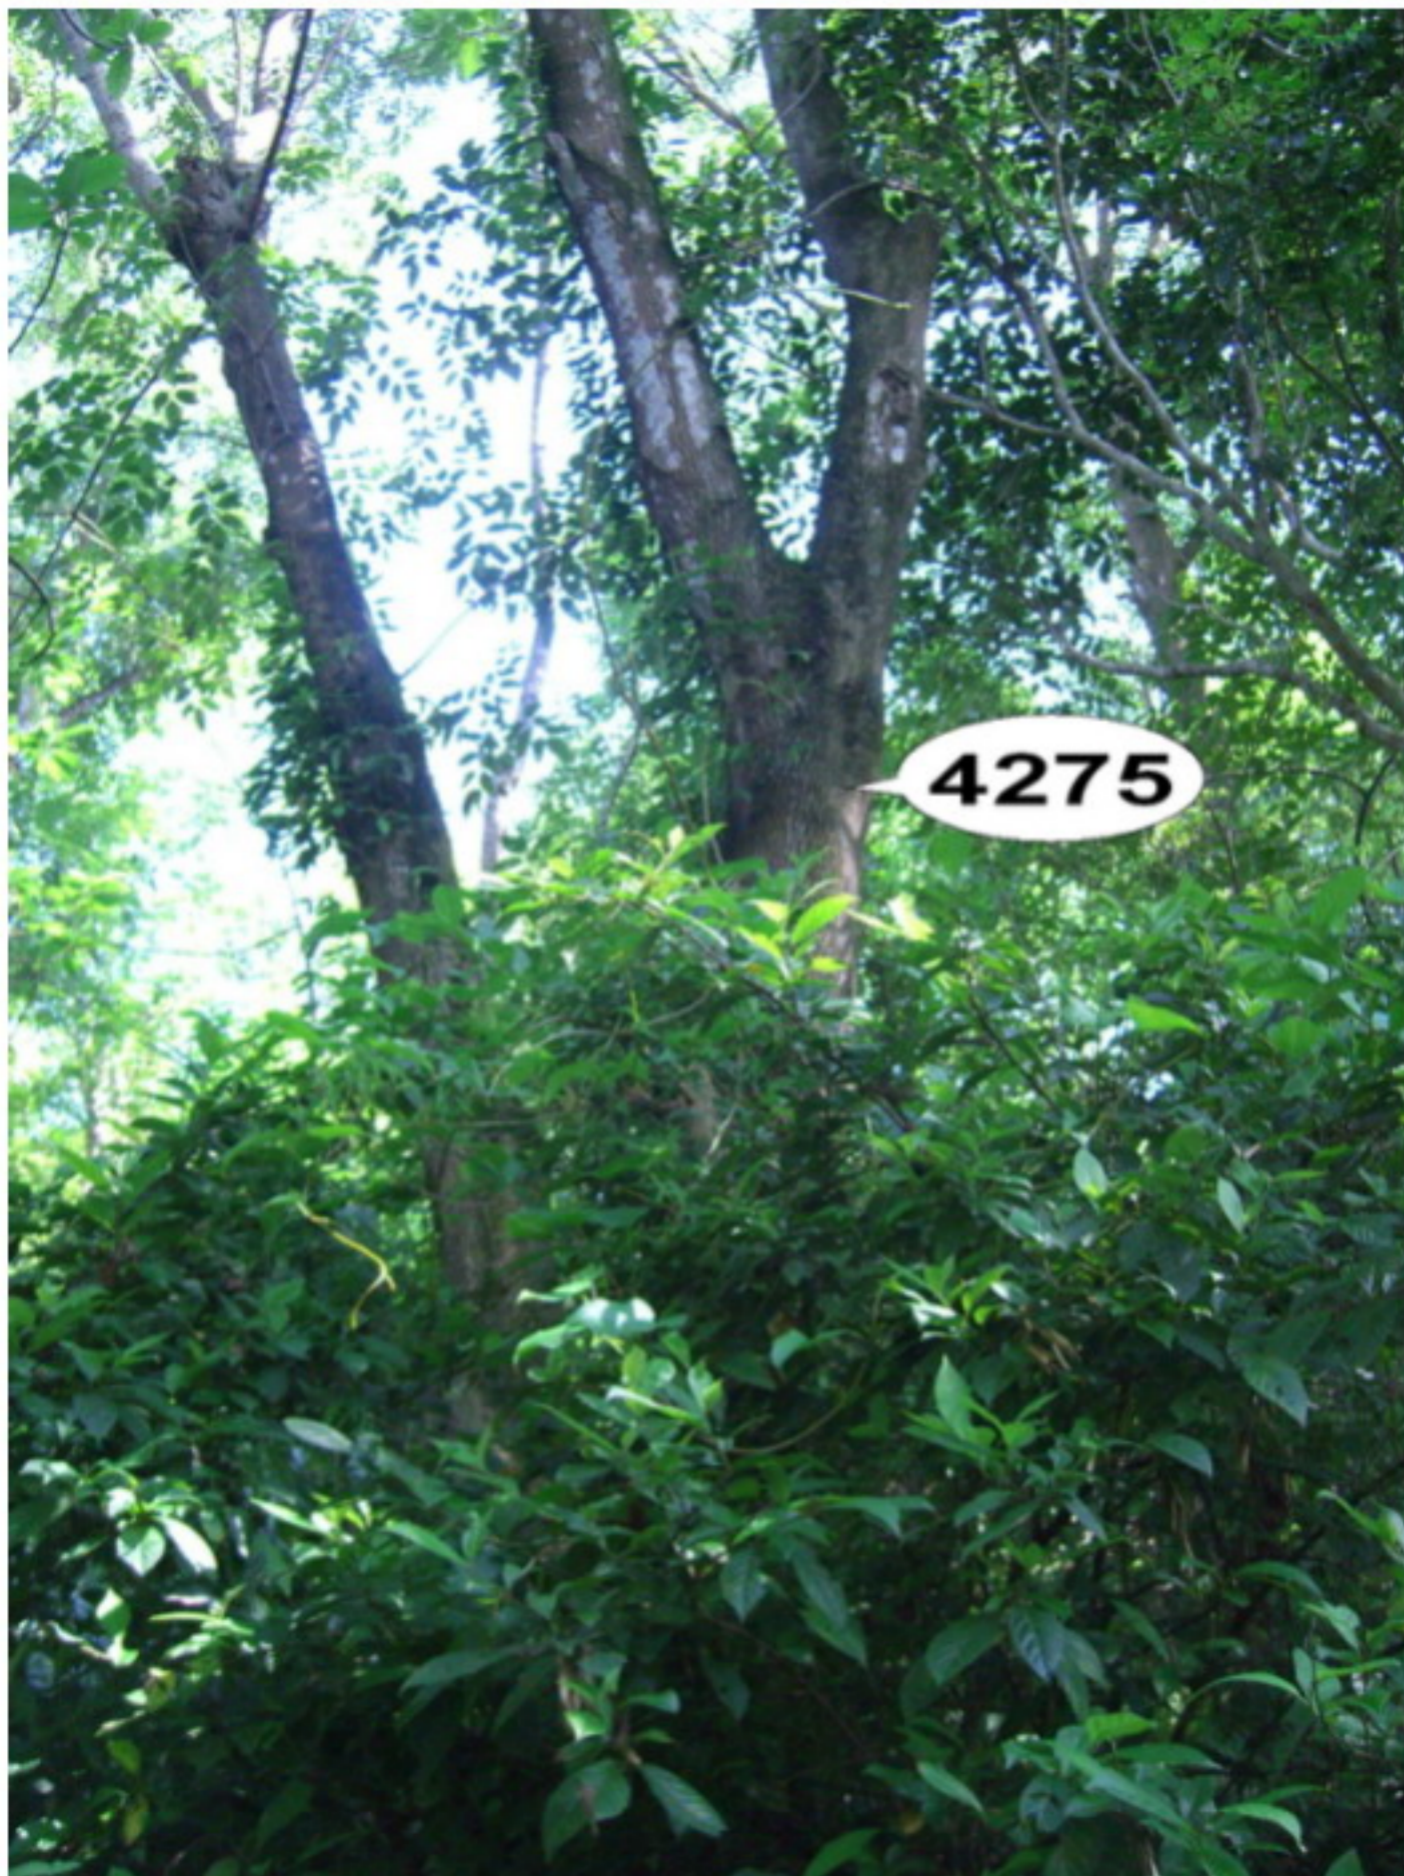
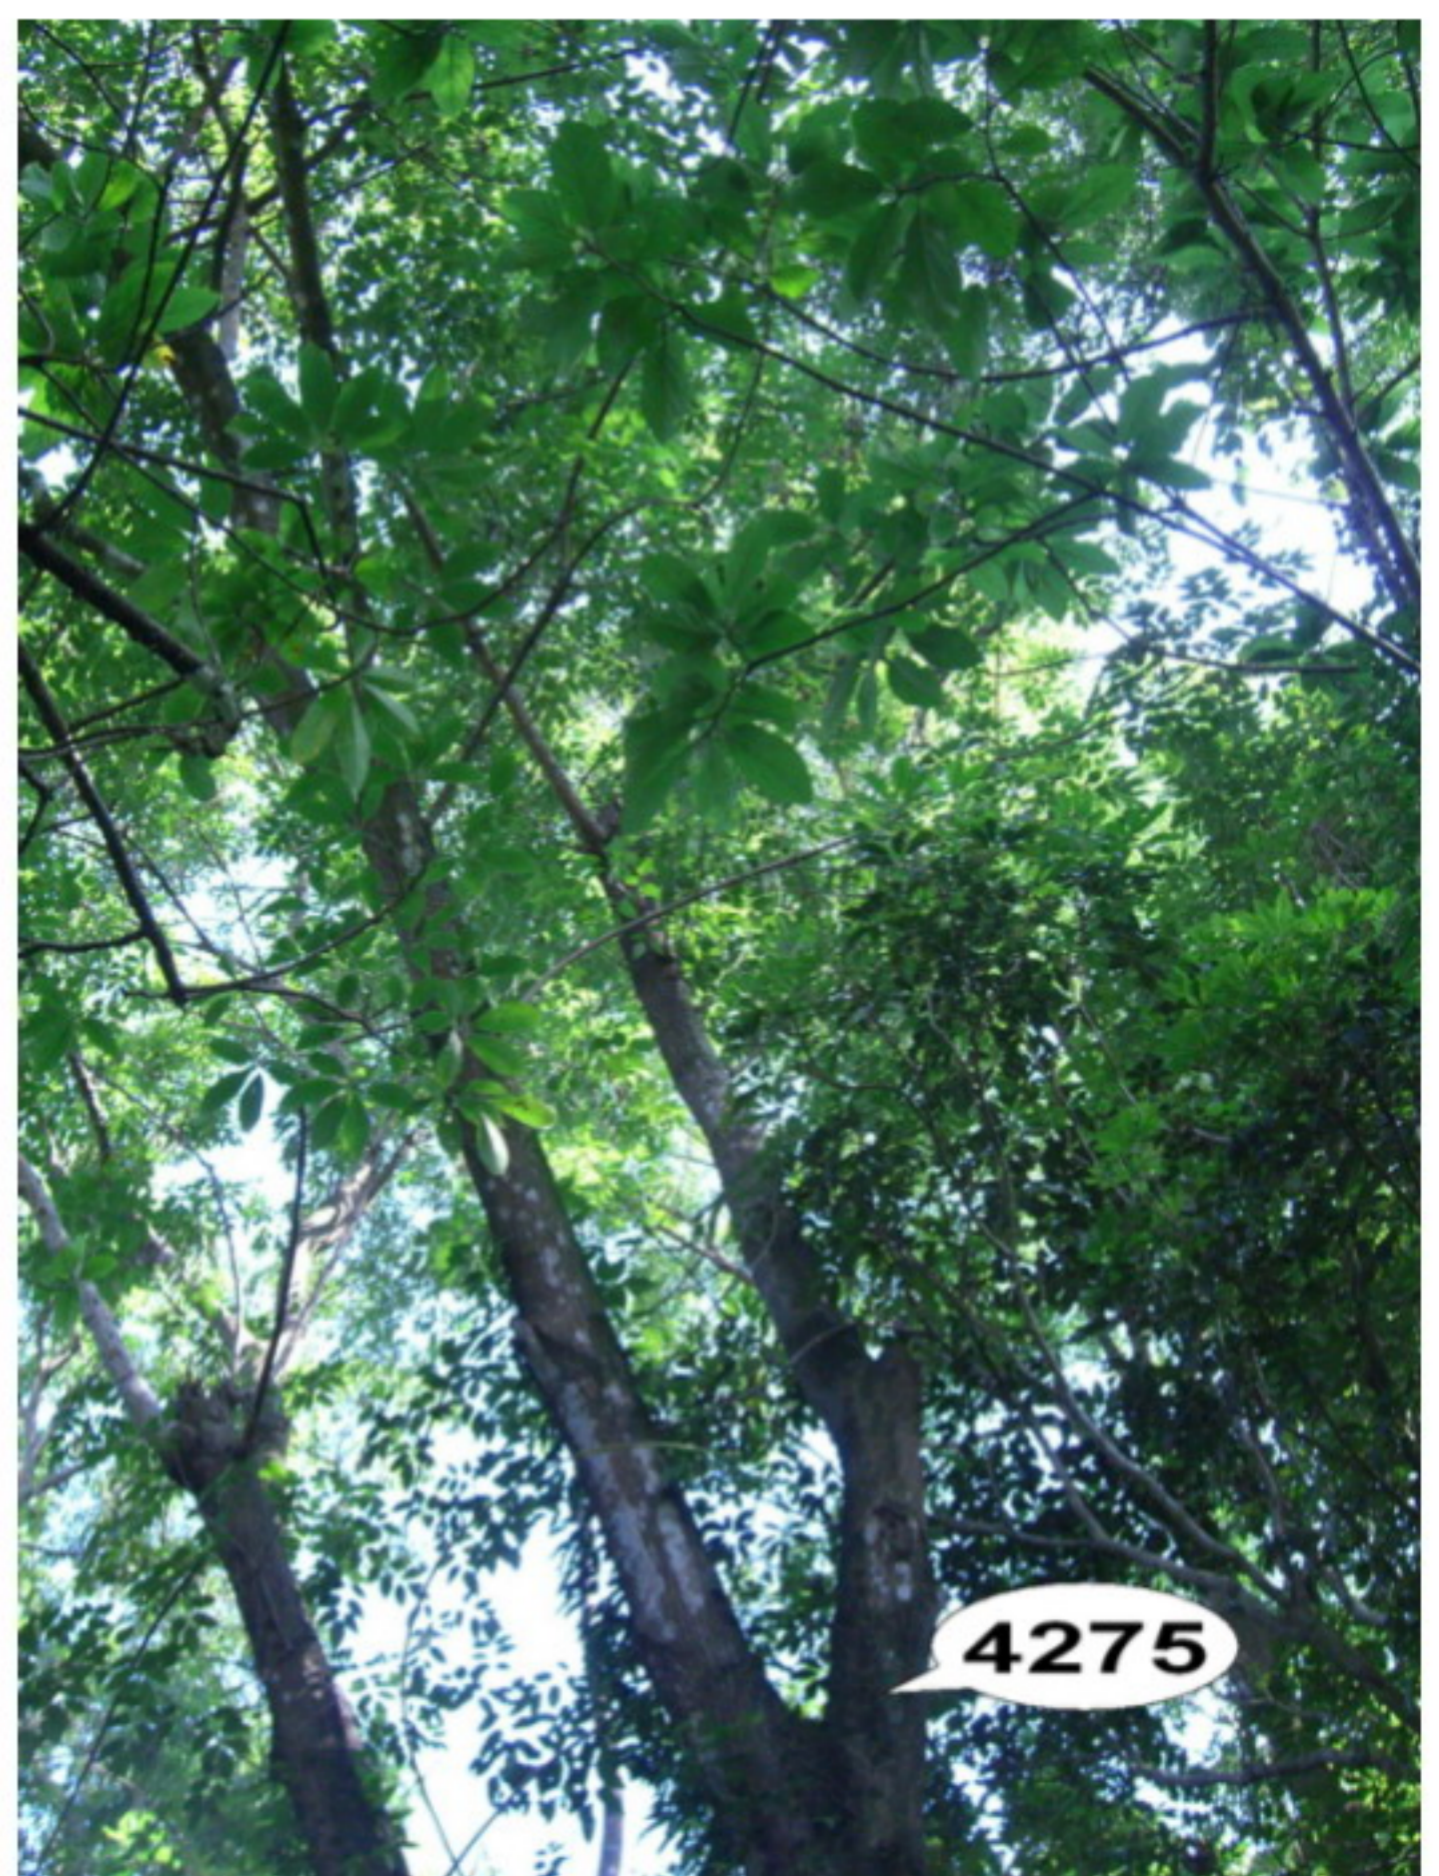
Tree 4275

Poor health will lead to low transplantation survival rate. Termites attack was found on tree trunk.
