# Provision of Cremators at Wo Hop Shek Crematorium

Tree Survey Report

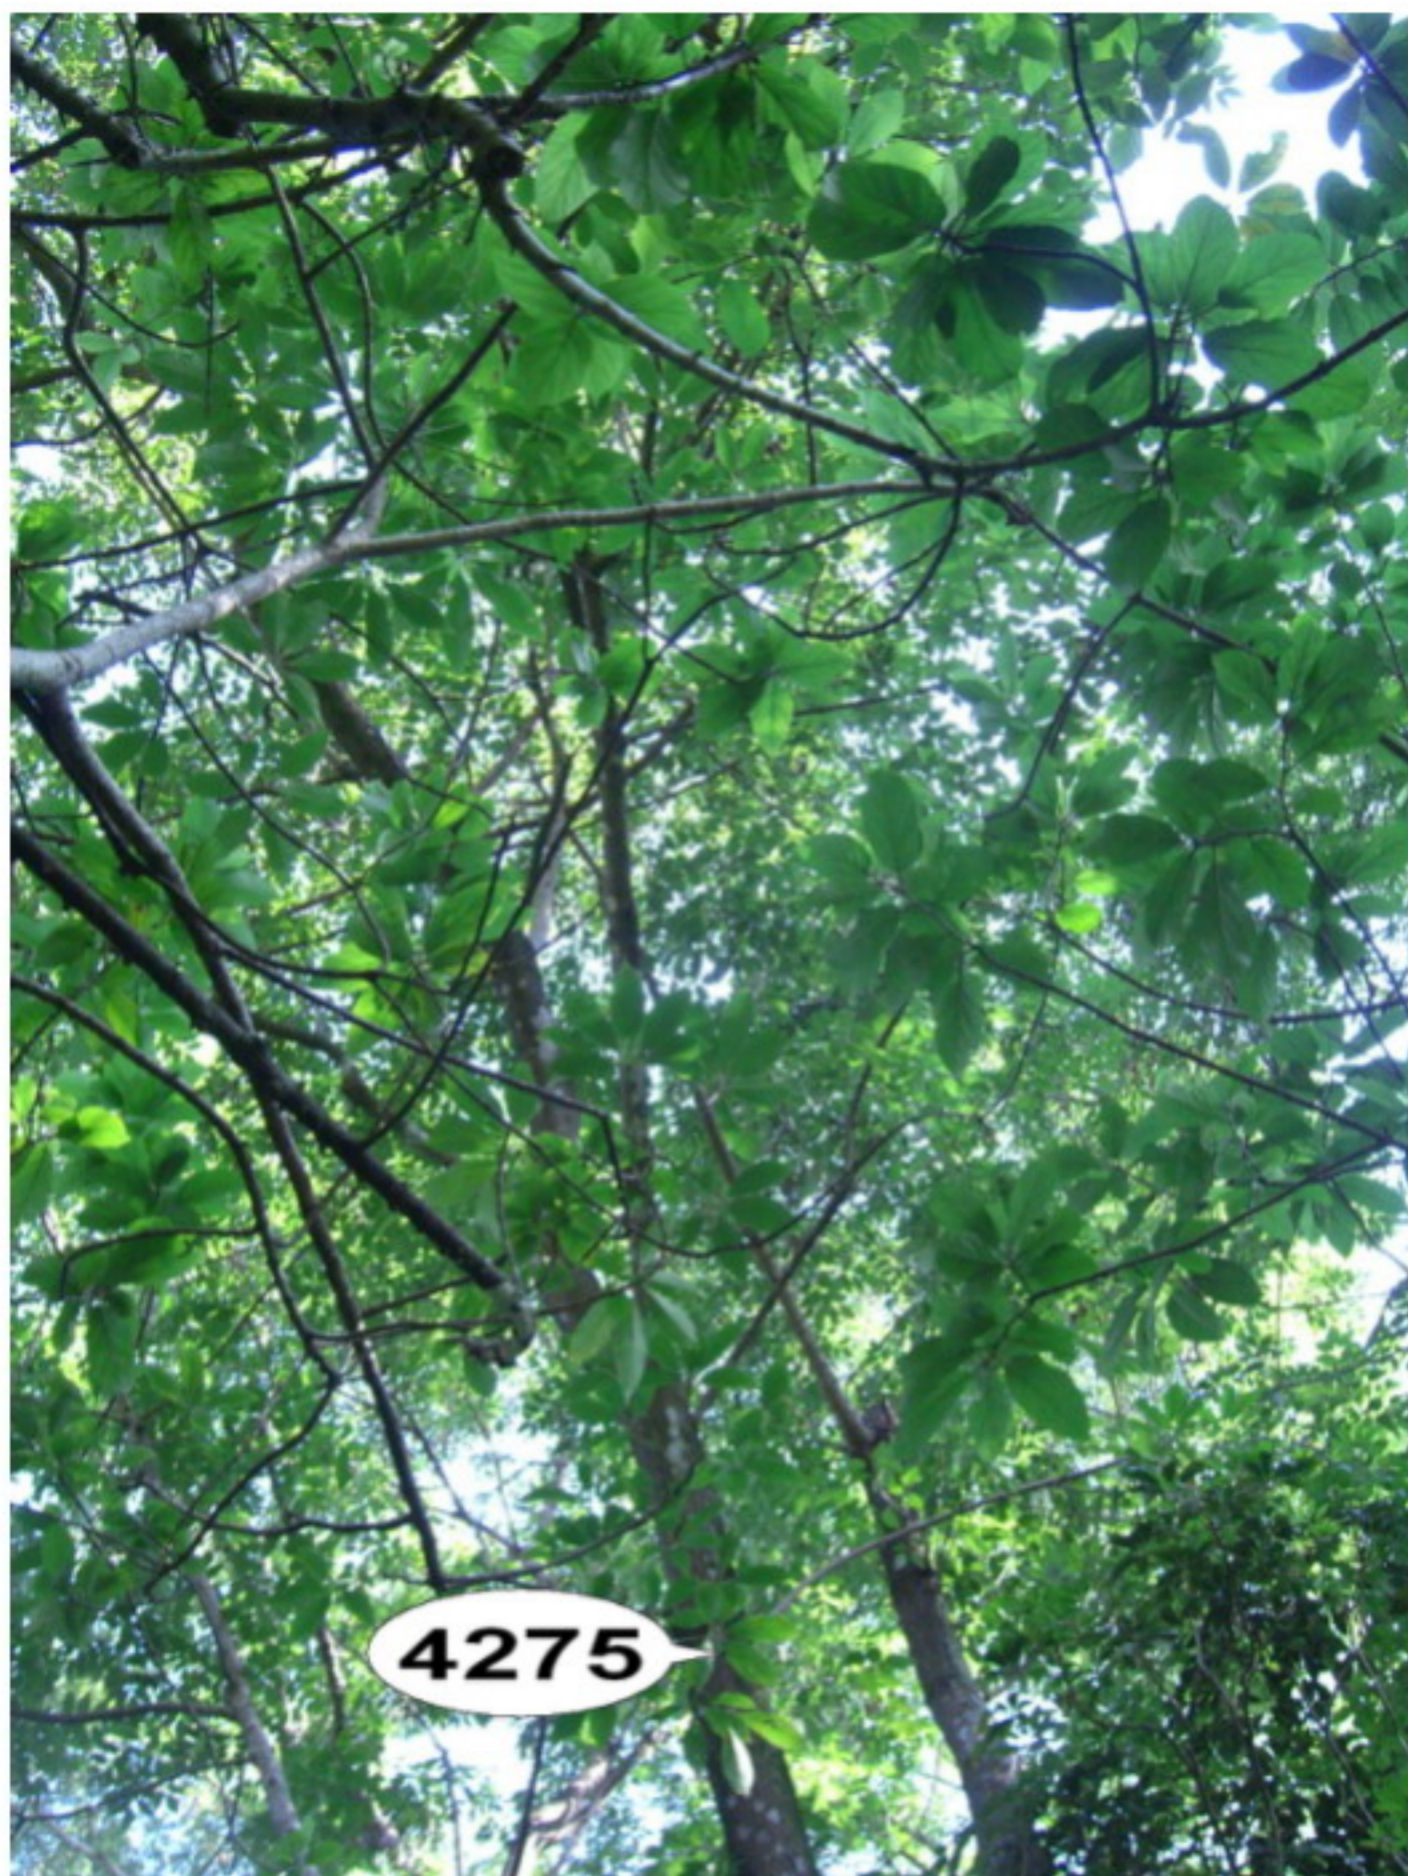
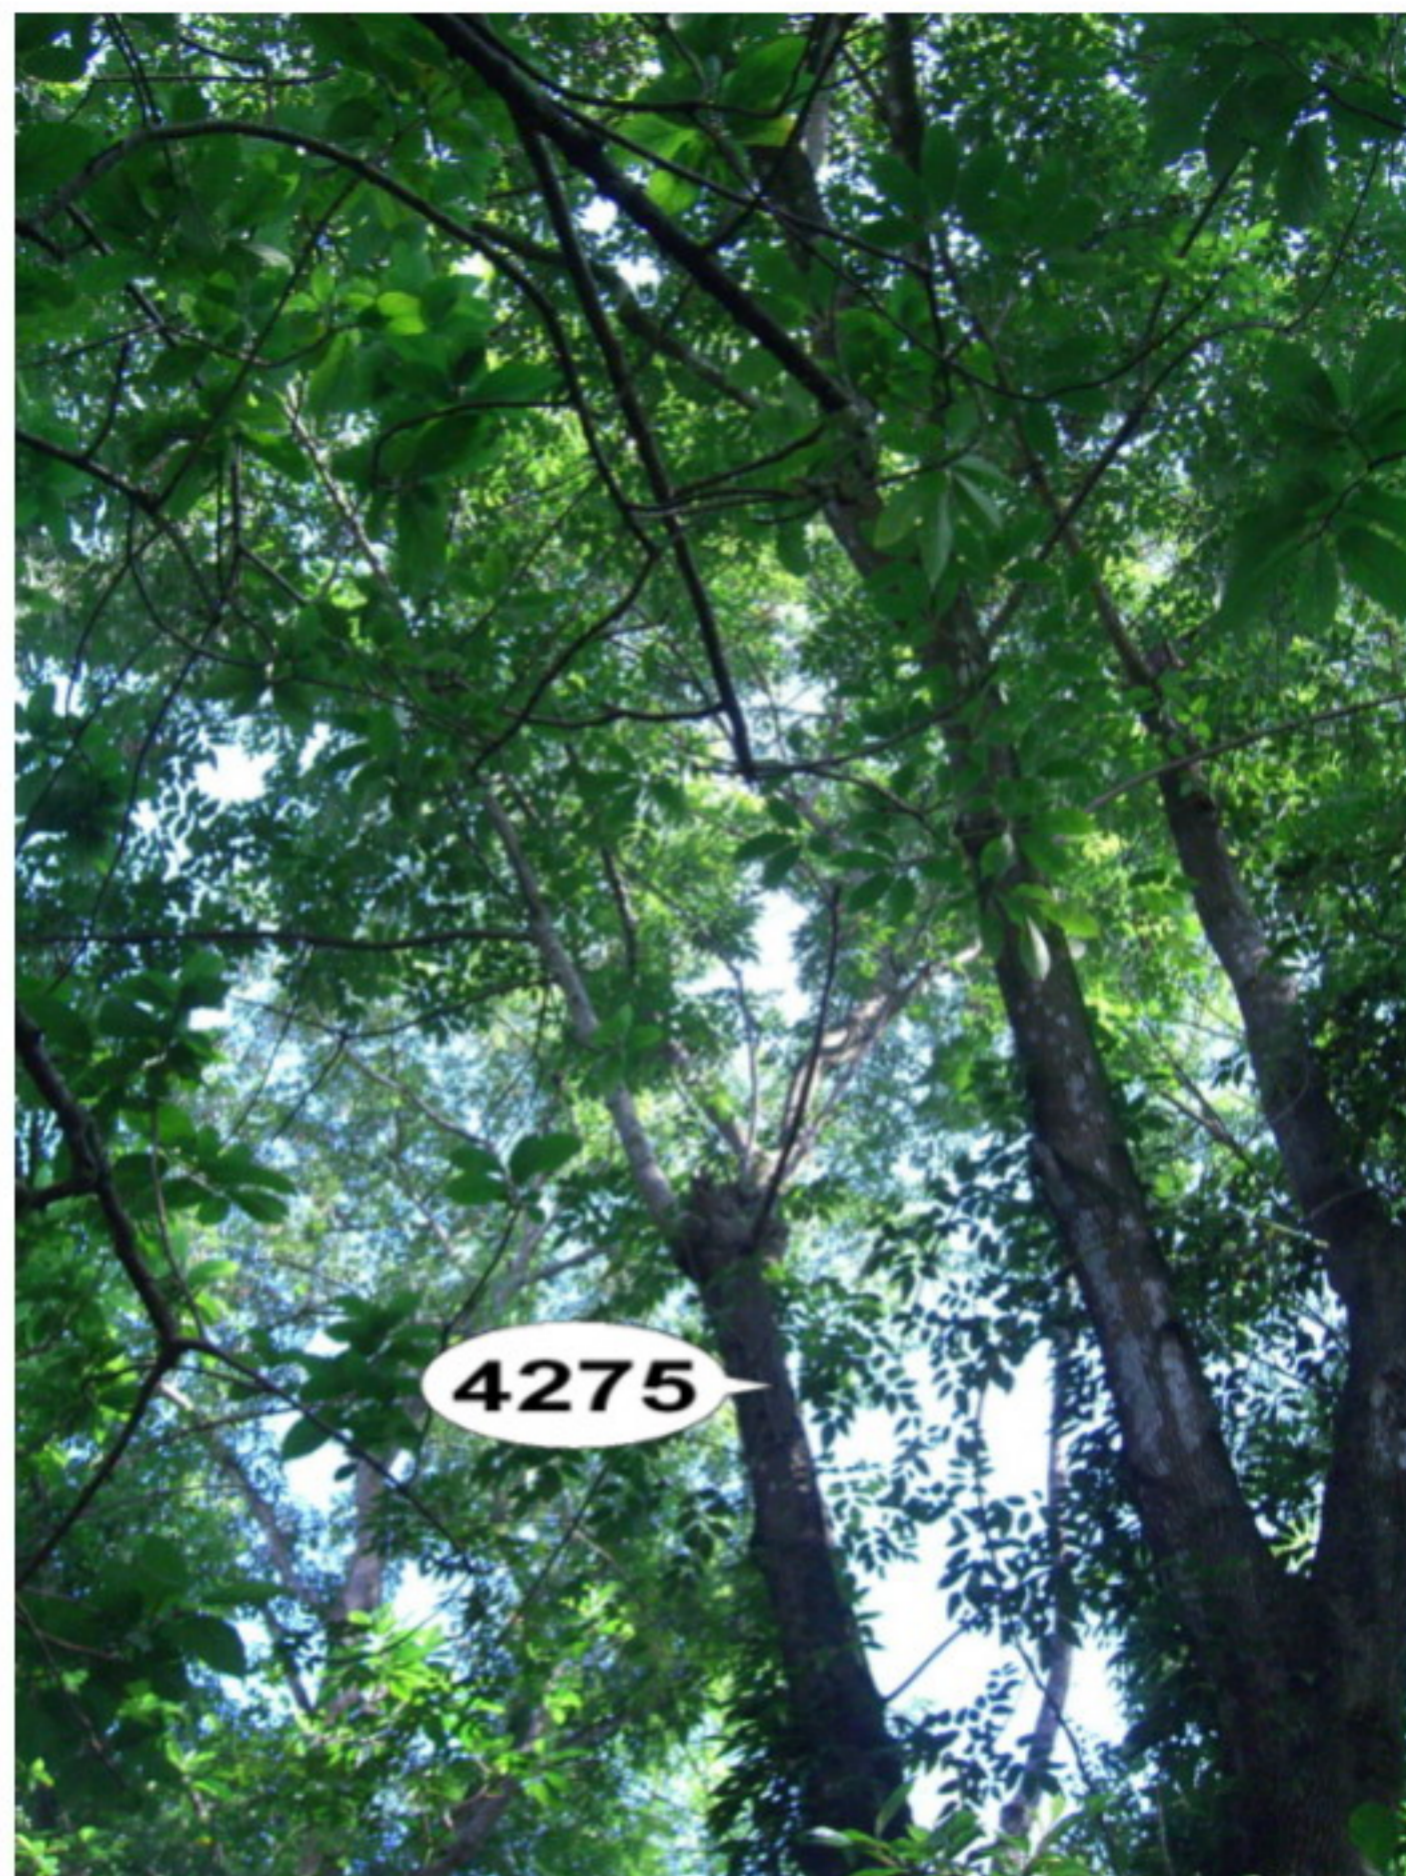
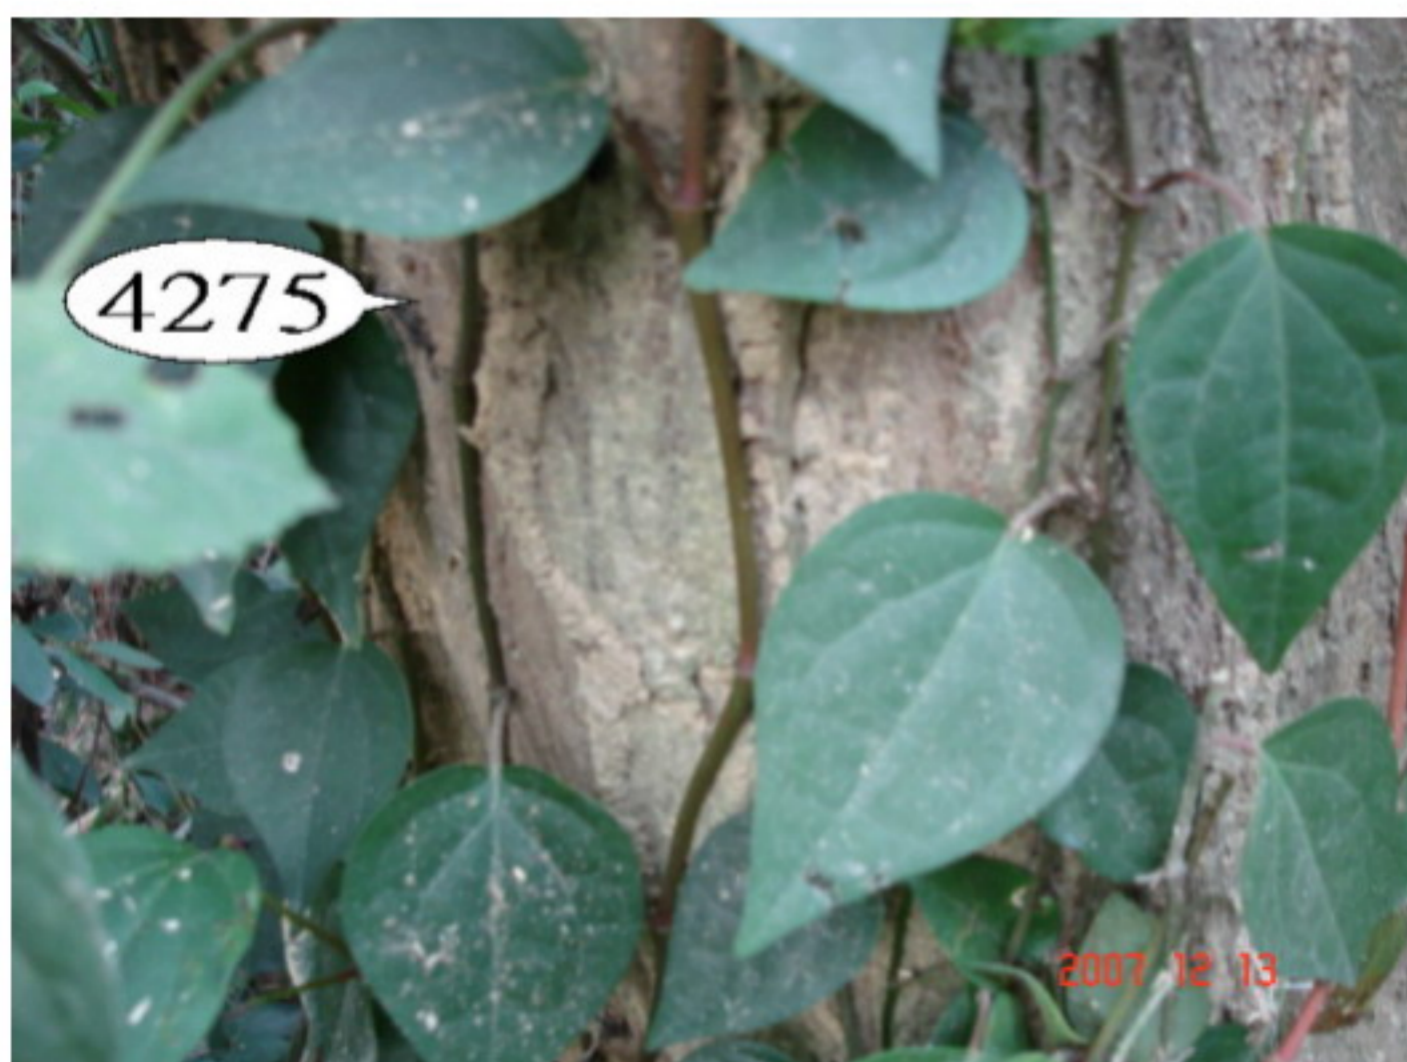
Tree 4275

Poor health will lead to low transplantation survival rate. Termites attack was found on tree trunk.

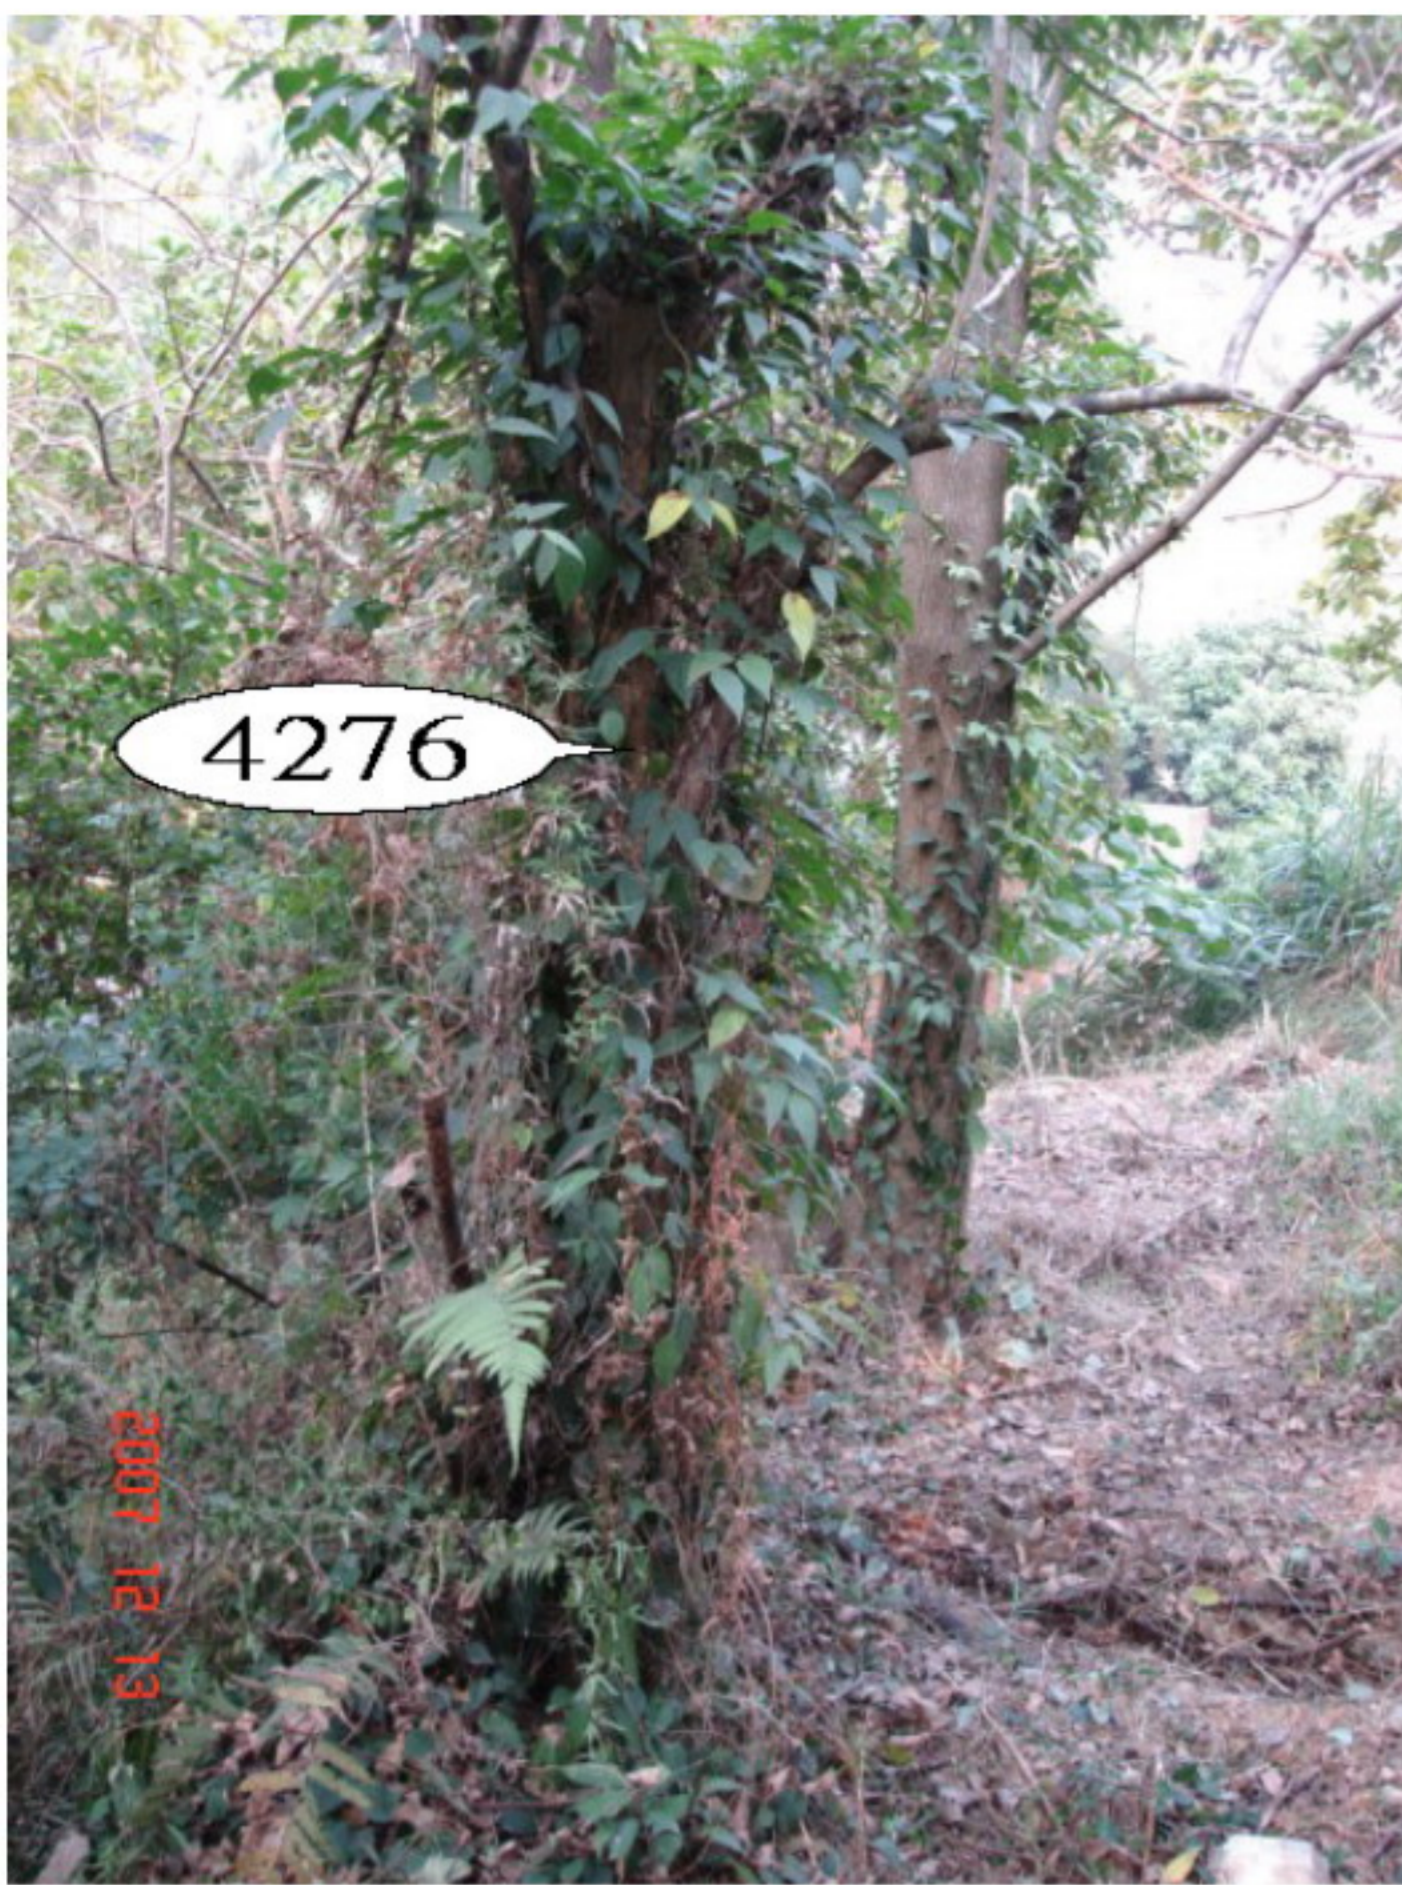
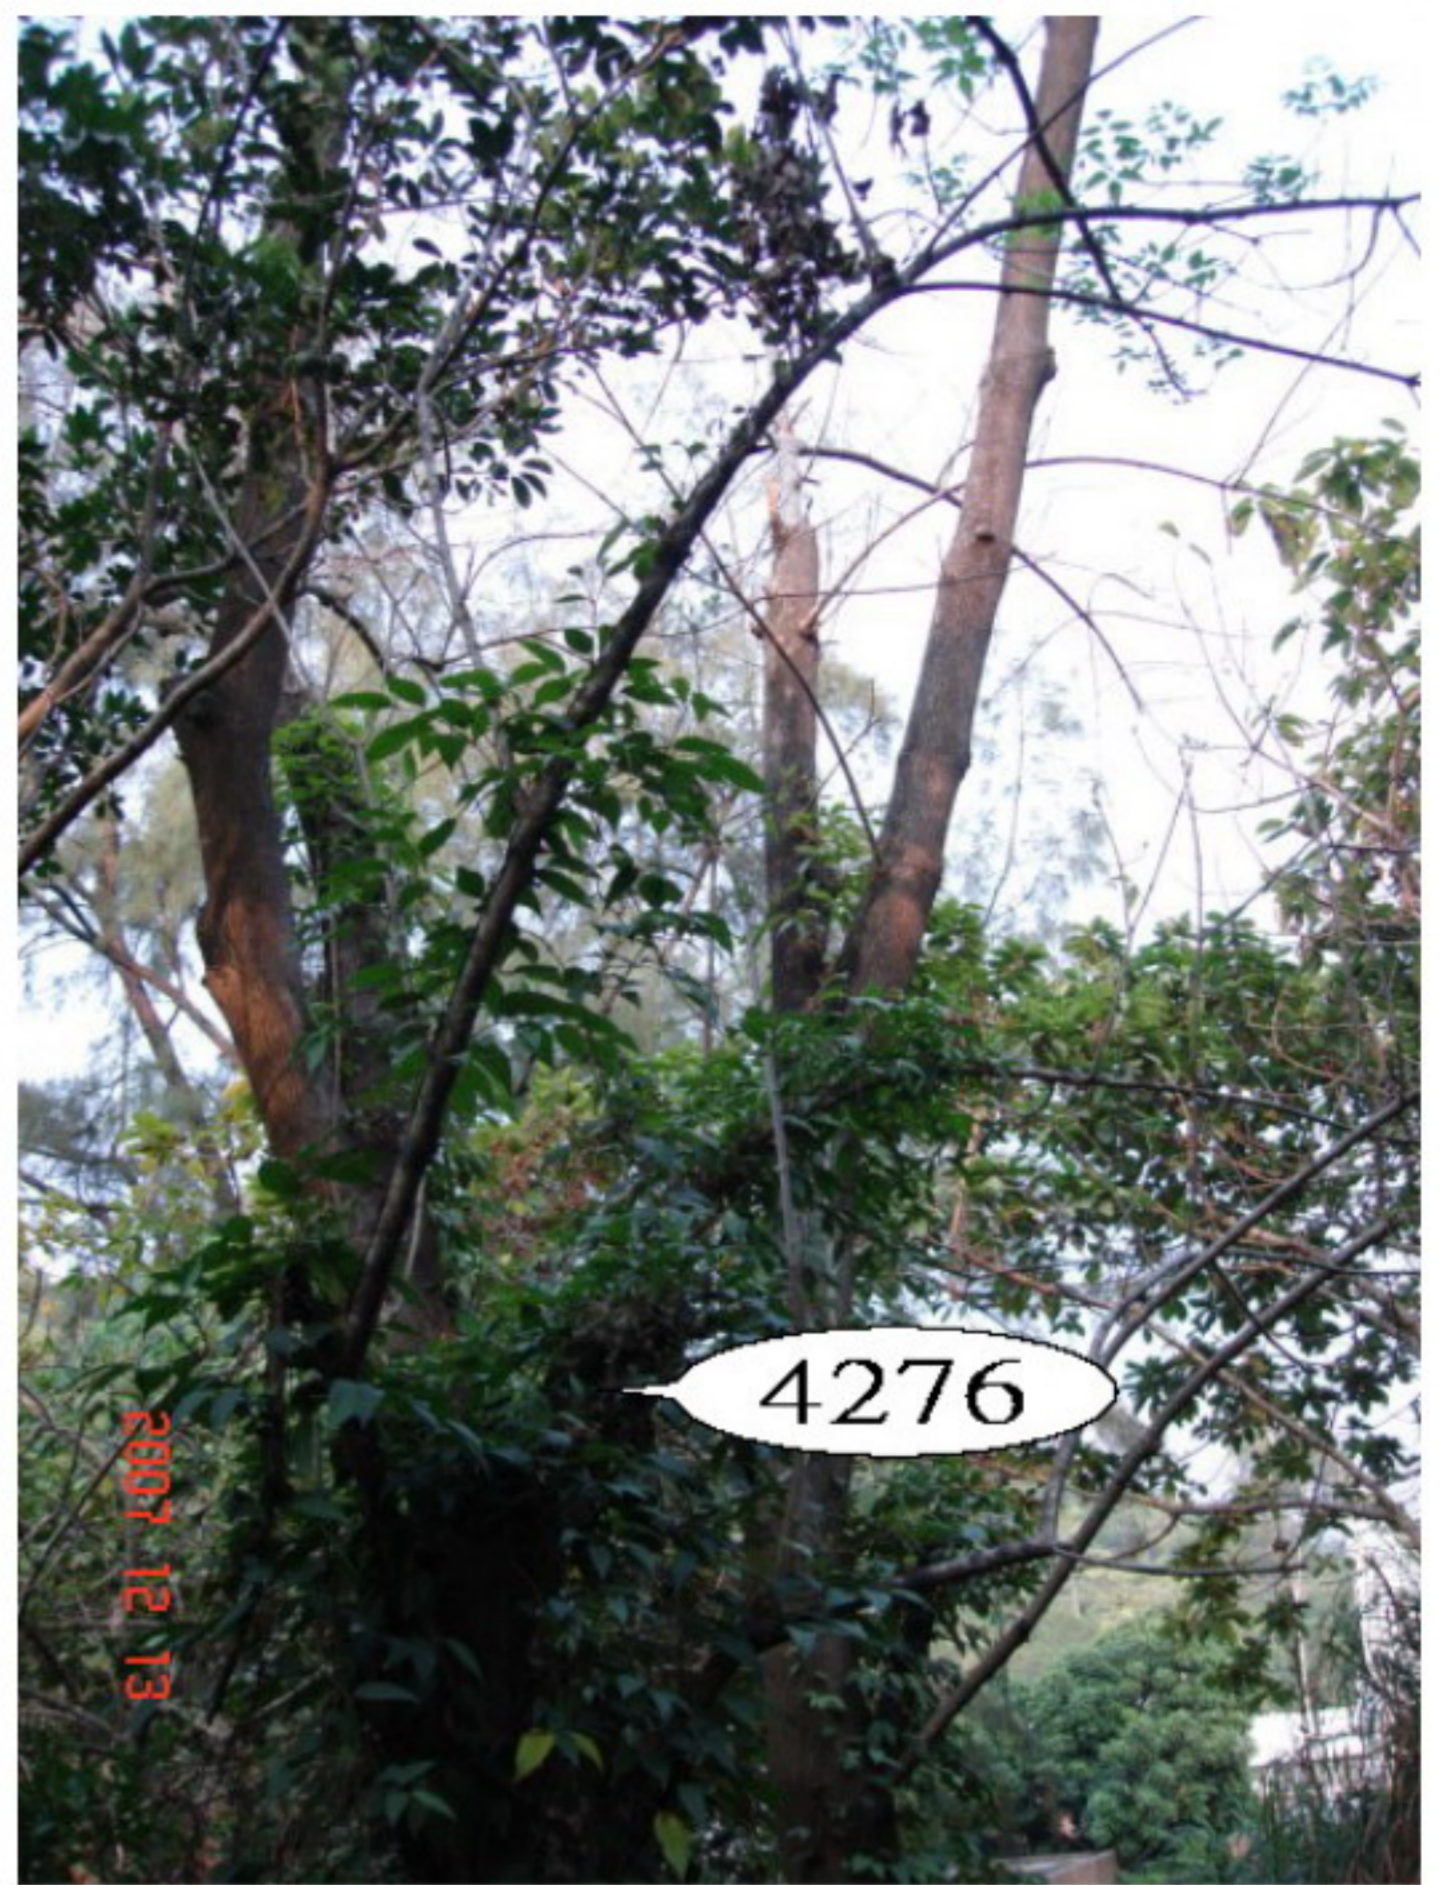
Tree 4276  
Dead tree

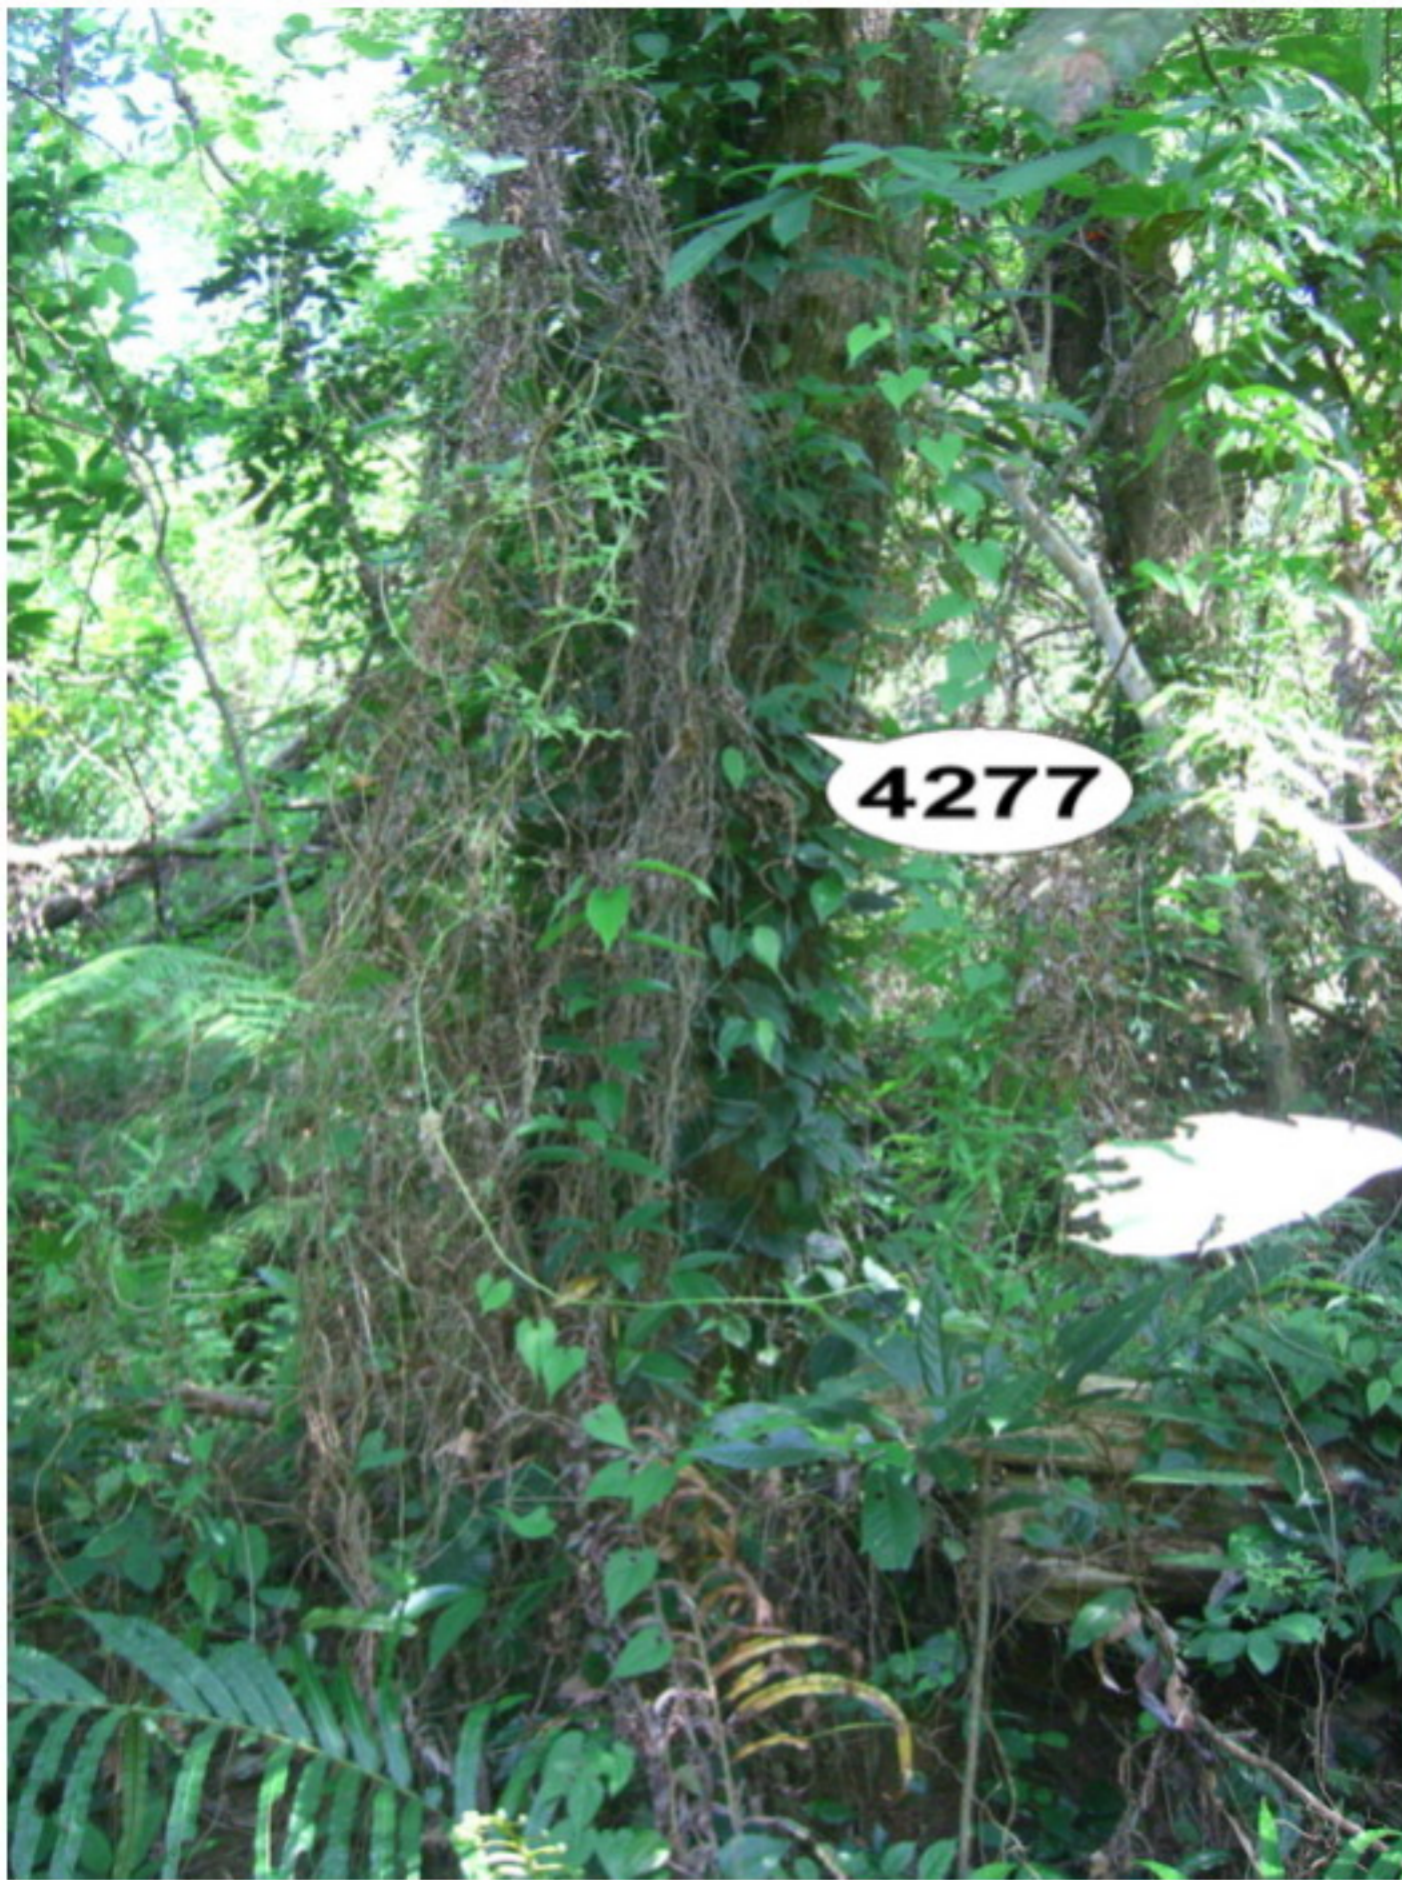
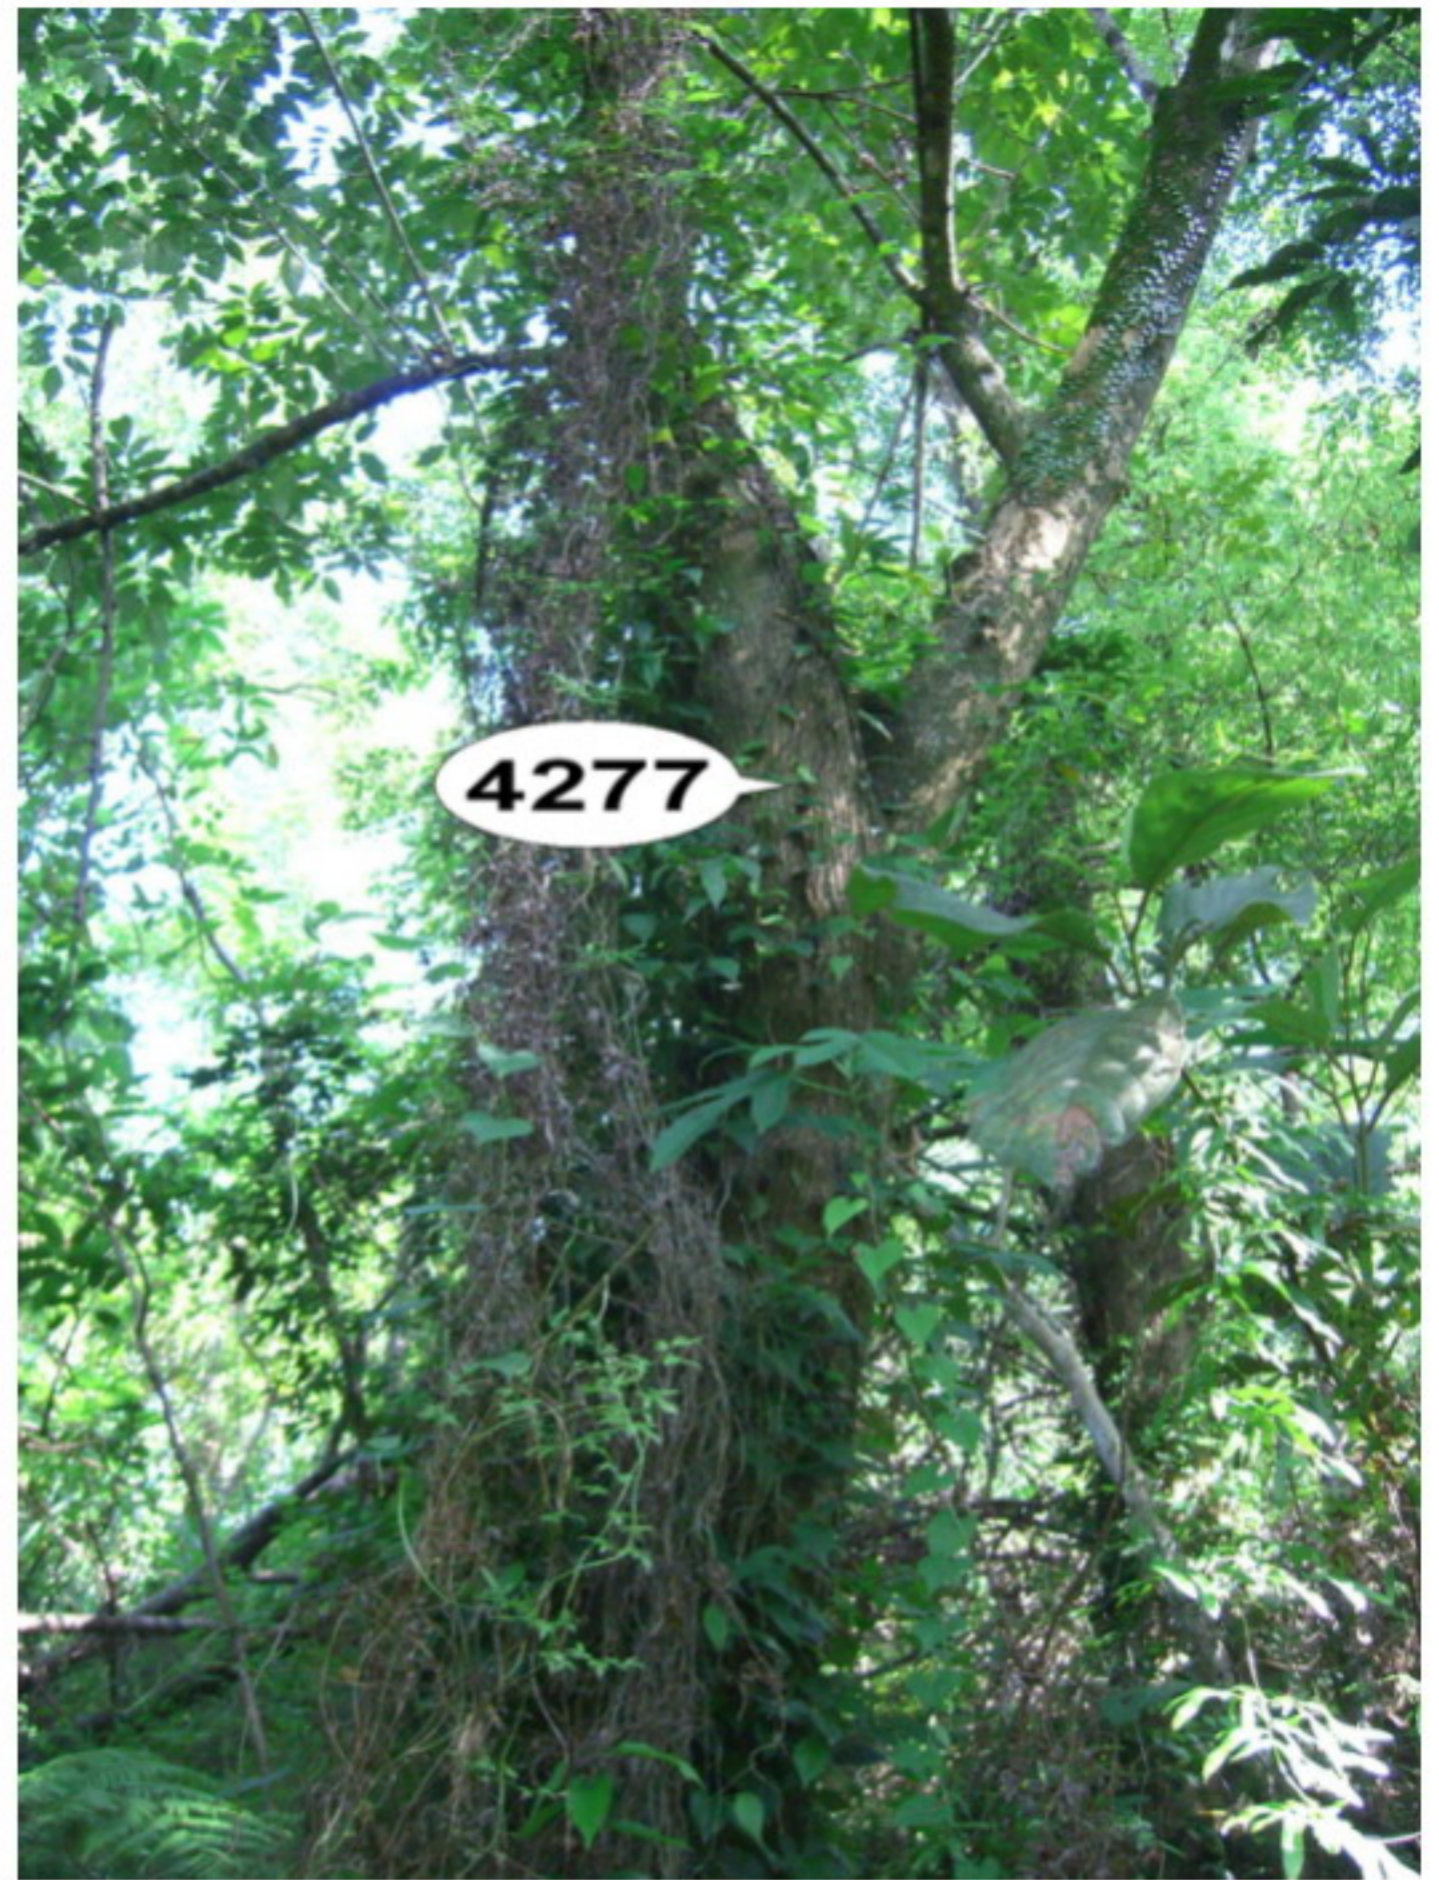
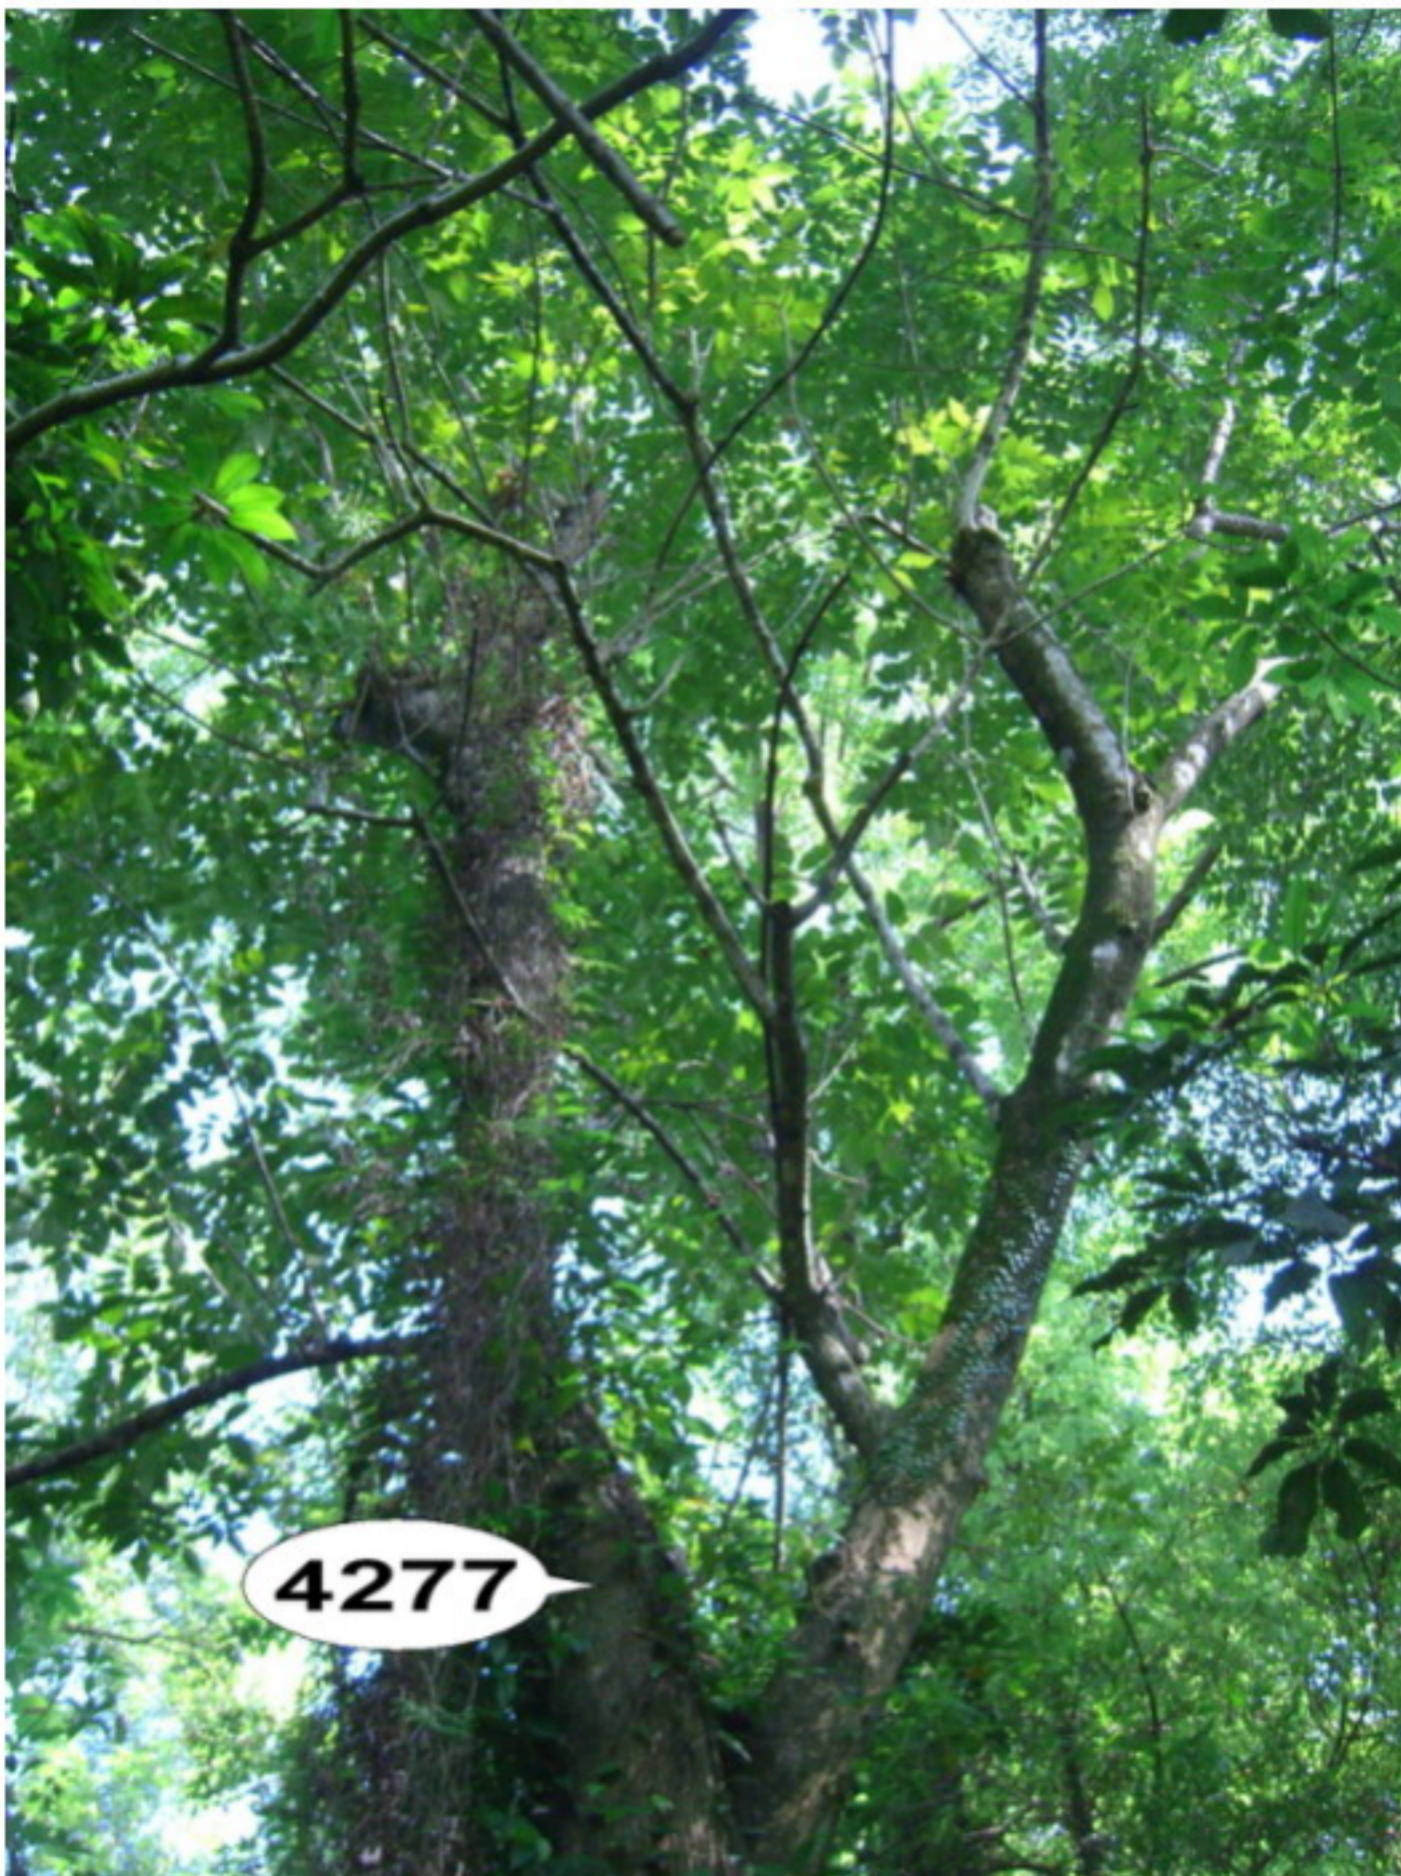
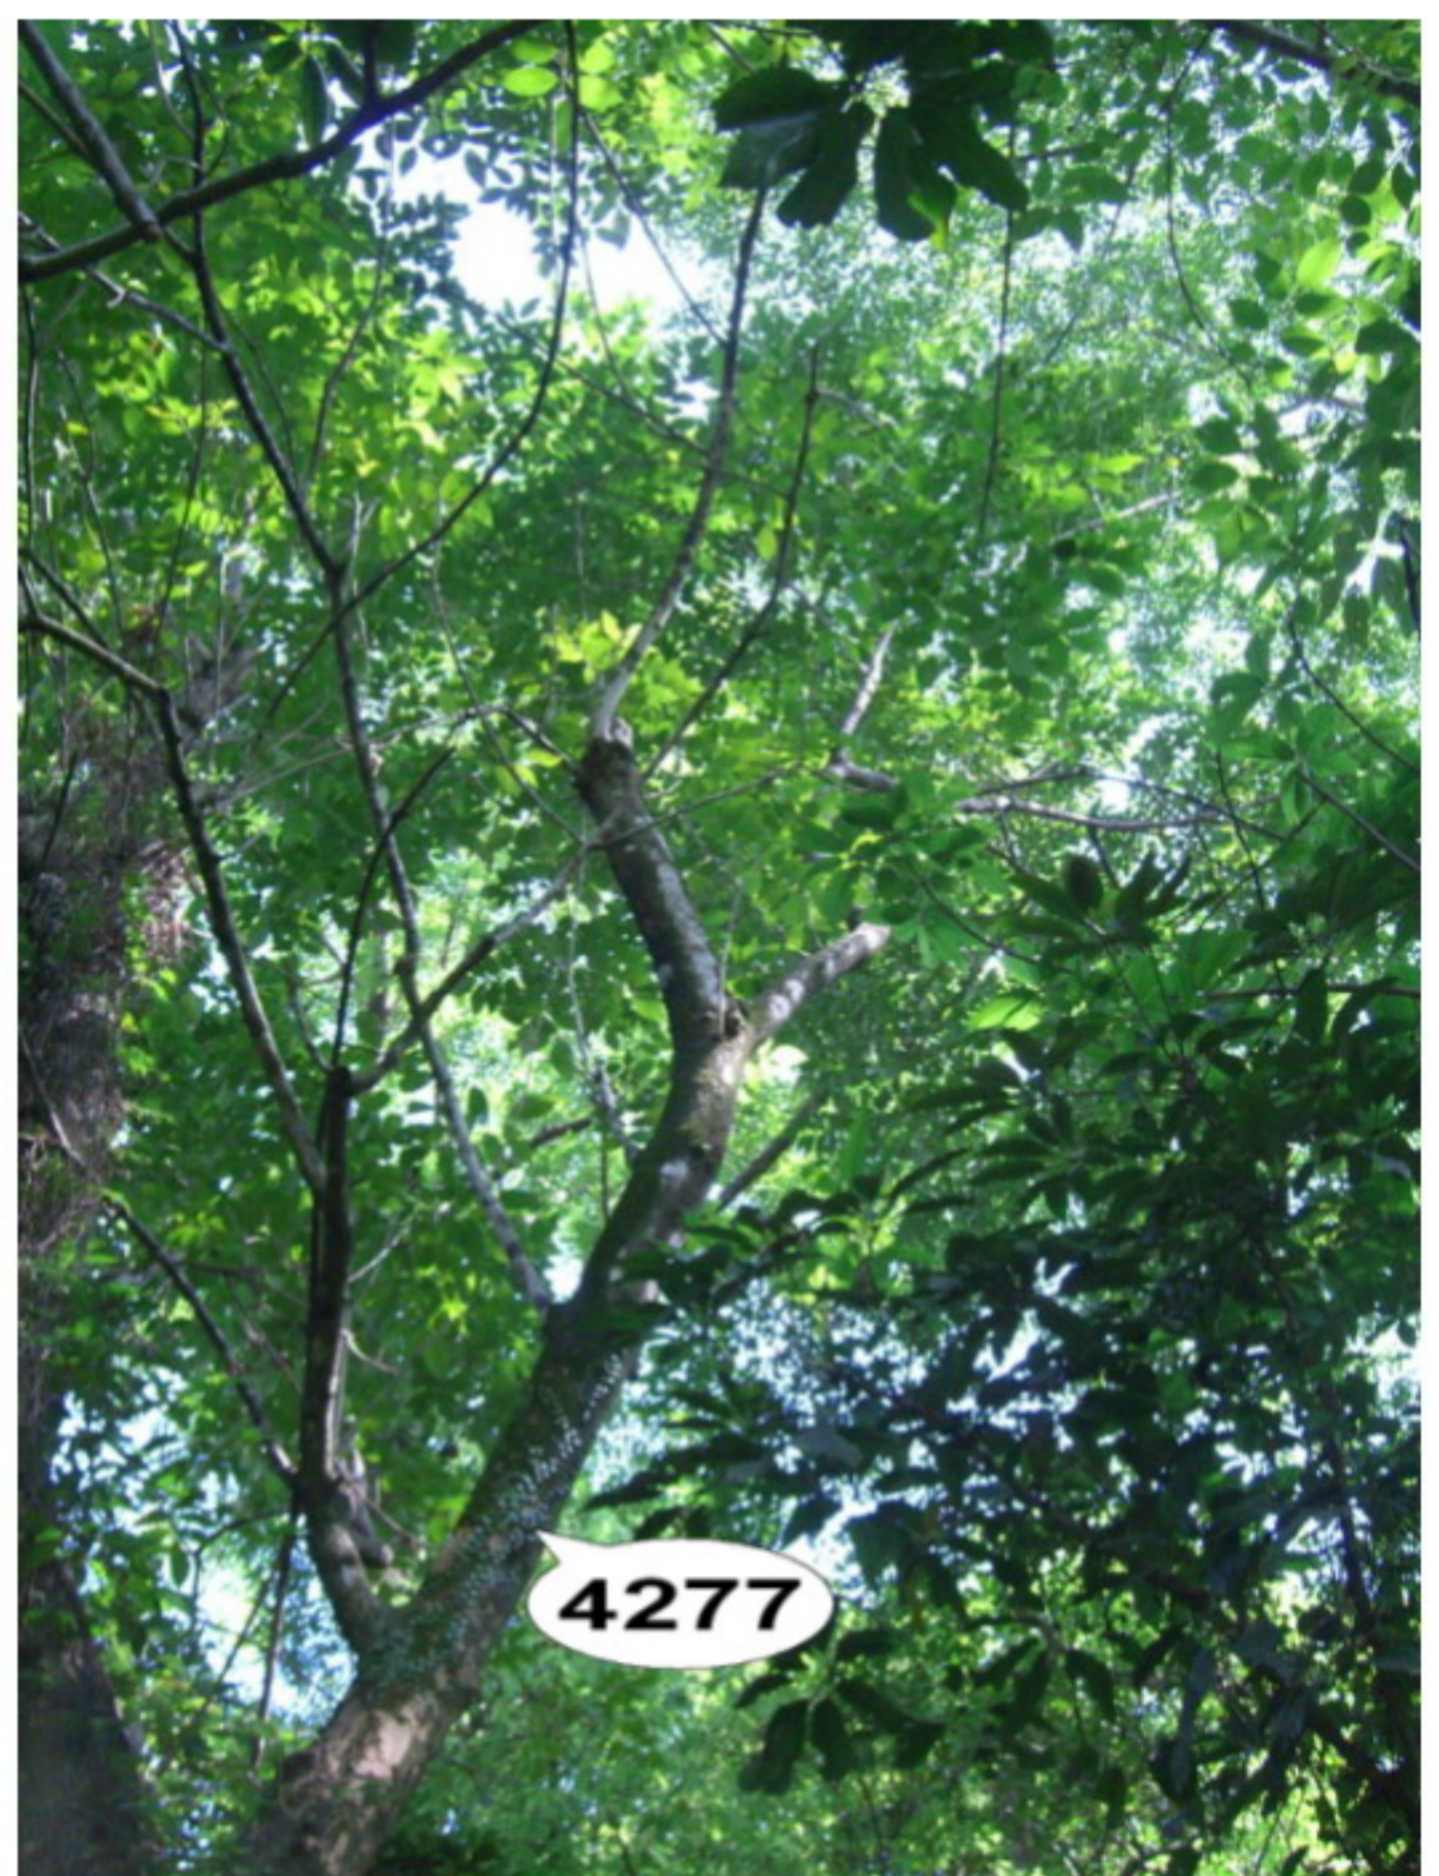
Tree 4277

Poor health will lead to low transplantation survival rate. Termites attack was found on tree trunk.
