# Provision of Cremators at Wo Hop Shek Crematorium

Tree Survey Report

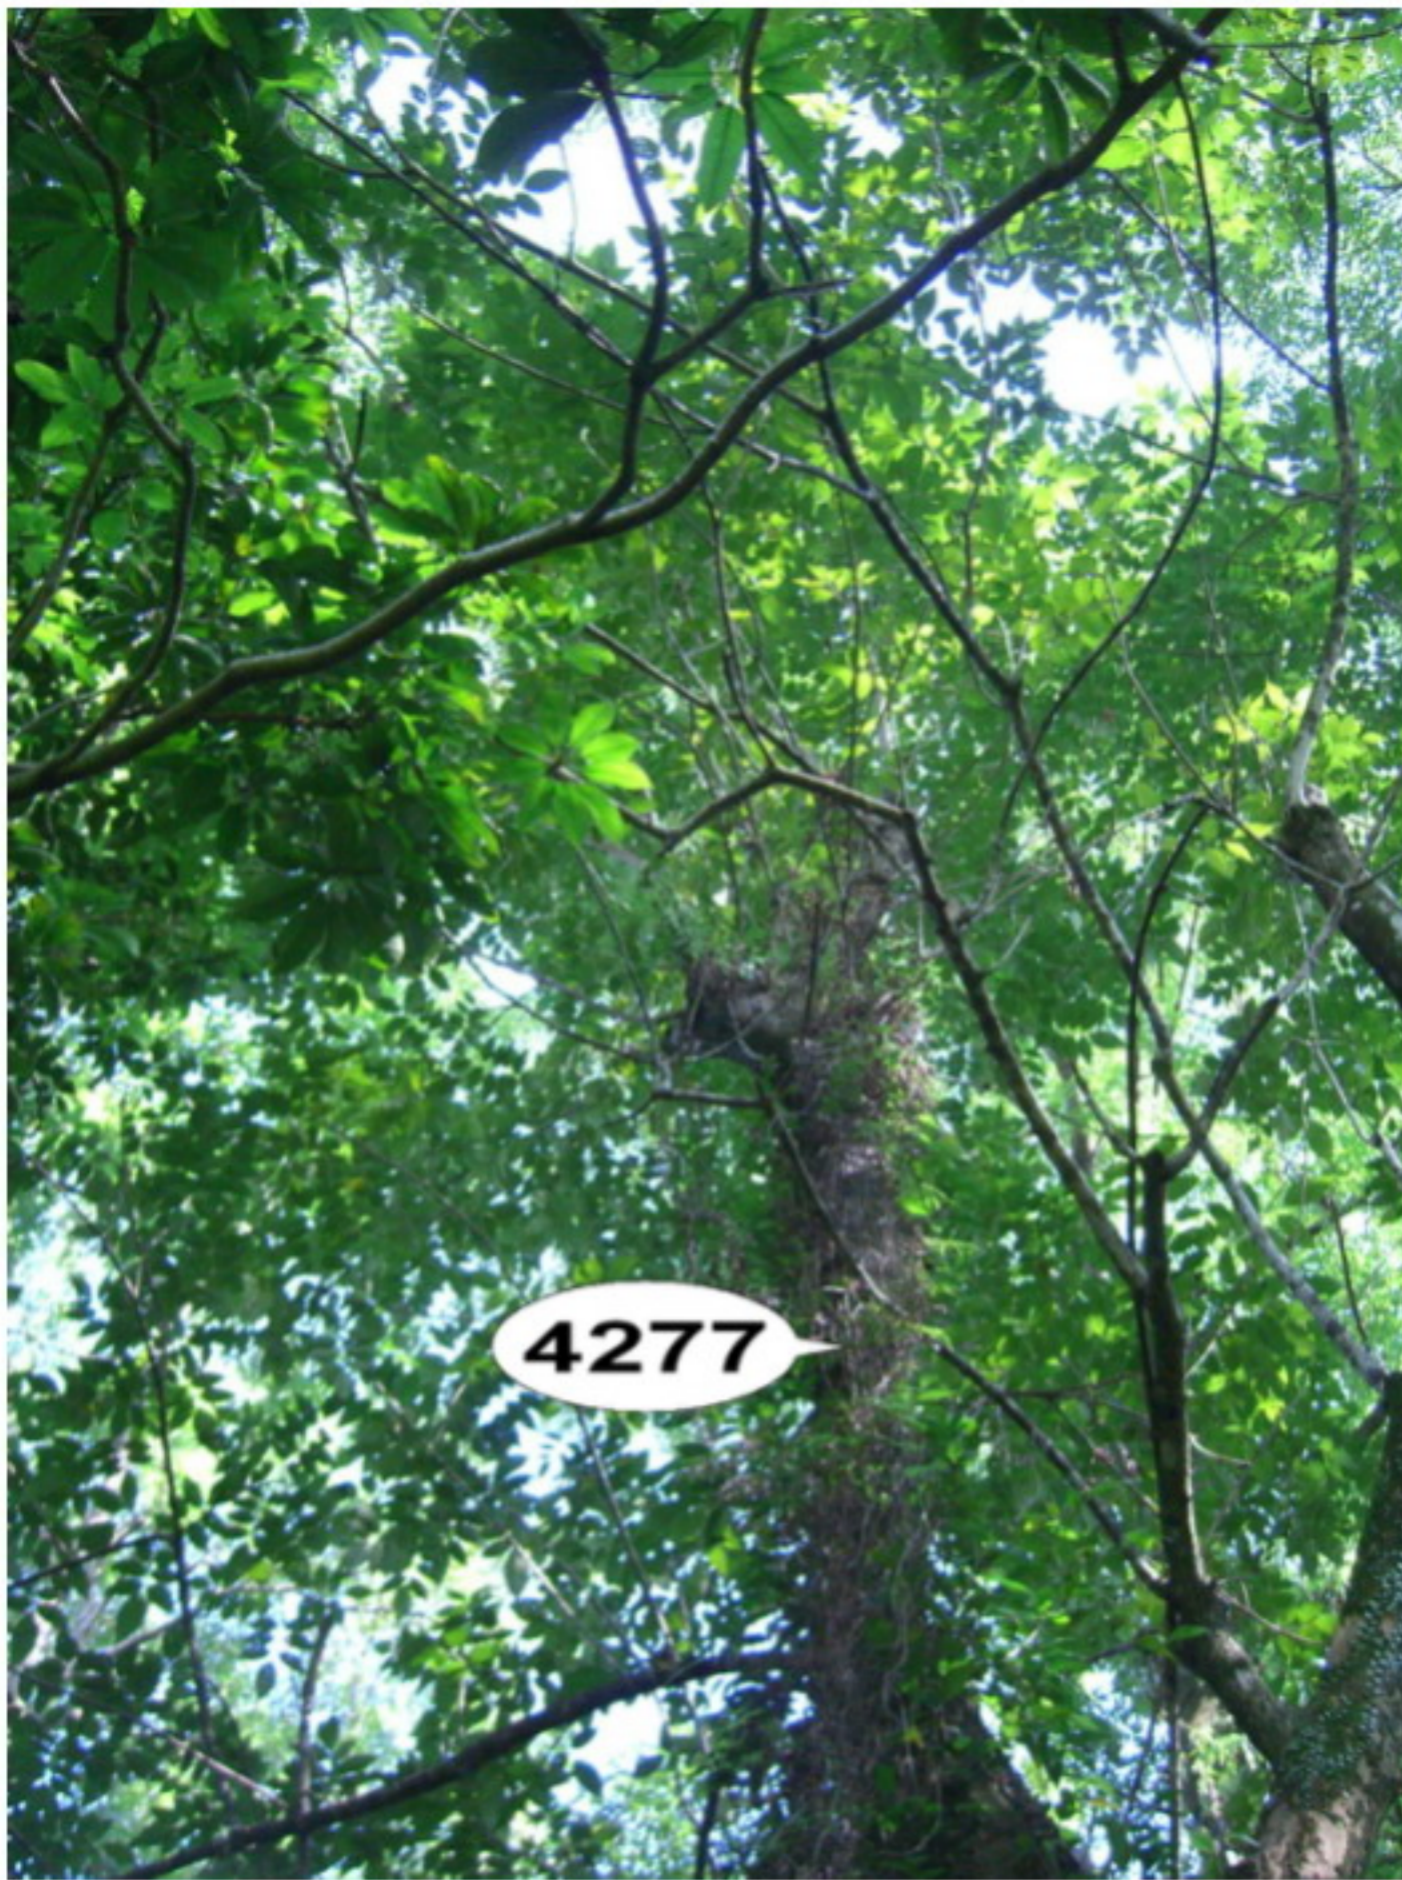
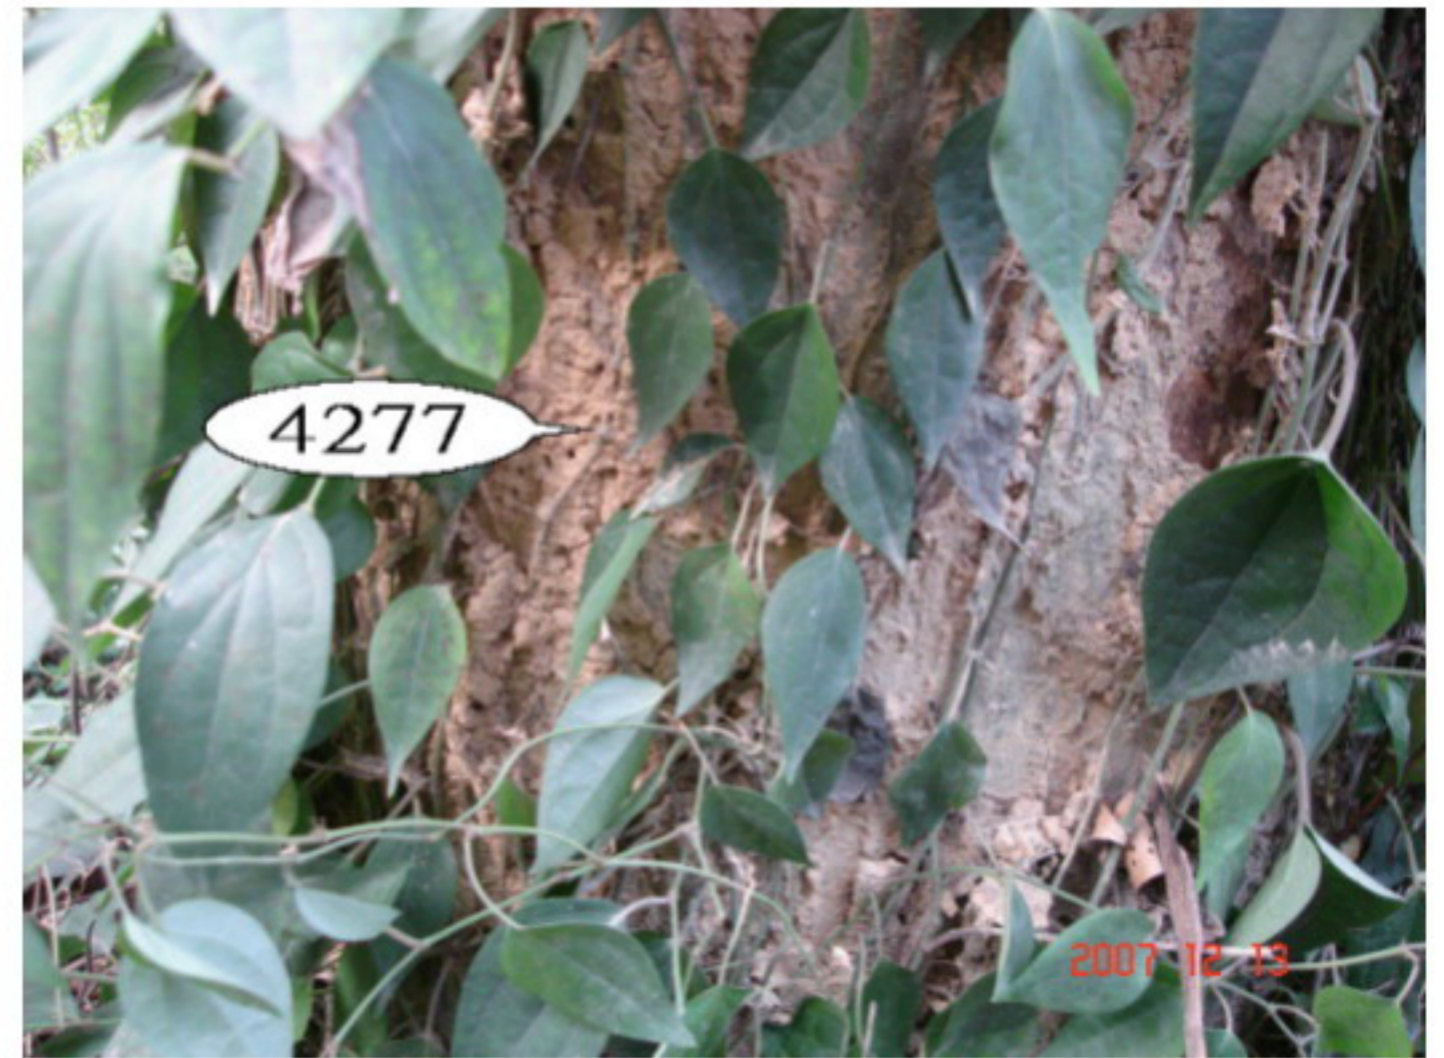
Tree 4277

Poor health will lead to low transplantation survival rate. Termites attack was found on tree trunk.

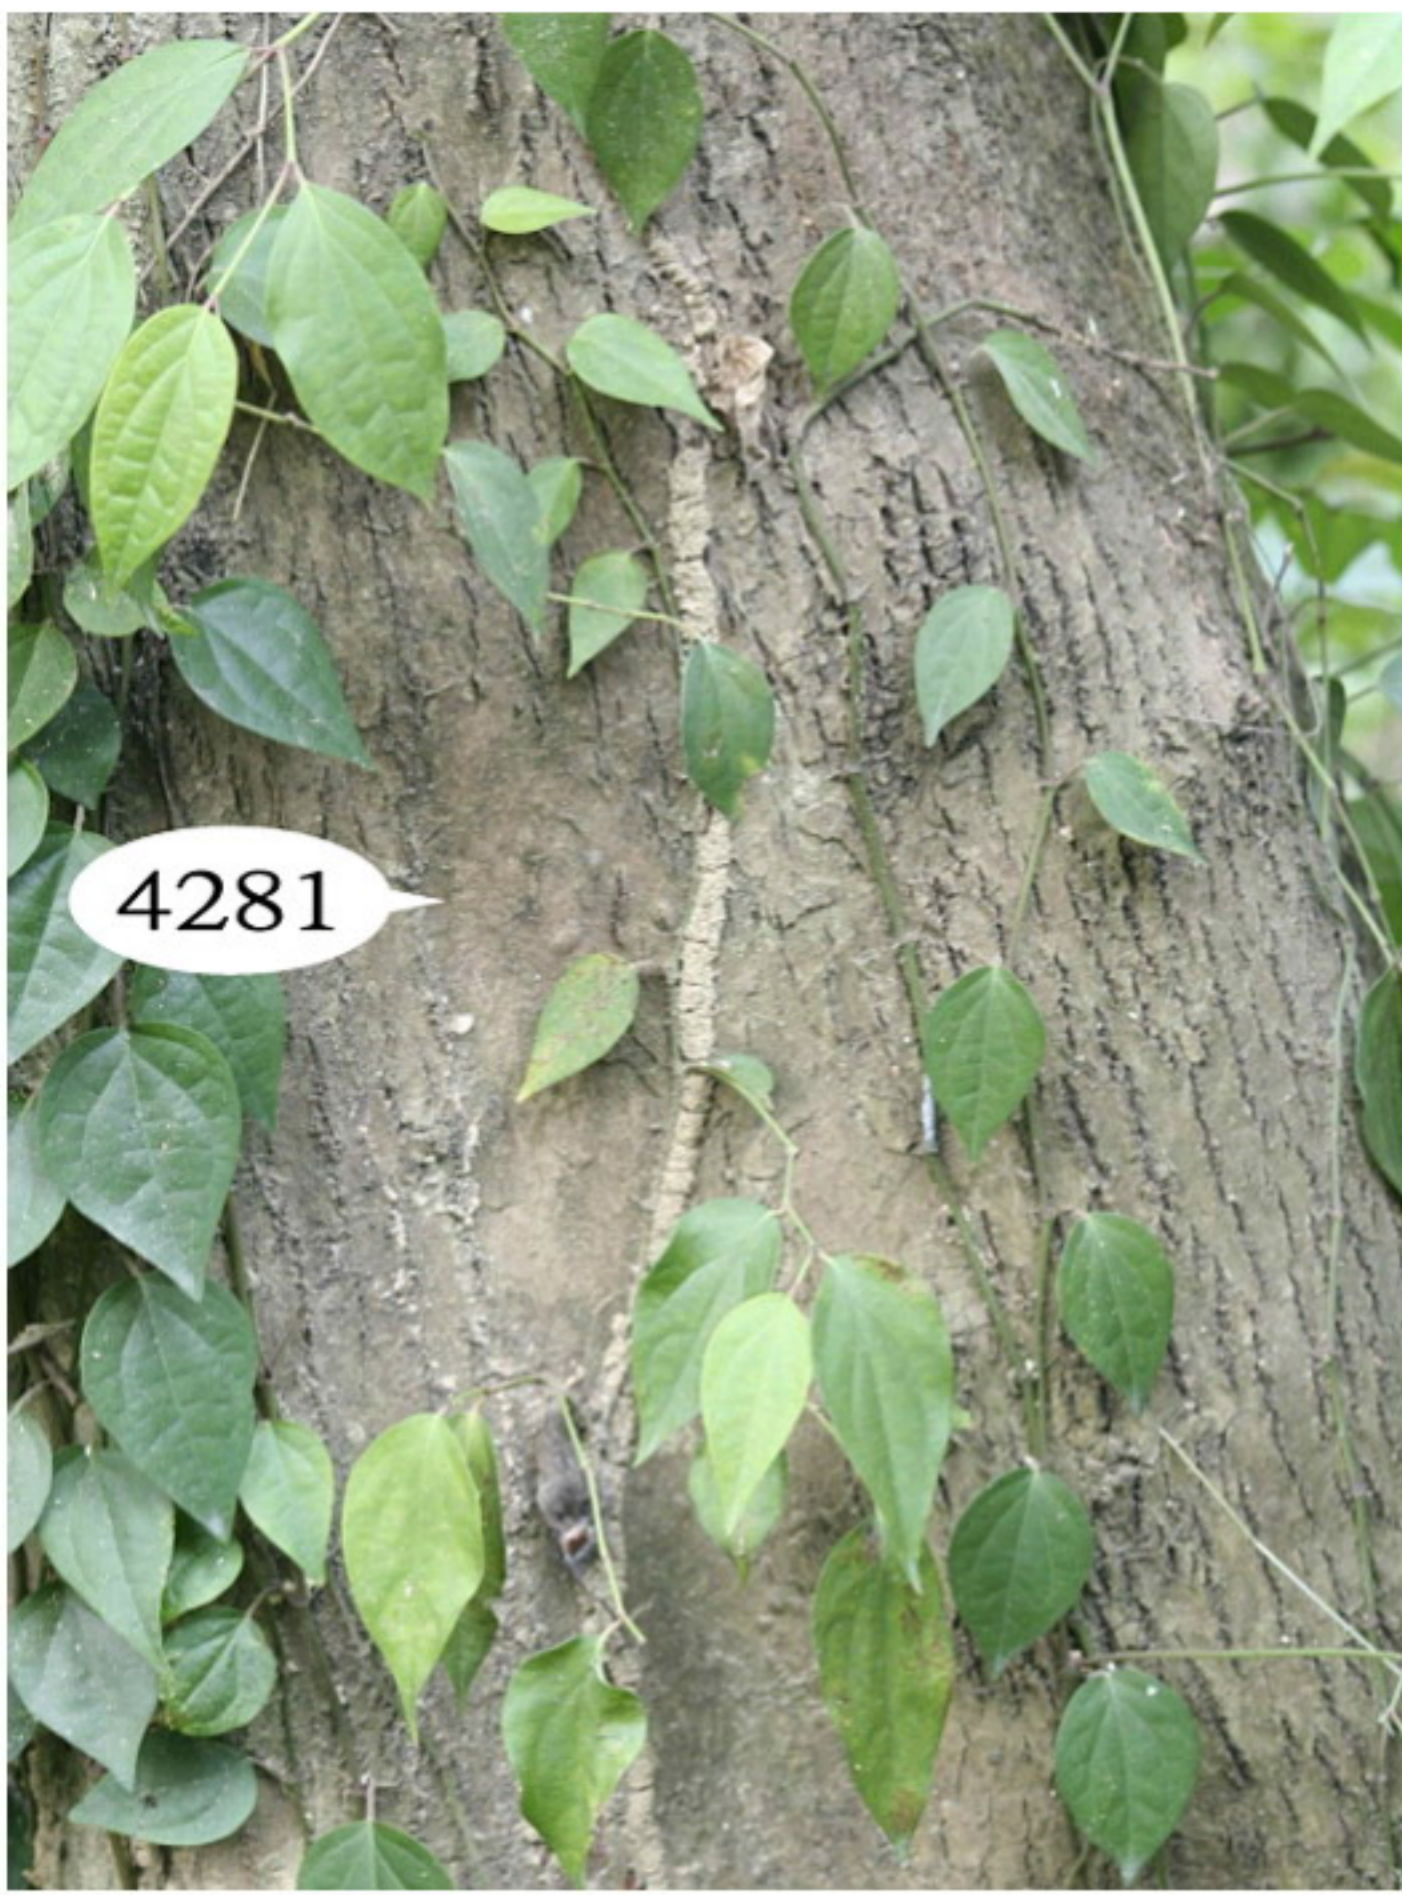
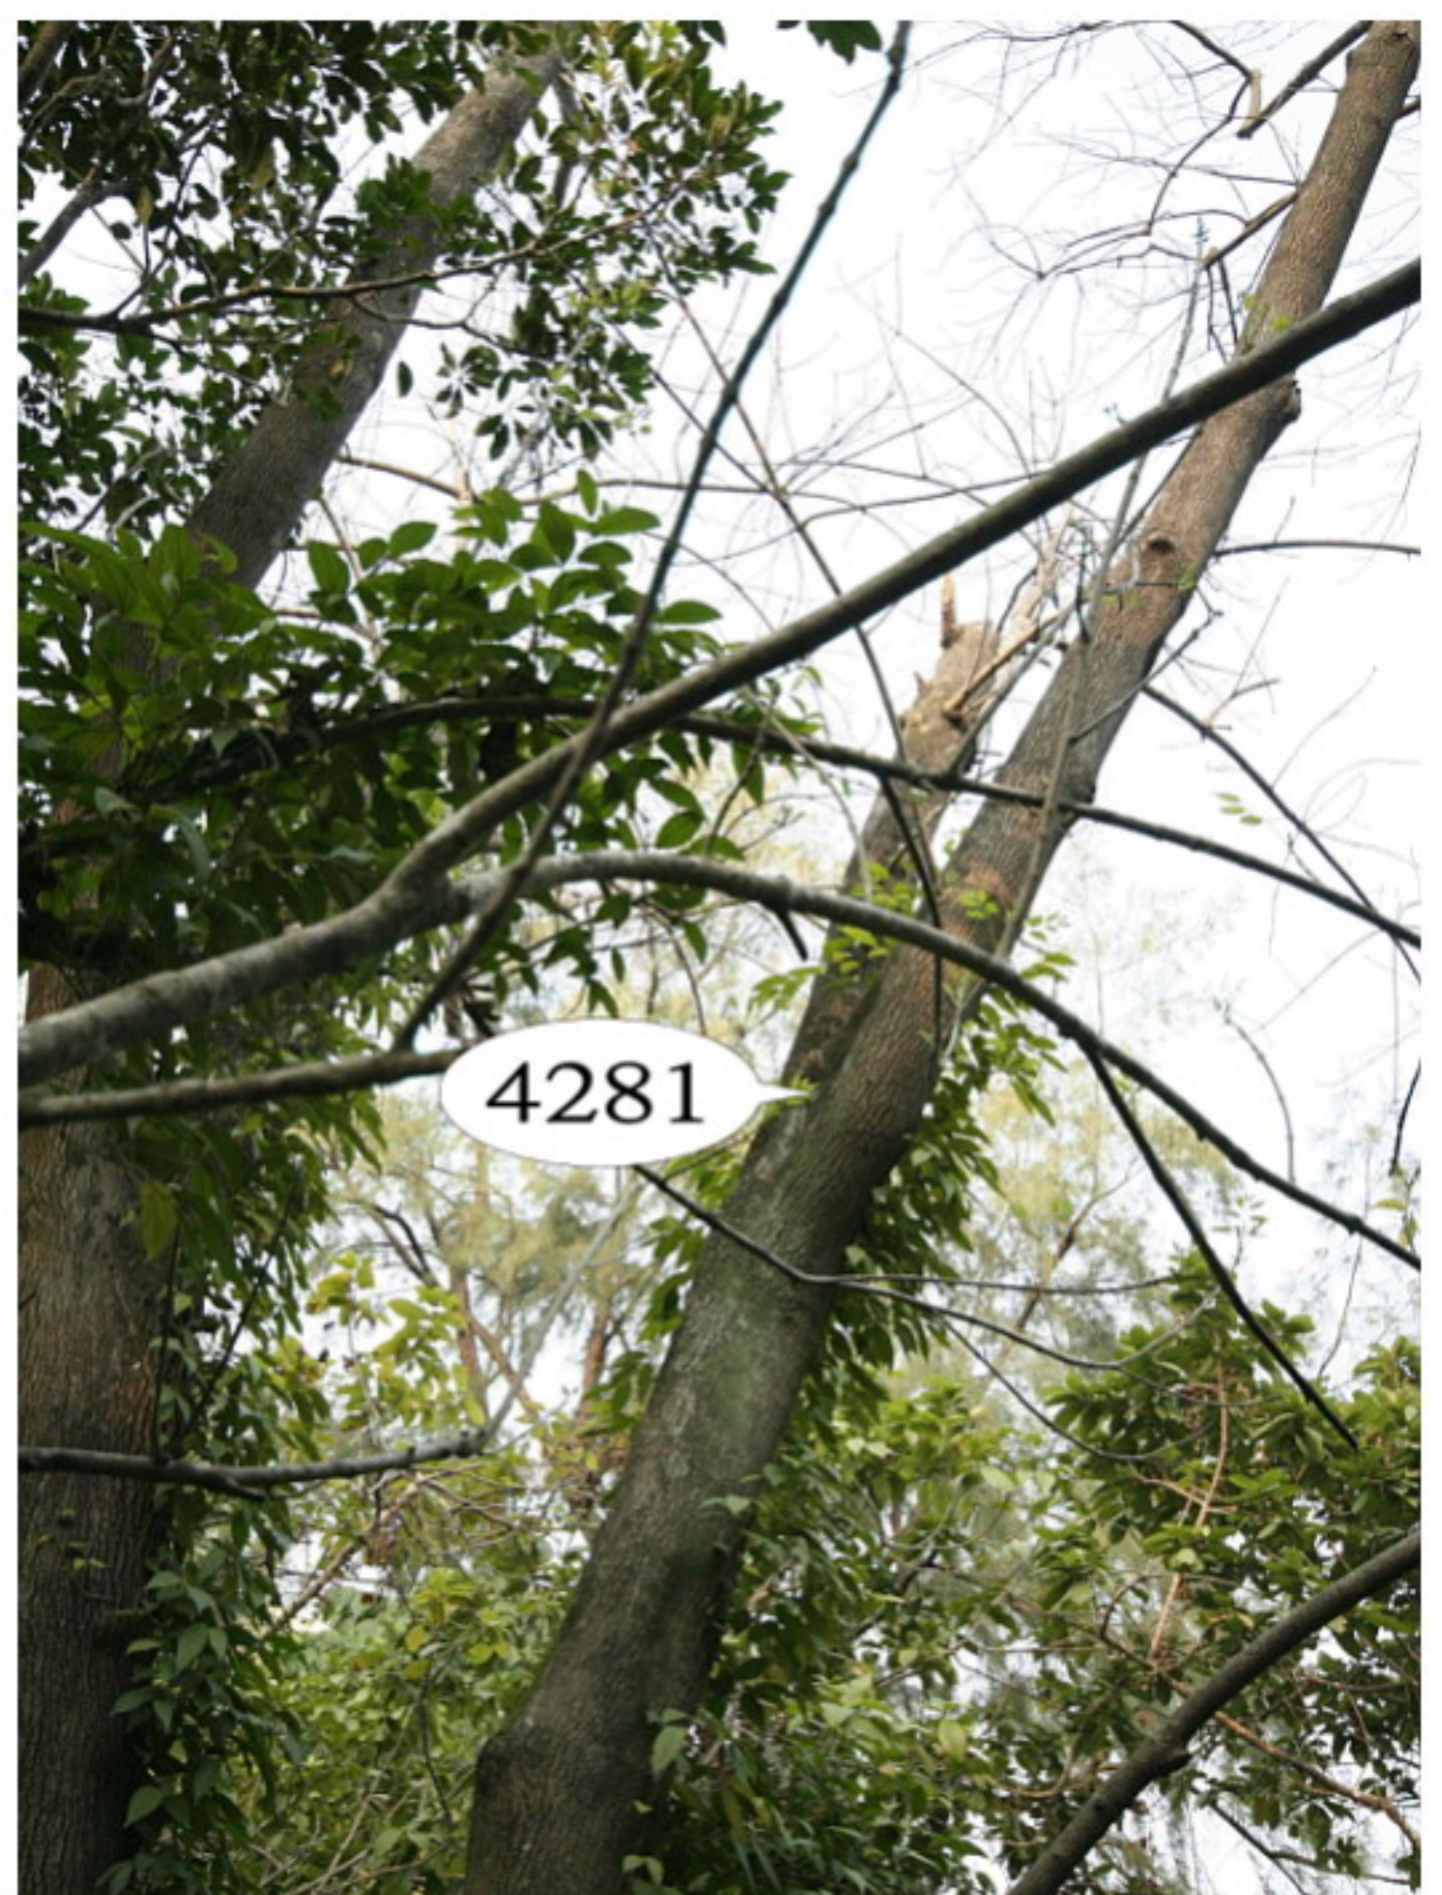
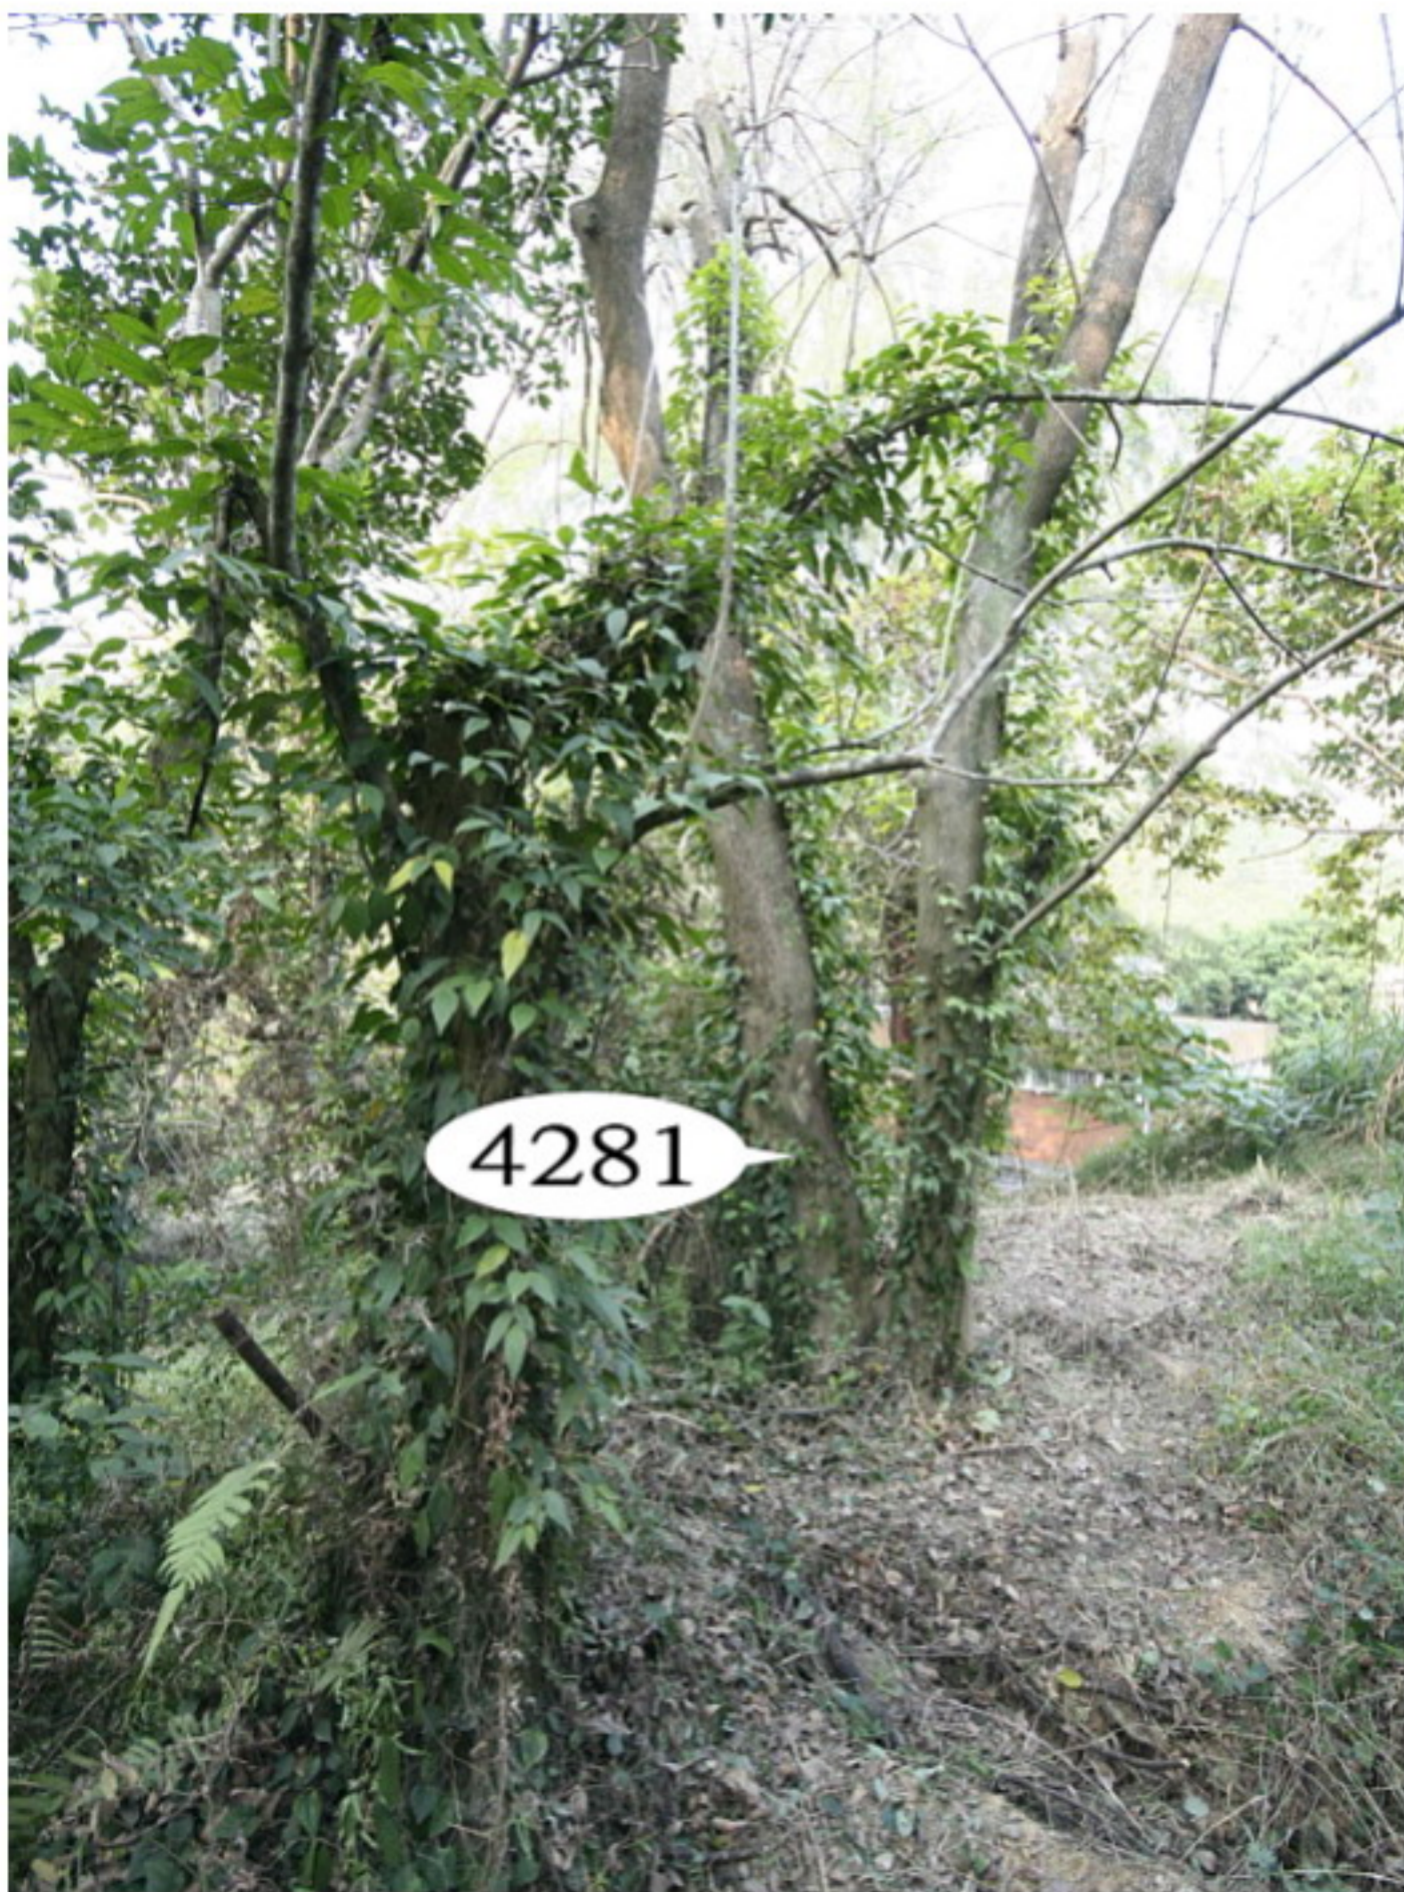
Tree 4281

Poor health will lead to low transplantation survival rate. Termites attack was found on tree trunk.

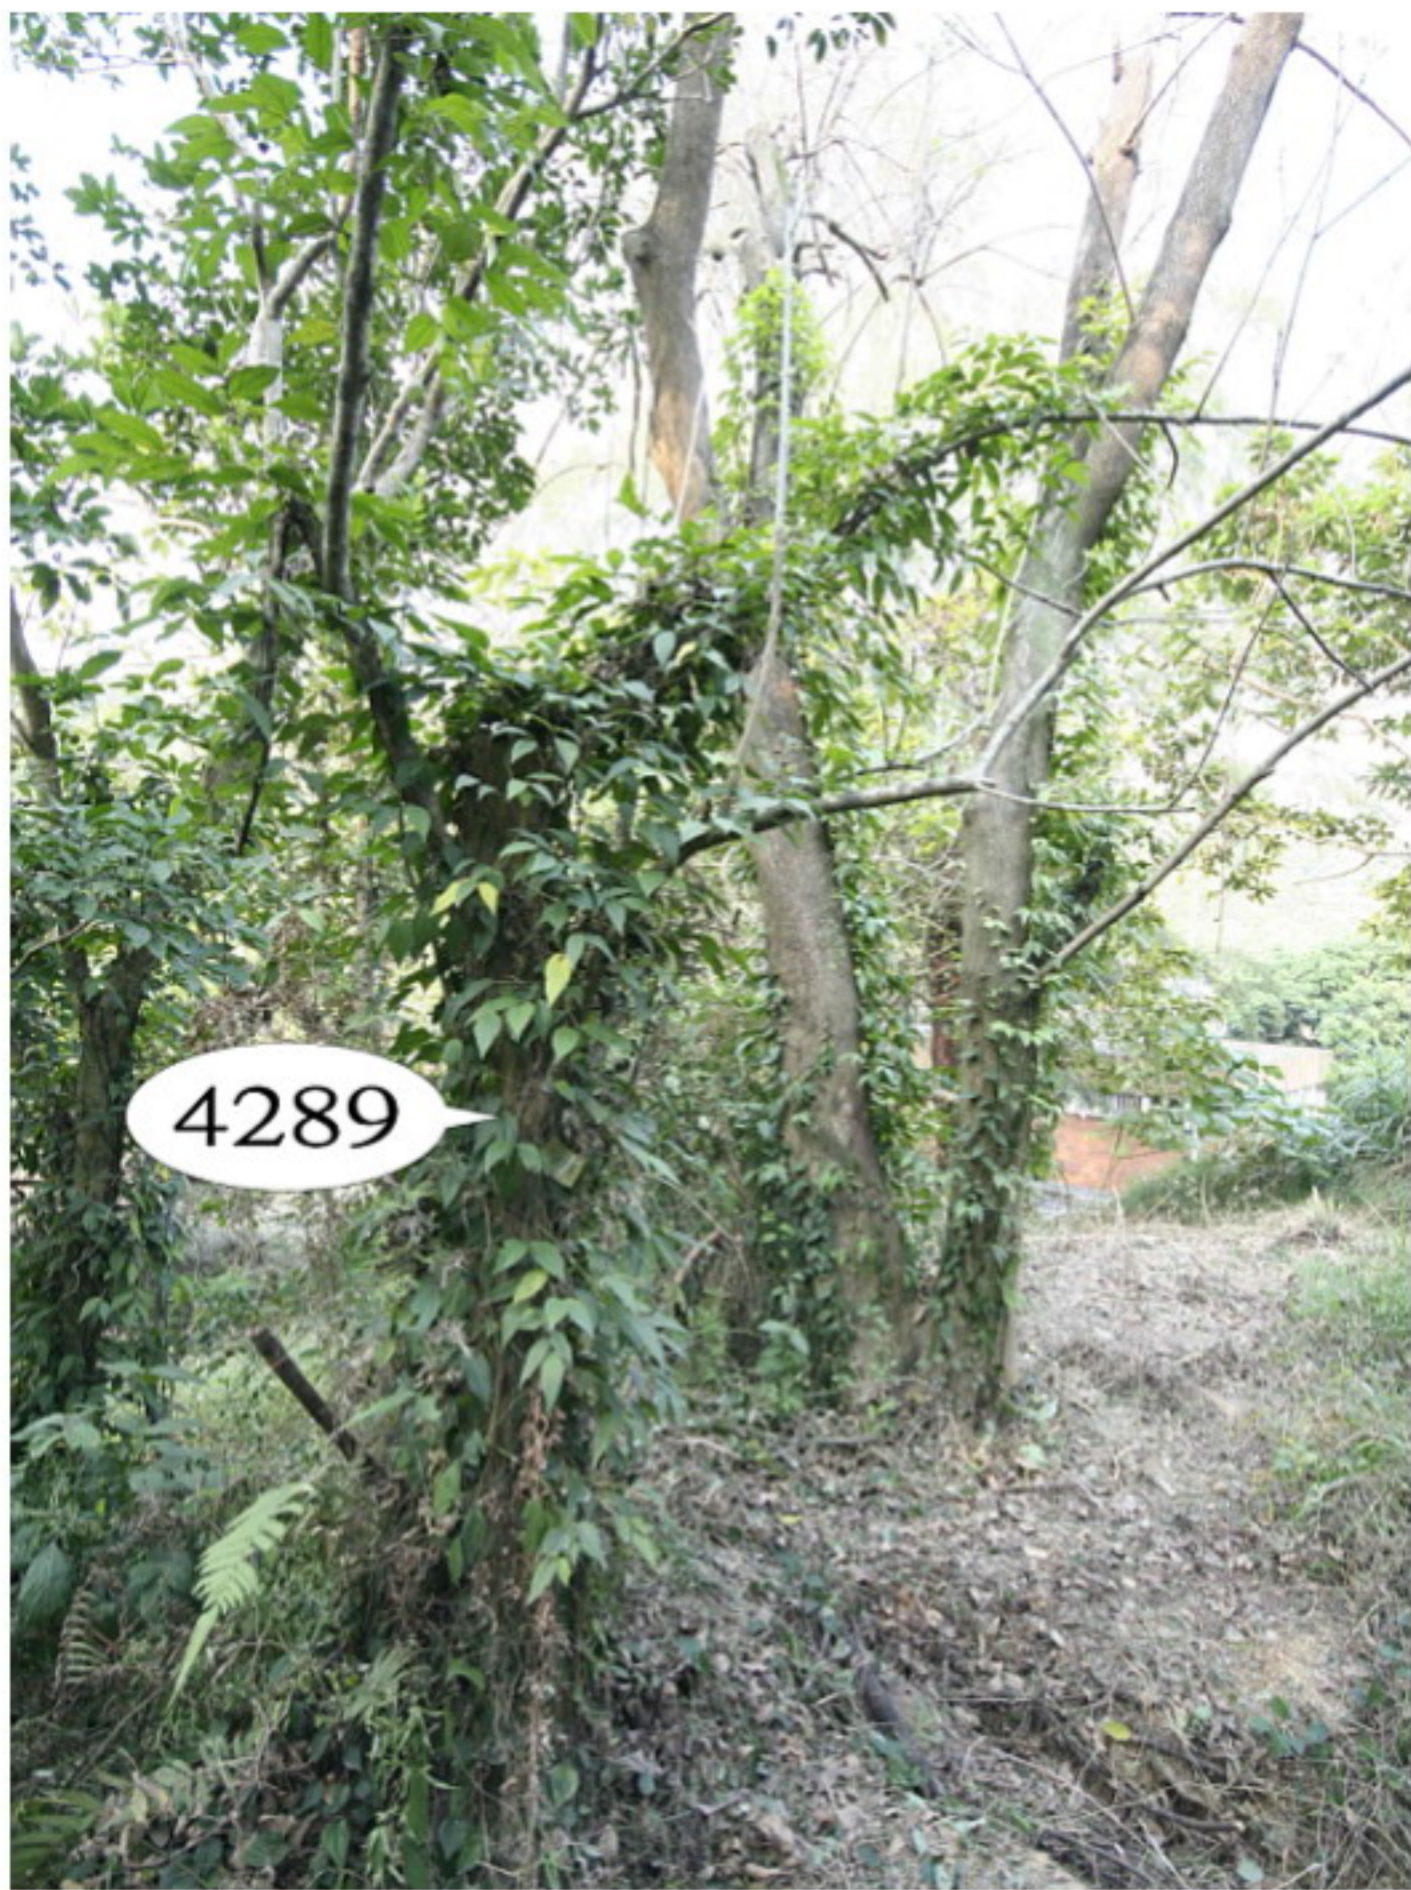
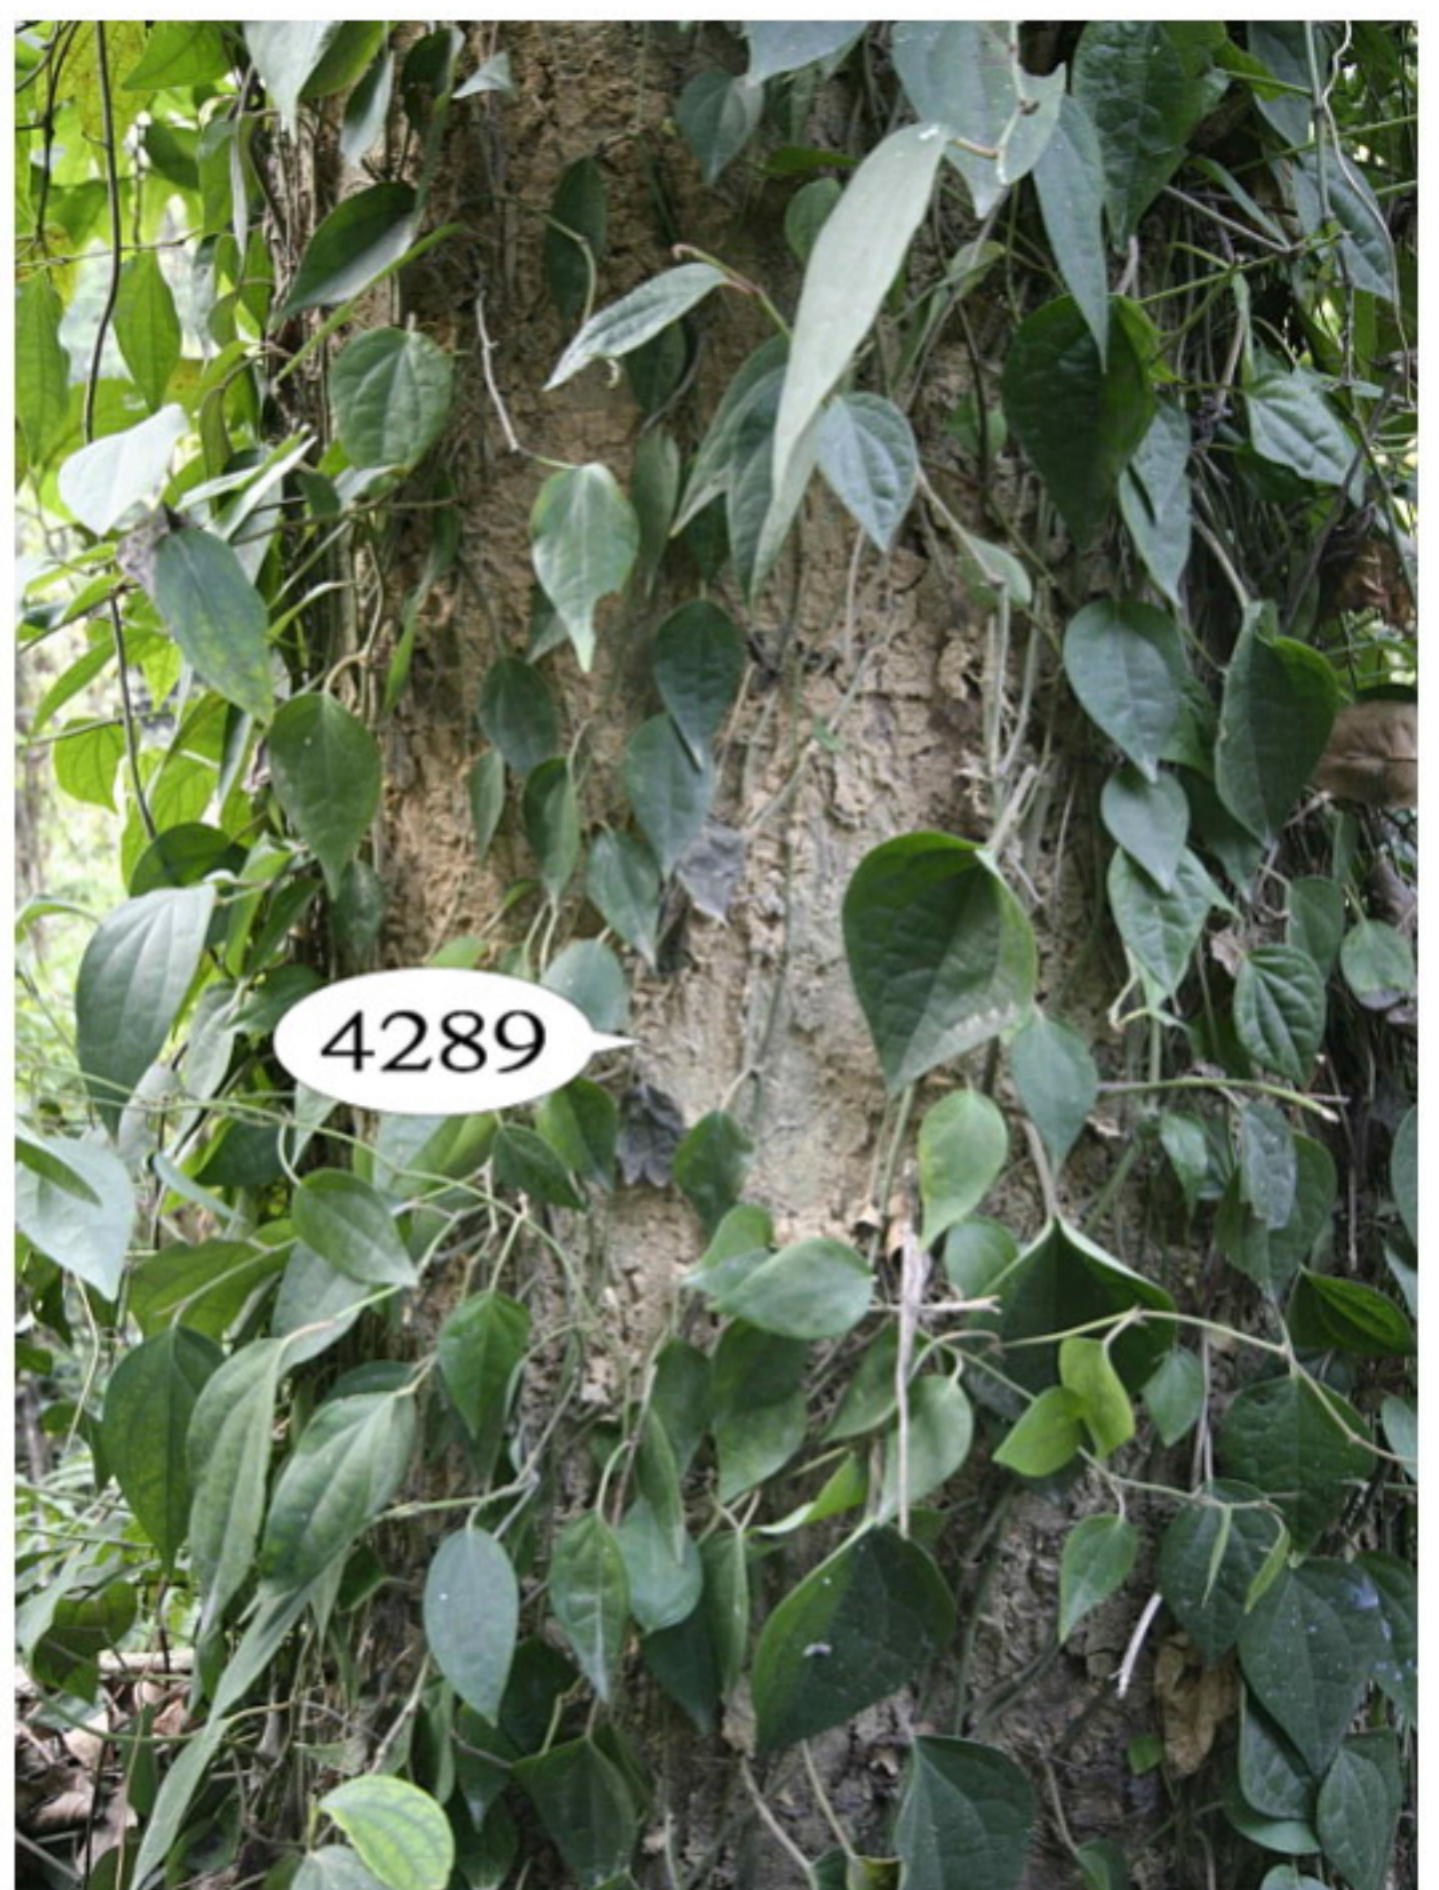
Tree 4289  
Dead Tree

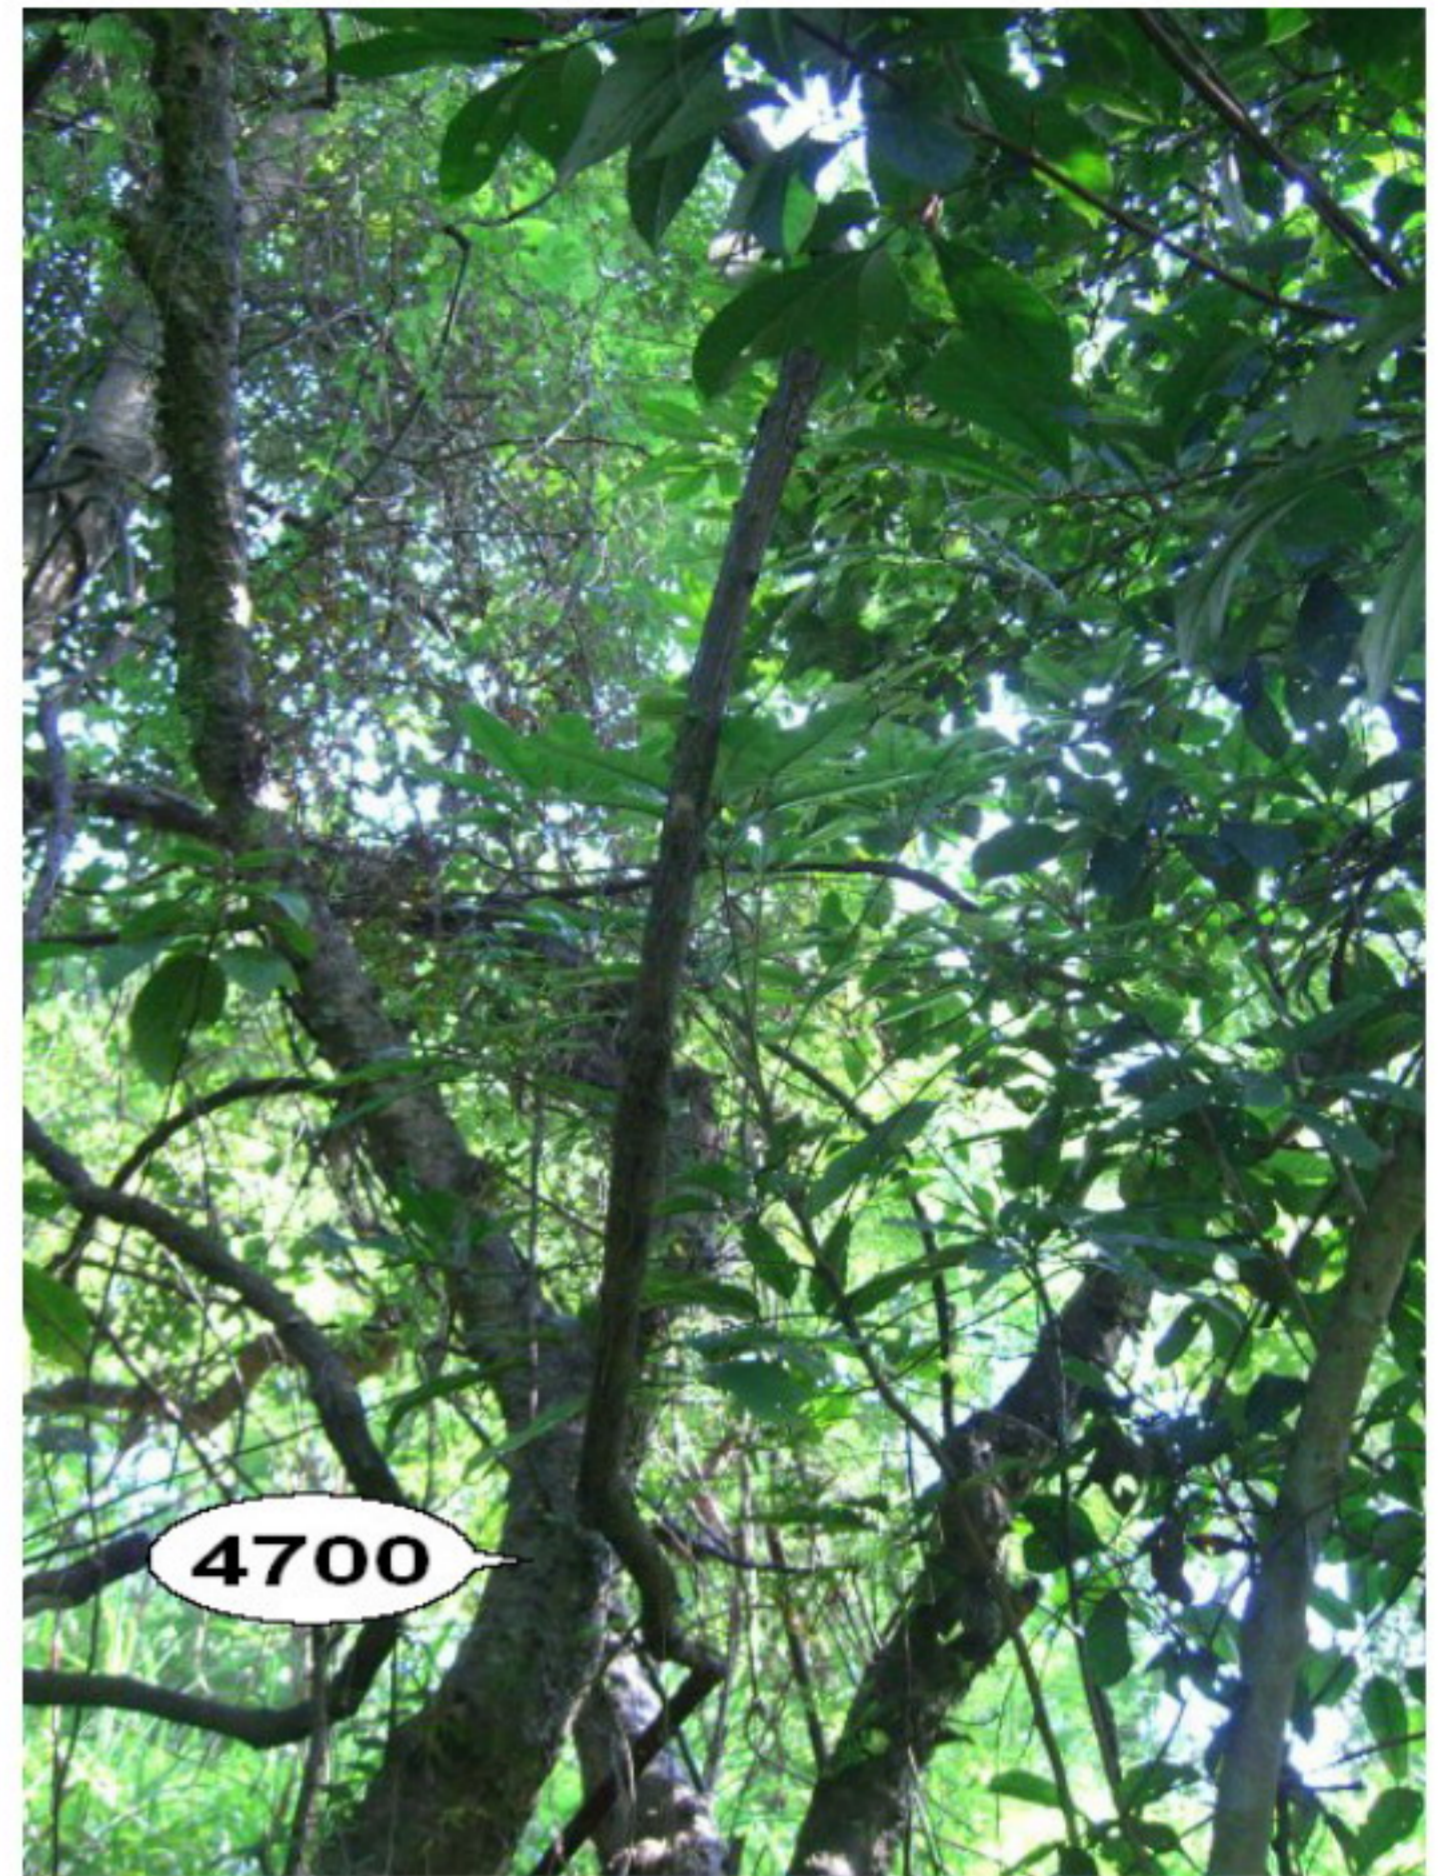
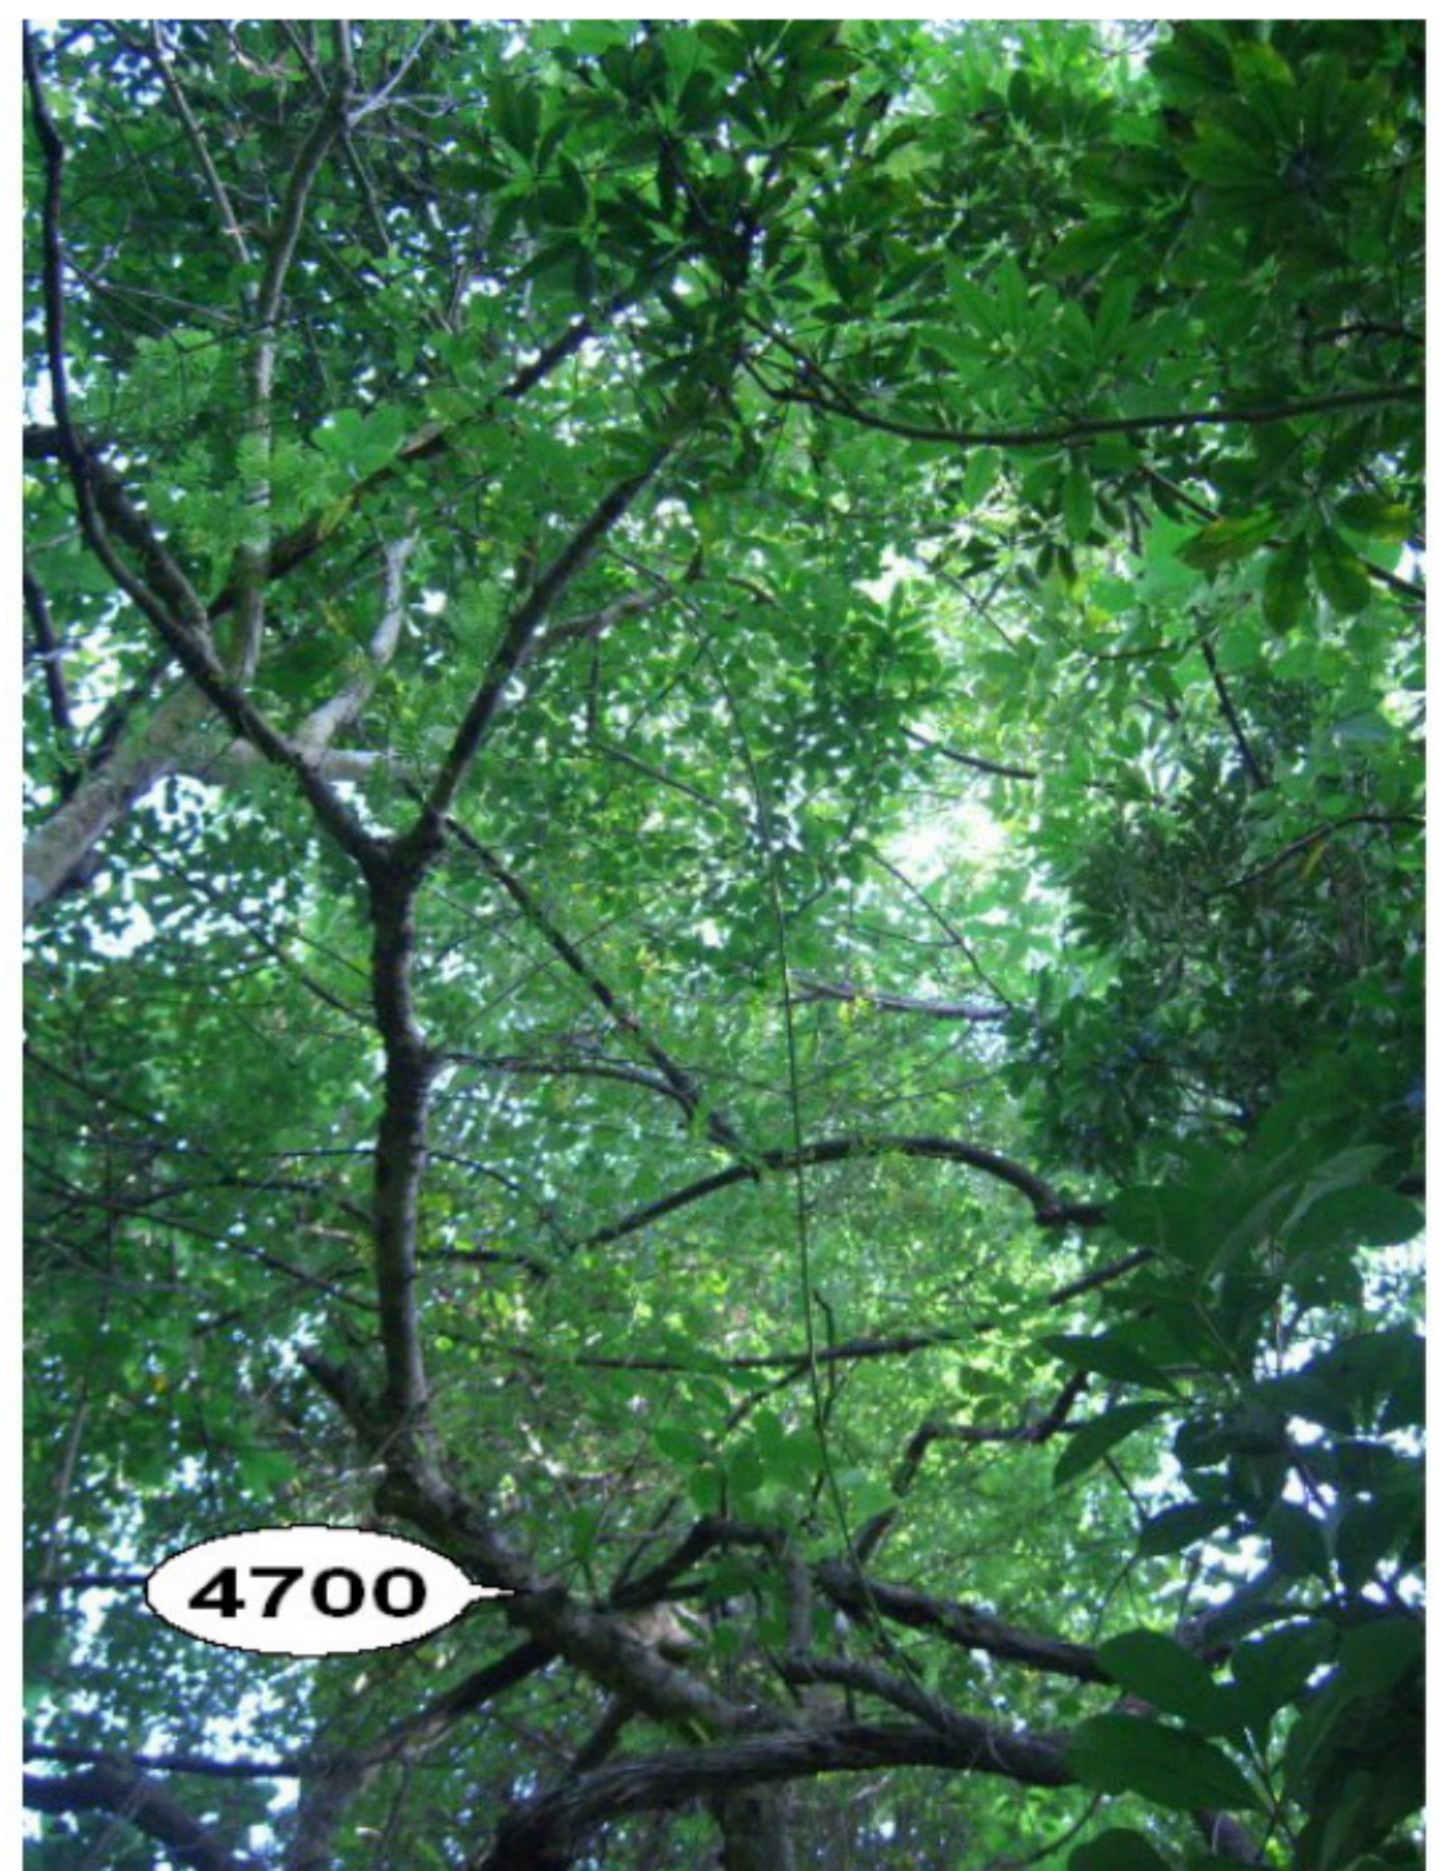
#### Tree 4700

Poor health will lead to low transplantation survival rate. Poor form which also lead to low amenity value. Besides, the tree is unbalance. It may need heavy pruning after transplantation that will affect its transplantation survival rate. Moreover, the operation of the transplantation for poor form tree is also difficult.
