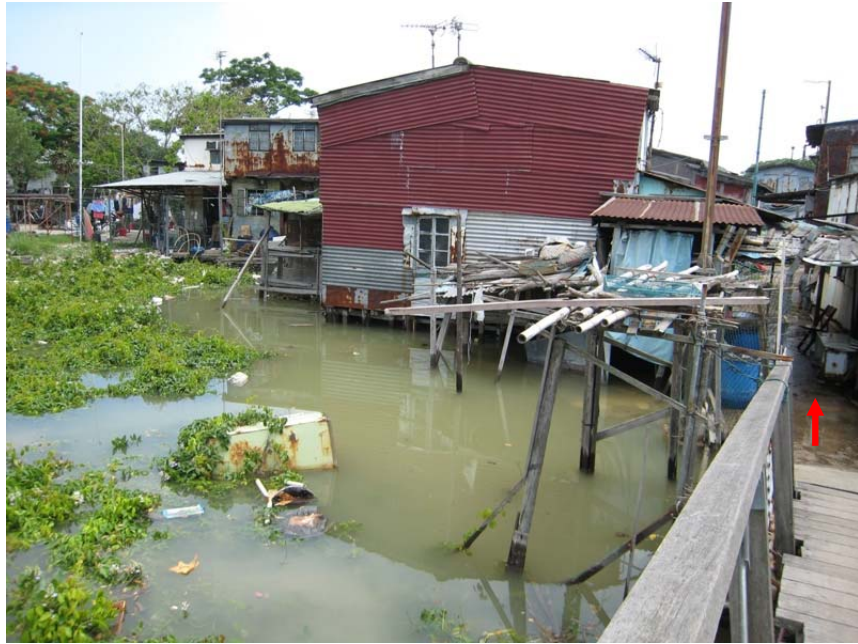
Plate 1
Majority of the dwellings in Hang Hau Tsuen are tin-sheeted and/or wooden structures on low-lying land. (red arrow indicates localized flooding of footpath due to over-topping of stream water during high tide)

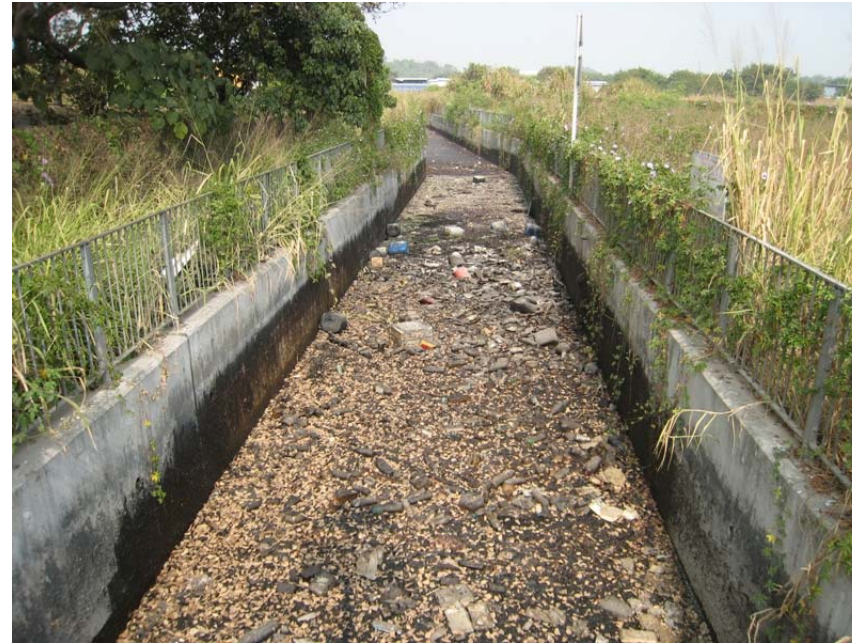
Plate 2
Polluted water from upstream San Hing Tsuen Channel.

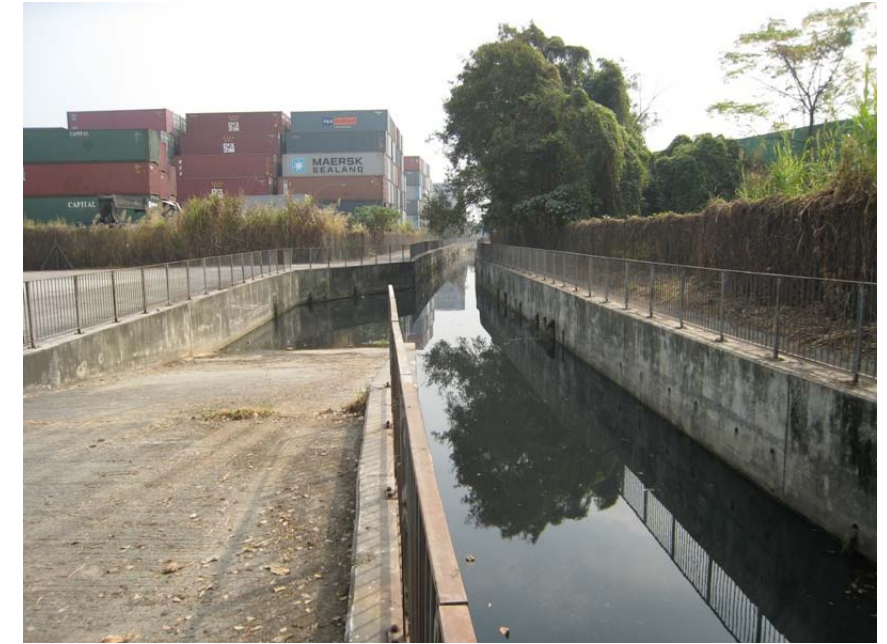
Plate 3
Polluted water from upstream Fung Kong Tsuen Channel.

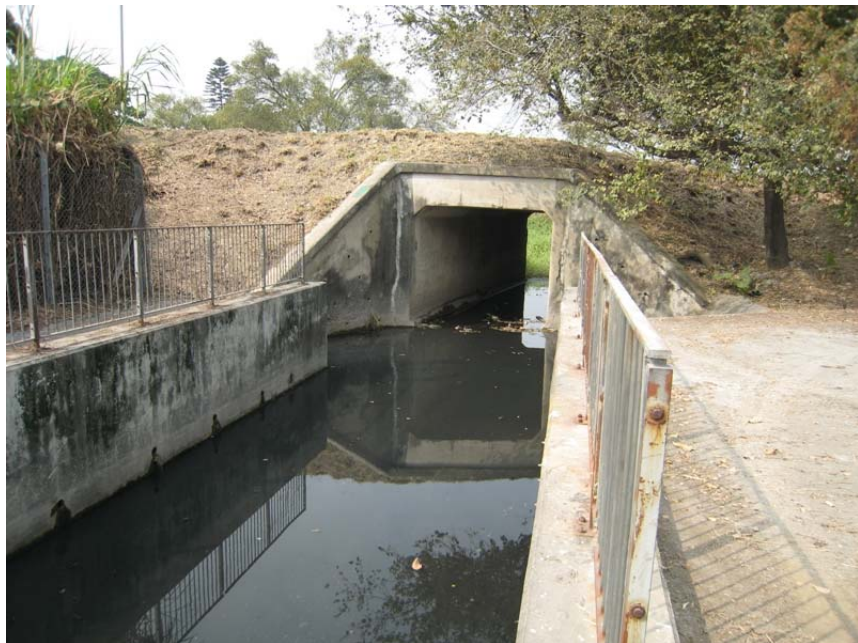
Plate 4
Water from San Hing Tsuen Channel and Fung Kong Tsuen Channel merges and drains into Hang Hau Tsuen stream via a single cell box culvert underneath Deep Bay Road.

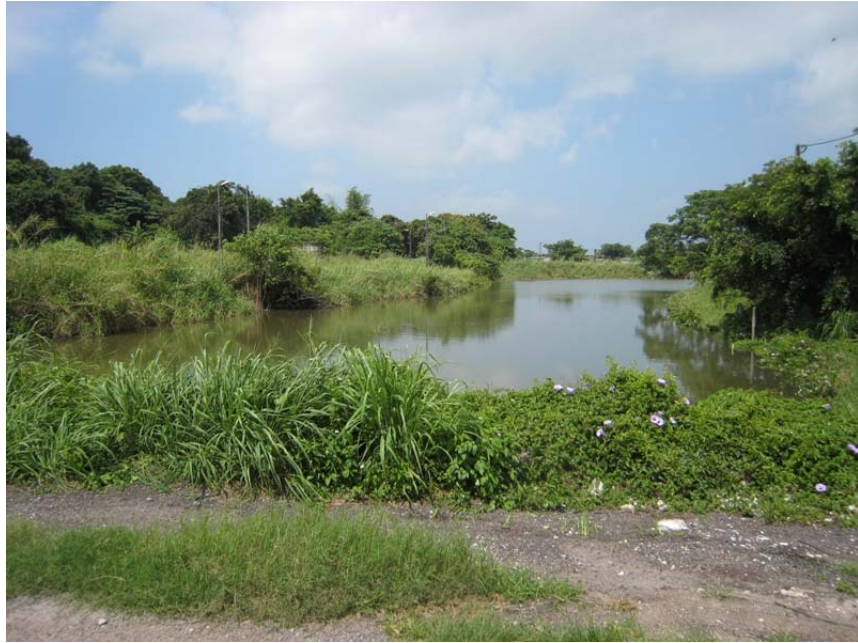
Plate 7
Abandoned fishpond within the Coastal Protection Area zone.

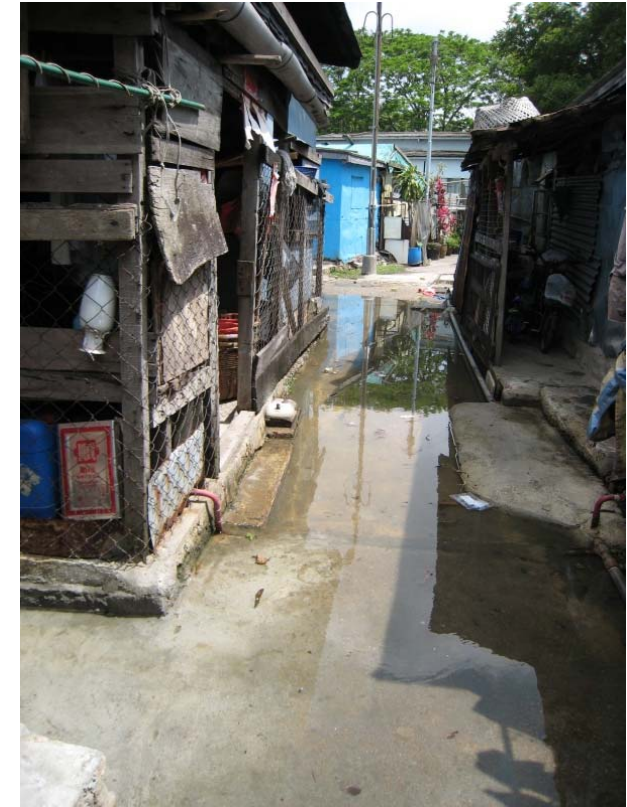
Plate 9
Localised flooding within Hang Hau Tsuen during high tide.

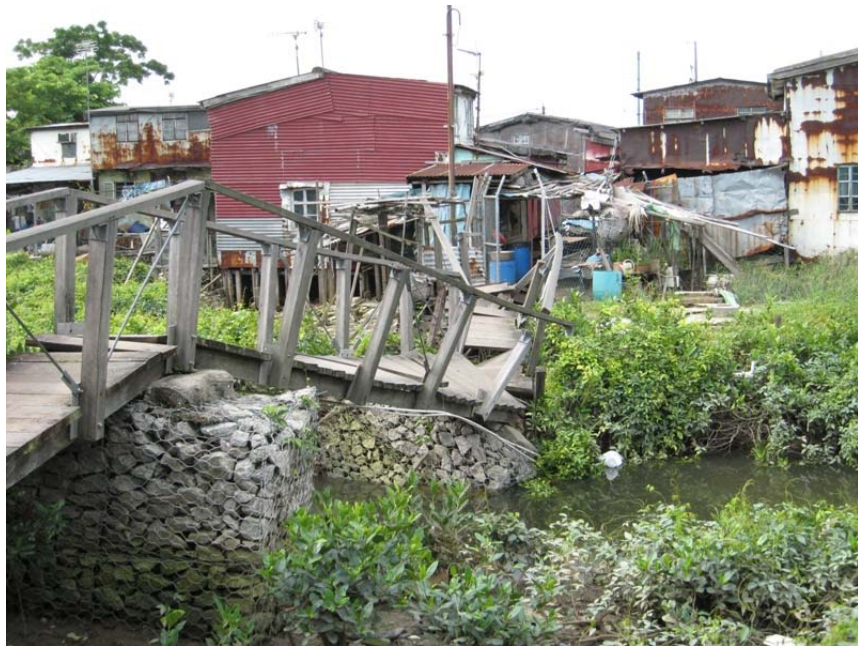
Plate 10
Collapsed footbridge (16 June 2008).

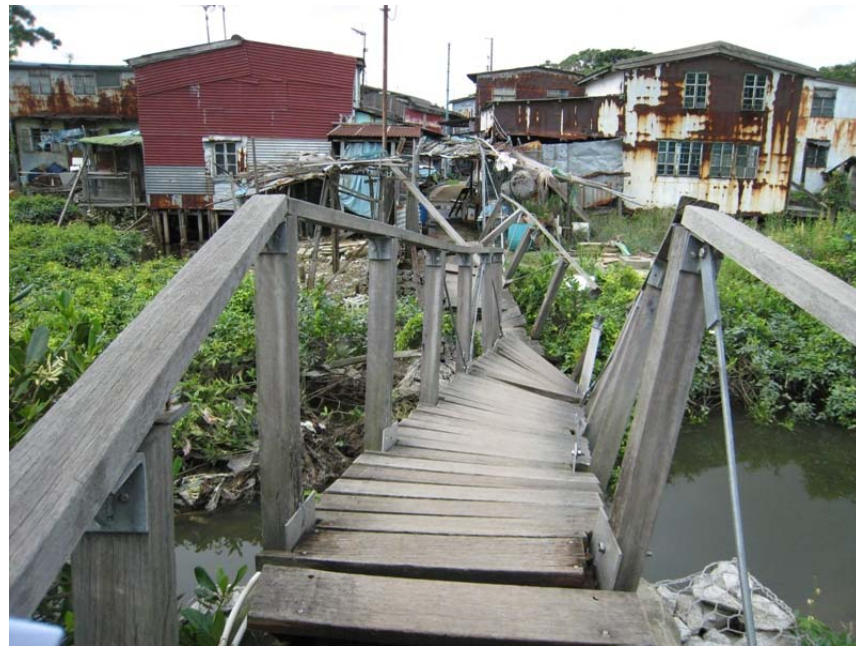
Plate 11
Collapsed footbridge (16 June 2008).
