**Asbestos Consultancy for
Phased Reprovisioning of
Cape Collinson Crematorium**

**Asbestos Investigation Report &
Asbestos Abatement Plan**

May 2008

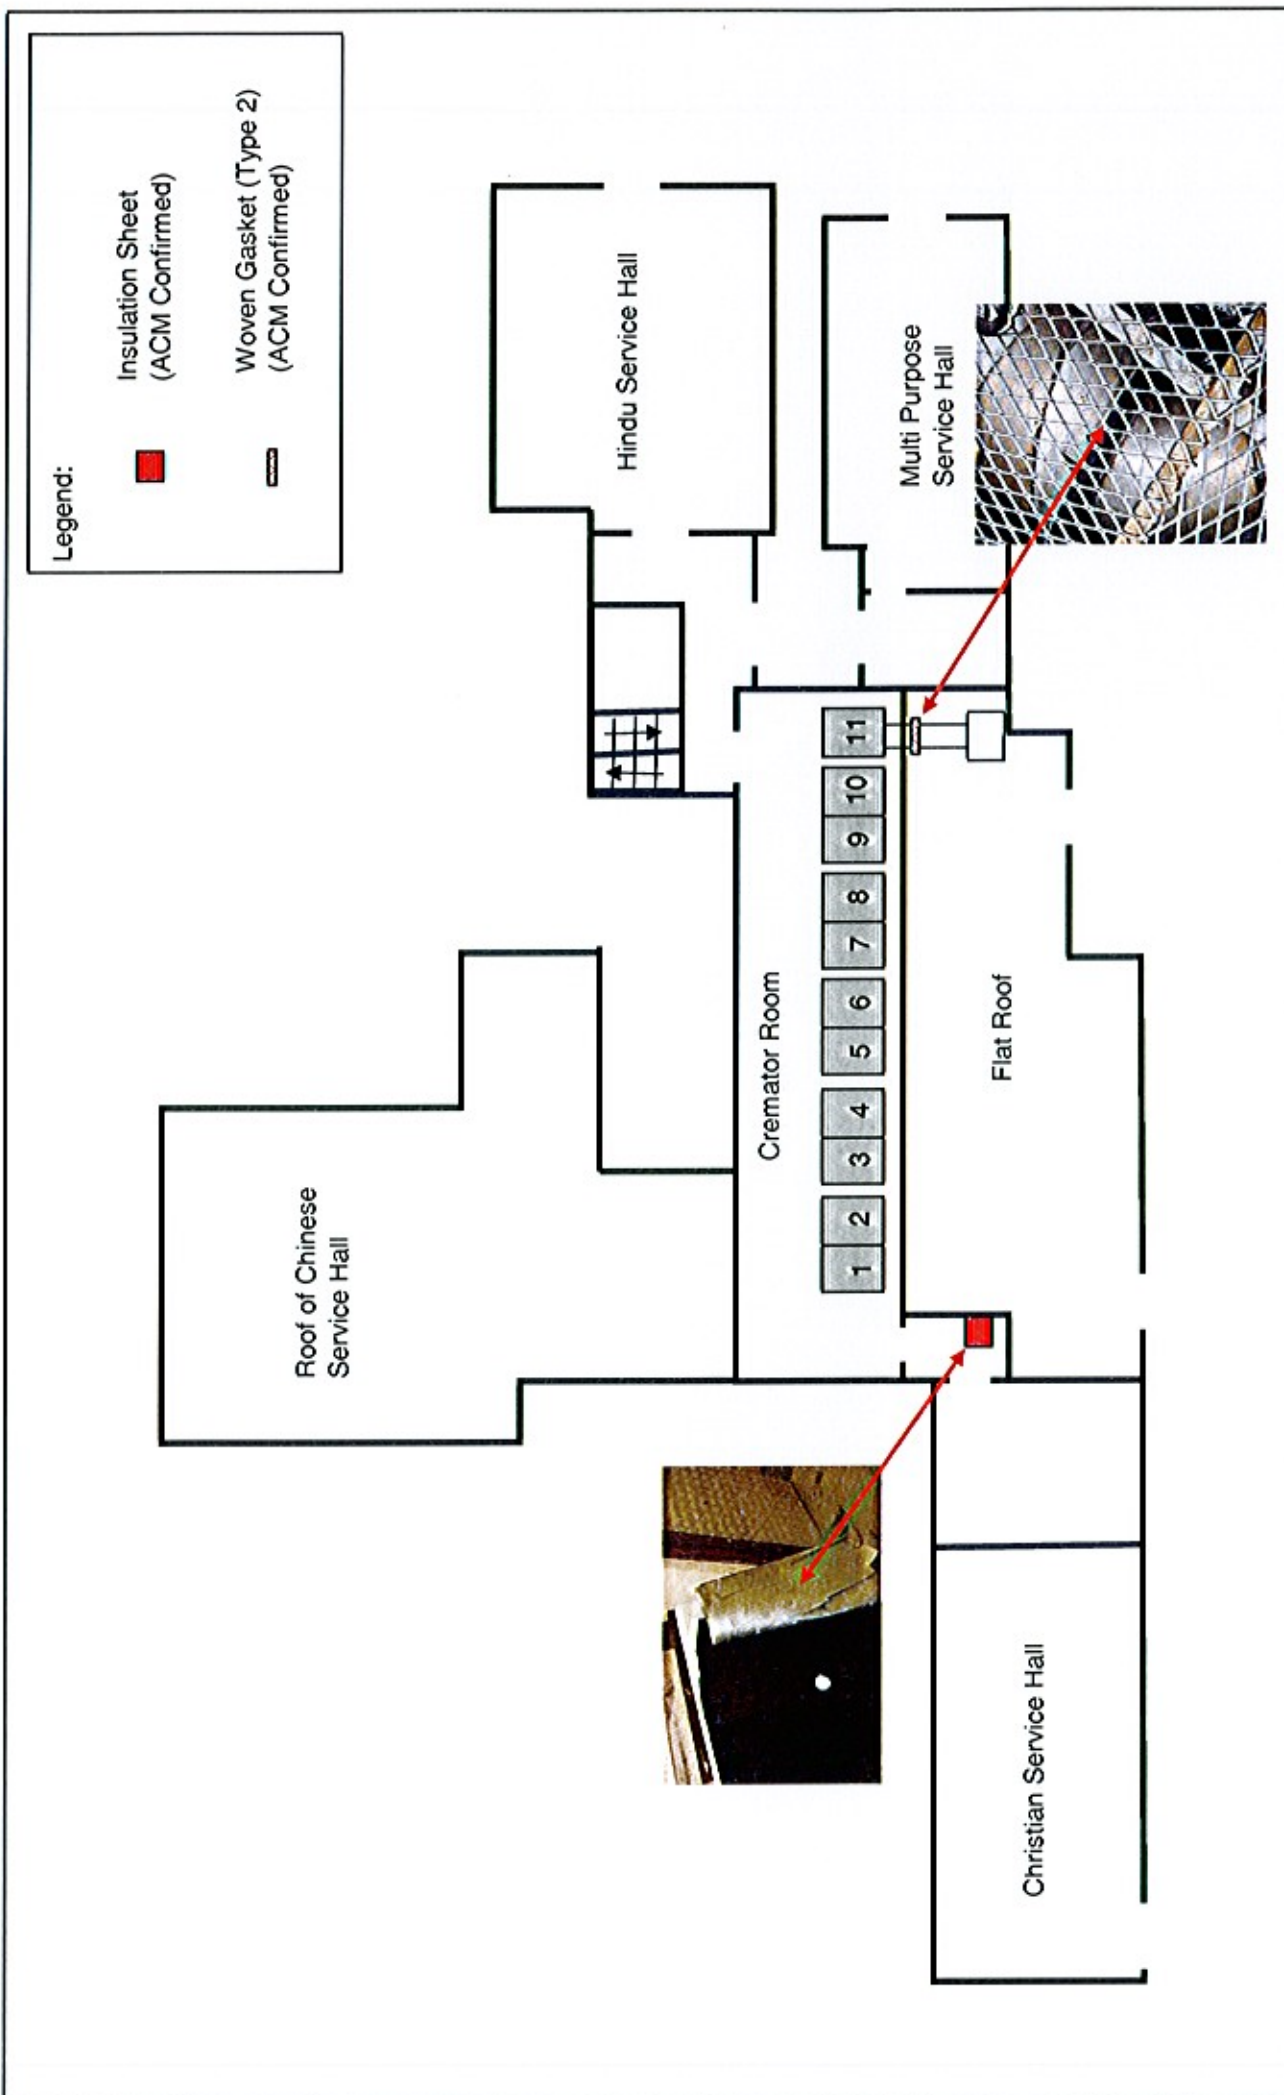
ENSR AECOM	Asbestos Consultancy for Reprovisioning of Cape Collinson Crematorium ACM Location Plan, G/F			SCALE N.T.S.	DATE Apr-08
	CHECK JOB NO.		DRAWN DRAWING No.		MCYT
	60028568		4.1		Rev -

4.1 Table 4-1 provide lists of ACMs based on the field inspection and the bulk sample analysis results. Locations of the ACMs are depicted in Figure 4.1 and photographs of these materials were shown in Appendix A.

- Insulation Sheet (ACM Confirmed)
- Woven Gasket (Type 2) (ACM Confirmed)

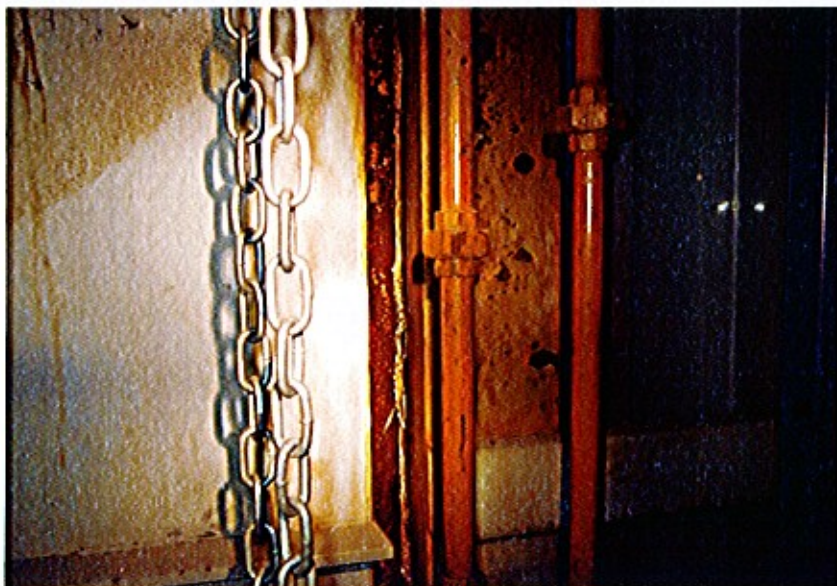
Photo 6:

Gasket (Type 1) at Hindu Service Hall

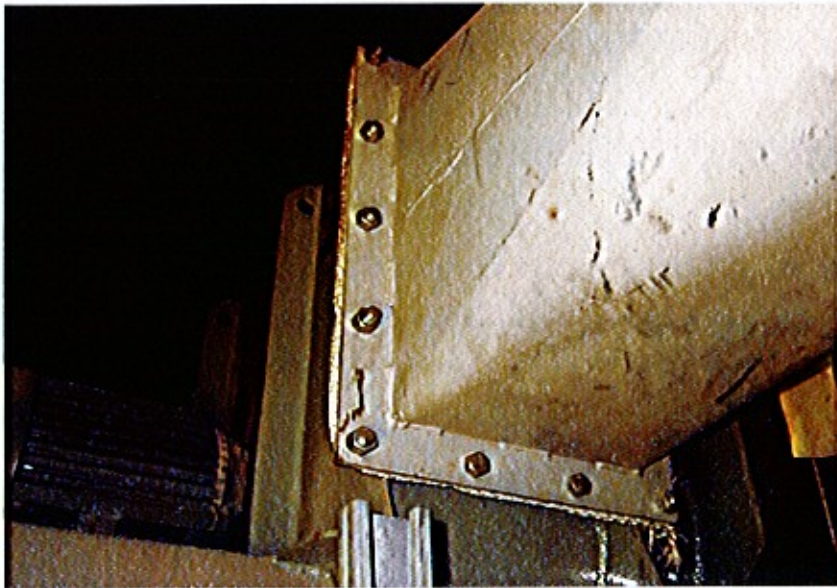
Photo 7:

Gasket (Type 1) at Hindu Service Hall

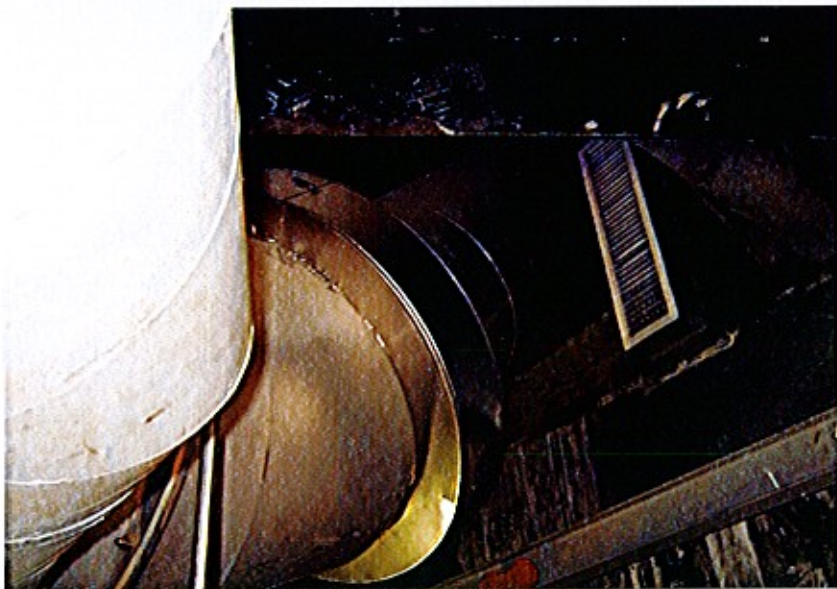
Photo 8:

Location	Photo No.
Gasket at flange of all flue exhaust at roof	8, 12, 18, 19, 24
Insulation material underneath the metal cover of exhaust flue	8, 12, 18, 19, 24
Interior lining of chimney stack	26
Connection between chimney stack and exhaust flue	29
Pipelines consealed in wall	12, 24
Cremator No. 1-11	11

Exhaust Flue for Cremator at Hindu Service Hall

- 7.5 Re-inspection to the in-accessible area (refer to section 2.2) by Registered Asbestos Consultant is necessary before any re-provisioning works to be carried out. A supplementary report to the accessible area shall be submitted to EPD for endorsement before any demolition work carry out.

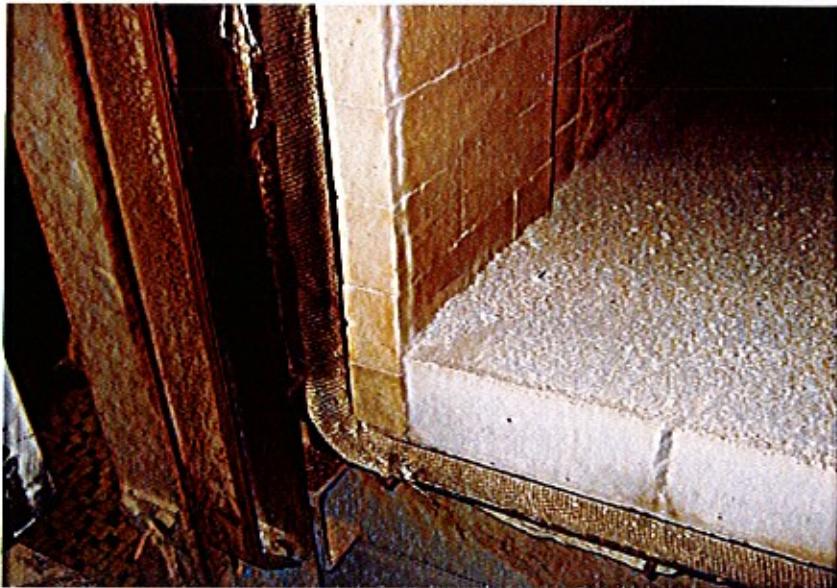
Photo 10:

Door Seal of Cremator at Hindu Service Hall

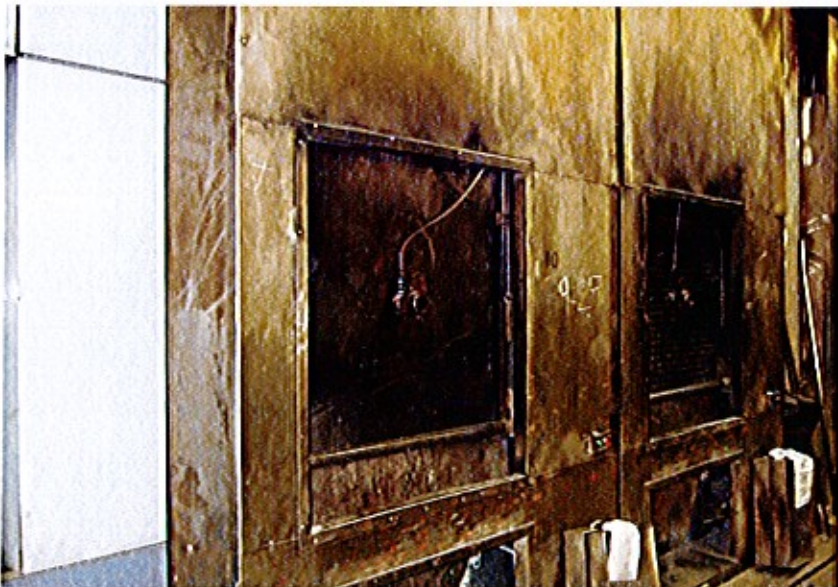
Photo 11:

Cremator No. 9 & 10 at Cremator Room

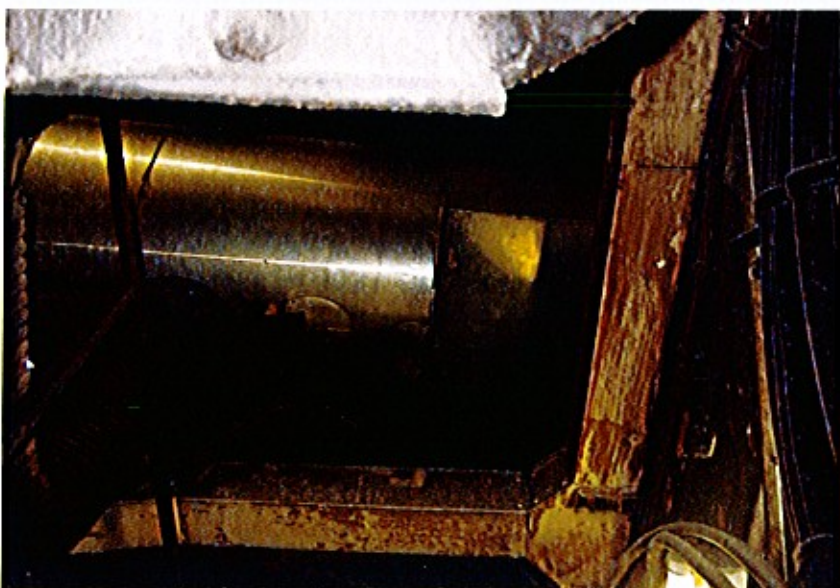
Photo 12:

Exhaust Flue at Cremator No. 1, Cremator Room

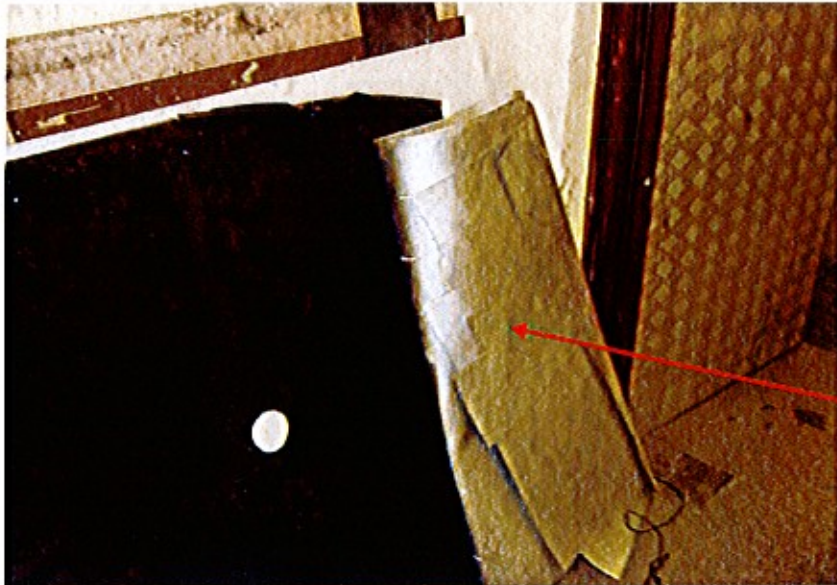
Photo 13:

Item	Description	Location	Estimated Quantity	Sample ID	Physical Condition	Photo	Figure	Type of Asbestos
CC-01	Flue gasket (Type 2)	Cremator No. 11 at Roof	1 no.	B/114/08/8 B/114/08/9	Good	23	4.1	80% Chrysotile
CC-02	Insulation sheet	Outside Cremation Room	1 sheet	B/114/08/6	Good	13	4.1	80% Chrysotile

ACM	Friability	ACM Condition	Factor of ACM Disturbance				Hazard Rank *
			Potential for Physical Contact	Potential for Air Erosion	Potential for Vibration	Overall Potential	
Flue gasket (Type 2)	Low	Good	Low	Low	Low	Low	1
Insulation sheet	Low	Good	Low	Low	Low	Low	1

Insulation Sheet outside Cremator Room

(ACM Ref. No. CC-02)
(ACM Confirmed)

- 7.3 Woven gasket found at cremator No. 11 is a non-exempted item under the APCO (Cap 311), therefore Registered Asbestos Contractors are required for the removal of the asbestos woven gasket. Whereas the insulation sheet outside the cremator room should be collected by Registered Asbestos Collector.

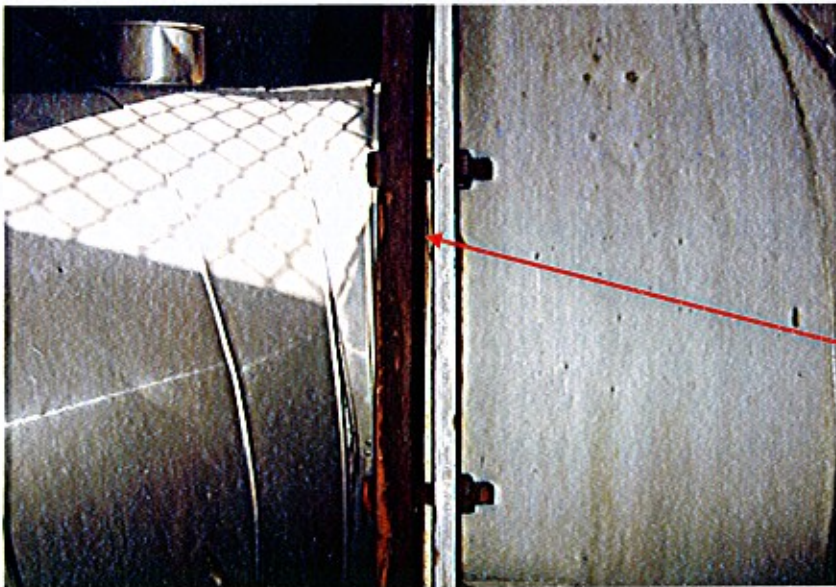
Photo 23:

Woven Gasket (Type 2) from
Cremator No. 11 outside Cremator
Room

(ACM Ref. No. CC-01)
(ACM Confirmed)

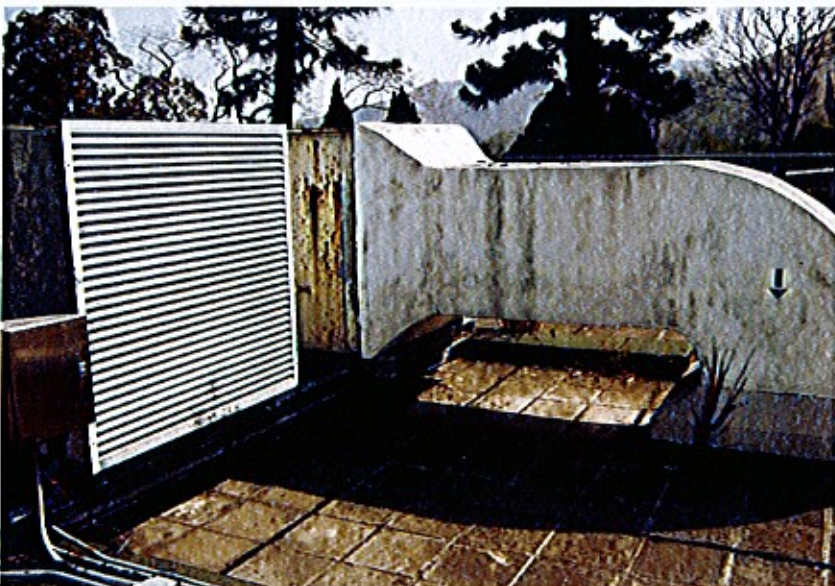
Photo 27:

Air duct insulation	B/114/08/11	Roof of Chinese Service Hall	3.1	27	Asbestos not detected	N
Air duct insulation	B/114/08/12	Roof of Chinese Service Hall	3.1	27	Asbestos not detected	N
Grille panel	B/114/08/13	Roof of Chinese Service Hall	3.1	4	Asbestos not detected	N
PVC floor tile with mastic (12" grey)	B/114/08/14	General Office	3.2	28	Asbestos not detected	N
PVC floor tile with mastic (12" grey)	B/114/08/15	General Office	3.2	28	Asbestos not detected	N

Air Duct Insulation Material at Roof of Chinese Service Hall

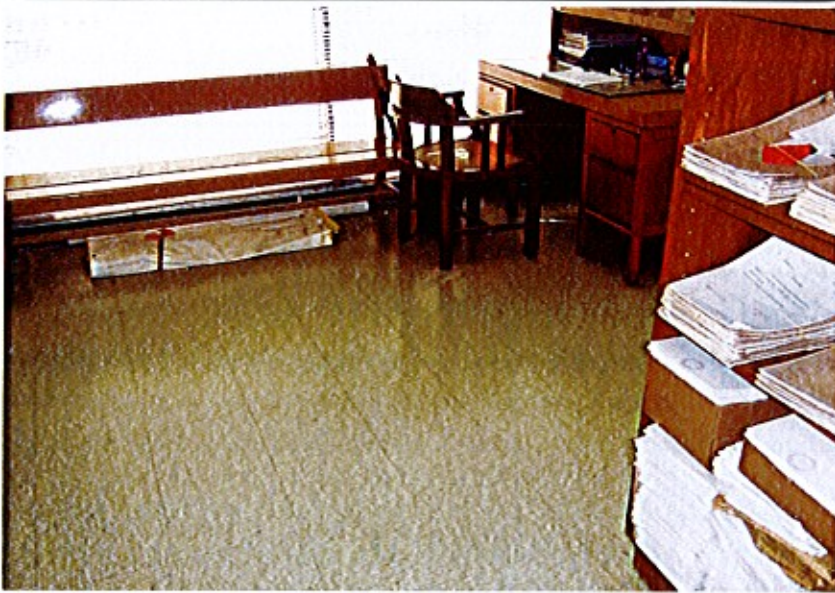
Photo 28:

Floor Tile at General Office

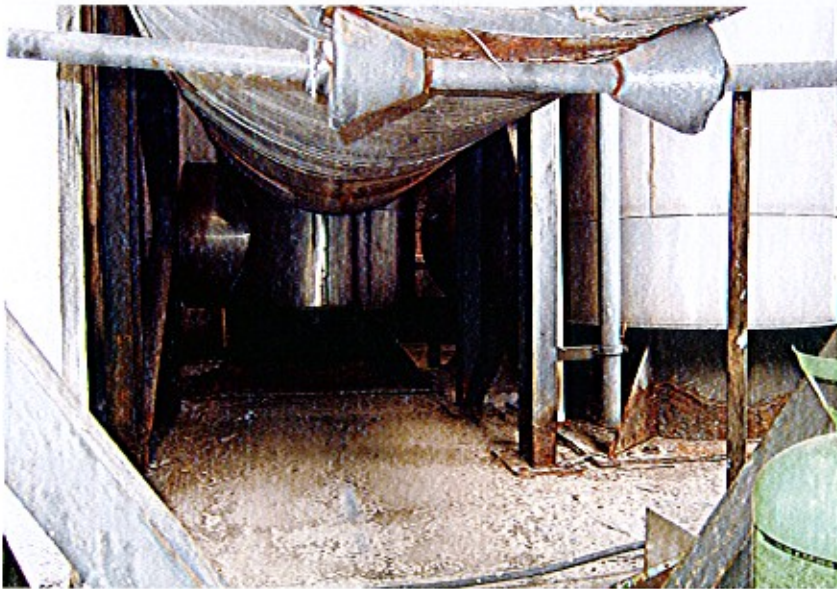
Photo 29:

Connection of Exhaust Flue to the Chimney Stack
