Shatin to Central Link Tai Wai to Hung Hom Section

WP CE15 Conditions Survey of
Former Royal Air Force Hangar in Diamond Hill

July 2009

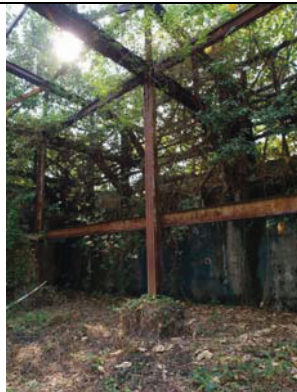
2.1.1 With reference to **Figure 1**, the site area of the aircraft hangar is about 60m x 30m. The structure is a single storey steel structure supported by 31 steel-I-columns with concrete footings (**Photo 1**) and retained by the concrete retaining wall (**Photo 2**). In order to locate and describe the structure member of the aircraft hangar clearly, the whole structure is divided into 31 locations of steel-I-columns as shown in **Appendix A**. It was essential to note down all the visually observable defects by the naked eyes particularly for the lower levels of the structures at safe and accessible level. The summary of visible defects and photographic records are presented in **Appendix B**.

Photo 1 – Steel-I-column with concrete footing

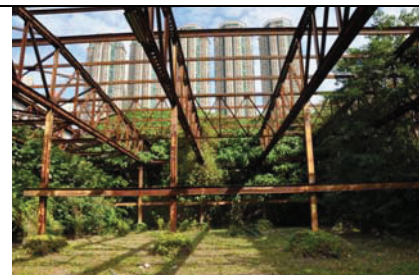
2.2.1 The original aircraft hangar is built of steel members and its roof is formed by the truss with corrugated zinc sheet roof and bitumen sheet waterproofing layer on top (**Photo 2**). The truss roof (**Photo 4**) is supported by a series of steel I-columns and concrete block footings, as shown in below photos. The side walls are also built of steel channels tied with the steel-I-columns along the perimeter of structure and covered with corrugated zinc sheet cladding. Typical defect photos are extracted and shown in **Appendix C**.

Photo 4 – Significant rusting at beam on roof

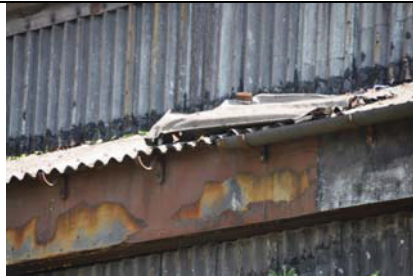
2.2.2 With reference to the visual survey, the existing aircraft hangar is in poor condition in view of lacking of maintenance and protection on the roof and side-walls. There are some corrugated zinc sheets with waterproofing bitumen sheet coating on the roof sheeting at the main entrance of the aircraft hangar (**Photo 5**). Majority of the defects identified in the survey were associated with corrosion and deterioration of the steel components, particularly the locations of interface between different materials or elements (**Photo 6**). Water and moisture were easily retained in these places and induced corrosion. Besides, both protective coatings peel off and direct contact of different metal materials (e.g. Stainless / galvanized steel with carbon steel), with so-called bi-metallic corrosion, will accelerate the corrosion of steel frames. The corrosion of metallic elements will reduce loading capacities and service life of the structure. Surface preparation and re-coating of these steelworks are recommended to stop further corrosion.

Photo 5– Corrugated zinc sheet with waterproofing bitumen sheet coating

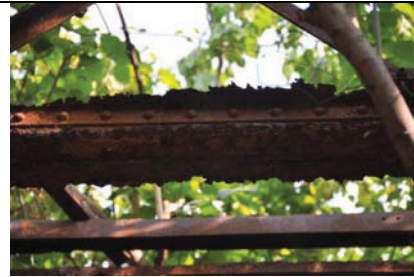
Photo 6– Significant rusting at beam on roof

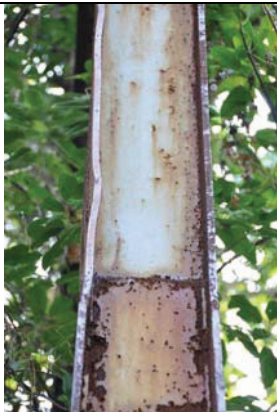
2.2.3 As the aircraft hangar structure had been exposed to the atmosphere for long period under wet and dry weather, most of the steel members of the frame were corroded with different levels of deterioration. Particular to the small steel members, they are deteriorated with less than 50% of original size left and some even broken and fallen down on the floor. Most of the bolts and nuts at the connection joints of the structure were corroded and deteriorated; this would reduce the whole structural strength of the aircraft hangar, and would also cause impacts to the relocation of the structure. A few steel-I-columns have buckled (**Photo 7**). Most of the concrete footings at each steel-I-column and side walls are grown with vegetation (**Photo 9 & 10**), which would increase the difficulty of relocation of the structure.

Photo 7 – Buckle at I-beam

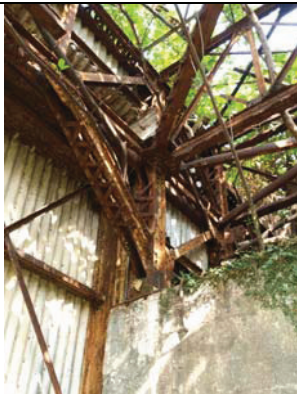
Photo 8 – Corroded and deteriorated steel frame

- 2.2.4 According to the survey result, it is difficult to relocate the aircraft hangar as most of the steel members and joints are partly or fully corroded and deteriorated (**Photo 8, 11 to 14**). The whole structure of the aircraft hangar may fall down if any member of the aircraft hangar is dismantled.

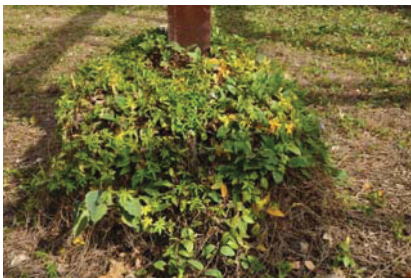
Photo 9 – Location 9 - Grown vegetation at the footing

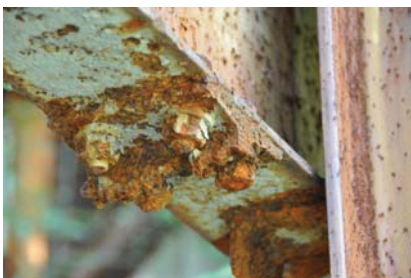
Photo 11 – Corroded bolts and nuts at joint

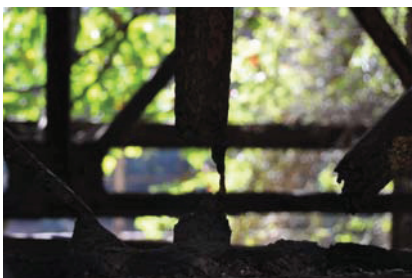
Photo 12 – Damaged steel members

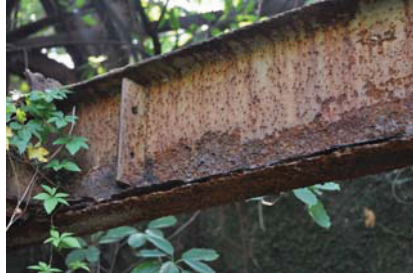
Photo 13 – Significant rusting at beam on roof

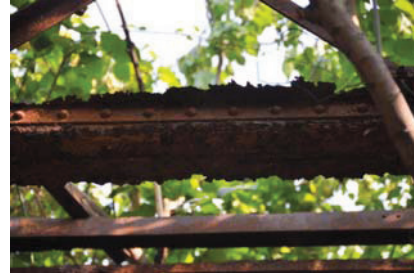
Photo 14 – Significant rusting at beam on roof

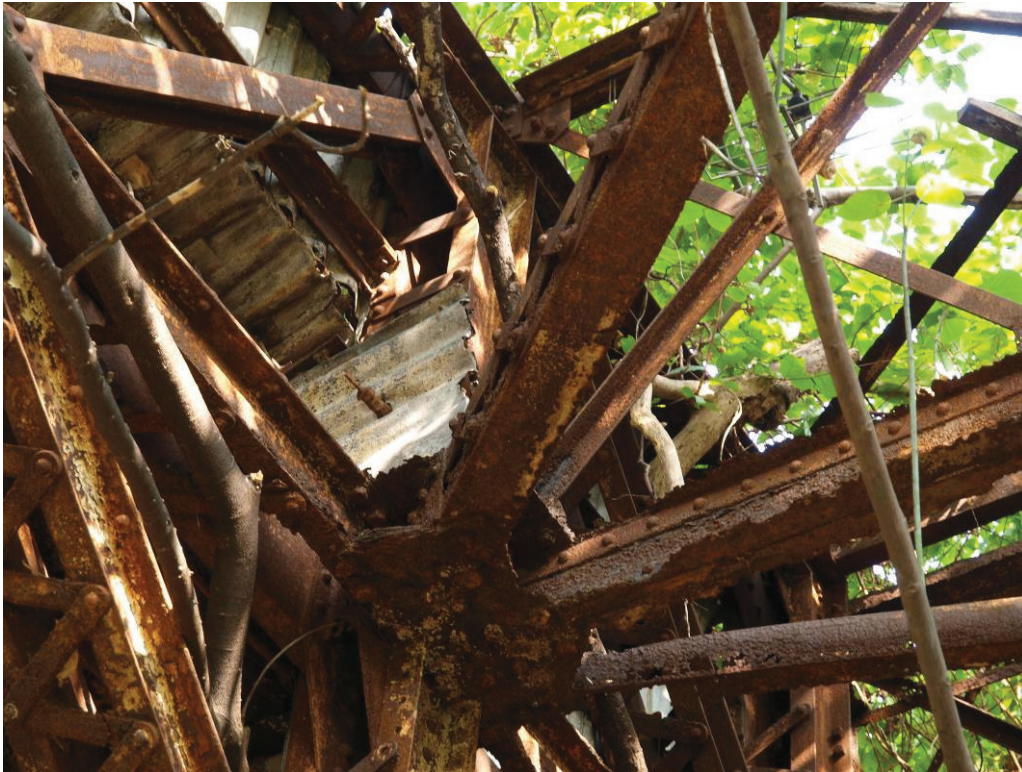
Photo P1070434 – Location 04 – roof structure

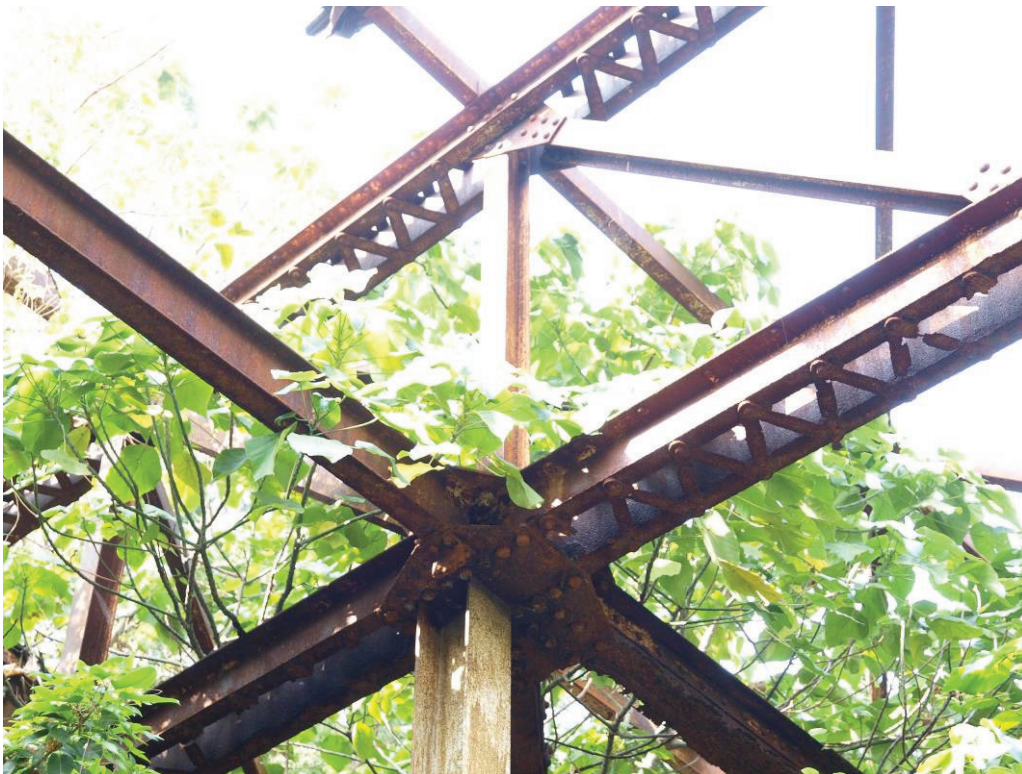
Photo P1070437 – Location 06 – roof structure and support

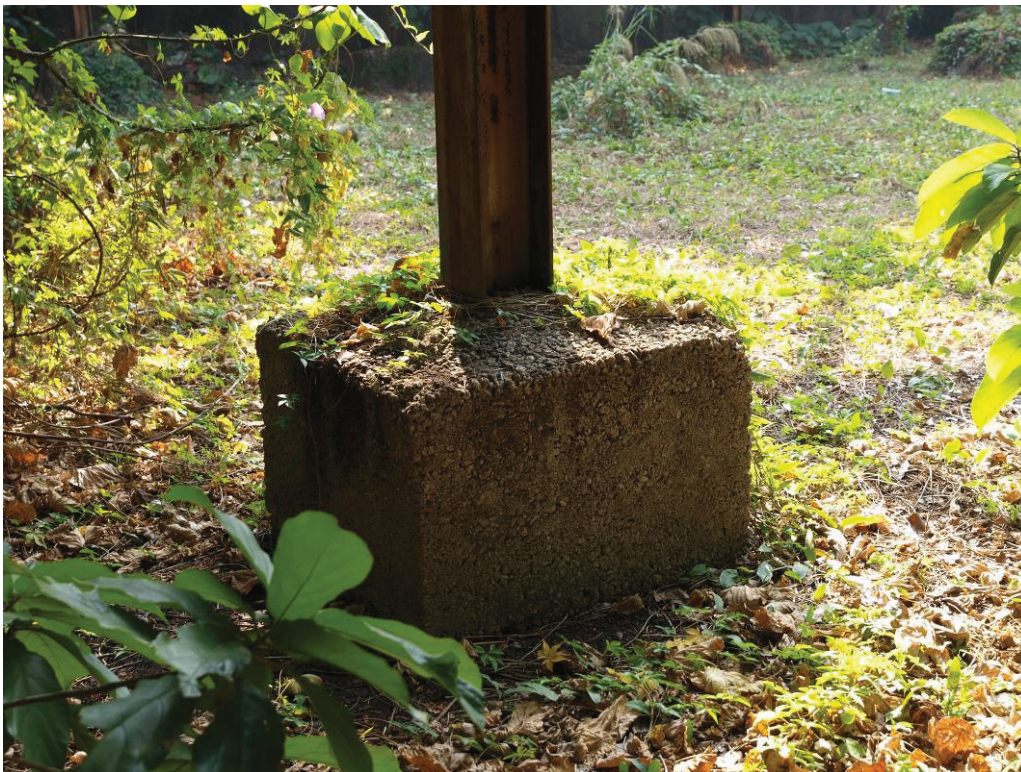
Photo P1070455 – Location 8 – footing block

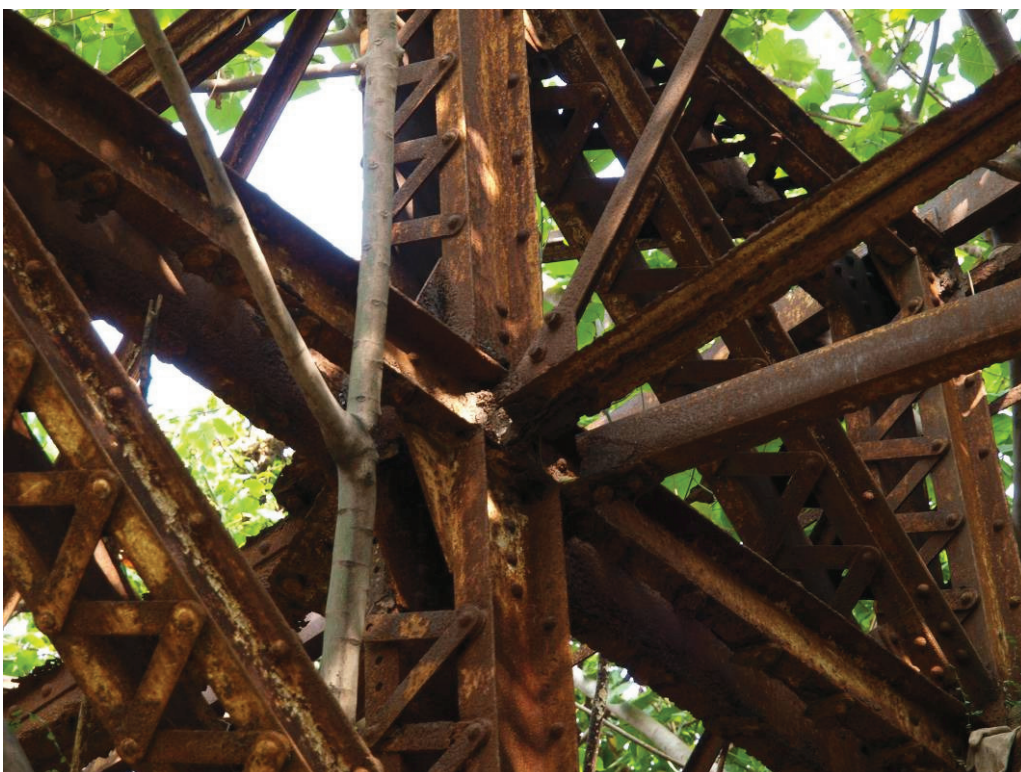
Photo P1070460 – Location 9 – roof structure

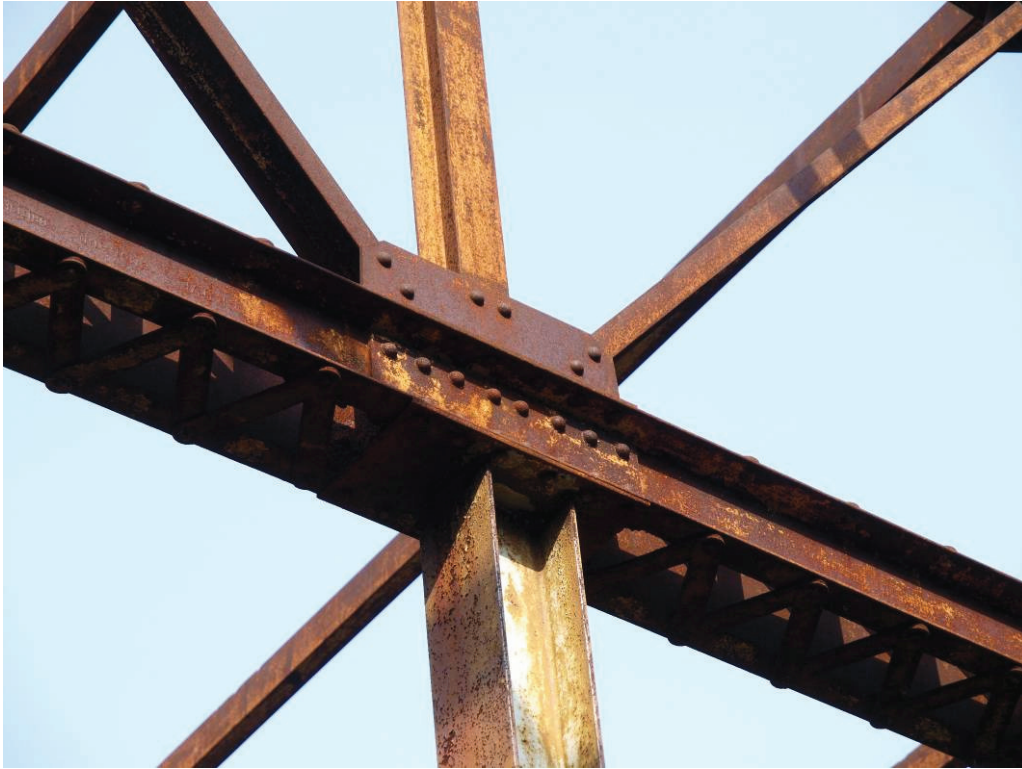
Photo P1070477 – Location 12 – roof structure and support

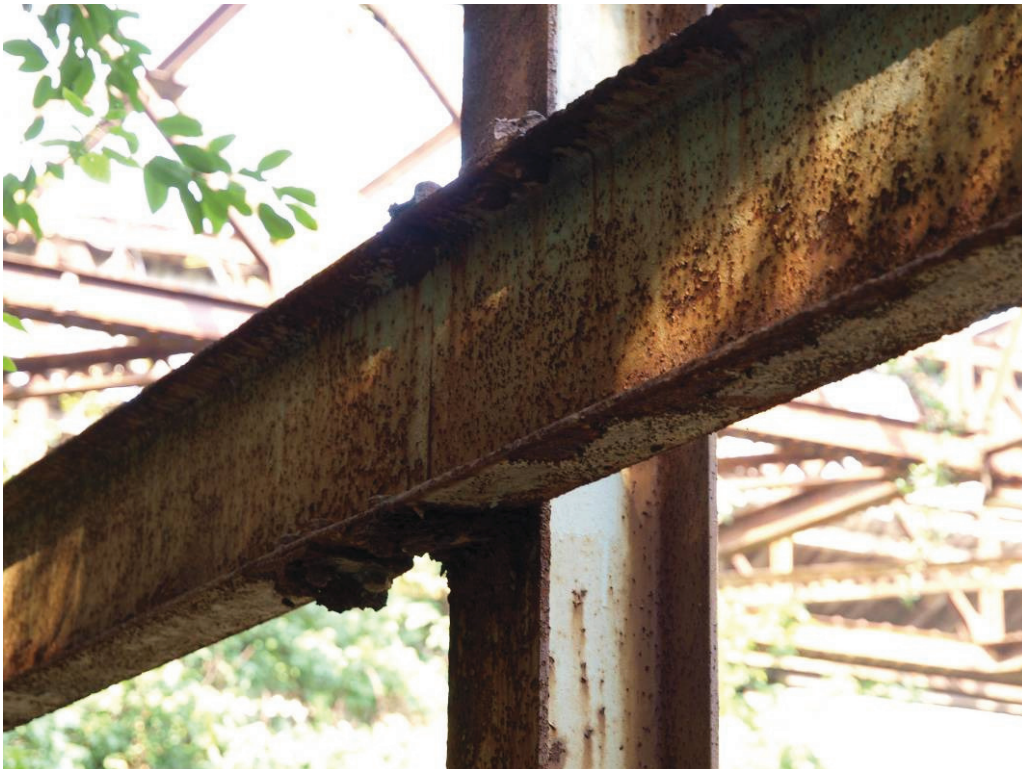
Photo P1070508 – Location 16 – at mid height of column

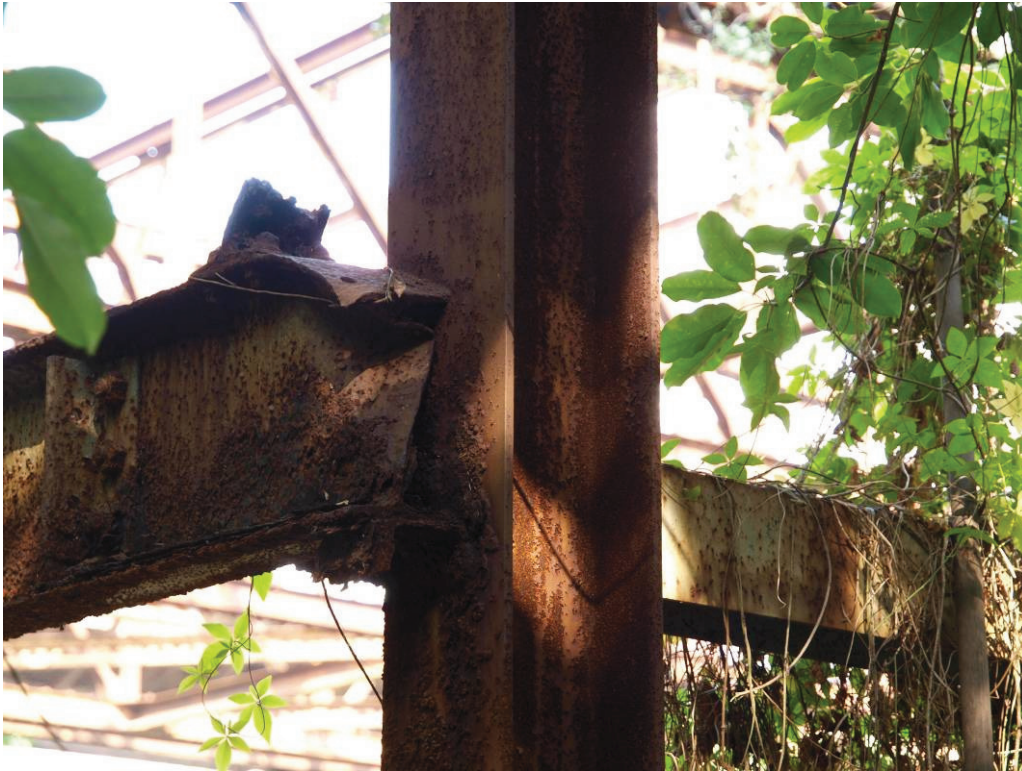
Photo P1070541 – Location 21 – at mid height of column

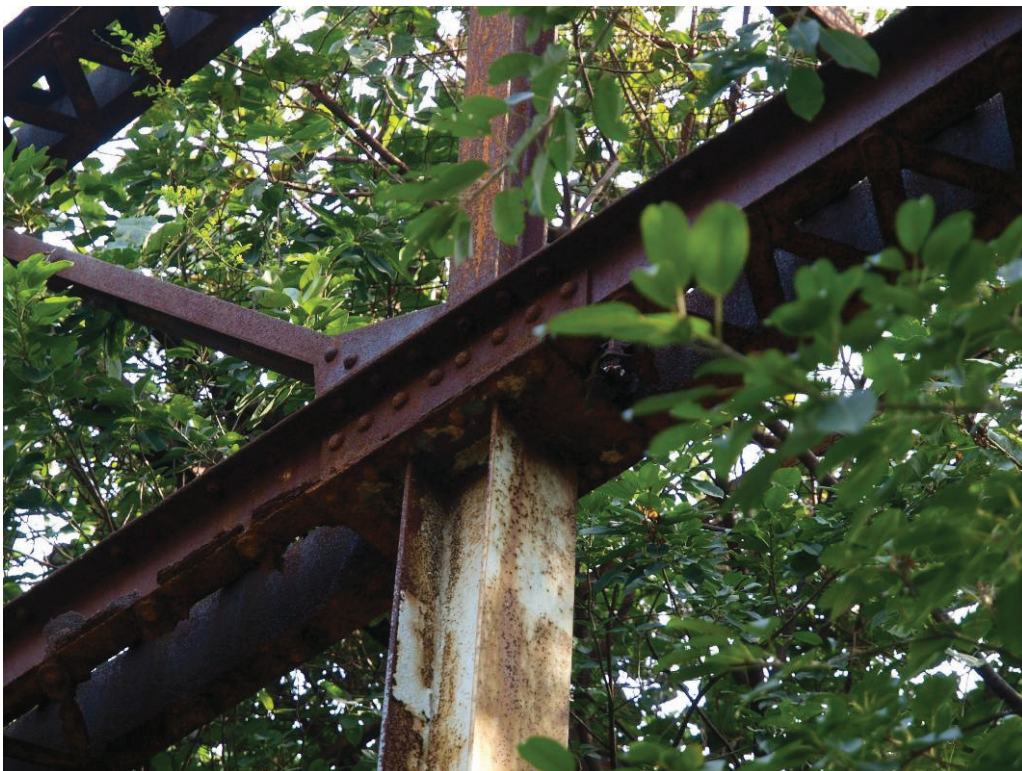
Photo P1070575 – Location 26 – roof structure and support

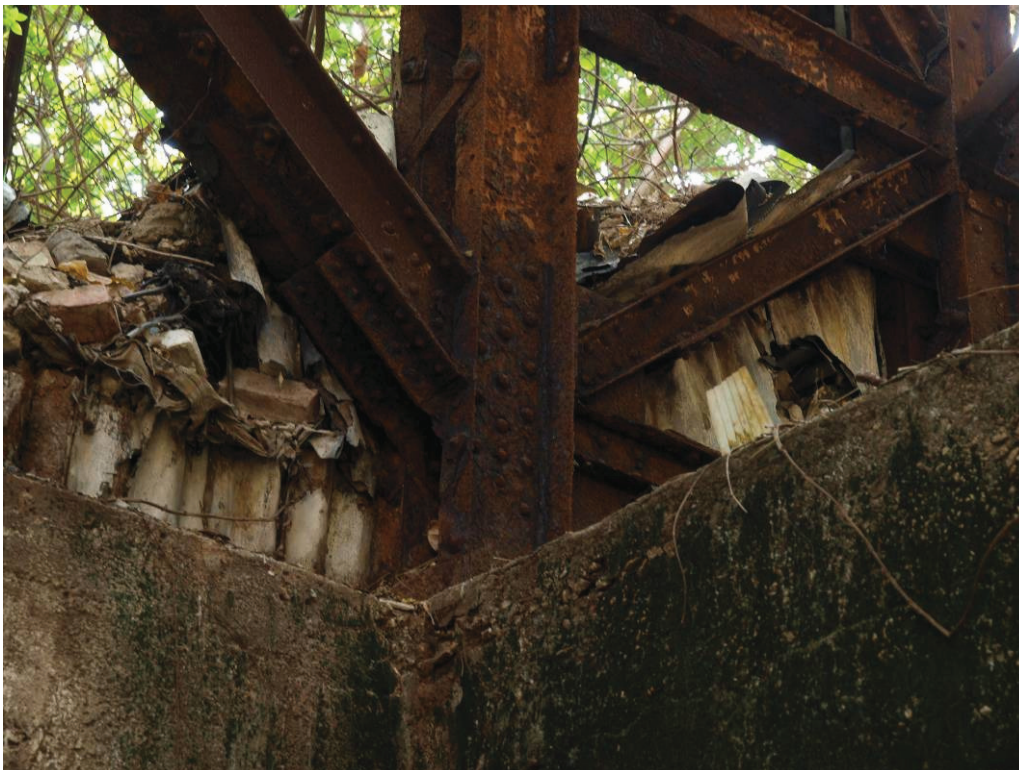
Photo P1070591 – Location 29 – roof structure and support

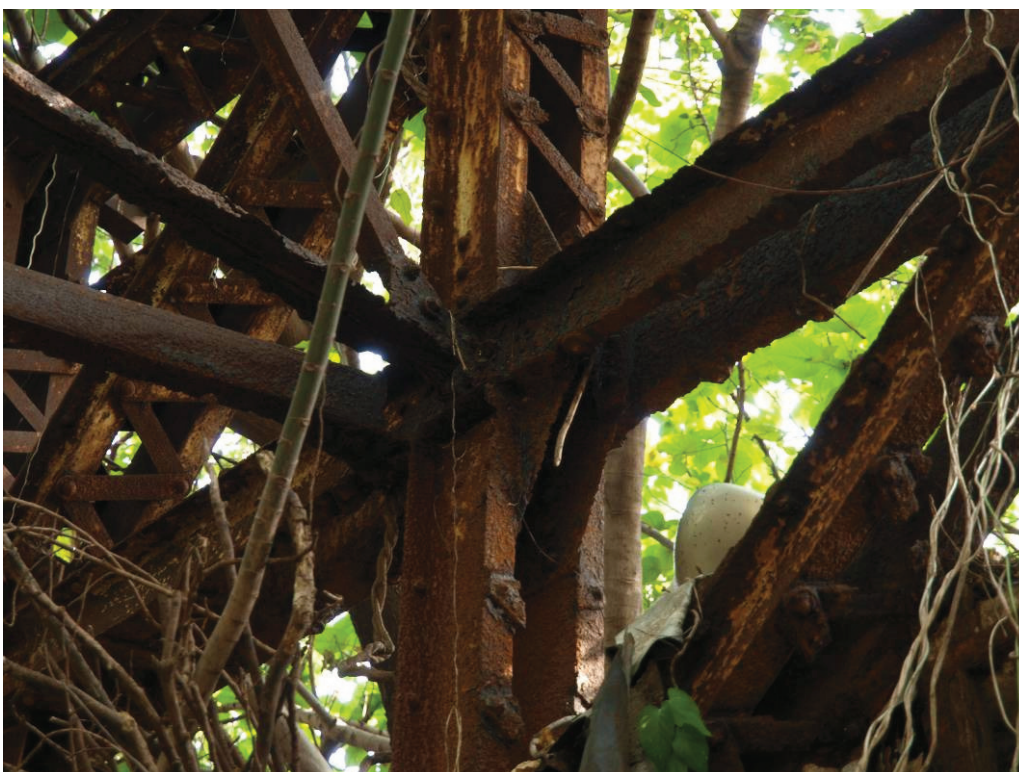
Photo P1070596 – Location 30 – roof structure

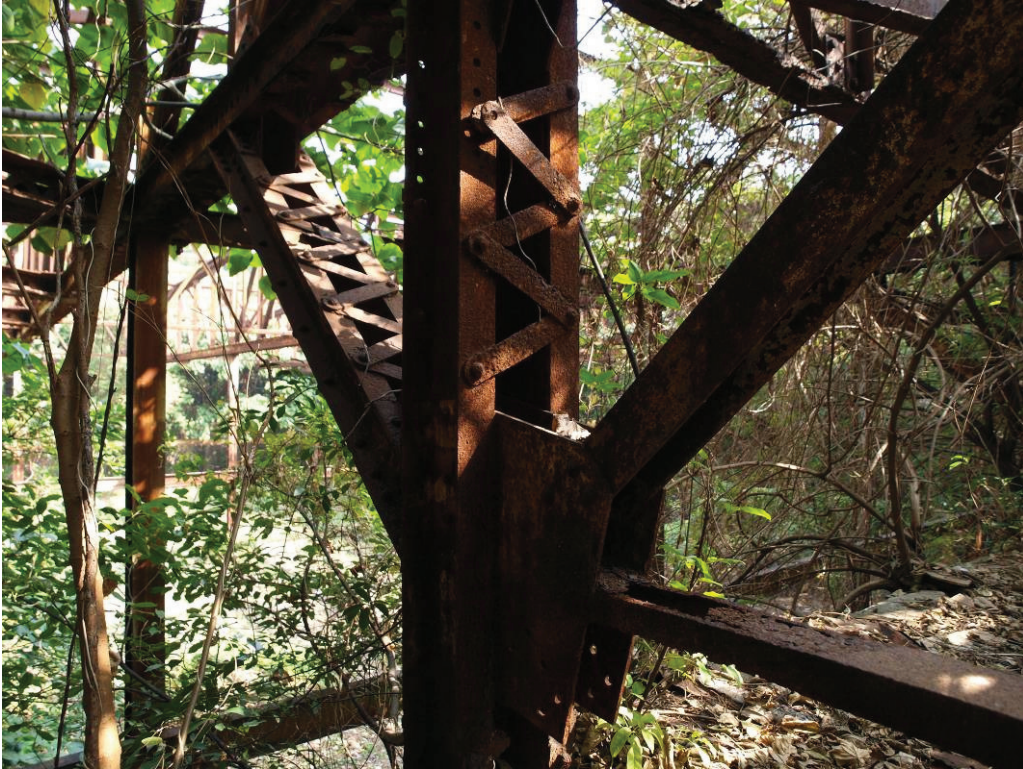
Photo P1070613 – Location 31 – roof structure

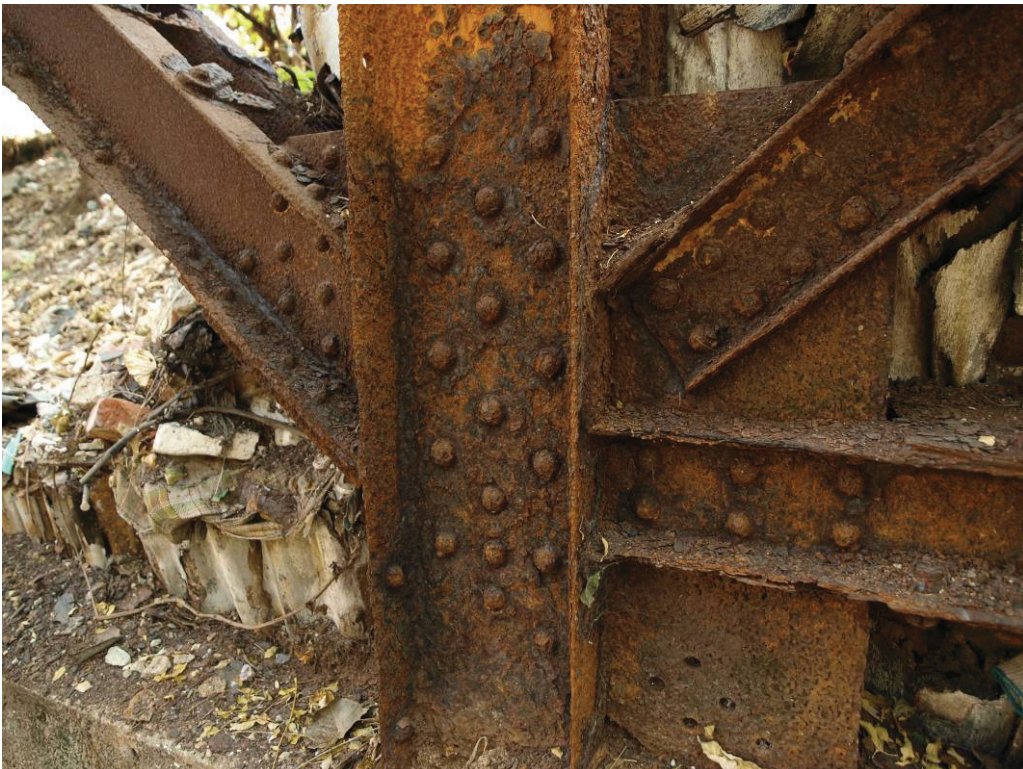
Photo P1070631 – Location 31 – roof structure and support

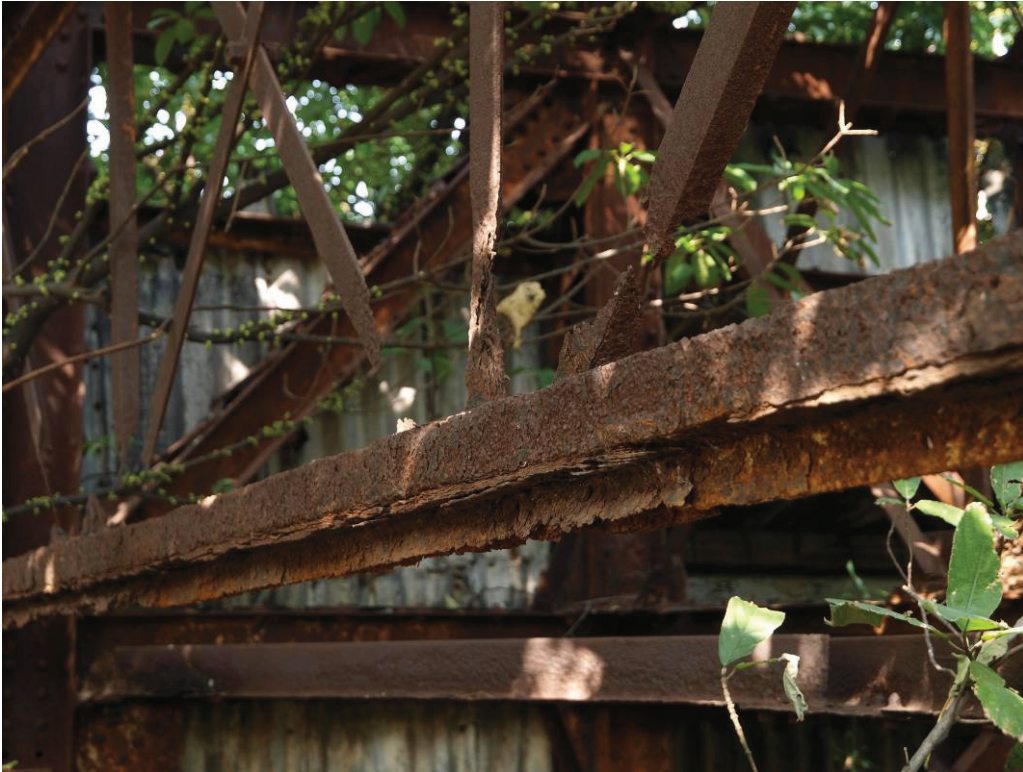
Photo P1070648 – Location 31 – roof structure

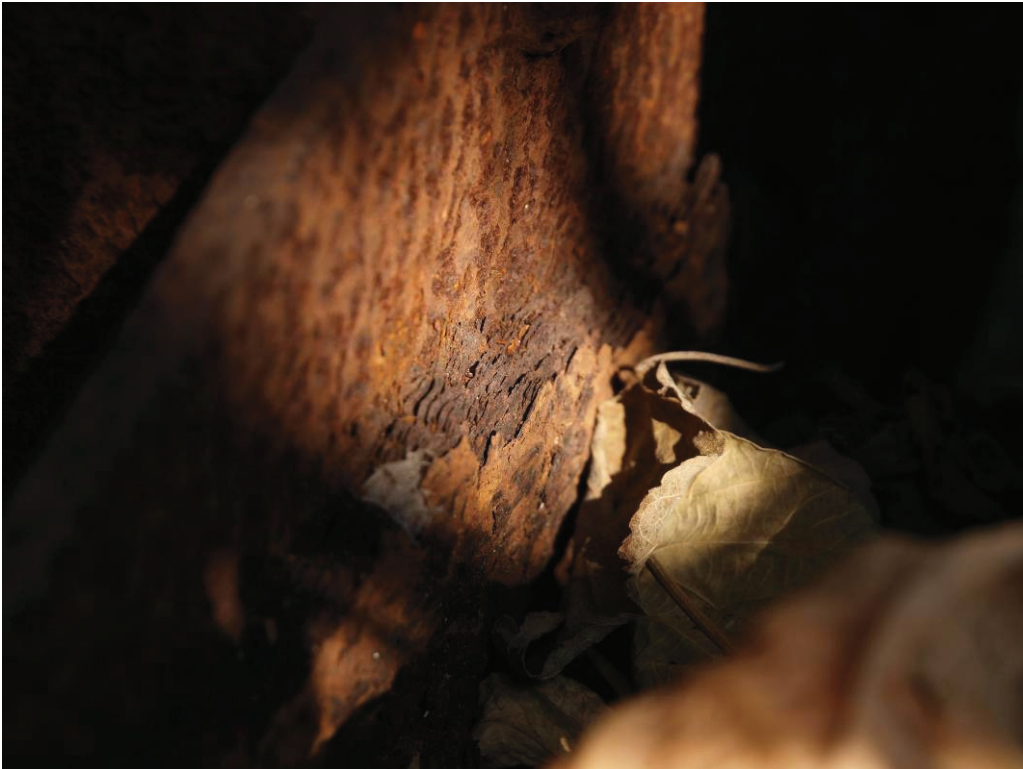
Photo P1070647 – Location 31 – roof structure

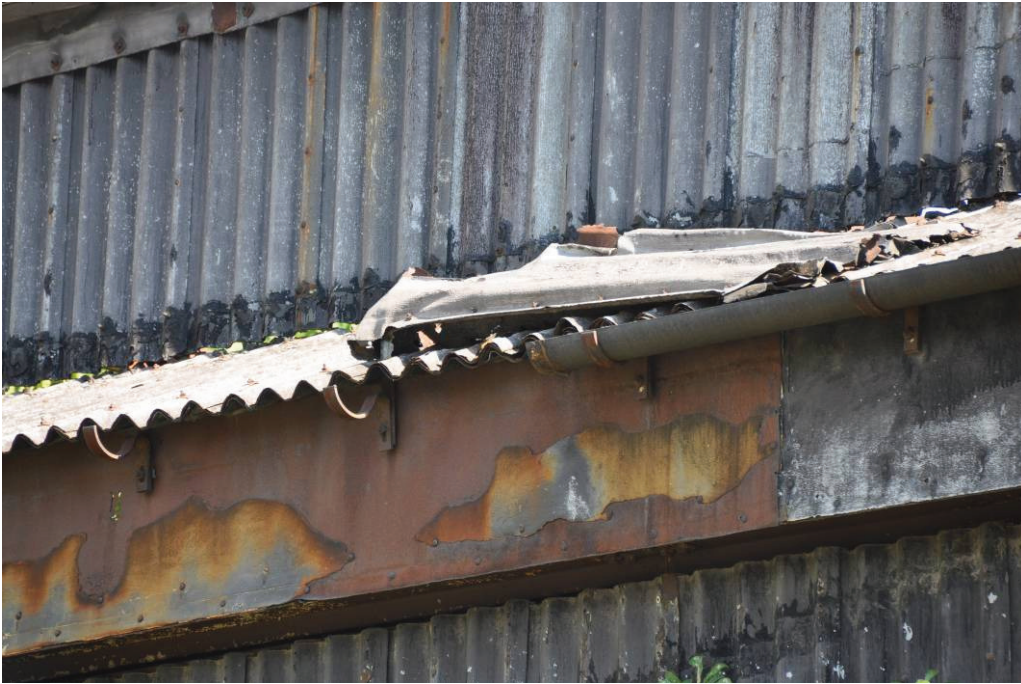
Photo DSC_0642 – Front of structure – typical cladding detail
