Condition Survey for the Existing Stone House and Pill Box at DIH CDA Site on 5 February 2009

A) Stone House (Tai Koon Yuen) (Graded 3 Historic Building)

B) Old Pill Box (Graded 2 Historic Building)

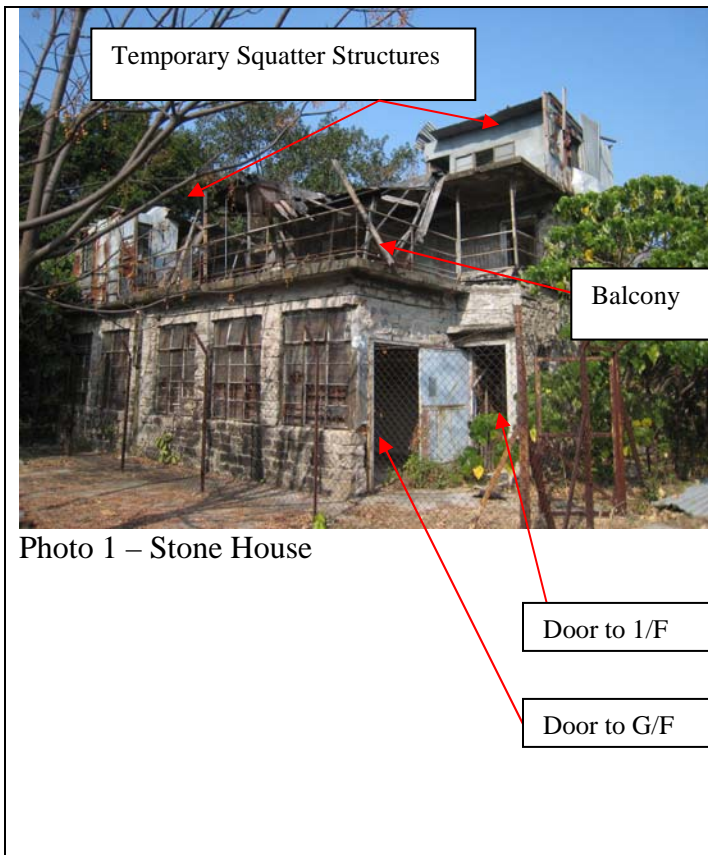
- 1) The Stone House is a two storey building (7m high) with some temporary squatter structures built on top of the roof of G/F(3m high) and 1/F (3m high). A balcony is found locating on the G/F roof (**Photo 1**). The balcony is the access to the temporary squatter structures. Steel pipe railing is constructed along the perimeter of balcony and a few pieces of timber posts to support corrugated steel sheeting as the shelter alongside the balcony (**Photo 2**). The external wall of the Stone House is built of granite stone. The granite stone is bonded together by chunam mortar (**Photo 3**). The roof top of G/F and 1/F is a reinforced concrete slab with some rusted reinforcement round bars found under the roof of G/F and 1/F (**Photo 4**) during the visit. In addition, the footprint of the stone house is about 13.6m (L) x 9m (W) and height of the 2 storey building is approximate 7m, the sketched floor plans for G/F (**Figure 1a**) and 1/F (**Figure 1b**) are attached in Appendix for reference.

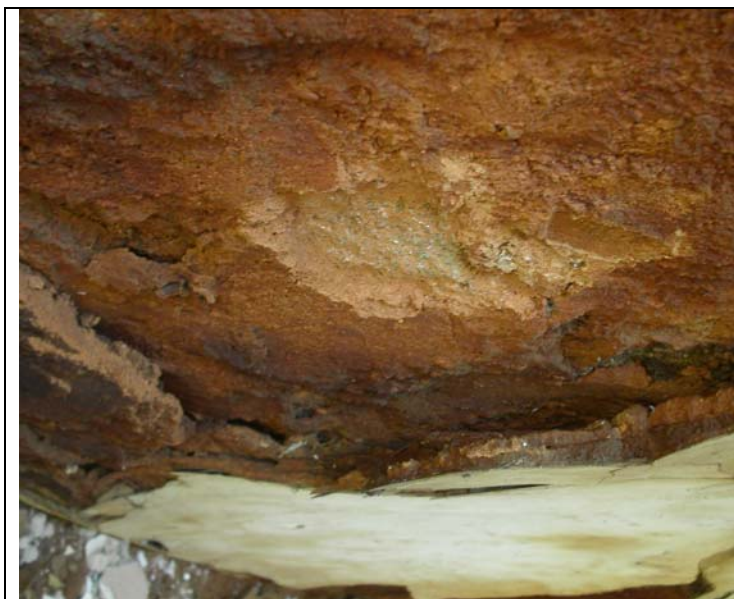
Photo 3 – Chunam Mortar & Cement Sand Plaster

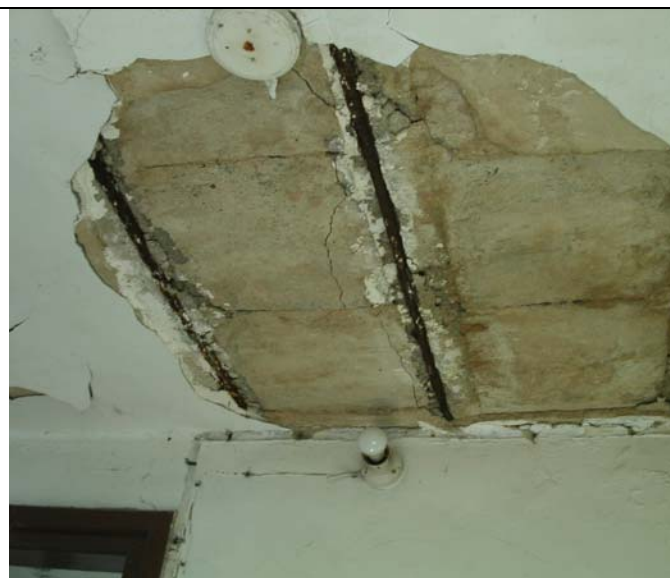
Photo 4 – Rusted Reinforcement under the 1/F Roof

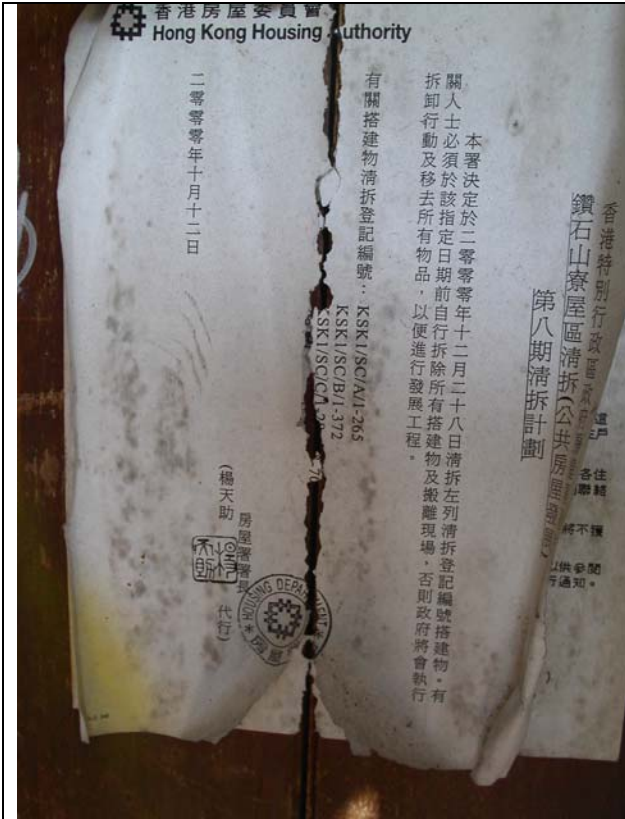
- 2) According to the notice of Hong Kong Housing Authority posted at the entrance of house (**Photo 5**), the occupant of this house has already moved out under instruction of the Phase 8 of Diamond Hill Demolition Squatter House Scheme in December 2000. Due to lack of maintenance, the condition of house is in poor condition and not suitable for living. It is noted that part of the temporary squatter structure at the roof of G/F and 1/F were collapsed and fallen to the house's backyard (**Photo 6**). The fallen structure is made of timber and steel sheeting. In addition, part of the balcony shelter has also collapsed (**Photo 7**). Spalling and exposed reinforcement are found under the roof of G/F and 1/F (**Photo 8**). The interior face of the granite stone wall is built of 2~3mm cement sand plaster with wall painting finishing. With the poor condition of the paint, large area of the paint has been peeled off or with damped patch marking (**Photo 9 & 10**). Some loose plaster, timber rods and boards are easy found on the floor of the house (**Photo 11**). Partition wall inside of the stone house are built of timber frame and insulation board or plywood, which is typical room partitioning material of the time when the house was built (**Photo 12**). During the visit, it is observed that most of the chunam mortars are fallen from the interior face of the granite wall with some location where the mortars fallen or degraded which reaches the exterior face of granite stone (**Photo 13**). In addition, a major crack is found at the external wall near the toilet extended from the roof to the ground (**Photo 14**). If no proper repairing of the granite stone wall the crack will be further expanded and the toilet will be damaged.

Photo 5 – Notice at the entrance door

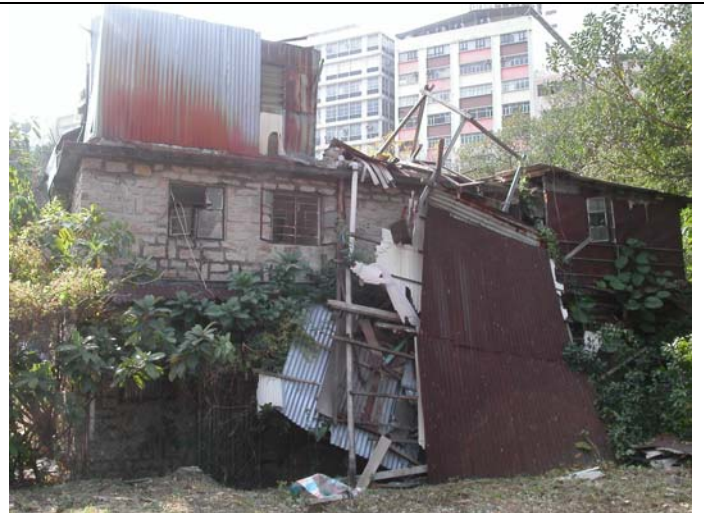
Photo 6 – Part of temporary squatter structure were fallen down to the backyard of Stone House

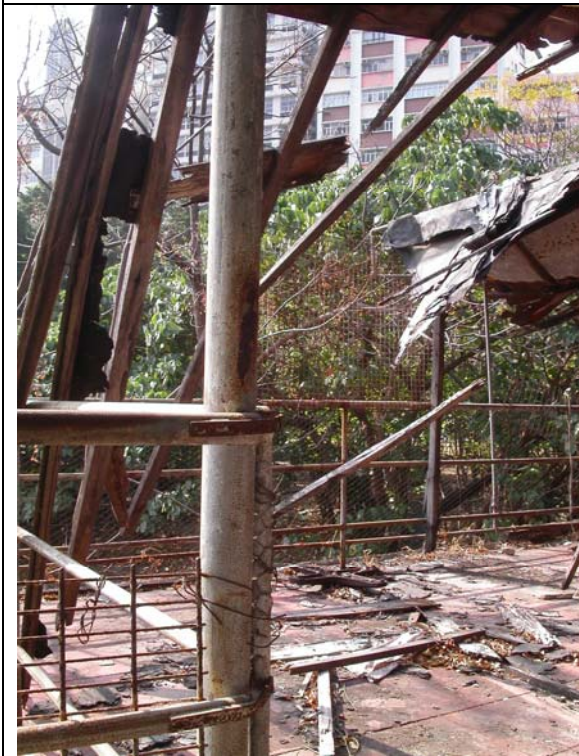
Photo 7 – Part of Shelter has collapsed

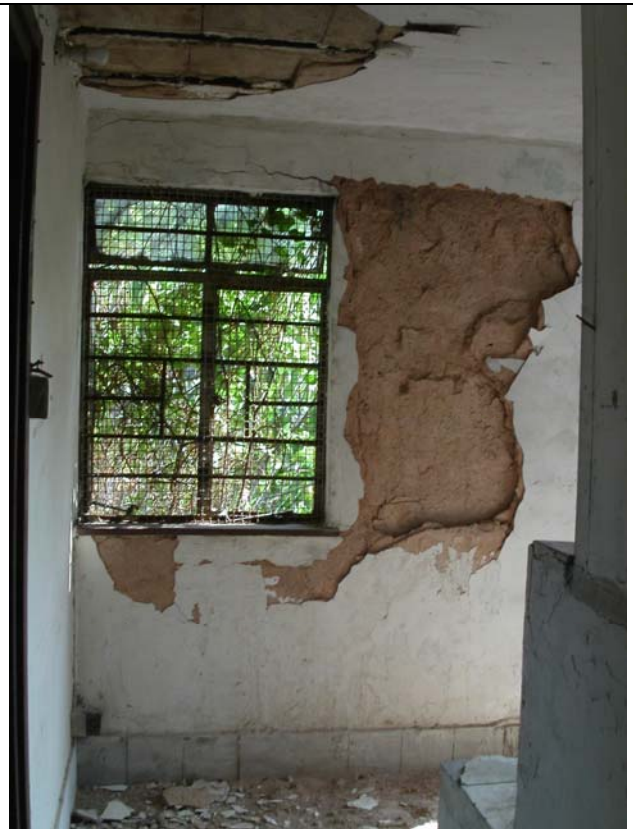
Photo 8 - Spalling and exposed reinforcement at 1/F

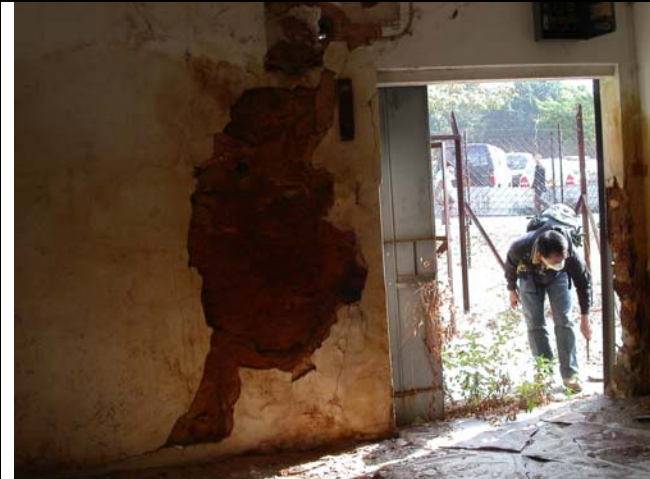
Photo 9 – Poor condition of internal wall

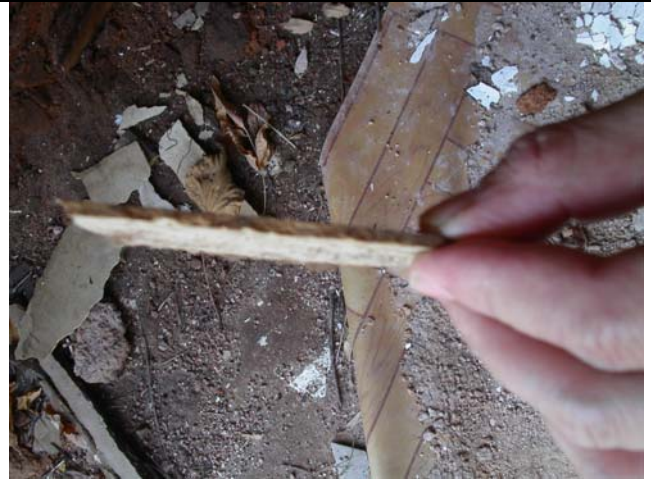
Photo 10 – 2 ~ 3 mm thick of cement sand plaster

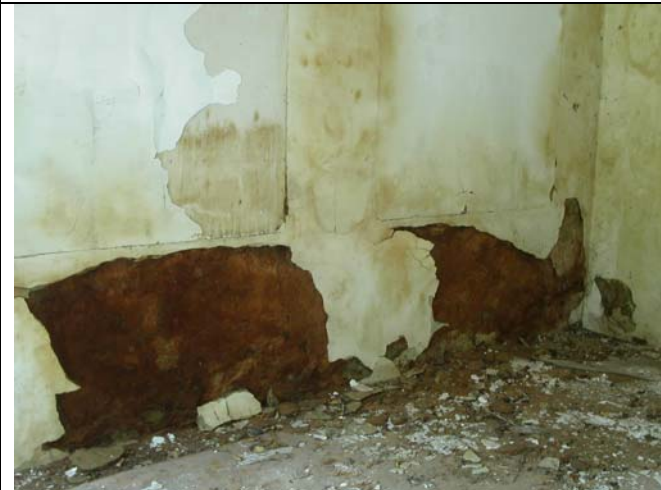
Photo 11 - Loose plaster, timber rods & boards

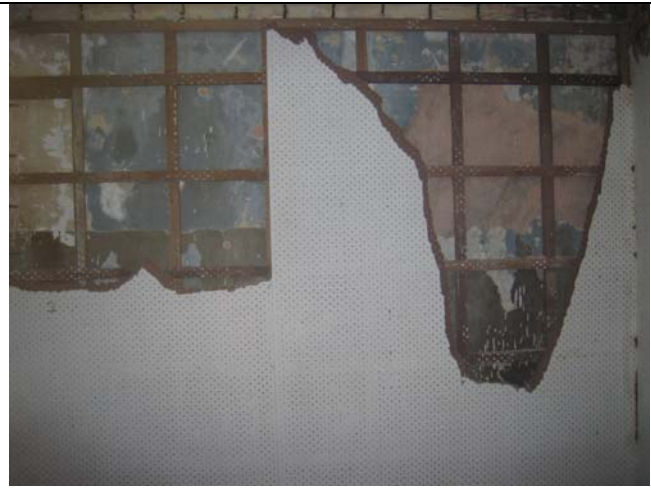
Photo 12 – Timber Frame Partition

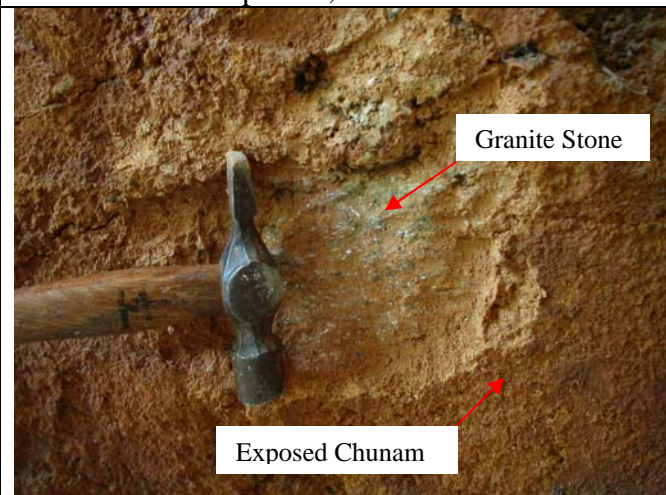
Photo 13 – Exposed Chunam mortar at external wall and granite stone can be seen.

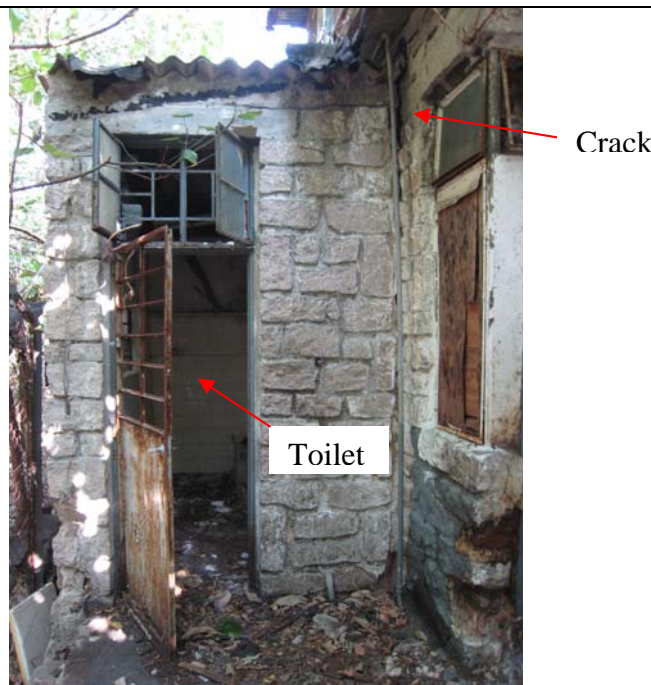
Photo 14 – Crack at G/F Toilet

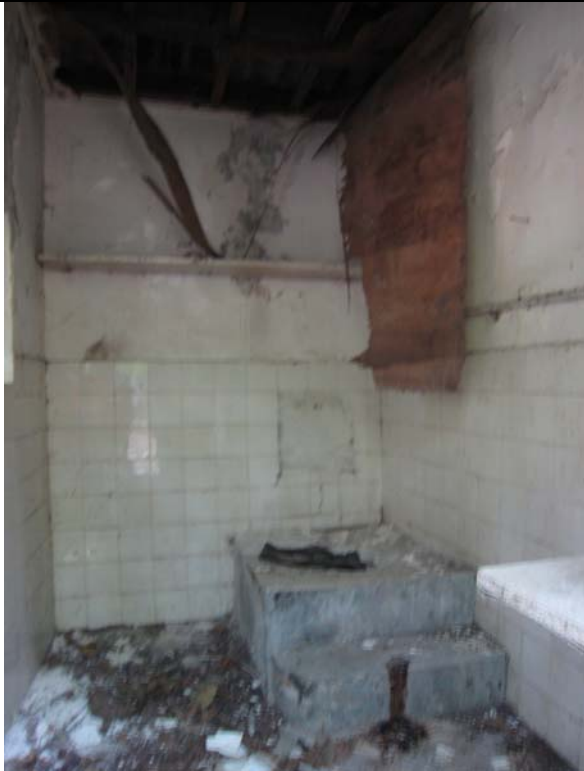
- 3) Regarding the drainage of the house, it is noted that the modern toilet seat is found at the toilet of G/F (**Photo 15**) and 1/F and drainage pipe (**Photo 16 & 17**) was connected from the 1/F to the G/F toilet. With this Tai Hum Village is full of illegal squatter houses, it is believed that there is no proper foul drainage system constructed this location; thus it is suspected that a septic tank may be built underneath of the House as part of the foundation.

Photo 15 – Toilet Seat

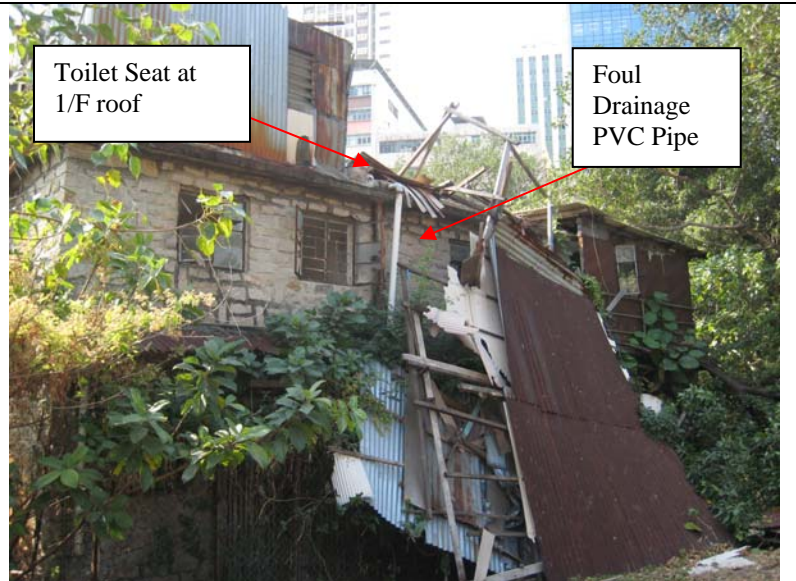
Photo 16 – Toilet Seat & Foul Drainage pipe at 1/F roof

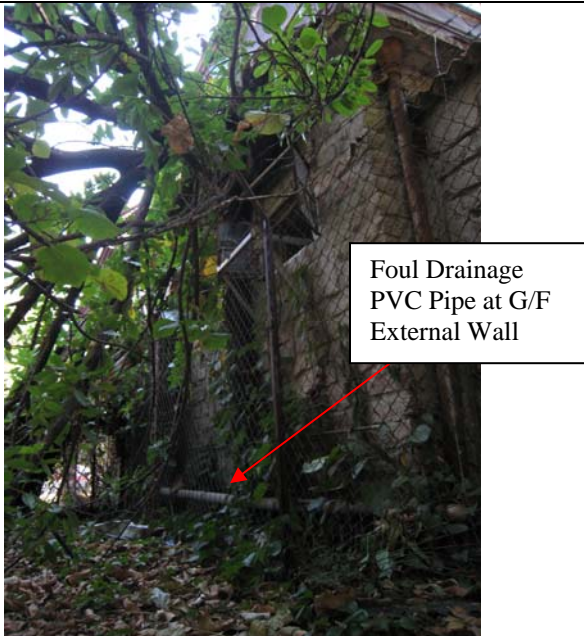
Photo 17 – Foul drainage PVC Pipe

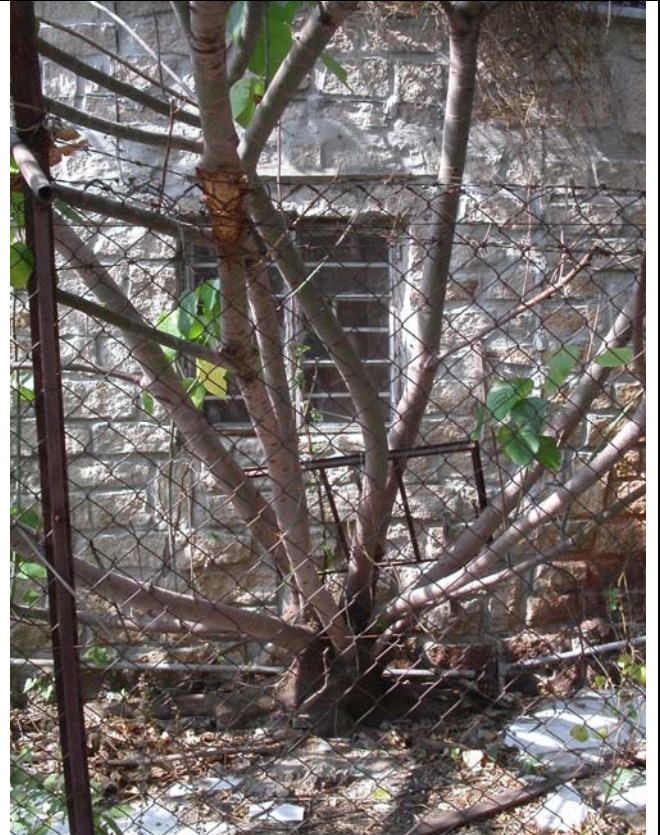
- 5) On other hand, two trees are found at the external wall of the house. One is growing from the north-west side of the house near the roof of G/F (**Photo 22**) but not in good form as it has already fallen down but is still alive. Another one is growing from the south-east side of house near toe of the exterior wall of staircase entrance to the 1/F (**Photo 23**).

Photo 23 - Tree at the South-East side of House near staircase entrance

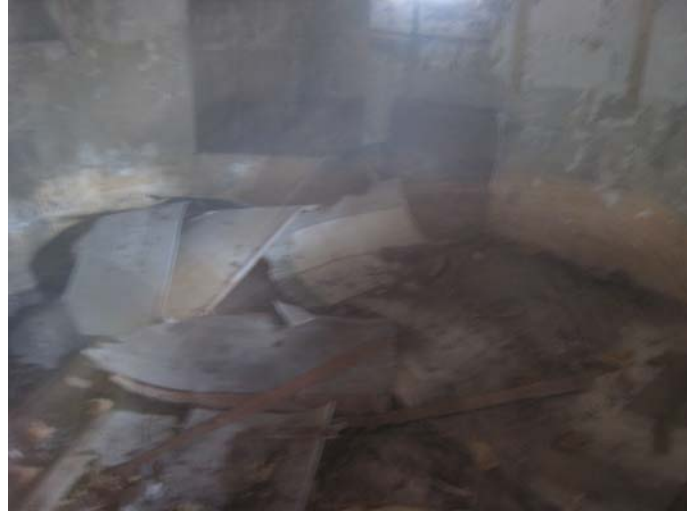
Photo 31 – Some debris, damaged timber boards and rods are found on the floor

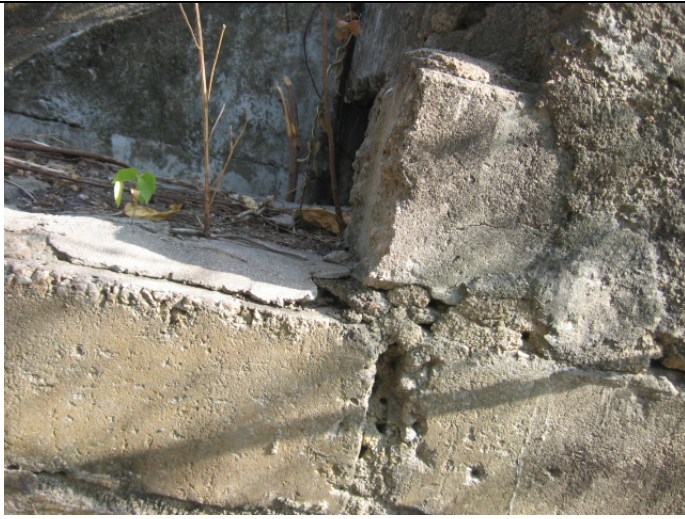
- 3) For the external wall of the Pill Box, some of the HMUs are found to have different level of damage including broken, disjointed and chipping of small pieces of brick (**Photo 35**). Delamination are found at the roof top and distributed from the top to the wall edge (**Photo 36 & 37**). The delamination is possible on the cement plaster layer as no visible crack is found from inside of the reinforcement concrete roof.

Photo 35 – Damaged HMU

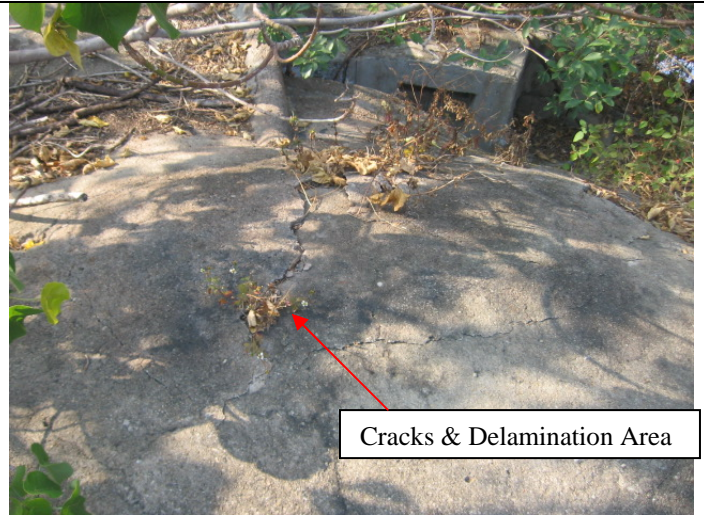
Photo 36 – Delamination at roof top

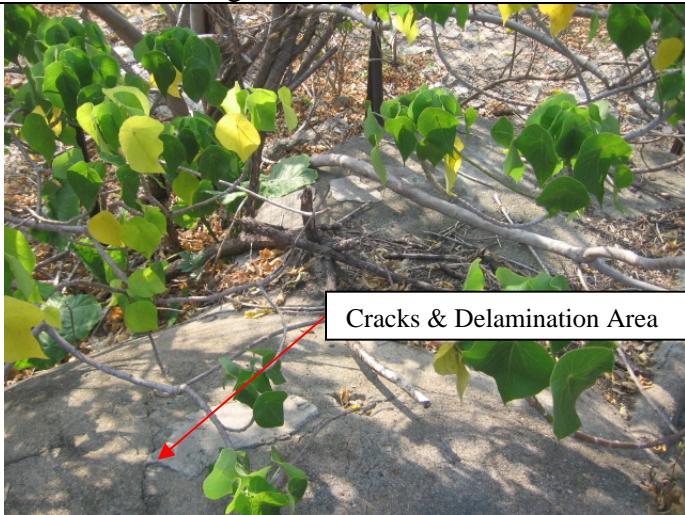
Photo 37 – Delamination at roof top
