Annex H4

Detailed Records of Lei Uk

Overview of Lei Uk

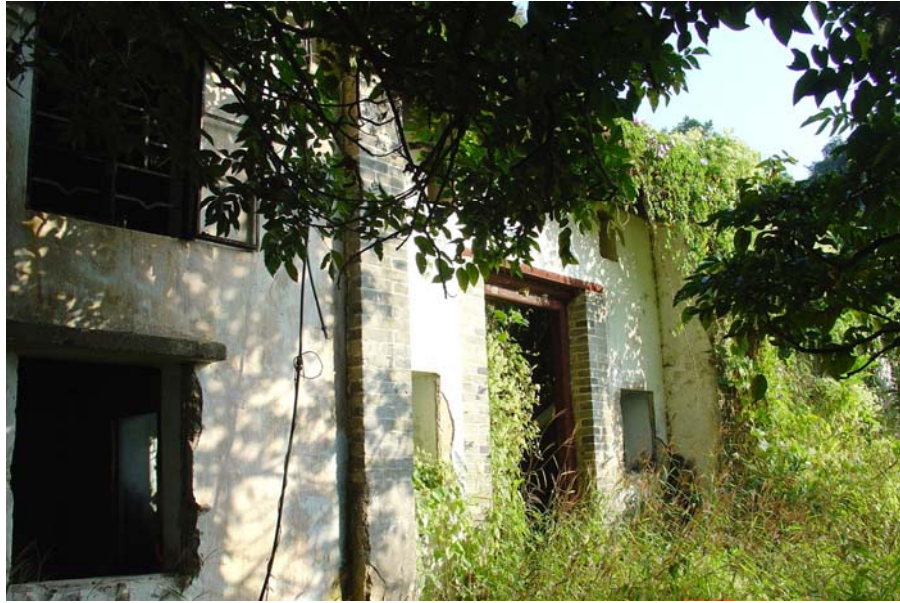
Interior: Not accessible/abandoned	
Details of Architectural Features: See photographic records.	
Past and Present Uses: They were residential houses and are currently ruined.	
Notes on Any Modifications: Some of the buildings were modified by modern material. Such as metal framed glass window.	
Existing Condition: Unroofed, ruined and mostly covered by vegetation and abandoned.	
Photographic Records:

Existing Condition

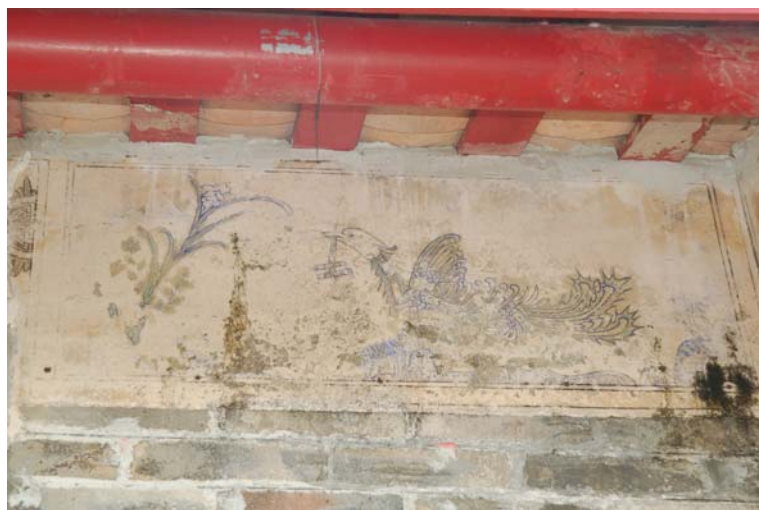
Wall frieze painting fading away

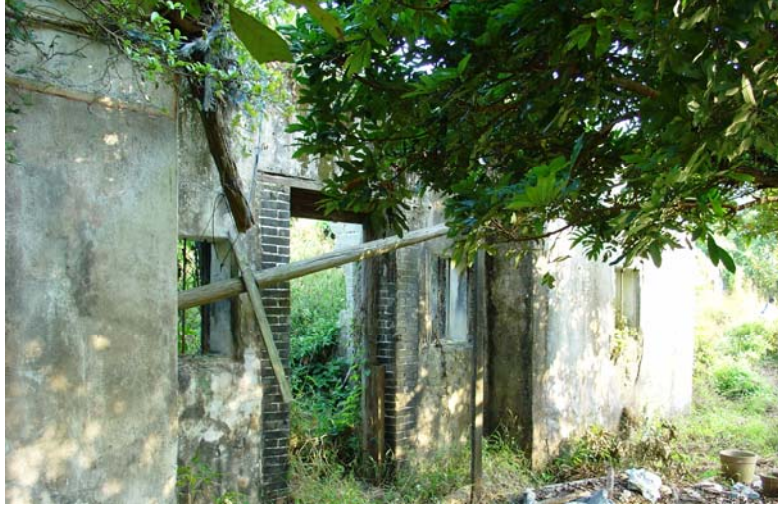
Notes on Any Modifications: Nil.	
Existing Condition: Unroofed, ruined and mostly covered by vegetation and abandoned.	
Photographic Records:

Examples of ruins

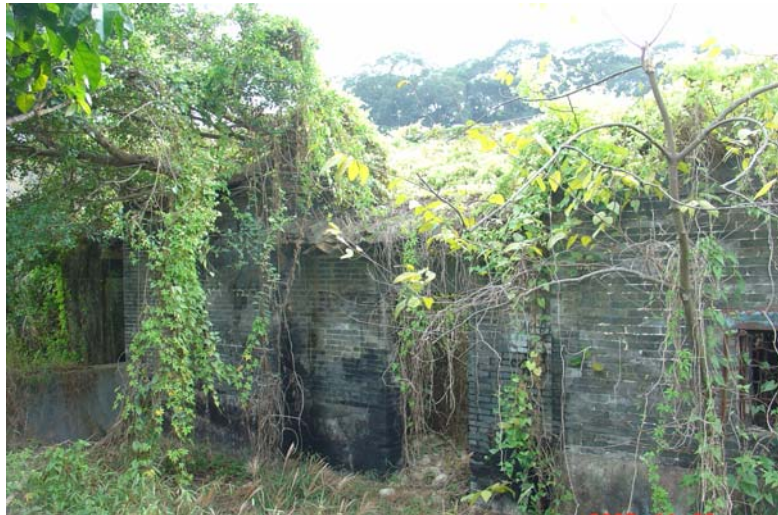
Examples of ruins
