Field Survey for Built Heritage

Historic Building: Lok Ma Chau Tsuen (落馬洲村) (Refer to Figure 10.4)

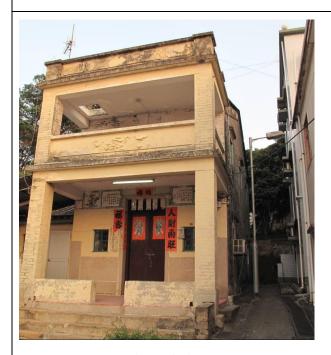
Photo 8 Frontview of village house No. 51

It is a two-storey "Ke Lau", which was renovated from the original green brick building at the back. The original building was built in the late 19th century, and the Ke Lau was added later. At the base of wall of the front "Ke Lau" addition are large cutting stones. The balcony is extended from the second floor and supported by pillars. There is a one-hall-one-room type building with pitch tile roof adjoining the two-storey building from the side view. It was obscured by the later addition in the front part. The house is kept in good condition and is still used as private dwelling.

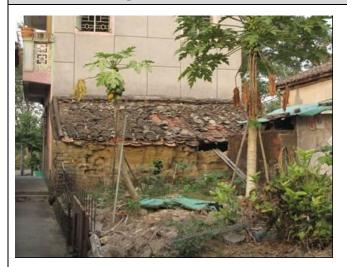
Photo 10 Sideview of the storage structure

It was built in the 19th century. It is a storage structure built with green brick and mud. Its roof is made of tile. The pitched tile roof was damaged and the building is vacant.

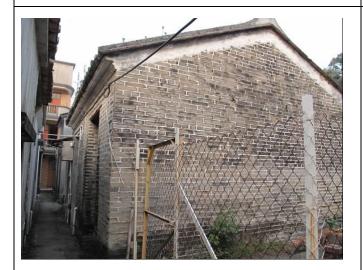
Photo 11 Sideview of village house No. 30C-31

They were built in the 19th century. They are a one-hall-one room type village houses built with green brick. The roof is made of tile. There is no entrance canopy. The houses are kept in good condition and are still used as private dwellings.

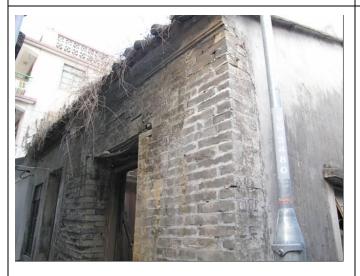
Photo 12 Frontview of unnumbered village

They were built in the 19th century. They are a one-hall-one room type village houses built with green brick. The roof is made of tile. There is no entrance canopy. The front of house No. 24E and the side wall of the unnumbered house are plastered. They are vacant.

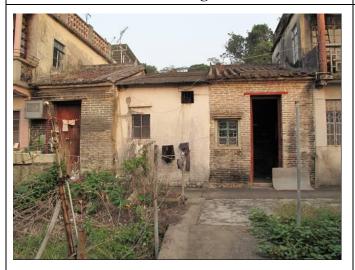
Photo 14 Frontview of village house No. 39-40

HB-1-11 Village houses No. 39 - 40
They were built in the 19th century.
They are one-hall-one room type village houses built with green brick. Village house No. 39 (left) retain much of its original appearance with its pitched roof with concave tiling and plastered cylindrical seal at eaves. House No.40 appeared to be two one-hall-one room houses combined. Its left side is renovated with corrugated metal roofing and plastered while its right side retains the traditional appearance. They are still used as private dwellings.

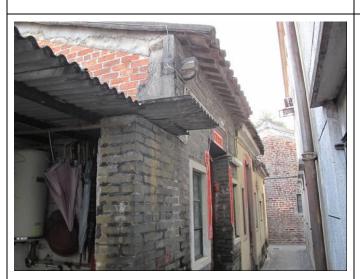
Photo 15 Frontview of the village houses No. 26-28

They were built in the 19th century. They are one-hall-one room type village houses built with mud brick. Its pitched roof is made of concave tiling with plastered cylindrical seals. The front wall of house No.26 is plastered with cement while the front walls of house No. 27 and 28 are painted in yellow. They are still used as private dwellings.

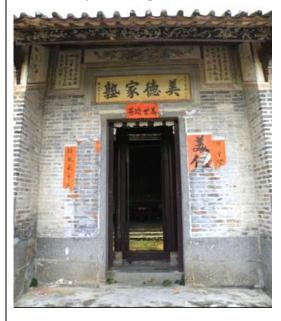
Photo 17 Façade of Mi Tak Study Hall

The Main Building is a traditional two-hall three room type building with a courtyard in the middle. There is a ceremonial screen door in the front hall. The base of the exterior wall made of mud brick is dressed with granite ashlar. The front wall is decorated with painting of calligraphy and flowers while the fascia boards are decorated with relief carvings. The side wall is also decorated with plastered sculptures and relief patterns but partly wear out.

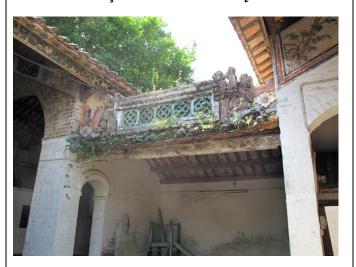
Photo 18 Interior walls and side chambers of Mi Tak Study Hall

The interior walls are also decorated with paintings of flowers. The chamber doors are all arch shaped.

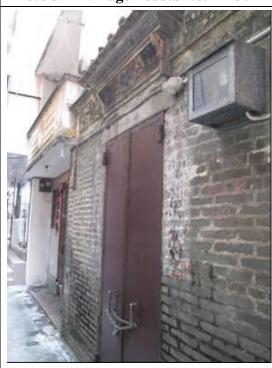
Photo 40 Frontview of village house No. 69

It was built in the 19th century. It is a traditional style terraced structure, which is also a one-hall-one room type building with enclosed courtyard. The village house is built in green brick and built by one header nine stretchers bond (一丁九順) method. The entrance door is replaced with metal door. It has traditional pitched roofs with decorative ridges over main portion of buildings and flat roof was added to cover the courtyard. Decorative canopies and friezes present and maintained in moderate condition. It is still used for dwelling purposes.

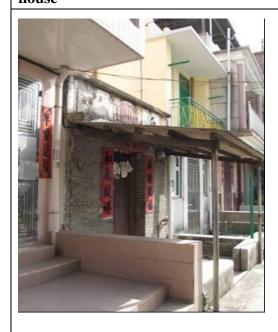
Photo 47 Frontview of village house No. 3

The house was built in the 19th century. It is a traditional style terraced building. The open courtyard is sheltered by metal frame and sheet in front of the village house. The original part was built of green brick and built by one header nine stretchers bond (一丁九順) method. It is still used for dwelling purposes.
