Appendix 10.1 Tree Assessment Schedule

Table A10.1 Tree Assessment Schedule of Existing Trees within the Project Area

Alternative Ground Decontamination Works at the Proposed Kennedy Town Comprehensive Development Area Site
Environmental Impact Assessment Report

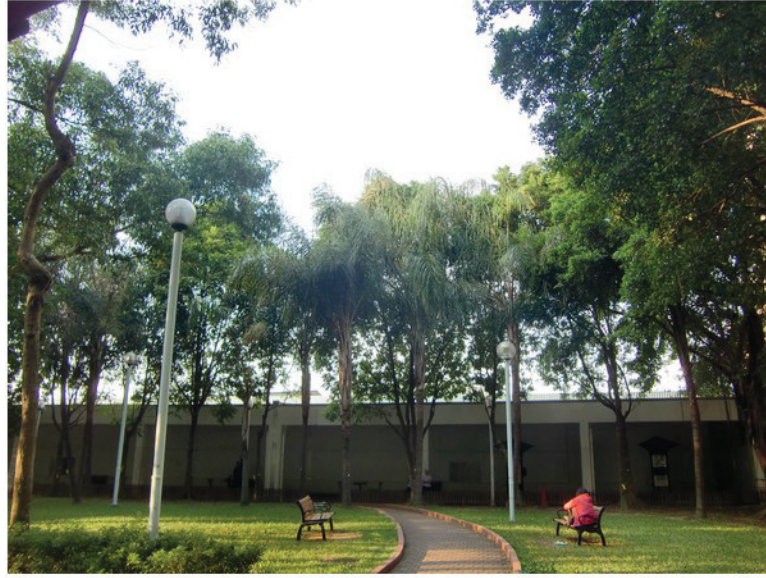
KT001 to KT002 & KT004 to KT006 & KT061 to KT065

Tree No.	Botanical Name	Chinese Name	DBH* (mm)	Height (m)	Crown Spread (m)	Health Condition (P/F/G)	Tree Form (P/F/G)	Amenity Value (L/M/H)	Suitability for Transplant	Proposed Treatment	Justification**	Remarks
KT001	<i>Dracontomelon duperreanum</i>	人面子	280	12.0	7.0	F	F	L	No	Fell	a, b, c	Codominant stems
KT002	<i>Syagrus romanzoffiana</i>	皇后葵	190	8.2	6.6	F	F	L	No	Fell	a, b, c	-
KT003	<i>Syagrus romanzoffiana</i>	皇后葵	190	8.0	5.6	F	F	L	No	Fell	a, b, c	Slightly crooked trunk
KT004	<i>Dracontomelon duperreanum</i>	人面子	170	12.0	4.0	F	P	L	No	Fell	a, b, c, d	Slightly leaning; crooked trunk
KT005	<i>Dracontomelon duperreanum</i>	人面子	210	12.0	8.0	F	F	L	No	Fell	a, b, c	-
KT006	<i>Syagrus romanzoffiana</i>	皇后葵	150	8.0	4.7	F	F	L	No	Fell	a, b, c	Wounds on trunk
KT007	<i>Syagrus romanzoffiana</i>	皇后葵	240	10.0	5.0	F	F	L	No	Fell	a, b, c	Slightly unbalanced canopy
KT008	<i>Ficus microcarpa</i>	細葉榕	330	9.5	4.5	F	P	L	No	Fell	a, b, c, d	Leaning; unbalanced canopy; die-back twigs; pruned wounds

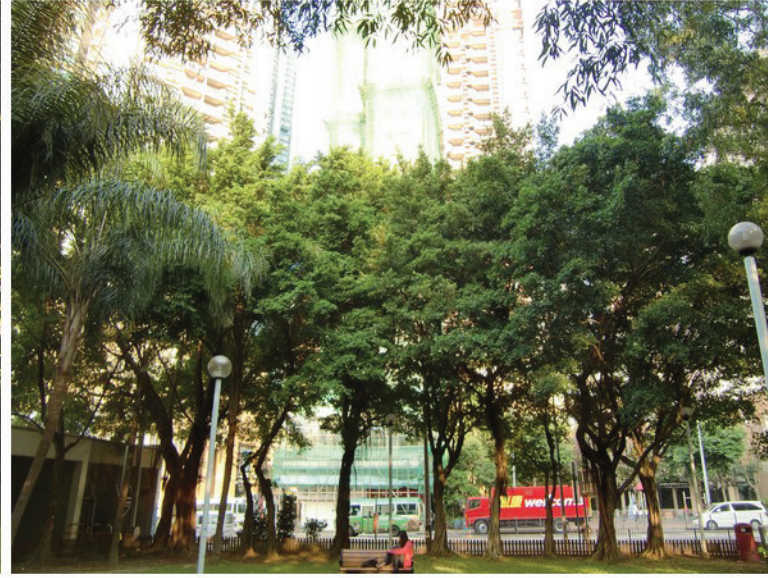
KT003 & KT007 to KT017

KT009	<i>Ficus microcarpa</i>	細葉榕	530	9.6	10.3	F	F	M	No	Fell	a, b, e	Growing close to drain cover and KT011, surface root in contact with KT010
KT010	<i>Ficus microcarpa</i>	細葉榕	380	9.0	8.0	F	P	L	No	Fell	a, b, c, d, e	Unbalanced canopy; growing close to drain cover and KT009
KT011	<i>Ficus microcarpa</i>	細葉榕	300	7.1	4.0	P	P	L	No	Fell	a, b, c, d	Growing near kerb; vigorous epicormic growth; unbalanced canopy; surface root in contact with KT009
KT012	<i>Ficus microcarpa</i>	細葉榕	320	11.3	9.0	F	F	L	No	Fell	a, b, c, e	Growing near kerb
KT013	<i>Ficus microcarpa</i>	細葉榕	260	10.2	8.0	F	F	L	No	Fell	a, b, c, e	Growing near kerb
KT014	<i>Ficus microcarpa</i>	細葉榕	300	10.0	5.0	F	P	L	No	Fell	a, b, c, d	Unbalanced canopy
KT015	<i>Ficus microcarpa</i>	細葉榕	230	10.0	5.0	F	P	L	No	Fell	a, b, c, d, e	Unbalanced canopy; epicormic growth; growing near kerb
KT016	<i>Ficus microcarpa</i>	細葉榕	400	12.3	10.5	F	F	M	No	Fell	a, b	-

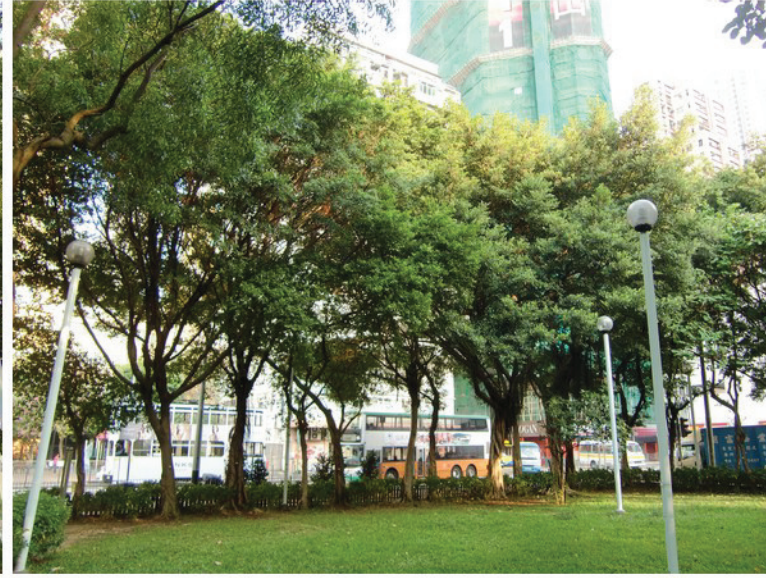
KT018 to KT028

Tree No.	Botanical Name	Chinese Name	DBH* (mm)	Height (m)	Crown Spread (m)	Health Condition (P/F/G)	Tree Form (P/F/G)	Amenity Value (L/M/H)	Suitability for Transplant	Proposed Treatment	Justification**	Remarks
KT017	<i>Ficus microcarpa</i>	細葉榕	390	9.2	8.6	F	F	M	No	Fell	a, b, e	Growing near kerb
KT018	<i>Ficus microcarpa</i>	細葉榕	200	4.2	3.6	F	P	L	No	Fell	a, b, c, d, e	Growing near kerb; unbalanced canopy
KT019	<i>Ficus microcarpa</i>	細葉榕	245	12.0	9.4	F	F	L	No	Fell	a, b, c, e	Growing near kerb
KT020	<i>Ficus microcarpa</i>	細葉榕	340	12.0	8.8	F	F	L	No	Fell	a, b, c, e	Growing near kerb
KT021	<i>Ficus microcarpa</i>	細葉榕	180	10.0	7.6	F	P	L	No	Fell	a, b, c, d	Unbalanced canopy; epicormic growth
KT022	<i>Ficus microcarpa</i>	細葉榕	290	8.0	5.8	F	P	L	No	Fell	a, b, c, d, e	Growing near kerb; unbalanced canopy; leaning
KT023	<i>Ficus microcarpa</i>	細葉榕	210	11.2	6.0	F	F	L	No	Fell	a, b, c	-
KT024	<i>Ficus microcarpa</i>	細葉榕	250	7.5	5.0	F	P	L	No	Fell	a, b, c, d, e	Leaning; epicormic growth; growing near kerb

KT025	<i>Ficus microcarpa</i>	細葉榕	370	12.0	10.0	F	F	L	No	Fell	a, b, c	-
KT026	<i>Ficus microcarpa</i>	細葉榕	320	10.0	5.0	F	P	L	No	Fell	a, b, c, d, e	Growing near kerb; unbalanced canopy; leaning; epicormic growth
KT027	<i>Ficus microcarpa</i>	細葉榕	360	11.4	7.9	F	F	L	No	Fell	a, b, c	-
KT028	<i>Ficus microcarpa</i>	細葉榕	300	11.6	7.0	F	F	L	No	Fell	a, b, c, e	Growing near kerb; slightly leaning; slightly unbalanced canopy
KT029	<i>Ficus microcarpa</i>	細葉榕	250	10.0	7.0	F	P	L	No	Fell	a, b, c, d, e	Growing near kerb; unbalanced canopy
KT030	<i>Ficus microcarpa</i>	細葉榕	180	10.0	5.0	F	F	L	No	Fell	a, b, c, e	Growing near kerb
KT031	<i>Ficus microcarpa</i>	細葉榕	130	10.0	3.0	F	P	L	No	Fell	a, b, c, d, e	Growing near kerb; low live crown ratio
KT032	<i>Bauhinia sp.</i>	羊蹄甲屬	150	9.4	4.5	F	P	L	No	Fell	a, b, c, d, e	Growing near kerb; crooked stems
KT033	<i>Ficus microcarpa</i>	細葉榕	410	13.5	9.3	F	F	M	No	Fell	a, b, e	Growing near kerb and KT034

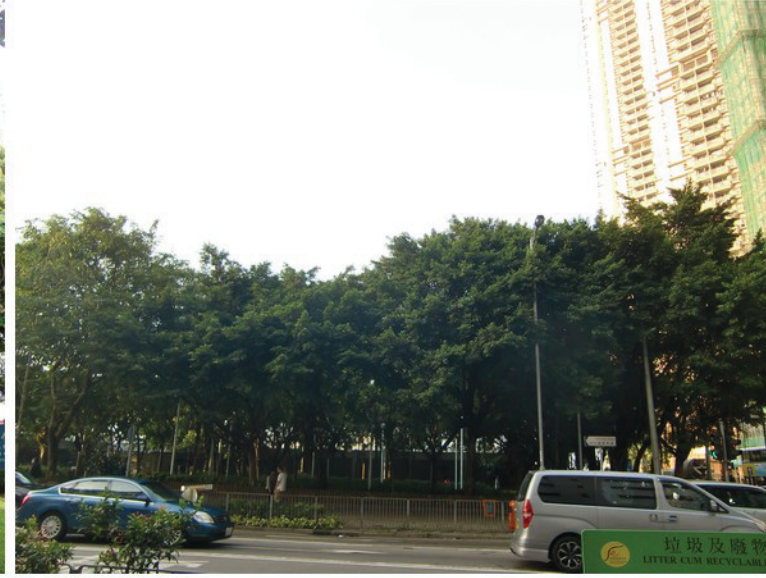
KT029 to KT038

KT034	<i>Bauhinia sp.</i>	羊蹄甲屬	230	10.0	7.0	F	F	L	No	Fell	a, b, c, e	Growing near KT033
KT036	<i>Ficus microcarpa</i>	細葉榕	250	10.0	4.2	F	F	L	No	Fell	a, b, c, e	Growing near kerb

Tree No.	Botanical Name	Chinese Name	DBH* (mm)	Height (m)	Crown Spread (m)	Health Condition (P/F/G)	Tree Form (P/F/G)	Amenity Value (L/M/H)	Suitability for Transplant	Proposed Treatment	Justification**	Remarks
KT037	<i>Bauhinia sp.</i>	羊蹄甲屬	120	10.0	3.5	F	P	L	No	Fell	a, b, c, d	Codominant stems ; unbalanced canopy
KT038	<i>Ficus microcarpa</i>	細葉榕	230	10.0	6.3	F	F	L	No	Fell	a, b, c, e	Growing near kerb
KT039	<i>Bauhinia sp.</i>	羊蹄甲屬	100	7.0	3.0	F	P	L	No	Fell	a, b, c, d	Leaning
KT040	<i>Bauhinia sp.</i>	羊蹄甲屬	130	7.0	3.0	F	F	L	No	Fell	a, b, c	Slightly crooked trunk; loose bark
KT041	<i>Bauhinia sp.</i>	羊蹄甲屬	190	10.0	7.0	F	F	L	No	Fell	a, b, c	Codominant stems
KT042	<i>Bauhinia sp.</i>	羊蹄甲屬	270	10.0	7.1	F	F	L	No	Fell	a, b, c	Codominant stems
KT043	<i>Hibiscus tiliaceus</i>	黃槿	200	10.0	9.0	F	F	L	No	Fell	a, b, c, e	Growing near kerb; crossed branches with included bark; epicormic growth
KT044	<i>Acacia auriculiformis</i>	耳果相思	230	10.3	4.3	F	P	L	No	Fell	a, b, c, d	Slightly unbalanced canopy; crooked trunk

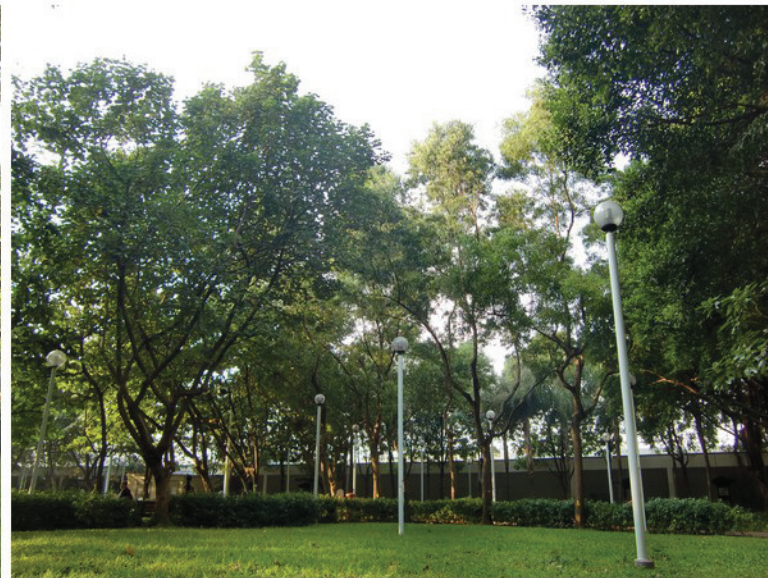
KT043 to KT047

KT045	<i>Acacia auriculiformis</i>	耳果相思	150	9.2	3.7	F	F	L	No	Fell	a, b, c	Dead stubs; die-back twigs
KT046	<i>Acacia auriculiformis</i>	耳果相思	300	11.2	5.3	F	F	L	No	Fell	a, b, c	Pruned wounds
KT047	<i>Acacia auriculiformis</i>	耳果相思	270	11.2	5.3	F	P	L	No	Fell	a, b, c, d	Crooked trunk; dead stubs
KT048	<i>Acacia auriculiformis</i>	耳果相思	180	12.1	3.7	F	F	L	No	Fell	a, b, c	One codominant stem pruned
KT049	<i>Acacia auriculiformis</i>	耳果相思	270	12.1	8.1	F	F	L	No	Fell	a, b, c	-
KT050	<i>Hibiscus tiliaceus</i>	黃槿	250	10.8	9.2	F	P	L	No	Fell	a, b, c, d	Leaning; pruned wounds
KT051	<i>Hibiscus tiliaceus</i>	黃槿	230	10.7	7.8	F	P	L	No	Fell	a, b, c, d	Leaning; ram's horn on trunk; epicormic growth
KT052	<i>Syagrus romanzoffiana</i>	皇后葵	170	7.0	3.1	F	F	L	No	Fell	a, b, c	-
KT053	<i>Syagrus romanzoffiana</i>	皇后葵	190	8.0	3.0	F	F	L	No	Fell	a, b, c	Seedling of epiphytic <i>Ficus microcarpa</i> found
KT054	<i>Syagrus romanzoffiana</i>	皇后葵	190	12.0	6.0	F	F	L	No	Fell	a, b, c	-

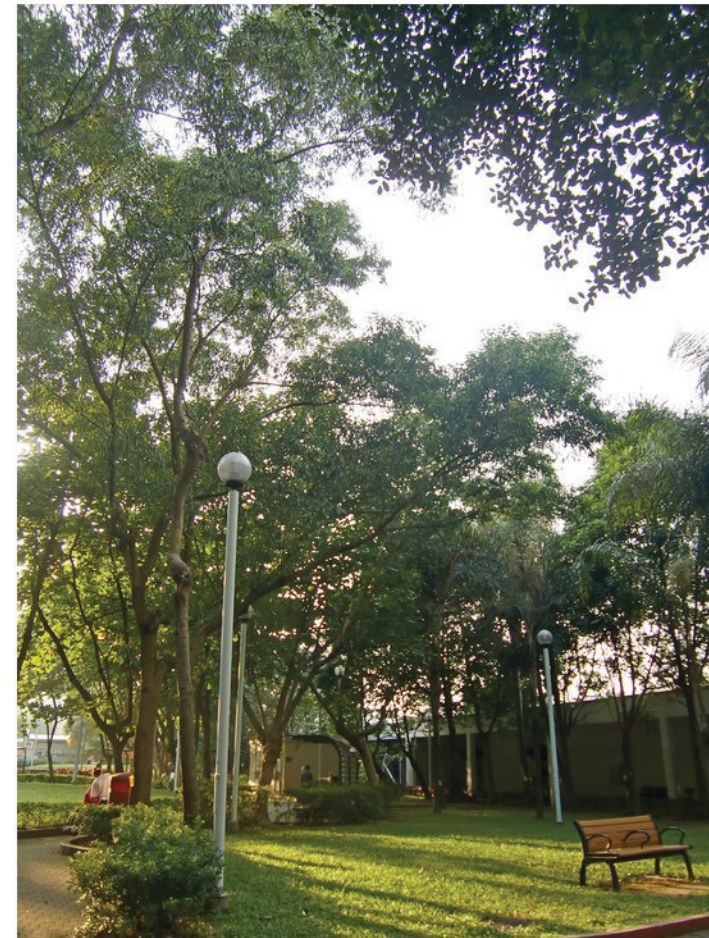
KT048 to KT060

KT055	<i>Dracontomelon duperreanum</i>	人面子	200	10.0	7.0	F	F	L	No	Fell	a, b, c	-
KT056	<i>Syagrus romanzoffiana</i>	皇后葵	170	12.0	6.0	F	F	L	No	Fell	a, b, c	Slightly crooked trunk

Tree No.	Botanical Name	Chinese Name	DBH* (mm)	Height (m)	Crown Spread (m)	Health Condition (P/F/G)	Tree Form (P/F/G)	Amenity Value (L/M/H)	Suitability for Transplant	Proposed Treatment	Justification**	Remarks
KT057	<i>Dracontomelon duperreanum</i>	人面子	170	10.0	6.1	F	F	L	No	Fell	a, b, c	-
KT058	<i>Syagrus romanzoffiana</i>	皇后葵	180	12.0	6.0	F	F	L	No	Fell	a, b, c	Slightly crooked trunk; sapping
KT059	<i>Syagrus romanzoffiana</i>	皇后葵	210	7.0	5.0	F	F	L	No	Fell	a, b, c	-
KT060	<i>Syagrus romanzoffiana</i>	皇后葵	120	8.0	2.0	P	P	L	No	Fell	a, b, c, d	Sign of withering at apical growing point; only a few leaves in full green
KT061	<i>Dracontomelon duperreanum</i>	人面子	230	10.3	6.3	F	F	L	No	Fell	a, b, c	-
KT062	<i>Dracontomelon duperreanum</i>	人面子	150	10.2	6.2	F	F	L	No	Fell	a, b, c	-
KT063	<i>Syagrus romanzoffiana</i>	皇后葵	160	6.0	7.0	F	F	L	No	Fell	a, b, c	-
KT064	<i>Syagrus romanzoffiana</i>	皇后葵	160	6.5	2.1	F	F	L	No	Fell	a, b, c	-

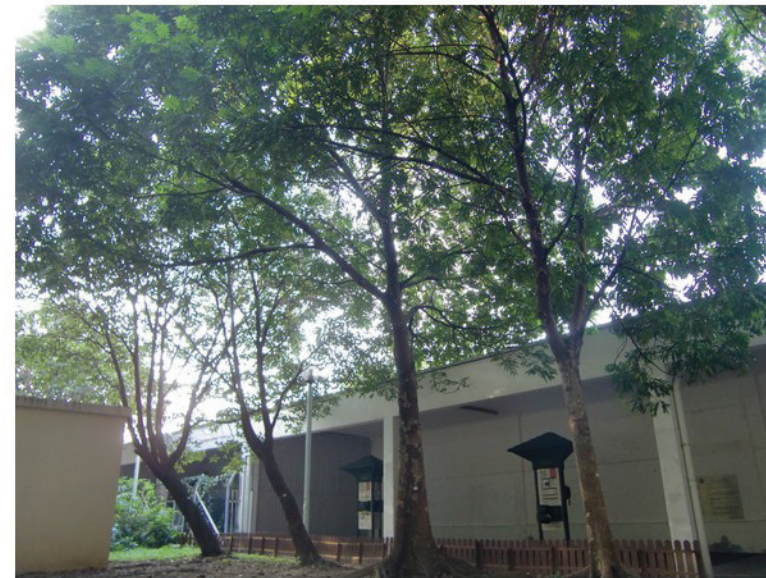
KT066 to KT069

KT065	<i>Syagrus romanzoffiana</i>	皇后葵	210	10.0	4.7	F	F	L	No	Fell	a, b, c	Seedling of <i>Macaranga tanarius</i> found in crown shaft
KT066	<i>Dracontomelon duperreanum</i>	人面子	220	12.0	7.0	F	F	L	No	Fell	a, b, c	Codominant stems
KT067	<i>Dracontomelon duperreanum</i>	人面子	300	12.0	7.1	F	F	L	No	Fell	a, b, c	Codominant stems
KT068	<i>Lophostemon confertus</i>	紅膠木	290	10.0	4.2	F	P	L	No	Fell	a, b, c, d	Leaning; die-back twigs
KT069	<i>Lophostemon confertus</i>	紅膠木	290	10.0	6.4	F	P	L	No	Fell	a, b, c, d	Leaning
KT070	<i>Terminalia catappa</i>	欖仁樹	270	10.0	7.0	F	P	L	No	Fell	a, b, c, d	Trifurcated; leaning
KT071	<i>Terminalia catappa</i>	欖仁樹	250	9.3	7.0	F	F	L	No	Fell	a, b, c	Forked
KT072	<i>Terminalia catappa</i>	欖仁樹	260	9.0	7.0	F	F	L	No	Fell	a, b, c	Codominant stems
KT073	<i>Terminalia catappa</i>	欖仁樹	210	10.0	6.0	F	F	L	No	Fell	a, b, c	No leader; swollen trunk base
KT074	<i>Terminalia catappa</i>	欖仁樹	200	9.0	6.0	F	P	L	No	Fell	a, b, c, d	Codominant stems; unbalanced canopy

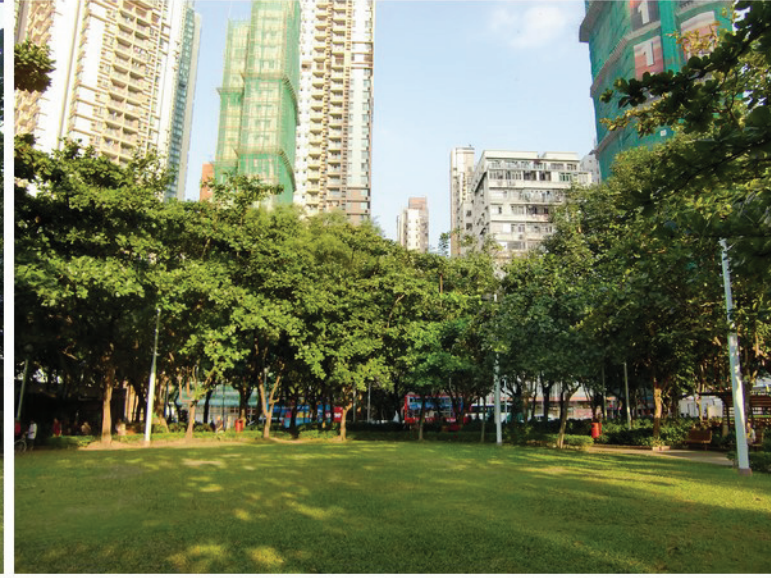
KT072 to KT078

KT075	<i>Terminalia catappa</i>	欖仁樹	240	9.0	6.0	F	F	L	No	Fell	a, b, c	Codominant stems
KT076	<i>Terminalia catappa</i>	欖仁樹	150	9.0	5.0	F	F	L	No	Fell	a, b, c	Slightly crooked trunk

Tree No.	Botanical Name	Chinese Name	DBH* (mm)	Height (m)	Crown Spread (m)	Health Condition (P/F/G)	Tree Form (P/F/G)	Amenity Value (L/M/H)	Suitability for Transplant	Proposed Treatment	Justification**	Remarks
KT077	<i>Terminalia catappa</i>	欖仁樹	140	7.0	4.0	F	P	L	No	Fell	a, b, c, d	Loose bark; unbalanced canopy; many pruned wounds
KT078	<i>Terminalia catappa</i>	欖仁樹	150	7.0	4.0	F	F	L	No	Fell	a, b, c	Slightly leaning
KT079	<i>Terminalia catappa</i>	欖仁樹	150	7.0	4.0	F	P	L	No	Fell	a, b, c, d	Slightly leaning; forked; unbalanced canopy
KT080	<i>Terminalia catappa</i>	欖仁樹	200	9.0	6.0	F	F	L	No	Fell	a, b, c	Slightly leaning; forked
KT081	<i>Terminalia catappa</i>	欖仁樹	150	7.0	4.0	F	P	L	No	Fell	a, b, c, d	Leaning; unbalanced canopy
KT082	<i>Terminalia catappa</i>	欖仁樹	170	10.0	4.0	F	P	L	No	Fell	a, b, c, d	Forked; V-shape crotch with included bark observed; unbalanced canopy
KT083	<i>Terminalia catappa</i>	欖仁樹	160	8.0	4.0	F	F	L	No	Fell	a, b, c	Forked

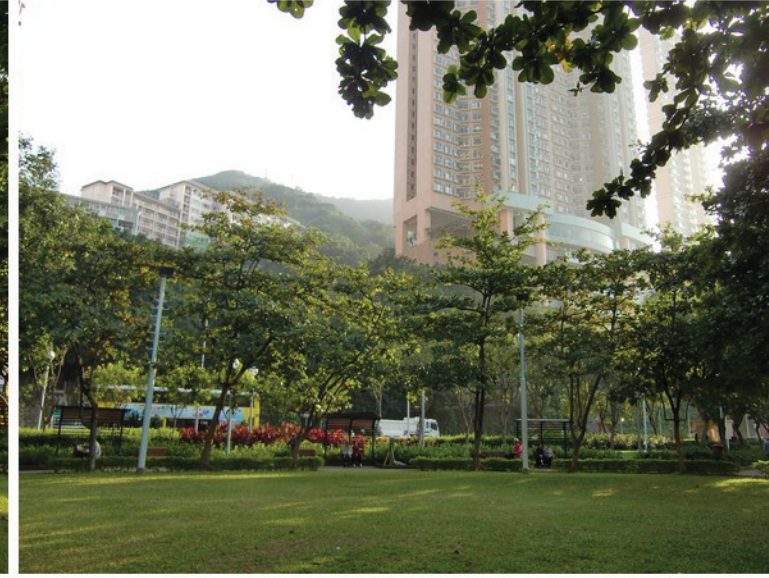
KT079 to KT084

KT084	<i>Terminalia catappa</i>	欖仁樹	160	8.0	6.0	F	F	L	No	Fell	a, b, c	Forked; codominant stems
KT085	<i>Terminalia catappa</i>	欖仁樹	190	8.0	6.0	F	P	L	No	Fell	a, b, c, d	Forked; unbalanced canopy
KT086	<i>Terminalia catappa</i>	欖仁樹	190	9.0	6.0	F	F	L	No	Fell	a, b, c	Forked
KT087	<i>Terminalia catappa</i>	欖仁樹	190	9.0	6.0	F	F	L	No	Fell	a, b, c	No leader
KT088	<i>Terminalia catappa</i>	欖仁樹	250	9.0	6.0	F	P	L	No	Fell	a, b, c, d	Bent trunk
KT089	<i>Lophostemon confertus</i>	紅膠木	130	6.0	4.0	F	P	L	No	Fell	a, b, c, d	Leaning
KT090	<i>Lophostemon confertus</i>	紅膠木	190	4.0	10.0	F	F	L	No	Fell	a, b, c	Slightly leaning; codominant stems
KT091	<i>Lophostemon confertus</i>	紅膠木	200	10.0	5.0	F	F	L	No	Fell	a, b, c	Slightly leaning; multi-attachments at a point
KT092	<i>Lophostemon confertus</i>	紅膠木	120	7.3	4.0	F	F	L	No	Fell	a, b, c	Die-back twigs
KT093	<i>Lophostemon confertus</i>	紅膠木	270	10.4	6.0	F	F	L	No	Fell	a, b, c	Codominant stems; die-back twigs

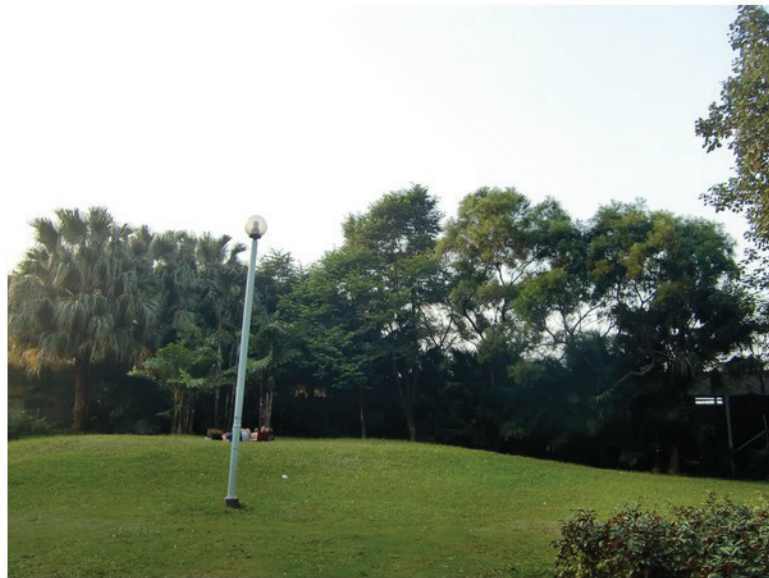
KT094 to KT172

KT094	<i>Livistona chinensis</i>	蒲葵	280	7.0	5.0	F	F	L	No	Fell	a, b, c	Crowded with other trees; slightly leaning; very close to KT095
KT095	<i>Livistona chinensis</i>	蒲葵	110	3.0	2.0	F	F	L	No	Fell	a, b, c	Crowded with other trees; slightly leaning; very close to KT094

Tree No.	Botanical Name	Chinese Name	DBH* (mm)	Height (m)	Crown Spread (m)	Health Condition (P/F/G)	Tree Form (P/F/G)	Amenity Value (L/M/H)	Suitability for Transplant	Proposed Treatment	Justification**	Remarks
KT096	<i>Livistona chinensis</i>	蒲葵	110	5.0	3.0	F	F	L	No	Fell	a, b, c	Crowded with other trees; slightly leaning
KT097	<i>Acacia confusa</i>	臺灣相思	220	8.0	5.0	F	P	L	No	Fell	a, b, c, d	Leaning; trunk crossing with an undersized <i>Livistona chinensis</i>
KT109	<i>Acacia confusa</i>	臺灣相思	230	9.3	5.8	F	F	L	No	Fell	a, b, c	Wound on a lower branch; slightly leaning; very close to an undersized <i>Livistona chinensis</i>
KT112	<i>Livistona chinensis</i>	蒲葵	210	4.9	3.7	F	F	L	No	Fell	a, b, c	Very close to an undersized <i>Livistona chinensis</i>
KT117	<i>Acacia confusa</i>	臺灣相思	180	9.3	5.6	F	F	L	No	Fell	a, b, c	Very close to an undersized <i>Livistona chinensis</i> , die-back twigs
KT124	<i>Livistona chinensis</i>	蒲葵	250	6.1	4.1	F	F	L	No	Fell	a, b, c	Crowded with other trees, slightly leaning

KT126	<i>Livistona chinensis</i>	蒲葵	260	7.2	5.1	F	F	L	No	Fell	a, b, c	Crowded with other trees; very close to an undersized <i>Livistona chinensis</i>
KT127	<i>Livistona chinensis</i>	蒲葵	170	5.2	3.8	F	F	L	No	Fell	a, b, c	Crowded with other trees
KT129	<i>Livistona chinensis</i>	蒲葵	210	6.1	4.5	F	F	L	No	Fell	a, b, c	Crowded with other trees
KT130	<i>Livistona chinensis</i>	蒲葵	220	6.8	5.2	F	F	L	No	Fell	a, b, c	Crowded with other trees; slightly leaning
KT131	<i>Livistona chinensis</i>	蒲葵	260	7.5	6.3	F	F	L	No	Fell	a, b, c	Crowded with other trees
KT133	<i>Livistona chinensis</i>	蒲葵	250	8.2	4.1	F	F	L	No	Fell	a, b, c	Crowded with other trees; slightly leaning
KT134	<i>Livistona chinensis</i>	蒲葵	160	7.8	3.2	F	F	L	No	Fell	a, b, c	Very close to KT140; trunk base girdled by KT140's root
KT140	<i>Acacia confusa</i>	臺灣相思	210	7.9	5.6	F	P	L	No	Fell	a, b, c, d	Very close to KT134; support materials being in conflict with its trunk; leaning; codominant stems

KT141	<i>Livistona chinensis</i>	蒲葵	230	7.8	4.2	F	F	L	No	Fell	a, b, c	Crowded with other trees
KT143	<i>Livistona chinensis</i>	蒲葵	280	7.3	4.2	F	F	L	No	Fell	a, b, c	Crowded with other trees

Tree No.	Botanical Name	Chinese Name	DBH* (mm)	Height (m)	Crown Spread (m)	Health Condition (P/F/G)	Tree Form (P/F/G)	Amenity Value (L/M/H)	Suitability for Transplant	Proposed Treatment	Justification**	Remarks
KT144	<i>Livistona chinensis</i>	蒲葵	160	7.2	4.1	F	F	L	No	Fell	a, b, c	Crowded with other trees
KT146	<i>Livistona chinensis</i>	蒲葵	190	5.7	4.8	F	F	L	No	Fell	a, b, c	Crowded with other trees
KT148	<i>Livistona chinensis</i>	蒲葵	240	7.2	5.1	F	F	L	No	Fell	a, b, c	Crowded with other trees
KT149	<i>Livistona chinensis</i>	蒲葵	240	7.8	4.2	F	F	L	No	Fell	a, b, c	Crowded with other trees
KT150	<i>Livistona chinensis</i>	蒲葵	240	8.2	4.1	F	F	L	No	Fell	a, b, c	Crowded with other trees
KT153	<i>Livistona chinensis</i>	蒲葵	250	8.3	5.2	F	F	L	No	Fell	a, b, c	Crowded with other trees
KT154	<i>Livistona chinensis</i>	蒲葵	260	8.2	5.3	F	F	L	No	Fell	a, b, c	Crowded with other trees
KT156	<i>Livistona chinensis</i>	蒲葵	210	5.1	3.2	F	F	L	No	Fell	a, b, c	Crowded with other trees; seedling of epiphytic <i>Ficus microcarpa</i> found

KT158	<i>Livistona chinensis</i>	蒲葵	260	8.5	4.7	F	F	L	No	Fell	a, b, c	Crowded with other trees
KT161	<i>Livistona chinensis</i>	蒲葵	220	3.3	2.8	F	F	L	No	Fell	a, b, c	Crowded with other trees; seedling of epiphytic <i>Ficus microcarpa</i> found
KT162	<i>Livistona chinensis</i>	蒲葵	210	4.8	2.6	F	F	L	No	Fell	a, b, c	Crowded with other trees
KT164	<i>Livistona chinensis</i>	蒲葵	310	8.5	3.8	F	F	L	No	Fell	a, b, c	Crowded with other trees
KT165	<i>Livistona chinensis</i>	蒲葵	270	8.1	4.5	F	F	L	No	Fell	a, b, c	Crowded with other trees
KT166	<i>Aquilaria sinensis</i>	土沉香	230	11.3	6.2	F	F	M	No	Fell	a, b, c	On gentle slope; codominant stems; scheduled under Cap. 586
KT167	<i>Aquilaria sinensis</i>	土沉香	120	10.2	4.8	F	P	L	No	Fell	a, b, c, d	On gentle slope; unbalanced canopy; scheduled under Cap. 586
KT168	<i>Aquilaria sinensis</i>	土沉香	150	11.8	5.2	F	F	M	No	Fell	a, b, c	On gentle slope; stubs and pruned wounds observed; scheduled under Cap. 586

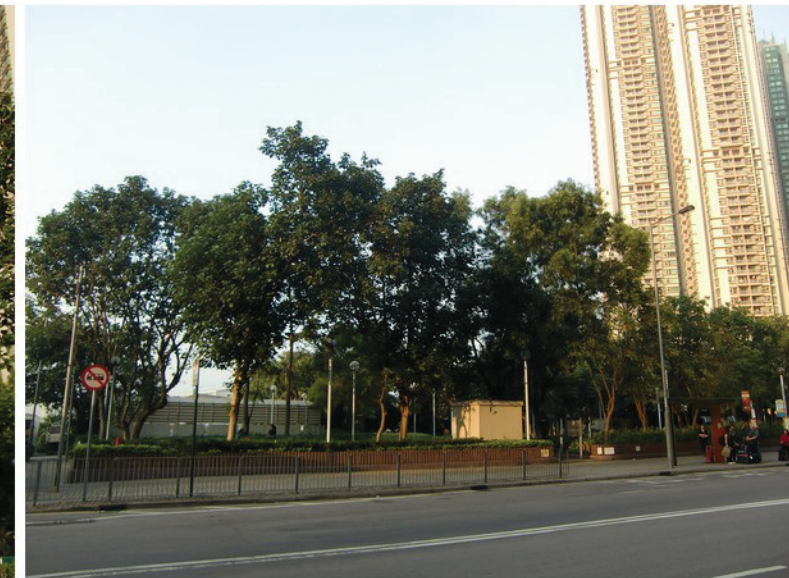
KT181 to KT185

KT177	<i>Erythrina variegata</i>	刺桐	170	6.3	4.0	F	F	L	No	Fell	a, b, c	Epicormic growth; unbalanced canopy; seedling of epiphytic <i>Ficus microcarpa</i> found
KT178	<i>Hibiscus tiliaceus</i>	黃槿	260	9.0	11.2	F	F	L	No	Fell	a, b, c	Torn bark; crossed branches; living stubs
KT179	<i>Hibiscus tiliaceus</i>	黃槿	270	9.0	11.3	F	F	L	No	Fell	a, b, c	Epicormic growth
KT180	<i>Erythrina variegata</i>	刺桐	220	8.0	8.0	F	P	L	No	Fell	a, b, c, d	Unbalanced canopy
KT181	<i>Hibiscus tiliaceus</i>	黃槿	240	7.6	3.7	F	F	L	No	Fell	a, b, c	Many pruned wounds on trunk; epicormic growth; small canopy
KT182	<i>Erythrina variegata</i>	刺桐	170	5.0	2.1	F	P	L	No	Fell	a, b, c, d	Slightly leaning; torn bark; hard pruned; epicormic growth; small canopy
KT183	<i>Hibiscus tiliaceus</i>	黃槿	250	8.5	6.0	F	F	L	No	Fell	a, b, c	Many pruned wounds; large torn bark; epicormic growth
KT184	<i>Acacia auriculiformis</i>	耳果相思	310	9.0	7.5	F	F	L	No	Fell	a, b, c	-

KT185	<i>Schefflera actinophylla</i>	傘樹	170	7.0	3.2	F	F	L	No	Fell	a, b, c	-
KT186	<i>Schefflera actinophylla</i>	傘樹	160	5.0	3.1	F	P	L	No	Fell	a, b, c, d	Leaning

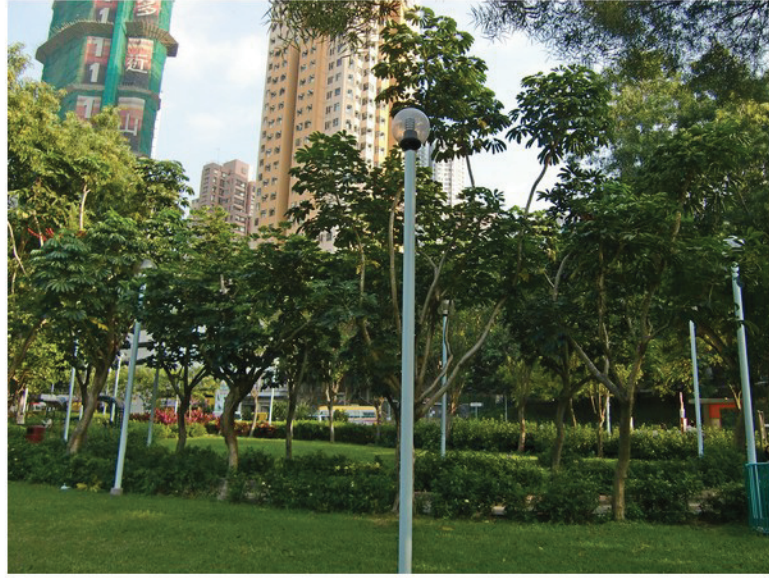
KT186 to KT190

Tree No.	Botanical Name	Chinese Name	DBH* (mm)	Height (m)	Crown Spread (m)	Health Condition (P/F/G)	Tree Form (P/F/G)	Amenity Value (L/M/H)	Suitability for Transplant	Proposed Treatment	Justification**	Remarks
KT187	<i>Schefflera actinophylla</i>	傘樹	240	5.2	4.0	F	F	L	No	Fell	a, b, c	-
KT188	<i>Schefflera actinophylla</i>	傘樹	160	5.0	3.6	F	P	L	No	Fell	a, b, c, d	Crooked trunk; poor taper
KT189	<i>Schefflera actinophylla</i>	傘樹	200	6.0	3.3	F	F	L	No	Fell	a, b, c	-
KT190	<i>Schefflera actinophylla</i>	傘樹	140	6.0	4.0	F	P	L	No	Fell	a, b, c, d	Leaning
KT191	<i>Acacia auriculiformis</i>	耳果相思	250	7.0	6.2	F	F	L	No	Fell	a, b, c	-
KT192	<i>Hibiscus tiliaceus</i>	黃槿	260	10.0	6.7	F	F	L	No	Fell	a, b, c	Surface root in conflict with kerb; torn bark; pruned wounds; crossed branches
KT193	<i>Hibiscus tiliaceus</i>	黃槿	290	10.0	7.6	F	F	L	No	Fell	a, b, c	Surface root in conflict with kerb; cavity on trunk
KT194	<i>Hibiscus tiliaceus</i>	黃槿	230	10.0	6.8	F	P	L	No	Fell	a, b, c, d, e	Growing near water point; bent trunk; unbalanced canopy; wound on trunk

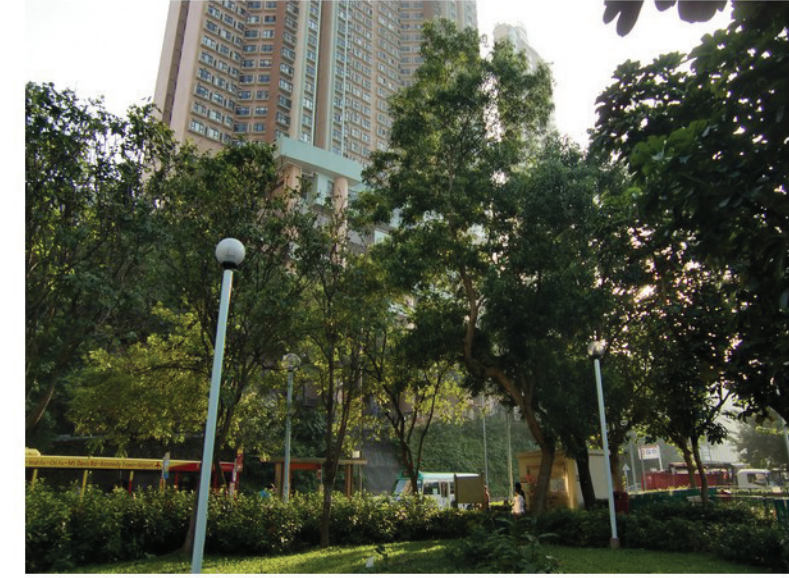
KT195 to KT196 & KT224 to KT225

KT195	<i>Pterocarpus indicus</i>	紫檀	160	5.4	4.1	F	F	M	No	Fell	a, b, c	-
KT196	<i>Acacia auriculiformis</i>	耳果相思	250	8.0	6.0	F	P	L	No	Fell	a, b, c, d	Unbalanced canopy
KT197	<i>Schefflera actinophylla</i>	傘樹	160	5.0	3.6	F	F	L	No	Fell	a, b, c	-
KT198	<i>Schefflera actinophylla</i>	傘樹	160	7.0	3.3	F	F	L	No	Fell	a, b, c	-
KT199	<i>Schefflera actinophylla</i>	傘樹	130	5.7	2.9	F	F	L	No	Fell	a, b, c	-
KT200	<i>Schefflera actinophylla</i>	傘樹	170	5.7	4.1	F	F	L	No	Fell	a, b, c	A large wound on trunk
KT201	<i>Schefflera actinophylla</i>	傘樹	150	6.0	3.6	F	F	L	No	Fell	a, b, c	-
KT202	<i>Hibiscus tiliaceus</i>	黃槿	270	8.0	10.0	F	F	L	No	Fell	a, b, c	Surface root in conflict with kerb
KT203	<i>Hibiscus tiliaceus</i>	黃槿	250	9.0	9.0	F	F	L	No	Fell	a, b, c	Surface root in conflict with kerb; crossed branches
KT204	<i>Hibiscus tiliaceus</i>	黃槿	220	9.0	7.0	F	F	L	No	Fell	a, b, c	Wound on trunk base
KT205	<i>Bauhinia sp.</i>	羊蹄甲屬	120	7.0	2.5	F	F	L	No	Fell	a, b, c	-

KT214	<i>Erythrina indica 'Picta'</i>	花葉刺桐	110	6.2	1.5	F	F	L	No	Fell	a, b, c	Pruned wounds
KT216	<i>Erythrina indica 'Picta'</i>	花葉刺桐	140	7.0	2.0	F	P	L	No	Fell	a, b, c, d	Leaning; exposed roots
KT218	<i>Erythrina indica 'Picta'</i>	花葉刺桐	170	7.0	3.0	F	F	L	No	Fell	a, b, c	Girdling root
KT219	<i>Erythrina indica 'Picta'</i>	花葉刺桐	180	7.0	3.0	F	F	L	No	Fell	a, b, c	-
KT220	<i>Erythrina indica 'Picta'</i>	花葉刺桐	180	7.2	3.3	F	F	L	No	Fell	a, b, c	-
KT221	<i>Erythrina indica 'Picta'</i>	花葉刺桐	210	7.2	3.3	F	F	L	No	Fell	a, b, c	Epicormic growth
KT222	<i>Erythrina indica 'Picta'</i>	花葉刺桐	210	7.2	4.4	F	F	L	No	Fell	a, b, c	Epicormic growth
KT223	<i>Erythrina indica 'Picta'</i>	花葉刺桐	190	7.5	3.0	F	F	L	No	Fell	a, b, c	Epicormic growth
KT224	<i>Erythrina indica 'Picta'</i>	花葉刺桐	160	7.3	2.0	F	F	L	No	Fell	a, b, c	Epicormic growth
KT225	<i>Pterocarpus indicus</i>	紫檀	130	5.0	3.5	F	P	L	No	Fell	a, b, c, d	Unbalanced canopy; codominant stems

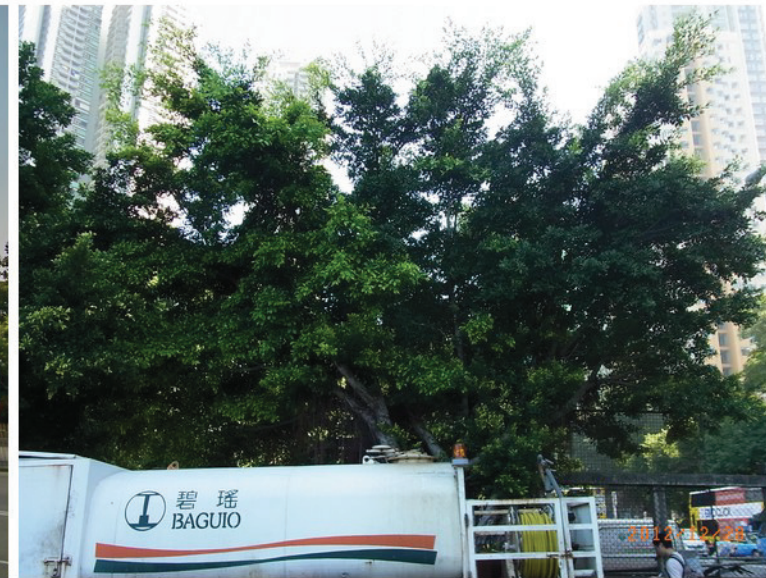
Tree No.	Botanical Name	Chinese Name	DBH* (mm)	Height (m)	Crown Spread (m)	Health Condition (P/F/G)	Tree Form (P/F/G)	Amenity Value (L/M/H)	Suitability for Transplant	Proposed Treatment	Justification**	Remarks
KT228	<i>Ficus microcarpa</i>	細葉榕	400	5.3	4.3	F	F	M	No	Fell	a, b, c, e	Growing in limited substrate, embedding boundary wall
KT229	<i>Ficus microcarpa</i>	細葉榕	400	6.1	5.2	F	F	M	No	Fell	a, b, c, e	Growing in limited substrate, embedding boundary wall; in conflict with temporary structure
KT230	<i>Celtis sinensis</i>	朴樹	330	7.0	11.0	F	F	L	No	Fell	a, b, c, e	Growing in limited space, root collar covered by concrete; embedding a metal at trunk base, a large wound on trunk observed
KT231	<i>Morus alba</i>	桑	220	7.3	7.1	F	F	L	No	Fell	a, b, c, e	Slightly leaning, a hanger observed, stock piling around
KT232	<i>Ficus benjamina</i>	垂葉榕	837	9.0	16.0	F	F	M	No	Fell	a, b, c, e, f	Growing across and embedding fencing, growing in limited substrate

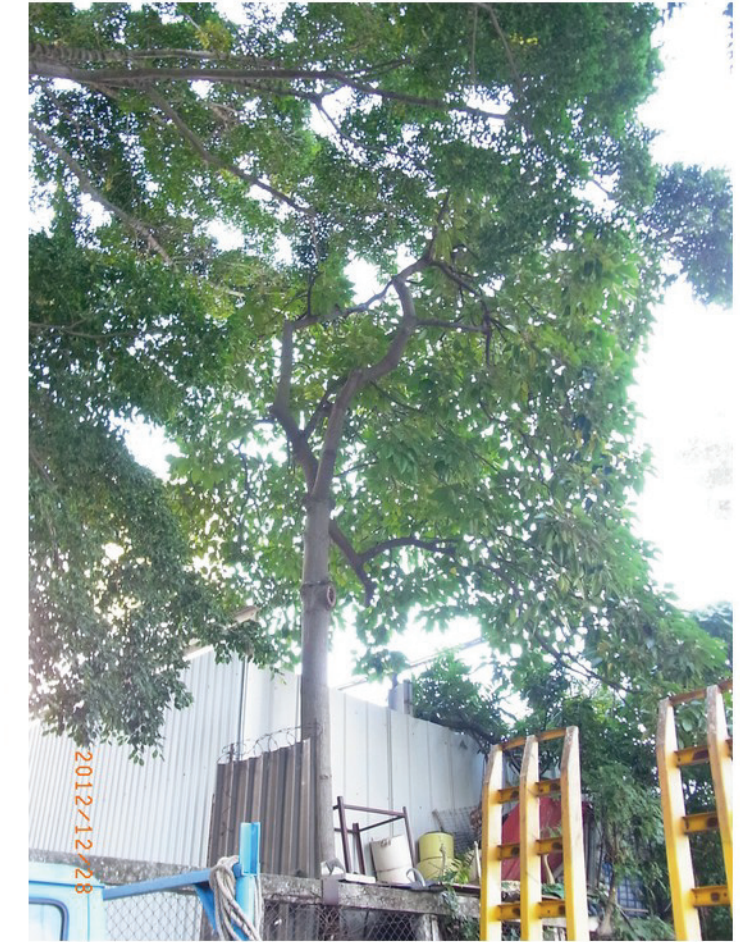
KT233	<i>Aleurites moluccana</i>	石栗	210	7.2	3.0	F	P	L	No	Fell	a, b, c, d, e	Unbalanced canopy, trunk base growing in restrictive space
KT234	<i>Macaranga tanarius</i>	血桐	120	4.0	4.0	F	P	L	No	Fell	a, b, c, d, e	Growing close to planter wall and trunk base in limited space, leaning, wounds on trunk, suckers, unbalanced canopy, trunk penetrating and embedding fencing
KT235	<i>Ficus microcarpa</i>	細葉榕	400	10.0	5.0	F	P	L	No	Fell	a, b, c, d, e	Growing in narrow planter, embedding metal framework, sparse canopy, unbalanced canopy; leaning
KT236	<i>Carica papaya</i>	番木瓜	150	6.4	2.0	F	F	L	No	Fell	a, b, c, e	Growing close to planter wall
KT237	<i>Ficus microcarpa</i>	細葉榕	600	7.7	10.2	F	F	M	No	Fell	a, b, c, e, f	Embedding fencing, planter wall and a wood strip, a large trunk lopped

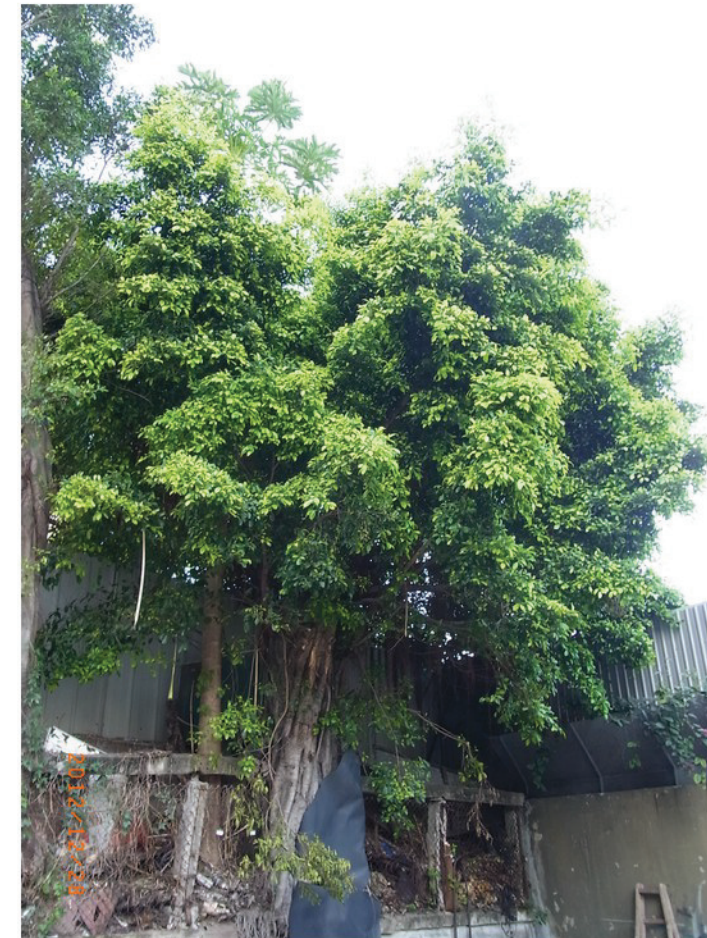
KT236 to KT238

Tree No.	Botanical Name	Chinese Name	DBH* (mm)	Height (m)	Crown Spread (m)	Health Condition (P/F/G)	Tree Form (P/F/G)	Amenity Value (L/M/H)	Suitability for Transplant	Proposed Treatment	Justification**	Remarks
KT238	<i>Morus alba</i>	桑	100	1.0	0.1	P	P	L	No	Fell	a, b, c, d, f	Topped; no canopy, except a few sprouting leaves
KT239	<i>Michelia x alba</i>	白蘭	200	9.0	5.0	F	P	L	No	Fell	a, b, c, d, e	Growing in small planter; crooked trunk; watersprouts on trunk, wounds on trunk base; in conflict with planter wall and nearby structure; girdled by wire around trunk base
KT240	<i>Celtis sinensis</i>	朴樹	510	8.0	10.0	F	F	M	No	Fell	a, b, c, e	Growing in limited space; root collar covered by concrete; branches embedding foreign matters; twigs die-back
KT241	<i>Bombax ceiba</i>	木棉	100	5.5	3.2	F	P	L	No	Fell	a, b, c, d, f	Growing in limited substrate; in close proximity of an undersized tree; unbalanced canopy

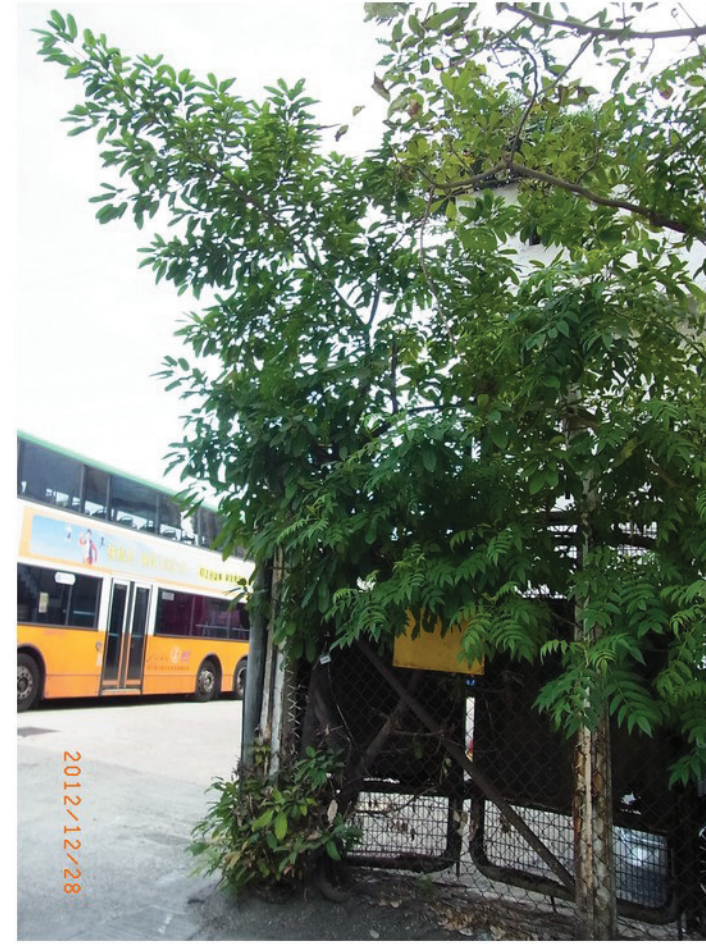
KT242	<i>Ficus subpisocarpa</i>	筆管榕	110	5.2	2.1	F	P	L	No	Fell	a, b, c, d, e	Growing across and embedding fencing, topped; vigorous epicormic growth
