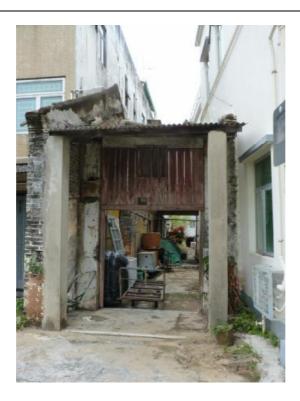
Brick façade only section of building remaining. Grey brick sides with wooden slat over doorway across the façade, the doors have been removed.

Existing Condition: Ruin (only façade wall remains)

Modifications: None , most of building has been demolished.

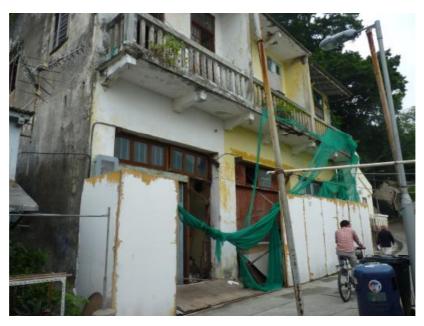
Modifications: Various modernisation features appear to have been carried out on the units over time.			
Photographic Record:
