**Independent Environmental Checker for
Contract No. YL/2009/01 – Hang Hau Tsuen Channel at
Lau Fau Shan**

Post-Construction Mangrove Monitoring

**1st Quarterly Mangrove Monitoring Report
(June 2013)**

Reference Number:
R3154_V1.1

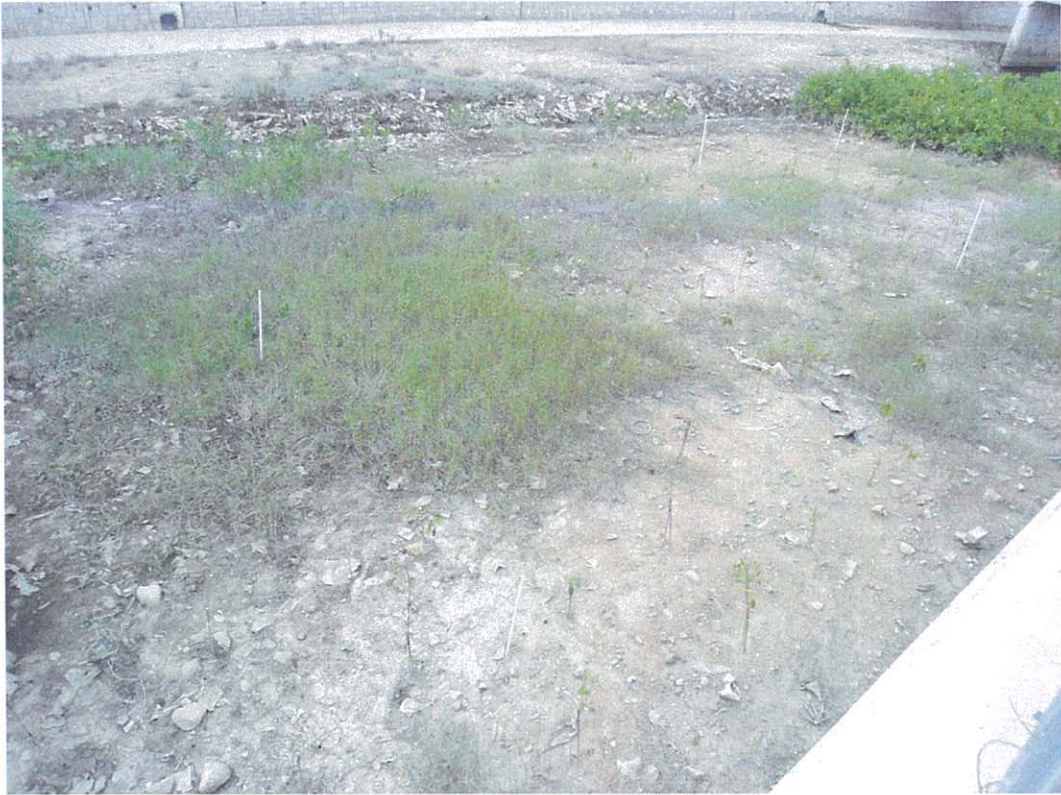
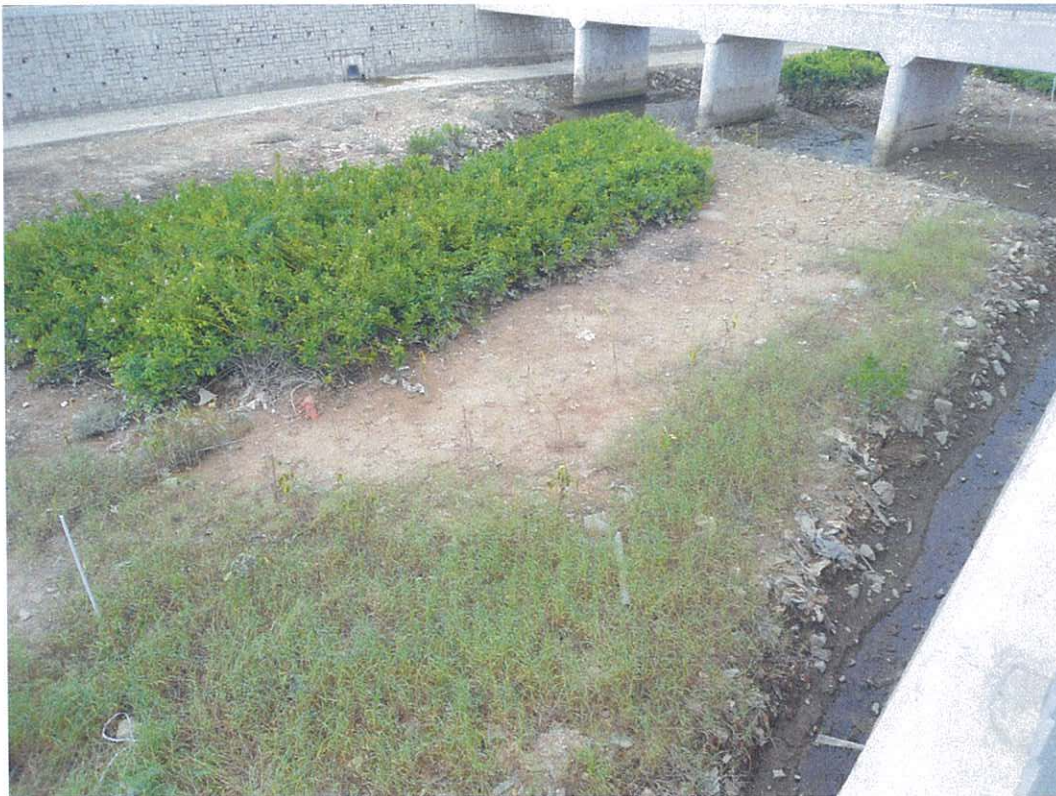
Photo 1 - 2

Overall view of mangrove compensation area

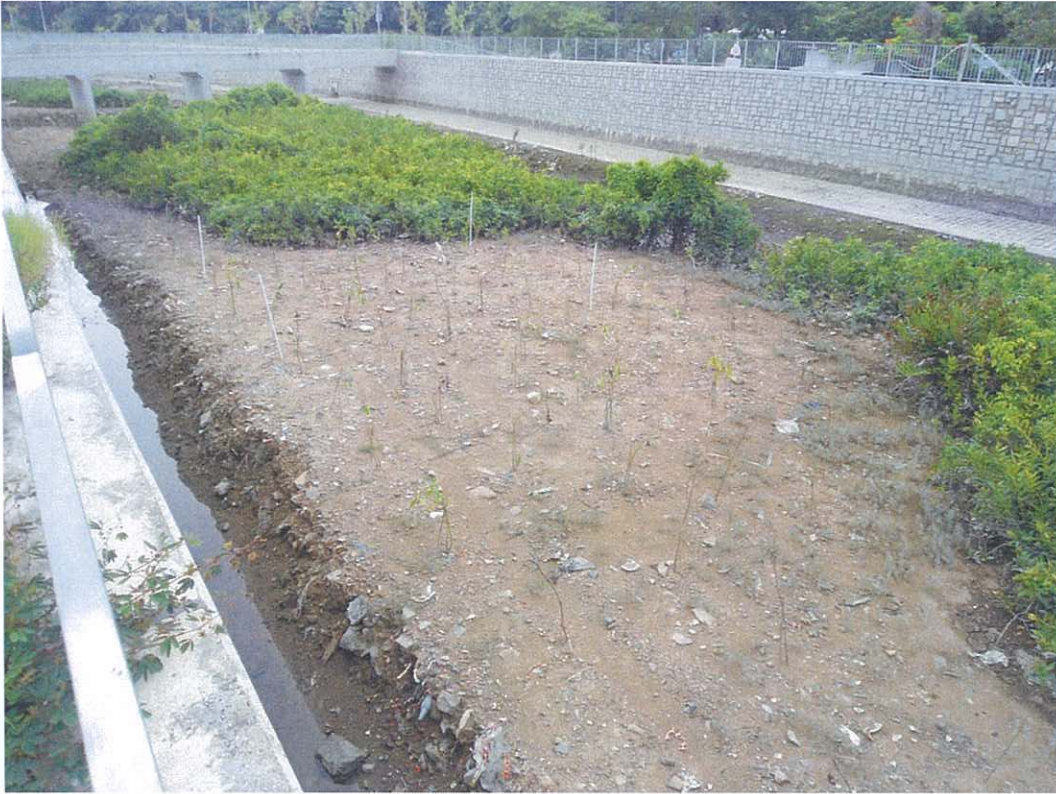
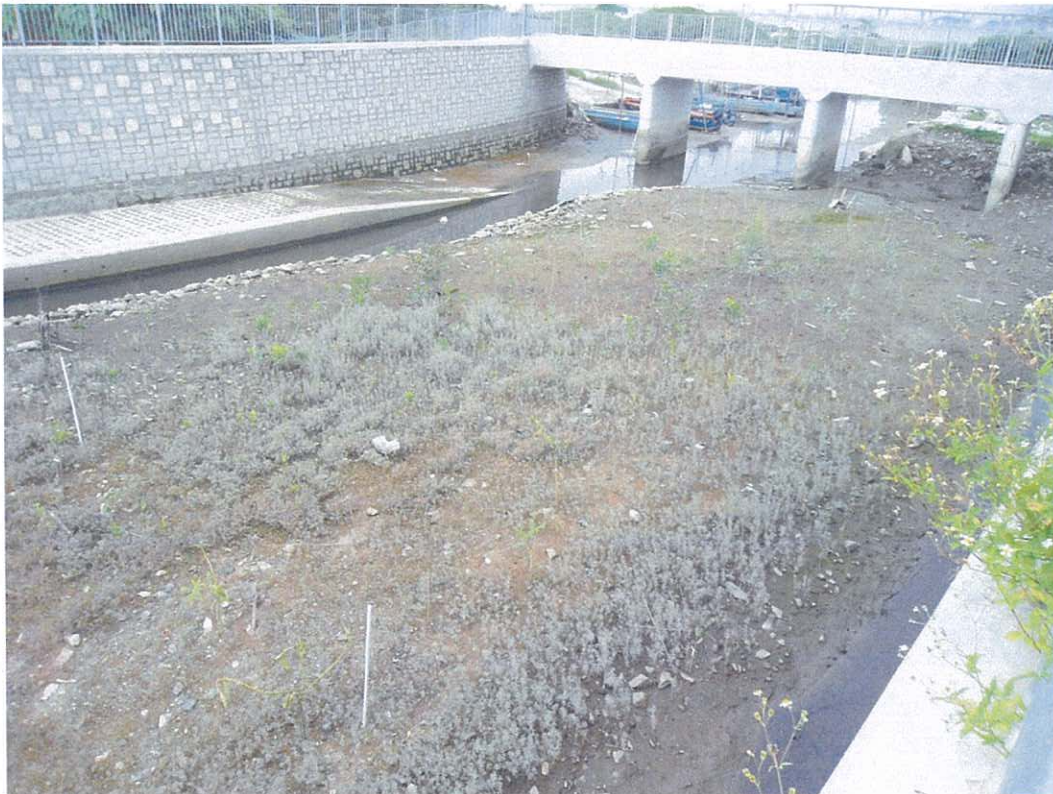
Photo 3 - 4

Overall view of mangrove compensation area

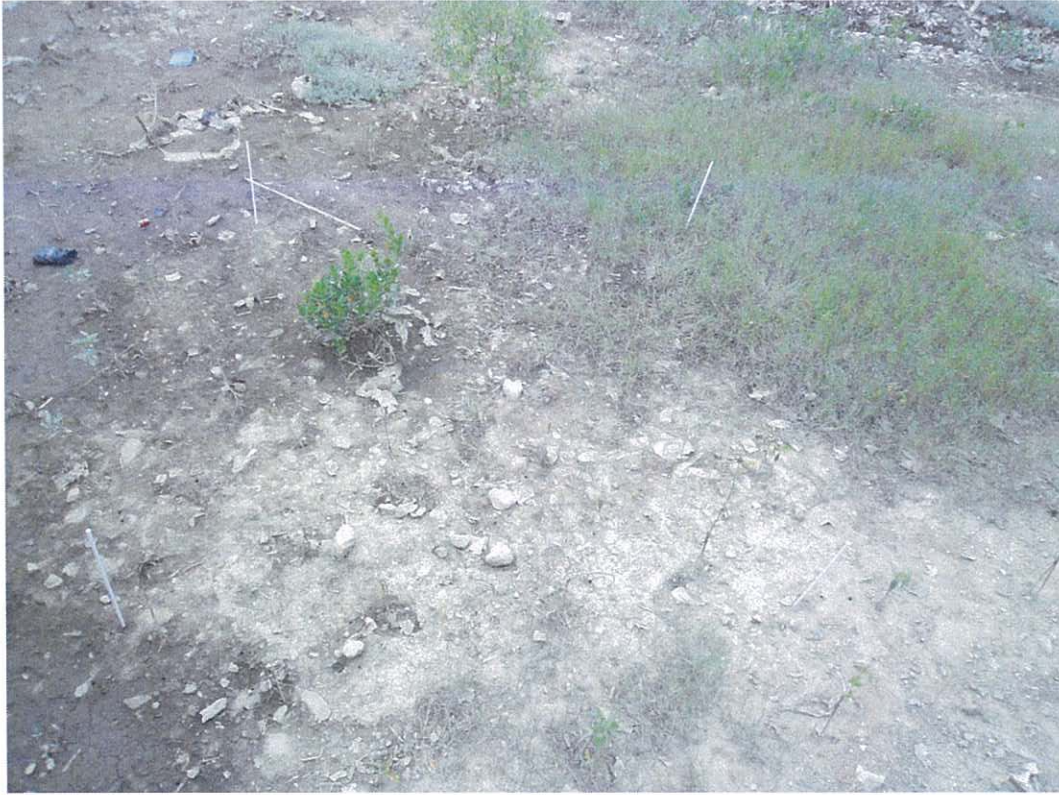
Overall view of Quadrant 1 - 2

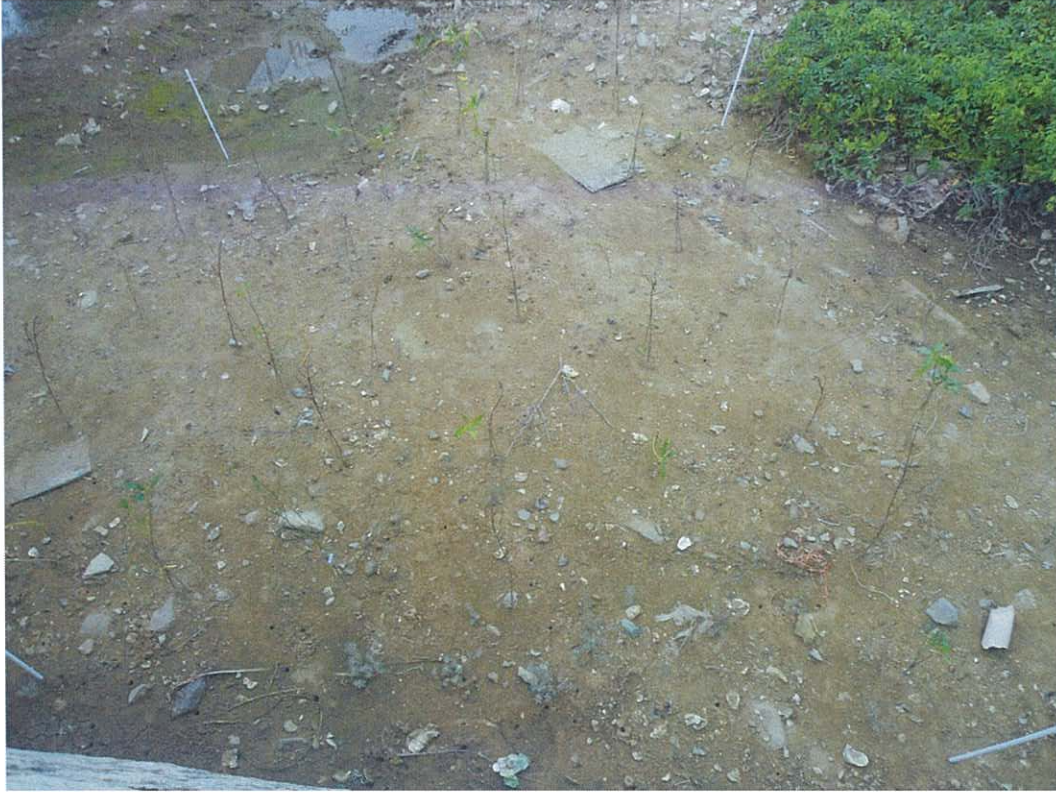
Overall view of Quadrat 3 - 4

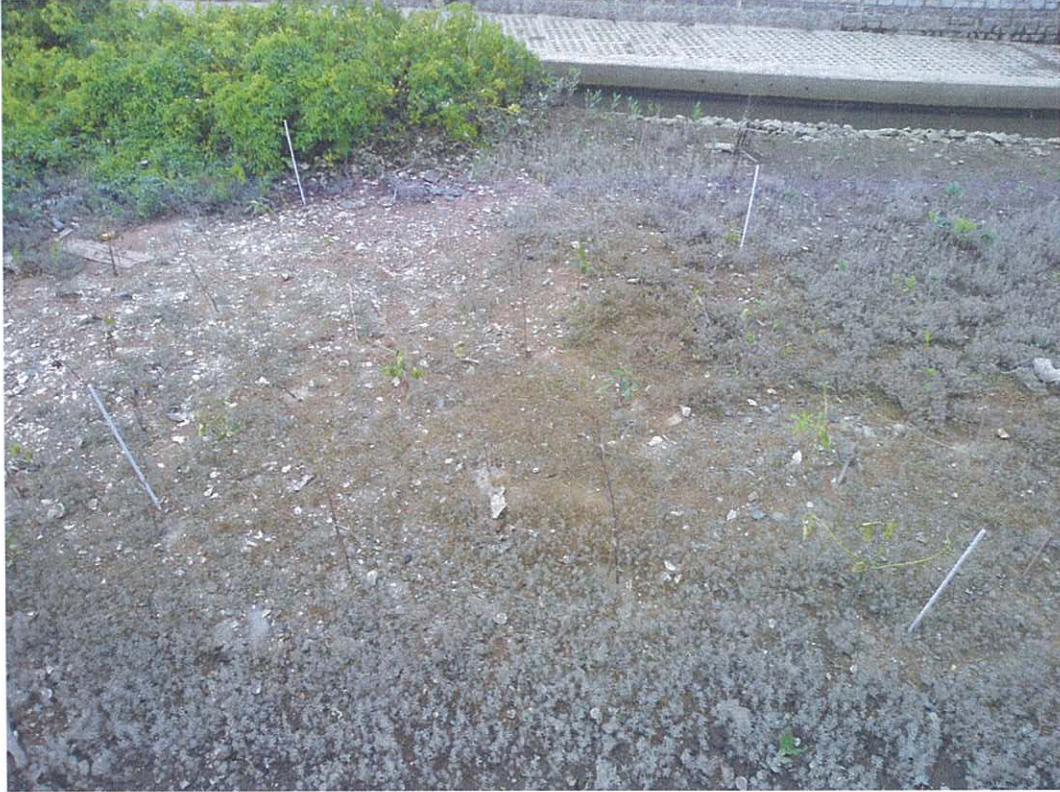
Photo 9

Overall view of Quadrat 5
