**Independent Environmental Checker for
Contract No. YL/2009/01 – Hang Hau Tsuen Channel at
Lau Fau Shan**

**Post-Construction Mangrove Monitoring
2nd Quarterly Mangrove Monitoring Report
(September 2013)**

Prepared for:
Civil Engineering and Development Department

Prepared by:
ENVIRON Hong Kong Limited

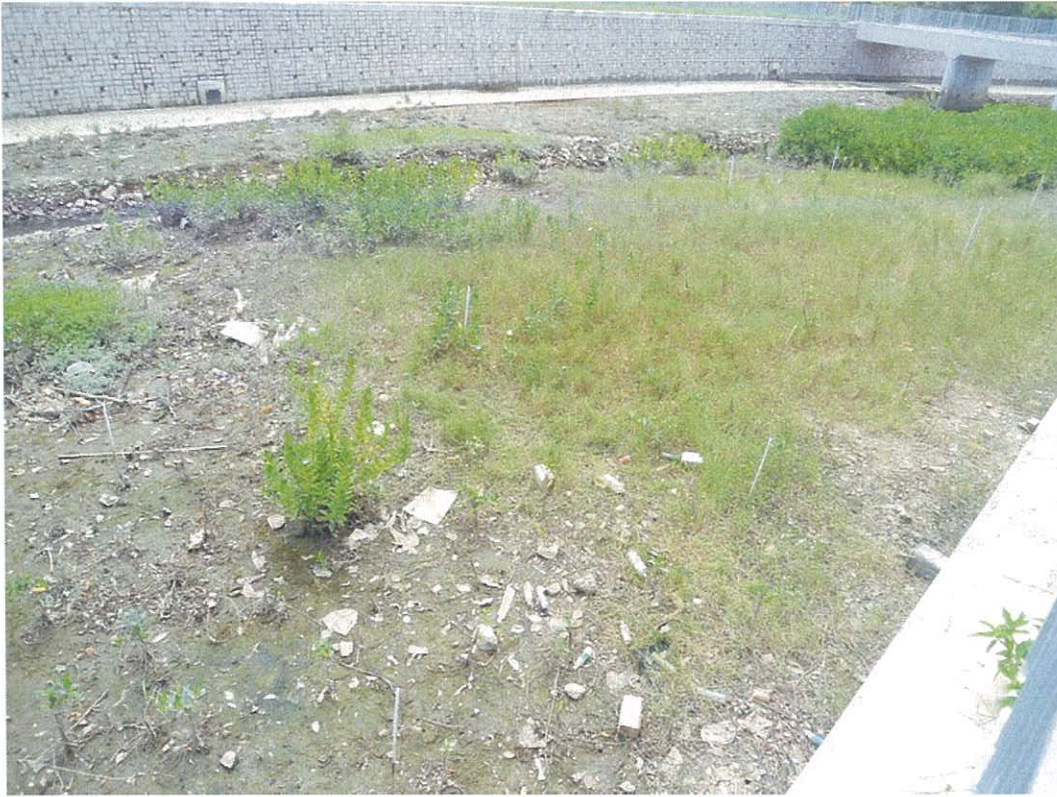
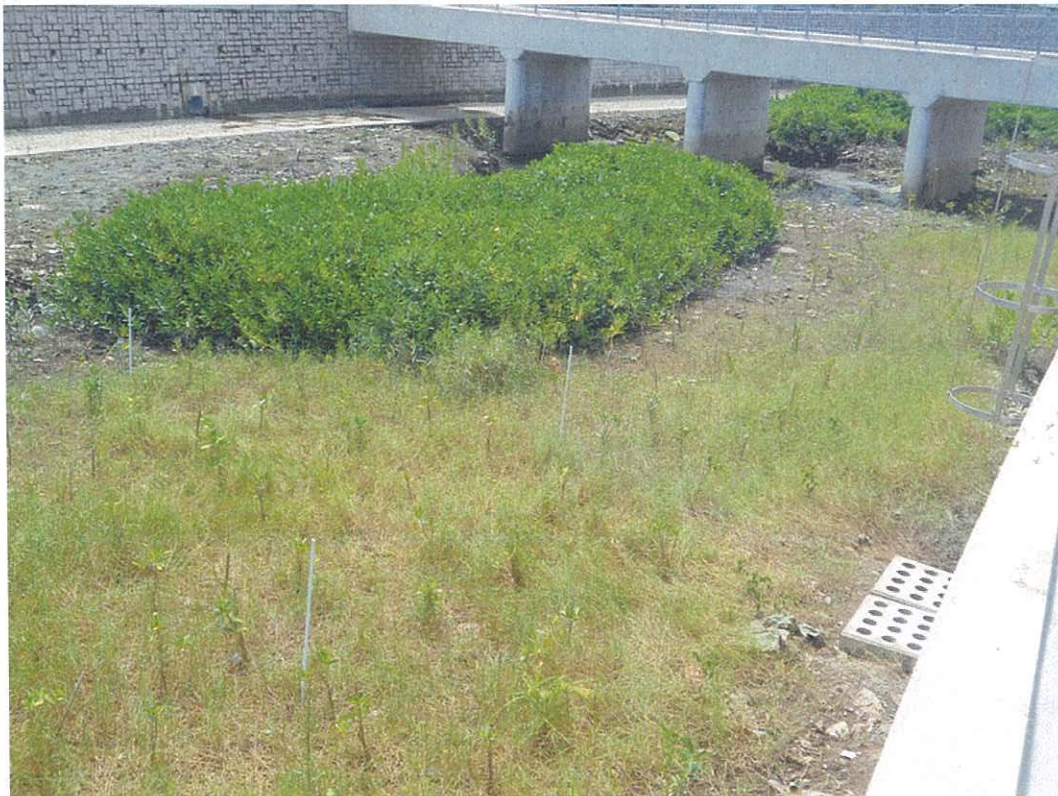
Photo 1 - 2

Overall view of mangrove compensation area

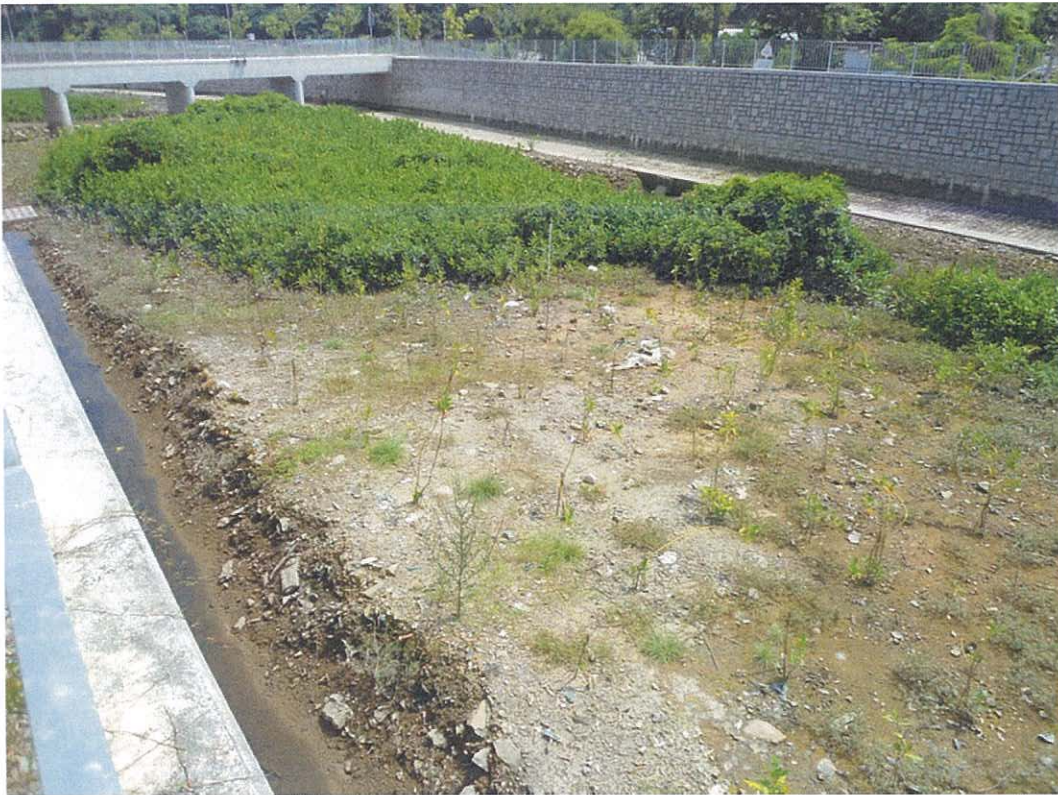
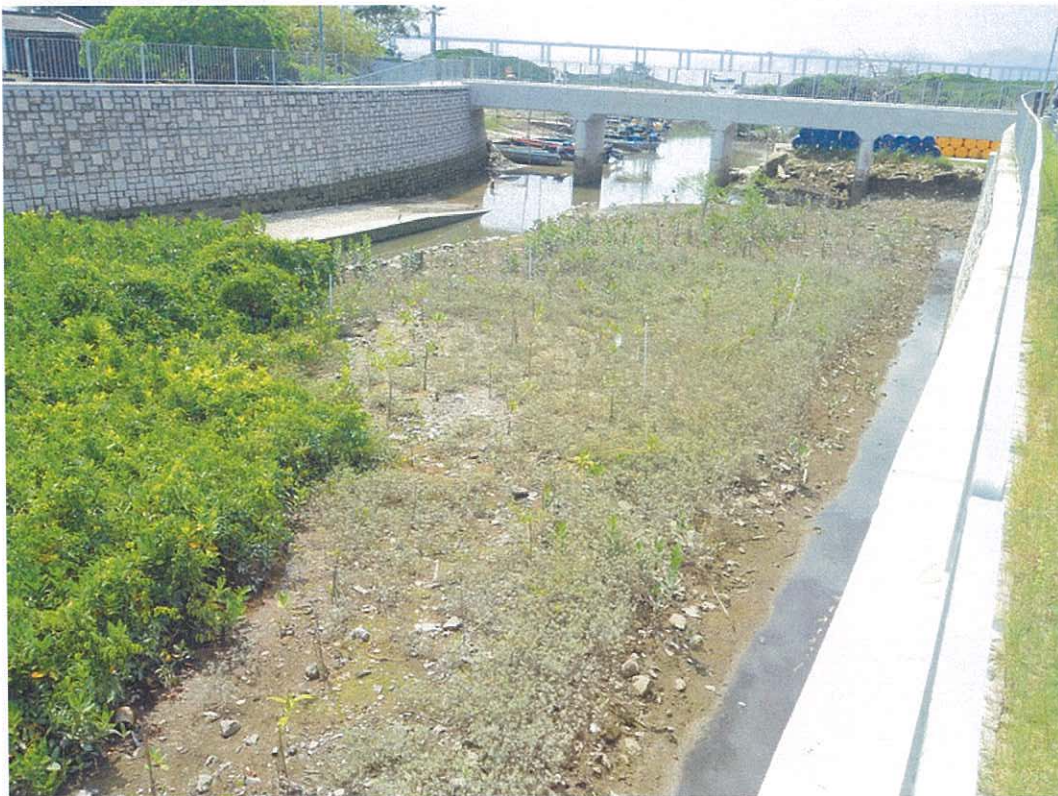
Photo 3 - 4

Overall view of mangrove compensation area

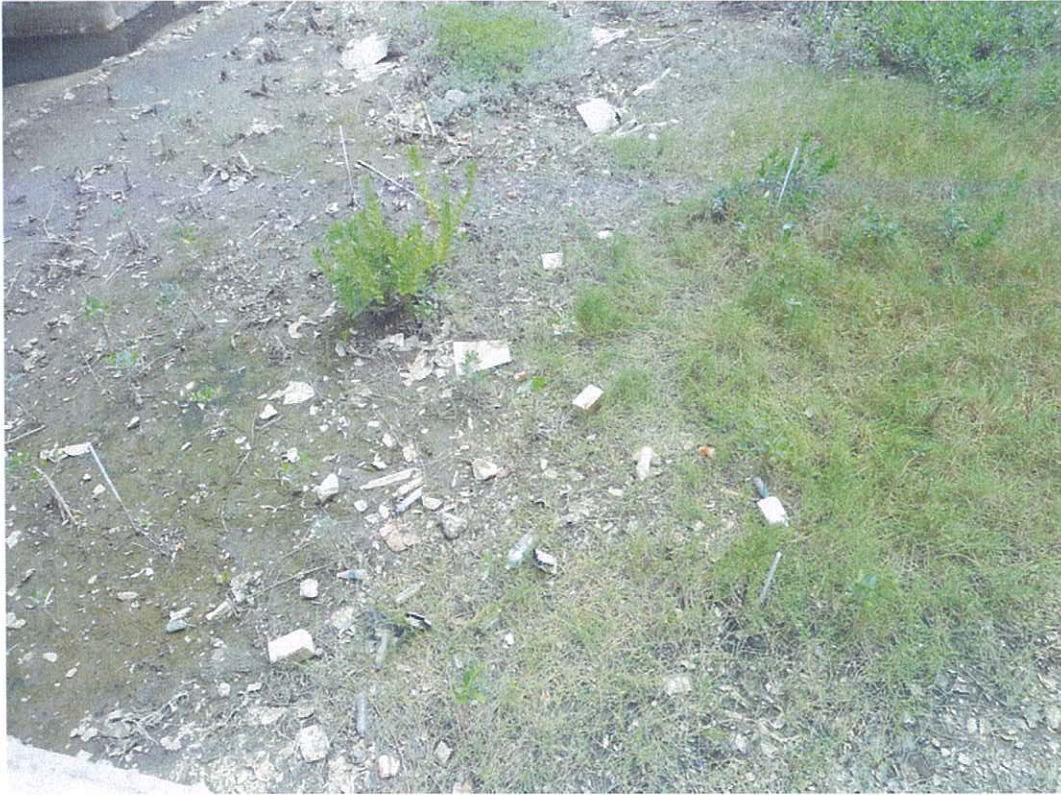
5

Quadrates 1

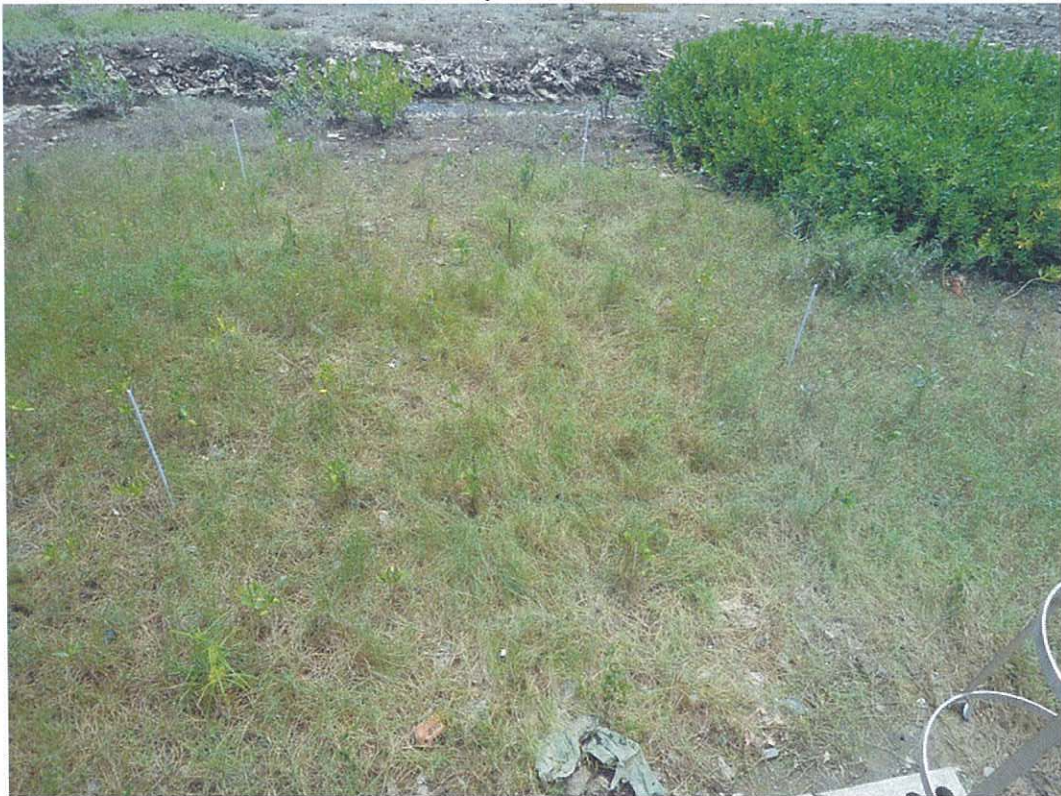
6

Quadrates 2

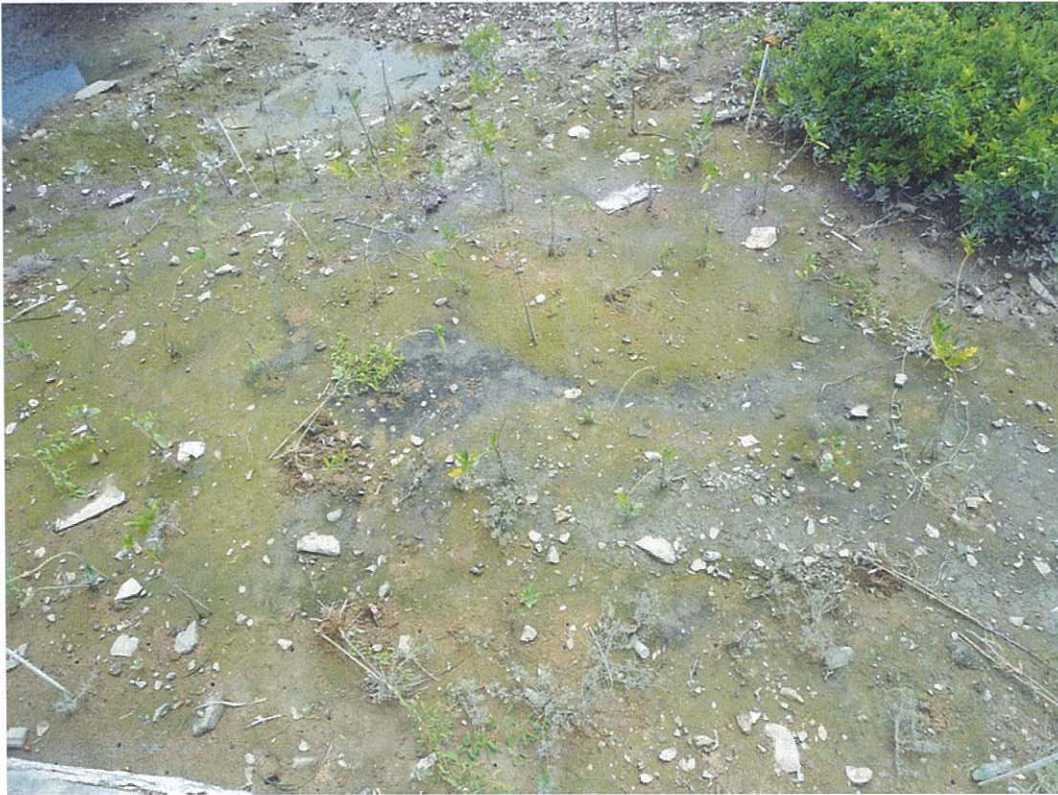
7

- 3.1.3 Generally, the overall health condition of *Acanthus ilicifolius* and *Kandelia obovata* was Fair as green foliage color was observed during the monitoring survey. However, the health condition of *Kandelia obovata* in Quadrat 3 was assessed as "Poor to Fair" due to sparse crown and dried up foliage, which indicated that the species *Kandelia obovata* in Quadrat 3 was currently under stress after plantation, thus continuous monitoring of the health condition is recommended.

- 4.1.2 Generally, the overall health condition of *Acanthus ilicifolius* and *Kandelia obovata* was Fair. However, the health condition of *Kandelia obovata* in Quadrat 3 was assessed as “Poor to Fair” due to sparse crown and dried up foliage, which indicated that the species *Kandelia obovata* in Quadrat 3 was currently under stress after plantation, thus continuous monitoring of the health condition is recommend.

Quadrat 3

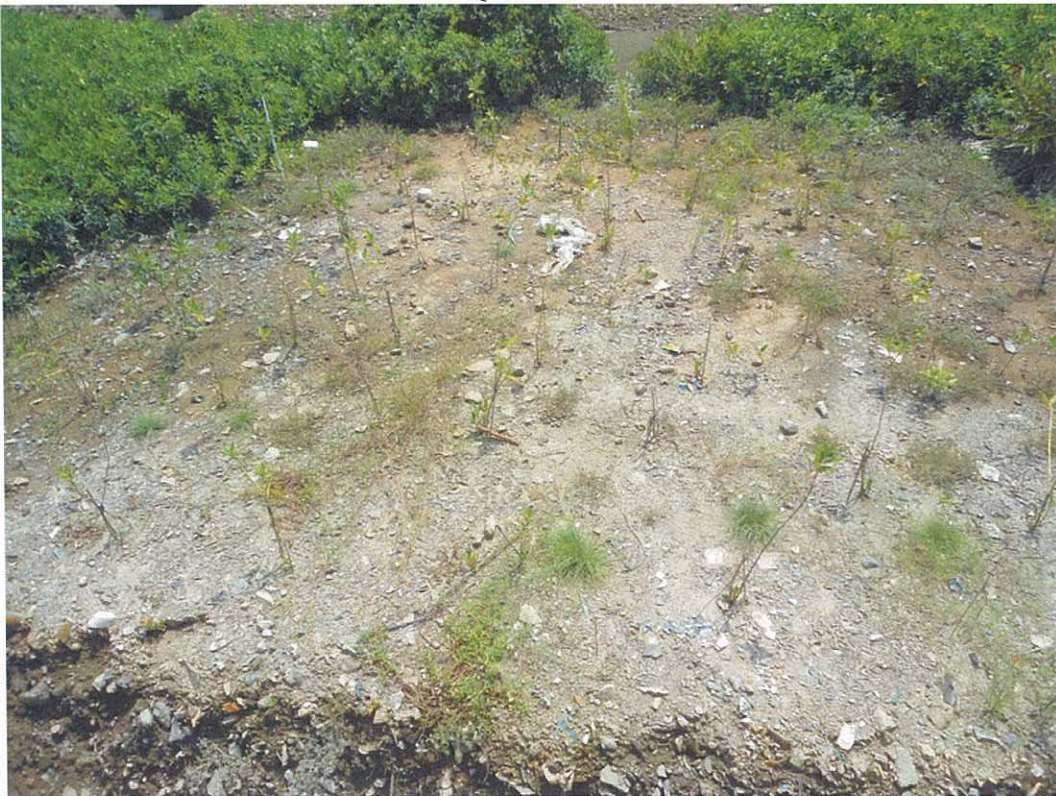
8

Quadrat 4

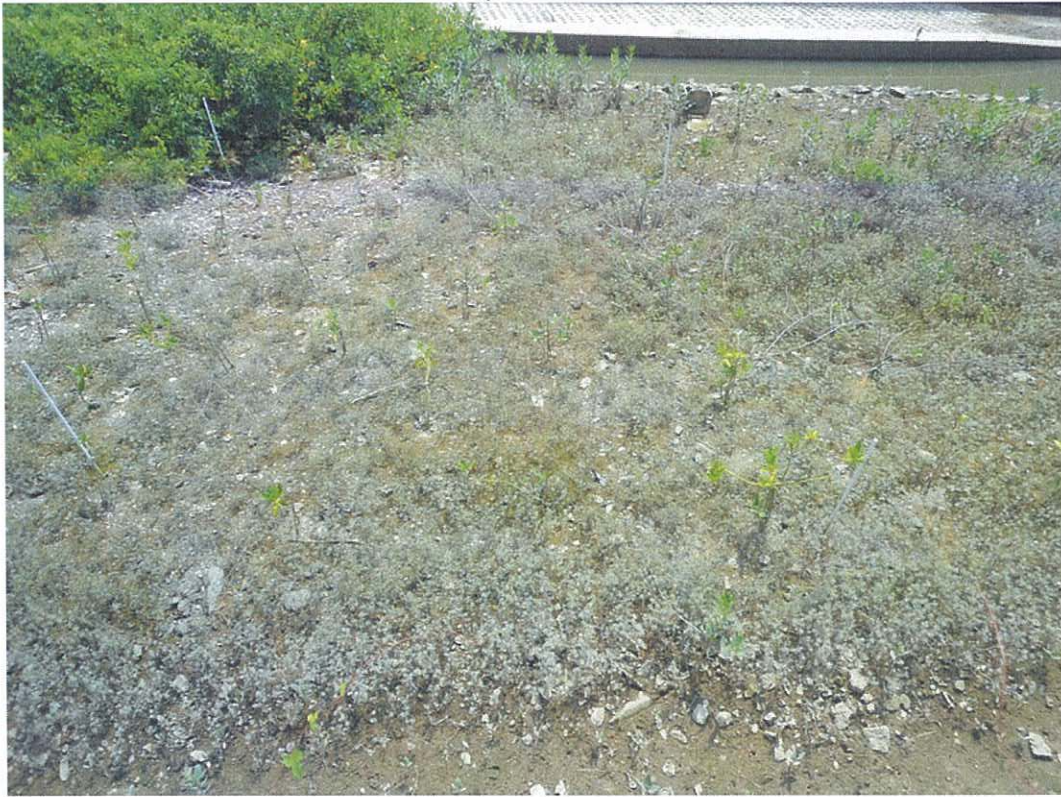
Photo 9

Overall view of Quadrant 5
