**Independent Environmental Checker for
Contract No. YL/2009/01 – Hang Hau Tsuen Channel at
Lau Fau Shan**

**Post-Construction Mangrove Monitoring
4th Quarterly Mangrove Monitoring Report
(March 2014)**

Reference Number:
R3604_V1.0 (draft)

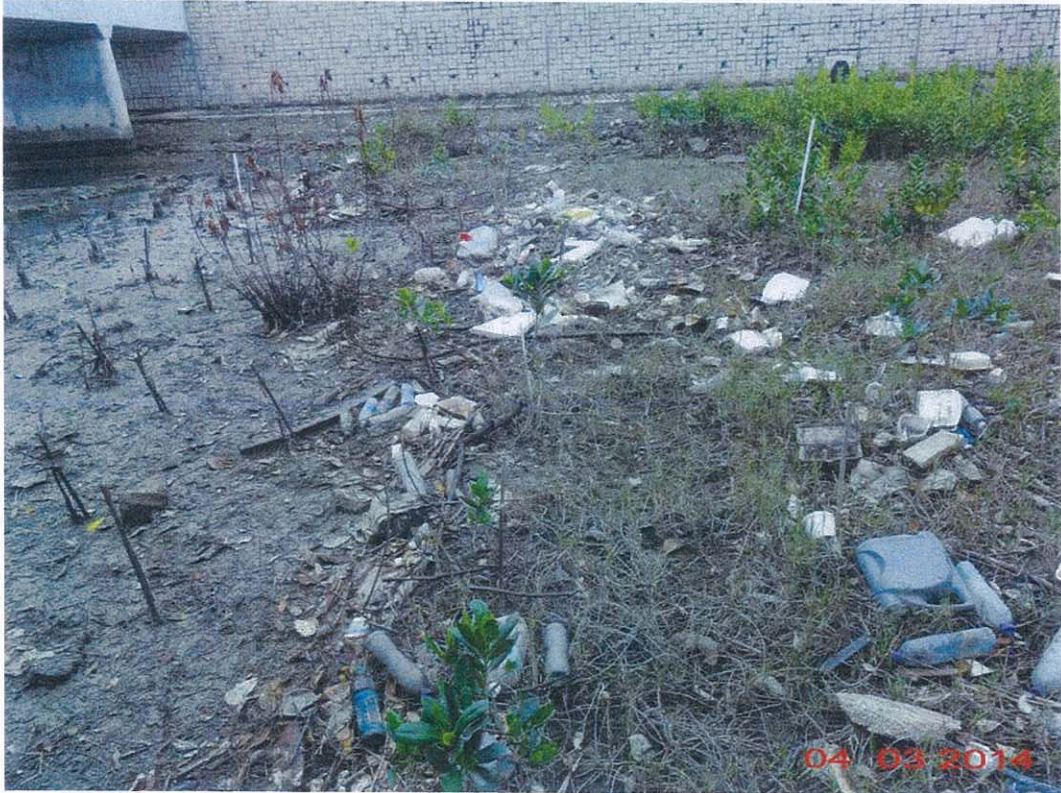
Quadrant 1

- 3.1.3 Generally, the overall health condition of *Acanthus ilicifolius* and *Kandelia obovata* was Fair as green foliage color was observed during the monitoring survey. However, the health condition of *Acanthus ilicifolius* and *Kandelia obovata* in Quadrat 1 was assessed as "Poor to Fair" due to the mangrove tree on eastern side of Quadrat 1 was dead since the inspection on December 2013. As that side of Quadrat 1 was nearest to the outlet of sewage, it was believed that eastern side of Quadrat 1 was immersed by sewage and lead to the death of mangrove tree on that area. However, the affected area was small compare to the whole compensatory site, thus the influence to the mangrove by the sewage is anticipated to be minor, but continuous monitoring of the health condition is still recommended.

- 4.1.2 Generally, the overall health condition of *Acanthus ilicifolius* and *Kandelia obovata* was Fair. However, the health condition of *Acanthus ilicifolius* and *Kandelia obovata* in Quadrat 1 was assessed as “Poor to Fair” due to the sudden dead of mangrove tree at eastern side, it was believed that eastern side of Quadrat 1 was immersed by sewage and lead to sudden dead of mangrove tree. However, the affected area was small compare to the whole compensatory site, thus the influence to the mangrove by the sewage is anticipated to be minor, but continuous monitoring of the health condition is recommended.
