**Independent Environmental Checker for
Contract No. YL/2009/01 – Hang Hau Tsuen Channel at
Lau Fau Shan**

Post-Construction Mangrove Monitoring

**5th Quarterly Mangrove Monitoring Report
(June 2014)**

Reference Number:
R3840_V1.0

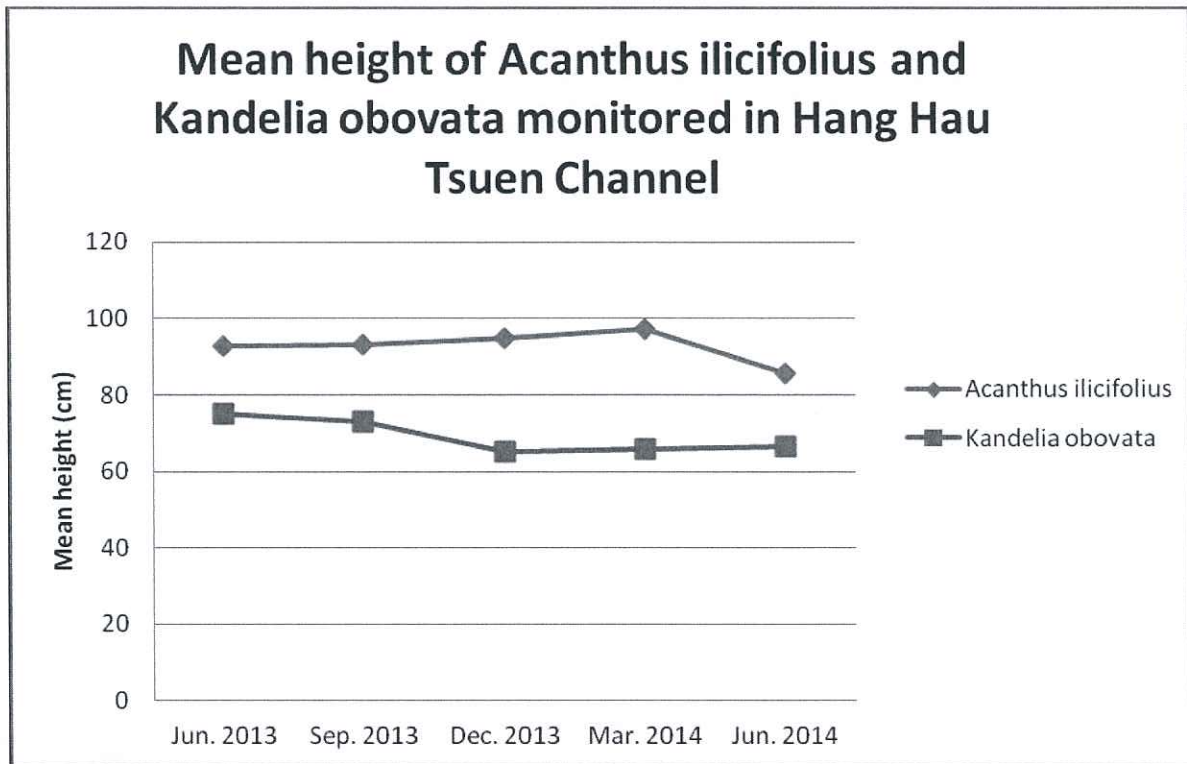
- 4.1.3 Maximum height and stem diameter of maximum 5 selected individual of each species in each quadrat was measured, the result of the measurement was shown in **Table 1**. Mean height & diameter of *Acanthus ilicifolius* and *Kandelia obovata* was calculated and shown in **Table 3 & 4**. The change of measurement parameters since June 2013 was shown in **Figures 1 & 2**. Generally, most mangrove trees were recorded in positive growth and increment in height or diameter was observed. However, height and diameter reduction was observed at some individual of *Acanthus ilicifolius* (Quadrat 4, Individual 1,3 and Quadrat 5, Individual 4) due to the death of the highest stem of these individual. Another healthy stem of this individual was chosen for measurement. Thus, the mean height and diameter of *Acanthus ilicifolius* was reduced compared with previous record.

Figure 1 - Mean height (cm) of *Acanthus ilicifolius* and *Kandelia obovata* monitored at Hang Hau Tsuen Channel from Jun 2013 to Jun 2014

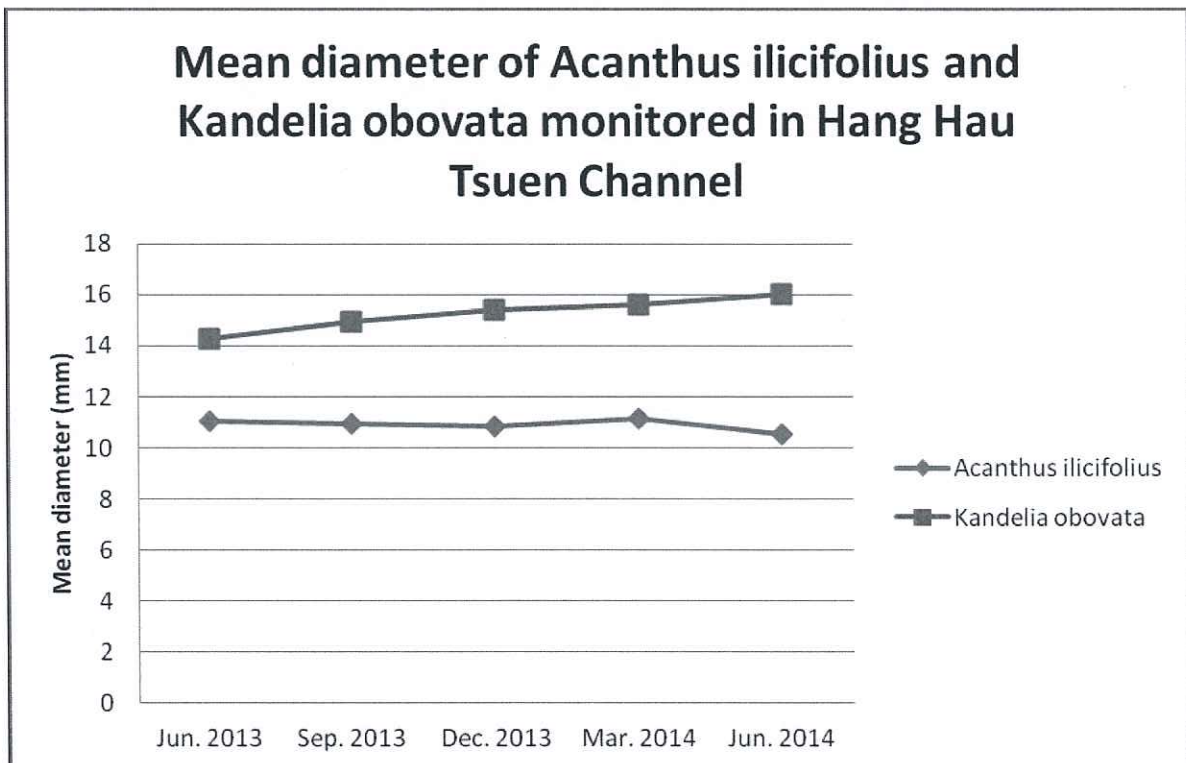
Figure 2 - Mean diameter (mm) of *Acanthus ilicifolius* and *Kandelia obovata* monitored at Hang Hau Tsuen Channel from Jun 2013 to Jun 2014

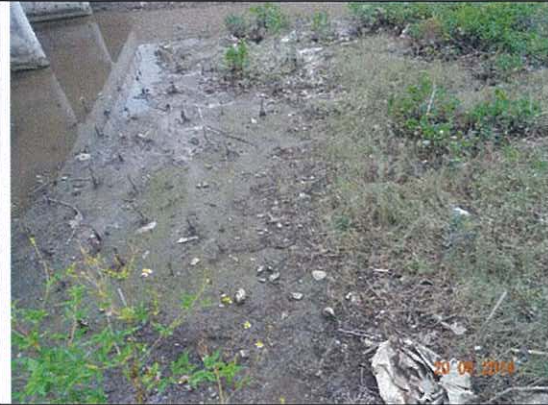
Quadrante 1

10. Current inspection : Rubbish from upstream was cleared up in this quadrante

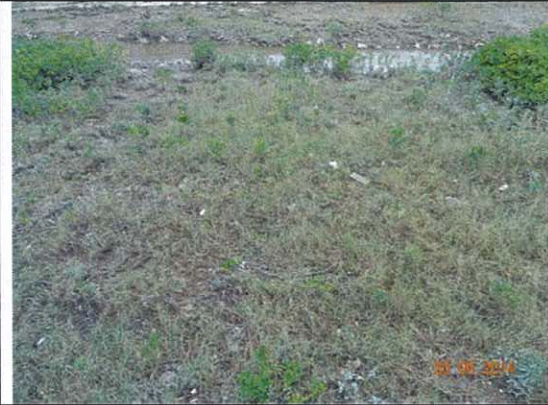
Quadrante 2

12. Current inspection: No significant change

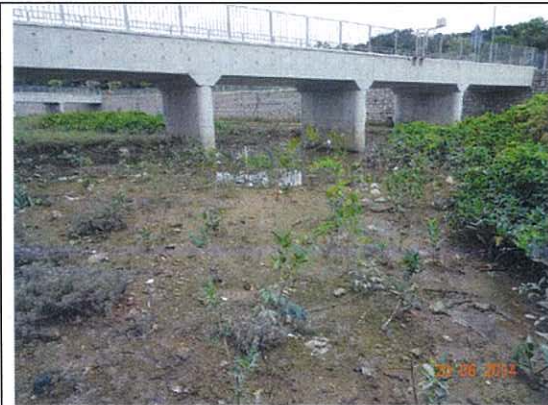
Quadrante 3

14. Current inspection: No significant change

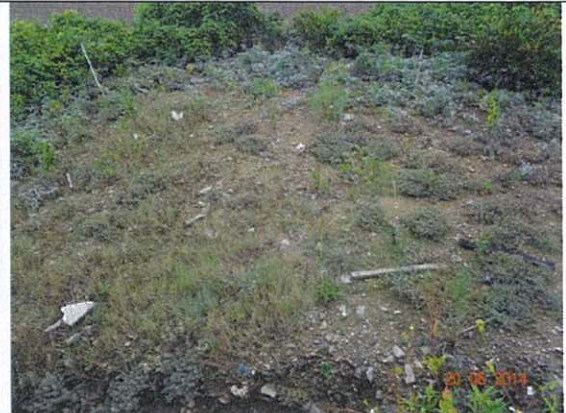
Quadrat 4

16. Current inspection: No significant change

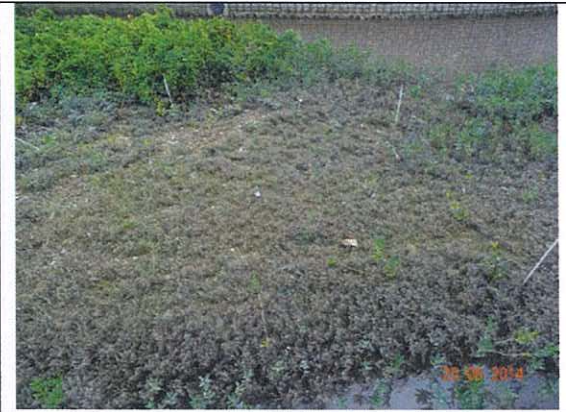
Quadrat 5

18. Current inspection: No significant change
