**Independent Environmental Checker for  
Contract No. YL/2009/01 – Hang Hau Tsuen Channel at  
Lau Fau Shan**

**Post-Construction Mangrove Monitoring  
6<sup>th</sup> Quarterly Mangrove Monitoring Report  
(September 2014)**

Prepared by:  
**ENVIRON Hong Kong Limited**

Date:  
**October 2014**

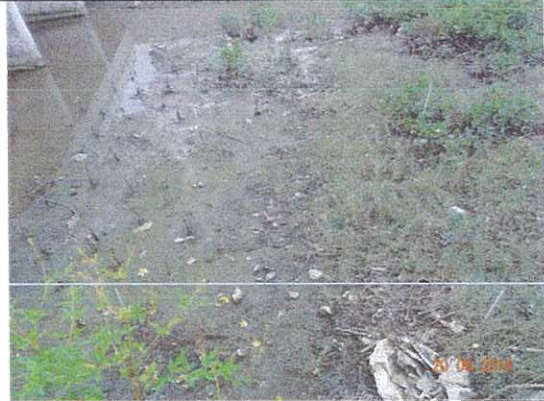
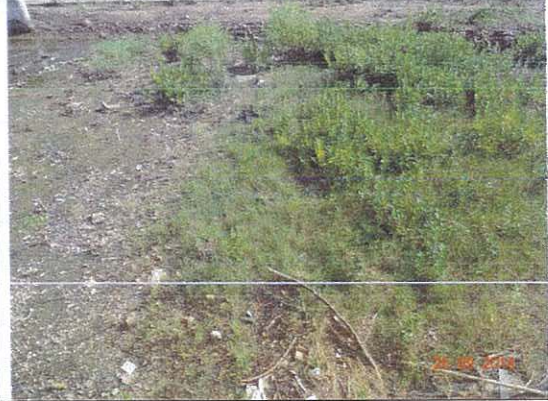
### Quadrates 1

- 3.1.3 Generally, the overall health condition of *Acanthus ilicifolius* and *Kandelia obovata* was fair as green foliage color was observed during the monitoring survey. However, the health condition of *Kandelia obovata* in Quadrat 1 was assessed as “Poor to Fair” due to the mangrove tree on eastern side of Quadrat 1 was dead since the inspection on December 2013. As that side of Quadrat 1 was nearest to the outlet of sewage, it was believed that eastern side of Quadrat 1 was immersed by sewage and lead to the death of mangrove tree on that area. However, the affected area was small compare to the whole compensatory site, thus the influence to the mangrove by the sewage is anticipated to be minor, but continuous monitoring of the health condition is still recommended.

- 4.1.2 Generally, the overall health condition of *Acanthus ilicifolius* and *Kandelia obovata* was fair. However, the health condition of *Kandelia obovata* in Quadrat 1 was assessed as “Poor to Fair” due to the death of mangrove tree on eastern side. It was believed that eastern side of Quadrat 1 was immersed by sewage and lead to the death of mangrove tree. However, the affected area was small compare to the whole compensatory site, thus the influence to the mangrove by the sewage is anticipated to be minor, but continuous monitoring of the health condition is recommend.

9. Last inspection

10. Current inspection : Rubbish from upstream was cleared up in this quadrate

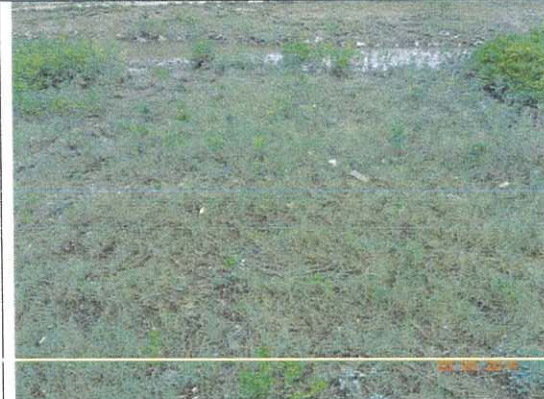
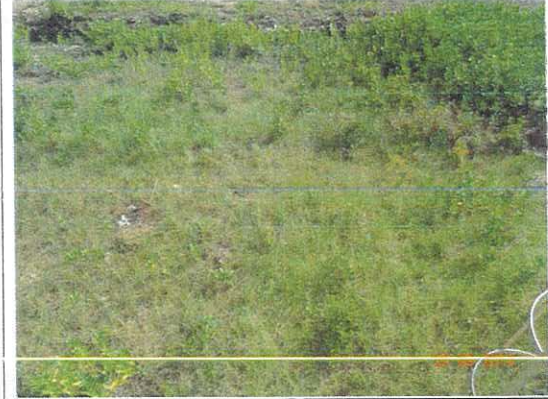
### Quadrates 2

12. Current inspection: No significant change

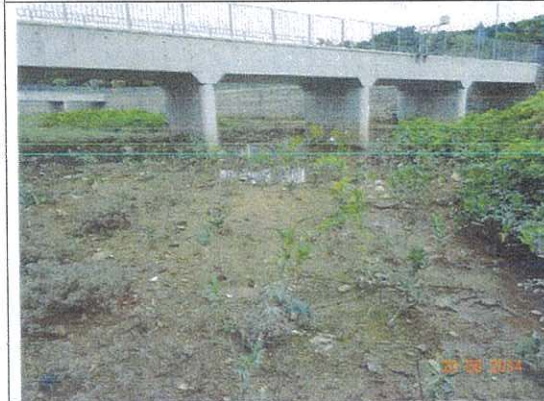
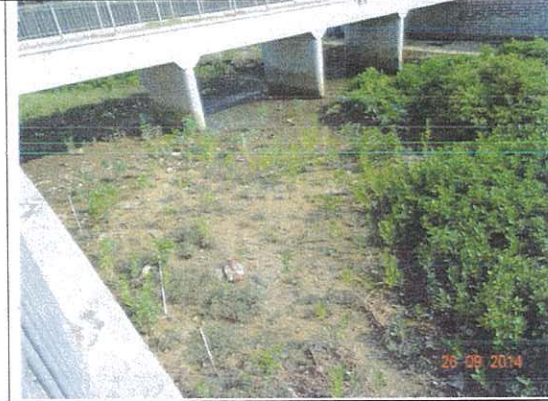
### Quadrates 3

- 3.2.2 Height and diameter reduction was observed at an individual of *Acanthus ilicifolius* (Quadrat 3, Individual 4, 5). The reduction was due to the death of the highest stem of this individual. Another healthy stem of this individual was chosen for measurement. Thus, the measurement was reduced compared with previous record.

14. Current inspection: No significant change

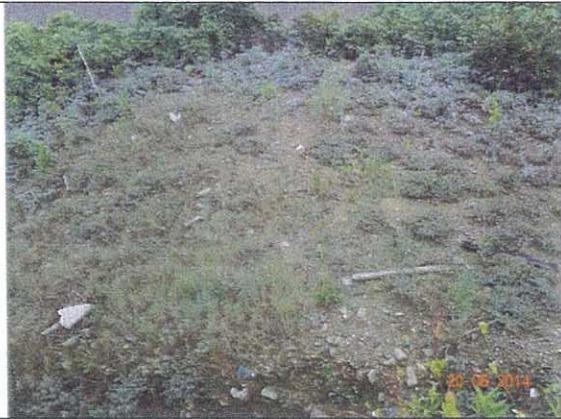
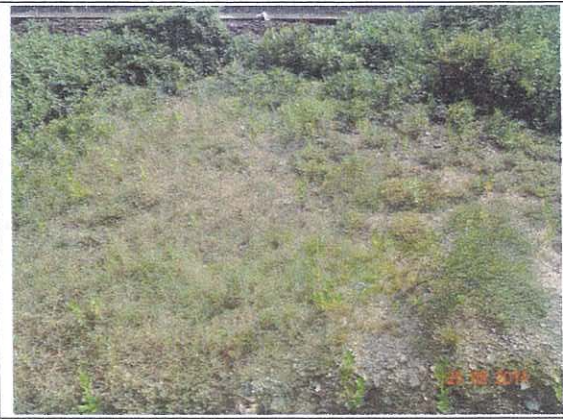
### Quadrat 4

16. Current inspection: No significant change

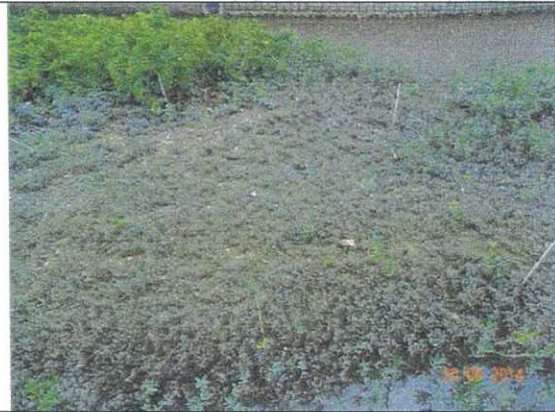
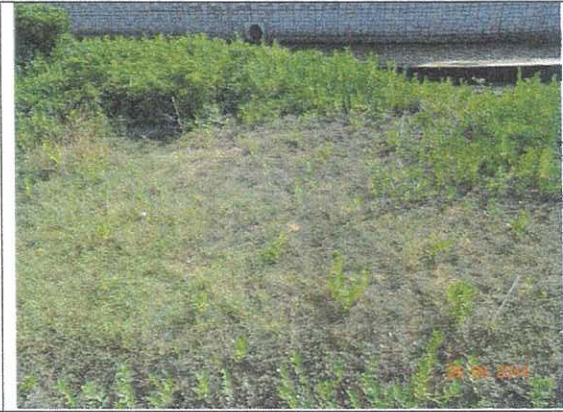
### Quadrat 5

18. Current inspection: No significant change
