**Independent Environmental Checker for
Contract No. YL/2009/01 – Hang Hau Tsuen Channel at
Lau Fau Shan**

**Post-Construction Mangrove Monitoring
7th Quarterly Mangrove Monitoring Report
(December 2014)**

Prepared for:
Civil Engineering and Development Department

Prepared by:
ENVIRON Hong Kong Limited

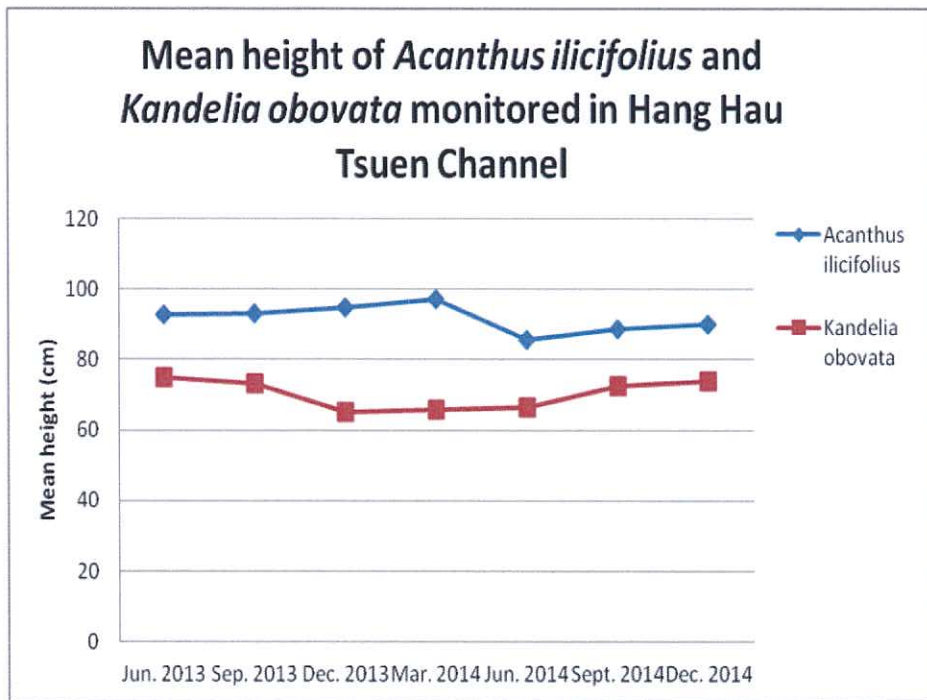
Figure 1 - Mean height (cm) of *Acanthus ilicifolius* and *Kandelia obovata* monitored at Hang Hau Tsuen Channel from Jun 2013 to Dec 2014

- 4.1.3 Maximum height and stem diameter of maximum 5 selected individual of each species in each quadrat was measured, the result of the measurement was shown in **Table 1**. Mean height & diameter of *Acanthus ilicifolius* and *Kandelia obovata* was calculated and shown in **Tables 3 & 4**. The change of measurement parameters since June 2013 was shown in **Charts 1 & 2**. Generally, most mangrove trees were recorded in positive growth and increment in height or diameter was observed.

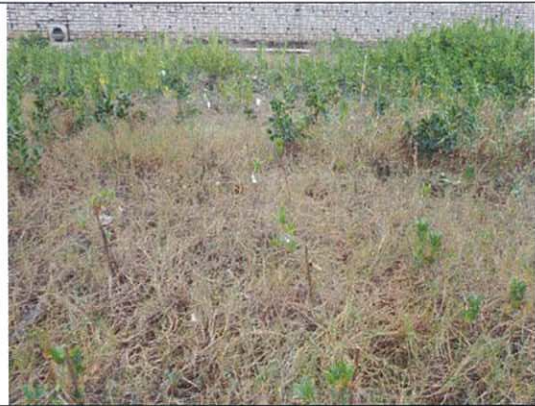
10. Current inspection: No significant change

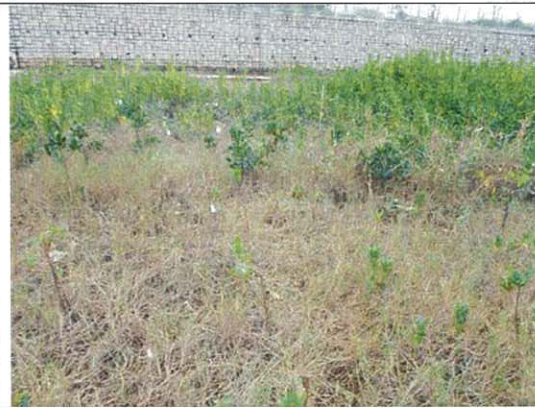
12. Current inspection: No significant change

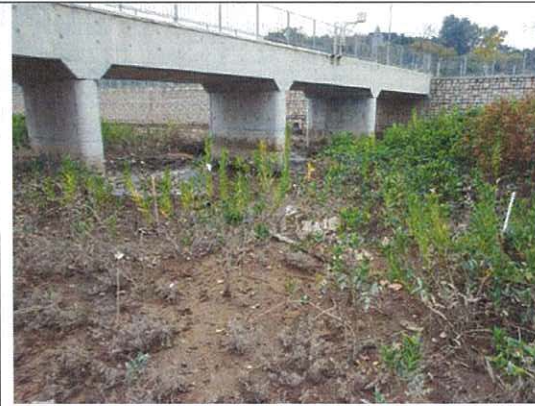
14. Current inspection: No significant change

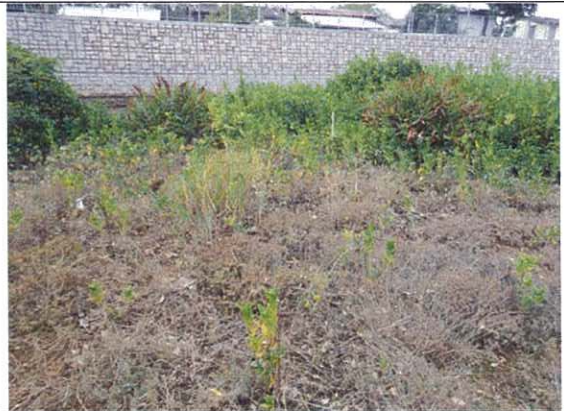
16. Current inspection: No significant change

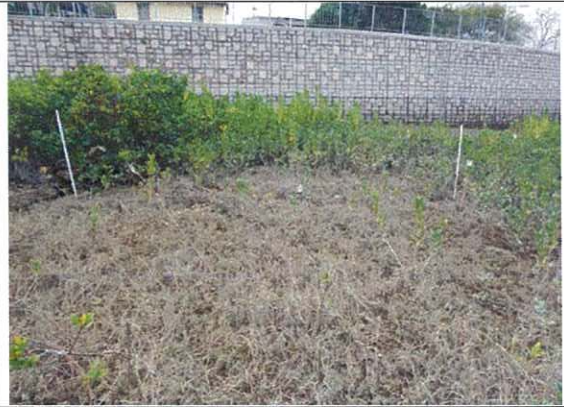
18. Current inspection: No significant change
