**Independent Environmental Checker for
Contract No. YL/2009/01 – Hang Hau Tsuen Channel at
Lau Fau Shan**

Post-Construction Mangrove Monitoring

**8th Quarterly Mangrove Monitoring Report
(March 2015)**

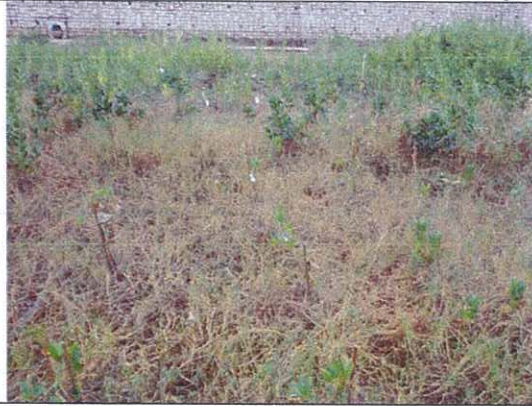
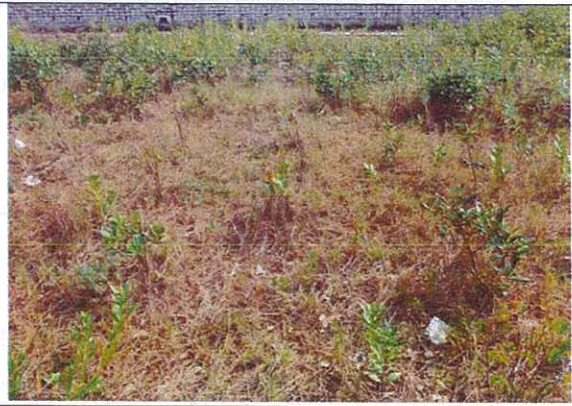
- 3.1.3 Generally, the overall health condition of *Acanthus ilicifolius* and *Kandelia obovata* was fair as green foliage color was observed during the monitoring survey. However, the health condition of *Kandelia obovata* in Quadrat 1 was assessed as “Poor to Fair” due to the mangrove tree on eastern side of Quadrat 1 was dead since the inspection on December 2013. As that side of Quadrat 1 was nearest to an outfall, it was believed that eastern side of Quadrat 1 was immersed by the discharge from outfall and lead to the death of mangrove tree on that area. However, the affected area was small compare to the whole compensatory site, and a total of 0.07 (1:1 ratio) compensation area is still complied as regeneration in other area was observed. Thus the loss of small proportion of trees is minor.

- 4.1.2 The health condition of *Kandelia obovata* in Quadrat 1 was assessed as “Poor to Fair” due to the death of mangrove tree on eastern side. It was believed that eastern side of Quadrat 1 was immersed by discharge from nearest outfall and lead to the death of mangrove tree. However, the affected area was small compare to the whole compensatory site, and a total of 0.07 (1:1 ratio) compensation area is still complied as regeneration in other area was observed. Thus the loss of small proportion of trees is minor.

10. Current inspection: No significant change

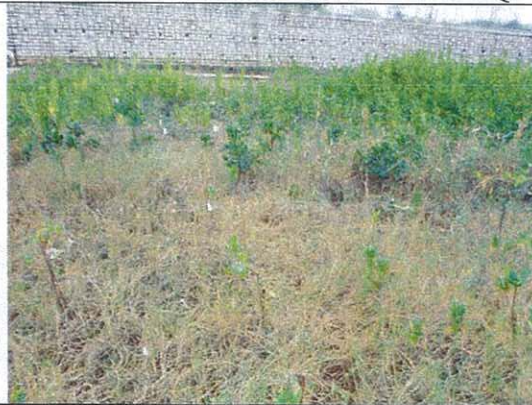
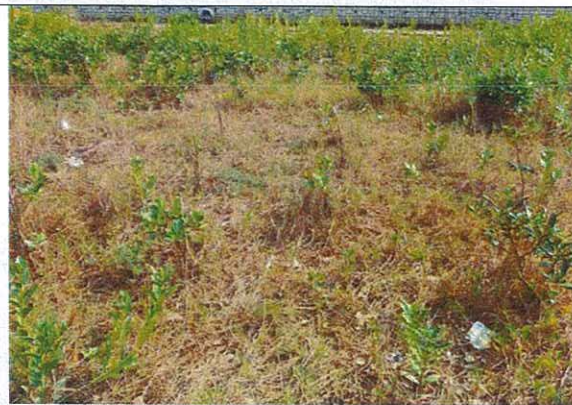
Quadrat 2

- 3.1.4 One of the selected *Kandelia obovate* was found dead in Quadrat 2. As the rest of the trees in the same quadrat were observed to have positive growth without significant change, it was believed that the tree was dead naturally and reason of the death is not related to any impacts raised from the compensatory site.

- 4.1.3 One of the selected *Kandelia obovate* was found dead in Quadrat 2. As the rest of the trees in the same quadrat were observed to have positive growth without significant change, it was believed that the tree was dead naturally and reason of the death is not related to any impacts raised from the compensatory site. Generally, the overall health condition of *Acanthus ilicifolius* and *Kandelia obovata* was fair.

12. Current inspection: No significant change

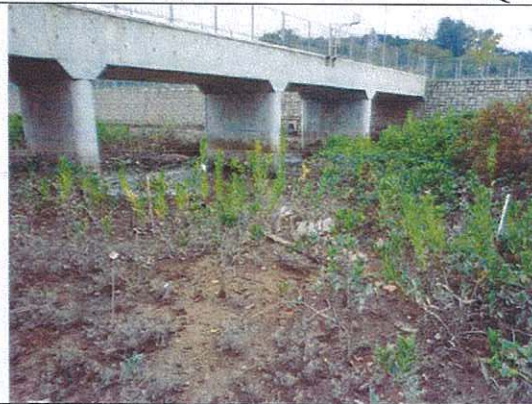
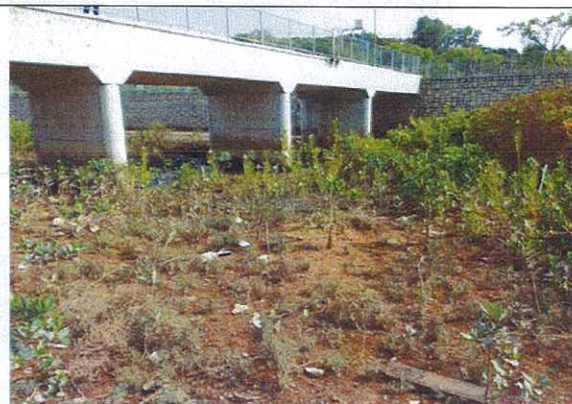
Quadrat 3

14. Current inspection: No significant change

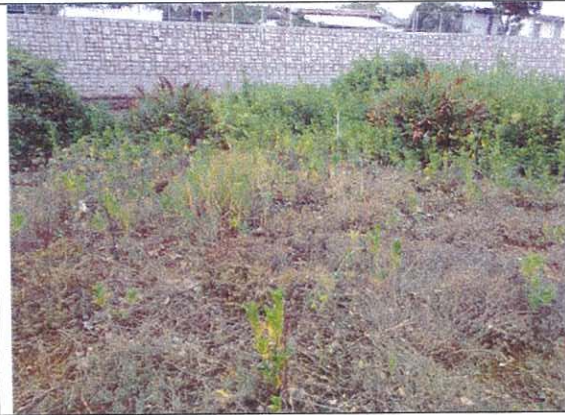
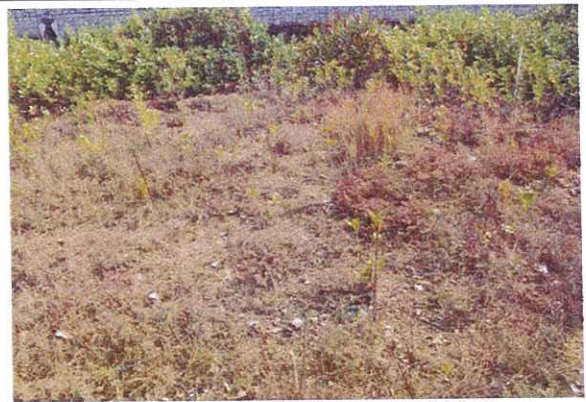
Quadrat 4

16. Current inspection: No significant change

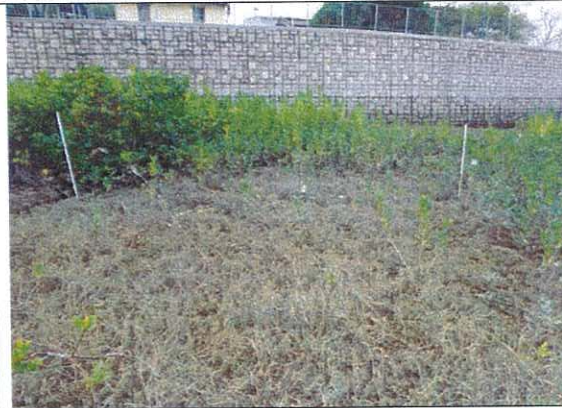
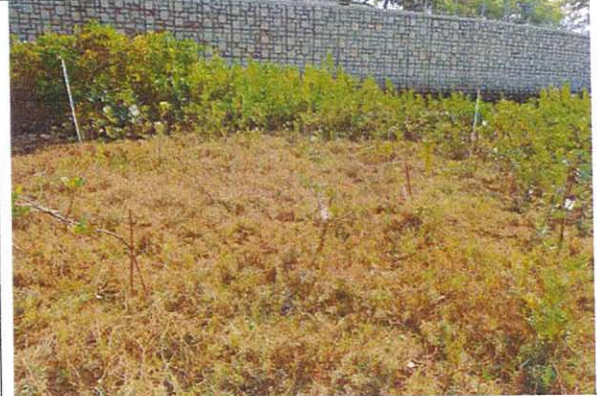
Quadrat 5

18. Current inspection: No significant change
