Detailed Vegetation Survey Report

IN-SITU REPROVISIONING OF SHA TIN WATER TREATMENT WORKS – SOUTH WORKS

(Rev. 3)

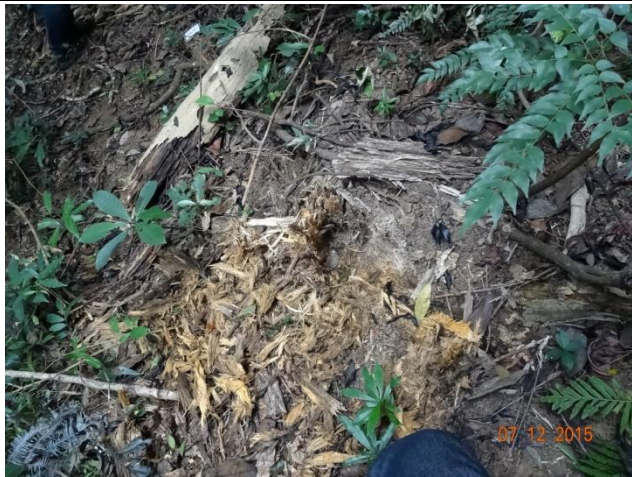
3.1.7. 19 numbers of Incense Tree (*Aquilaria sinensis*) are observed either removed/cut down by suspected agarwood harvester (17 nos.) or with poor growing form (2 nos.) (Please refer to Photos in Appendix C). These trees are considered with low transplantation survival rate and are not suitable for transplantation. 2 numbers (i.e. TA326 and TA327) of Incense Tree (*Aquilaria sinensis*) are with fair growing form but observed with open wound on their tree trunk and growing on slope which will slightly reduce its transplantation survival rate. Nevertheless, transplantation with great care and preparing with larger root ball would be helpful in preserving TA326 and TA327. 1 individual of each Hairy-fruited Ormosia (*Ormosia pachycarpa*) and Hong Kong Pavetta (*Pavetta hongkongensis*) were recorded about 300 meter away from the project site boundary and will not be disturbed, and hence, no transplantation or protection works was proposed.

Photo 1. TA127 Incense Tree (*Aquilaria sinensis*)

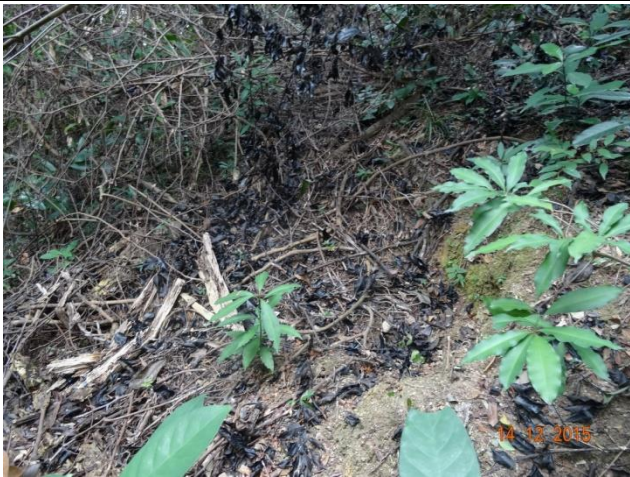
Photo 9. TA181 was removed including basal part by agarwood harvester
Incense Tree (*Aquilaria sinensis*)

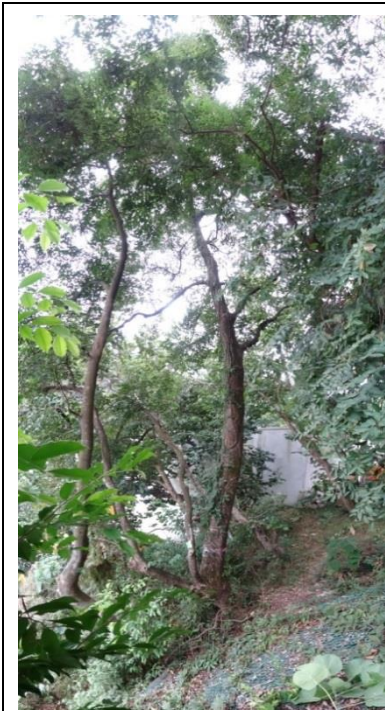
Photo 18. TA326 Incense Tree (*Aquilaria sinensis*)
 *Tree to be Transplanted

5.1.2. 2 numbers of Incense Tree (*Aquilaria sinensis*) and 1 number of Ailanthus (*Ailanthus fordii*) tree will be transplanted to the enhanced compensatory woodland area within existing STWTW. This enhanced area is a flat land, with the shortest distance to the transplanting trees and adjacent to access road. As such, this enhanced compensatory woodland area is a suitable location for transplanting Incense trees and Ailanthus tree in term of planting and transportation. The enhanced compensatory woodland area like the other two compensatory woodland areas within STWTW falls within the Project's works areas as shown in Figure 3 (extracted from Figure 8.3 of the approved EIA Report). The existing vegetation within the enhanced compensatory woodland area will be affected by the construction of temporary access road to facilitate the transportation works for the cut-back of the existing engineered slope and the construction of the Water Treatment Works Logistics Centre as mentioned in Section 8.6.1 of the approved EIA Report. Upon completion of the above mentioned works, the affected area for construction of temporary access road together with the other two locations will turn into the compensatory woodland area within STWTW. The habitat at the enhanced compensatory woodland area is shown in Figure 3 and the impacts to plantation had been mentioned in the Section 8.7.4 of the approved EIA Report that *“The Project would unavoidably require removal of the existing vegetation in secondary woodland, plantation and developed area habitats. Vegetation cover in the plantation and developed area is low and the affected vegetation is confined to common and amenity planting”*. Furthermore, the overall impact evaluation of plantation had been summarized in Table 8.19 of the approved EIA Report and it was concluded that the overall impact was low. Besides, the numbers of trees/vegetation to be affected within the enhanced compensatory woodland area had been taken into account in the approved EIA Report. Approval on tree felling within the enhanced compensatory woodland area has also been granted by the District Lands Office in July 2015. The approval letter together with the submitted tree survey plans is in Appendix D. The Incense trees and Ailanthus tree will be transplanted directly to the receptor site upon the completion of the construction works at the enhanced compensatory woodland area. The photos of receptor site at the enhanced compensatory woodland area are shown in Appendix E. All other climber and ferns including Lamb of Tartary (*Cibotium barometz*) and Hong

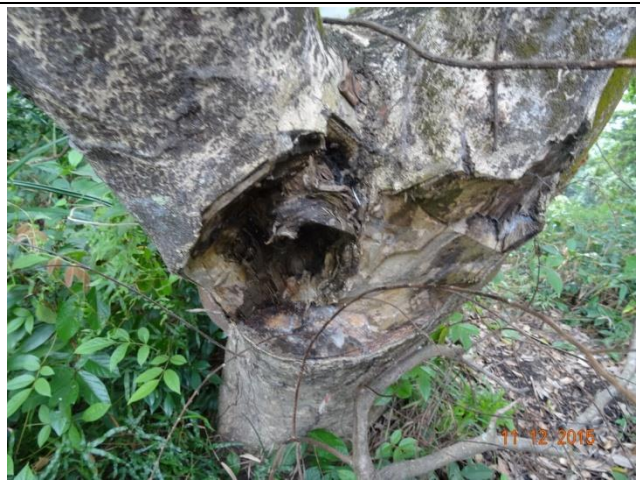
Photo 19. TA326 Incense Tree (*Aquilaria sinensis*)
 *Tree to be Transplanted

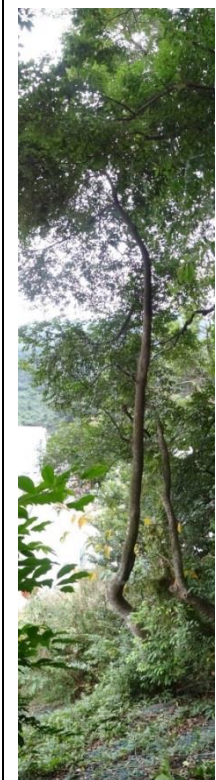
Photo 20. TA327 Incense Tree (*Aquilaria sinensis*)
 *Tree to be Transplanted

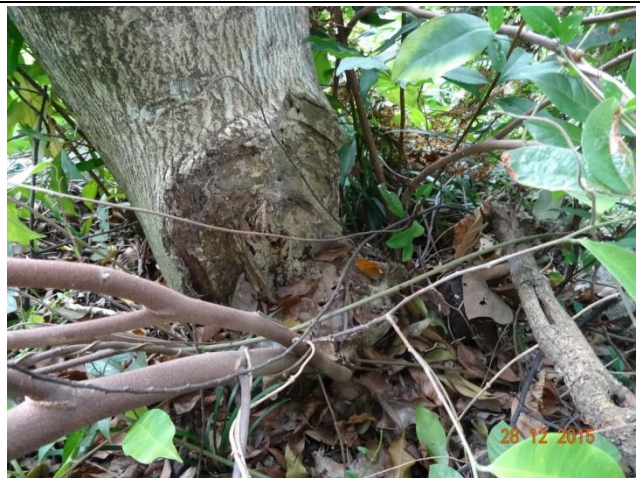
Photo 21. TA327 Incense Tree (*Aquilaria sinensis*)
 *Tree to be Transplanted

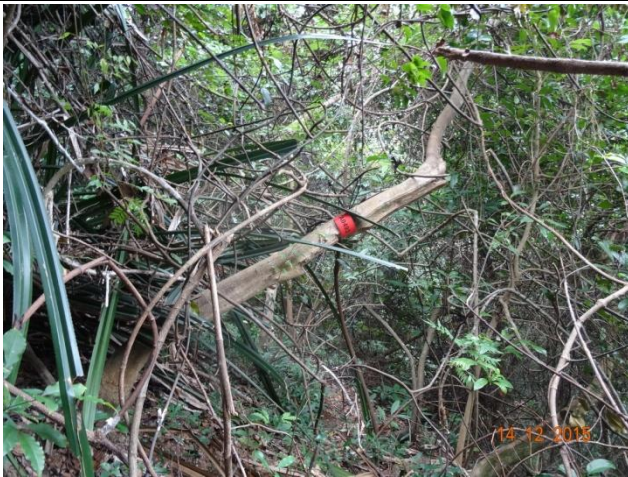
Photo 24. TA493 Incense Tree (*Aquilaria sinensis*)

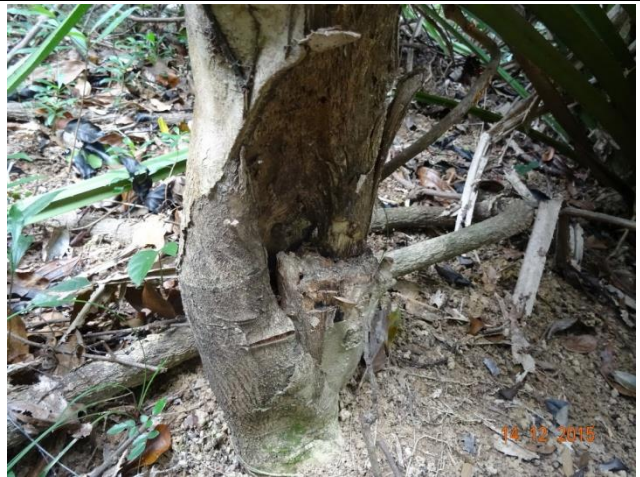
Photo 25. Open wound at the basal of TA493 Incense Tree (*Aquilaria sinensis*)

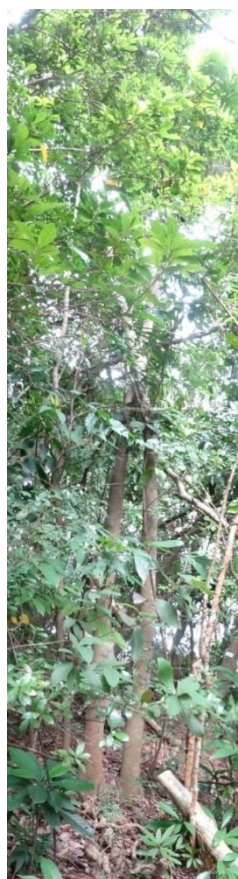
Photo 29. TA572 Ailanthus (*Ailanthus fordii*)
*Tree to be Transplanted

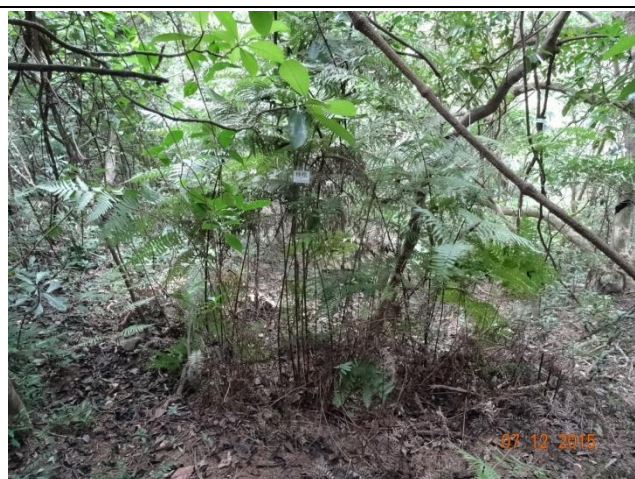
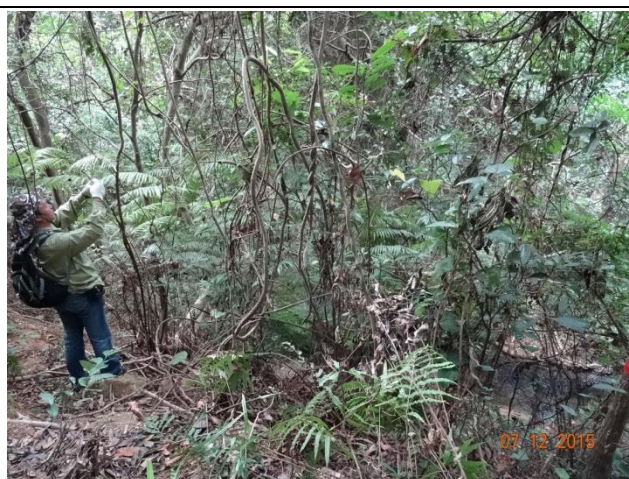
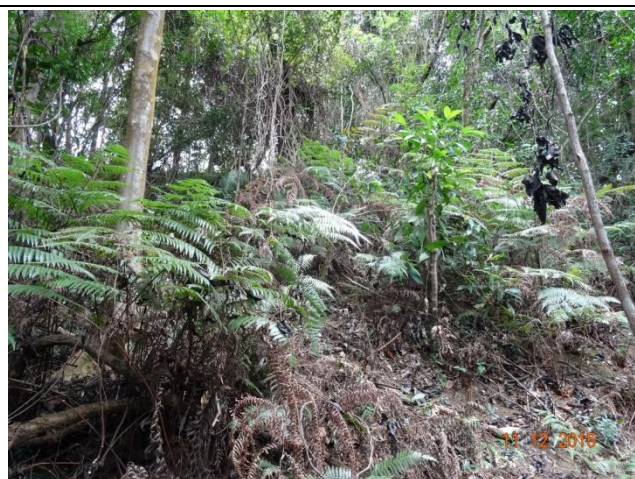
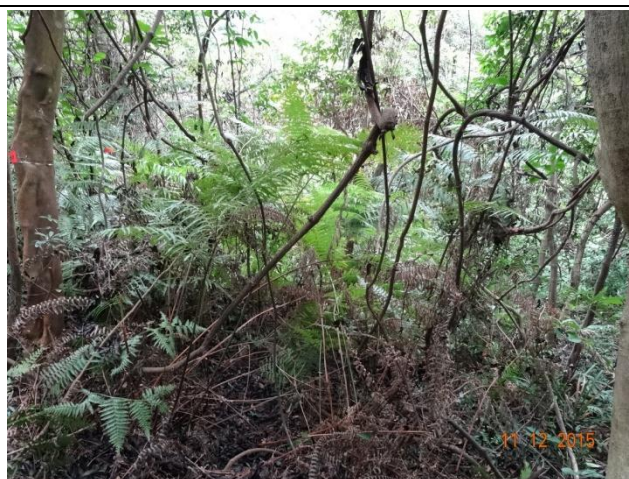
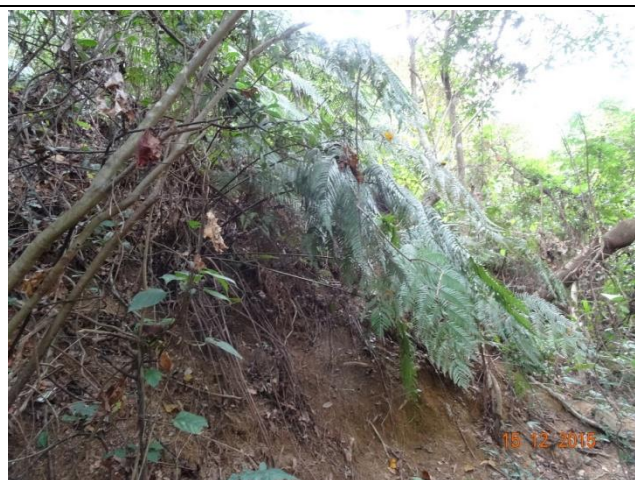
Photo 29. Colony of Lamb of Tartary (*Cibotium barometz*) *Shrub to be Transplanted

Photo 30. Colony of Lamb of Tartary (*Cibotium barometz*) *Shrub to be Transplanted

Photo 31. Colony of Lamb of Tartary (*Cibotium barometz*) *Shrub to be Transplanted

Photo 32. Colony of Lamb of Tartary (*Cibotium barometz*) *Shrub to be Transplanted

Photo 33. Colony of Lamb of Tartary (*Cibotium barometz*) *Shrub to be Transplanted

Kong Eagle's Claw (*Artabotrys hongkongensis*) will be transplanted to the woodland compensation area of STSFWSR.

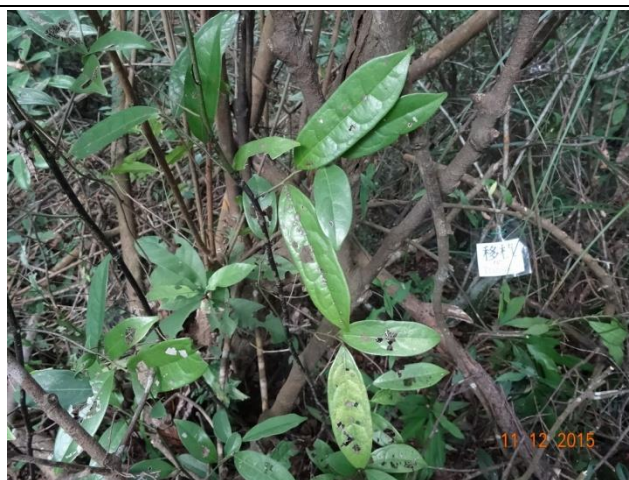
Photo 34. Hong Kong Eagleø Claw (*Artabotrys hongkongensis*) *Shrub to be Transplanted

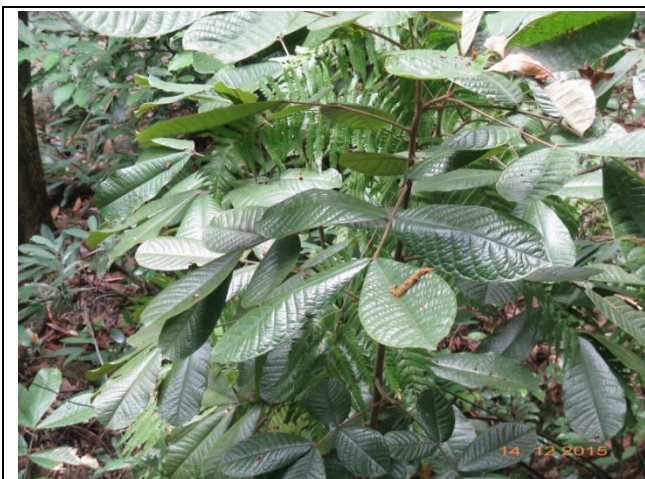
*** Flora species are approx. 300-350 m away from the site boundary and will not be disturbed.

Photo 35. Hairy-fruited Ormosia (*Ormosia pachycarpa*) *Outside project site boundary

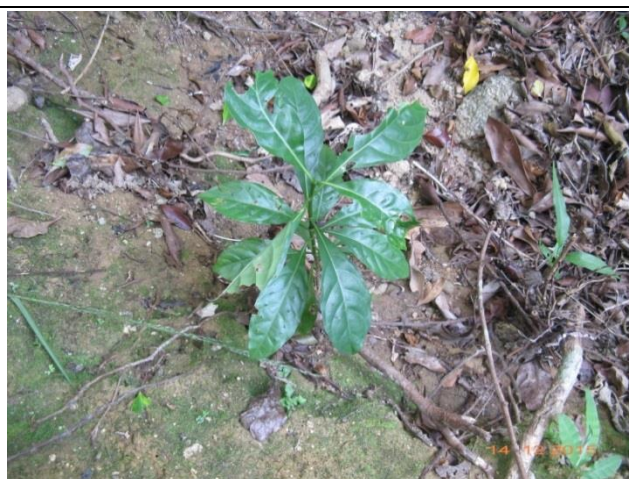
Photo 36. Hong Kong Pavetta (*Pavetta hongkongensis*) *Outside project site boundary
