## **Appendix F**

### **Details of Cultural Heritage Impact Assessment**

#### **(Built Heritage Catalogue)**

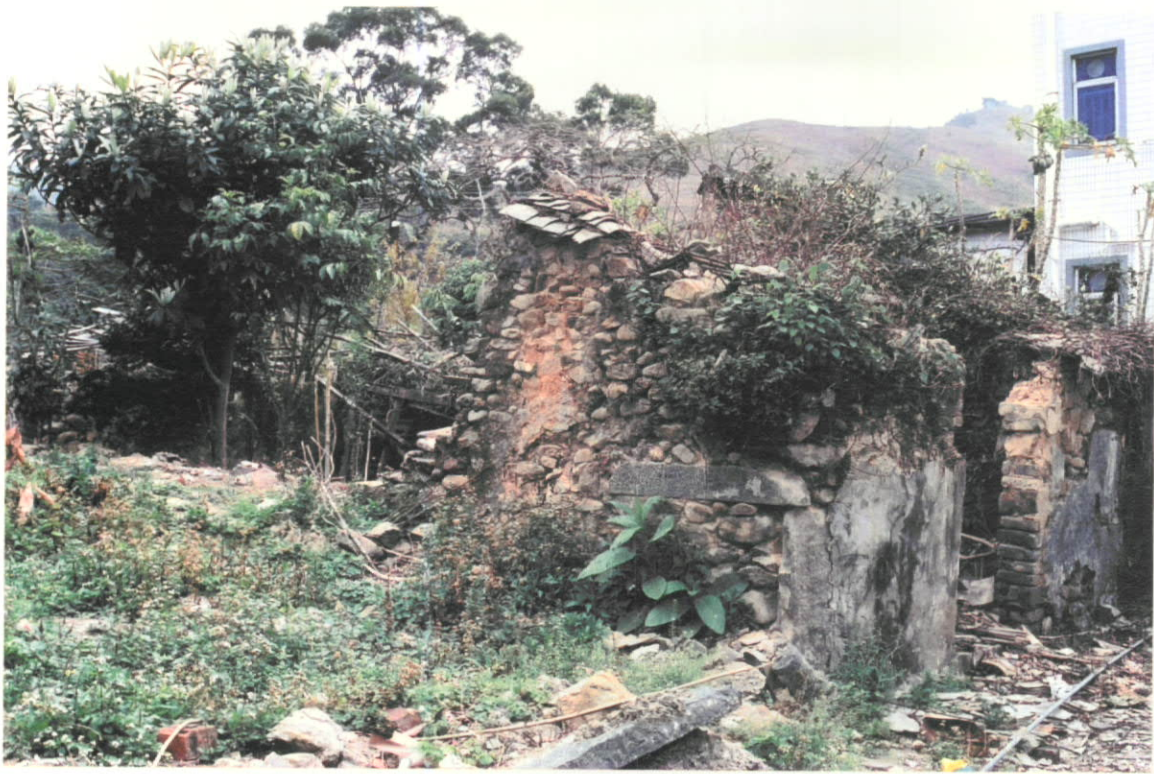
<b>Building Type:</b> Indeterminate	<b>Architectural Style:</b> Traditional Chinese
<b>Layout:</b> Indeterminate	<b>Modifications:</b> None
<b>Original # of Stories:</b> One	<b>Current # of Stories:</b> One
<b>Original # of Units:</b> Indeterminate	<b>Current # of Units:</b> One
<b>Roof:</b> Roof has collapsed, there are some pan tiles at the edge of the wall and scattered on the ground.	
<b>Façade:</b> Rubble stone wall with some green brick and patched of render in places.	
<b>Side Walls:</b> Rubble stone with back section missing.	
<b>Rear Wall:</b> Collapsed.	
<b>Inscriptions:</b> None

View of ruin AAHB-838

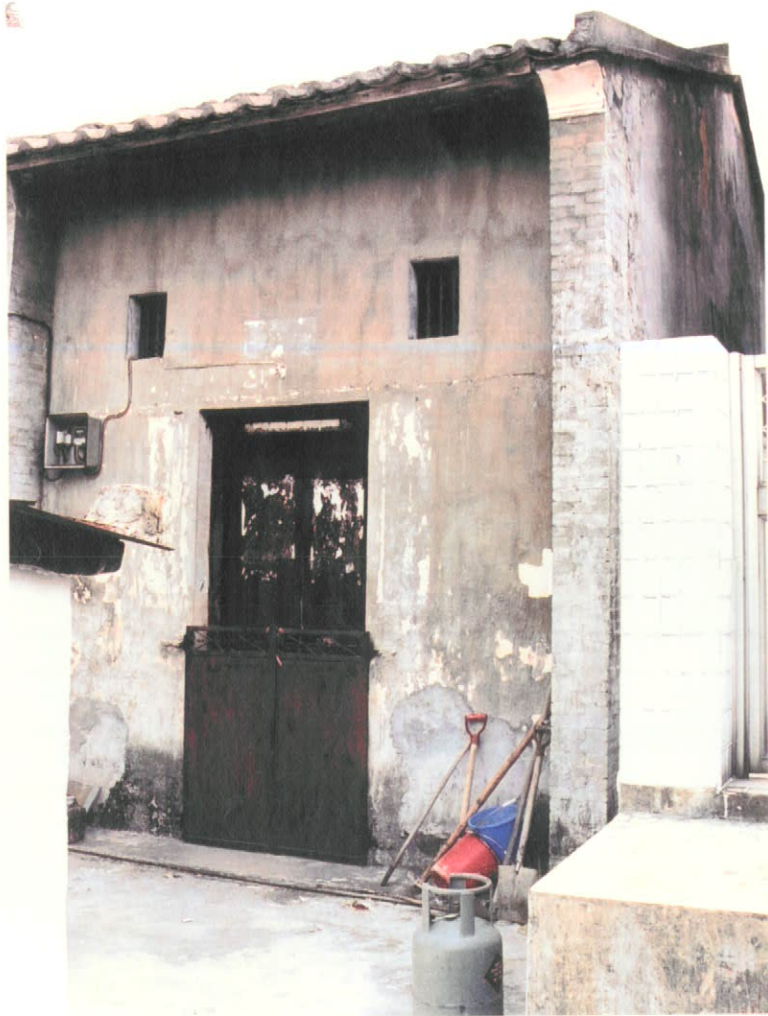
Front Elevation of AAHB-840

Walls have been repaired badly and the northern side wall is bowed outward from water leakage.
--

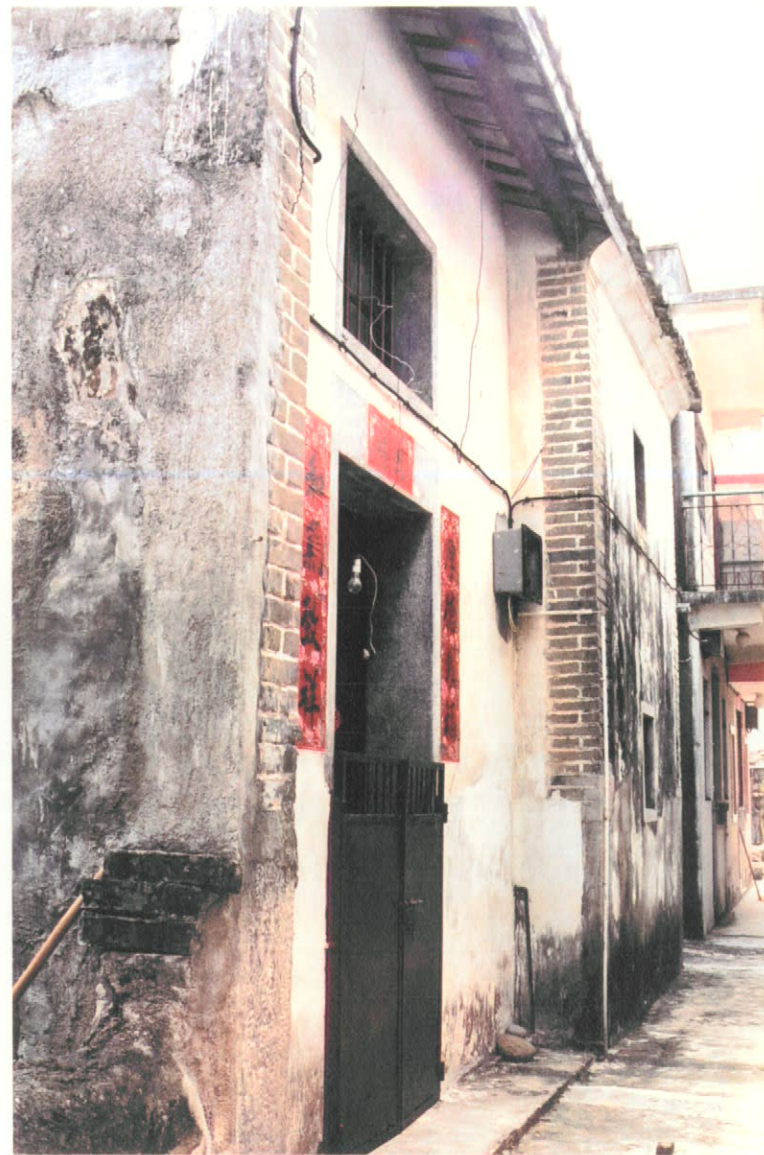
Front elevation of AAHB-841

Side chamber on the north has been demolished.
--

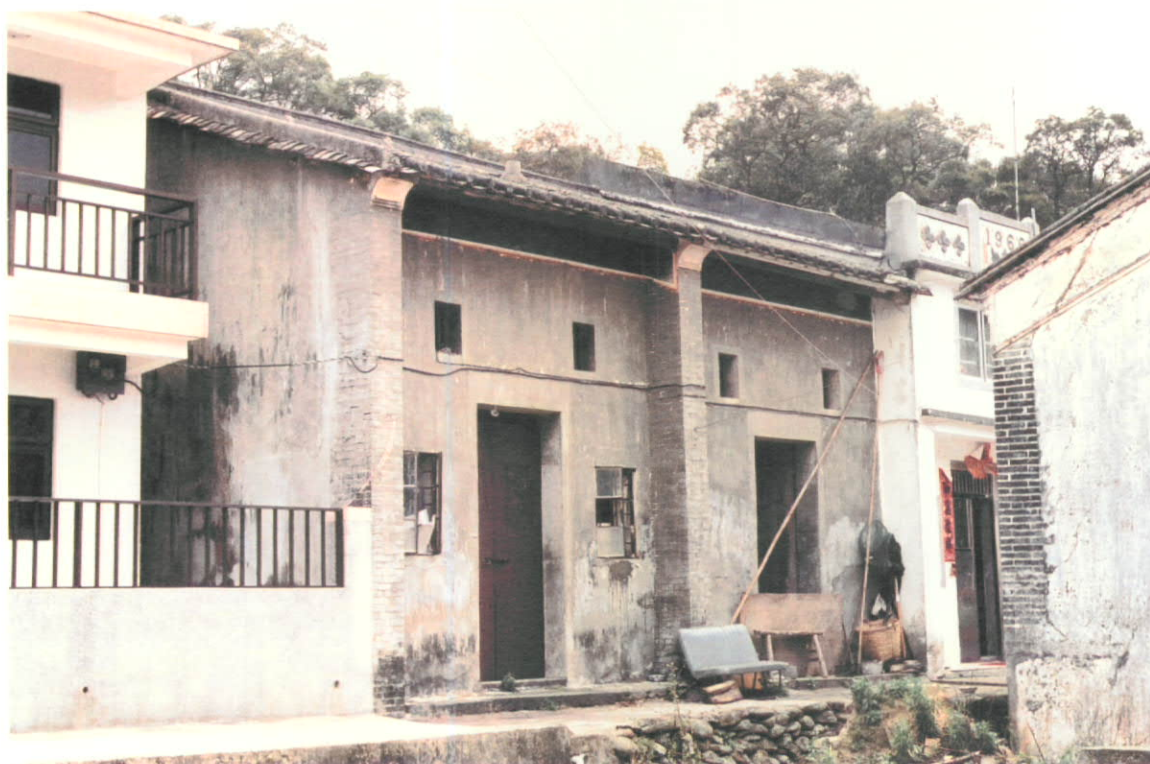
Front elevation of AAHB-845

<b>Side Wall:</b> Render covered with concrete patches.	
<b>Rear Wall:</b> Render covered with many concrete patches and two major vertical cracks.	
<b>Inscriptions:</b> None

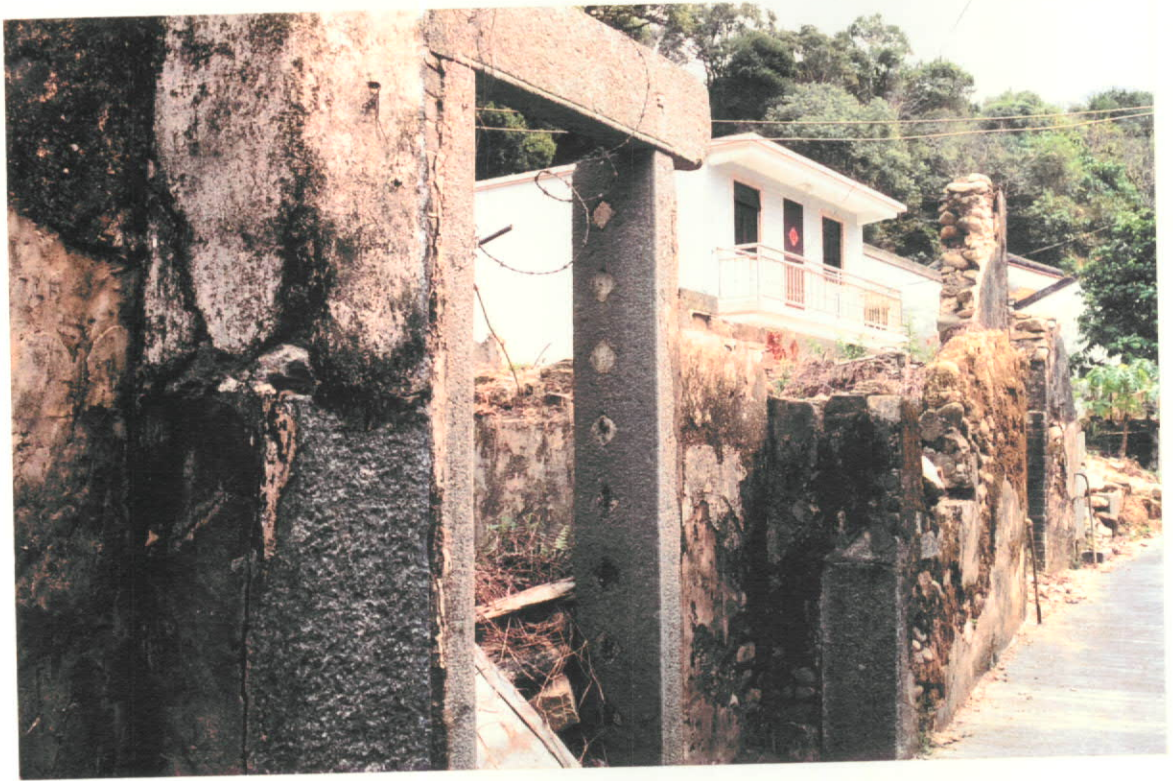
The interiors are filled with rubble and building debris and are over grown with vegetation.

View of former façade of AAHB-850

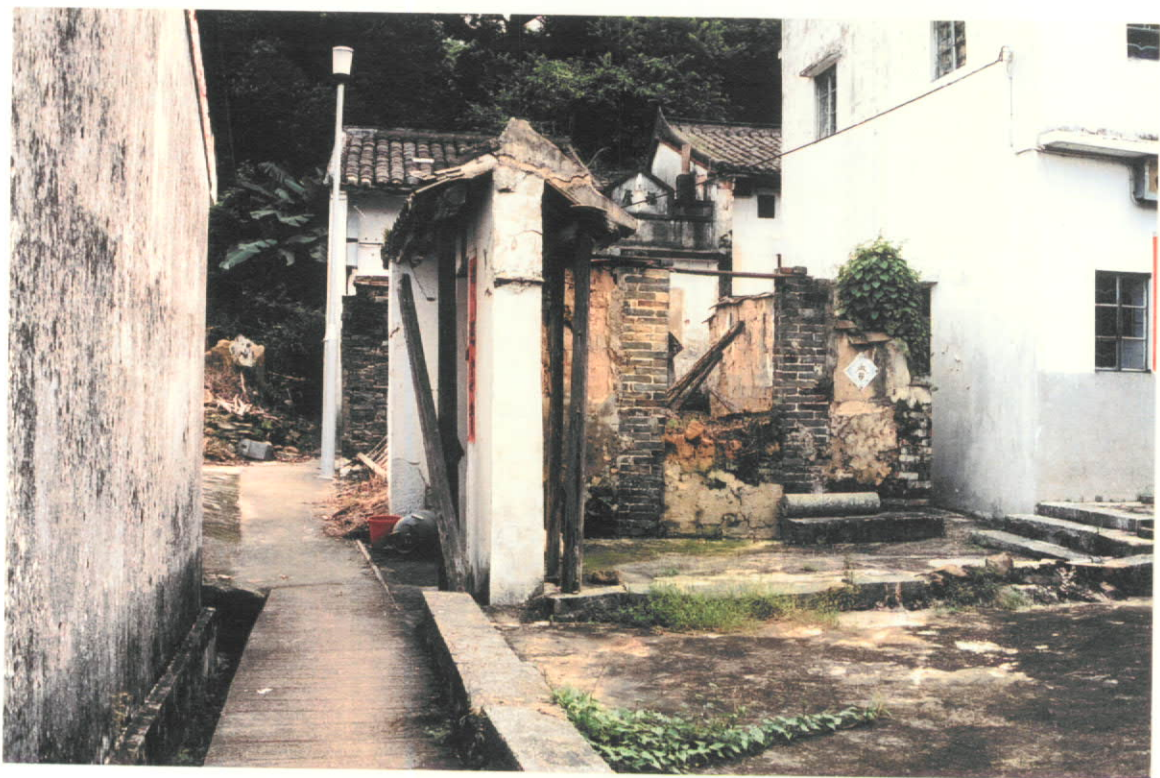
<b>Project:</b> NNT-C	<b>Location:</b> Lin Ma Hang	<b>Ref #</b> AAHB - 869 (Feature)
<b>Originally Recorded:</b> 06.09.04	<b>Updated On:</b> N/A	
<b>Original Usage:</b> Entrance gate and residential	<b>Current Usage:</b> Traditional symbolism and residential	
<b>Orientation:</b> Gate: Northwest, Ruin: South southwest	<b>Map Reference:</b> N/A	
<b>Construction Date:</b> Unknown	<b>Ownership:</b> Private	
<b>Setting:</b> Central back section of the village.	<b>Historical Associations:</b> None	
<b>Condition:</b> Gate: Poor, other structure is ruinous.	<b>Degree of Modification:</b> Unmodified	
<b>Architectural Significance:</b> Low	<b>Cultural Significance:</b> Low to medium	
<b>Description:</b> Gate: Render covered wall, painted white. Double panel wooden door. There is a pitched roof over the wall (tile with plain ridge, a lot of concrete patches). The ruinous structure consists of a green brick doorframe with pounded earth walls, some render remaining on them. The other remaining walls consist of mud brick. The roof has entirely collapsed and the interior is filled with rubble.

<b>Inscriptions:</b> None		
<b>Additional Notes:</b> The gate is currently being propped up with wooden beams.

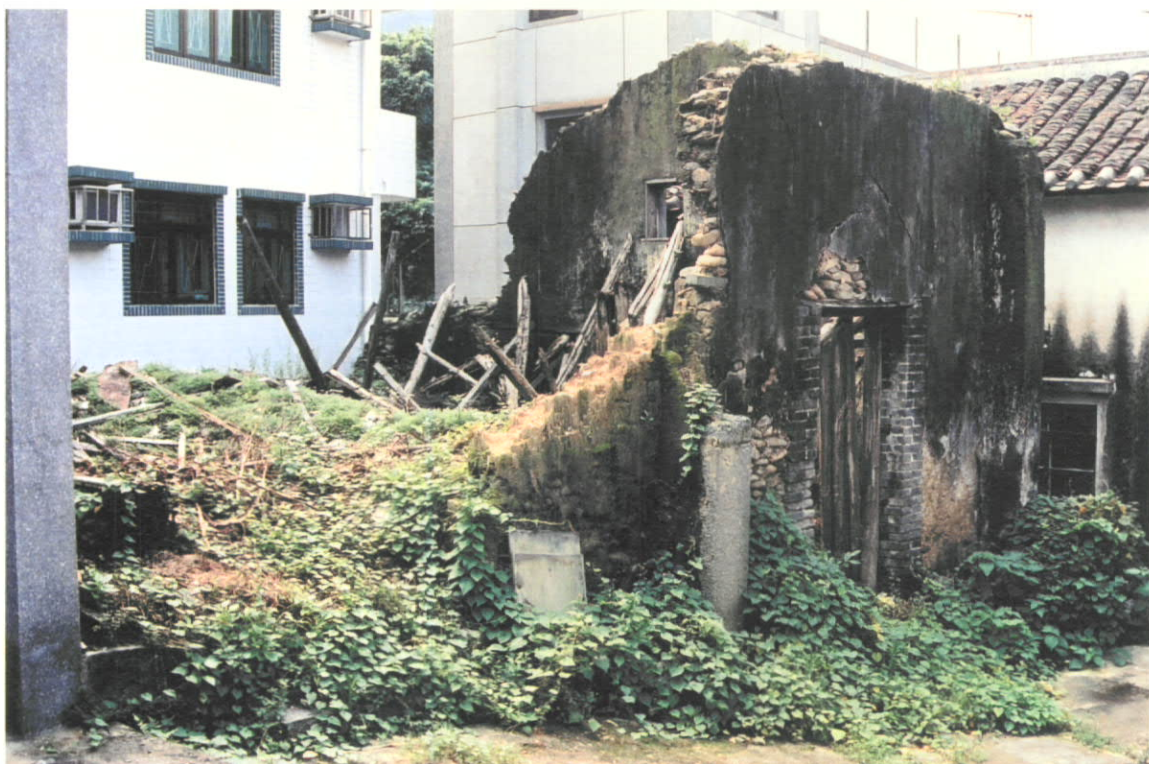
<b>Project:</b> NNT-C	<b>Location:</b> Lin Ma Hang	<b>Ref #</b> AAHB - 872 (Feature)
<b>Originally Recorded:</b> 06.09.04	<b>Updated On:</b> N/A	
<b>Original Usage:</b> Residential	<b>Current Usage:</b> Abandoned	
<b>Orientation:</b> Northwest	<b>Map Reference:</b> N/A	
<b>Construction Date:</b> Unknown	<b>Ownership:</b> Private	
<b>Setting:</b> Near the eastern gate, surrounded by modern buildings.	<b>Historical Associations:</b> None	
<b>Condition:</b> Ruin	<b>Degree of Modification:</b> Unmodified	
<b>Architectural Significance:</b> Low	<b>Cultural Significance:</b> Low	
<b>Description:</b> Two former attached structures. Two walls partially remain, rubble stone and pounded earth covered by render. One of the units has green brick entranceway and remains of double panel wooden door. The interior has some collapsed roof supporting beams (roof has completely collapsed) and is completely overgrown with vegetation.

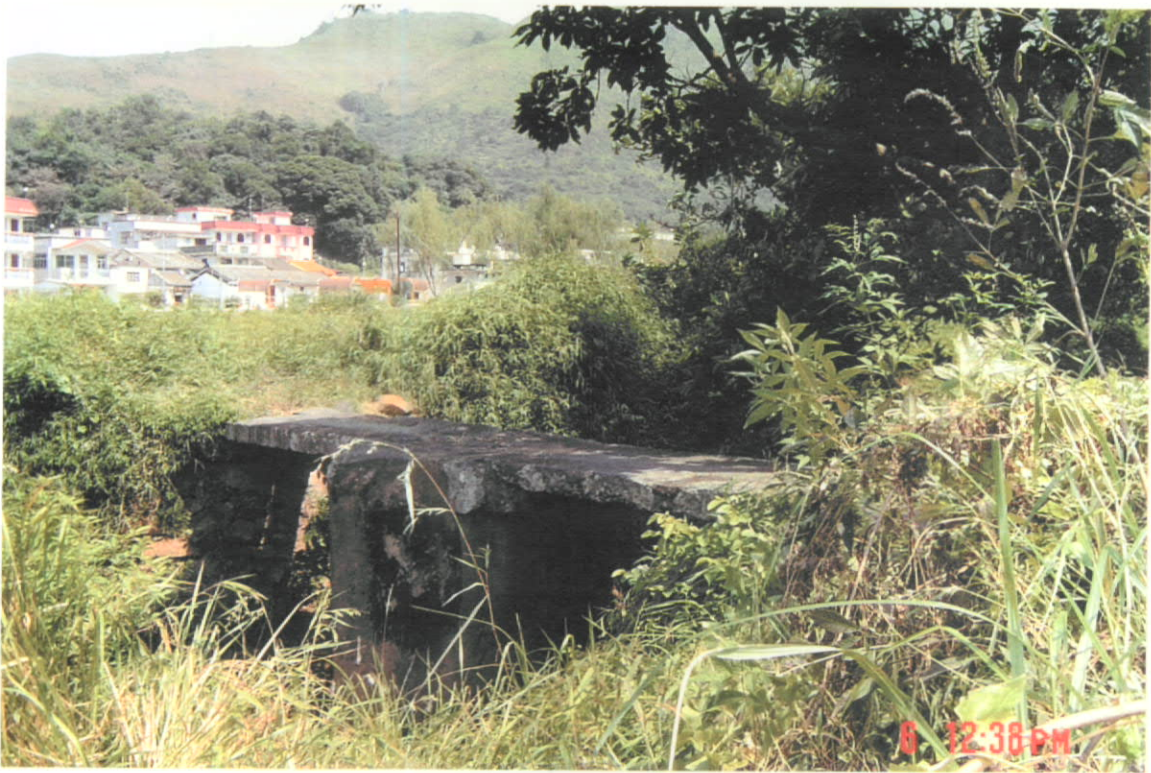
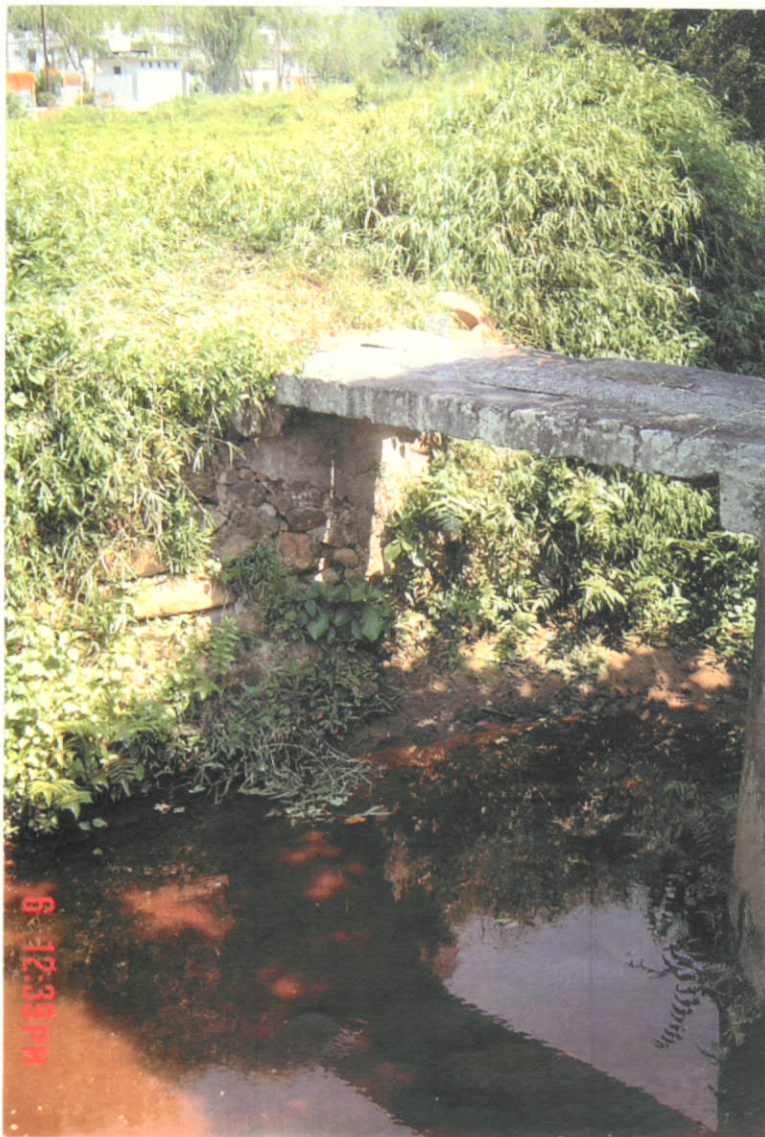
<b>Project:</b> NNT-C	<b>Location:</b> Lin Ma Hang	<b>Ref #</b> AAHB - 881 (Feature)
<b>Originally Recorded:</b> 06.09.04	<b>Updated On:</b> N/A	
<b>Original Usage:</b> Foot bridge	<b>Current Usage:</b> Foot bridge	
<b>Orientation:</b> Crosses river from south west to north east	<b>Map Reference:</b> N/A	
<b>Construction Date:</b> Over 200 years ago.	<b>Ownership:</b> N/A	
<b>Setting:</b> At the eastern end of the village	<b>Historical Associations:</b> Lin Ma Hang village	
<b>Condition:</b> Good	<b>Degree of Modification:</b> Minimal	
<b>Architectural Significance:</b> High	<b>Cultural Significance:</b> High	
<p><b>Description:</b> The bridge consists of the following structural elements; uncut stone abutments (with concrete patching) built directly into each side of the riverbank, one pier, centrally positioned and situated directly on the streambed and a deck consisting of two sets of cut granite slabs (running three across and meeting above the central pier).</p> <p>The central pier consists of uncut stone and mortar and the majority of the exterior has been covered in concrete. The exterior ends of the granite slabs rest directly on the abutments. The interior ends of the cut granite slabs rest directly on the central portion of the pier. There are two triangular shaped projections on each side of the pier that originally supported cut granite blocks placed at the deck level and intended to secure the deck slabs in place (only one of the blocks remains, as the block on the southeast side of the bridge is missing). Some concrete has been added in order to secure the slabs.</p>

<b>Inscriptions:</b> None		
<p><b>Additional Notes:</b></p> <p>The bridge does not have a name, but the area where it is located is known locally as "Wong Nai Tam" 黃泥潭. The name means "yellow mud pool" and according to the locals there used to be a deep pool at this point in the river. Historically, the bridge was used mostly for access to agricultural fields. These fields were abandoned for the most part in the 1950's, when many of the villagers immigrated to England or moved closer to the city. The bridge was also on a path that was used by the villagers for traveling to Ping Che or to the market at Luen Wo Hui.</p> <p>The concrete additions on the bridge were added the last time the bridge was renovated (the exact date of the renovation could not be recalled by the informant).</p> <p>This structure is an excellent example of a type of footbridge that could once be found all over the New Territories. The vast majority of these bridges have been replaced by concrete slabs and it should be noted that the rarity value of the bridge structure is extremely high.</p>
