ICP407D:REAL_JOB1382486_02011617.5_7_A4_CDR1NOV06

Drainage Services Department
渠務署

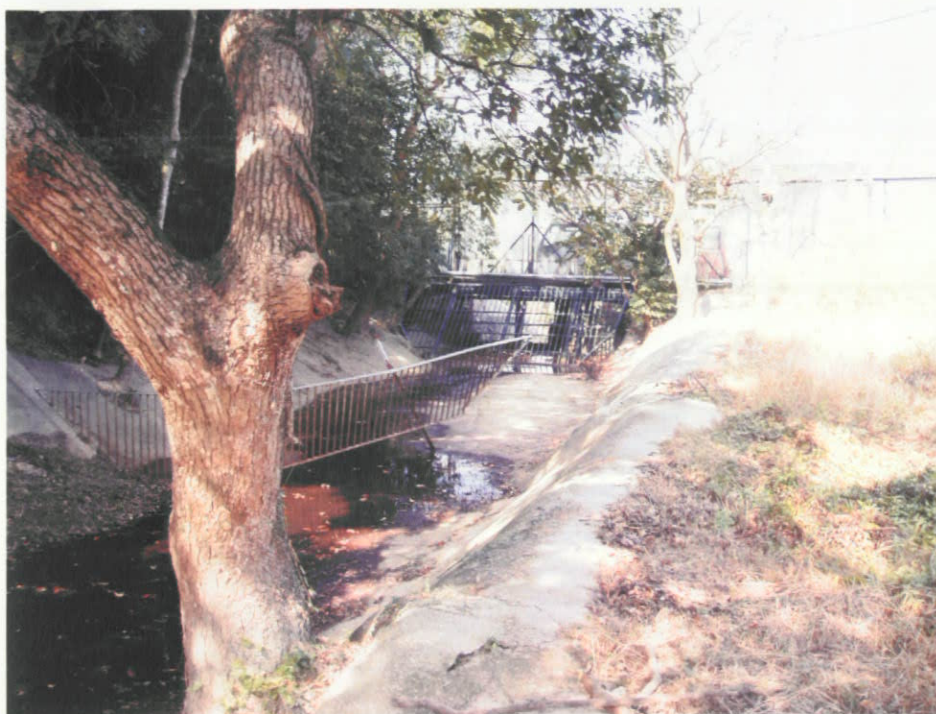
Figure 7.4 - Downstream section of LMH01 - concrete-lined channel to be replaced by gabion lining.

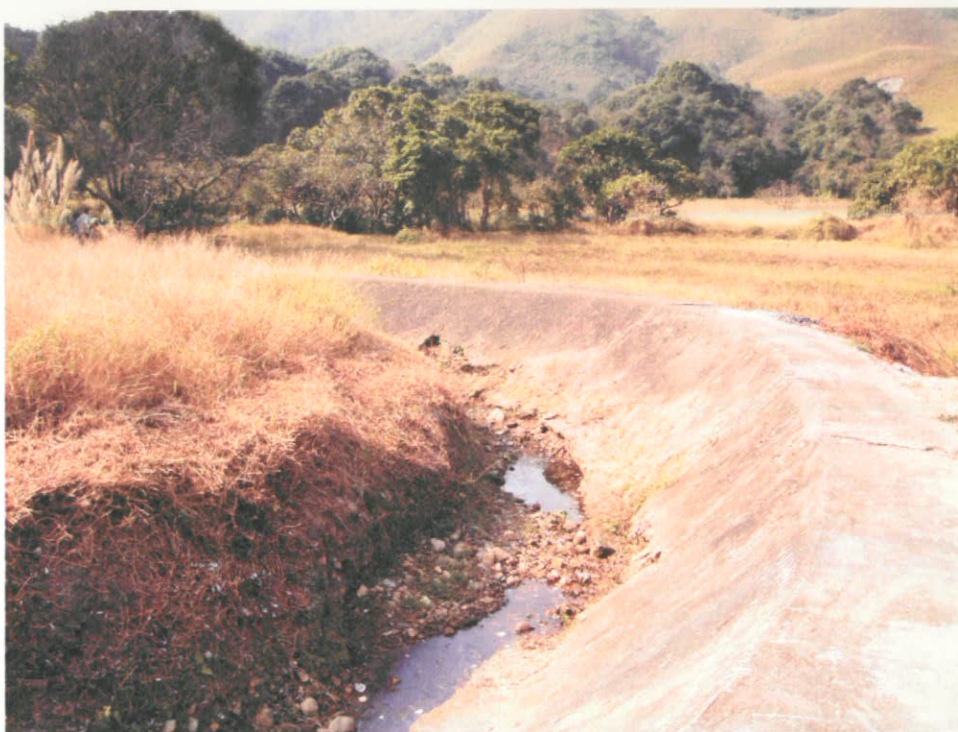
Figure 7.5 - Existing concrete-lined bank of LMH01 to be replaced by gabion lining
