Annex A1

Built Heritage Resources: Baseline Studies and Impact Assessments

Police Headquarters Block (01)

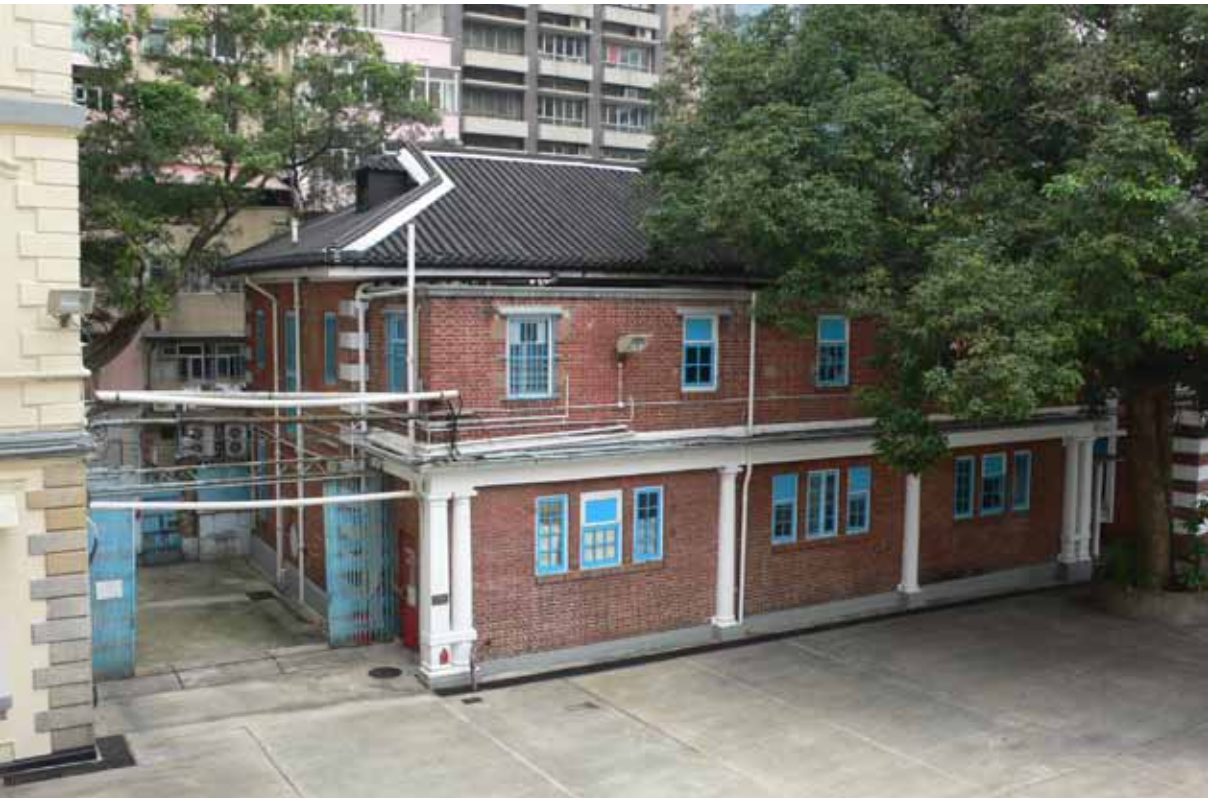
Figure 1 - East (Parade Ground) elevation showing the infilled ground floor arcade and the poor quality first floor addition

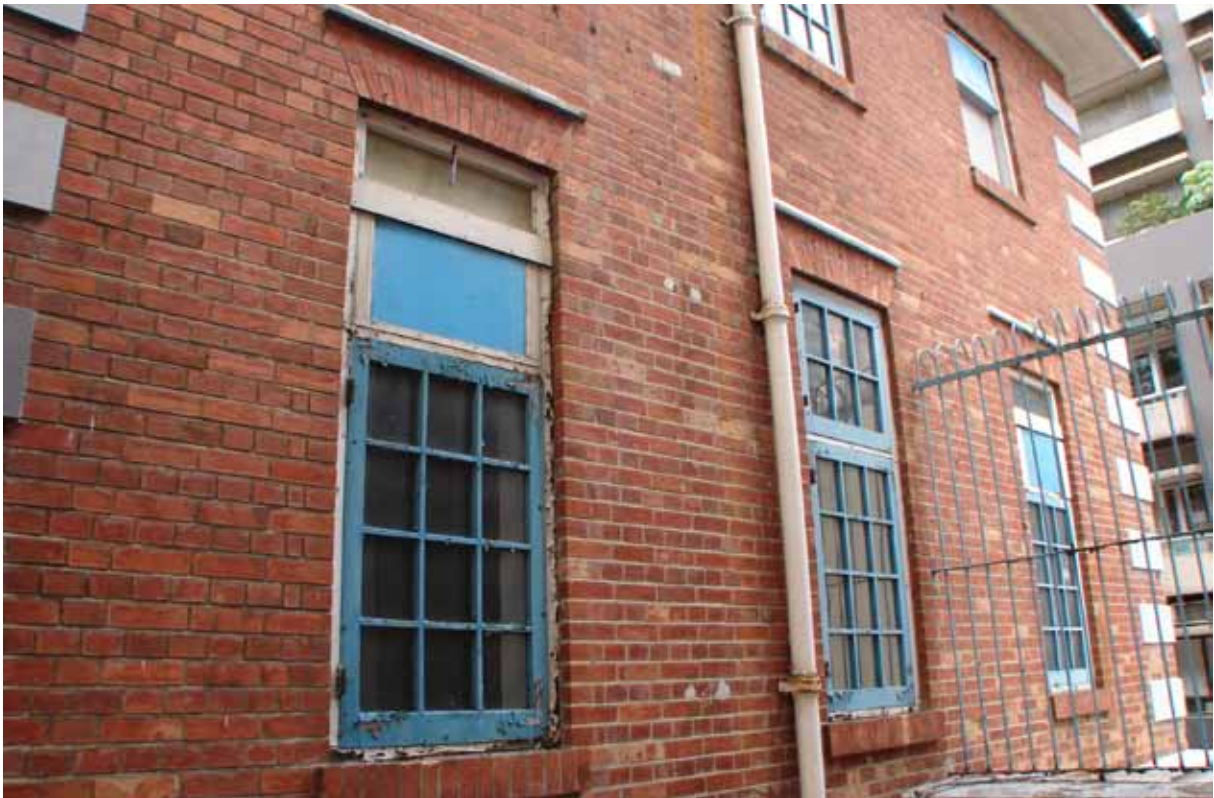
Figure 3 - Windows on the south elevation. The ground floor central window has the original/early casement with fanlight casement above, while those either side have been altered to accommodate air conditioning units.

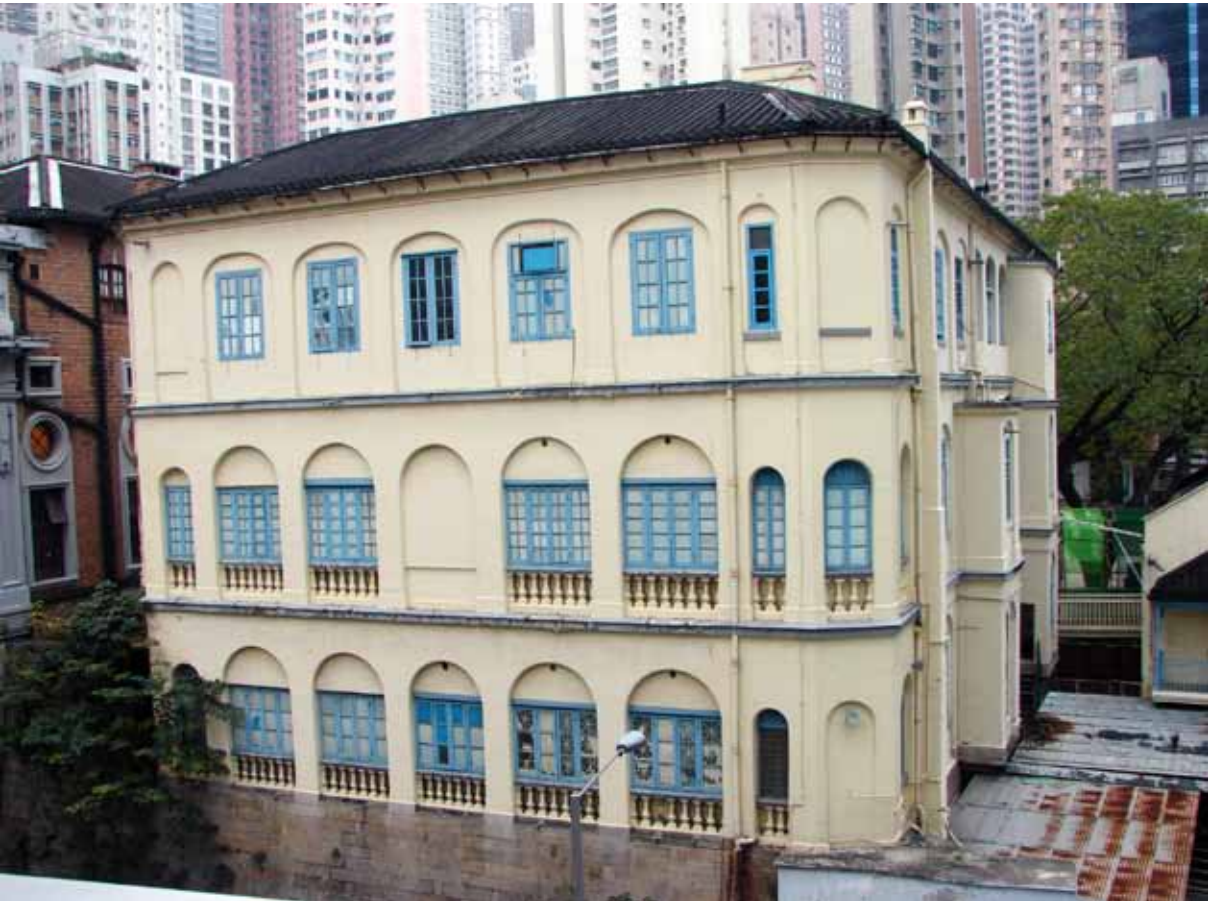
Figure 1 - East elevation overlooking Arbutnot Road; note the ground and first floor verandah infill

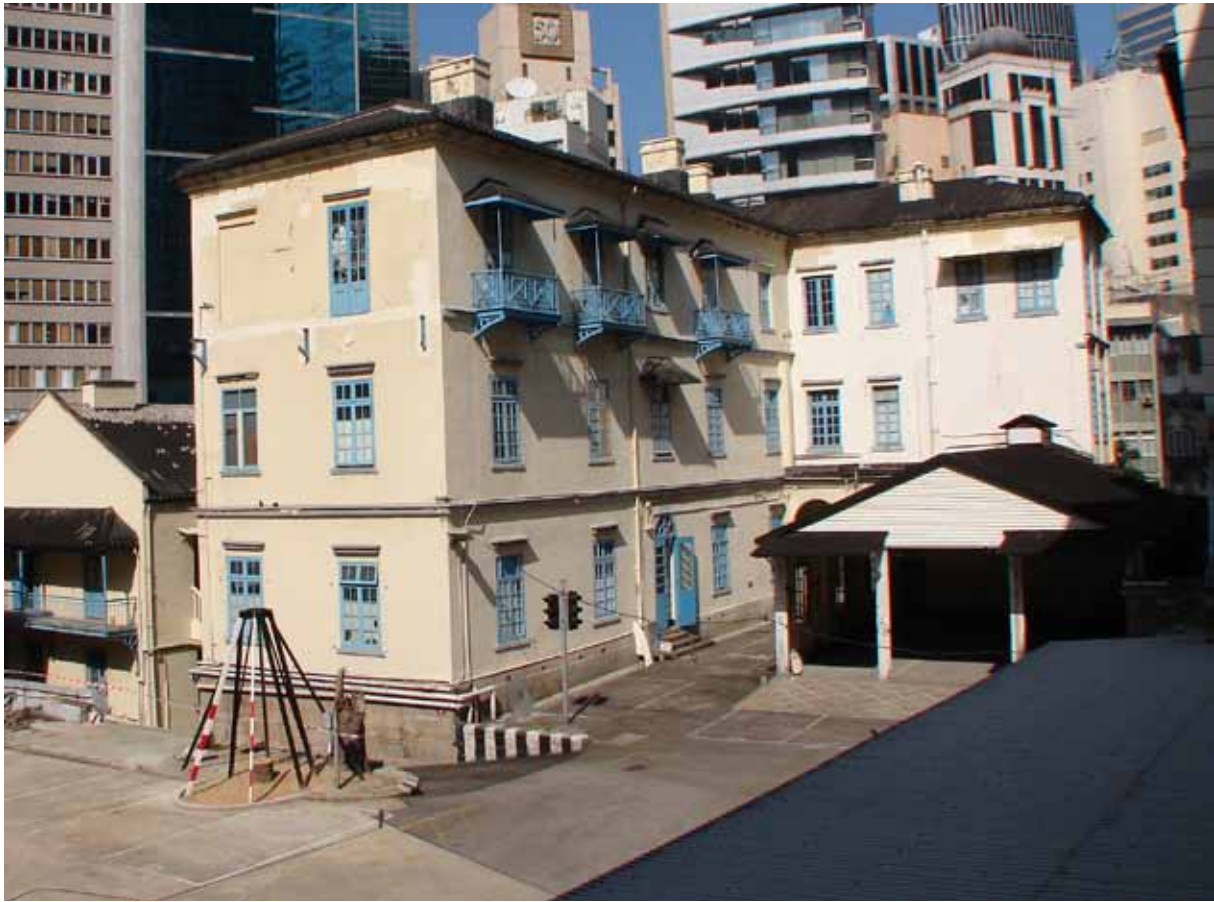
Figure 2 - Southwest elevation; note the missing balcony on the west end, second floor

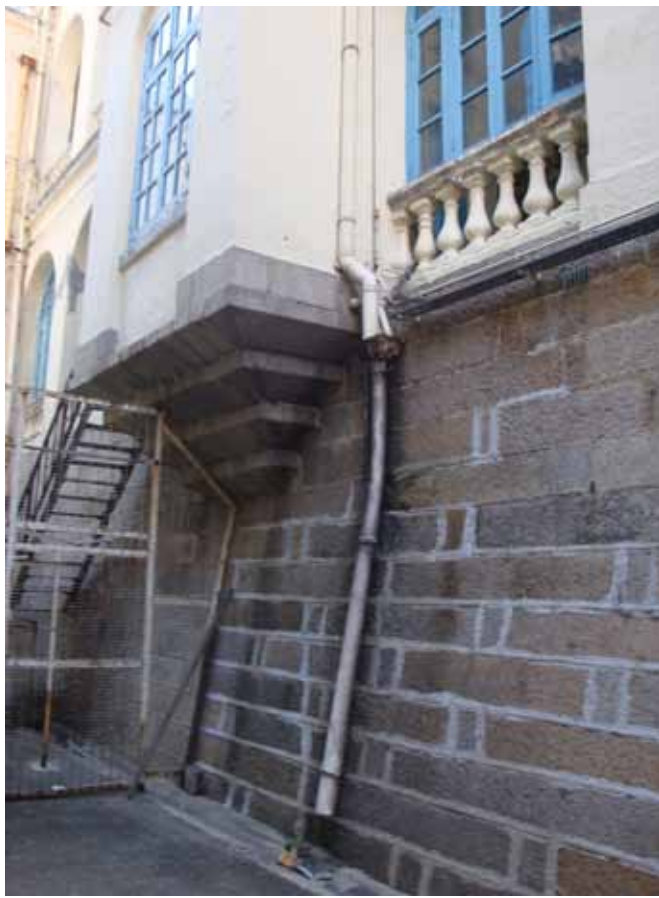
Figure 6 - Granite corbel supporting one of the north projecting bays. The other is in need of urgent repair.

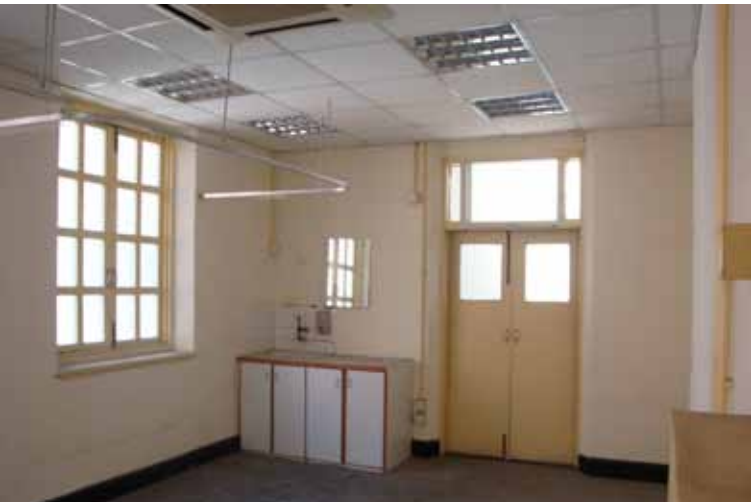
Figure 5 - Typical interior space, with later suspended ceilings and replacement double doors. The fanlight has been altered to accommodate air-conditioning.

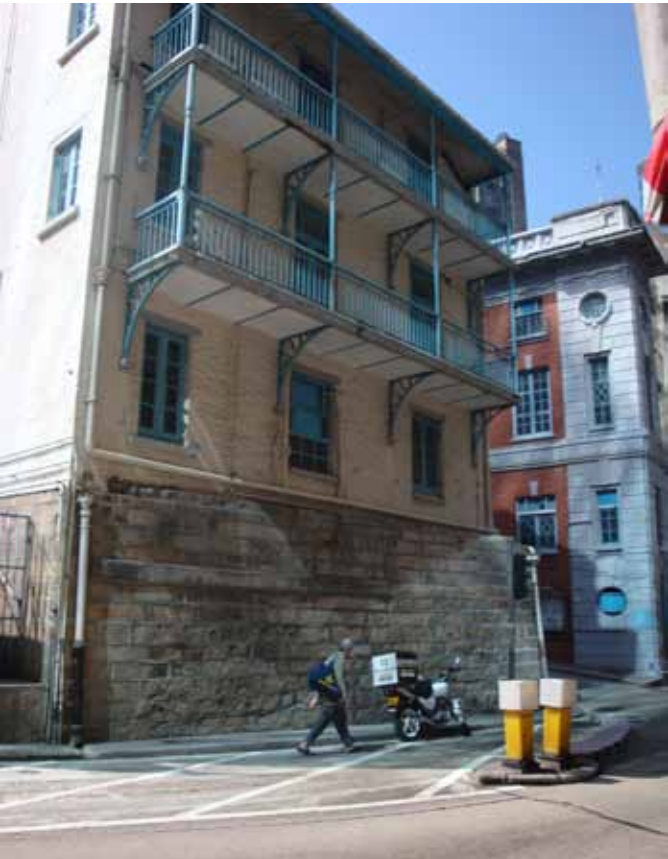
Figure 2 - North elevation of the building overlooking Hollywood Road. The ground floor balcony was removed at an unknown date.

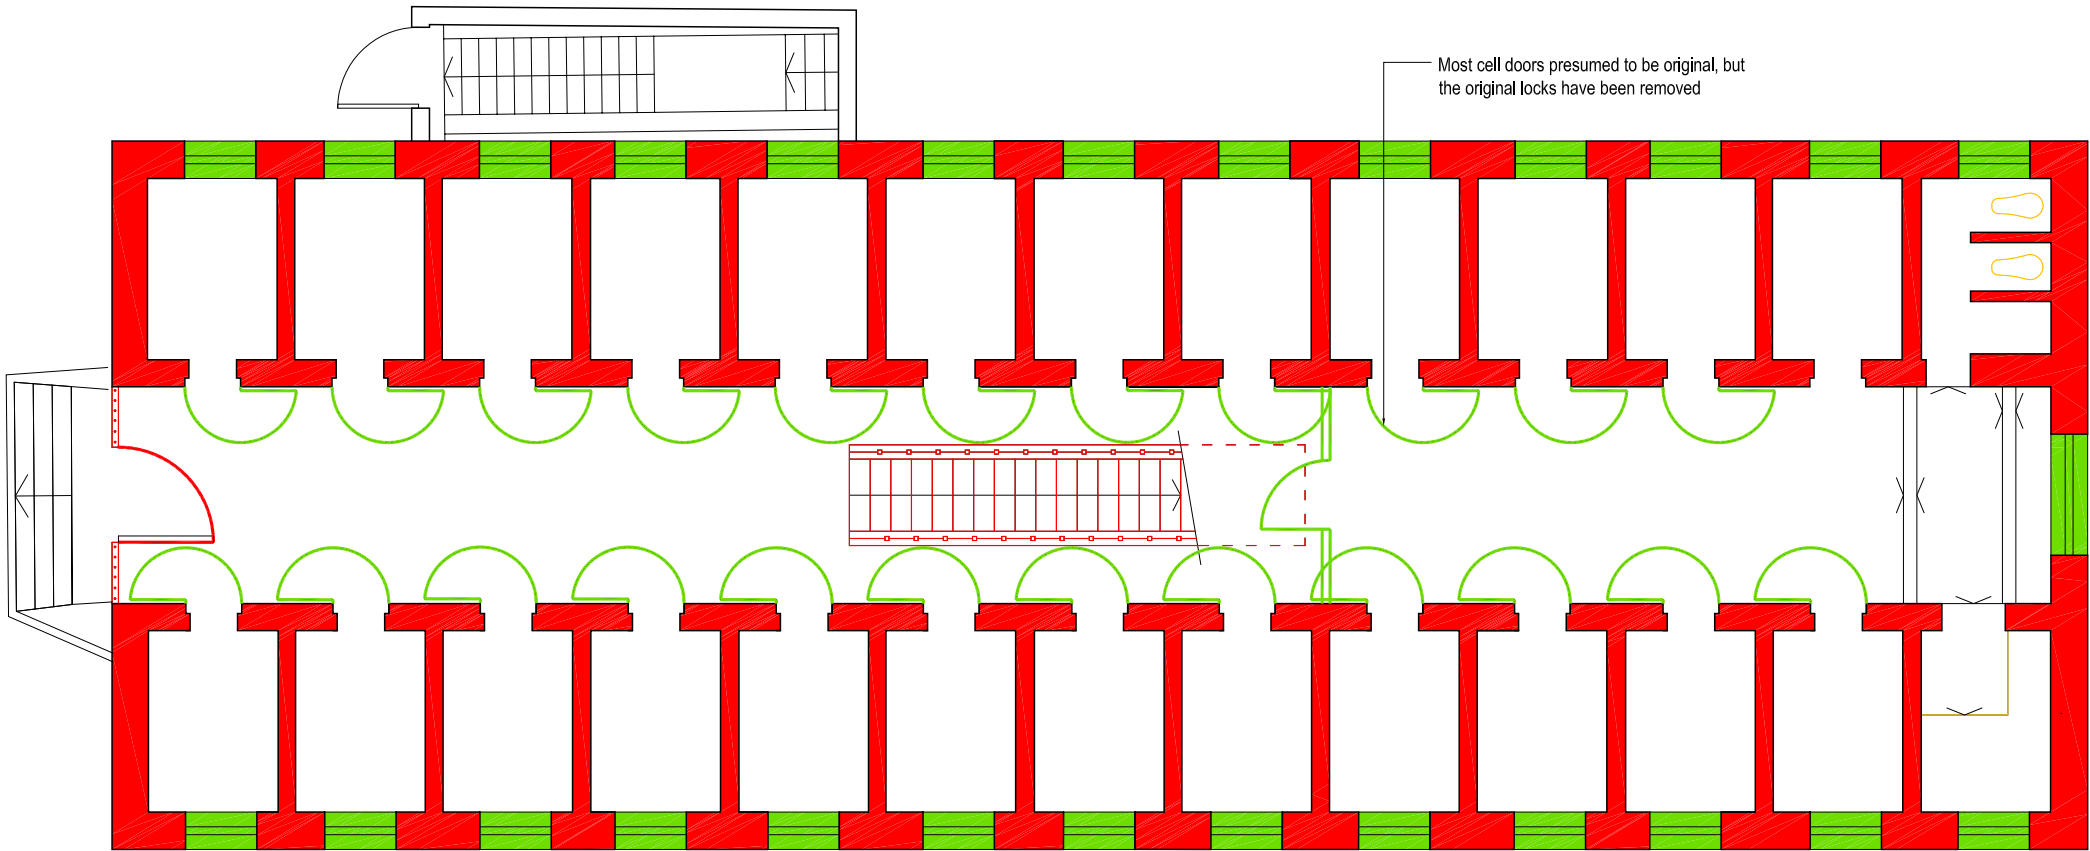
Building 15. E Hall
Ground Floor Plan

Most cell doors presumed to be original, but the original locks have been removed

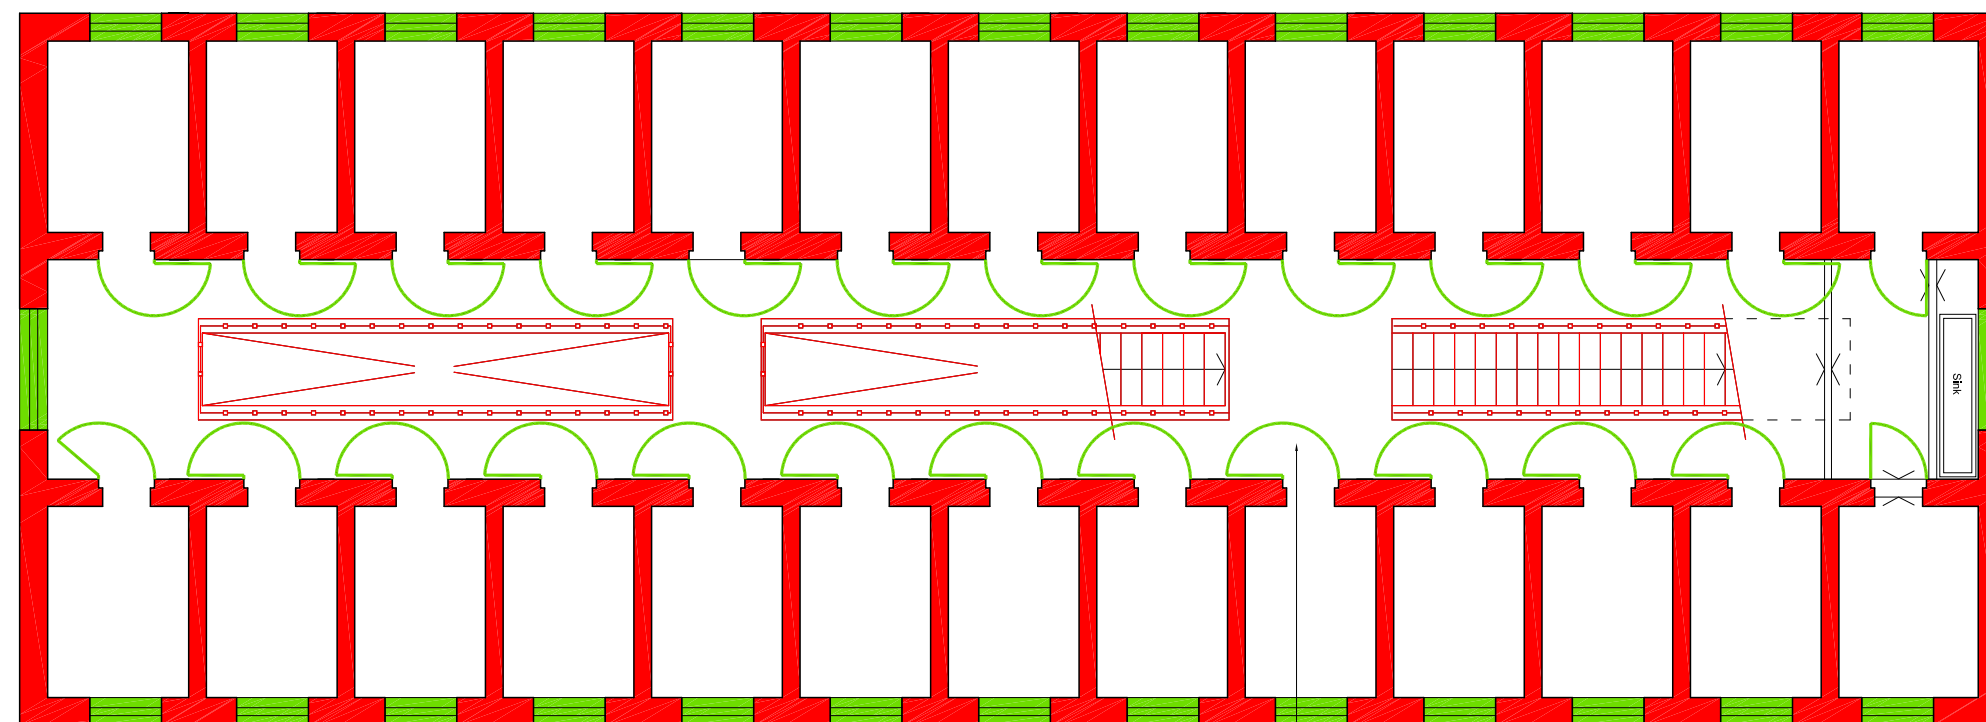
**Building 15. E Hall
First Floor Plan**

Cell windows retain original openings and concrete frames, but the original glass louvre's have been replaced with metal ones and metal wire mesh has been installed on the interior

Most cell doors presumed to be original, but the original locks have been removed.

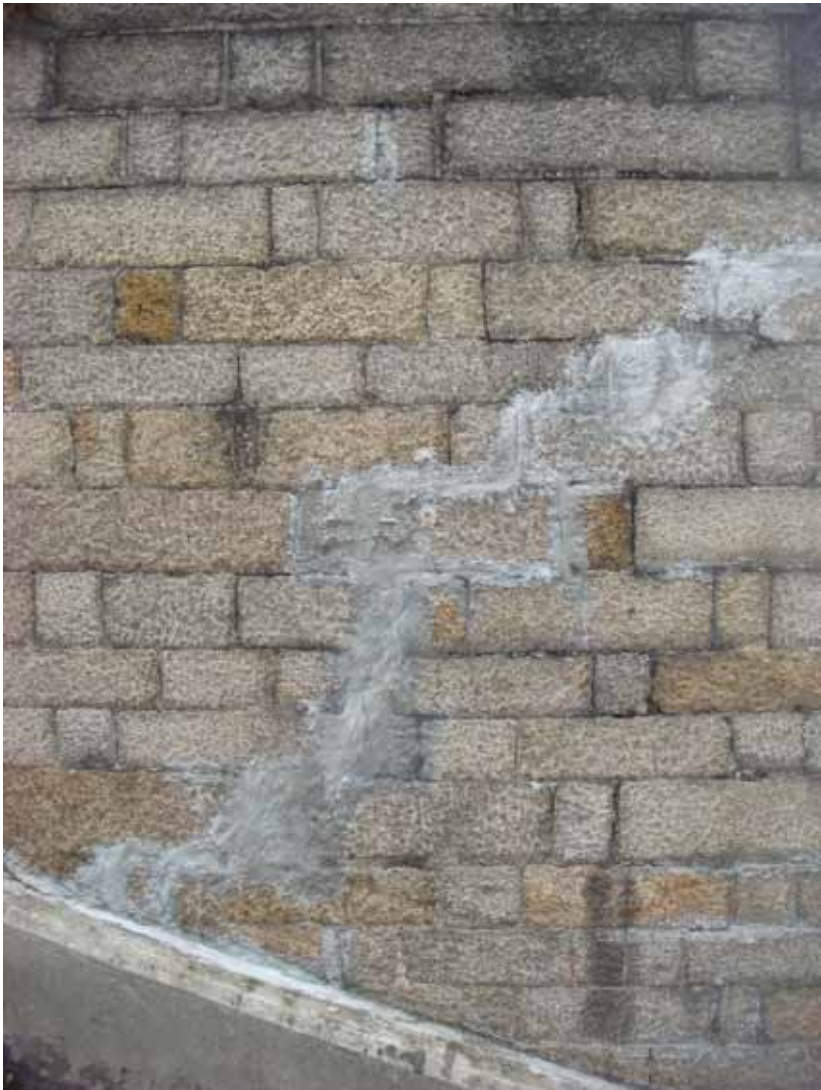
A poor quality repair to stonework in EX08-A

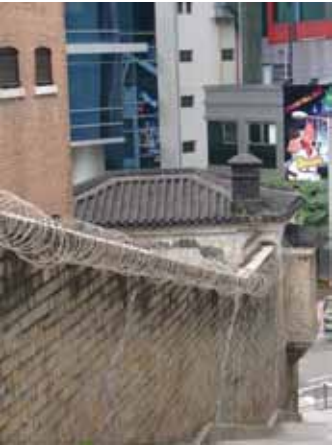
EX08 – B

Granite boundary wall running along Chancery Lane, forming the south wall of the Prison Yard. Buttresses have been built on both the north and south sides at an unknown date, and parts of the wall have been rendered and painted cream. Due to variations in ground level, the wall is much taller inside the site than from Chancery Lane. The tops of the walls and buttresses have been set with mortar and glass shards for safety; this can be seen in photographs as early as the 1890s.

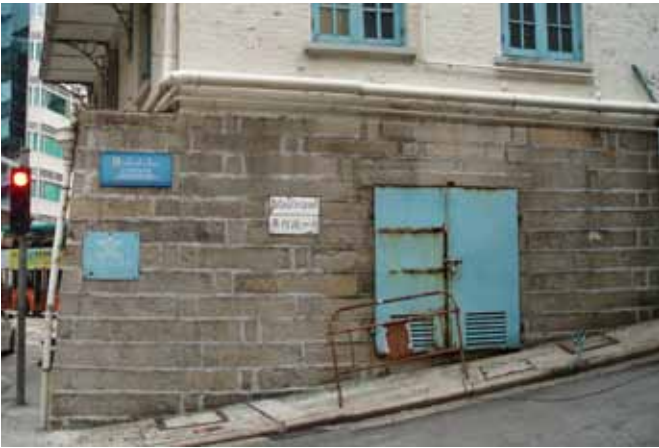
LL12

Granite block revetment wall forming part of the early site walls c.1850s. The wall now forms the north foundation for Buildings 10 and 13, and has been painted white at some stage.
