Agreement No. CE 21/2012 (WS)

Contract title
DESALINATION PLANT AT
TSEUNG KWAN O -
FEASIBILITY STUDY

Drawing title
VEGETATION SURVEY AND PHOTOGRAPHS
(SHEET 3 OF 10)

Drawing no. FIGURE 11.21c

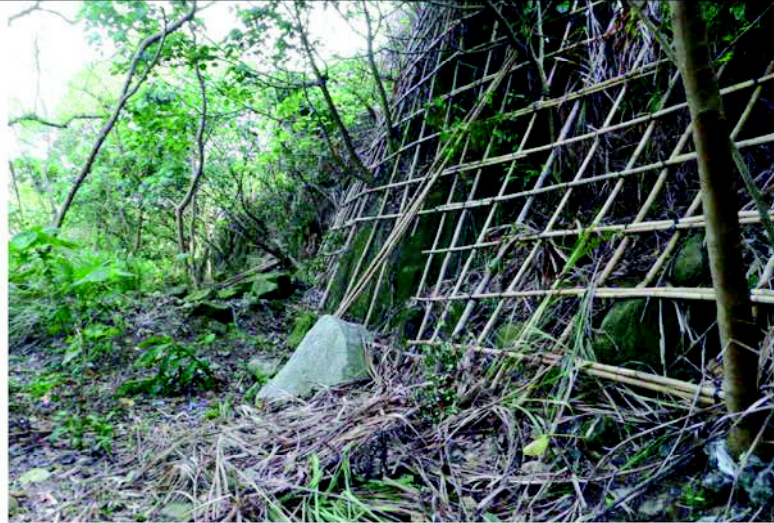
General Condition of Trees

The survey area is located within a degraded mixed woodland which is evidenced by the presence of large proportion of invasive species of *Leucaena leucocephala* and common pioneer species of *Macaranga tanarius*. Most of the trees are young in age. The average trunk diameter ranges 100mm-200mm while the average height ranges 6-9m. The overall health condition of the trees is fair in general.

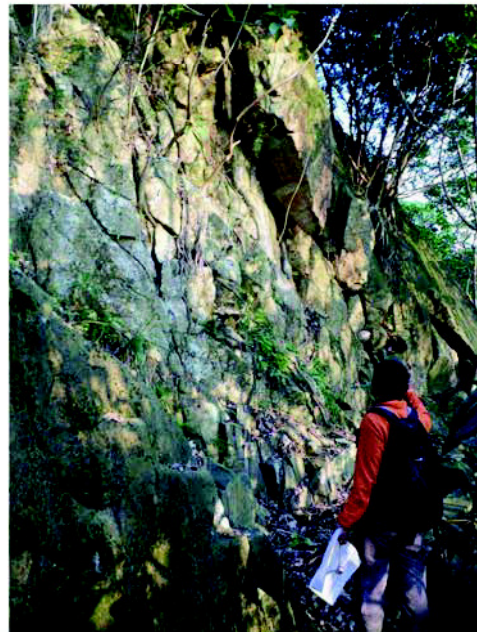
Plate 3

General Condition of the Vegetation

The survey area (i.e. the proposed works area) was observed to be disturbed recently by vegetation clearance and hill fires. The overall health condition of the undisturbed vegetation is fair in general.
