Agreement No. CE 21/2012 (WS)

Contract title  
**DESALINATION PLANT AT TSEUNG KWAN O - FEASIBILITY STUDY**

Drawing title  
VEGETATION SURVEY AND PHOTOGRAPHS (SHEET 10 OF 10)

Drawing no. **FIGURE 11.21j** Revision

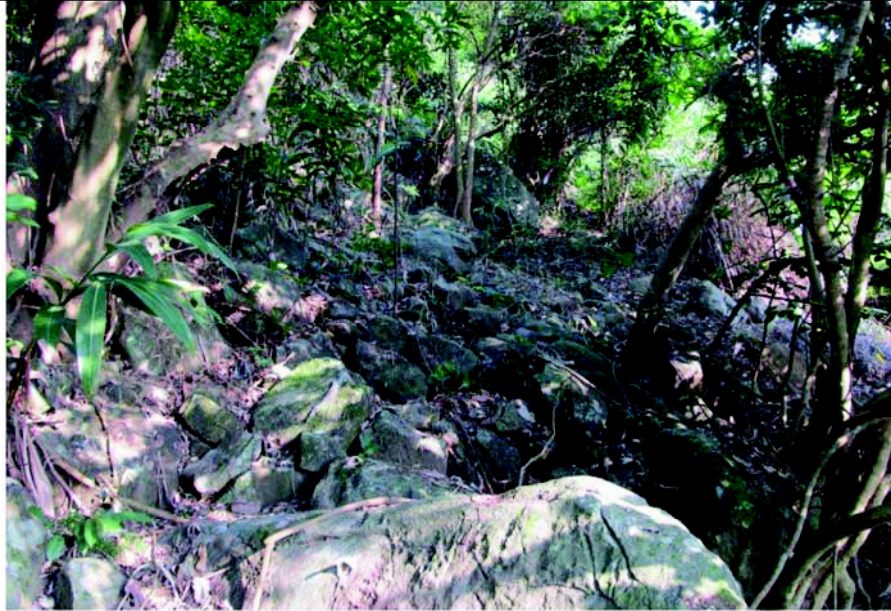
Photo 17

The survey area is located within a degraded mixed woodland which is evidenced by the presence of large proportion of invasive species of *Leucaena leucocephala* and common pioneer species of *Macaranga tanarius*. Most of the trees are young in age. The average trunk diameter ranges 100mm-200mm while the average height ranges 6-9m. The overall health condition of the trees is fair in general.

The survey area (i.e. the proposed works area) was observed to be disturbed recently by vegetation clearance and hill fires. The overall health condition of the undisturbed vegetation is fair in general.
