Appendix 1
Photographic Record

Project Title
 DESALINATION PLANT AT
 TSEUNG KWAN O
 - FEASIBILITY STUDY

Photo Records for Vegetation Survey

Photographic Record of Collared Scops Owl Survey

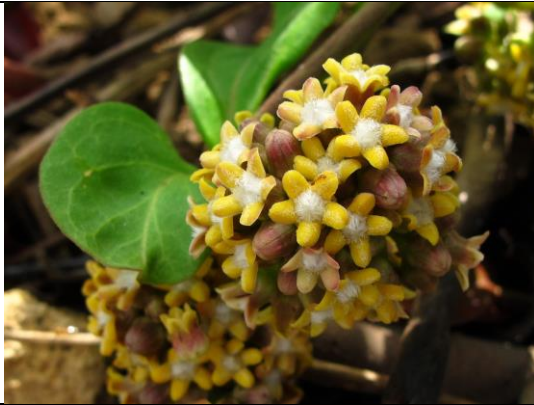
- 4.4 The species of conservation importance is *Marsdenia lachnostoma*, which has been included in AFCD's publication **Rare and Precious Plants of Hong Kong**. It is a very rare local plant species with status of Critically Endangered (CR) in mainland China.
- 4.5 A total of 10 individuals of *Marsdenia lachnostoma* were recorded during the survey and their locations are indicated in **Appendix 2**. As a protection measure, the flexible barrier will be realigned around this area to avoid this species totally as shown in **Appendix 2**.
- 4.6 Photographic records of this concerned species are given in **Appendix 1**.

Photo 1 – Flowers of *Marsdenia lachnostoma*

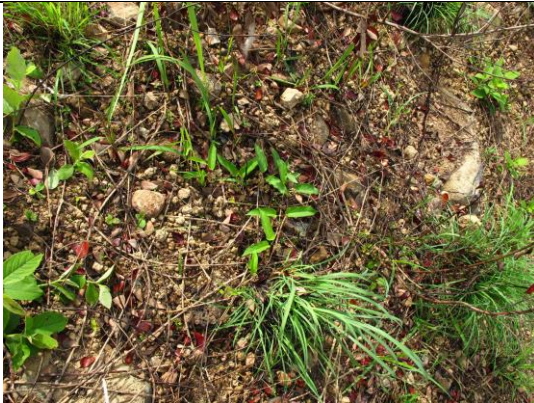
Photo 2 – Mature individual of *Marsdenia lachnostoma*

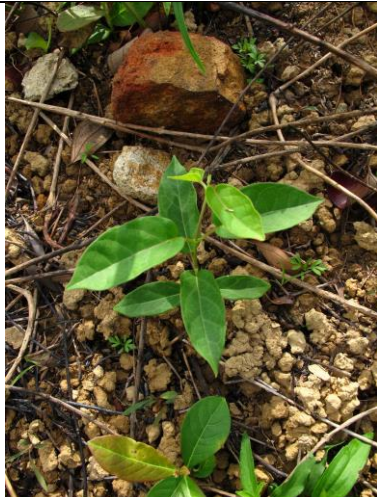
Photo 3 – Young individual of *Marsdenia lachnostoma*

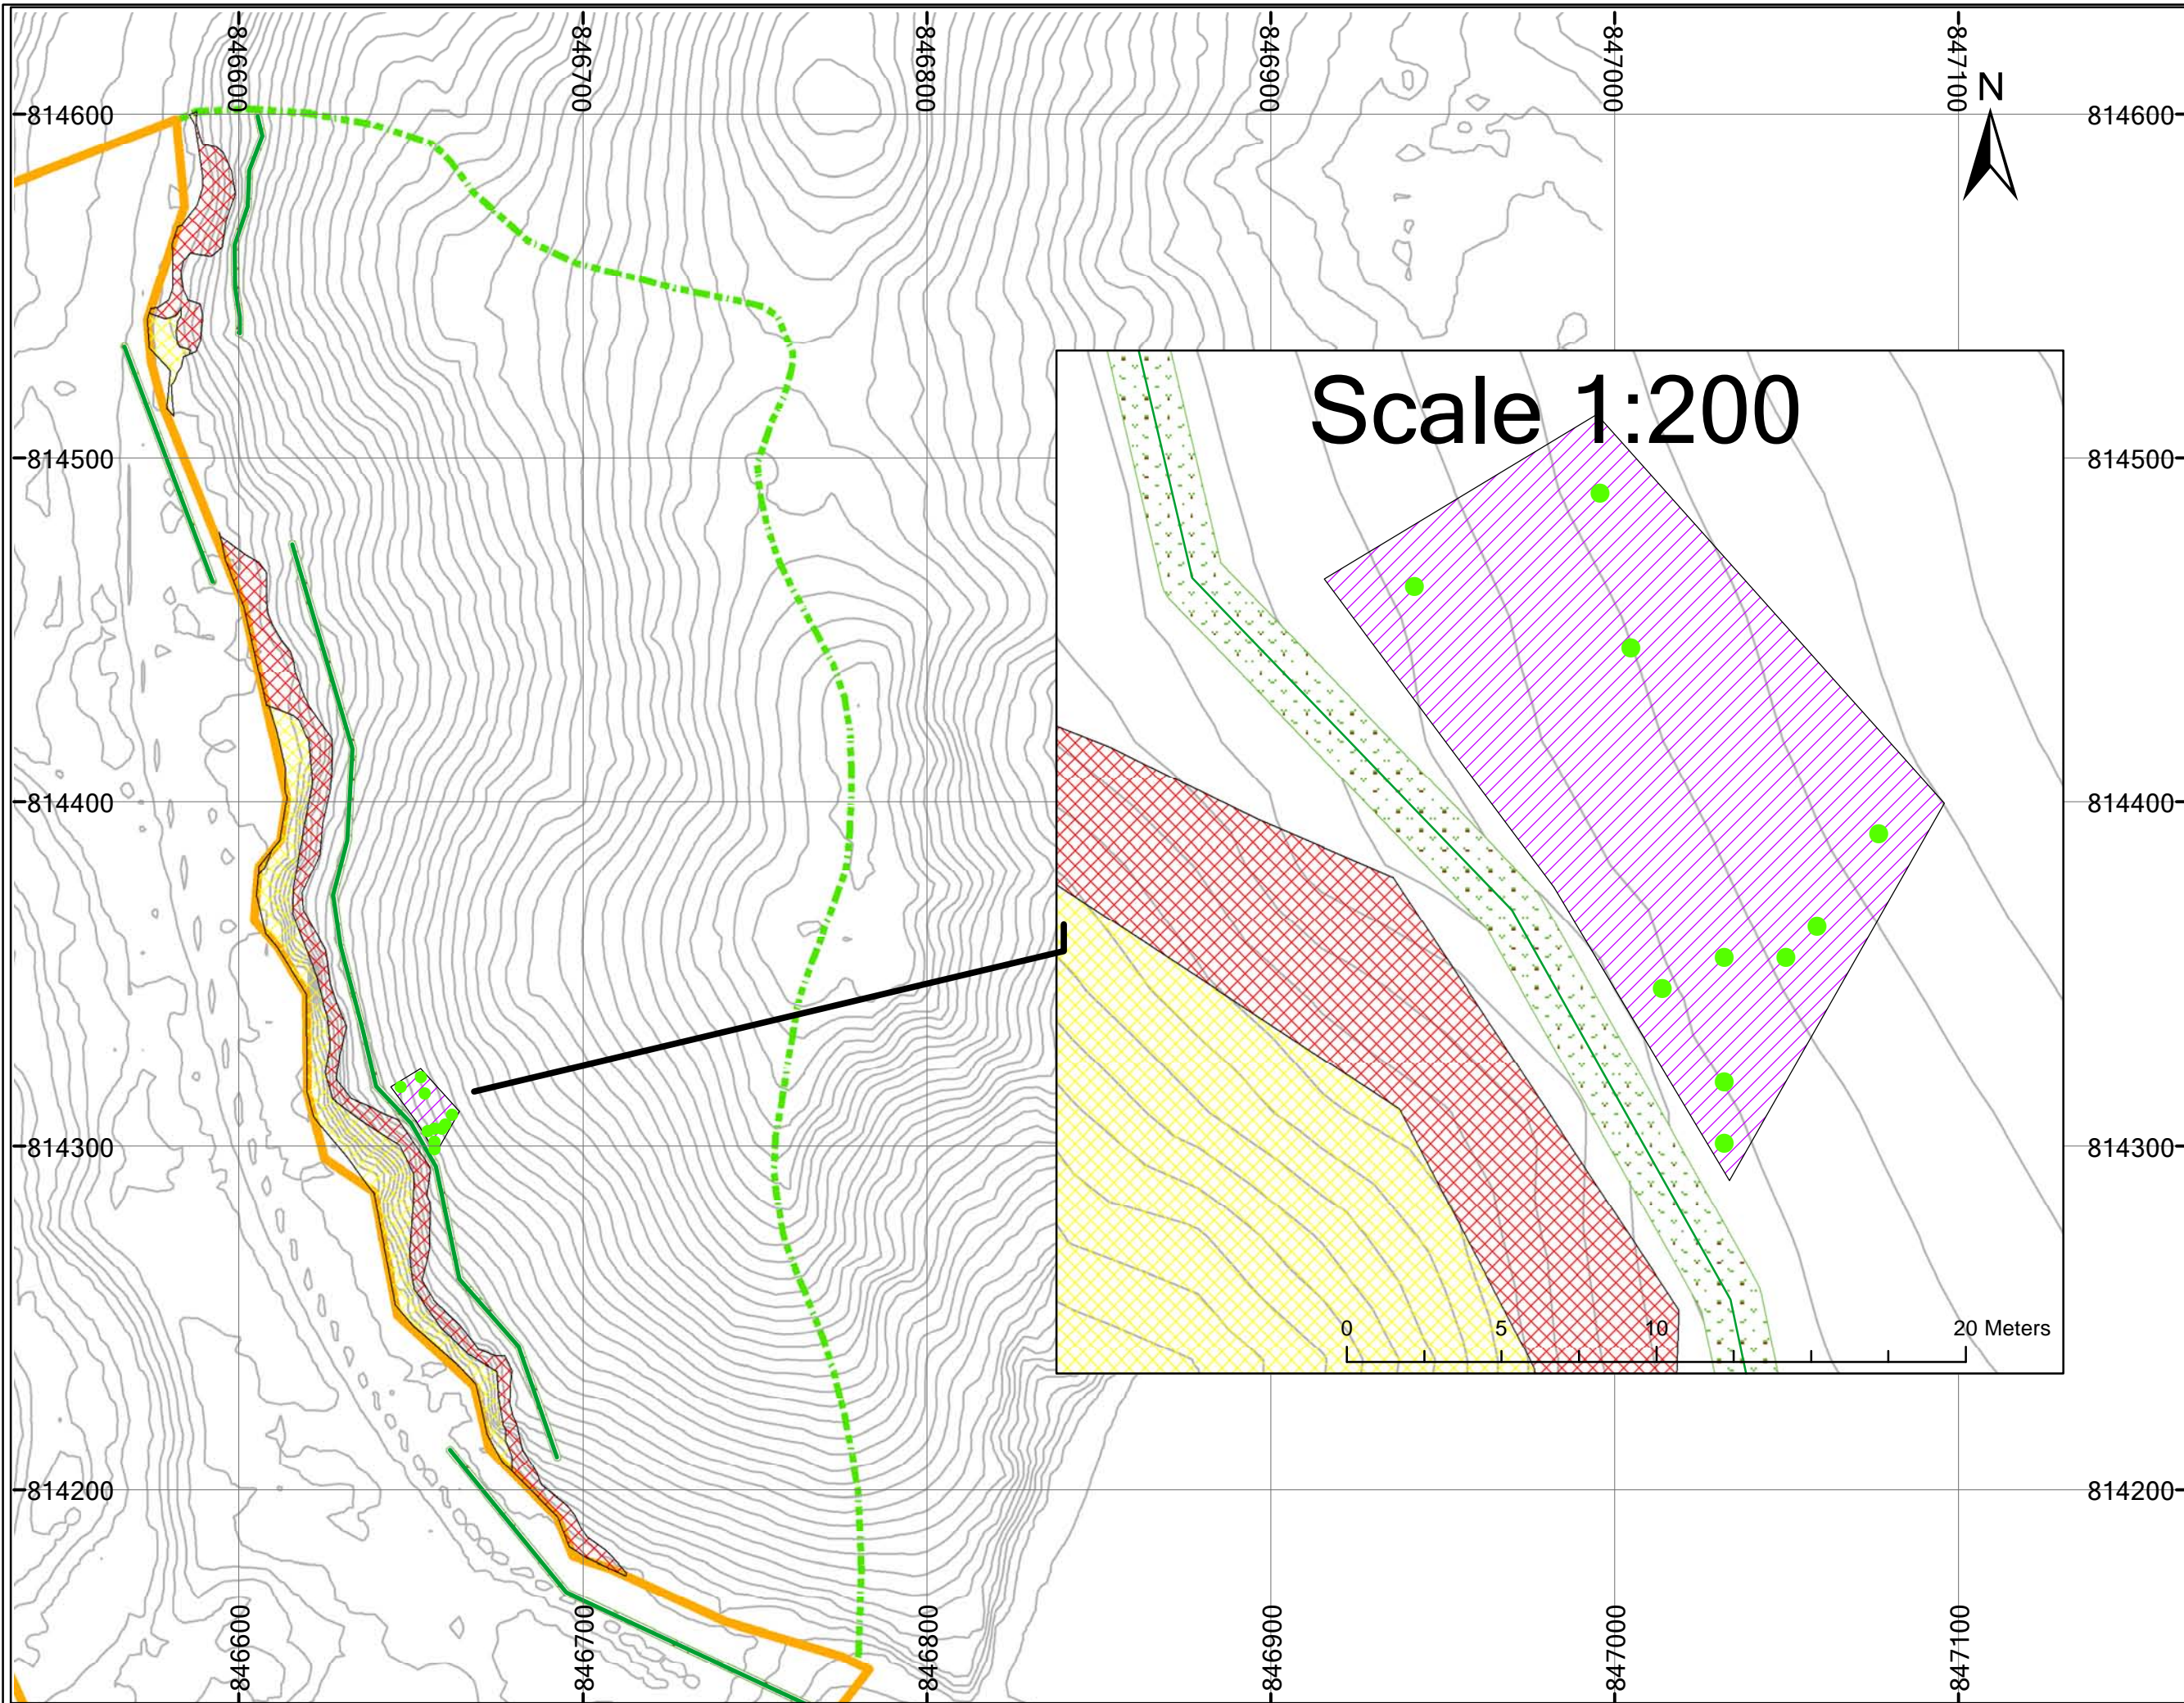
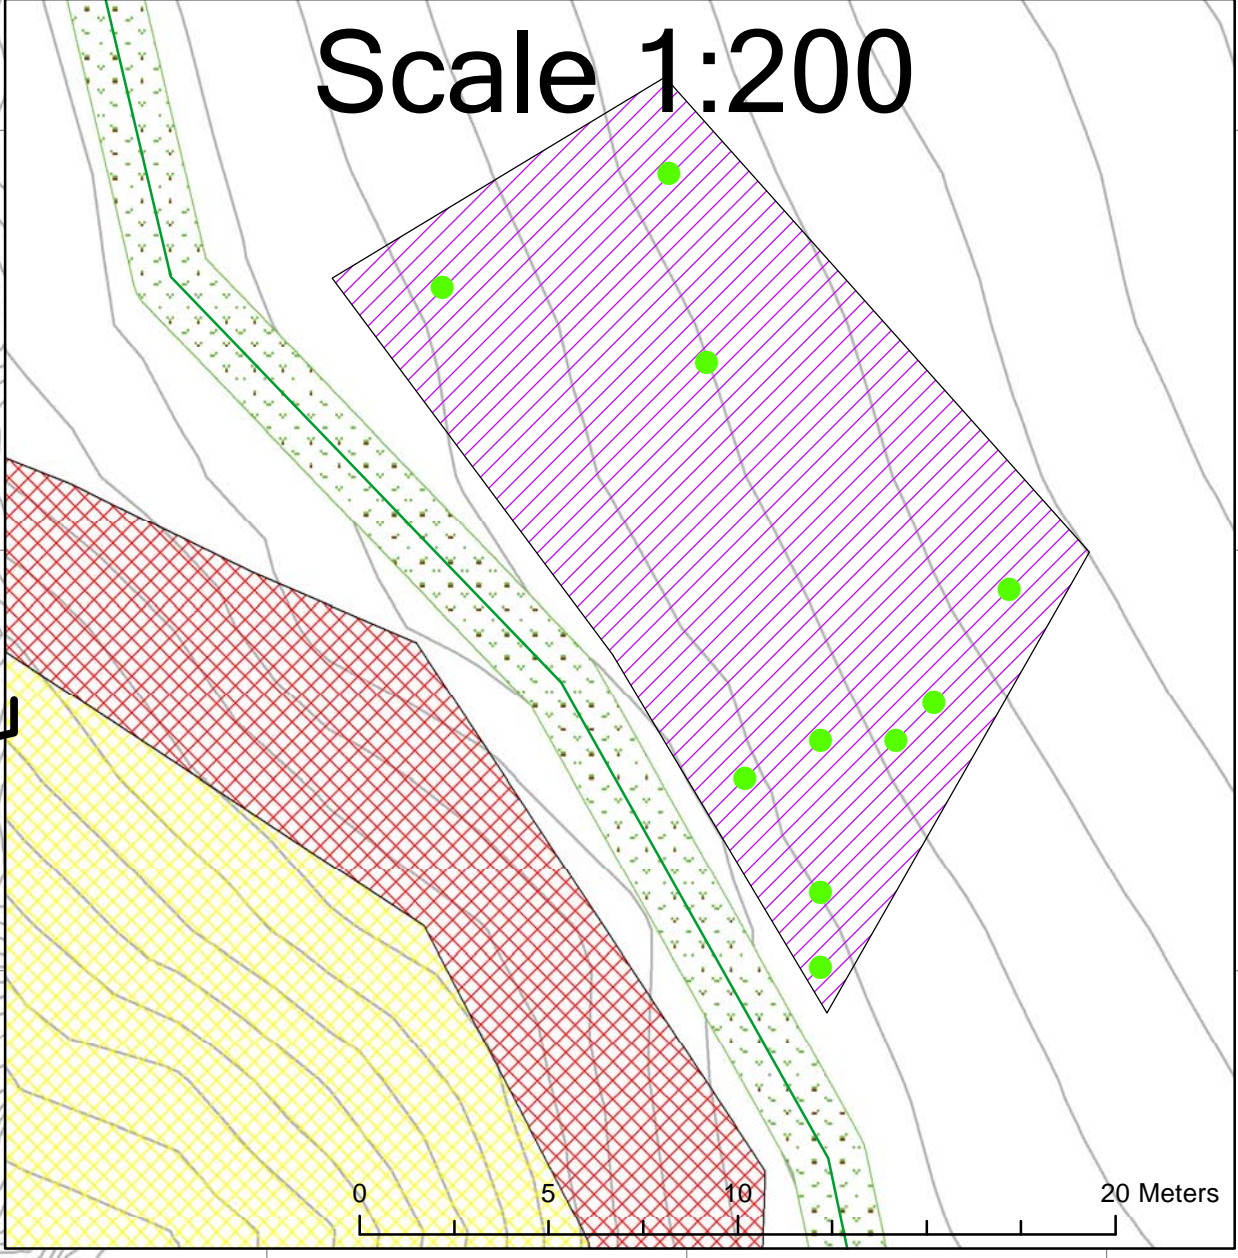
Drawing No. Figure 9.1 **Scale** 1:1,800 @ A3

Figure Title
 Location Plan and Protection Measures
 for Marsdenia Lachnostoma

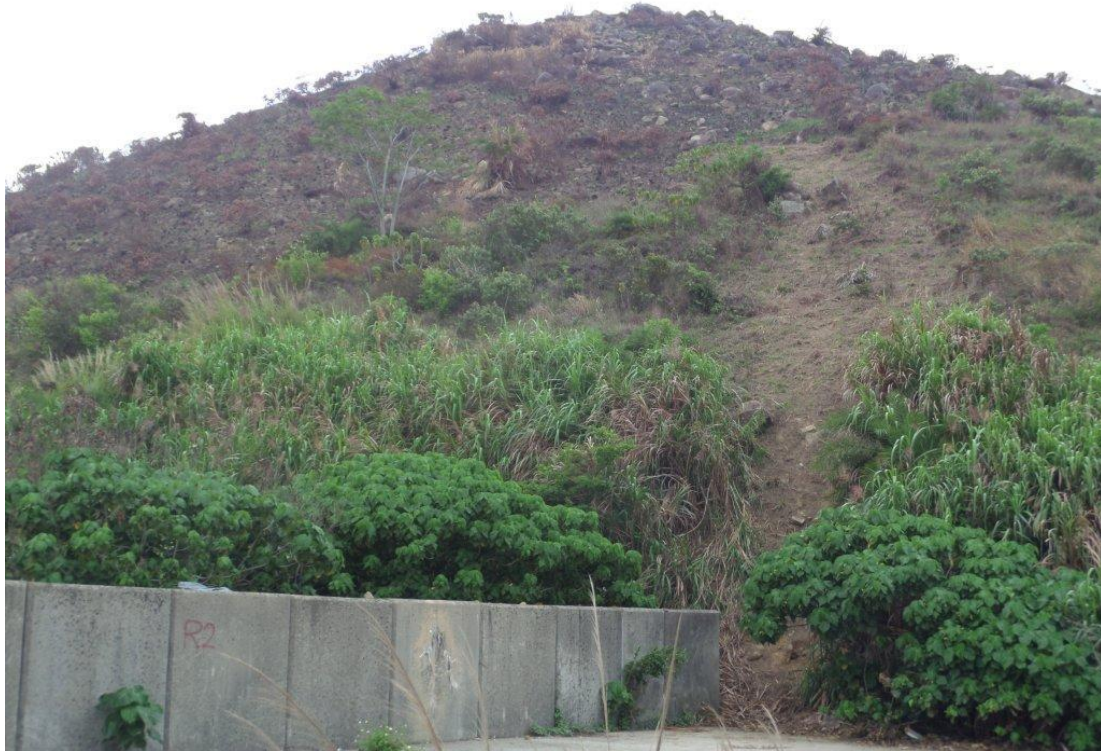
Plate 1

The survey area (i.e. the proposed works area) was observed to be disturbed recently by vegetation clearance and hill fires. The overall health condition of the undisturbed vegetation is fair in general.

The survey area is located within a degraded mixed woodland which is evidenced by the presence of large proportion of invasive species of *Leucaena leucocephala* and common pioneer species of *Macaranga tanarius*. Most of the trees are young in age. The average trunk diameter ranges 100mm-200mm while the average height ranges 6-9m.

The overall health condition of the trees is fair in general.

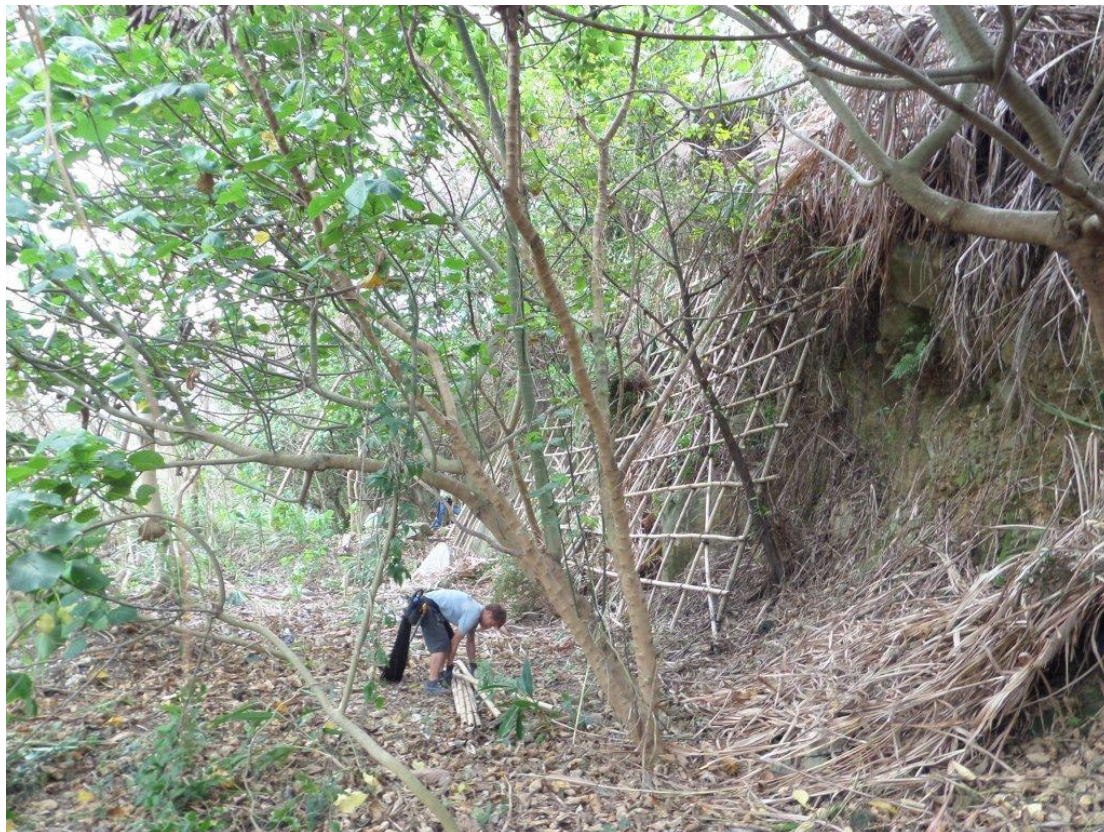
Plate 2

The survey area (i.e. the proposed works area) was observed to be disturbed recently by vegetation clearance and hill fires. The overall health condition of the undisturbed vegetation is fair in general.

The survey area is located within a degraded mixed woodland which is evidenced by the presence of large proportion of invasive species of *Leucaena leucocephala* and common pioneer species of *Macaranga tanarius*. Most of the trees are young in age. The average trunk diameter ranges 100mm-200mm while the average height ranges 6-9m.

The overall health condition of the trees is fair in general.

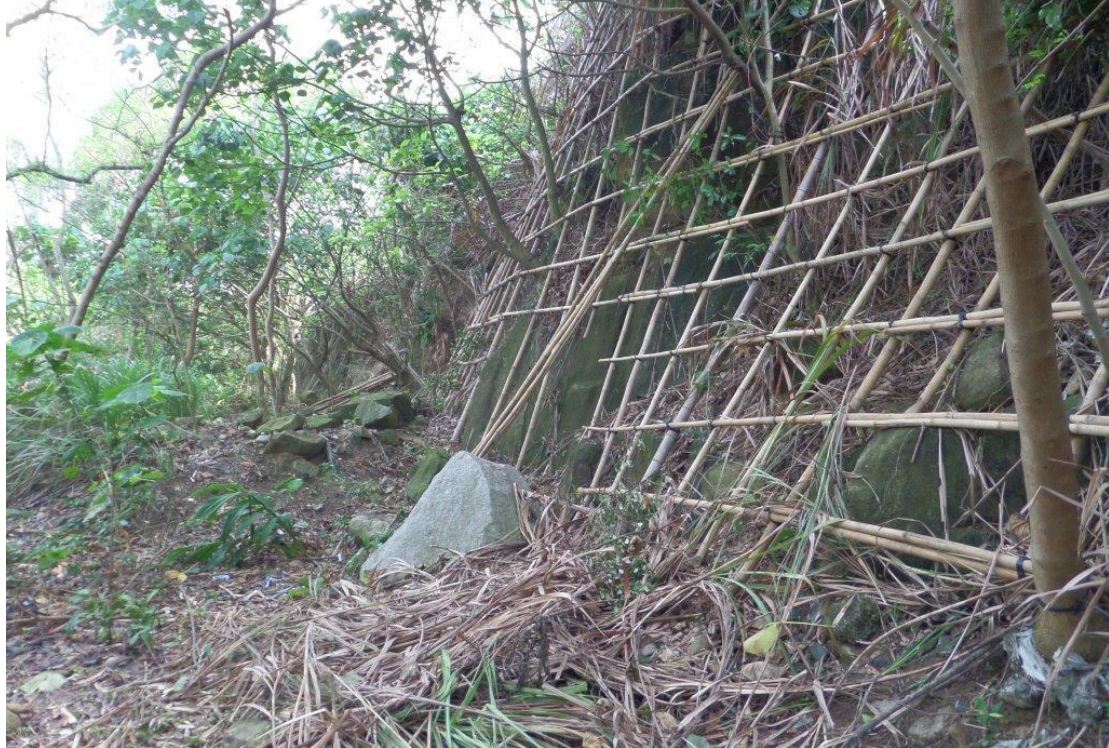
Plate 3

The survey area (i.e. the proposed works area) was observed to be disturbed recently by vegetation clearance and hill fires. The overall health condition of the undisturbed vegetation is fair in general.

The survey area is located within a degraded mixed woodland which is evidenced by the presence of large proportion of invasive species of *Leucaena leucocephala* and common pioneer species of *Macaranga tanarius*. Most of the trees are young in age. The average trunk diameter ranges 100mm-200mm while the average height ranges 6-9m. The overall health condition of the trees is fair in general.

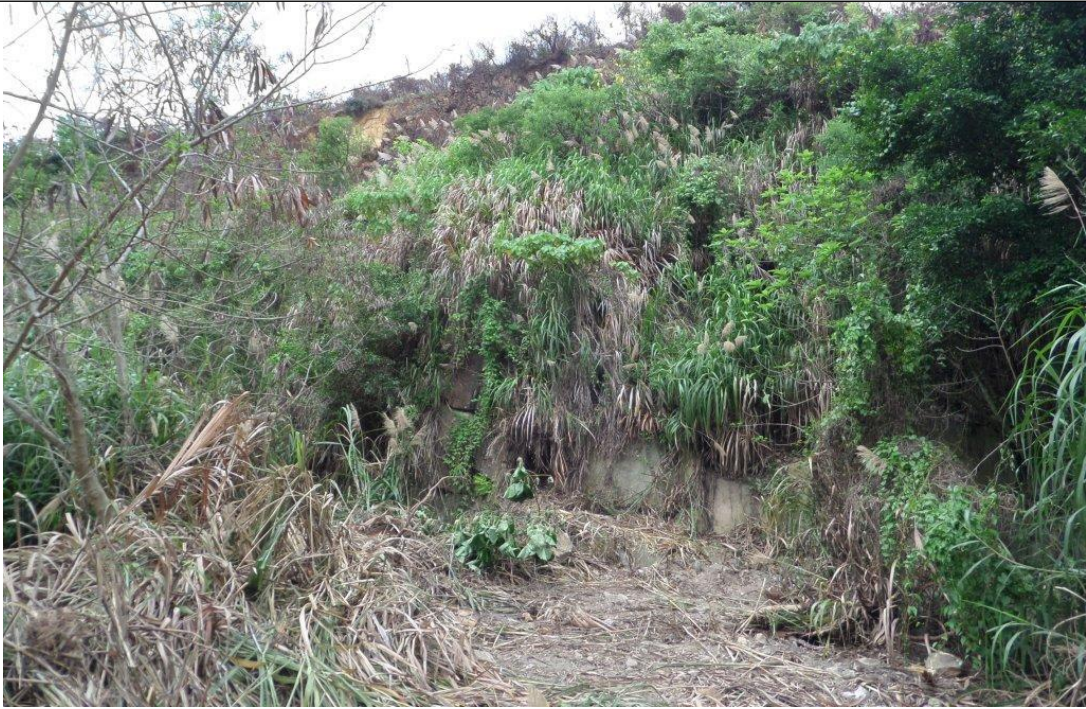
Plate 5

The survey area (i.e. the proposed works area) was observed to be disturbed recently by vegetation clearance and hill fires. The overall health condition of the undisturbed vegetation is fair in general.

The survey area is located within a degraded mixed woodland which is evidenced by the presence of large proportion of invasive species of *Leucaena leucocephala* and common pioneer species of *Macaranga tanarius*. Most of the trees are young in age. The average trunk diameter ranges 100mm-200mm while the average height ranges 6-9m. The overall health condition of the trees is fair in general.

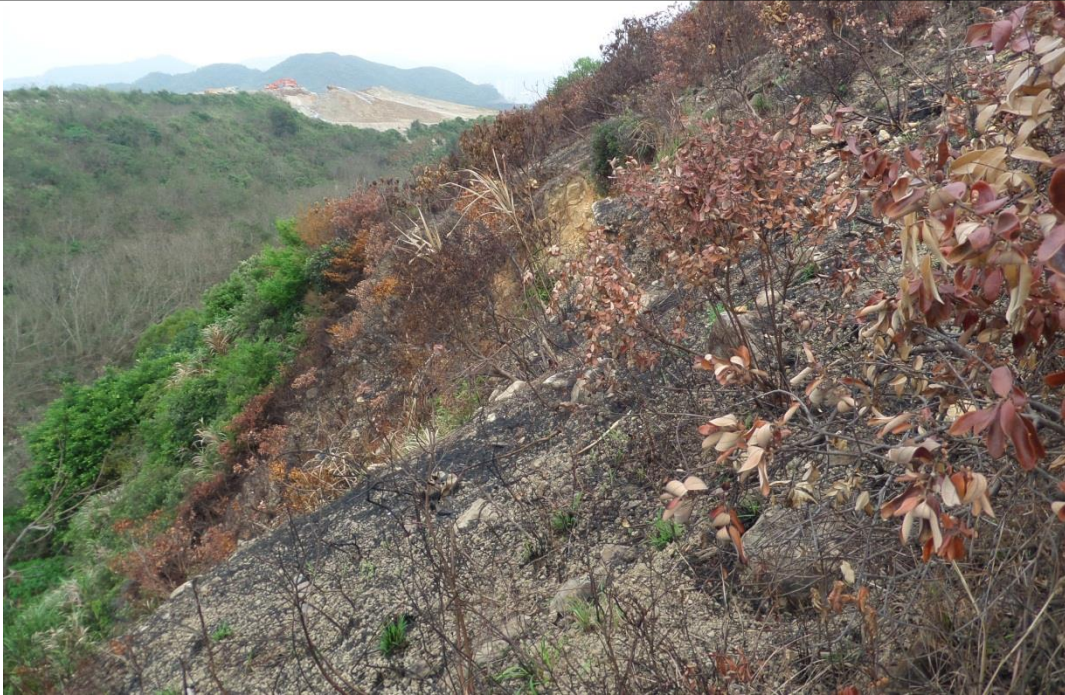
Plate 7

The survey area (i.e. the proposed works area) was observed to be disturbed recently by vegetation clearance and hill fires. The overall health condition of the undisturbed vegetation is fair in general.

The survey area is located within a degraded mixed woodland which is evidenced by the presence of large proportion of invasive species of *Leucaena leucocephala* and common pioneer species of *Macaranga tanarius*. Most of the trees are young in age. The average trunk diameter ranges 100mm-200mm while the average height ranges 6-9m. The overall health condition of the trees is fair in general.

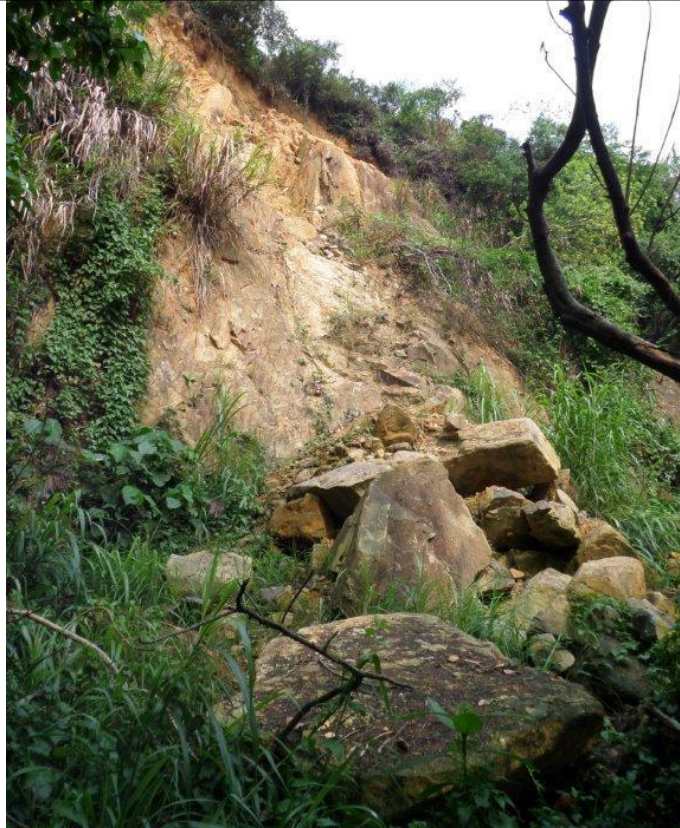
Plate 9

The survey area (i.e. the proposed works area) was observed to be disturbed recently by vegetation clearance and hill fires. The overall health condition of the undisturbed vegetation is fair in general.

The survey area is located within a degraded mixed woodland which is evidenced by the presence of large proportion of invasive species of *Leucaena leucocephala* and common pioneer species of *Macaranga tanarius*. Most of the trees are young in age. The average trunk diameter ranges 100mm-200mm while the average height ranges 6-9m.

The overall health condition of the trees is fair in general.

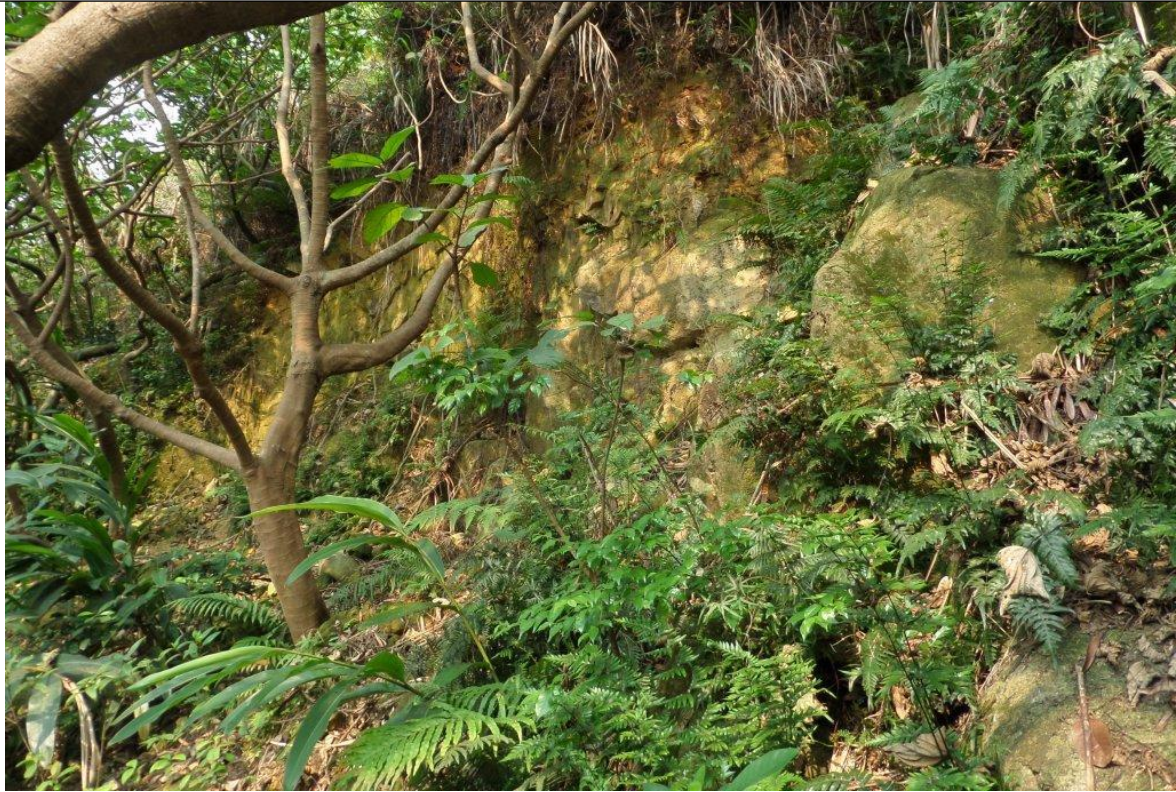
Plate 11

The survey area (i.e. the proposed works area) was observed to be disturbed recently by vegetation clearance and hill fires. The overall health condition of the undisturbed vegetation is fair in general.

The survey area is located within a degraded mixed woodland which is evidenced by the presence of large proportion of invasive species of *Leucaena leucocephala* and common pioneer species of *Macaranga tanarius*. Most of the trees are young in age. The average trunk diameter ranges 100mm-200mm while the average height ranges 6-9m. The overall health condition of the trees is fair in general.

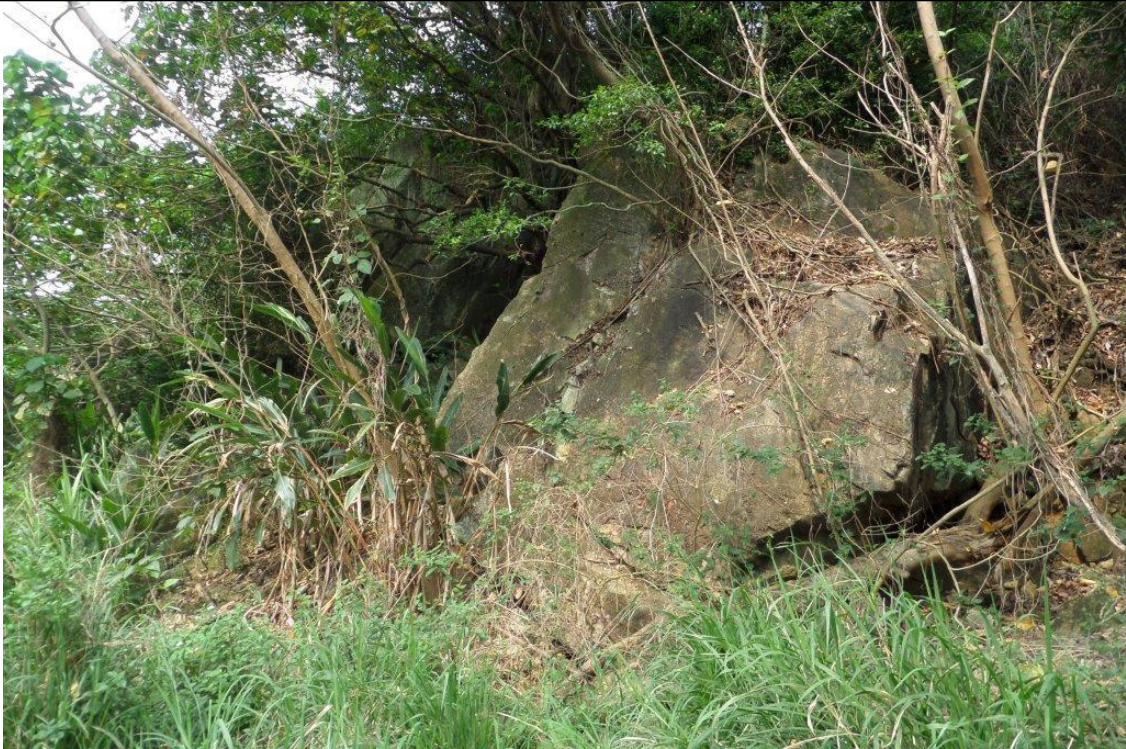
Plate 13

The survey area (i.e. the proposed works area) was observed to be disturbed recently by vegetation clearance and hill fires. The overall health condition of the undisturbed vegetation is fair in general.

The survey area is located within a degraded mixed woodland which is evidenced by the presence of large proportion of invasive species of *Leucaena leucocephala* and common pioneer species of *Macaranga tanarius*. Most of the trees are young in age. The average trunk diameter ranges 100mm-200mm while the average height ranges 6-9m.

The overall health condition of the trees is fair in general.

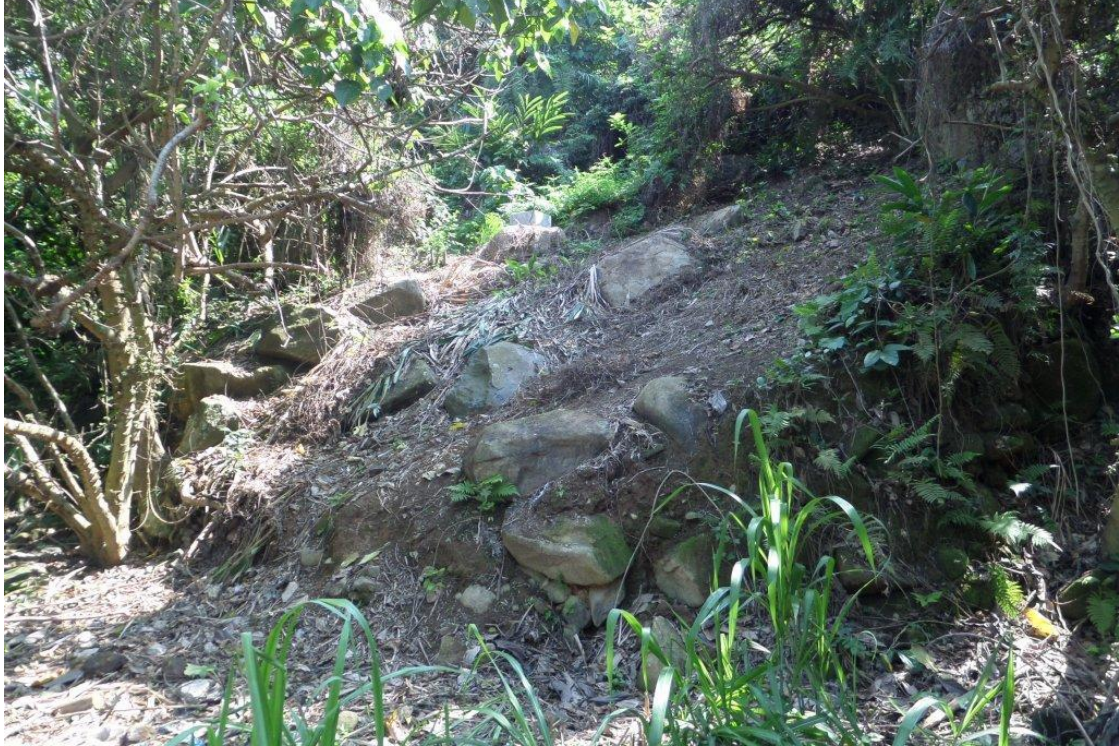
Plate 15

The survey area (i.e. the proposed works area) was observed to be disturbed recently by vegetation clearance and hill fires. The overall health condition of the undisturbed vegetation is fair in general.

The survey area is located within a degraded mixed woodland which is evidenced by the presence of large proportion of invasive species of *Leucaena leucocephala* and common pioneer species of *Macaranga tanarius*. Most of the trees are young in age. The average trunk diameter ranges 100mm-200mm while the average height ranges 6-9m.

The overall health condition of the trees is fair in general.

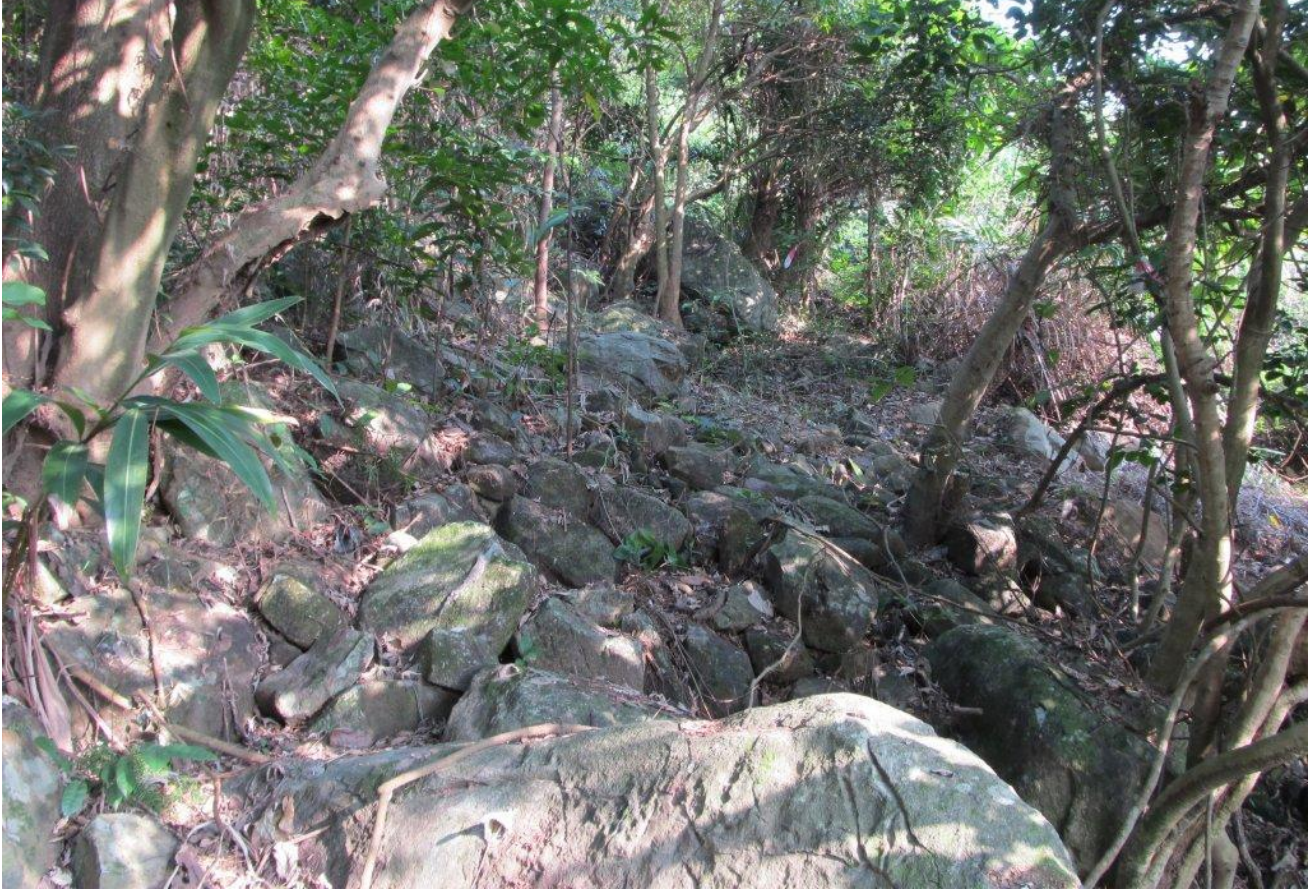
Photo 17

The survey area (i.e. the proposed works area) was observed to be disturbed recently by vegetation clearance and hill fires. The overall health condition of the undisturbed vegetation is fair in general.

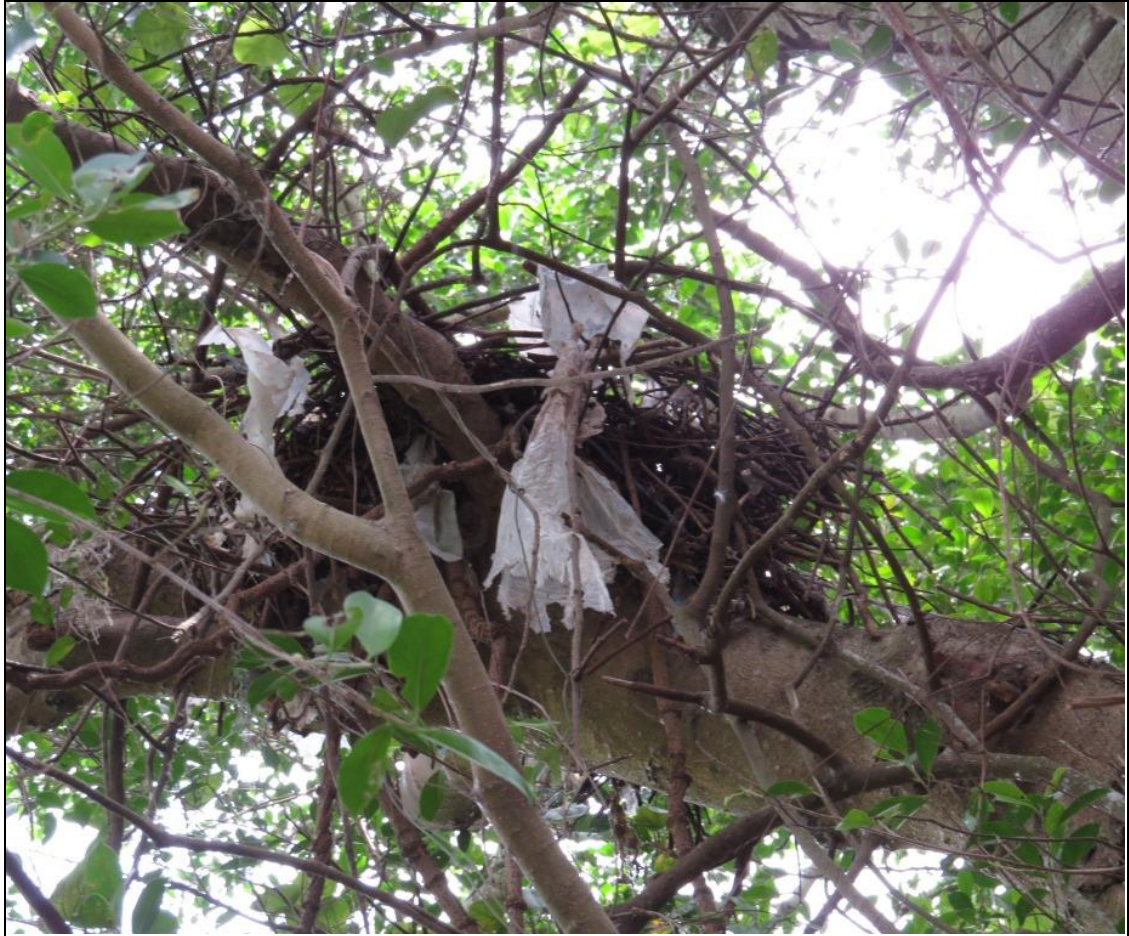
4.13 No Collared Scops Owl was found during the day and night time field survey on 14 May 2015. An abandoned nest, but not belong to Collared Scops Owl, was discovered on a *Ficus microcarpa*, **Appendix 5**. Representative photographs are shown in **Appendix 4**. Neither breeding activities nor presence of Collared Scops Owl were observed at or in the vicinity of the abandoned nest.

Plate 3: Abandoned bird nest on *Ficus microcarpa* on 14 May 2015

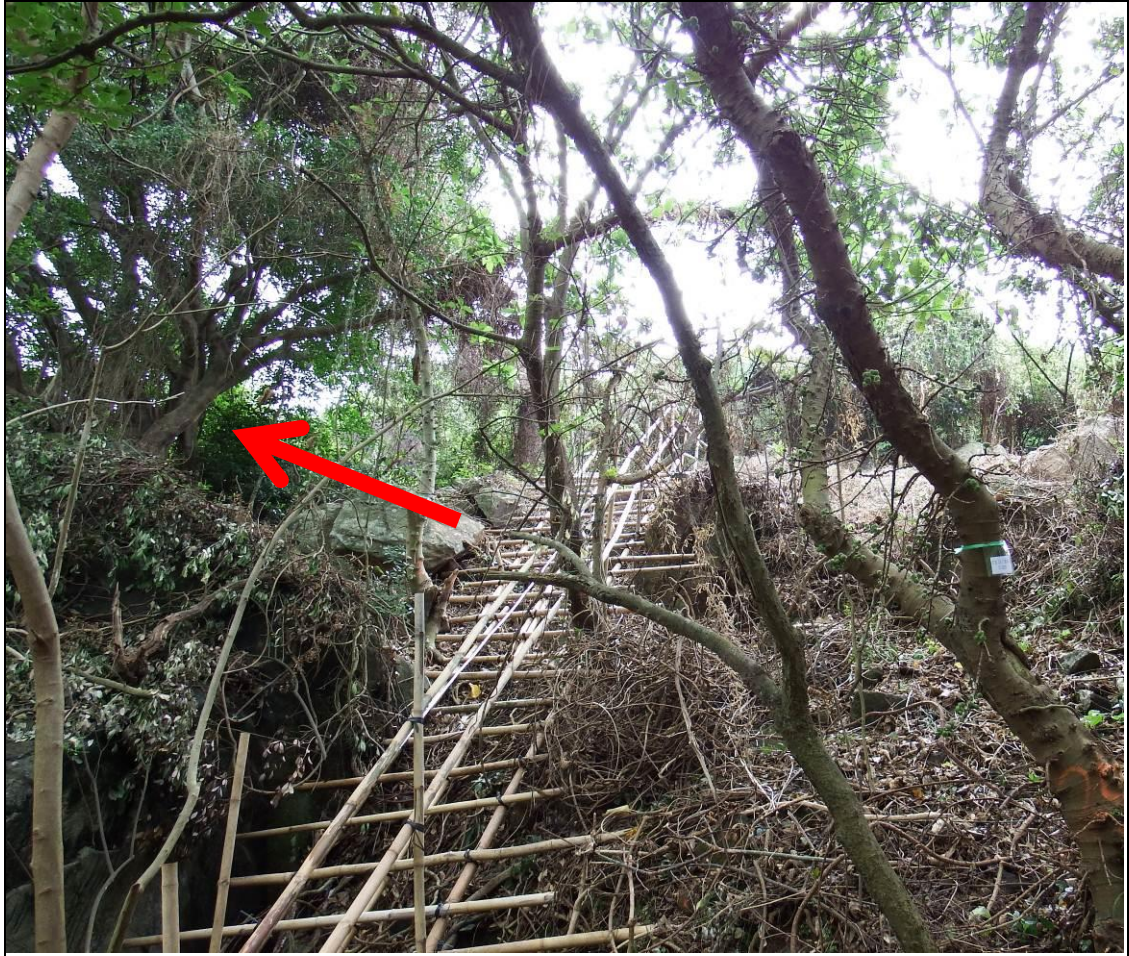
Plate 4: *Ficus microcarpa* location
on 14 May 2015

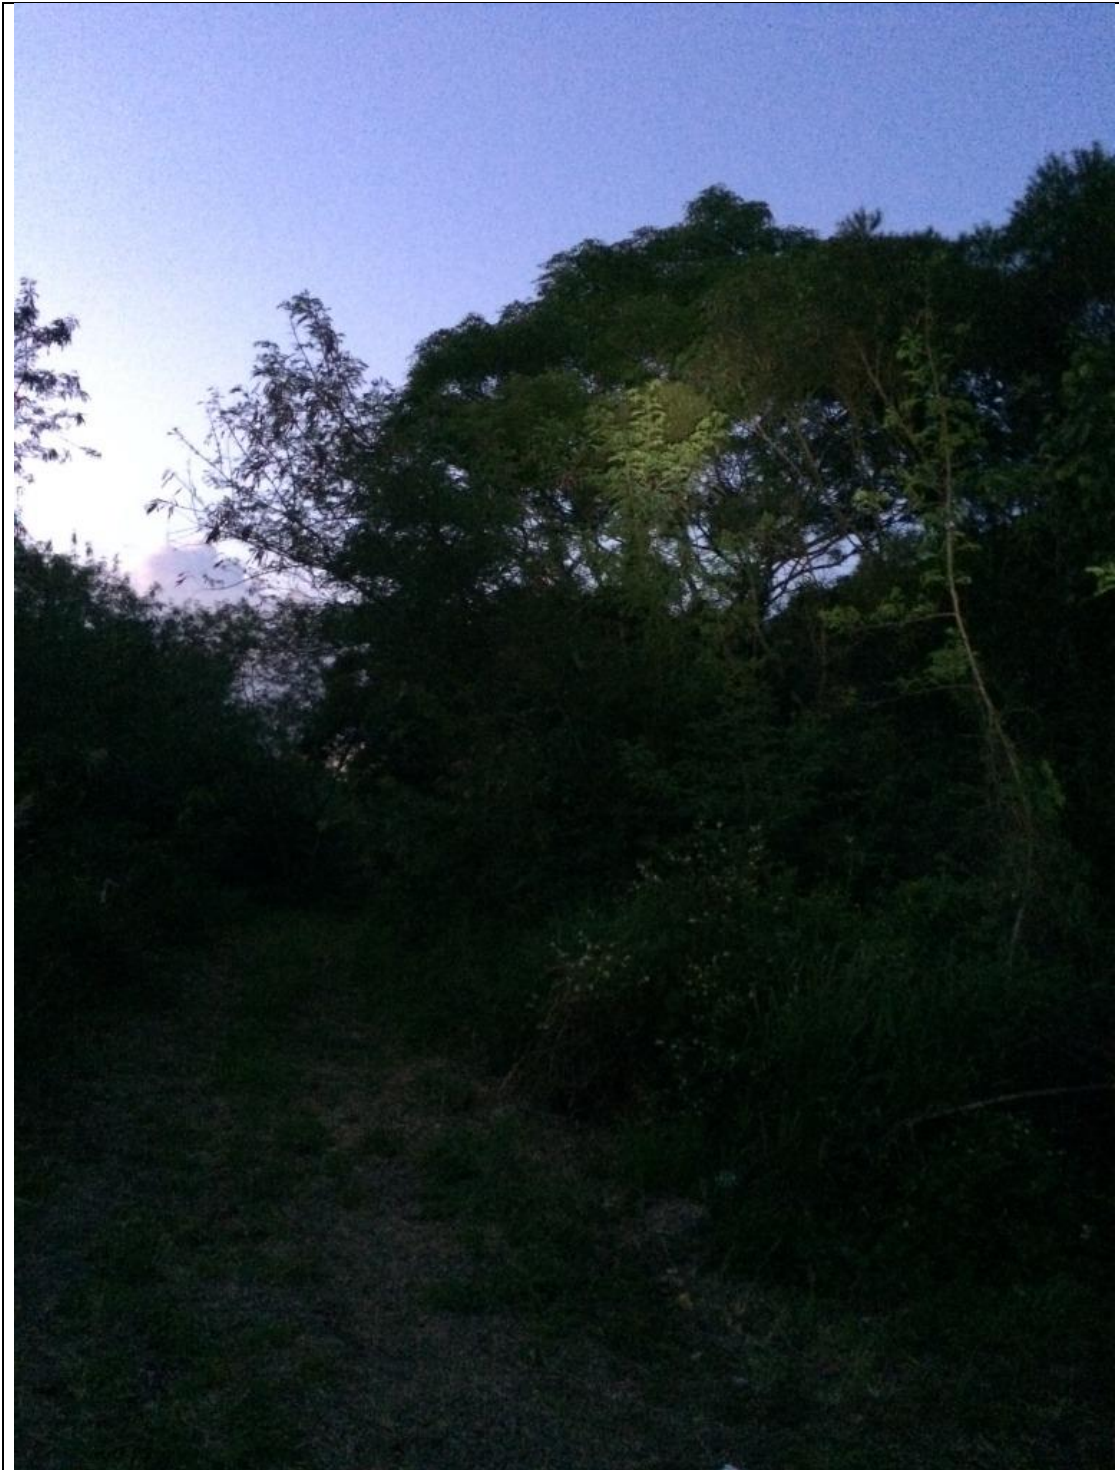
5.3 The Collared Scops Owl inspection was undertaken on 14 May 2015 before EIA submission. The Collared Scops Owl inspection confirmed that no Collared Scops Owl was present at the area around the study area for slope mitigation works.

Plate 5: Night time inspection
on 14 May 2015

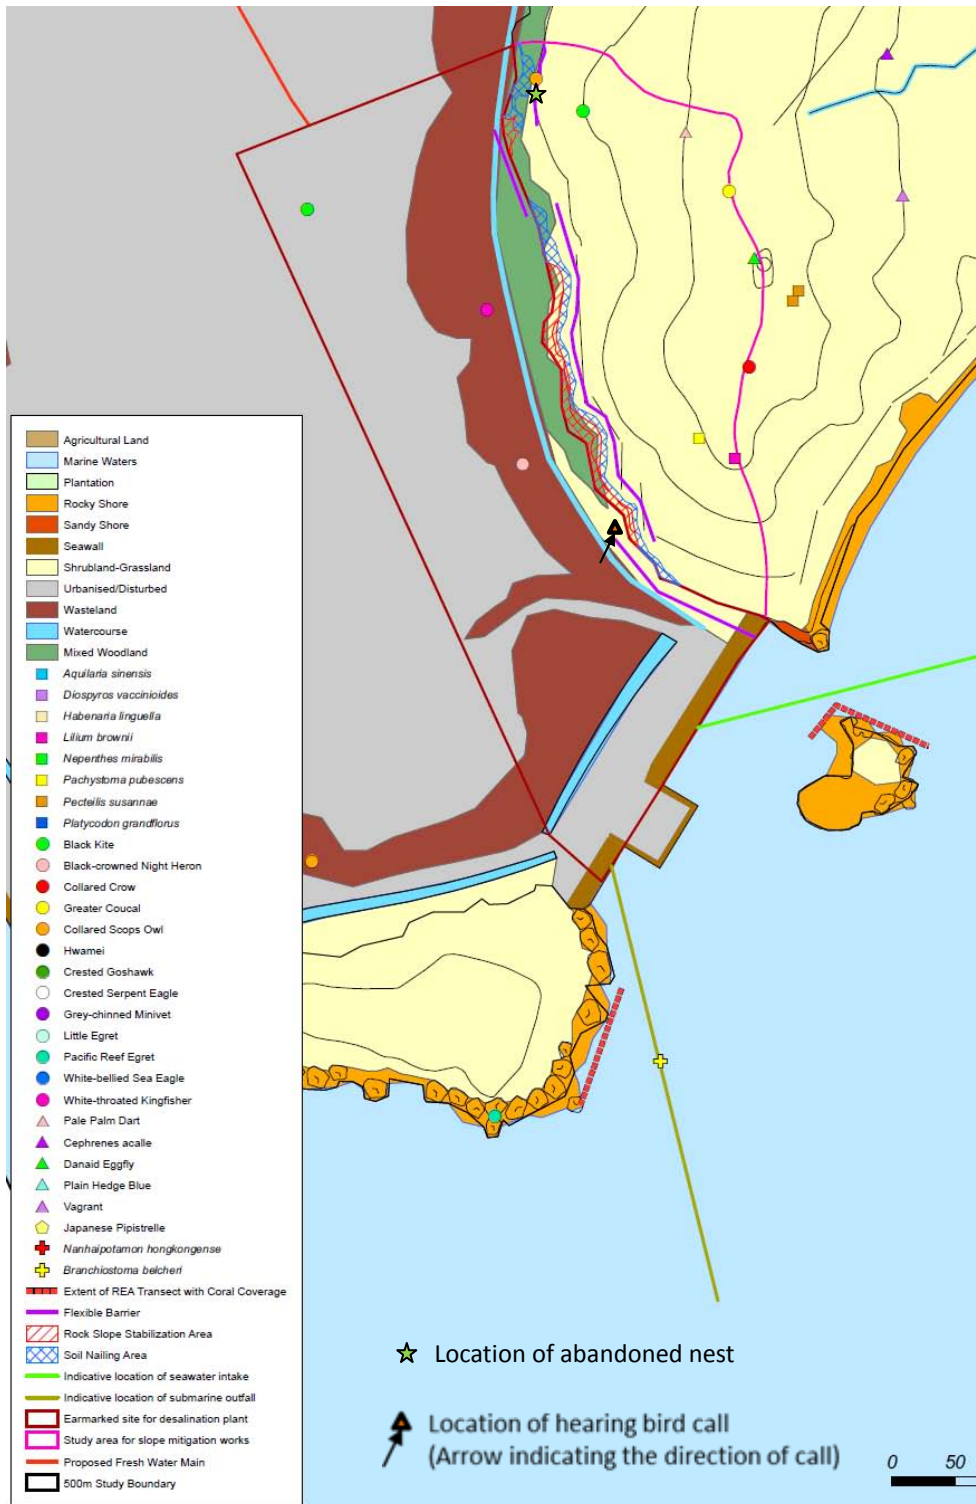
**Location of Hearing Bird Call
and
Location of Abandoned Nest**

4.14 During the day time field survey, bird call from Lesser Coucal was recorded, referring to **Appendix 5** for location. No sign of breeding of this bird was observed.
