**Wan Chai Development Phase II –  
Central – Wan Chai Bypass at Wan Chai West  
Contract No. HK/2012/08**

**Final Landscape Plan  
for FEP-02/376/2009**

Revision 1

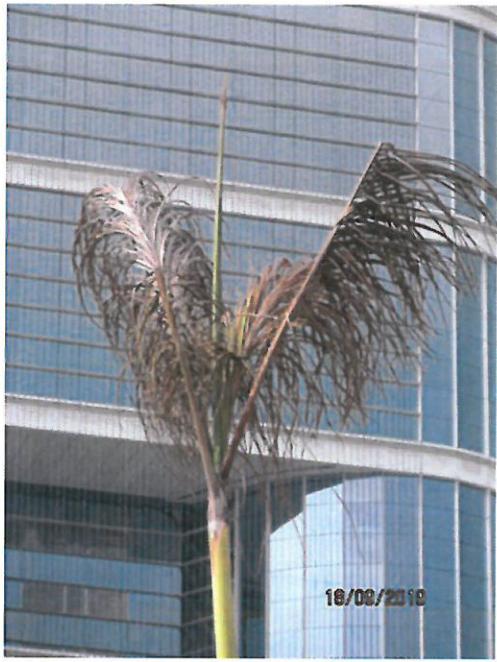
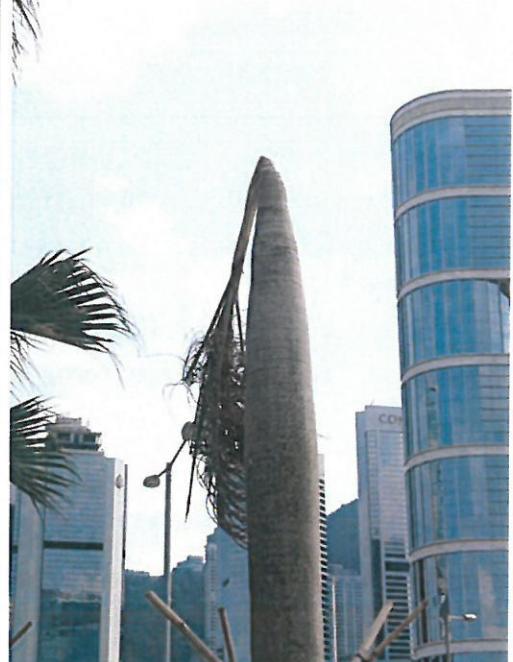
Referring to joint site inspection among our landscape subcontractor and ITS at Planter between Road A2 and Road P2 eastbound on 23 September 2019, ITS reported that tree no. H08 was found dead after the tree transplanted to site.

A transplanted trees, named H08 (C2) was observed dead during the site inspection on 21 September 2019. The general information of the tree is listed in the following table:

Crown wilting was observed on 18 Sept 2019	Growing point of the tree was dead on 21 Sept 2019

During this inspection, this tree is obviously dead after transplanting within 1 month. Tree felling may require but it will subject to the condition of TPRP under this Contract. Compensatory planting may necessary considered. Detail assessment of this tree please refers to the Form 2 attached.

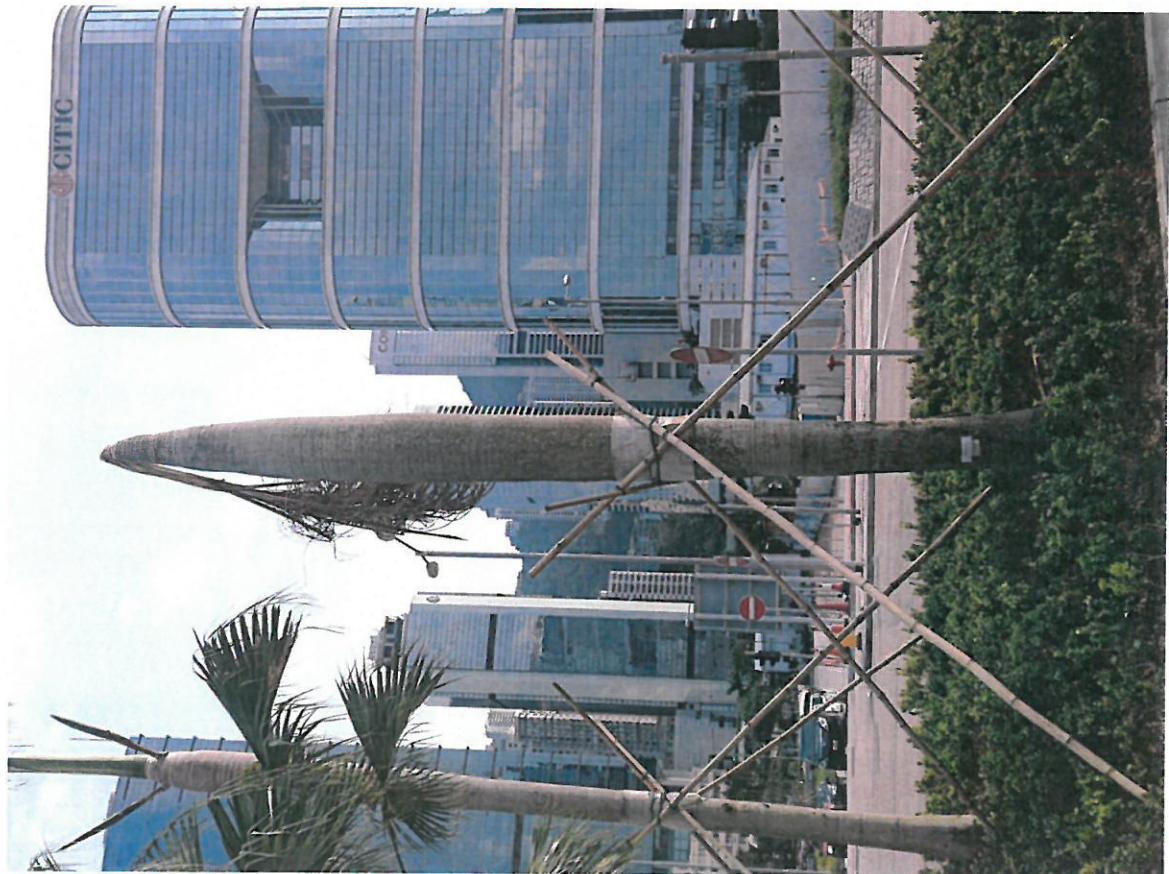
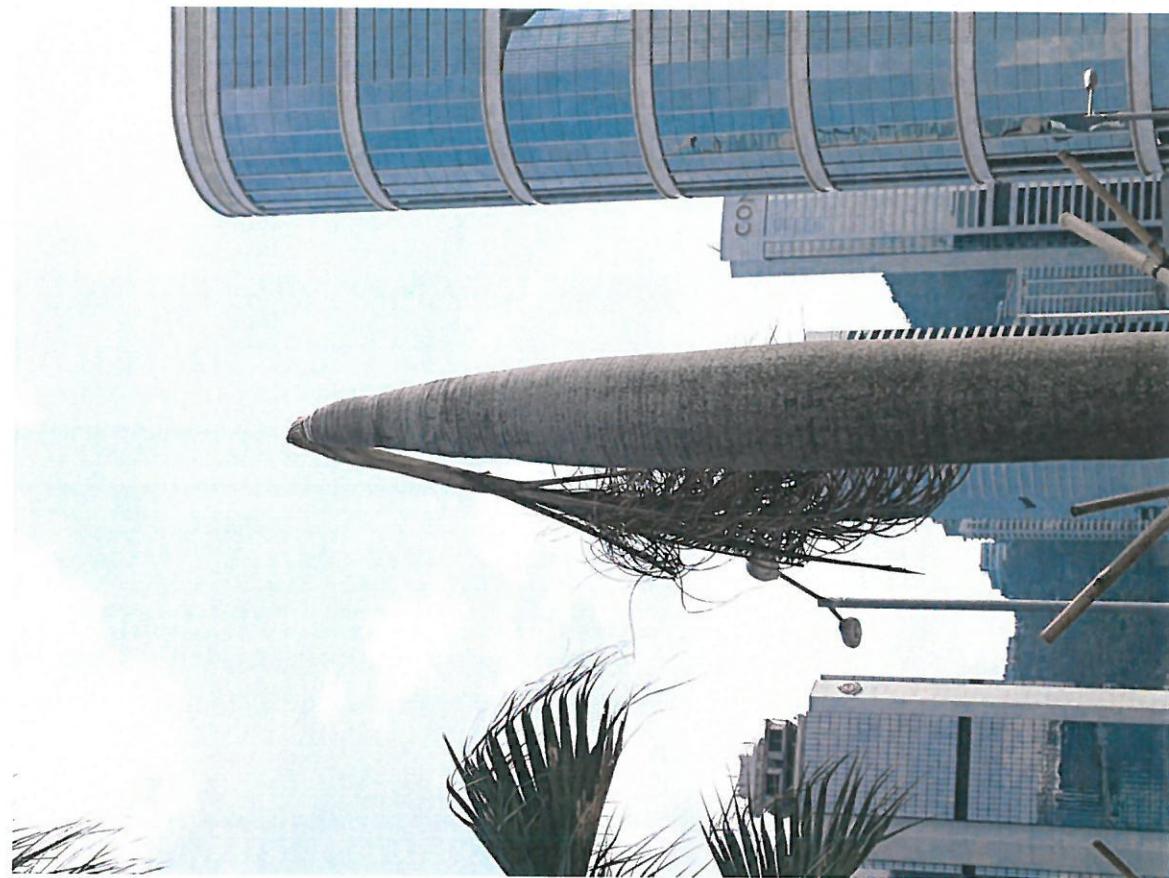
Overview of H08

Wilting tree crown (Dead of growing point)

This tree is designated for transplanting, but health condition of this tree declined after transplanting from holding nursery. Tree removal may required.

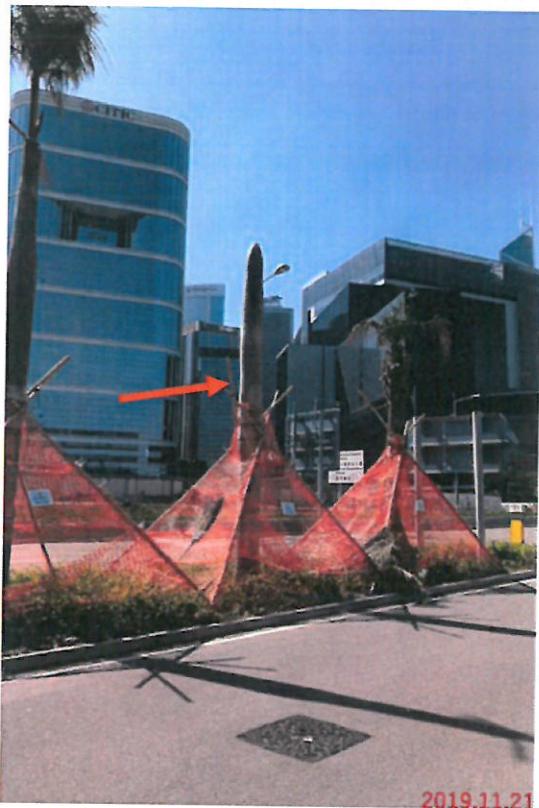
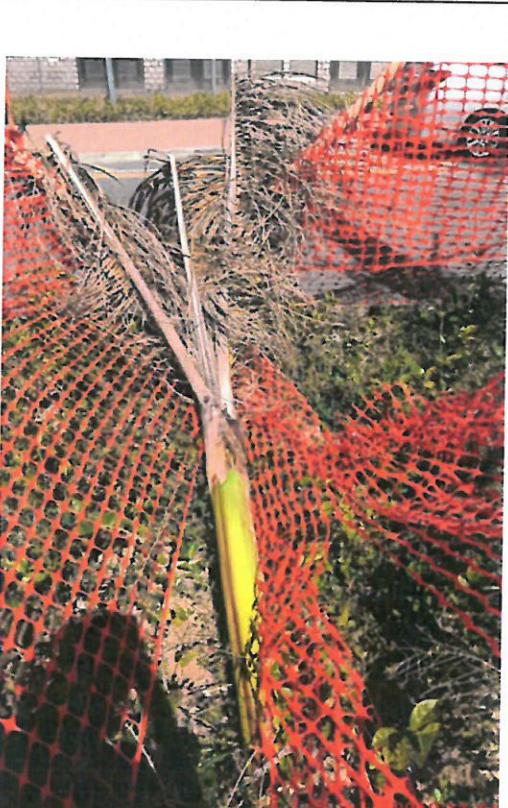
A close-up photograph of the fallen tree crown lying on the ground. The trunk is visible, and the surrounding area is covered with orange safety netting.
<b>Overview of H28 on 22 Nov 2019</b>	<b>Tree crown fell on ground</b>

During this inspection, it is observed that the tree crown was fell on ground. As the growing point of palm tree (at the tip of the trunk) was damaged, the tree is unlikely to recover.

Tree felling is recommended and compensatory planting may necessary considered under the condition of TPRP of this Contract, detail assessment of this tree please refers to the Form 2 attached.

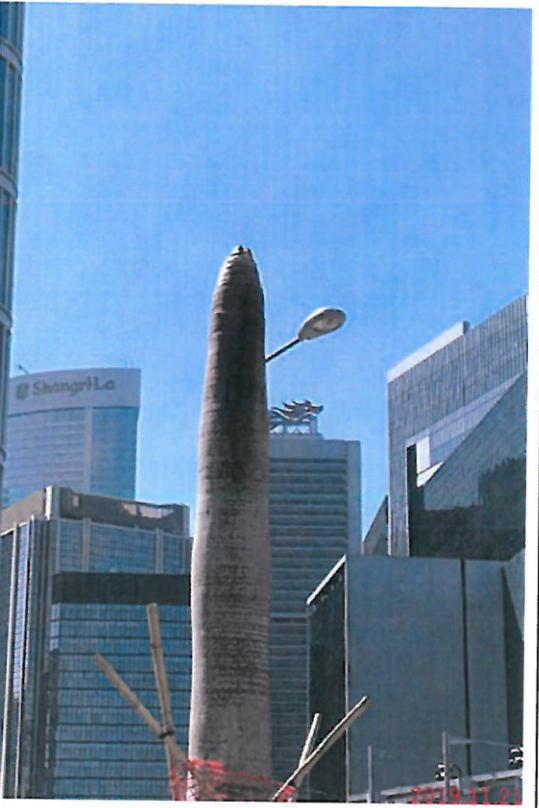
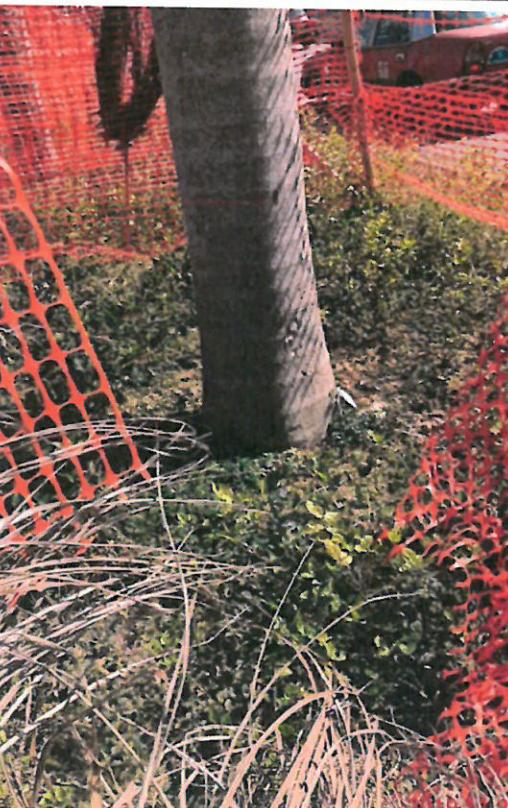
<b>Close up of the tip of trunk</b>	<b>Tree root area</b>

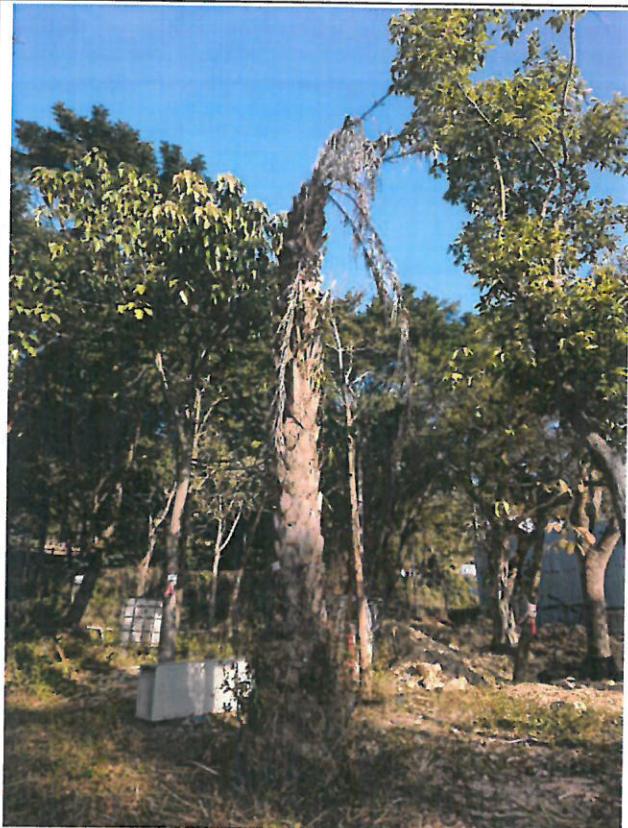
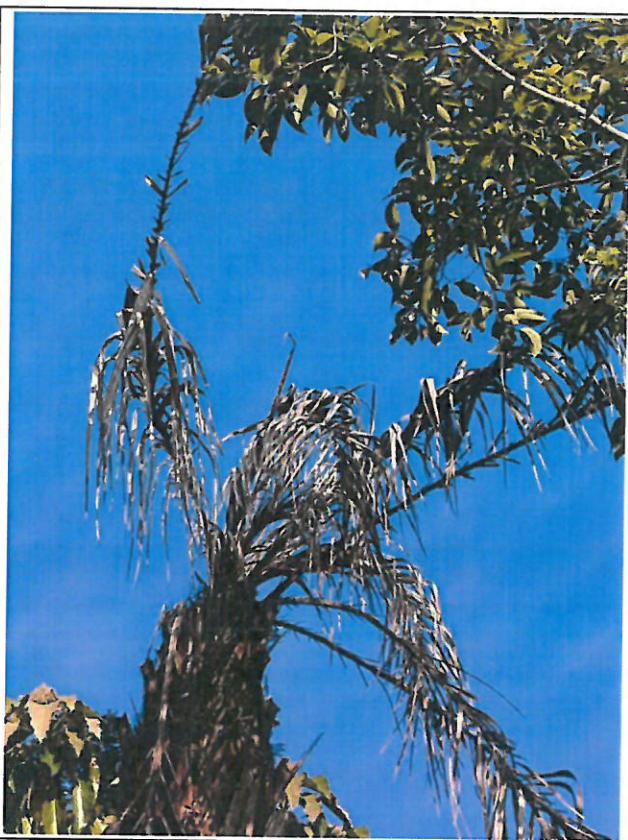
T462- *Phoenix hanceana* (刺葵)

The tree is dead. Tree removal and compensatory planting is required.

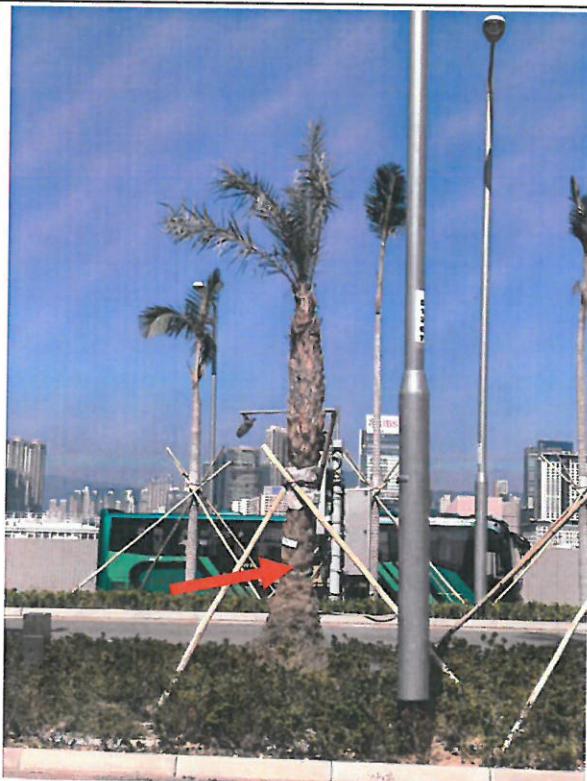
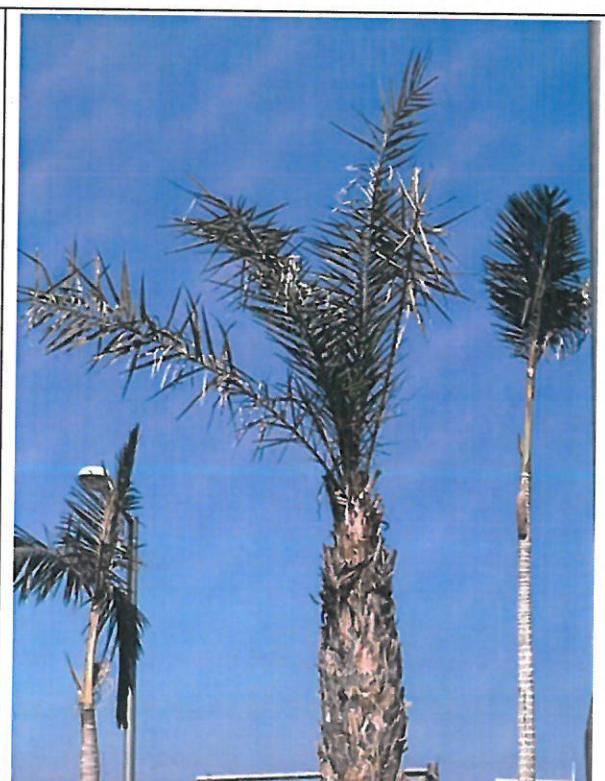
T464-*Phoenix hanceana* (刺葵)

Health condition improved and was transplanted to receptive location

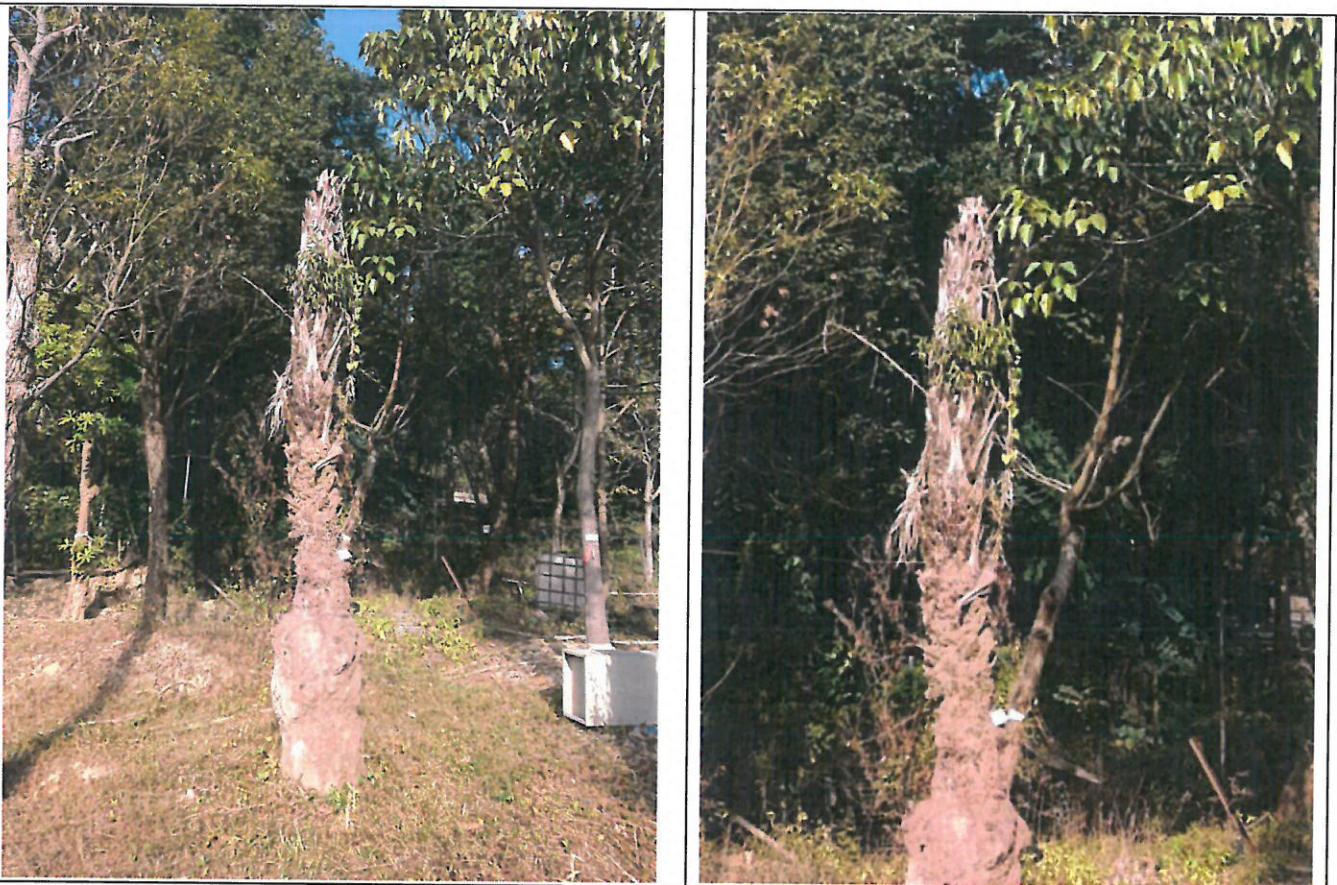
T466 -*Phoenix hanceana* (刺葵)

The tree is dead. Tree removal and compensatory planting is required.
