Updated Contamination Assessment Plan

Client : Sum Kee Construction Ltd.
Project : Contract No. DC/2006/01
Drainage Improvement Works in Sai Kung
Report No. : 075117EN70416A

31. Aug 2007

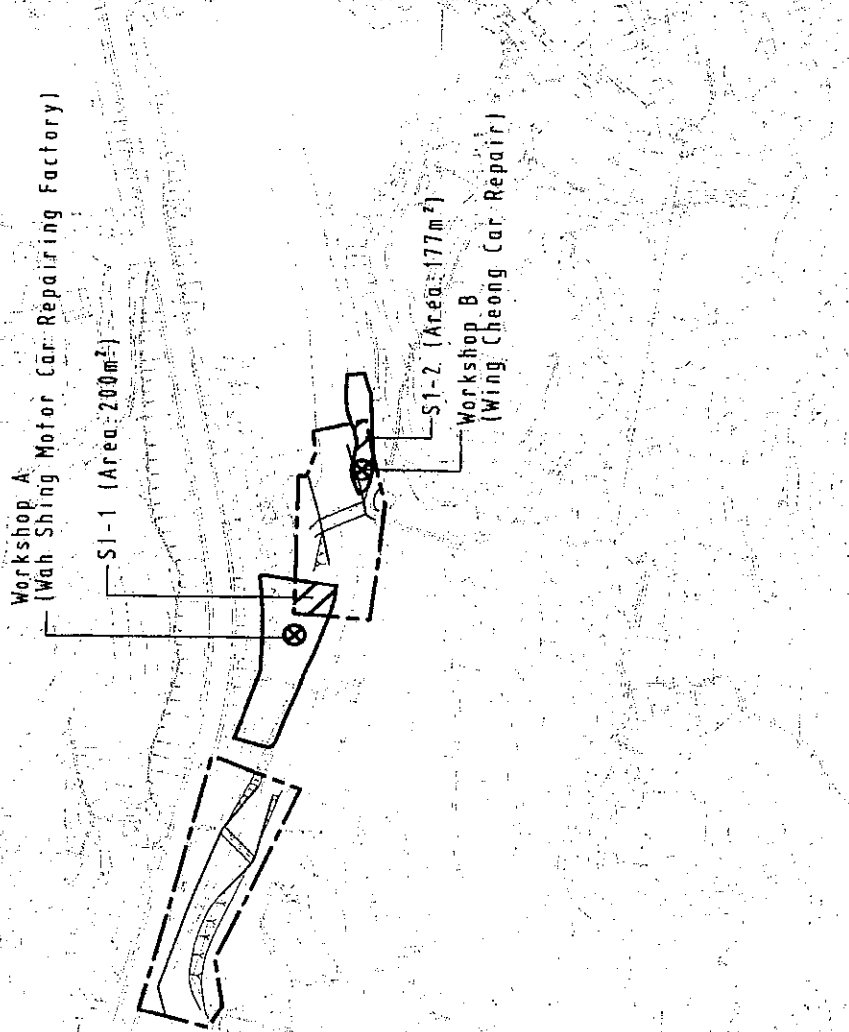
Figure No. 6.1

- 6.3 As shown in Appendix II, there are two workshops, including *Workshop A - Wah Shing Motor Repairing Factory* and *Workshop B - Wing Chong Car Repair*, with part of the site areas encroaching upon the proposed drainage work area of Pak Kong River. The major concern associated with these workshops would be of lube oil, engine oil and/or solvents that could be inaptly be disposed of by workers or leaked from vehicles causing contamination in the site and its vicinity. According to EPD's "*Guidance Notes for Investigation and Remediation of Contaminated Sites of Petrol Filling Stations, Boatyards, and Car Repair / Dismantling Workshops*" and "*ProPECC PN3/94*", site contamination assessment and remediation, where necessary, are required to avoid or minimise any risks or hazards associated with the sites prior to any construction works taken place. In regard to this, two potential zones, namely SI-1 and SI-2, are confined for conducting site contamination investigation, as shown in Appendix I.

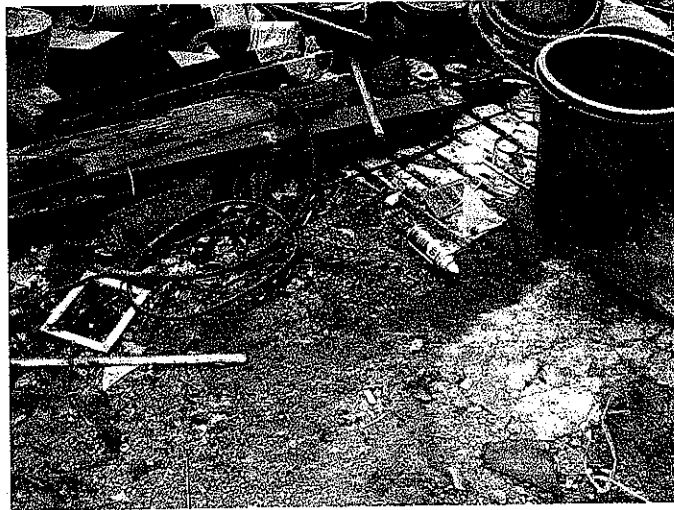
Workshop A

- 5.2 This motor repair workshop has been operated for more than 10 years as revealed by the site personnel and historical aerial photographs. It located at the area adjacent to the riverbank of Pak Kong River. As observed during the site visits, activities of general maintenance for truck had been carried out in the site. Physical evidence of contamination was identified as oil stains were noted on the paved ground. This might be caused by the local spillage of engine oils/lubricating oils during repairing or direct leakage from the parking vehicles. Equipment for motor maintenance was observed inside the working hut of the workshop. This workshop has been registered as a Chemical Waste Producer with EPD. As told by the site personnel, the chemical waste would be stored in a 220 litre lid drum inside a chemical waste storing room with size of approximately 1.5m x 1.5m in the past. Now, no chemical waste is produced since the trade nature had changed since June 2007. Based on the nature of the industry and the general site observation, further investigation for contaminated land is recommended for this workshop.

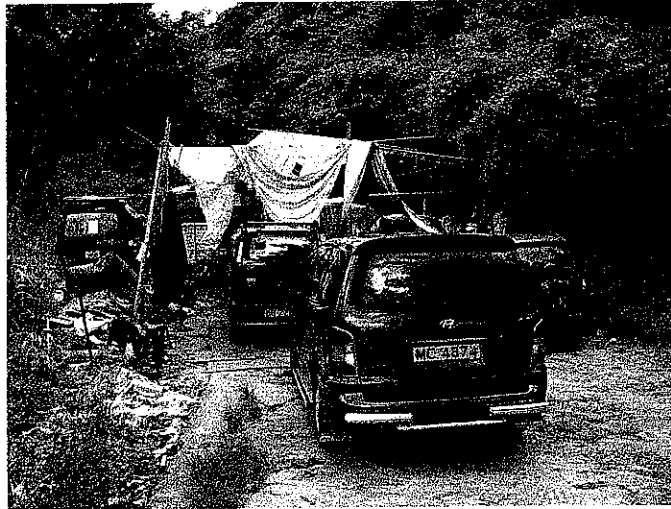
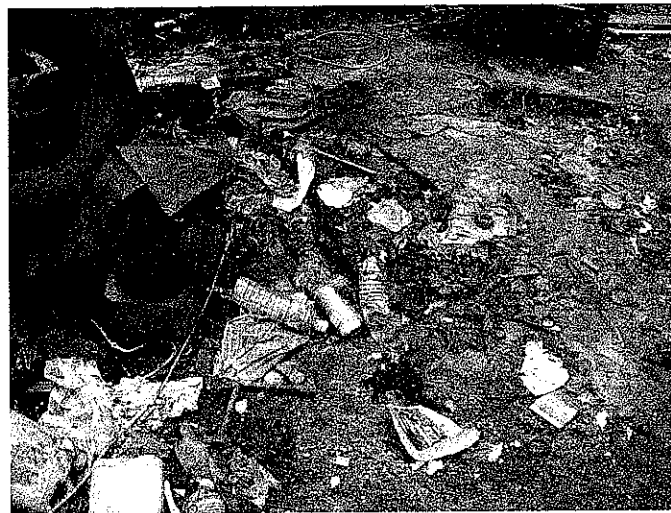
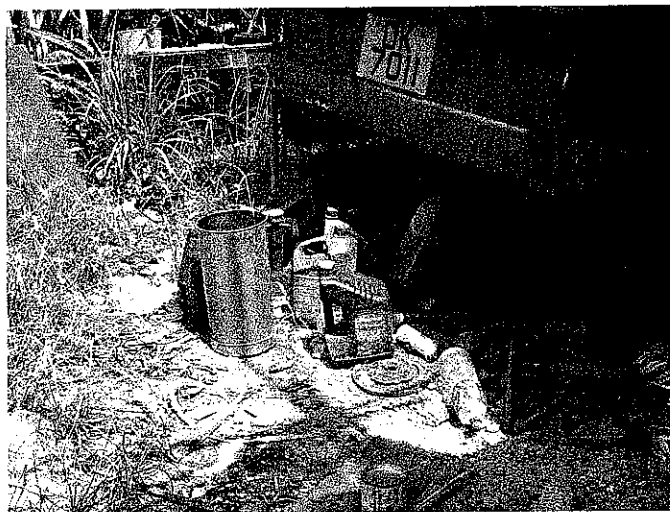
Workshop B

- 5.3 As shown in the review of historical aerial photographs, this car repair workshop being relatively smaller in scale than the Wah Shing Motor Repairing Factory has been operated for about 14 years. It located just next to the Pak Kong River with land location number of Lot DD 217 989 6A. The business nature of this workshop is engine repairing for private cars and mini-vans. During the site inspection, oil stains were observed at a few locations and the ground was not well paved. Interview had been carried out with the site personnel and they expressed that chemical waste generated from this site would be usually transferred to the chemical waste storage drum of Wah Shing Motor Car Repair Factory. Due to the nature of business and its long history of operation, further investigation for contaminated land is also recommended for this workshop.

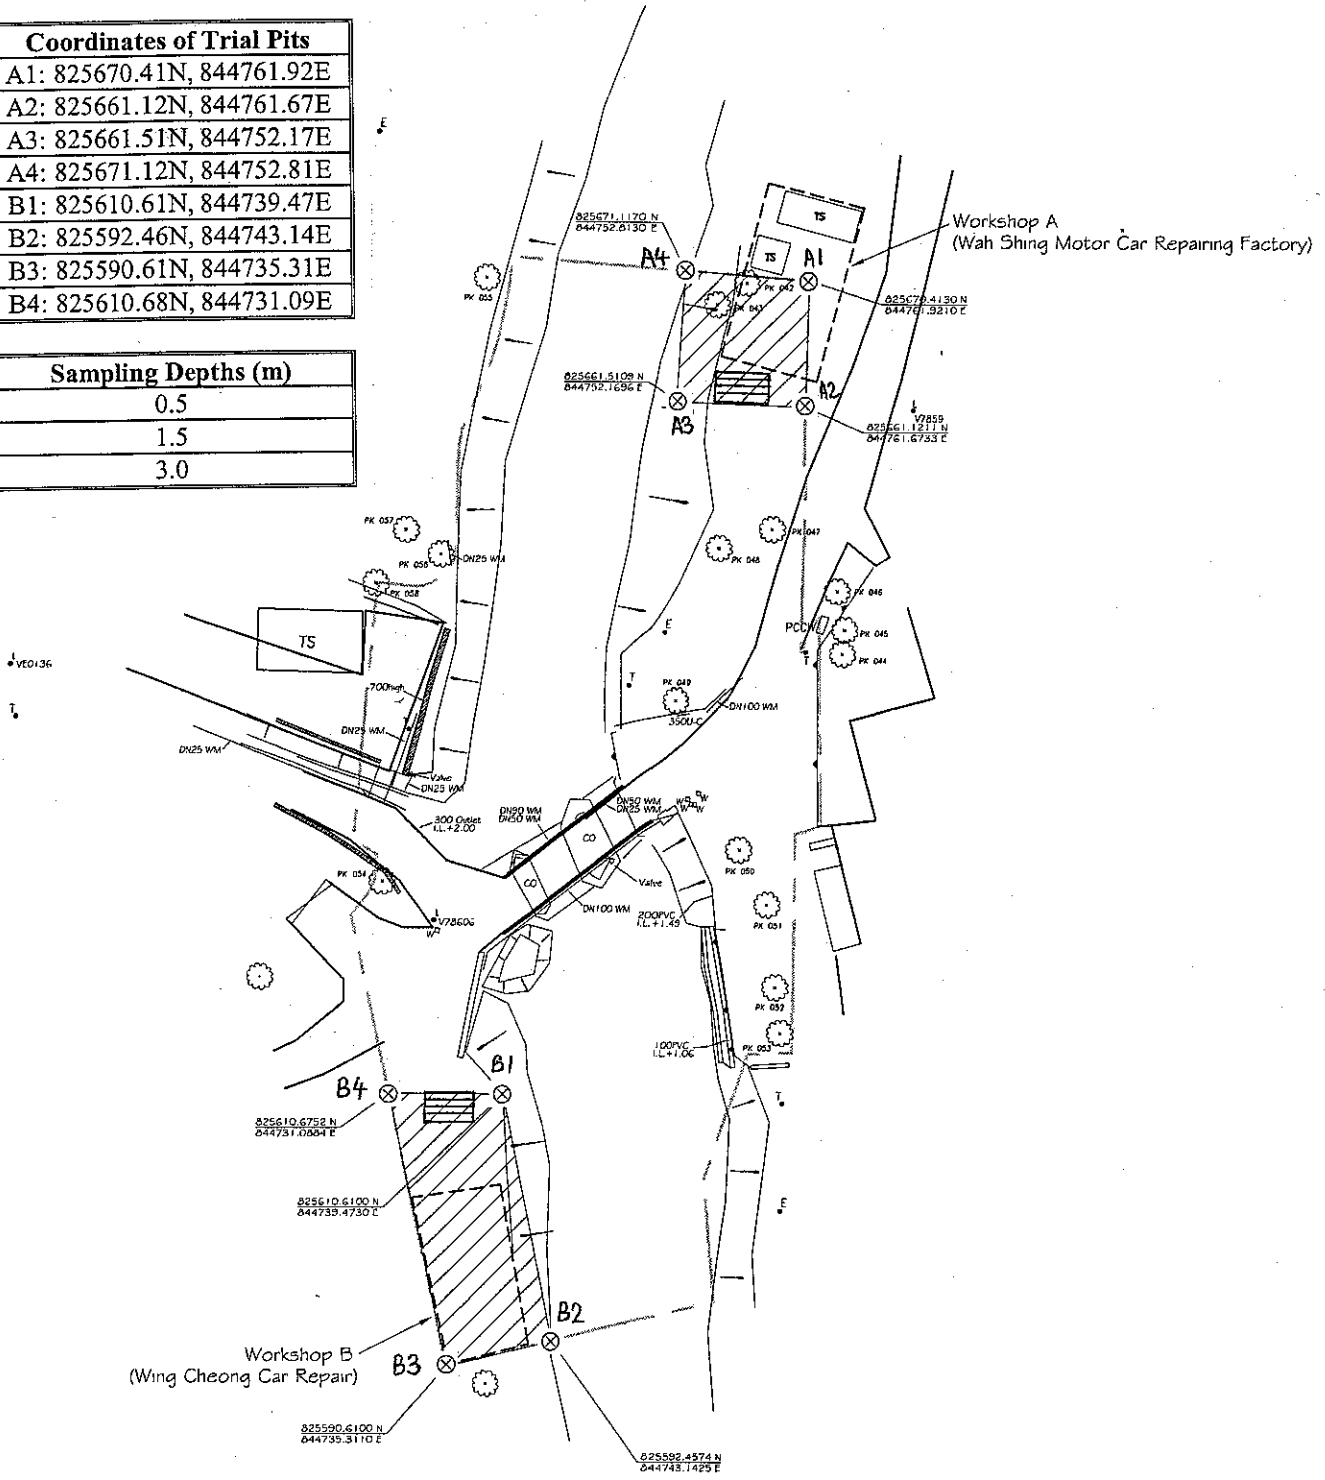
Proposed Locations of Trial Pits (A1 to A4 and B1 to B4)

Coordinates of Trial Pits	
A1:	825670.41N, 844761.92E
A2:	825661.12N, 844761.67E
A3:	825661.51N, 844752.17E
A4:	825671.12N, 844752.81E
B1:	825610.61N, 844739.47E
B2:	825592.46N, 844743.14E
B3:	825590.61N, 844735.31E
B4:	825610.68N, 844731.09E

Sampling Depths (m)	
0.5	
1.5	
3.0
