1st Post-transplantation Monitoring and Audit Report (24th November 2022)

Northeast New Territories Landfill Extension (NENTX) | Contract No. EP/SP/77/15

0092/22/ED/0281 02 | 31 January 2023

Formal Submission

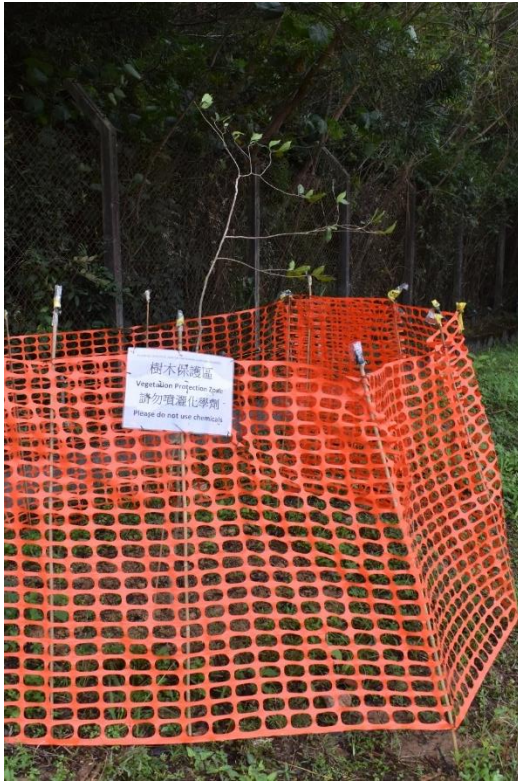
Photo B.1.1 : General view of the transplanted individual AS-03.

- The watering frequency for the two saplings of Incense Tree should be increased to 3-4 times a week.

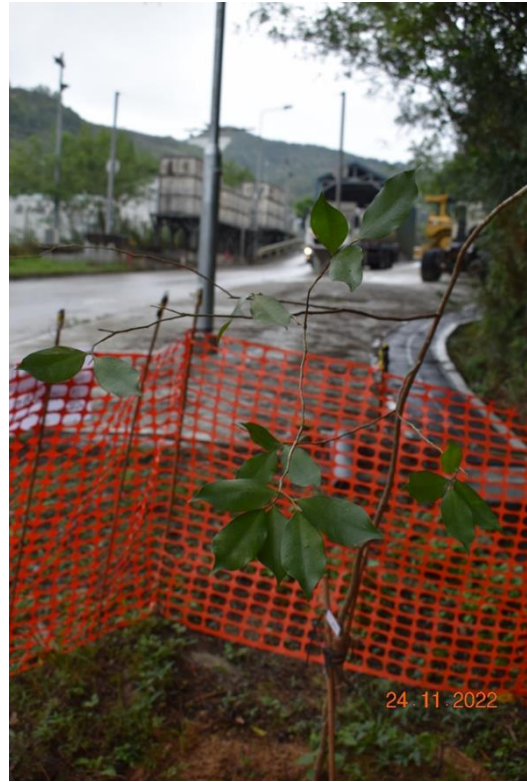
Photo B.2.2.: Leaf condition of the transplanted individual AS-03

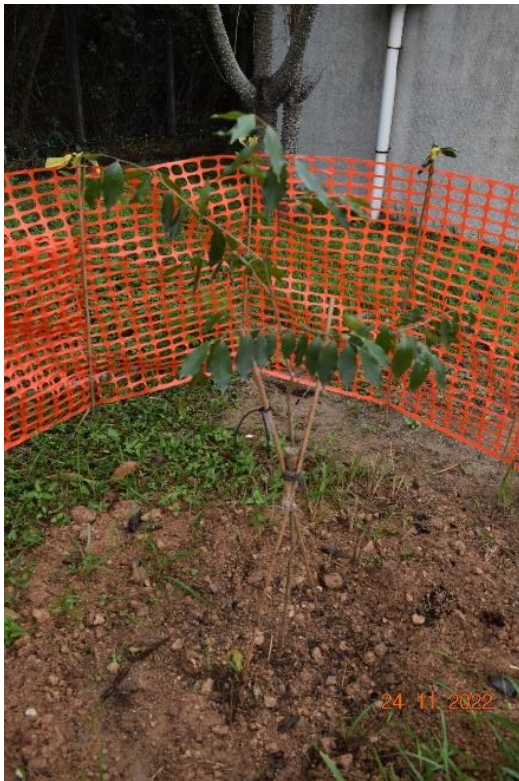
Photo B.3.2.: General view of the transplanted individual AS-02.

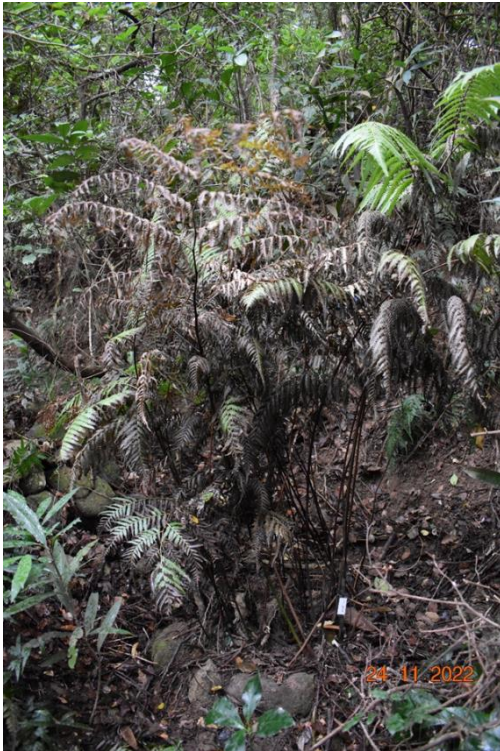
2.1.1 The transplanted individuals, i.e., two nos. of saplings of the Incense Tree *Aquilaria sinensis*, one cluster of Lamb of Tartary *Cibotium barometz*, and about 19 clusters of Bottlebrush Orchid *Goodyera procera* were generally in fair to good condition. The Lamb of Tartary, however, exhibited discoloration and wilting of leaves. Albeit strict compliance of the transplantation works and post-transplantation maintenance to the approved Transplantation Proposal, transplanted individuals would require time to adapt and establish in the new environment/substrate of the receptor site. Hence, signs of leaf discoloration and/or wilting, dehydration, and even die-off are expected. Thus, succeeding post-transplantation maintenance and monitoring and audit are crucial to assess the progress of recovery and establishment of transplanted individuals in the receptor site.

Photo B.2.1: General view of the transplanted individual CB-01

- The watering frequency of the cluster of Lamb of Tartary should be reduced to once a week.
- The watering frequency for all 19 clusters of Bottlebrush Orchid should remain the same. During watering activities, the surrounding weeds and decaying leaves should be removed.

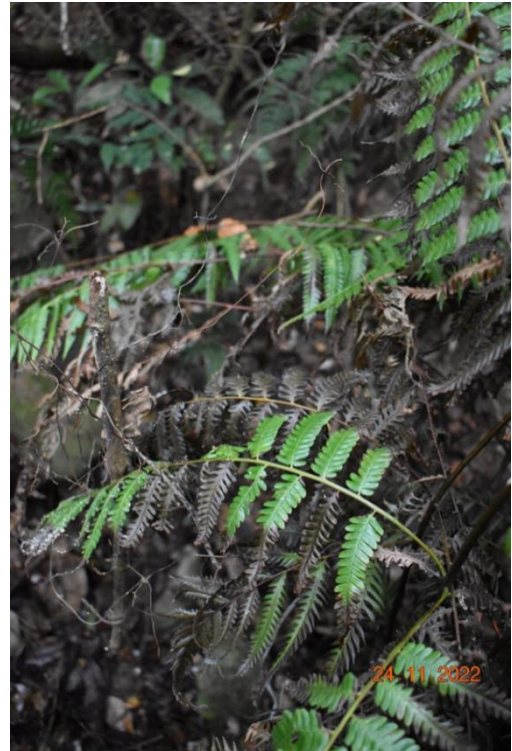
Photo B.2.2: Figure 2.2: Wilted leaves of the transplanted individual CB-01.

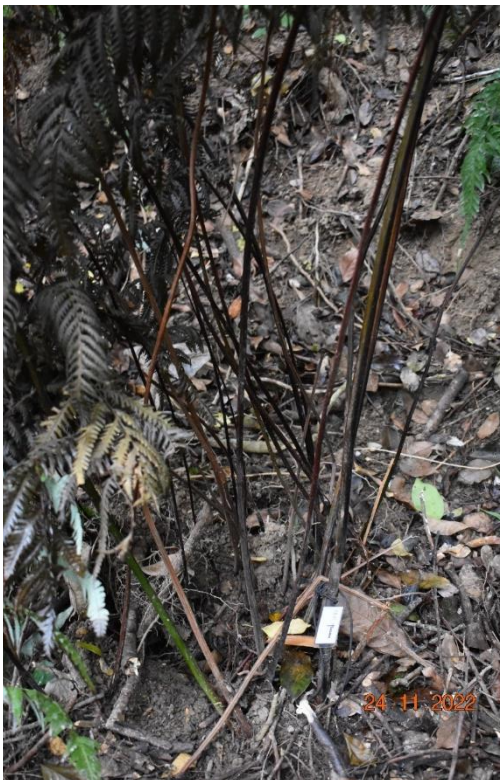
Photo B.2.3: Stem conditions of the transplanted individual CB-01.

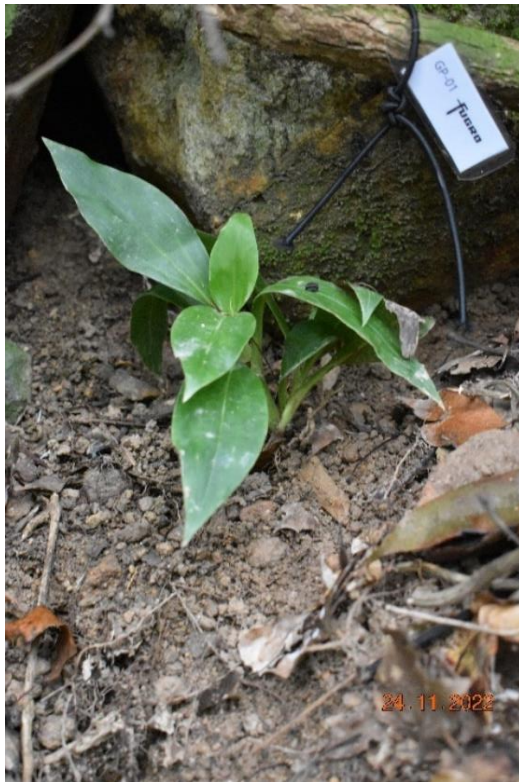
Photo B.3.1: Individual GP-01. Partially wilted leaf.

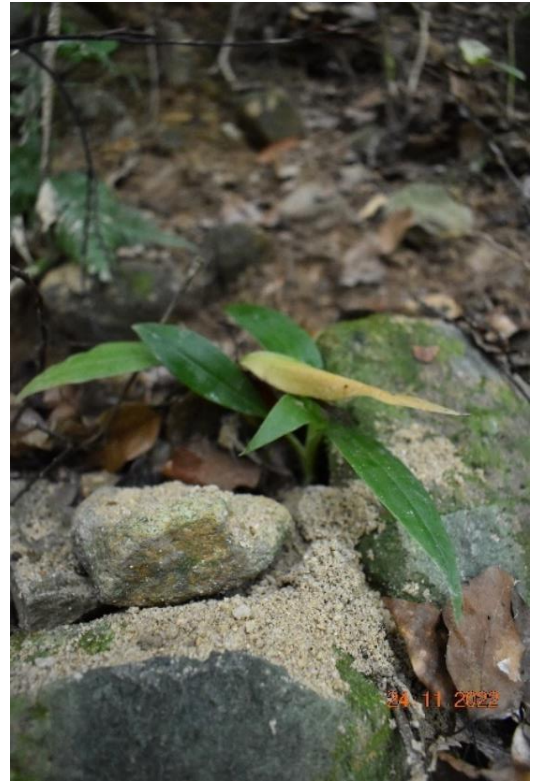
Photo B.3.2: Individual GP-02. Chlorotic leaf.

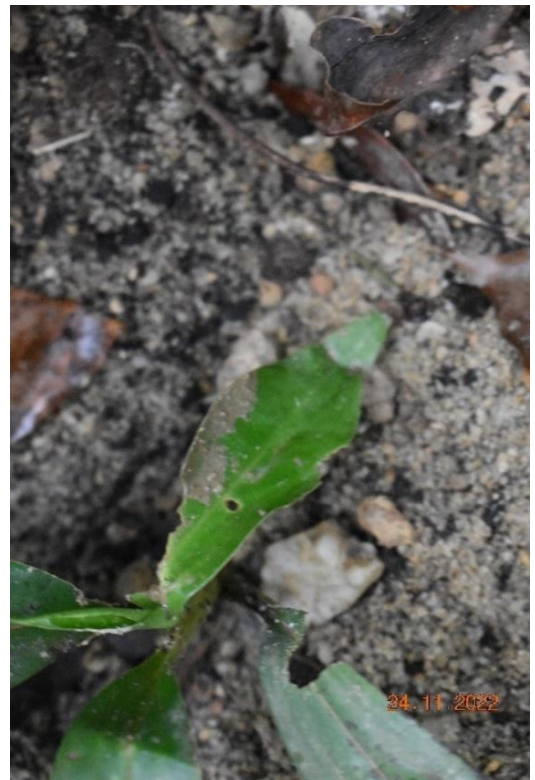
Photo B.3.4: Individual GP-03. Hole in leaf.

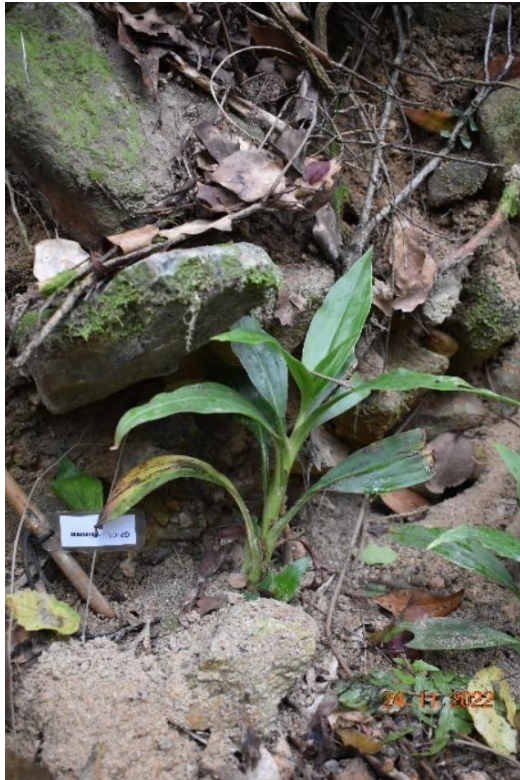
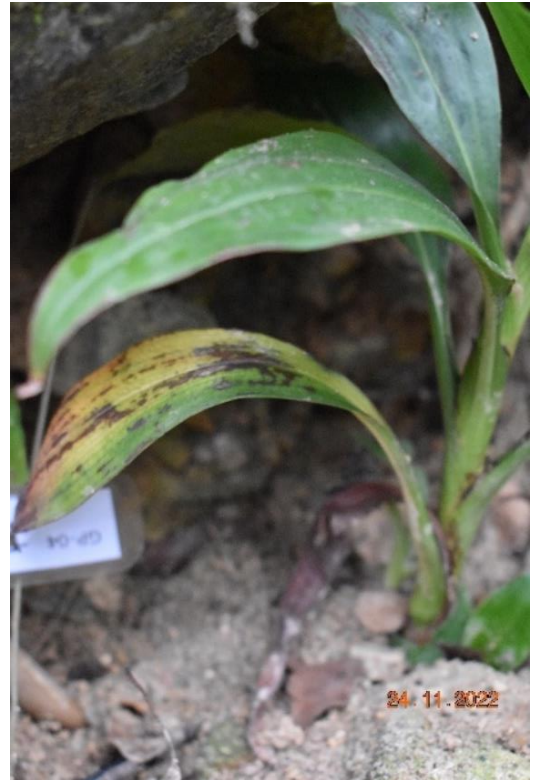
Photo B.3.5: Individual GP-04. Chlorotic leaf.

Photo B.3.6: Individual GP-04. Chlorotic leaf.

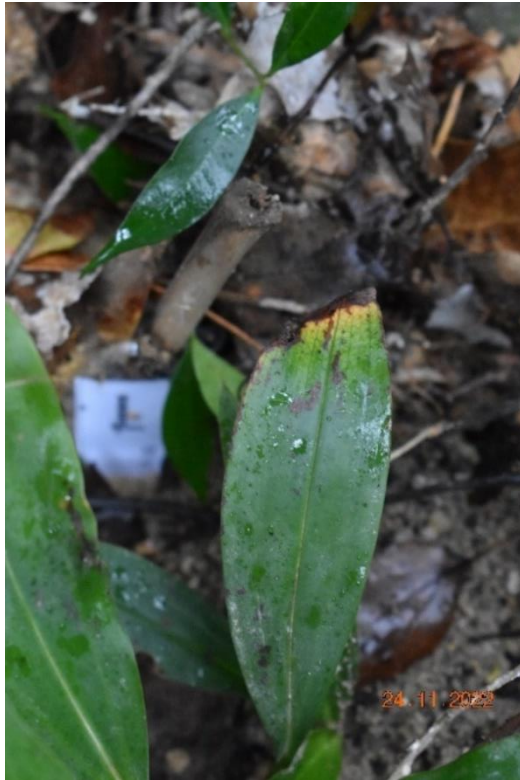
Photo B.3.9: Individual GP-06. Partially wilted leaf.

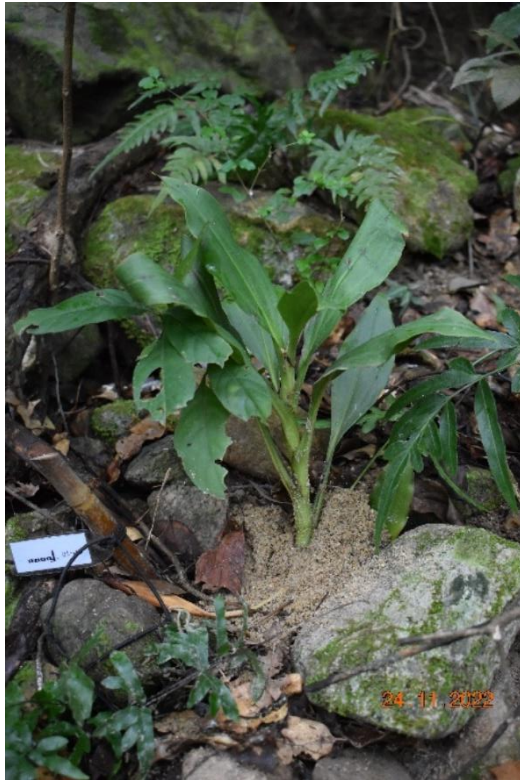
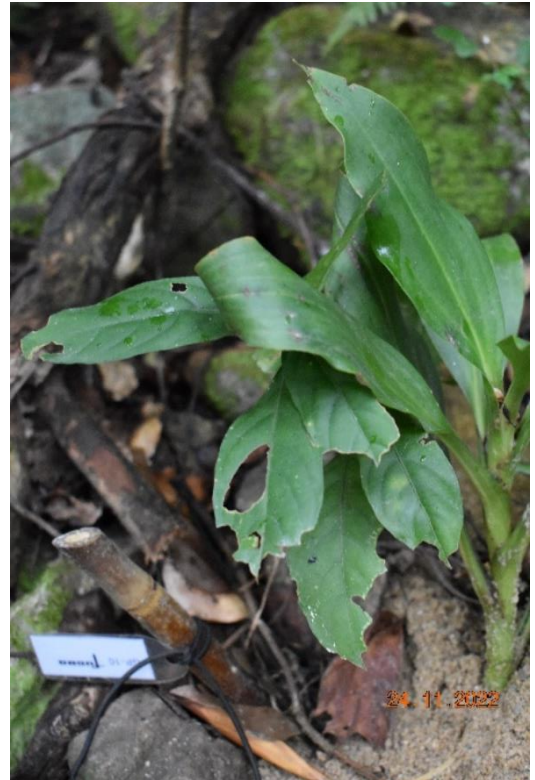
Photo B.3.13: Individual GP-10. Holes in leaves.

Photo B.3.14: Individual GP-10. Holes in leaves.

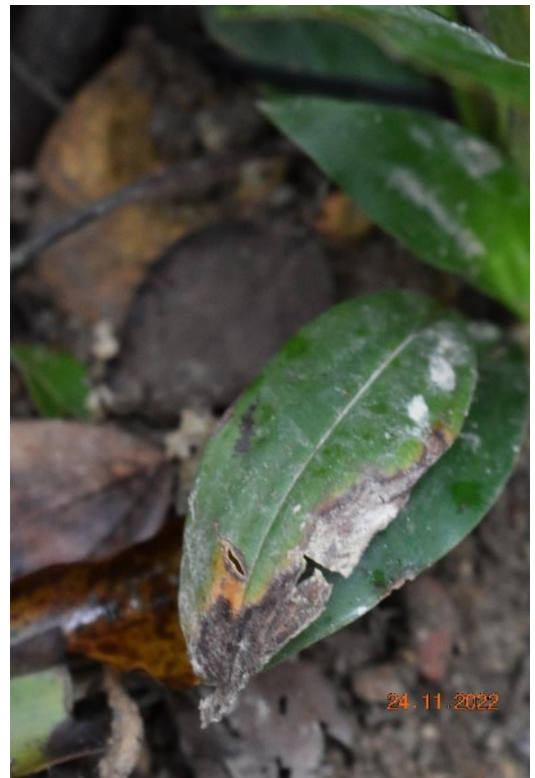
Photo B.3.16: Individual GP-11. Partially wilted leaves.

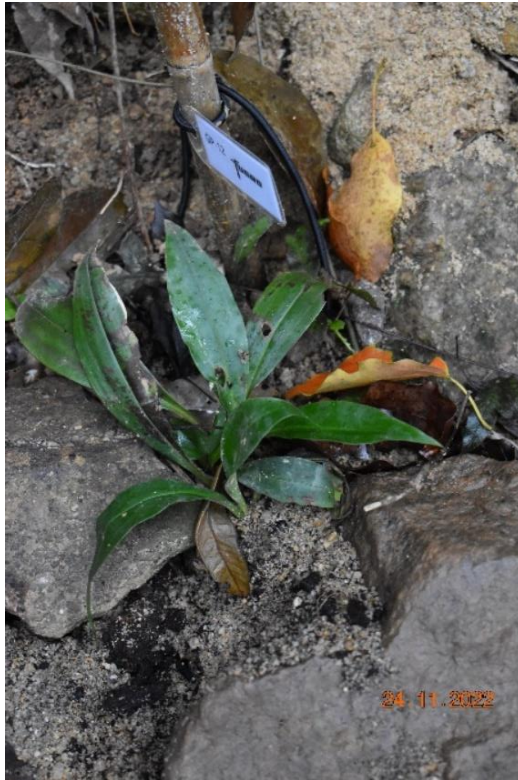
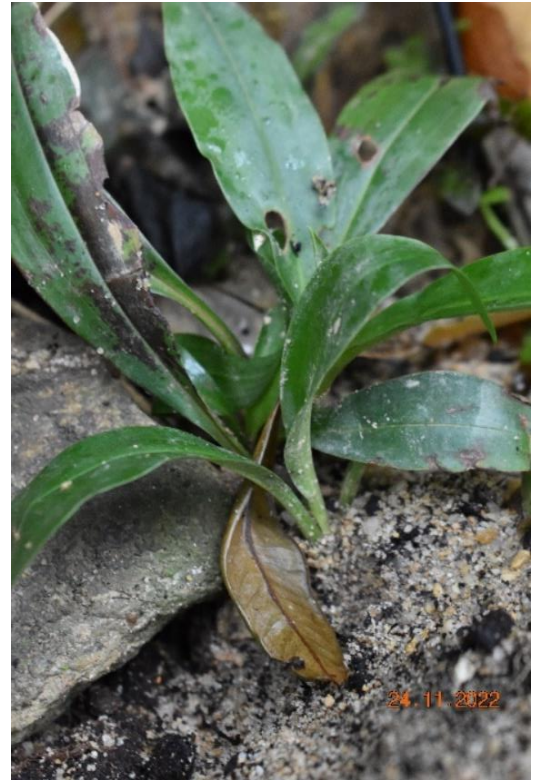
Photo B.3.17: Individual GP-12. Hole in leaf.

Photo B.3.18: Individual GP-12. Hole in leaf.

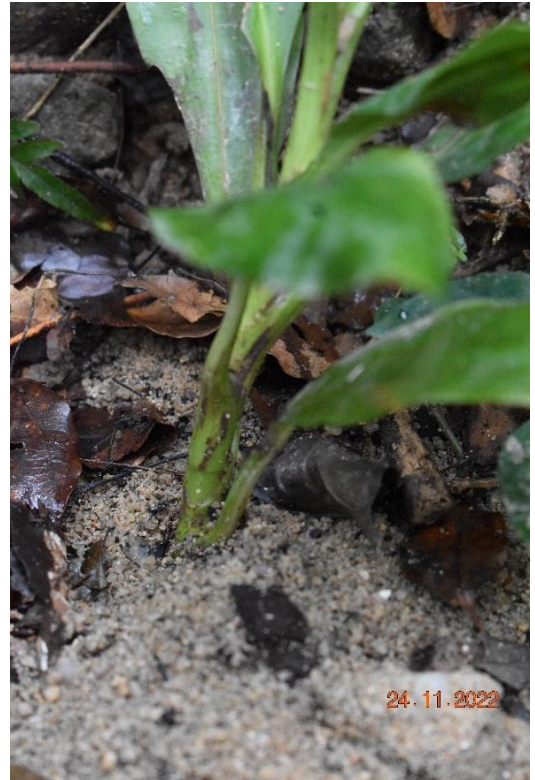
Photo B.3.26: Individual GP-19. Partially wilted leaves.
