## 2nd Post-transplantation Monitoring and Audit Report (9th December 2022)

Northeast New Territories Landfill Extension (NENTX) | Contract No. EP/SP/77/15

0092/22/ED/0296 02 | 3 February 2023

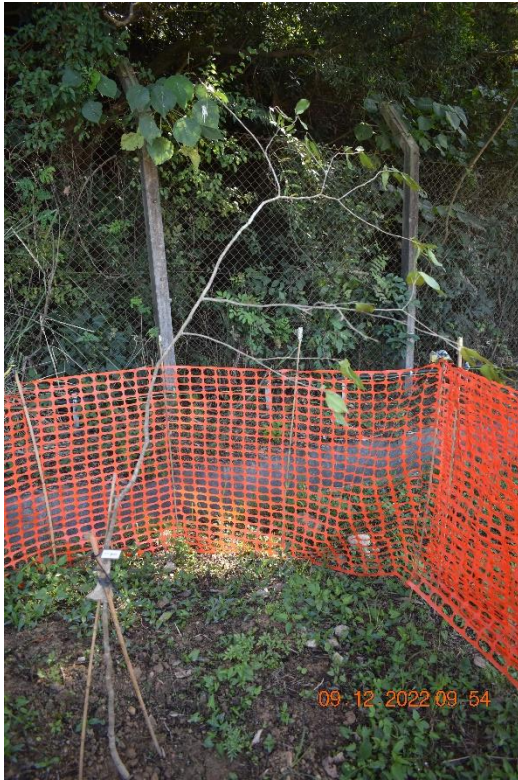
Photo B.1.1 : General view of the transplanted individual AS-03.

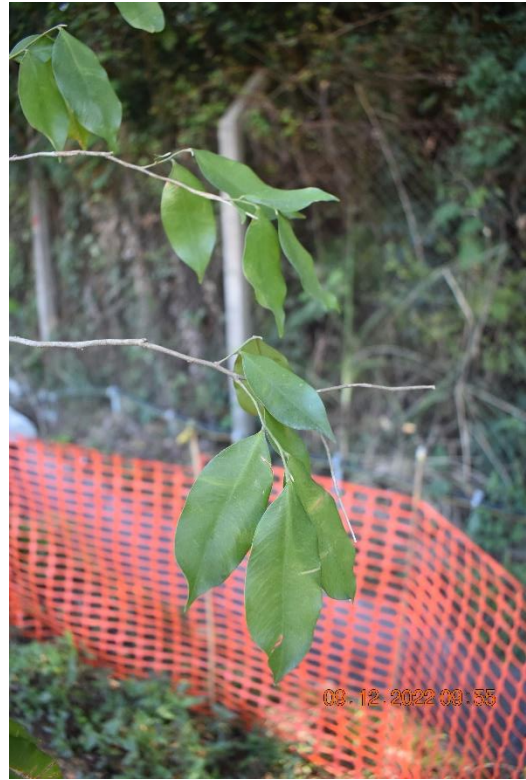
Photo B.1.2 : Leaf condition of the transplanted individual AS-03.

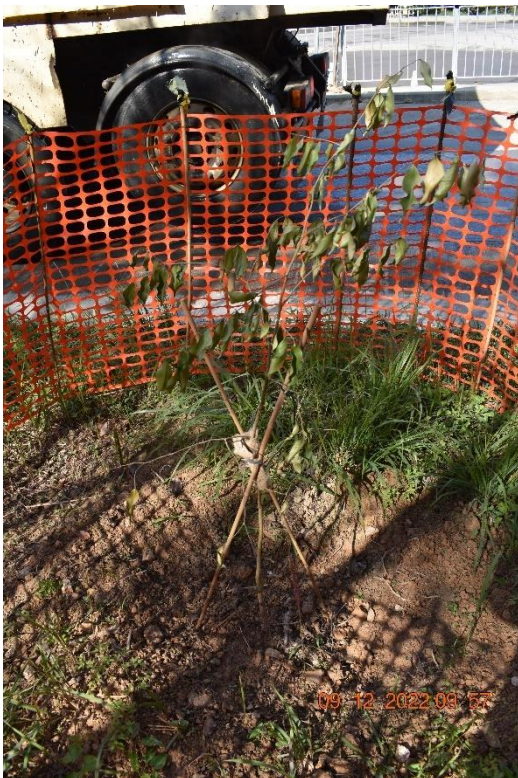
2.1.1 The transplanted individuals of the 19 clusters of Bottlebrush Orchid *Goodyera procera* were all in fair to good condition with minor health issues observed in some individuals, i.e., slightly chlorotic leaves and presences of holes in the leaves. The Lamb of Tartary *Cibotium barometz*, however, exhibited further discoloration and wilting of leaves following the last monitoring period. Its stems also showed some decay but its roots were still in fair condition. Moreover, one of the two saplings of the Incense Tree *Aquilaria sinensis* (AS-03) demonstrated fair health condition while the other individual (AS-02) showed poor health conditions with die back and drying and falling leaves.

Photo B.2.3 : General view of the transplanted individual AS-02.

- The watering frequency for the two saplings of Incense Tree should be maintained at 2-3 times a week. Improve/place organic mulch around the two saplings of Incense Tree to retain soil moisture, protect damaged roots against extreme temperatures, and improve soil quality.
- The watering frequency of the cluster of Lamb of Tartary should be reduced to once a week.
- The watering frequency for all 19 clusters of Bottlebrush Orchid should remain the same. During watering activities, the surrounding weeds and decaying leaves should be removed.

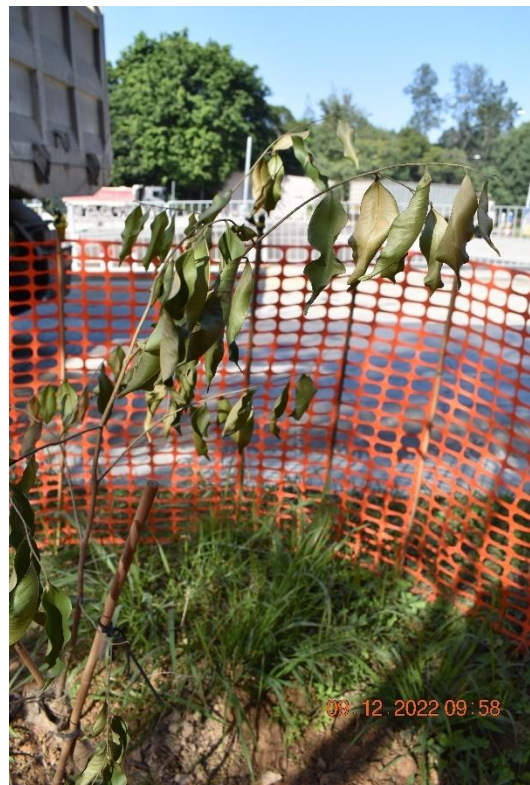
Photo B.1.4 : Leaf condition of the transplanted individual AS-02.

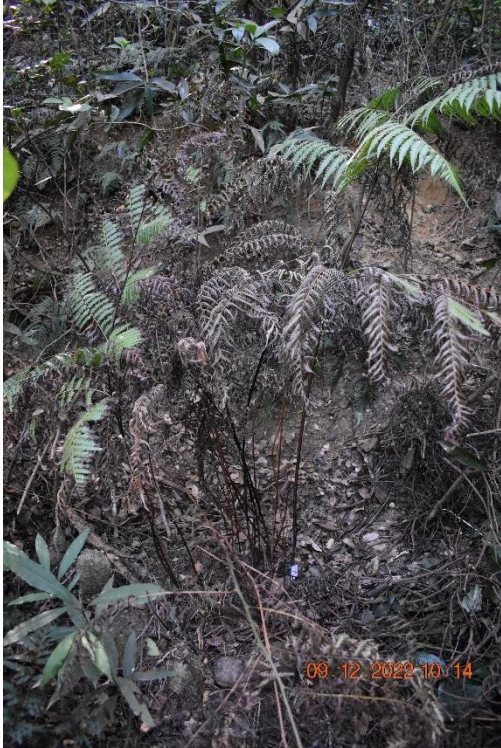
Photo B.2.1: General view of the transplanted individual CB-01.

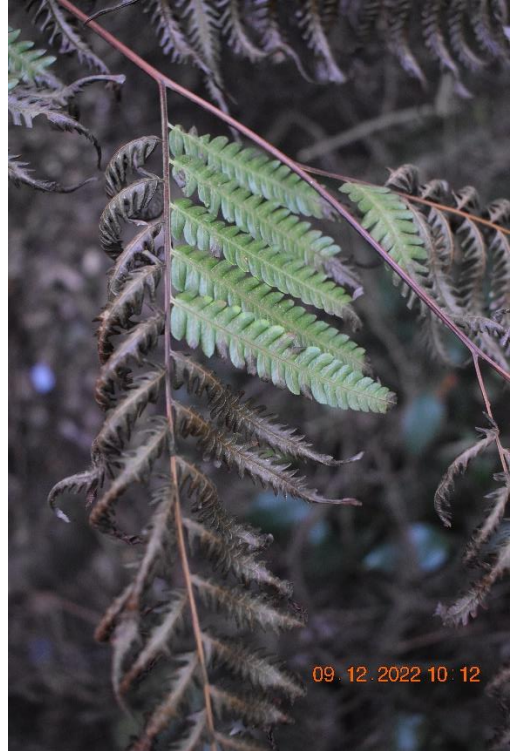
Photo B.2.2: Figure 2.2: Wilted leaves of the transplanted individual CB-01.

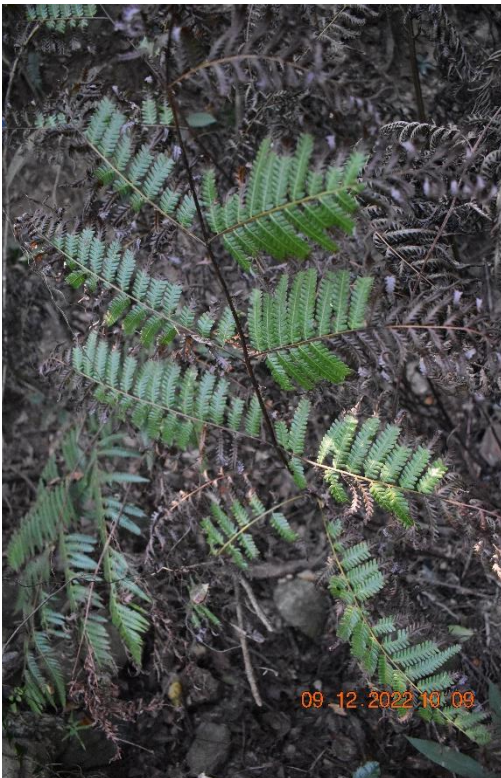
Photo B.2.3: Wilted leaves of the transplanted individual CB-01.

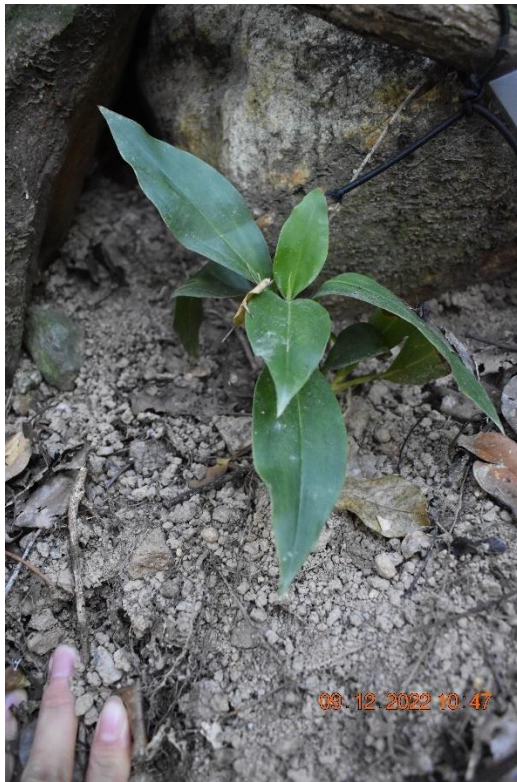
Photo B.3.1: Individual GP-01. Partially wilted leaf.

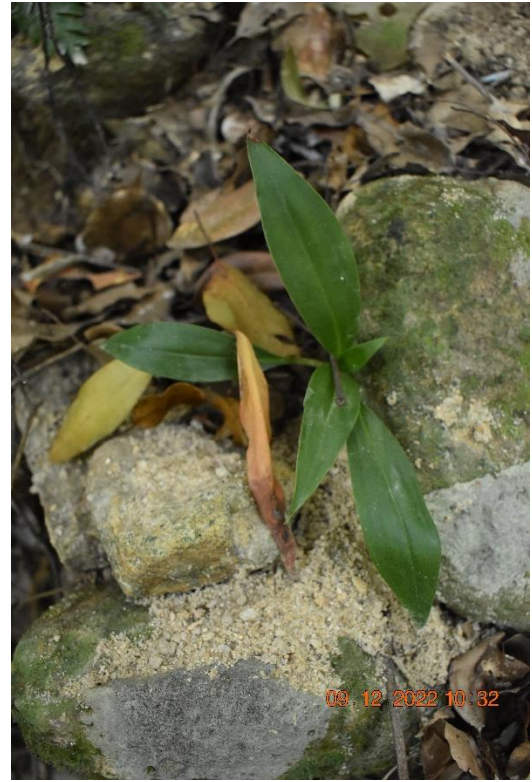
Photo B.3.2: Individual GP-02. Chlorotic leaf.

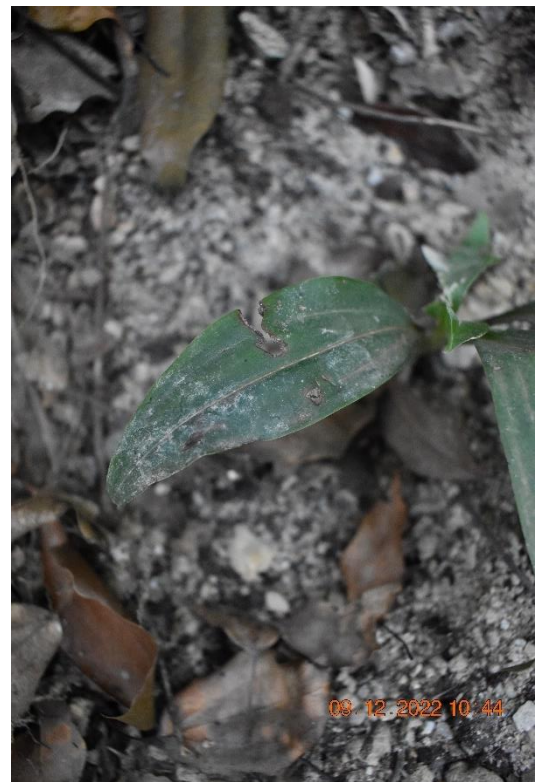
Photo B.3.4: Individual GP-03. Perforated leaves.

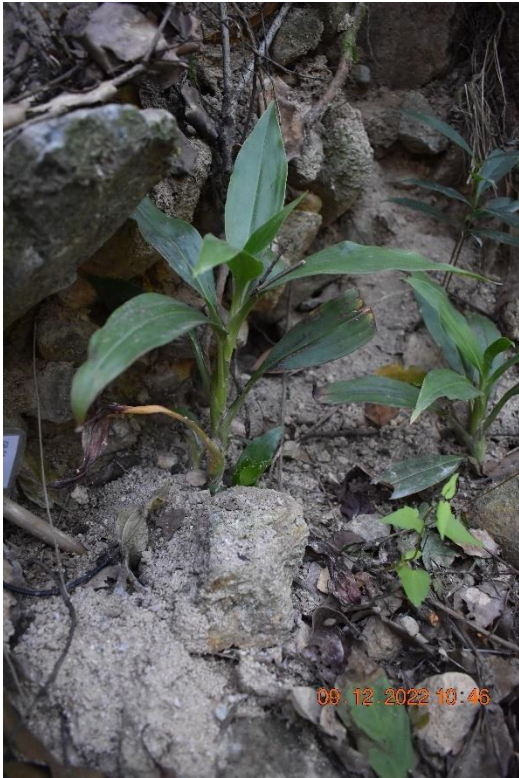
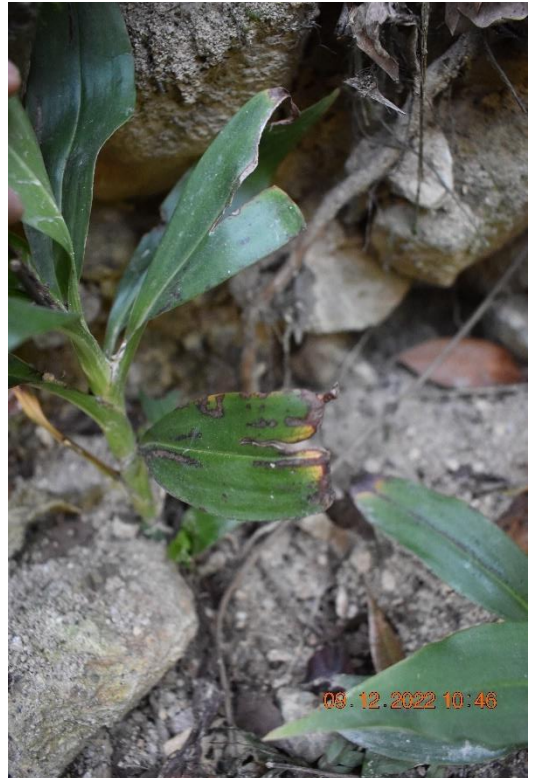
Photo B.3.5: Individual GP-04. Wilted leaf.

Photo B.3.6: Individual GP-04. Wilted leaf.

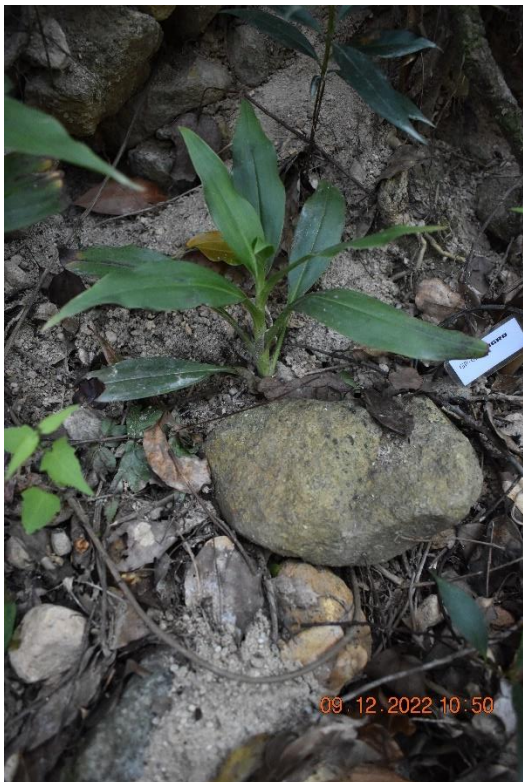
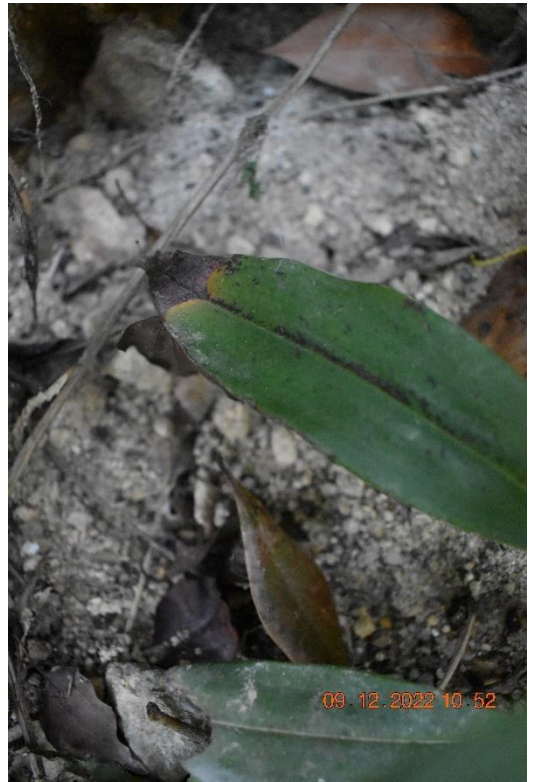
Photo B.3.7: Individual GP-05. Partially wilted leaf.

Photo B.3.8: Individual GP-05. Partially wilted leaf.

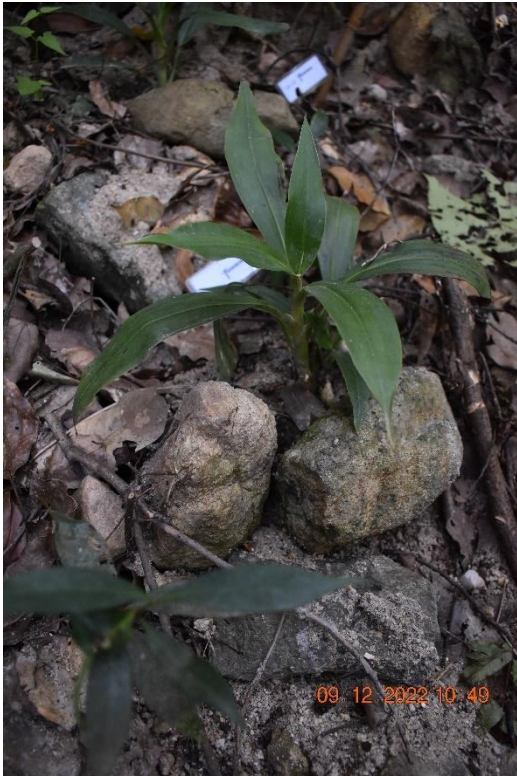
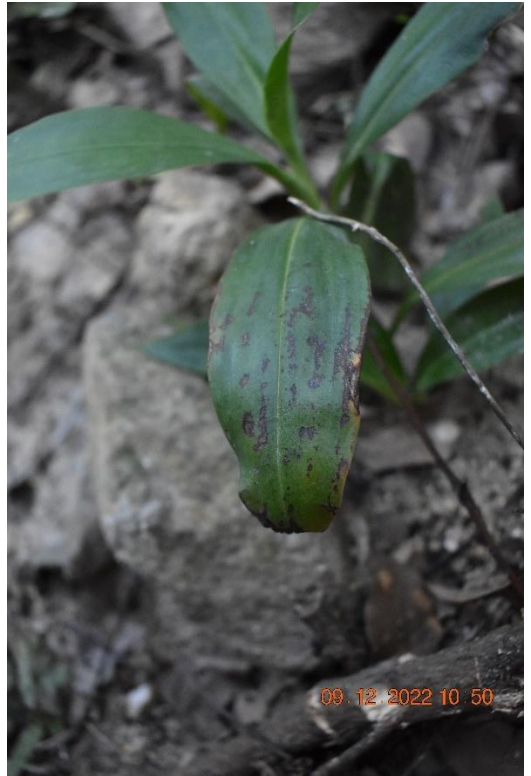
Photo B.3.9: Individual GP-06. Partially wilted leaf.

Photo B.3.10: Individual GP-06. Partially wilted leaf.

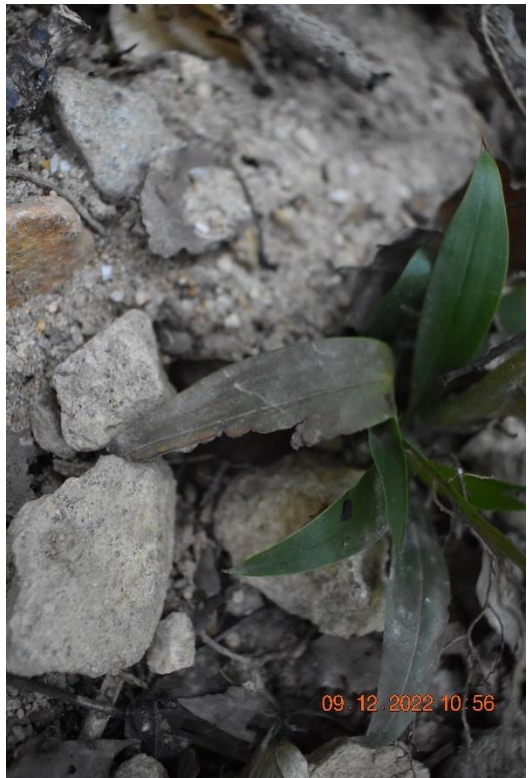
Photo B.3.12: Individual GP-07. Single chlorotic leaf.

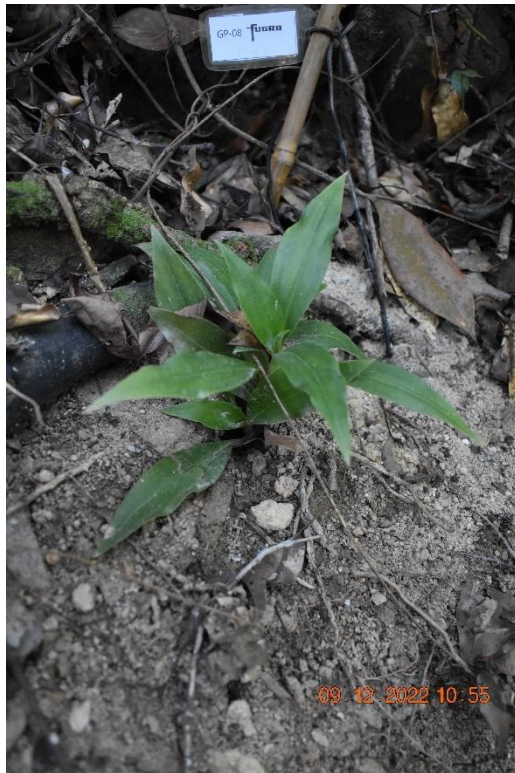
Photo B.3.13: Individual GP-08. Holes in leaves.

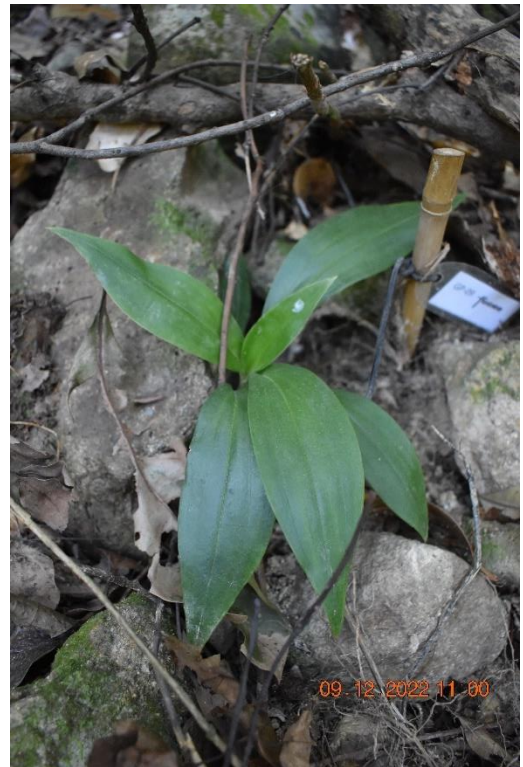
Photo B.3.14: Individual GP-09. Holes in leaves.

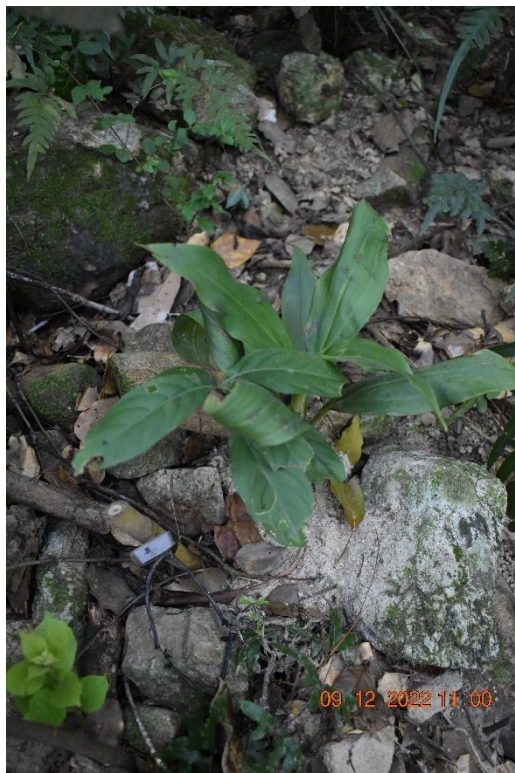
Photo B.3.15: Individual GP-10. Holes in leaves.

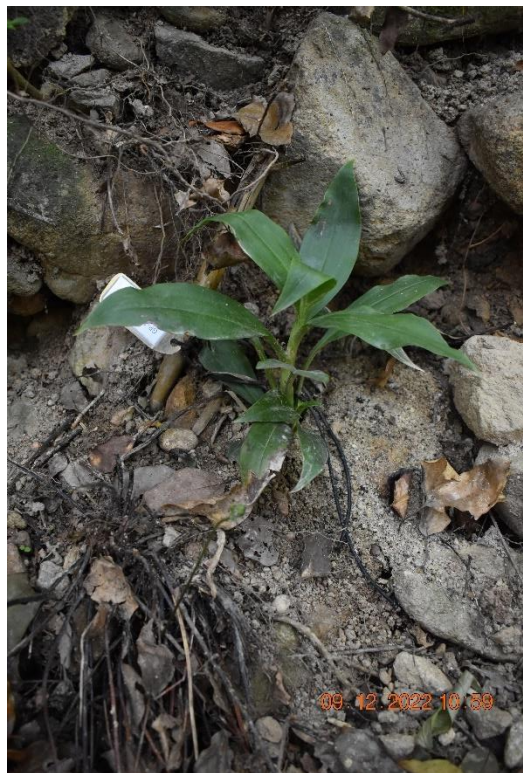
Photo B.3.16: Individual GP-11. Partially wilted leaves.

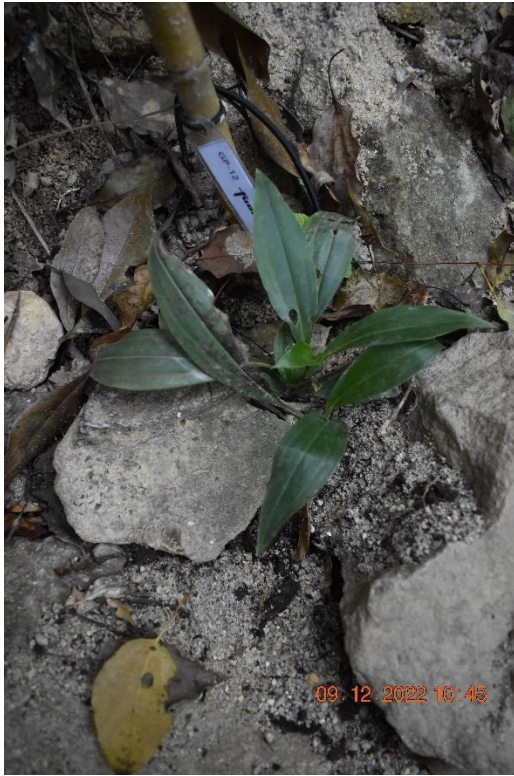
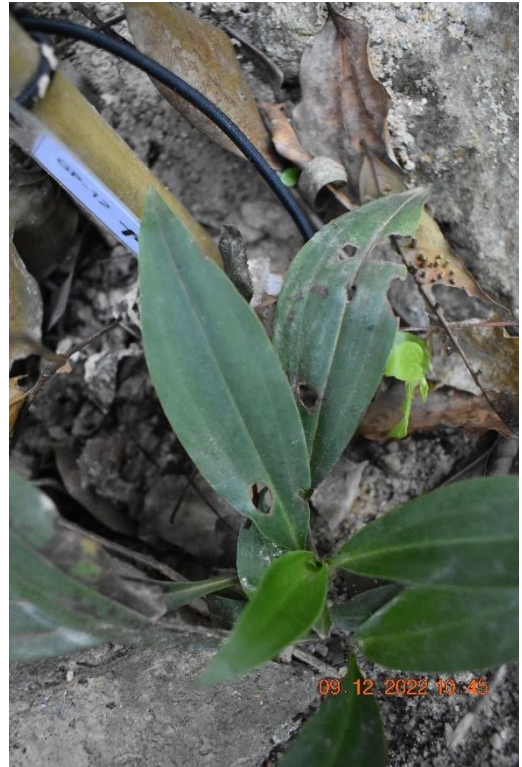
Photo B.3.17: Individual GP-12. Perforated leaves.

Photo B.3.18: Individual GP-12. Perforated leaves.

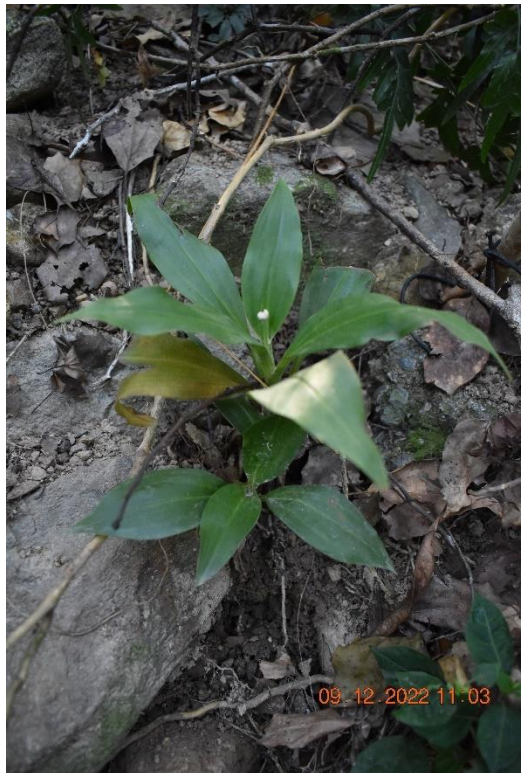
Photo B.3.20: Individual GP-14. Chlorotic leaves.

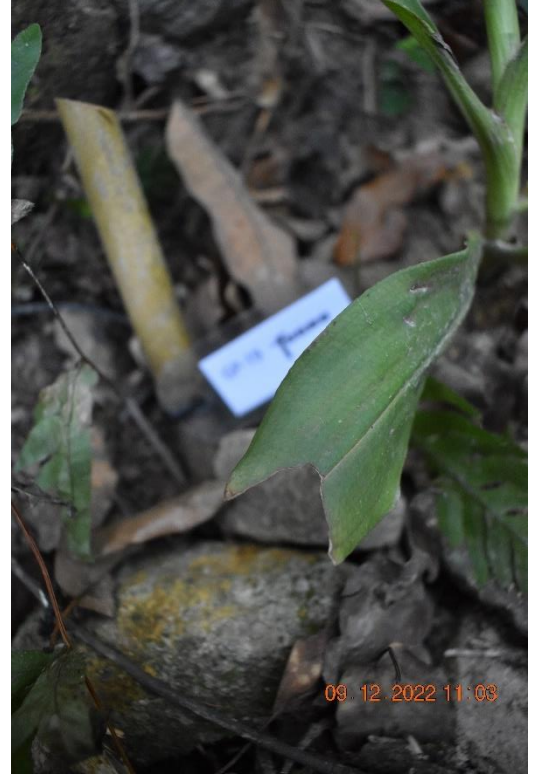
Photo B.3.26: Individual GP-19. Partially wilted leaves.
