## 3rd Post-transplantation Monitoring and Audit Report (21st December 2022)

Northeast New Territories Landfill Extension (NENTX) | Contract No. EP/SP/77/15

0092/22/ED/0302 02 | 3 February 2023

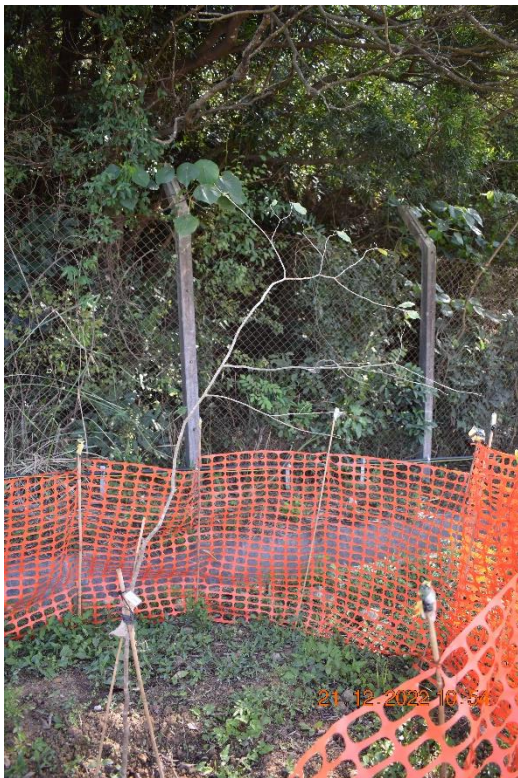
Photo B.1.1. : General view of the transplanted individual AS-03.

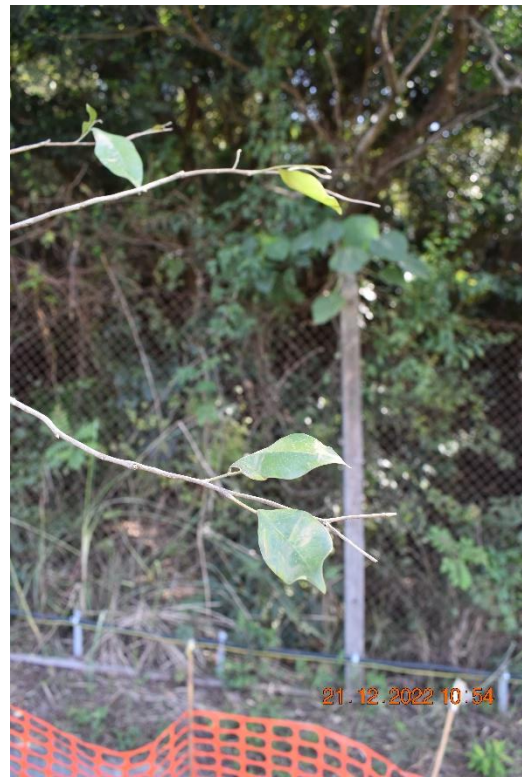
Photo B.1.2. : Leaf condition of the transplanted individual AS-03.

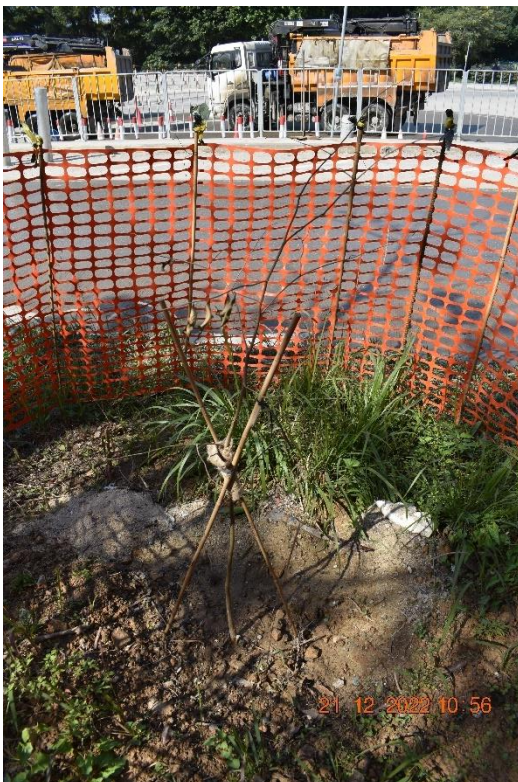
Photo B.1.3. : General view of the transplanted individual AS-02.

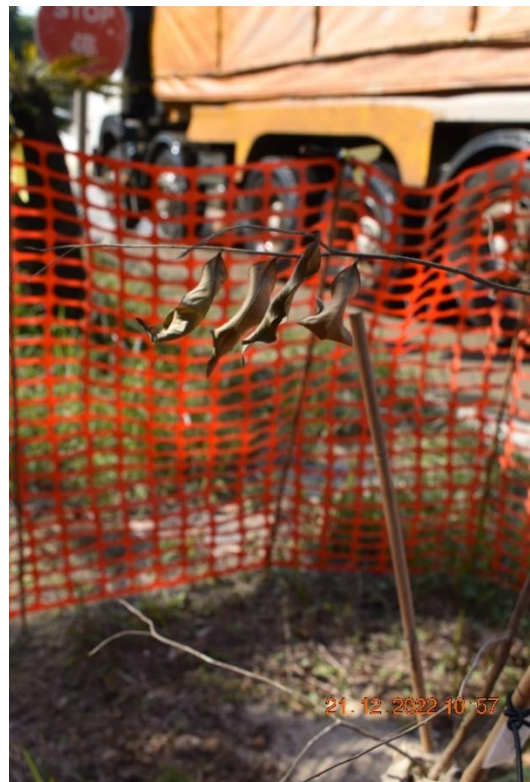
Photo B.1.4. : Leaf condition of the transplanted individual AS-02.

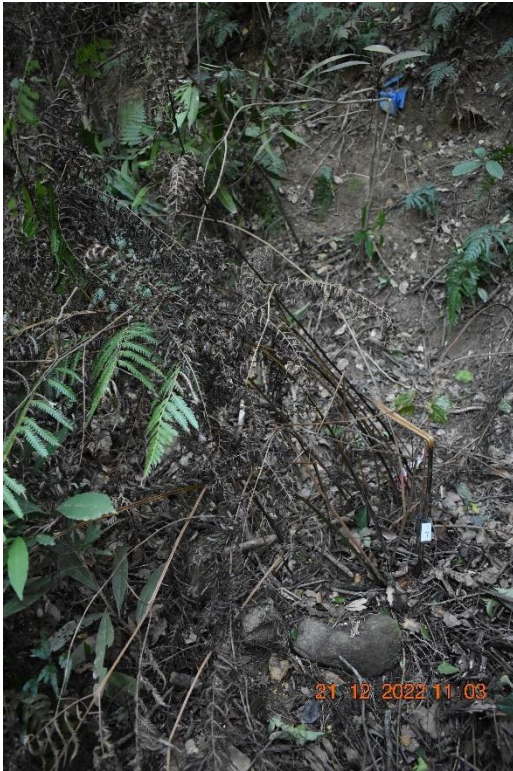
Photo B.2.1. : General view of the transplanted individual CB-01.

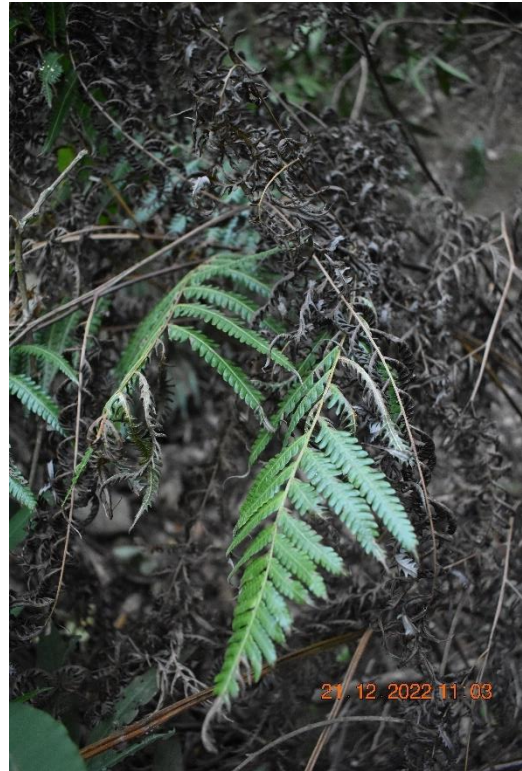
Photo B.2.2. : Leaf condition of the transplanted individual CB-01.

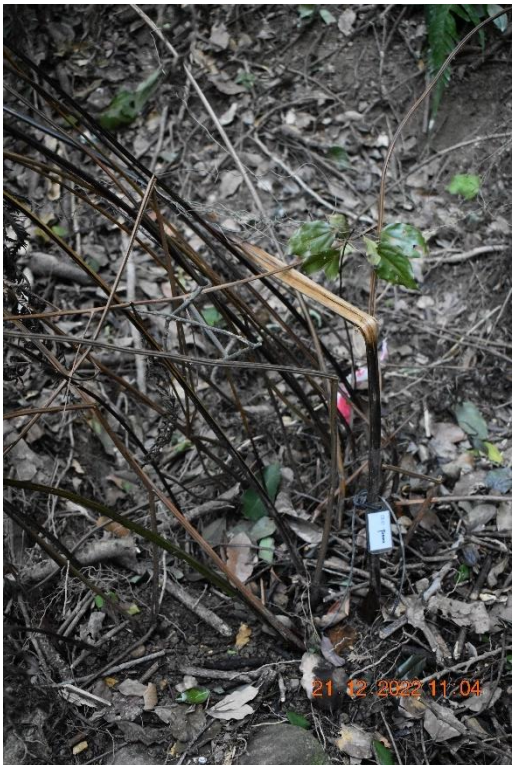
Photo B.2.3. : Stem condition of the transplanted individual CB-01.

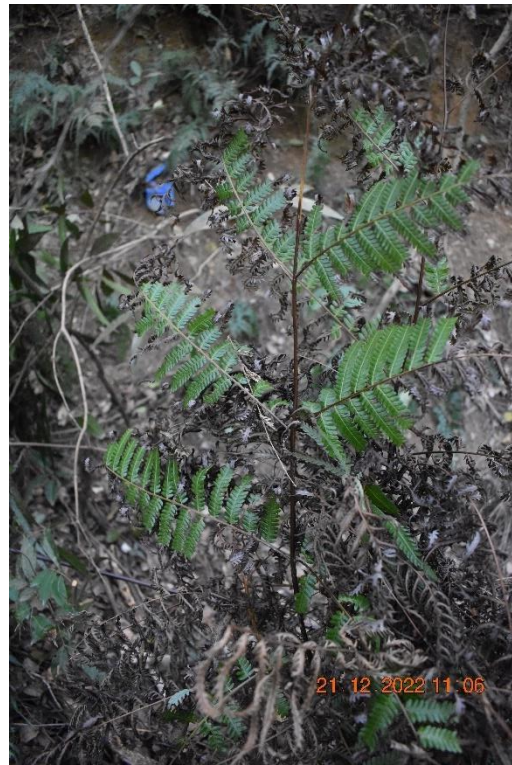
Photo B.2.4. : Leaf condition of the transplanted individual CB-01.

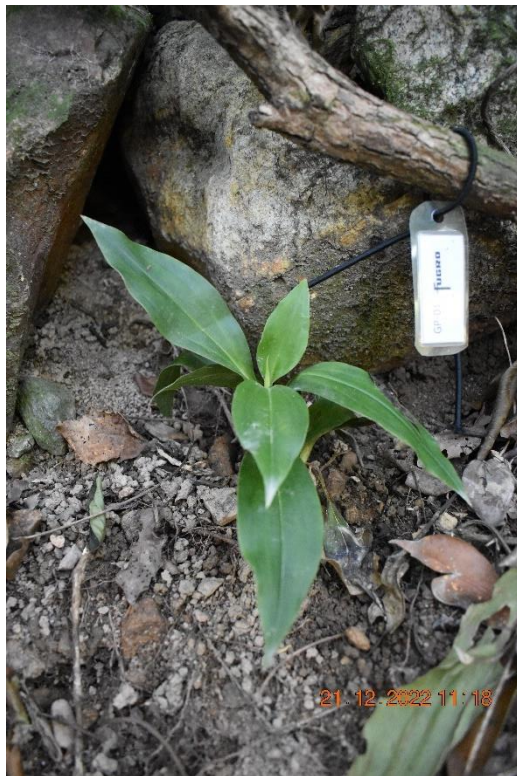
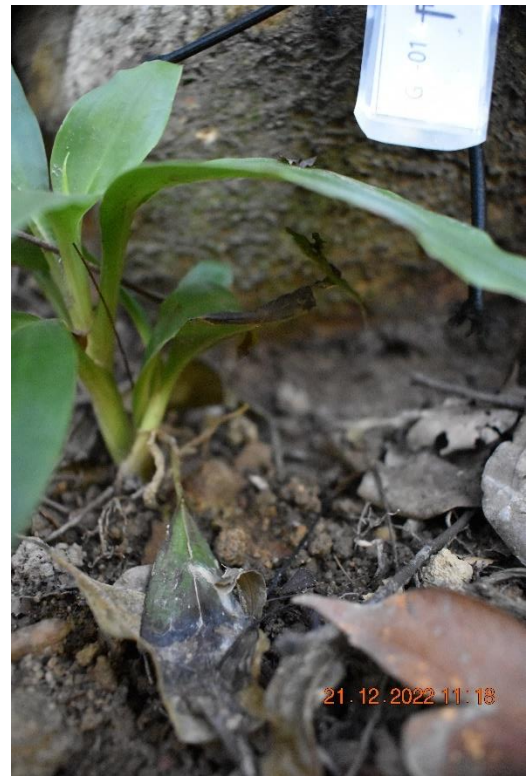
Photo B.3.1: Individual GP-01. Partially wilted leaf.

Photo B.3.2: Individual GP-01. Partially wilted leaf.

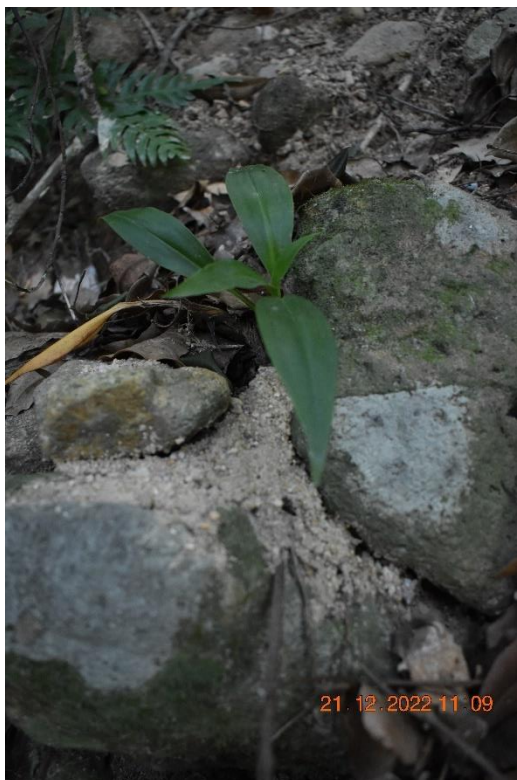
Photo B.3.3: Individual GP-02. Wilted leaf.

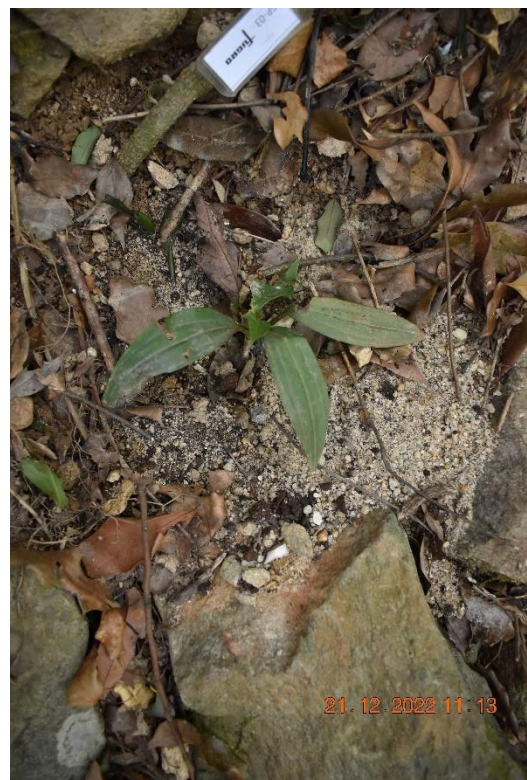
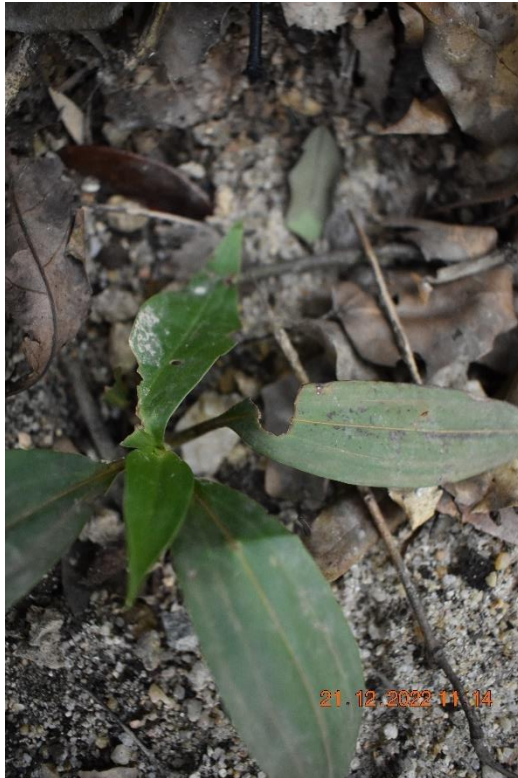
Photo B.3.4: Individual GP-03. Perforated leaves.

Photo B.3.5: Individual GP-03. Perforated leaves.

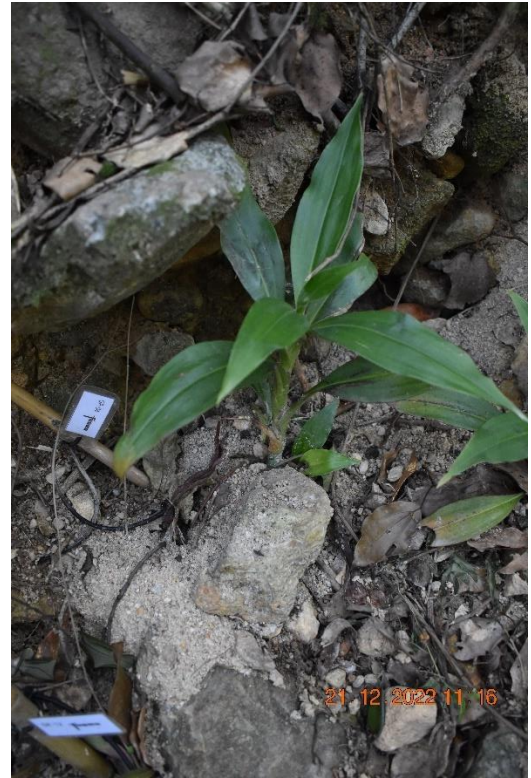
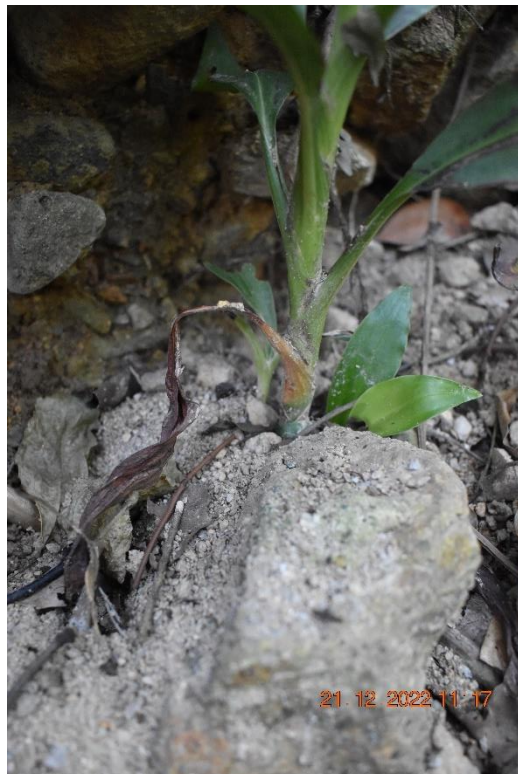
Photo B.3.6: Individual GP-04. Wilted leaf.

Photo B.3.7: Individual GP-04. Wilted leaf.

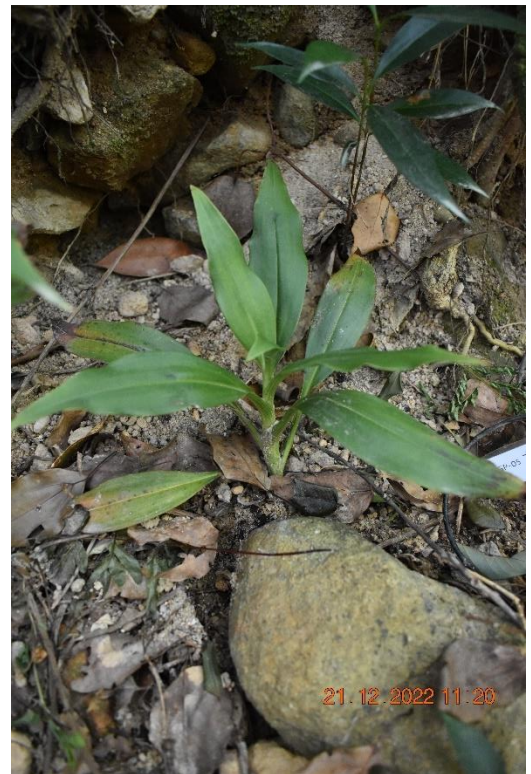
Photo B.3.8: Individual GP-05. Partially wilted leaf.

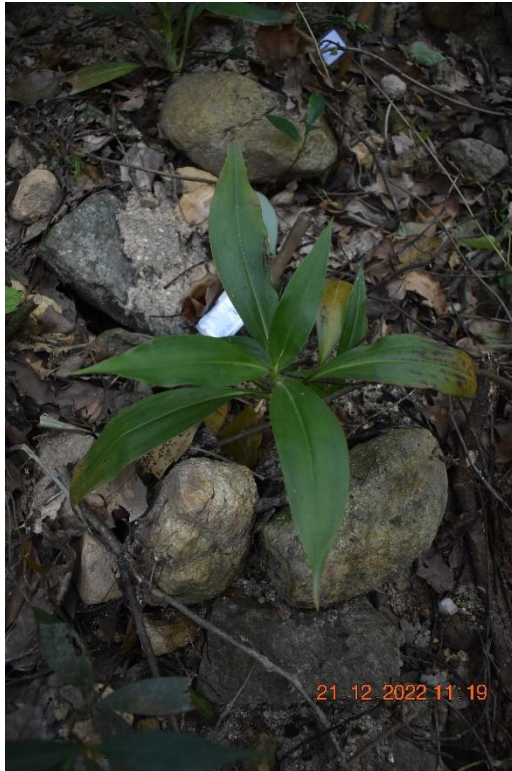
Photo B.3.9: Individual GP-06. Partially wilted leaf.

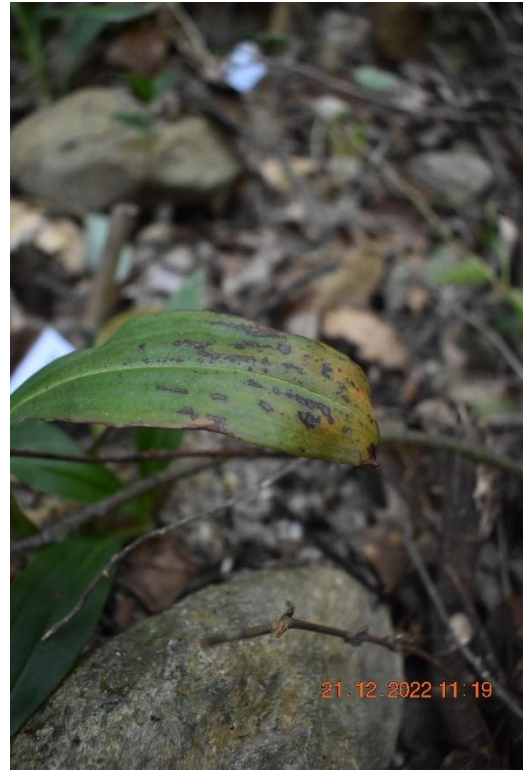
Photo B.3.10: Individual GP-06. Partially chlorotic and wilted leaf.

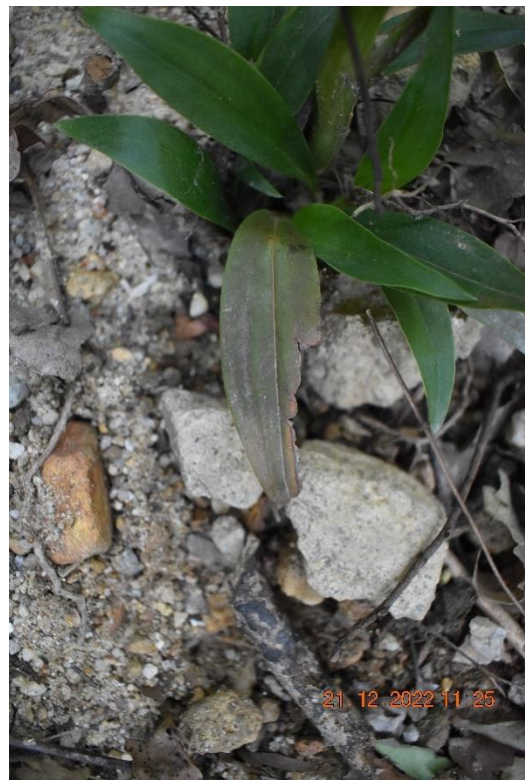
Photo B.3.12: Individual GP-07. Single chlorotic leaf.

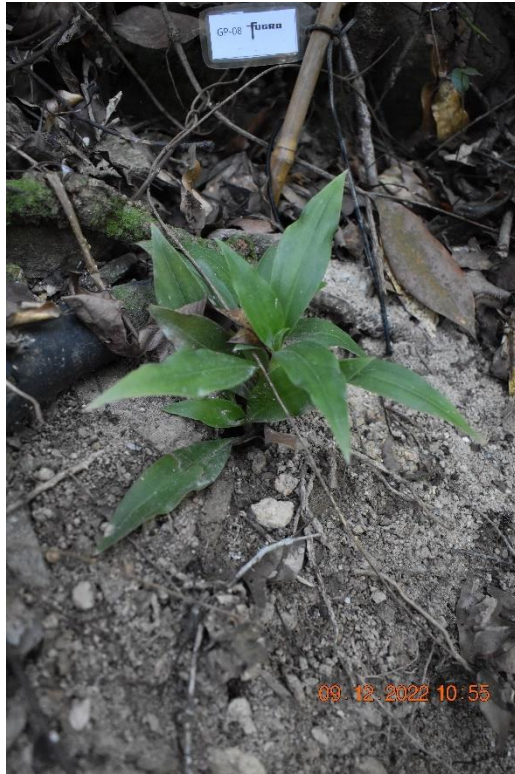
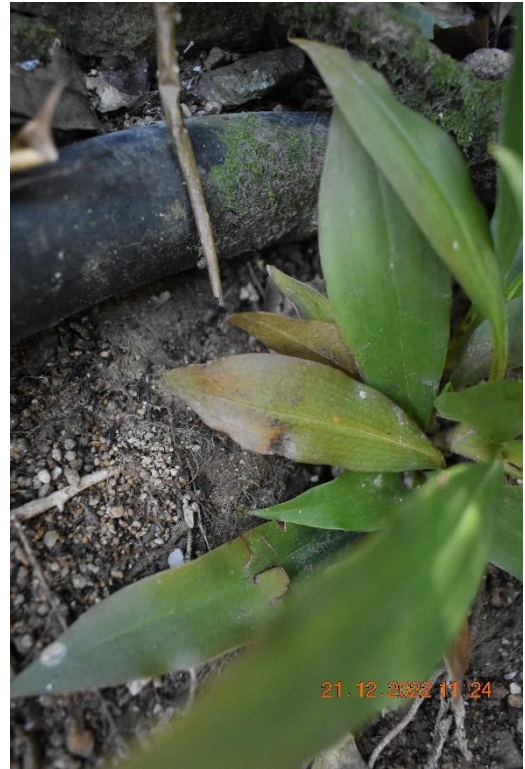
Photo B.3.13: Individual GP-08. Minor chlorotic leaves.

Photo B.3.14: Individual GP-08. Minor chlorotic leaves.

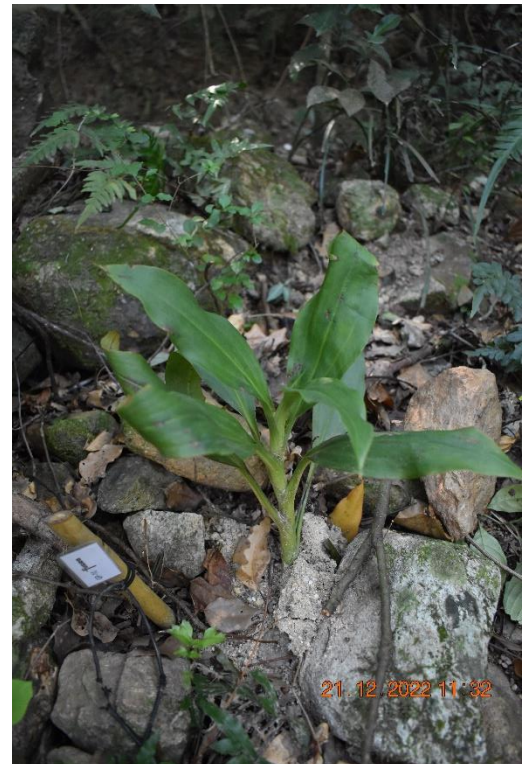
Photo B.3.16: Individual GP-10. Holes in leaves.

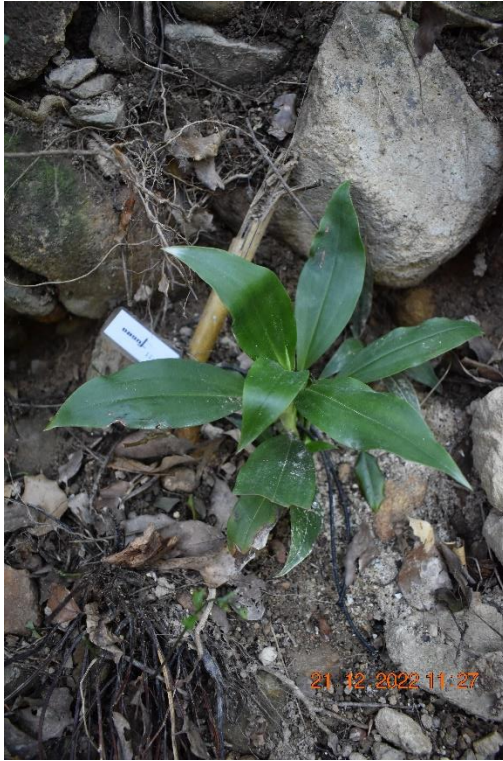
Photo B.3.17: Individual GP-11. Partially wilted leaves.

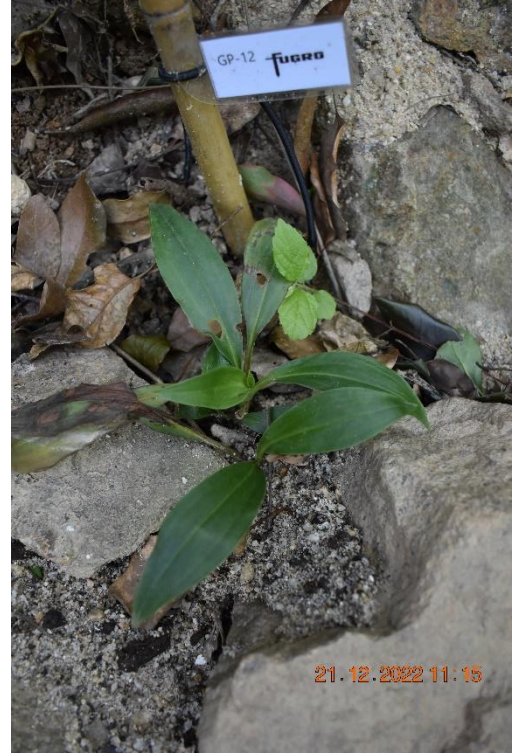
Photo B.3.18: Individual GP-12. Perforated leaves.

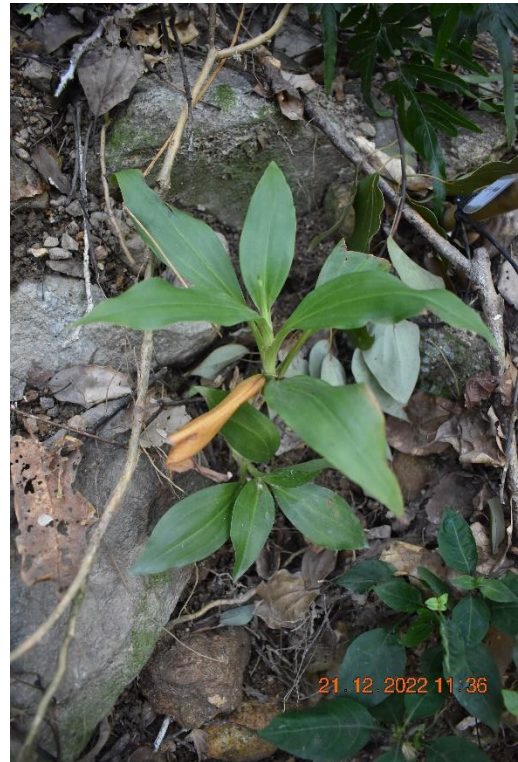
Photo B.3.20: Individual GP-14. Chlorotic leaves.

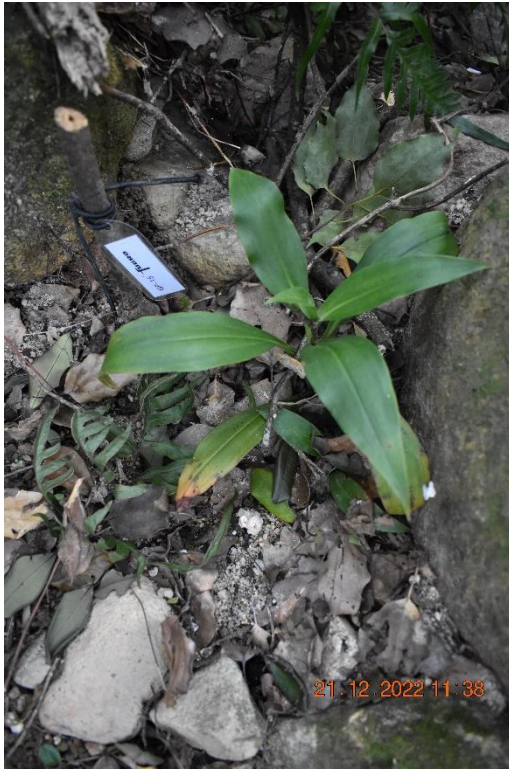
Photo B.3.21: Individual GP-15. Partially chlorotic leaves.

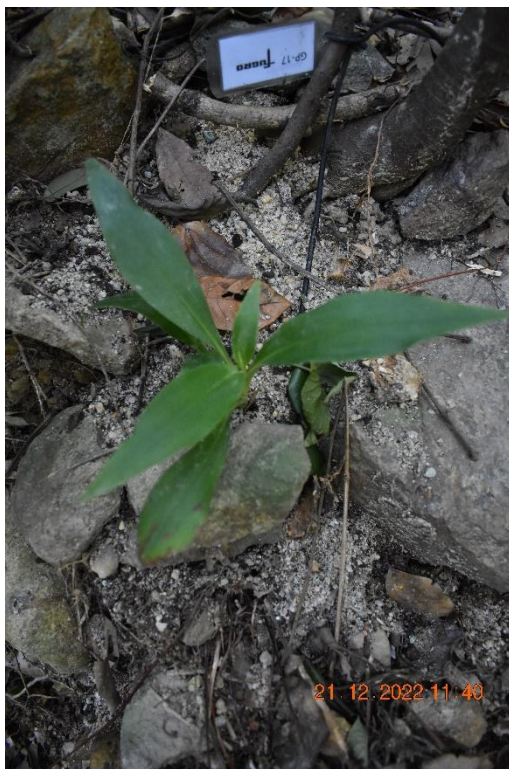
Photo B.3.23: Individual GP-17. Partially wilted leaf.

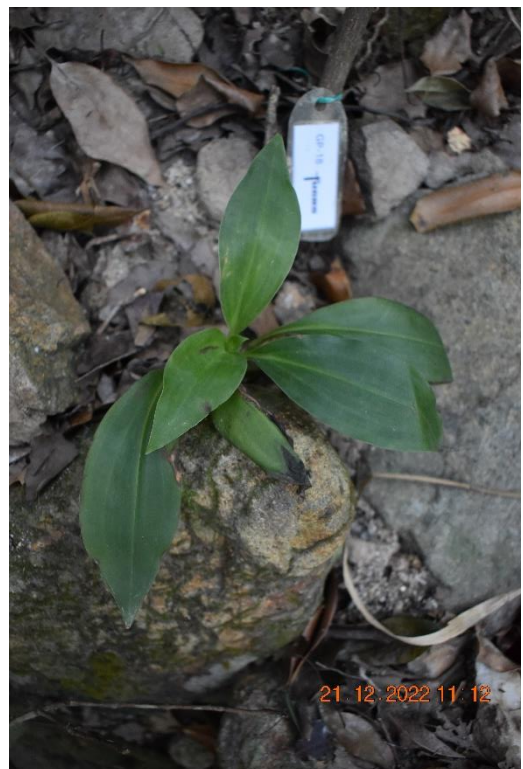
Photo B.3.24: Individual GP-18. Partially wilted leaves.

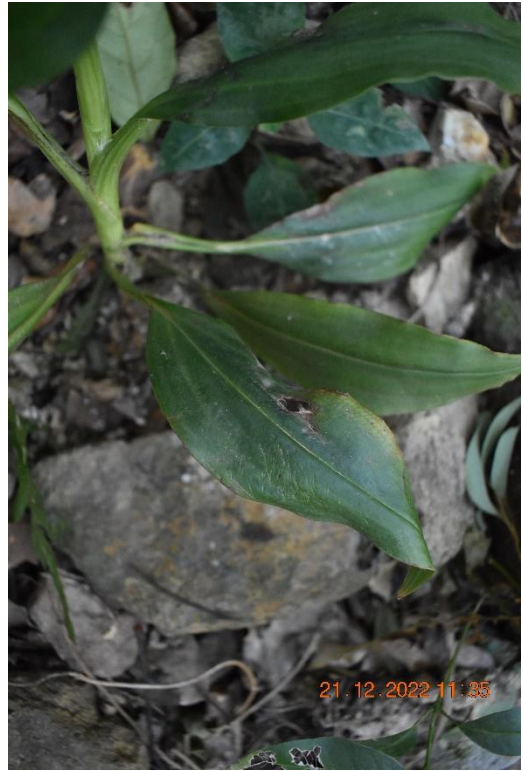
Photo B.3.26: Individual GP-19. Holes in leaves.
