4th Post-transplantation Monitoring and Audit Report (13th January 2023)

Northeast New Territories Landfill Extension (NENTX) | Contract No. EP/SP/77/15

0092/22/ED/0316 02 | 3 February 2023

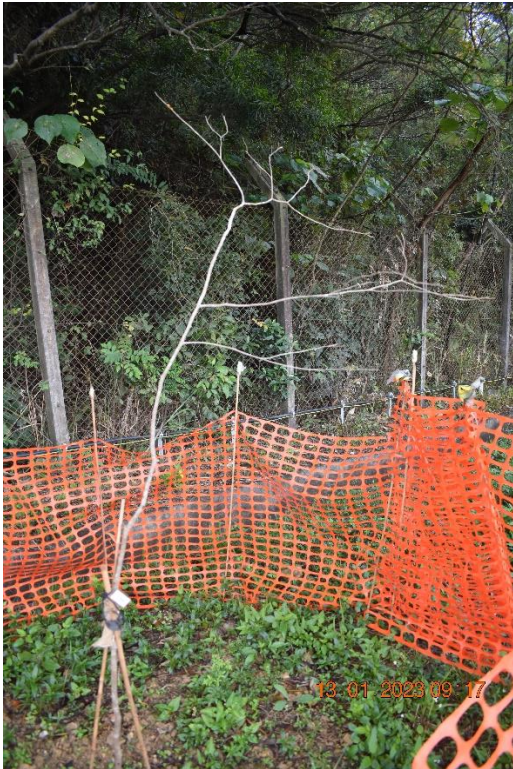
2.1.1 The transplanted individuals of the 19 clusters of Bottlebrush Orchid *Goodyera procera* were all in fair to good condition with minor health issues observed in some individuals, i.e., slightly chlorotic leaves and presences of holes in the leaves. The Lamb of Tartary *Cibotium barometz*, however, exhibited further discoloration and wilting of leaves following the last monitoring period. Its stems also showed some decay but its roots were still in fair condition. The two saplings of the Incense Tree *Aquilaria sinensis* also both demonstrated poor health conditions with die back and fallen leaves.

Photo B.1.1 : General view of the transplanted individual AS-03.

- The watering frequency for the two saplings of Incense Tree should be maintained at 2-3 times a week. Improve/place organic mulch around the two saplings of Incense Tree to retain soil moisture, protect damaged roots against extreme temperatures, and improve soil quality.
- The watering frequency of the cluster of Lamb of Tartary should be maintained at twice a week. Wilted leaves should be pruned away.
- The watering frequency for all 19 clusters of Bottlebrush Orchid should remain the same. During watering activities, the surrounding dead branches and dry leaves should be removed to ensure no plants are damaged by them.

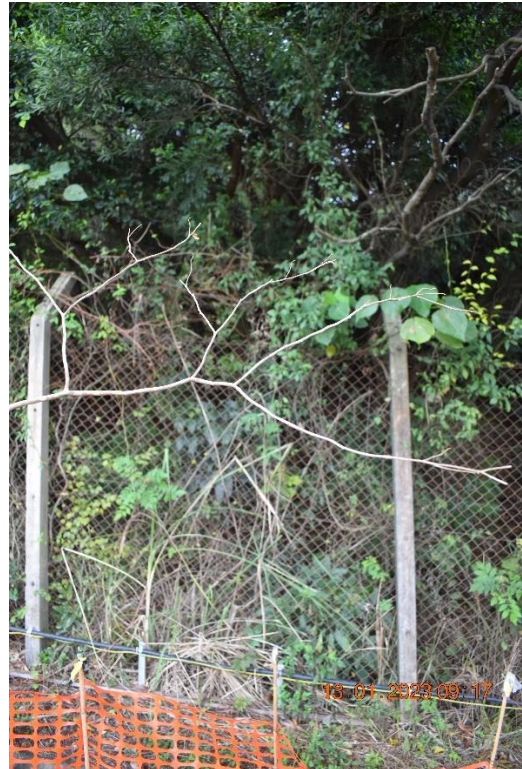
Photo B.1.2 : Branch condition of the transplanted individual AS-03.

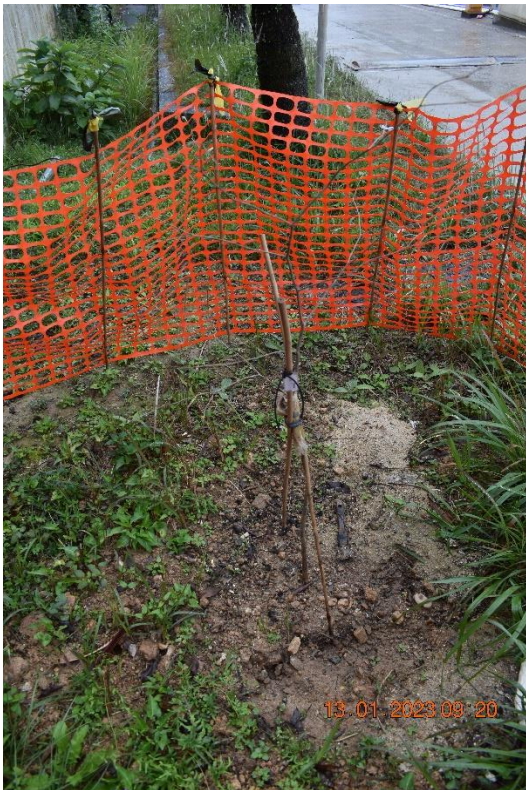
Photo B.1.3 : General view of the transplanted individual AS-02.

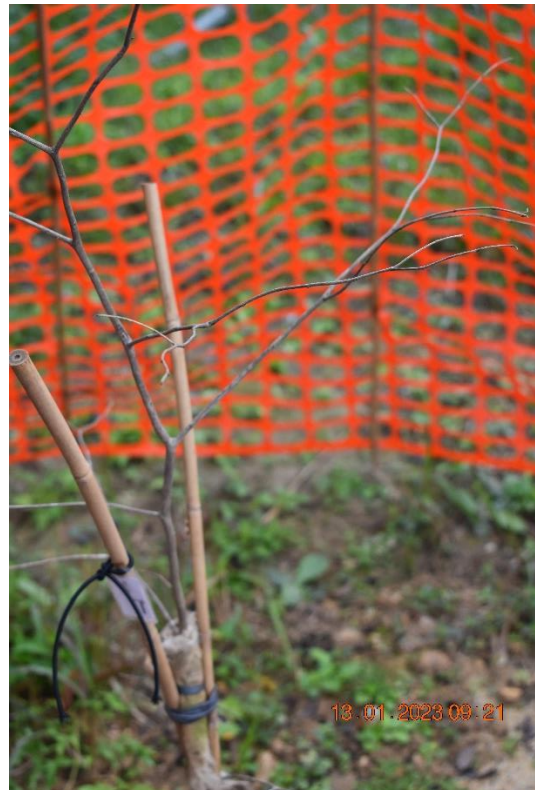
Photo B.1.4 : Branch condition of the transplanted individual AS-02.

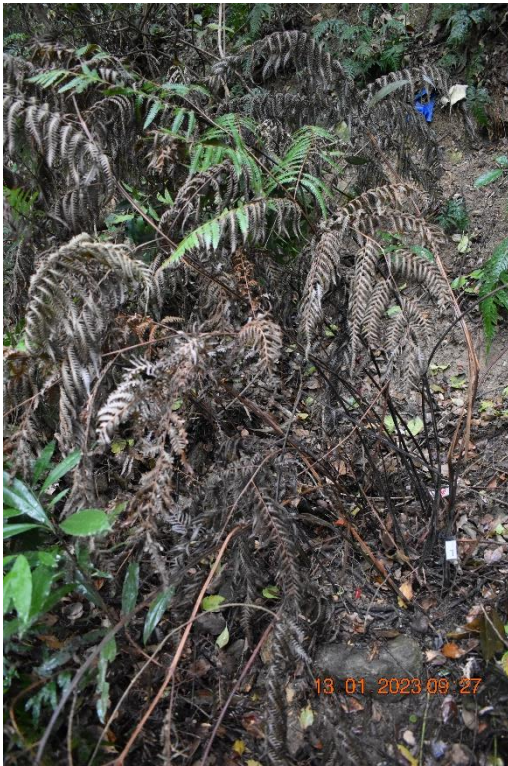
Photo B.2.1 : General view of the transplanted individual CB-01.

4.1.2 It is recommended to pay additional attention to the health conditions of the Lamb of Tartary cluster and the Incense Tree saplings. Moreover, should there be drastic change in the health conditions of these individuals observed during post-transplantation maintenance activities, the Contractor is advised to immediately advise the ecologist to discuss possible remedial actions.

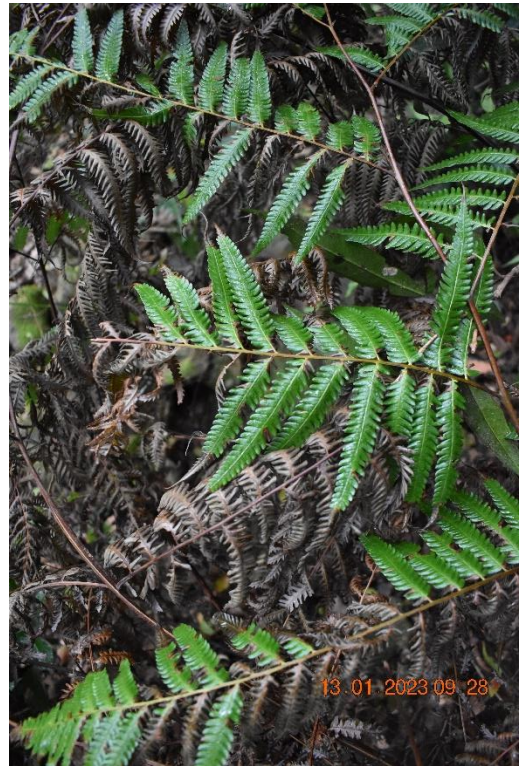
Photo B.2.2 : Leaf condition of the transplanted individual CB-01.

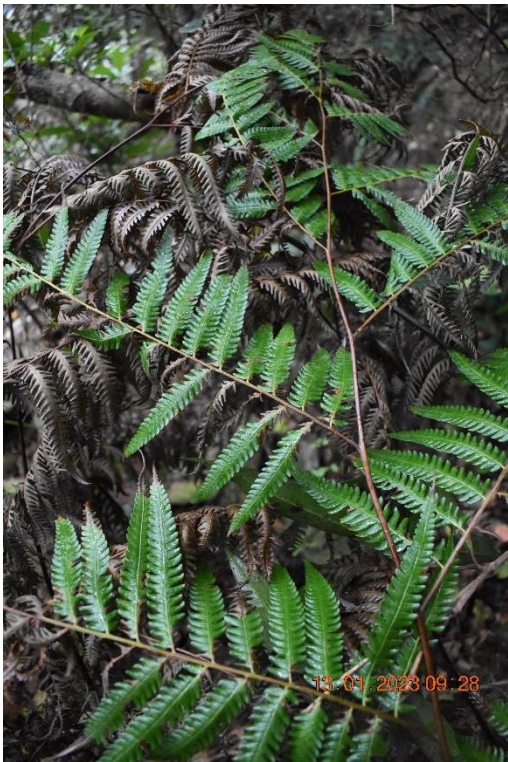
Photo B.2.3 : Leaf condition of the transplanted individual CB-01.

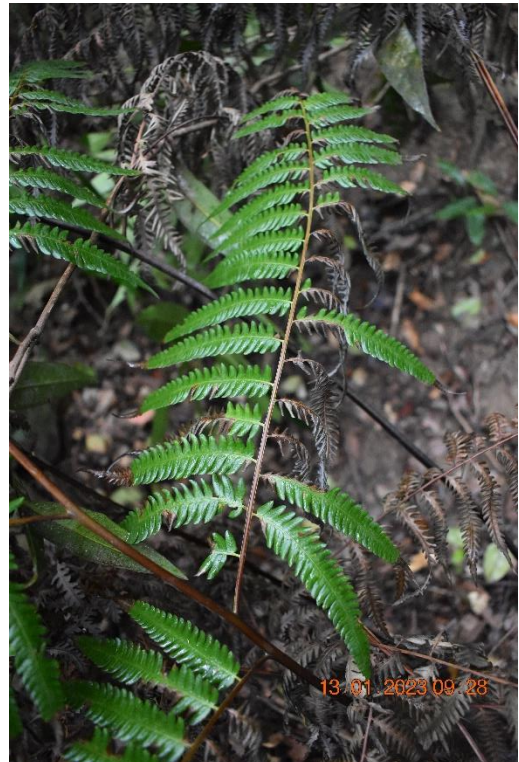
Photo B.2.4 : Leaf condition of the transplanted individual CB-01.

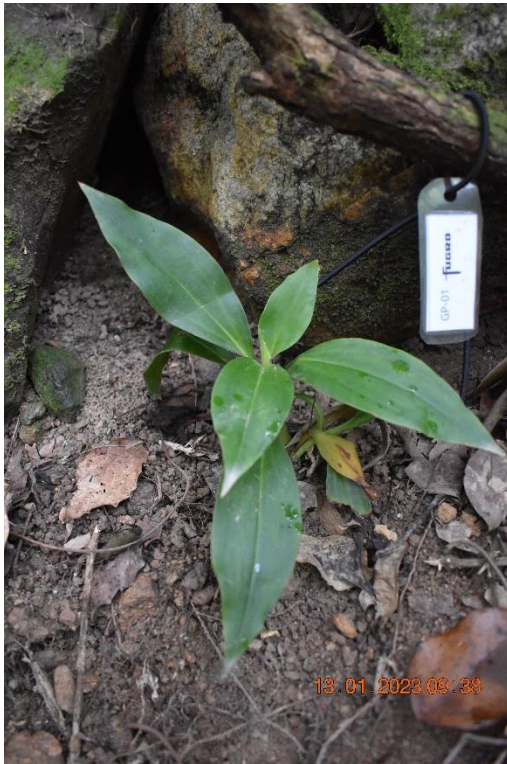
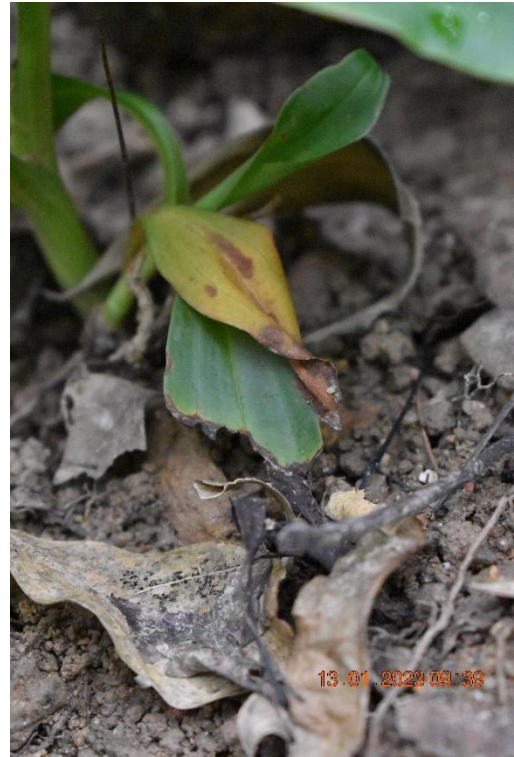
Photo B.3.1: Individual GP-01. Partially wilted leaf.

Photo B.3.2: Individual GP-01. Partially wilted leaf.

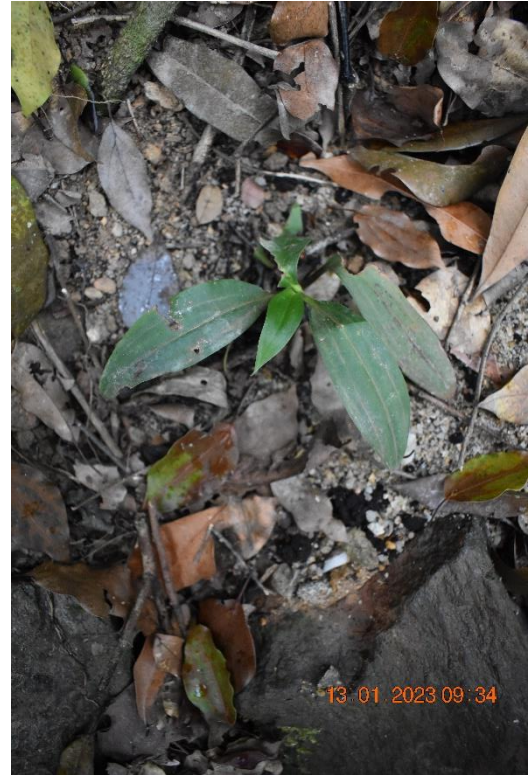
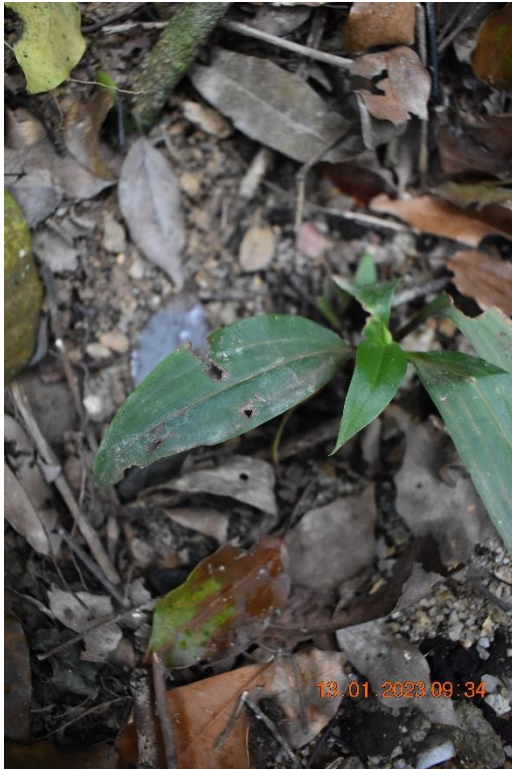
Photo B.3.4: Individual GP-03. Perforated leaves.

Photo B.3.5: Individual GP-03. Perforated leaves.

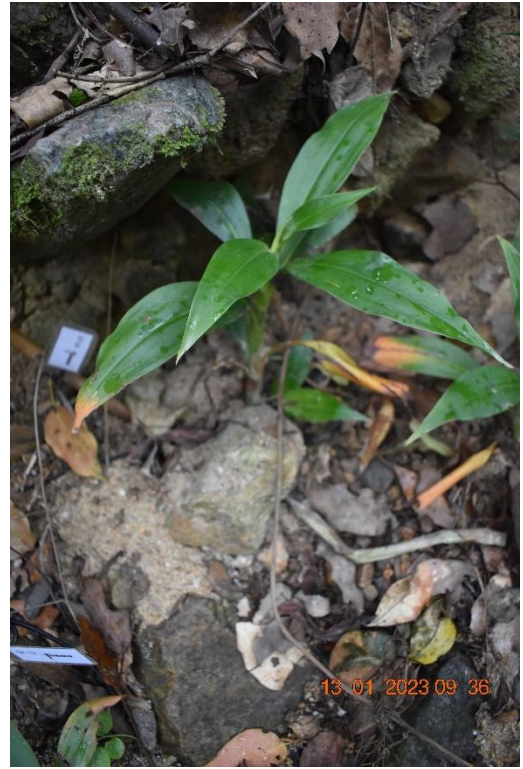
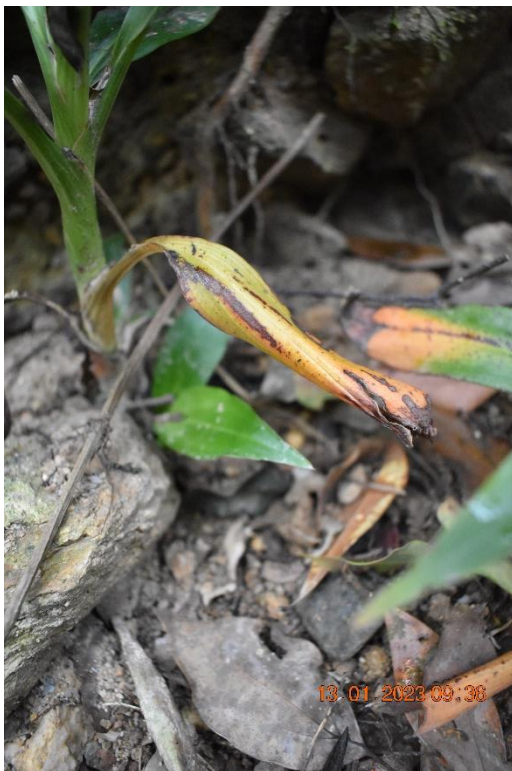
Photo B.3.6: Individual GP-04. Wilted leaf.

Photo B.3.7: Individual GP-04. Wilted leaf.

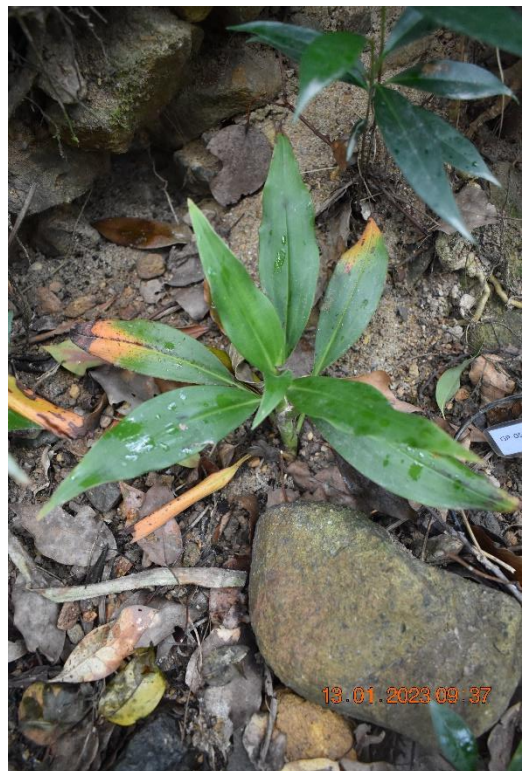
Photo B.3.8: Individual GP-05. Partially wilted leaf.

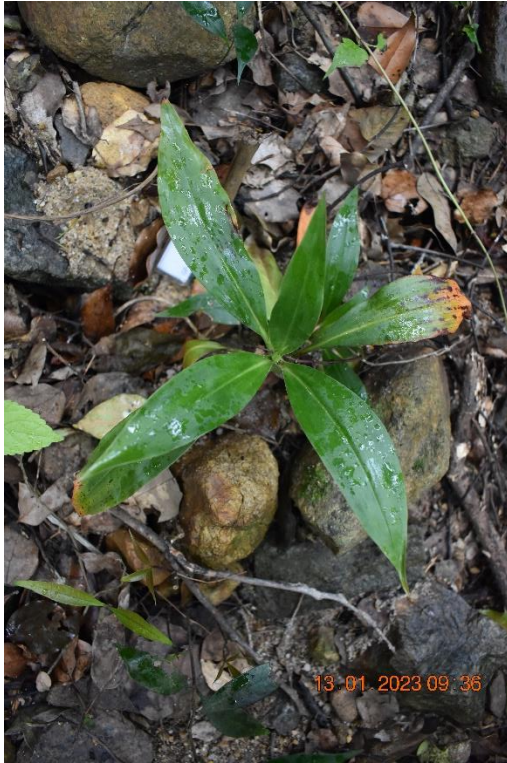
Photo B.3.9: Individual GP-06. Partially wilted leaf.

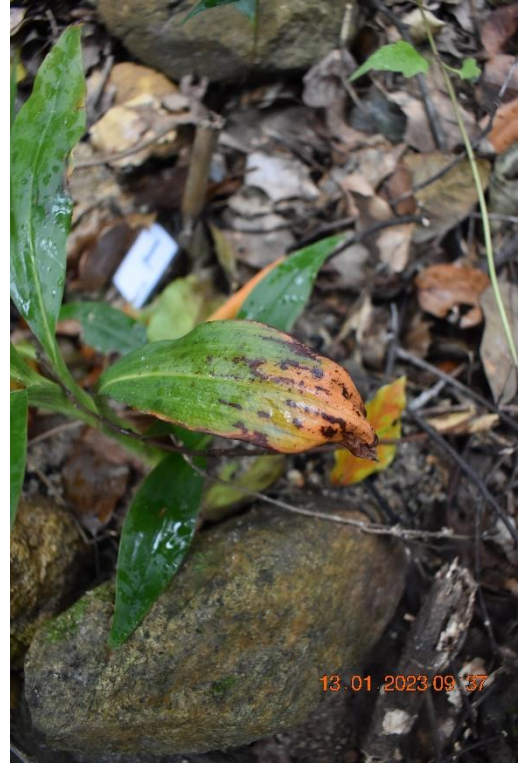
Photo B.3.10: Individual GP-06. Partially chlorotic and wilted leaf.

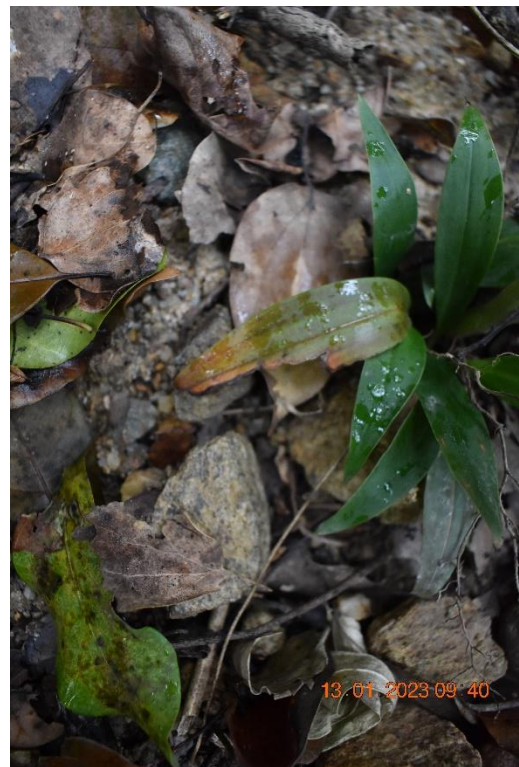
Photo B.3.12: Individual GP-07. Single chlorotic leaf.

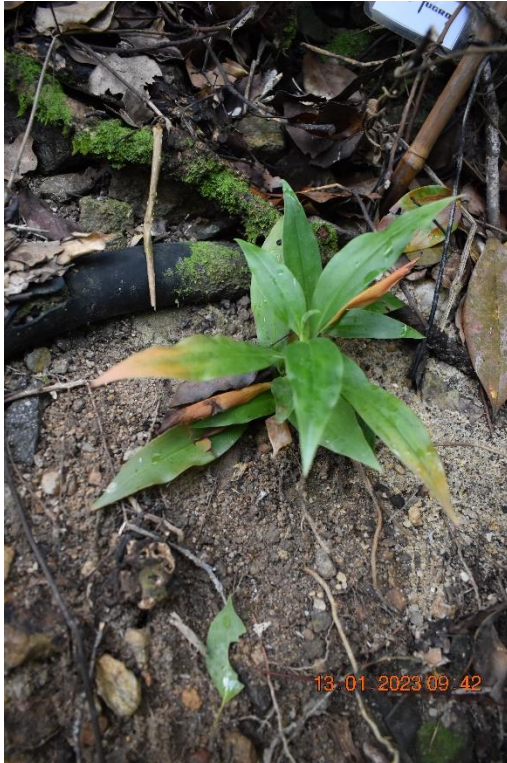
Photo B.3.13: Individual GP-08. Chlorotic leaves.

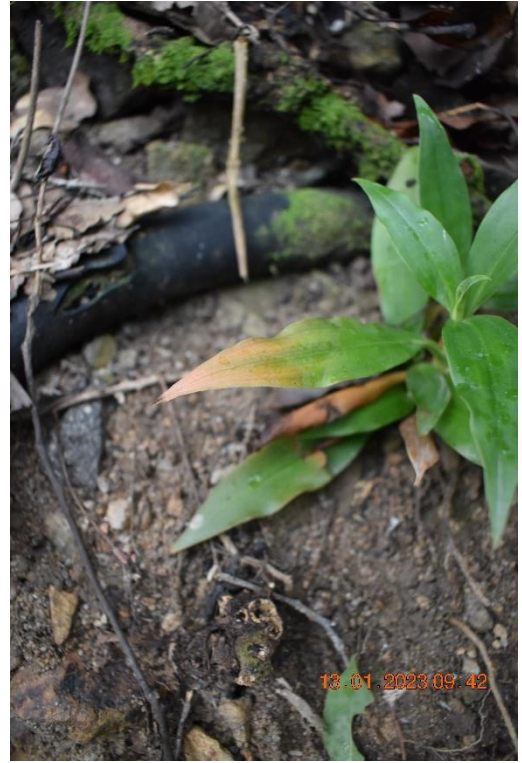
Photo B.3.14: Individual GP-08. Minor chlorotic leaves.

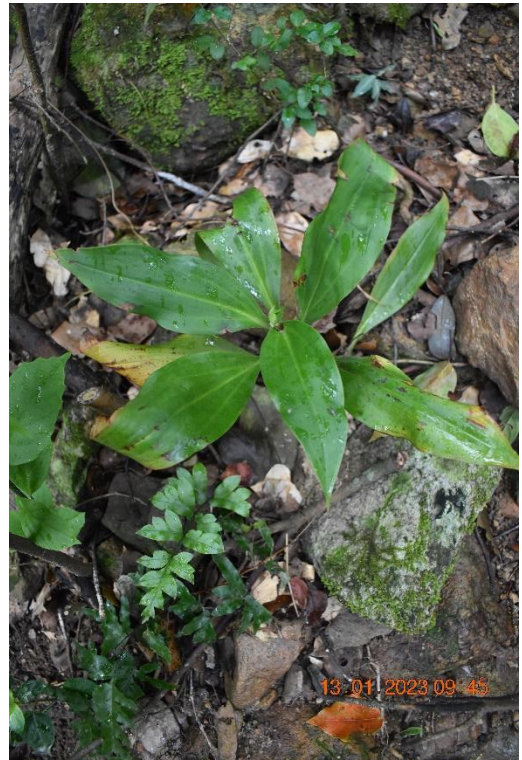
Photo B.3.16: Individual GP-10. Holes in leaves.

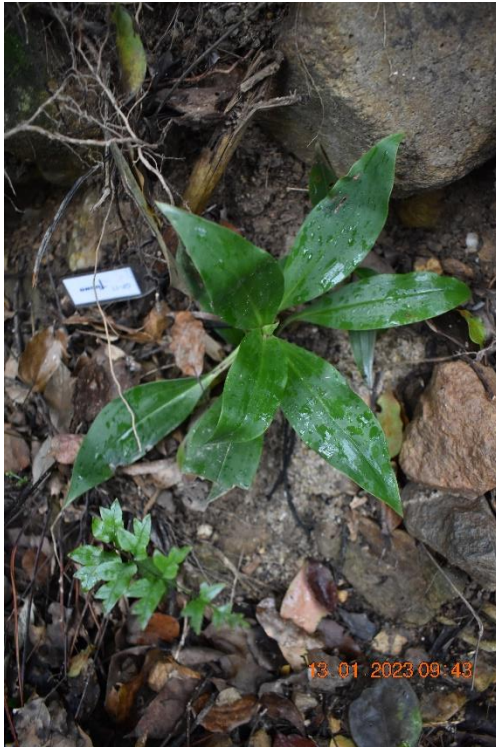
Photo B.3.17: Individual GP-11. Partially wilted leaves.

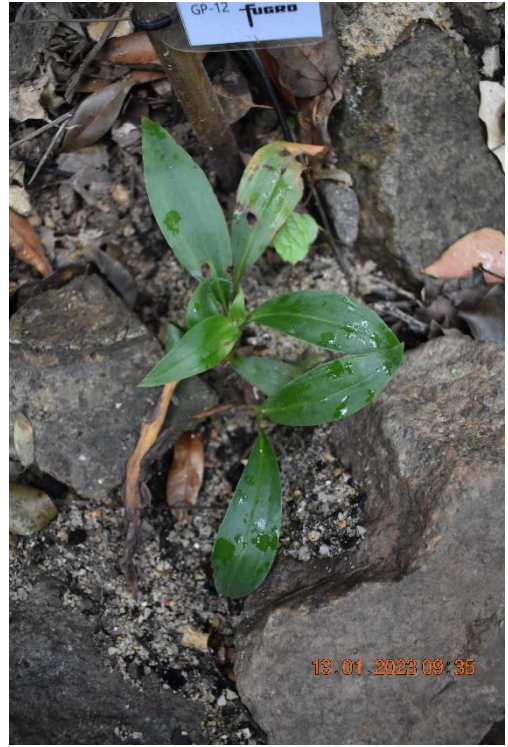
Photo B.3.18: Individual GP-12. Perforated leaves.

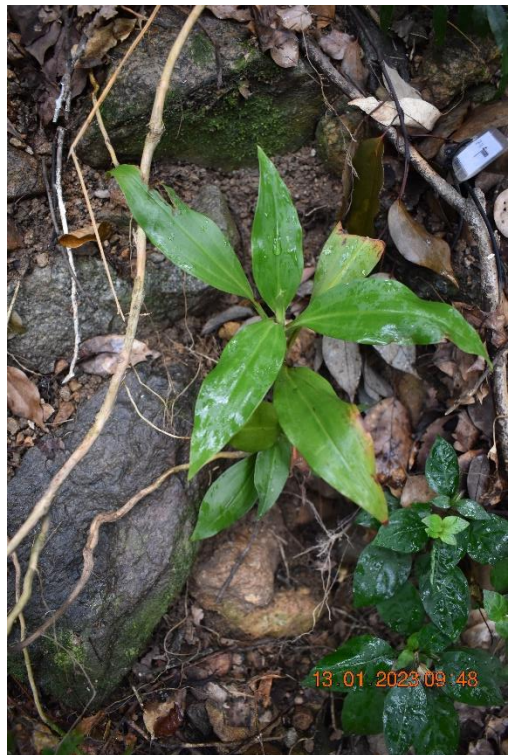
Photo B.3.20: Individual GP-14. Chlorotic leaves.

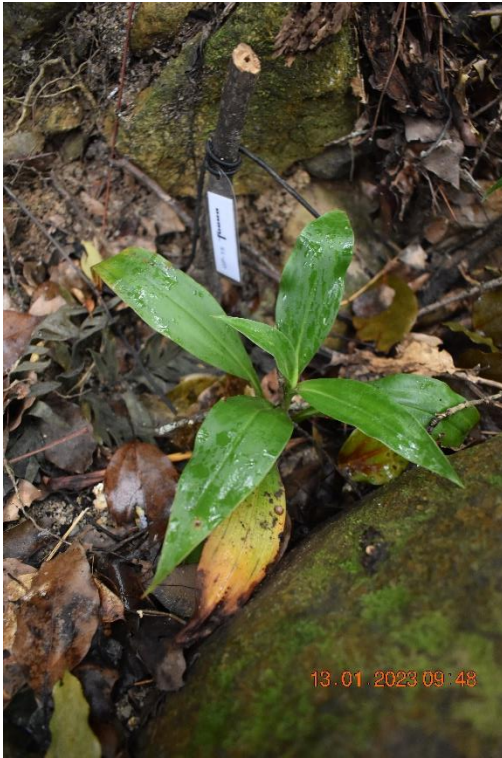
Photo B.3.21: Individual GP-15. Partially chlorotic leaves.

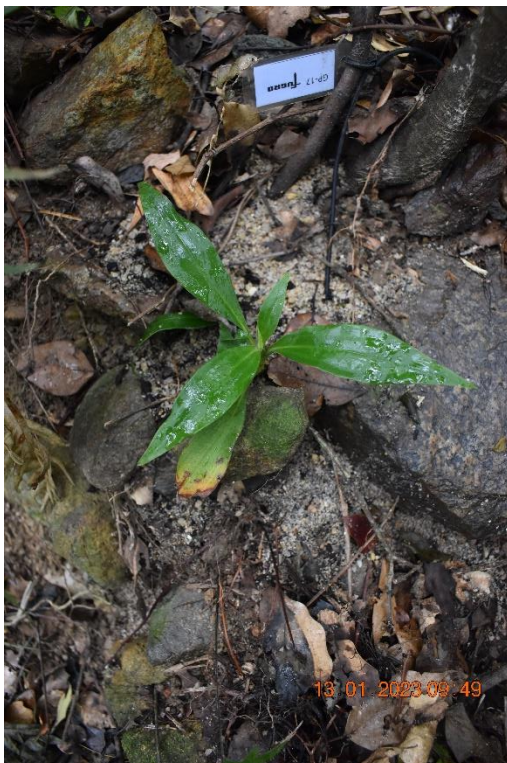
Photo B.3.23: Individual GP-17. Partially wilted leaf.

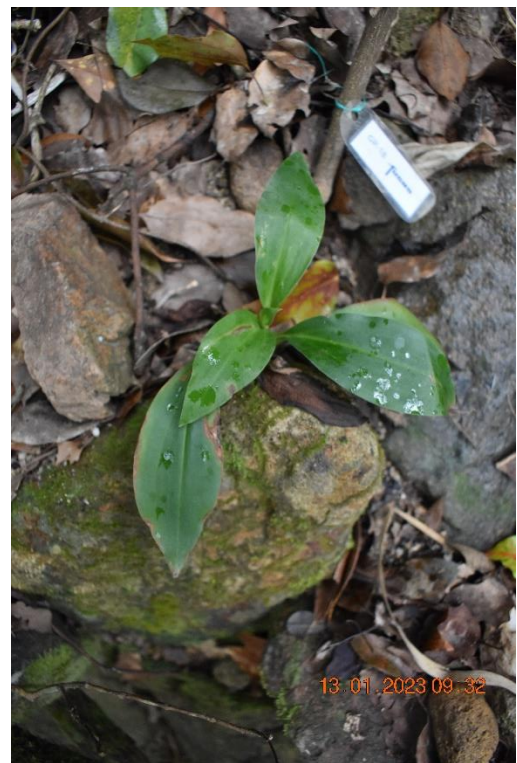
Photo B.3.24: Individual GP-18. Partially wilted leaves.

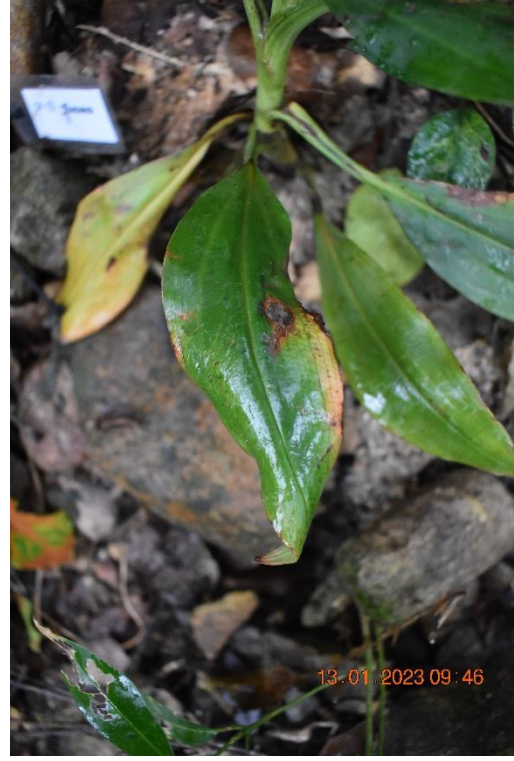
Photo B.3.26: Individual GP-19. Chlorotic and partially wilted leaves.
