5th Post-transplantation Monitoring and Audit Report (26th January 2023)

Northeast New Territories Landfill Extension (NENTX) | Contract No. EP/SP/77/15

0092/22/ED/0317 02 | 3 February 2023

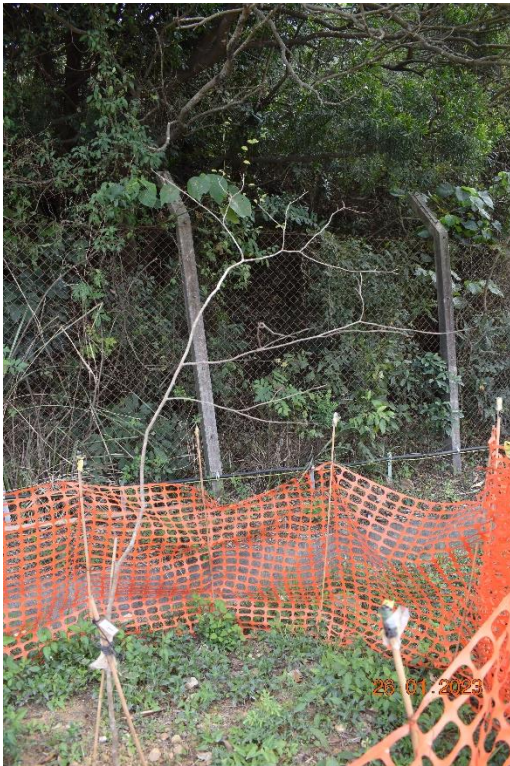
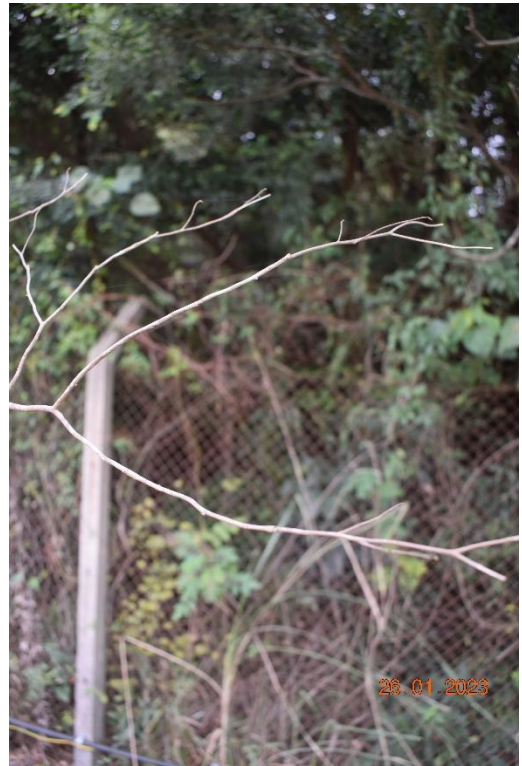
Photo B.1.1 : General view of the transplanted individual AS-03.

Photo B.1.2 : Branch condition of the transplanted individual AS-03.

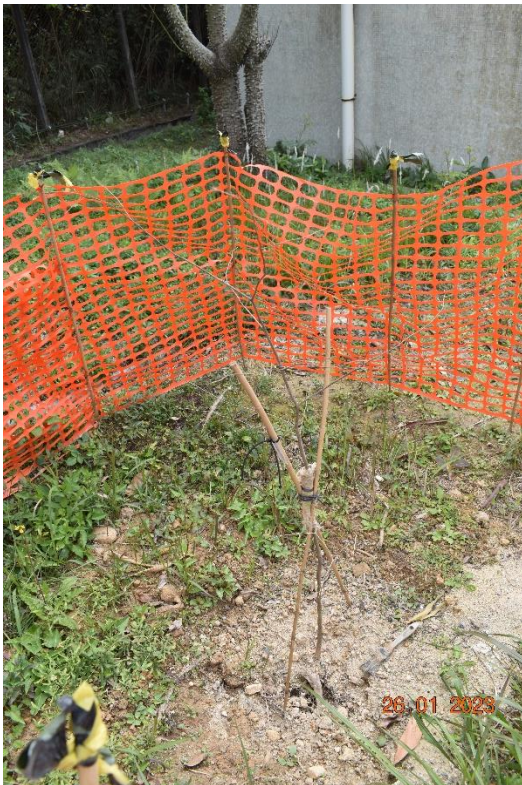
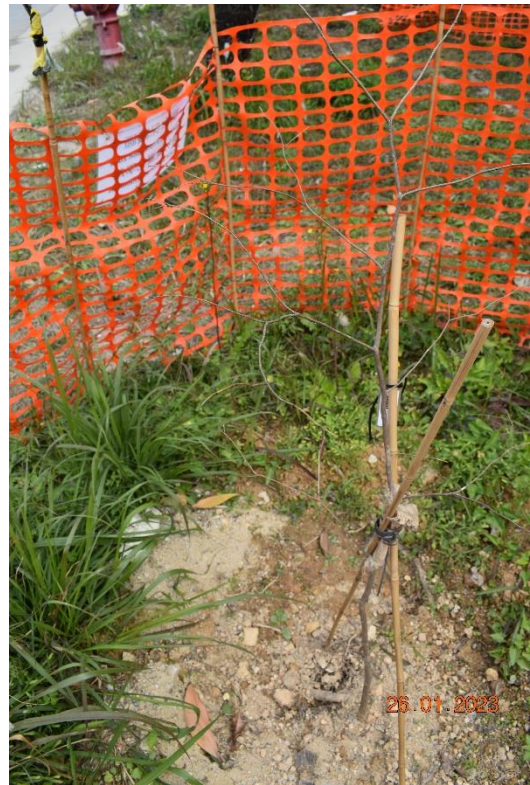
Photo B.1.3 : General view of the transplanted individual AS-02.

Photo B.1.4 : Branch condition of the transplanted individual AS-02.

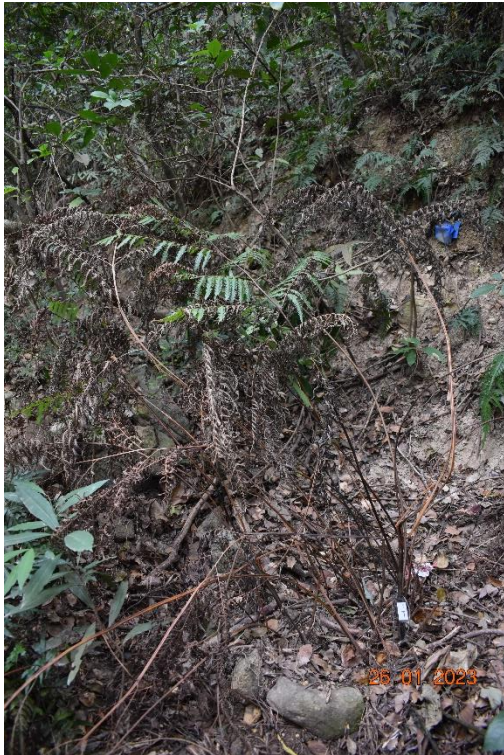
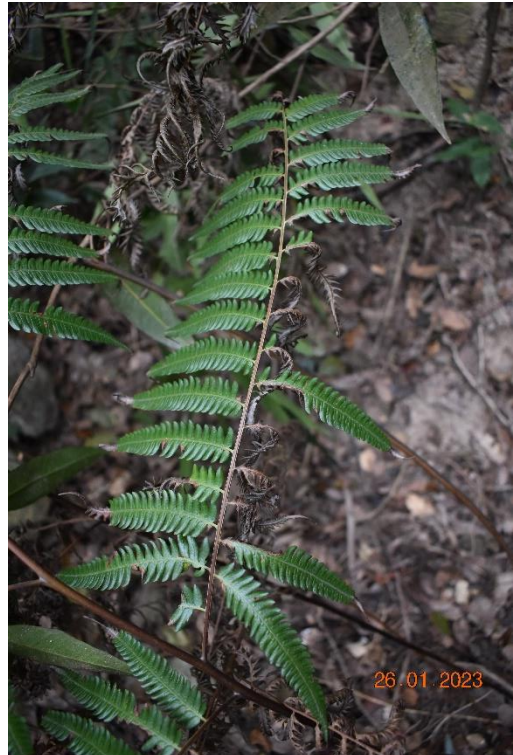
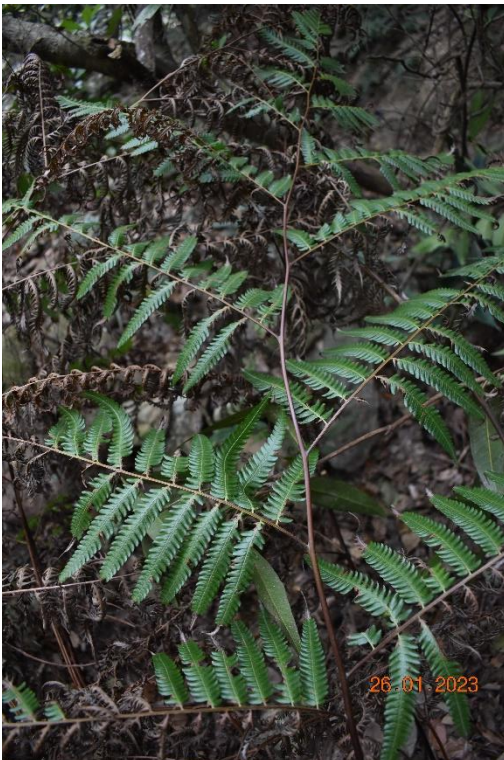
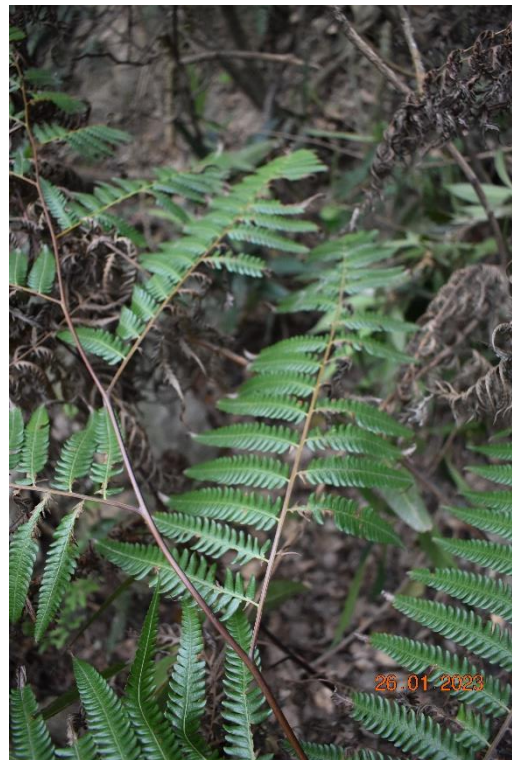
Photo B.2.1. : General view of the transplanted individual CB-01.

Photo B.2.2. : Leaf condition of the transplanted individual CB-01.

Photo B.2.3. : Leaf condition of the transplanted individual CB-01.

Photo B.2.4. : Leaf condition of the transplanted individual CB-01.

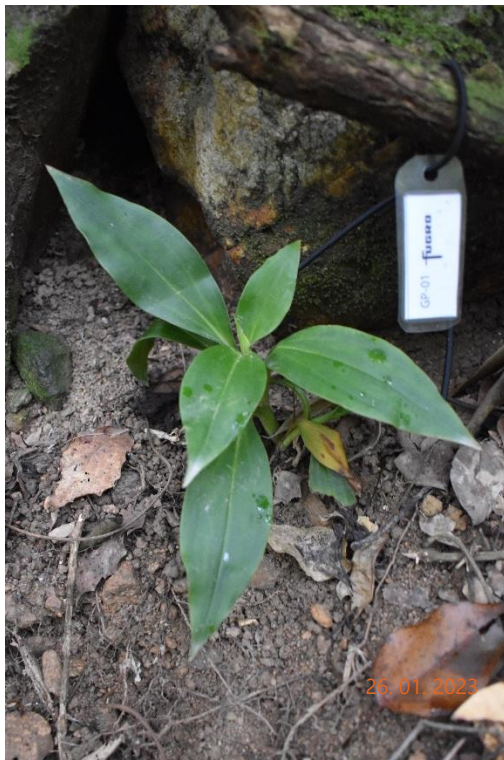
Photo B.3.1: Individual GP-01. Partially wilted leaf.

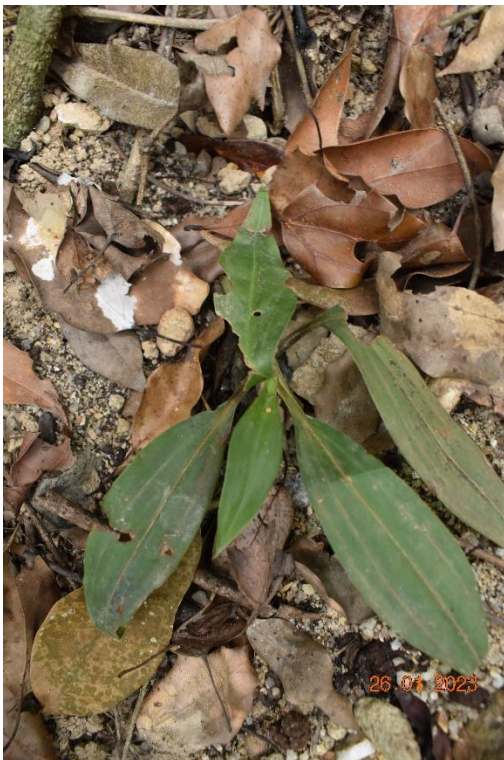
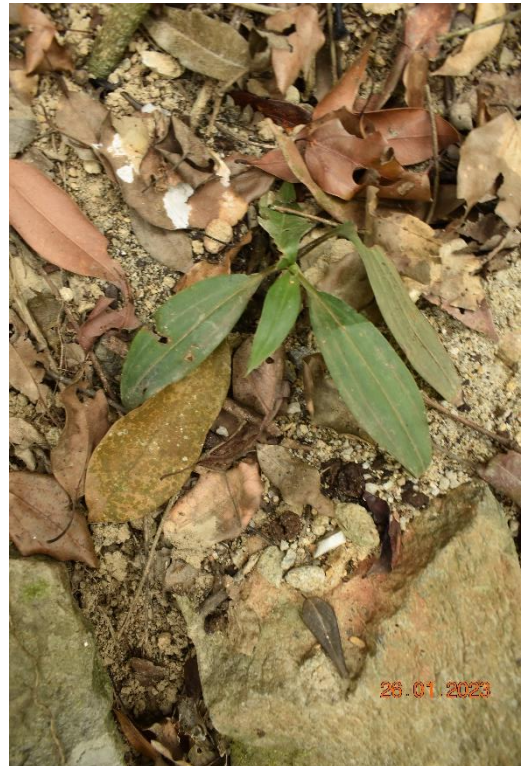
Photo B.3.3: Individual GP-03. Perforated leaves.

Photo B.3.4: Individual GP-03. Perforated leaves.

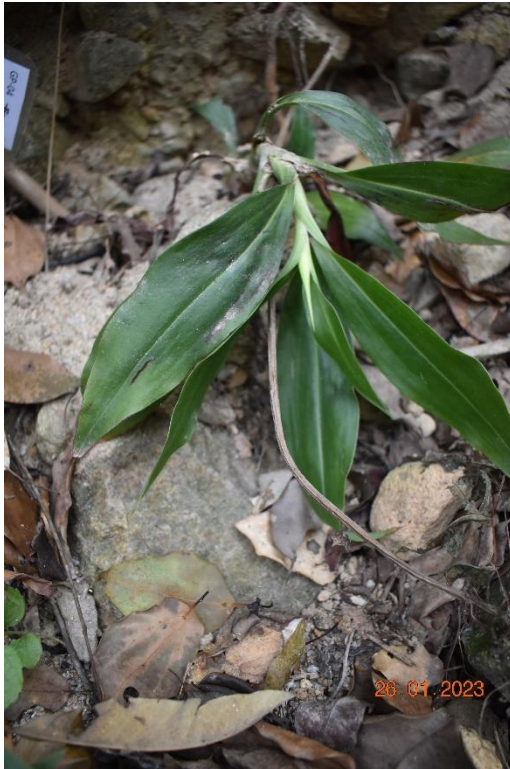
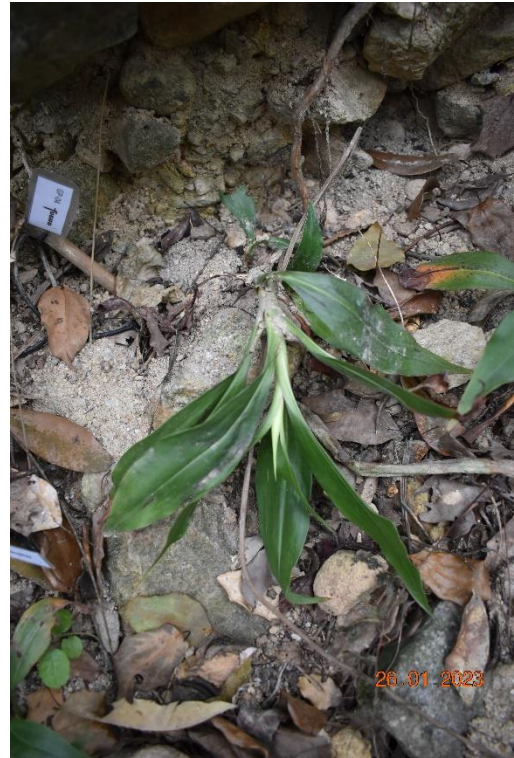
Photo B.3.5: Individual GP-04. Leaning.

Photo B.3.6: Individual GP-04. Leaning.

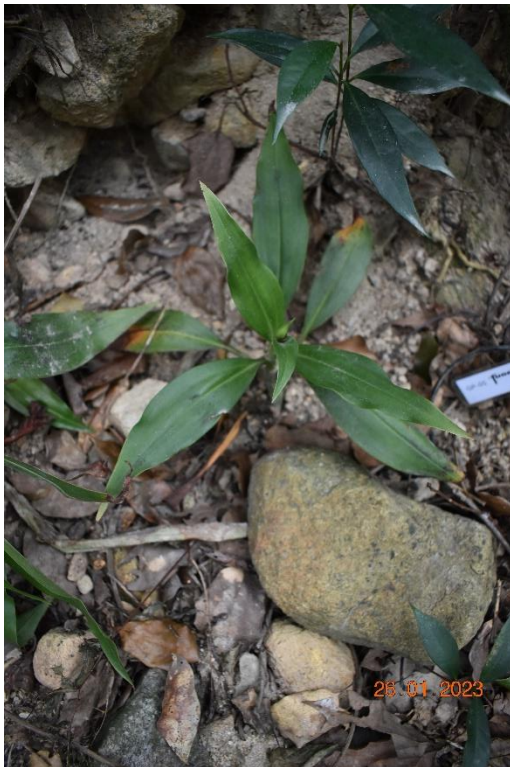
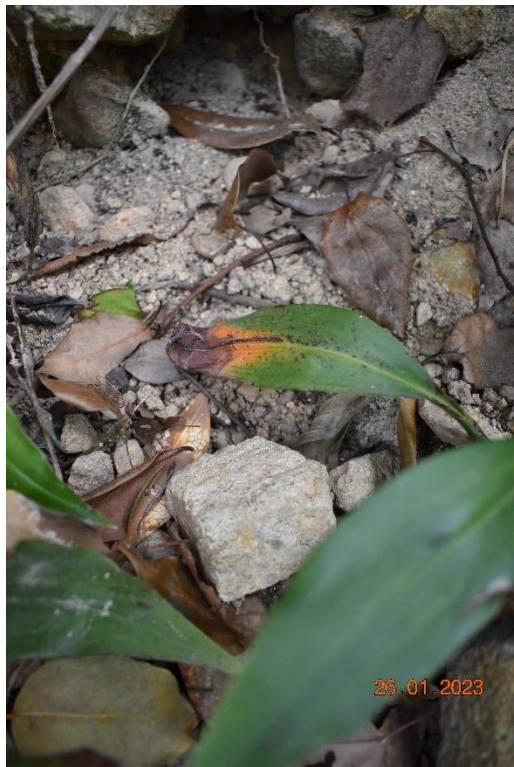
Photo B.3.7: Individual GP-05. Partially wilted leaf.

Photo B.3.8: Individual GP-05. Partially wilted leaf.

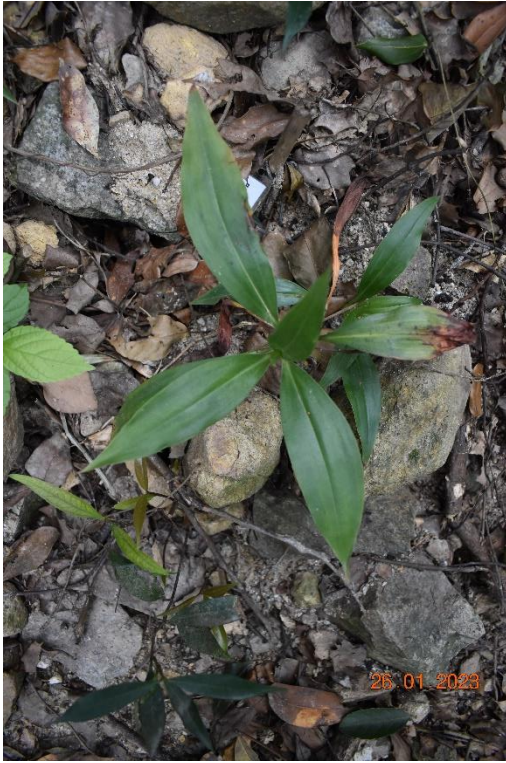
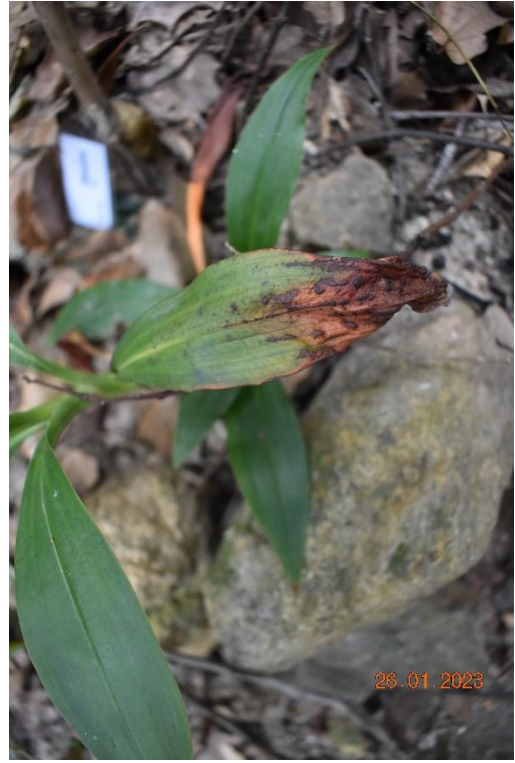
Photo B.3.9: Individual GP-06. Partially wilted leaf.

Photo B.3.10: Individual GP-06. Partially chlorotic and wilted leaf.

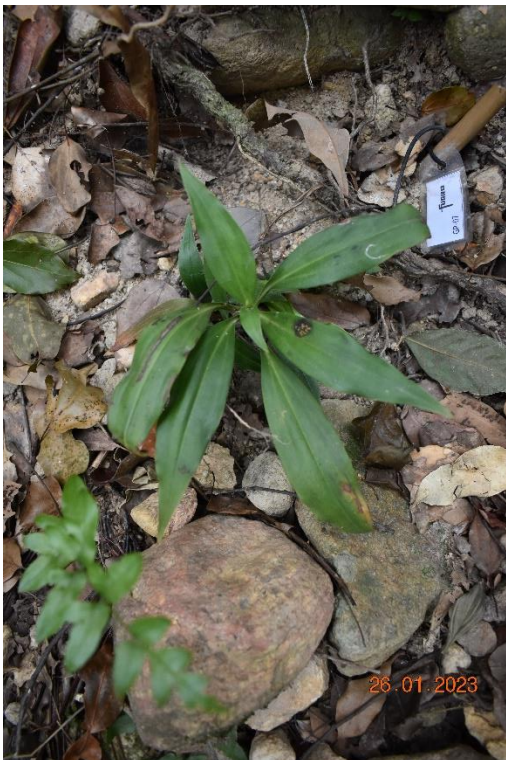
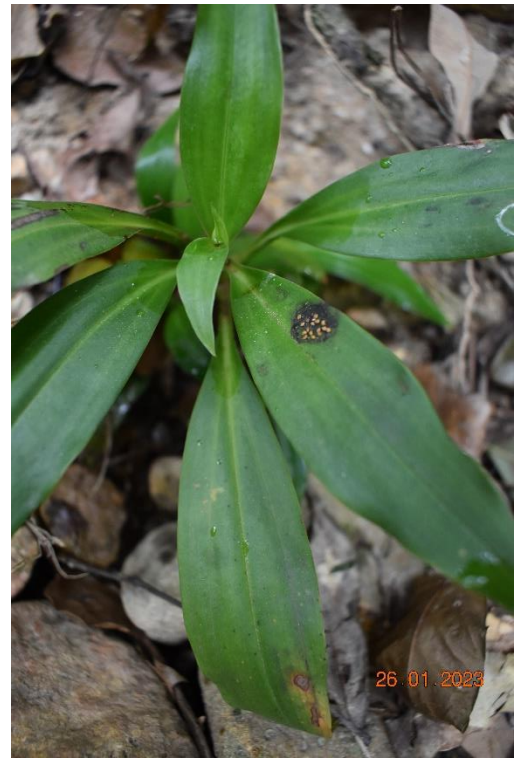
Photo B.3.12: Individual GP-07. Pest sign.

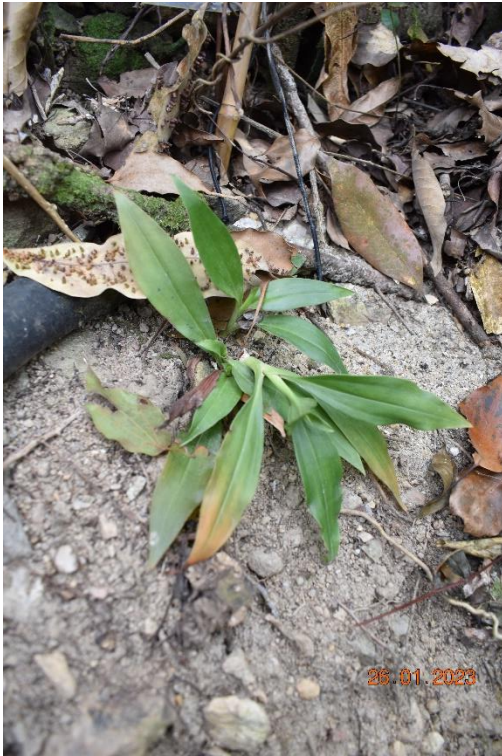
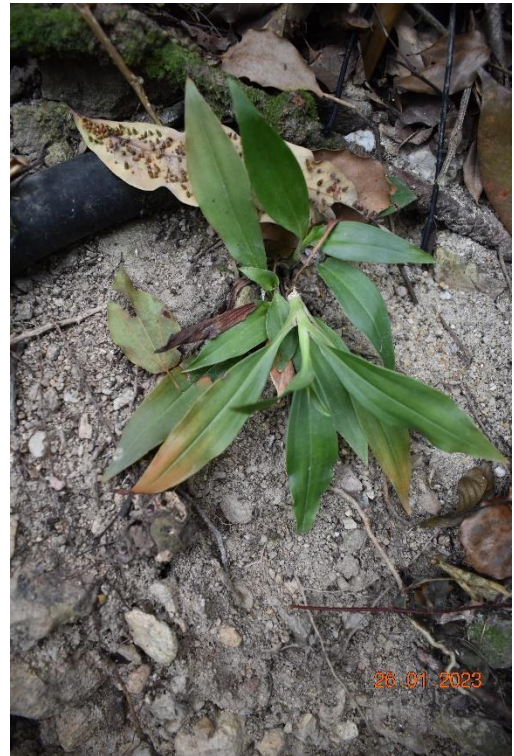
Photo B.3.13: Individual GP-08. Chlorotic leaves.

Photo B.3.14: Individual GP-08. Minor chlorotic leaves.

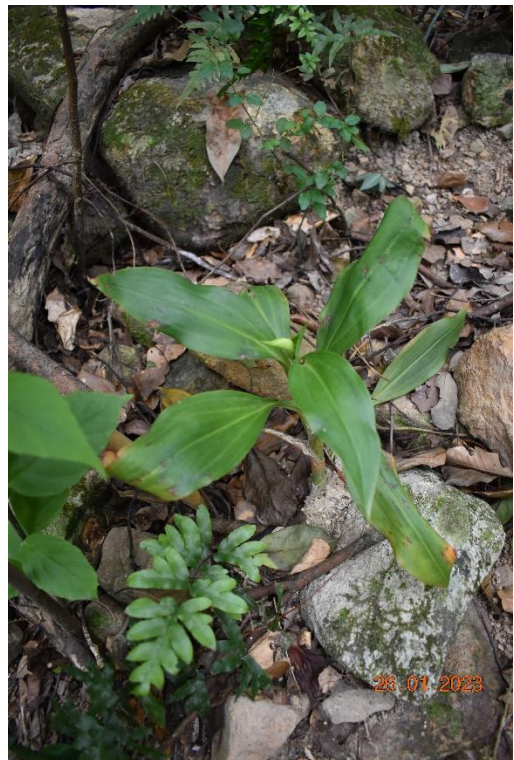
Photo B.3.16: Individual GP-10. Holes in leaves.

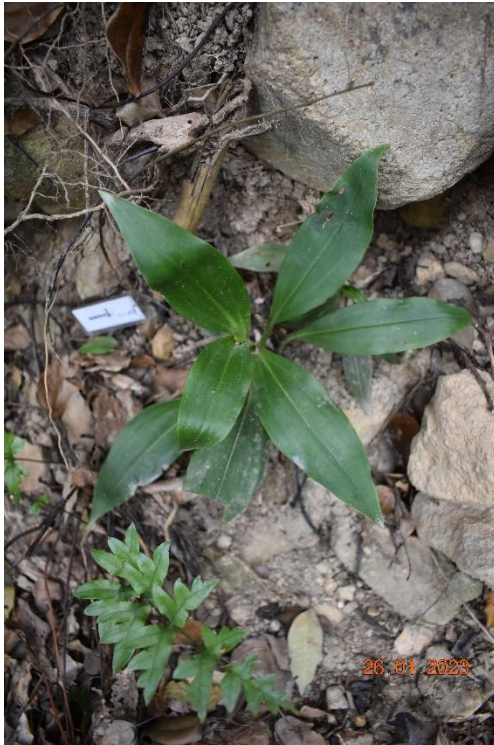
Photo B.3.17: Individual GP-11. Partially wilted leaves.

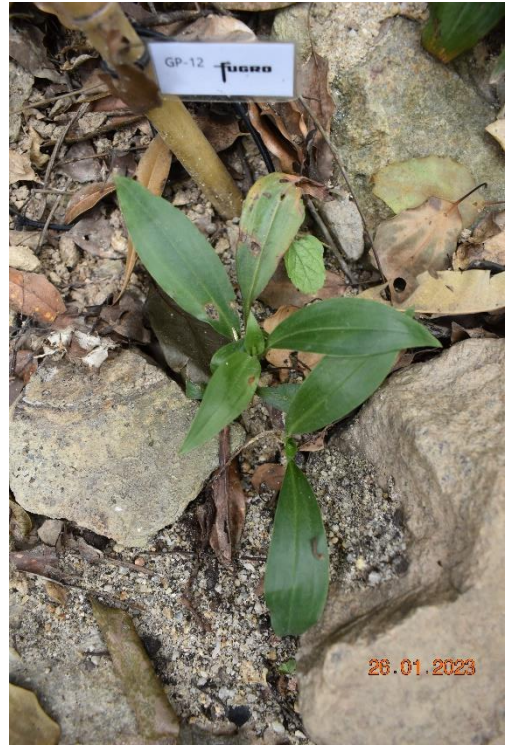
Photo B.3.18: Individual GP-12. Perforated leaves.

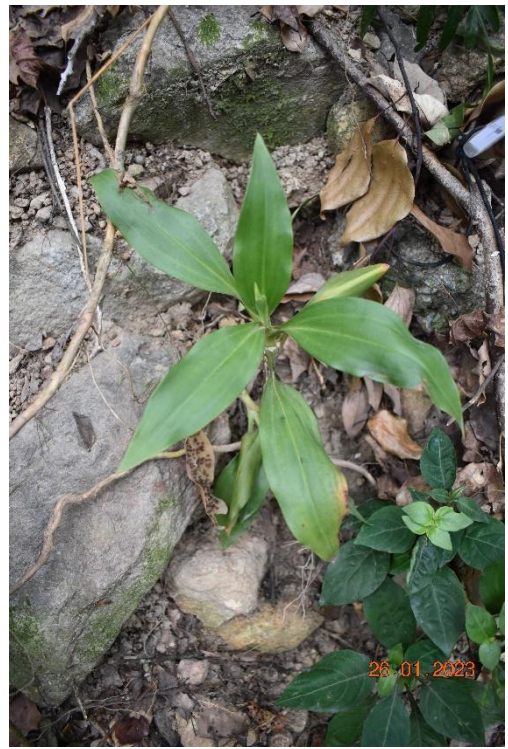
Photo B.3.20: Individual GP-14. Chlorotic leaves.

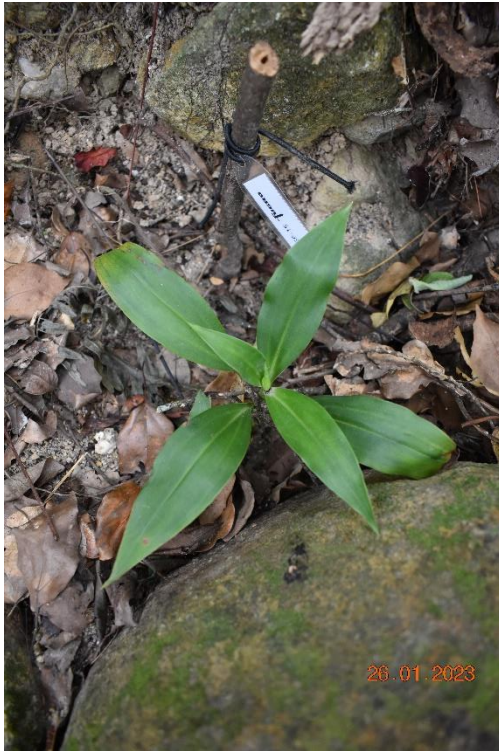
Photo B.3.21: Individual GP-15. Partially chlorotic leaves.

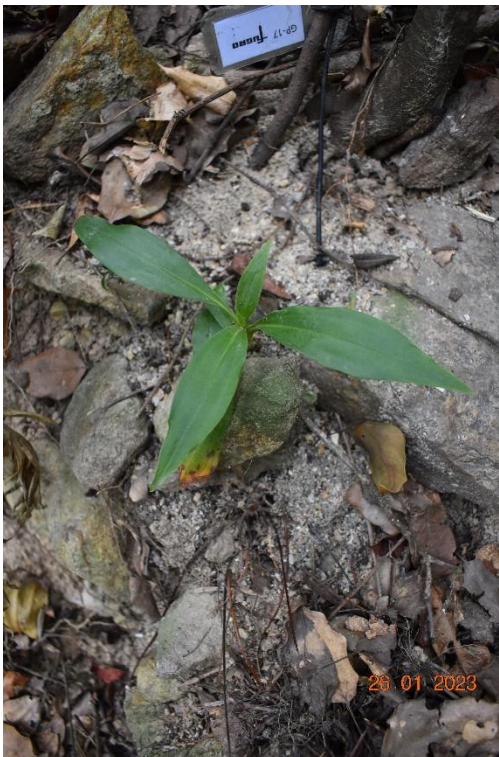
Photo B.3.23: Individual GP-17. Partially wilted leaf.

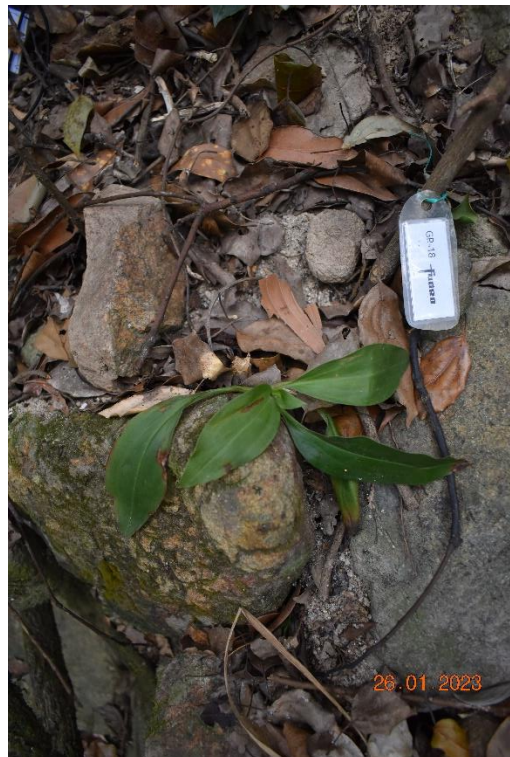
Photo B.3.24: Individual GP-18. Partially wilted leaves.

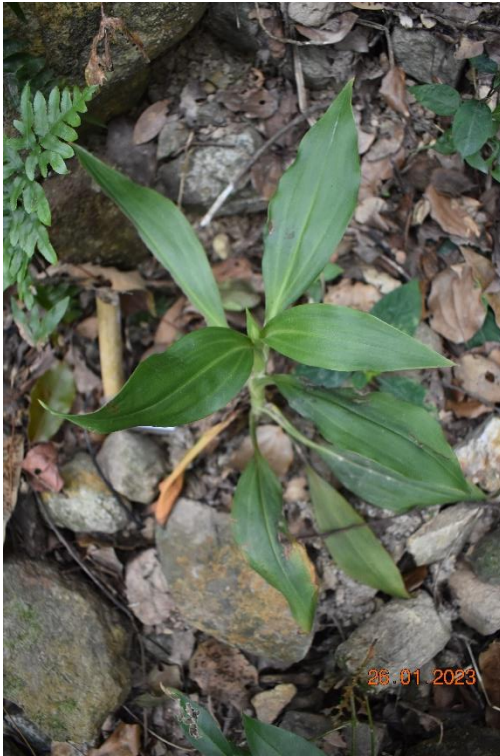
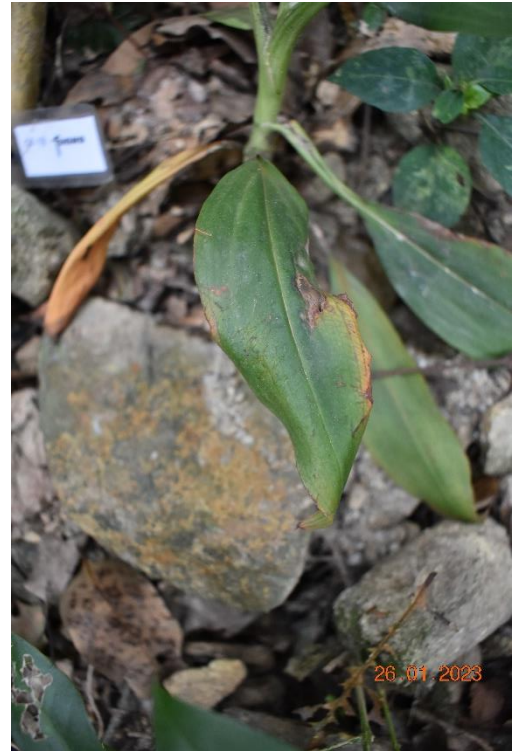
Photo B.3.26: Individual GP-19. Chlorotic and partially wilted leaves.
