6th Post-transplantation Monitoring and Audit Report (8th February 2023)

Northeast New Territories Landfill Extension (NENTX) | Contract No. EP/SP/77/15

0092/22/ED/0330 02 | 16 February 2023

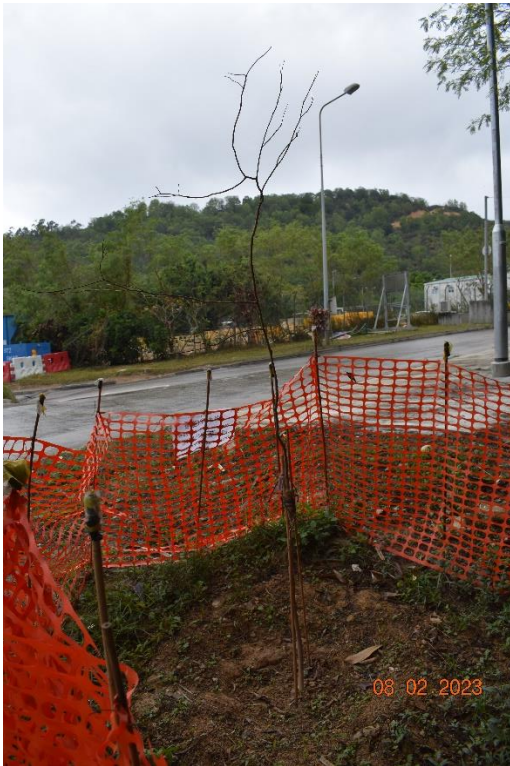
Photo B.1.1 : General view of the transplanted individual AS-03.

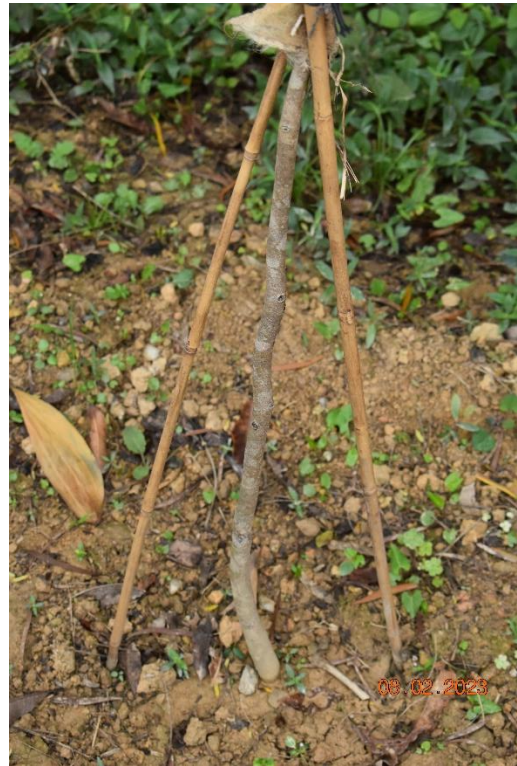
Photo B.1.2 : Stem condition of the transplanted individual AS-03.

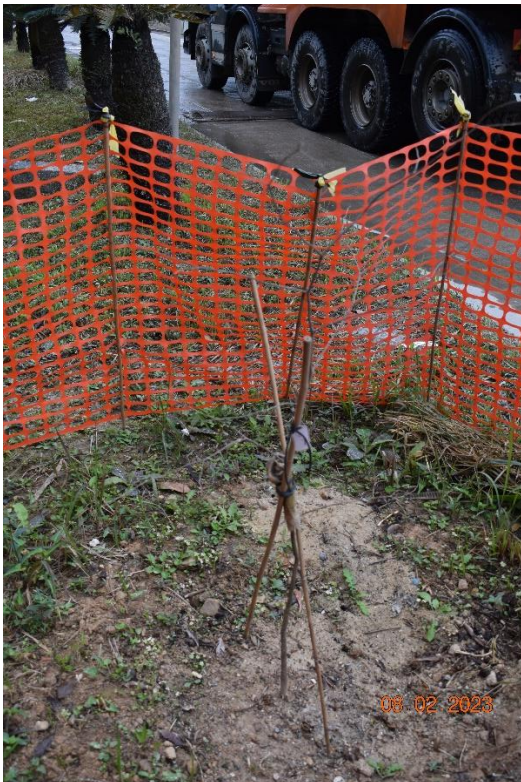
Photo B.1.3 : General view of the transplanted individual AS-02.

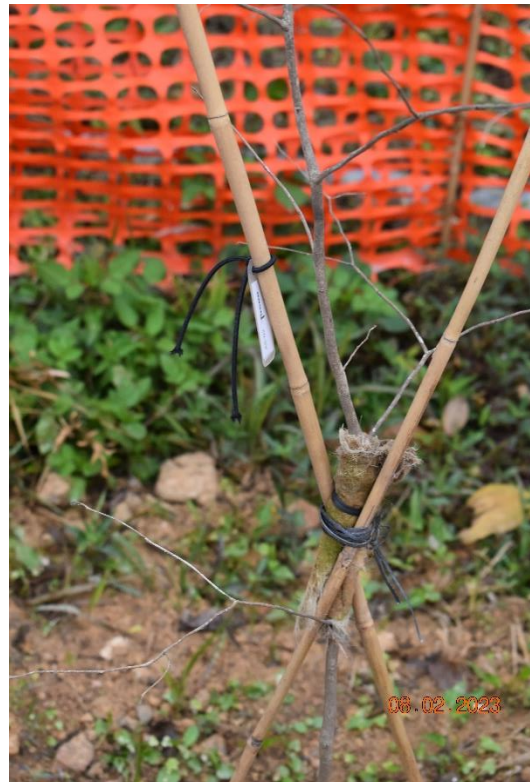
Photo B.1.4 : Branch condition of the transplanted individual AS-02.

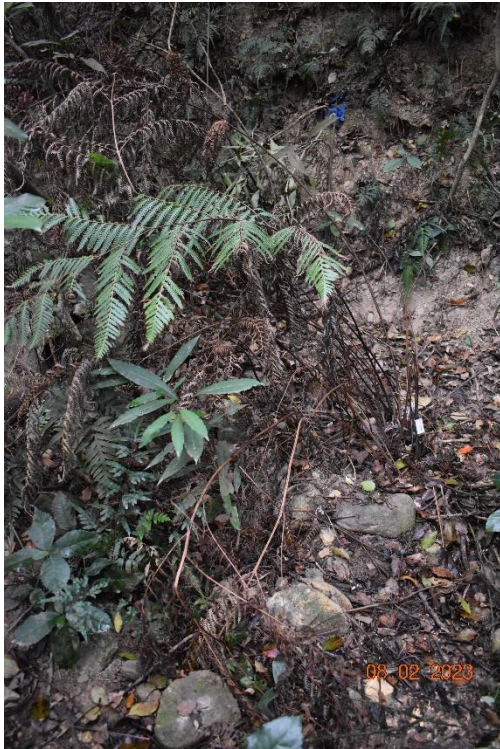
Photo B.2.1 : General view of the transplanted individual CB-01.

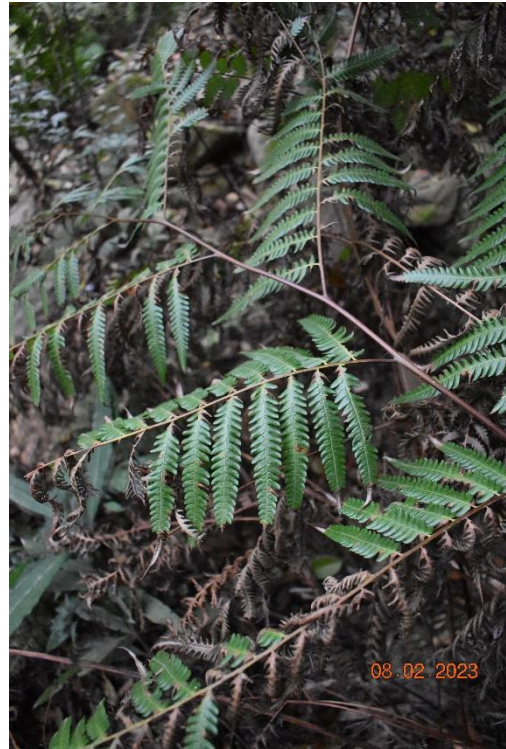
Photo B.2.2 : Leaf condition of the transplanted individual CB-01.

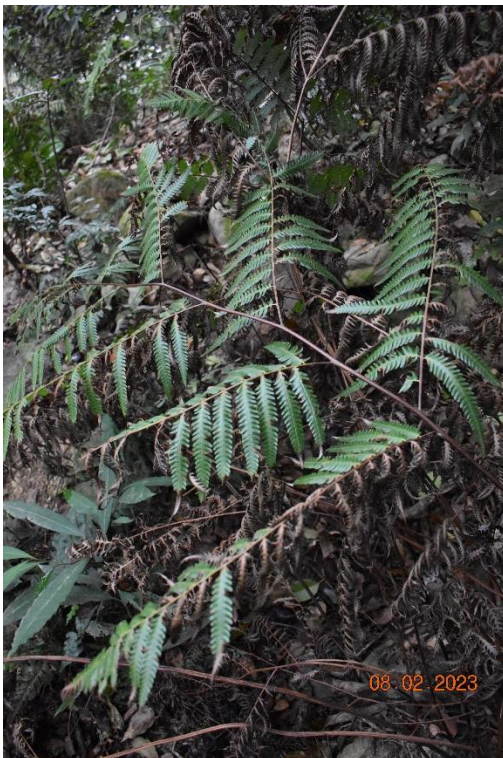
Photo B.2.3 : Leaf condition of the transplanted individual CB-01.

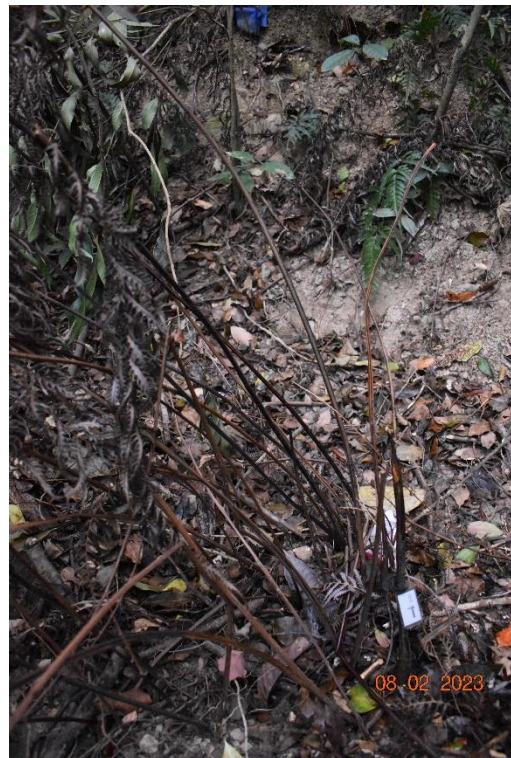
Photo B.2.4 : Stem condition of the transplanted individual CB-01.

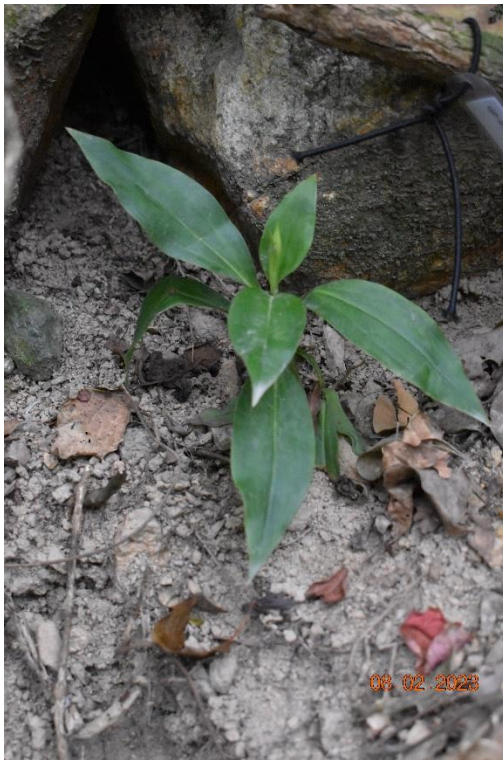
Photo B.3.1: Individual GP-01. Partially wilted leaf.

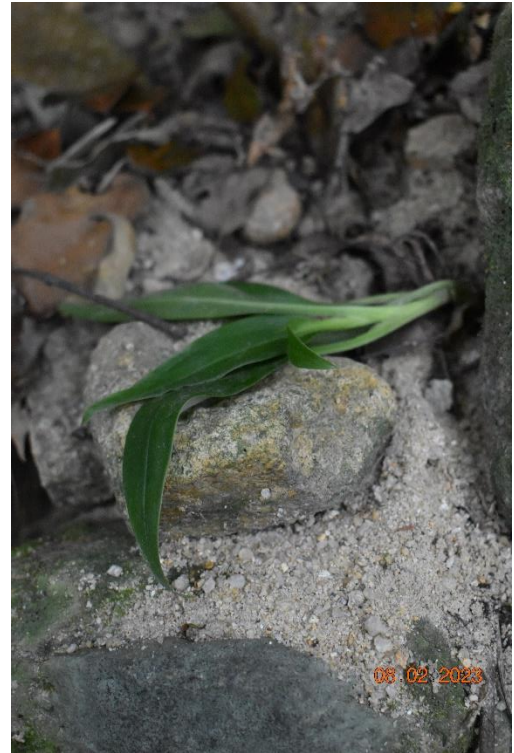
Photo B.3.2: Individual GP-02. Leaning.

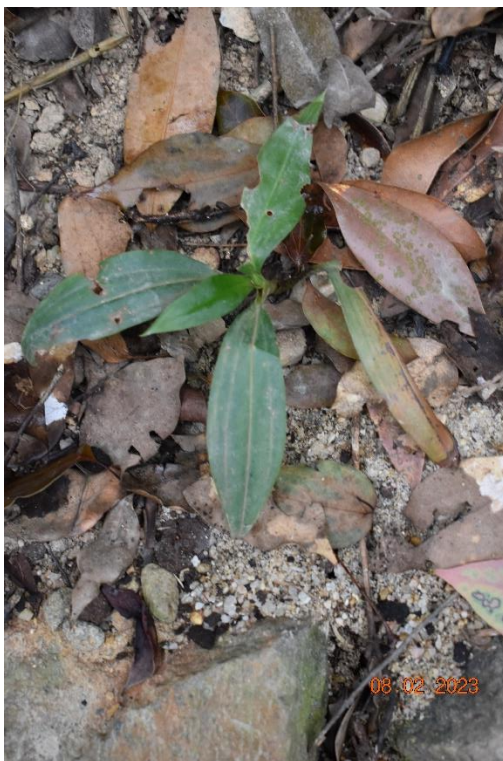
Photo B.3.3: Individual GP-03. Perforated leaves.

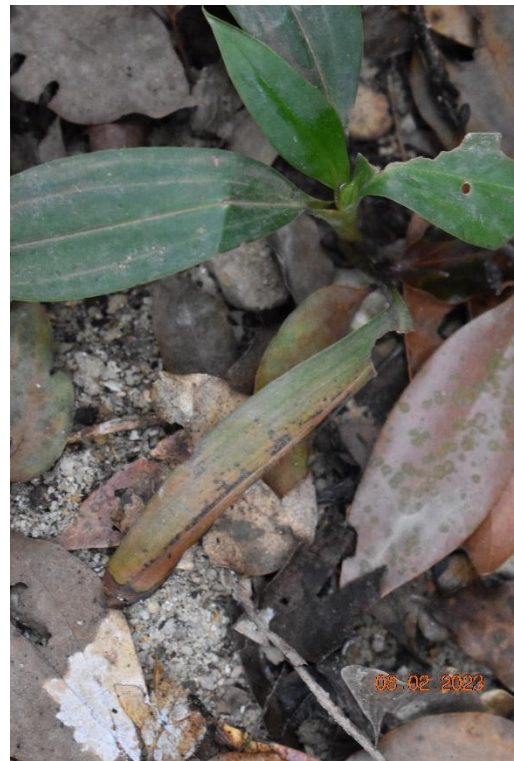
Photo B.3.4: Individual GP-03. Perforated leaves.

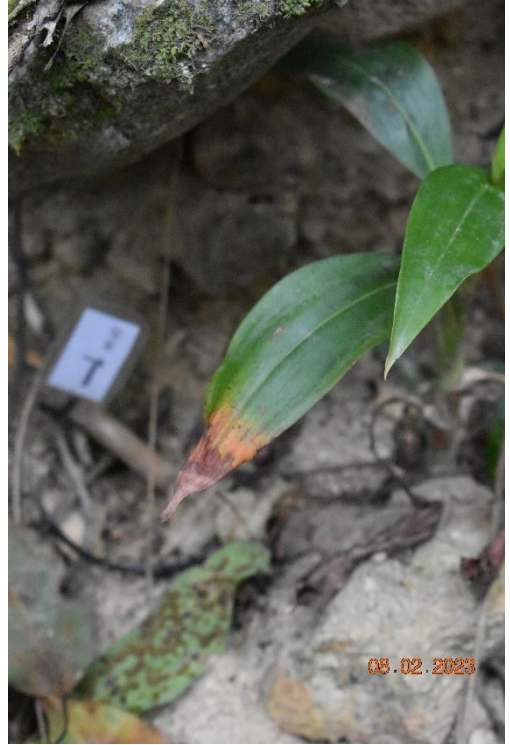
Photo B.3.6: Individual GP-04. Partially wilted leaves.

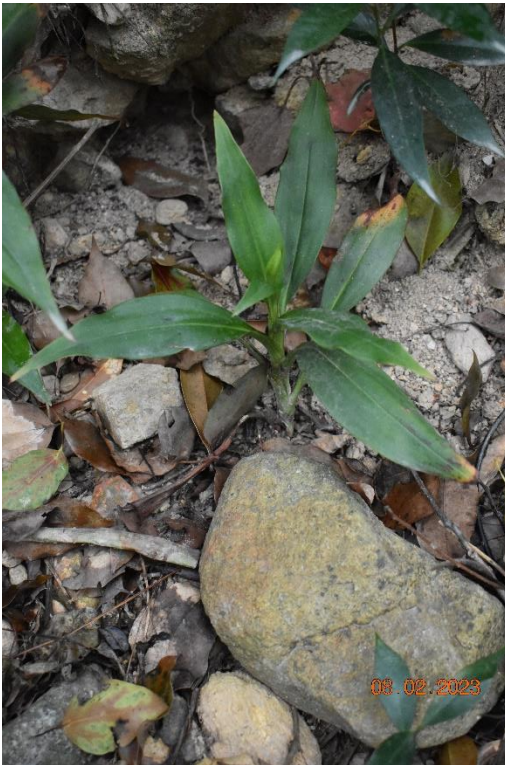
Photo B.3.7: Individual GP-05. Partially wilted leaf.

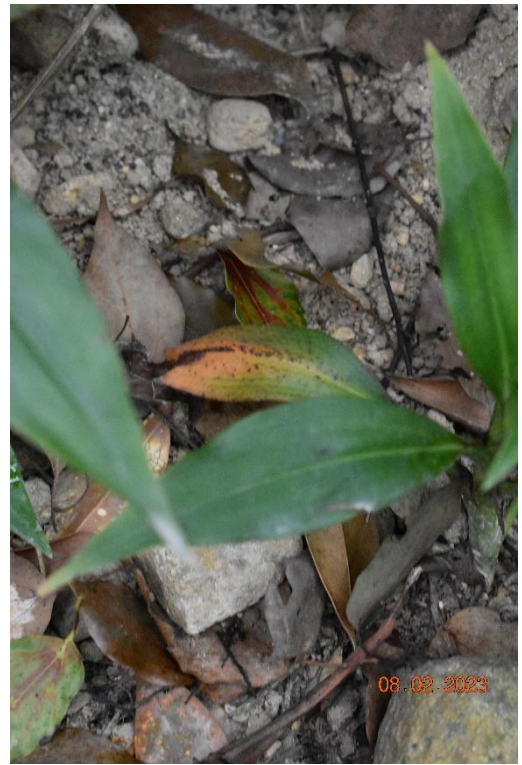
Photo B.3.8: Individual GP-05. Partially wilted leaf.

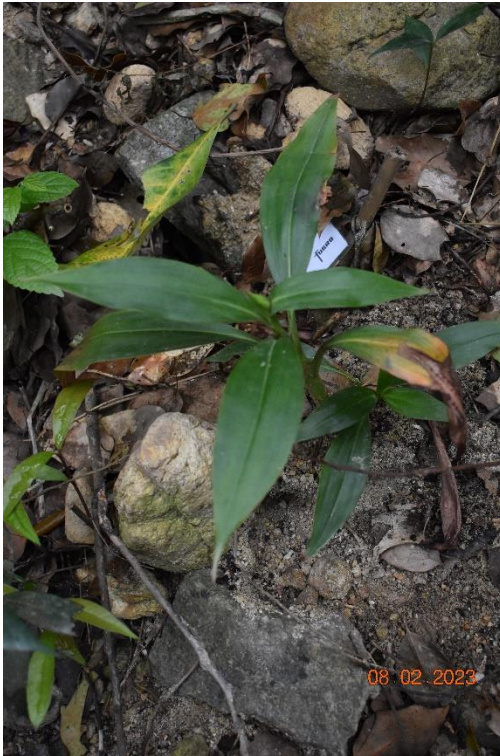
Photo B.3.9: Individual GP-06. Partially wilted leaf.

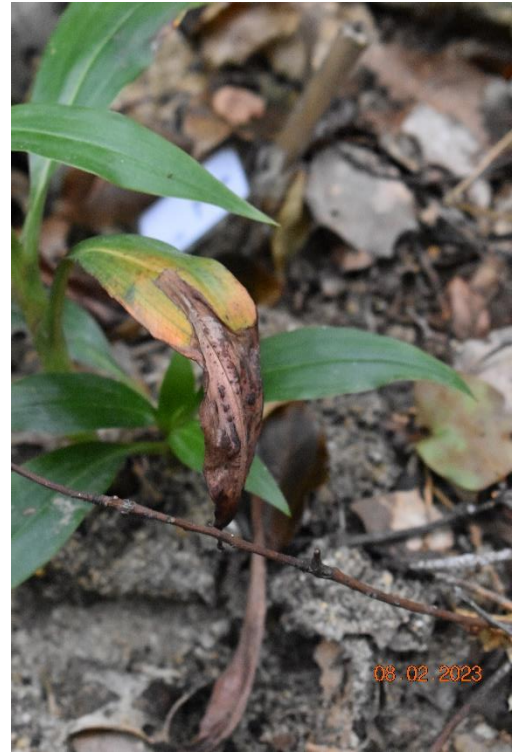
Photo B.3.10: Individual GP-06. Partially chlorotic and wilted leaf.

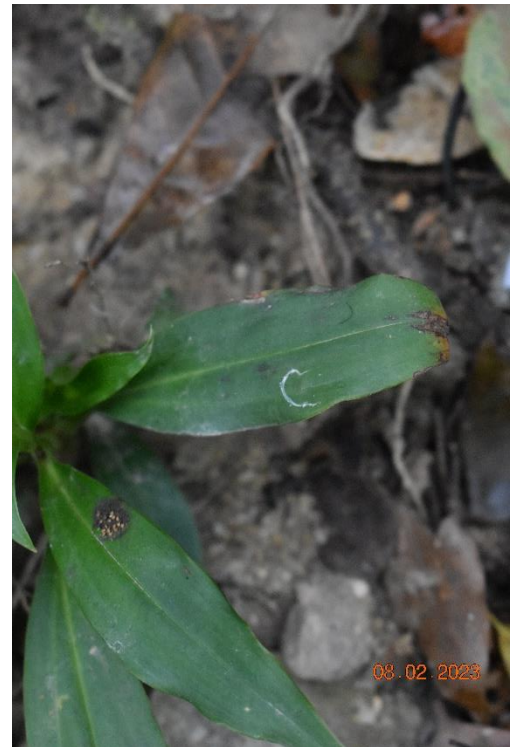
Photo B.3.12: Individual GP-07. Pest sign.

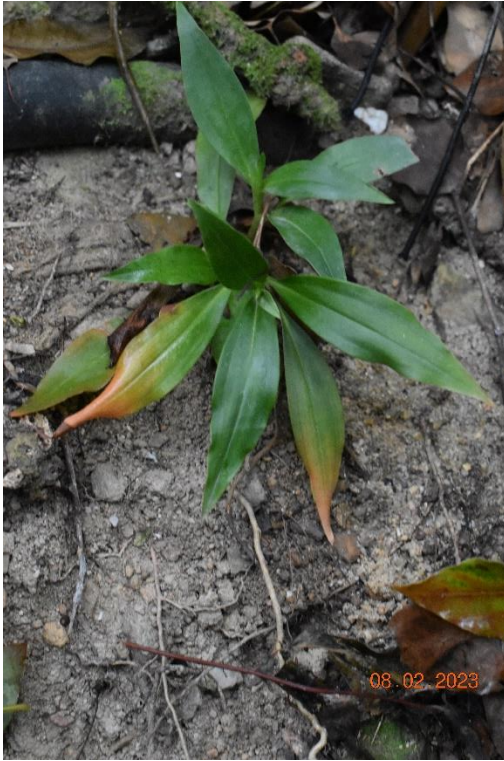
Photo B.3.13: Individual GP-08. Chlorotic leaves.

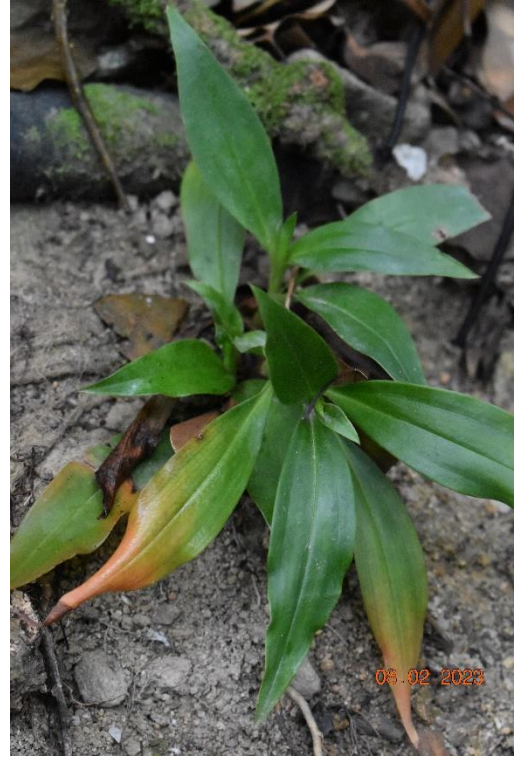
Photo B.3.14: Individual GP-08. Minor chlorotic leaves.

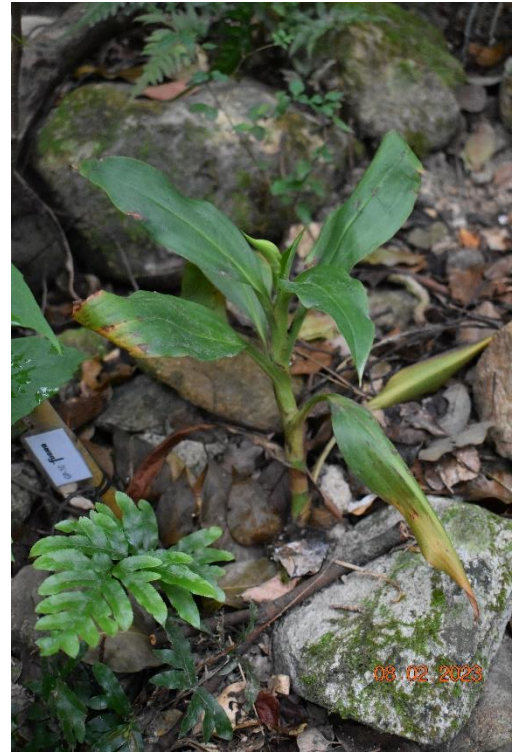
Photo B.3.16: Individual GP-10. Holes in leaves.

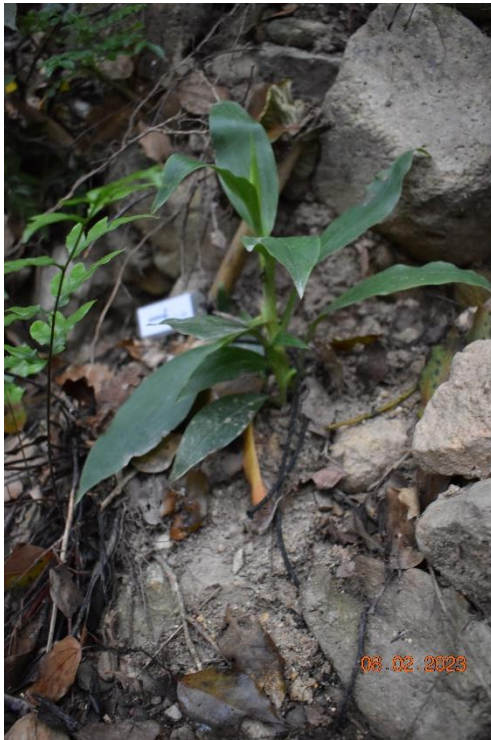
Photo B.3.17: Individual GP-11. Partially wilted leaves.

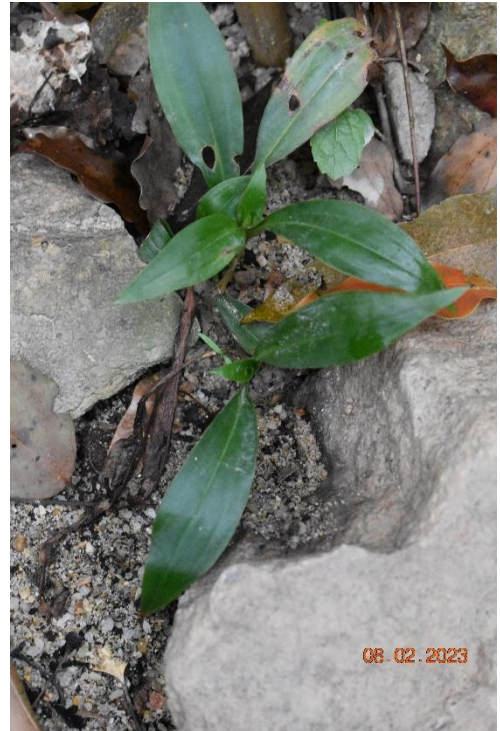
Photo B.3.18: Individual GP-12. Perforated leaves.

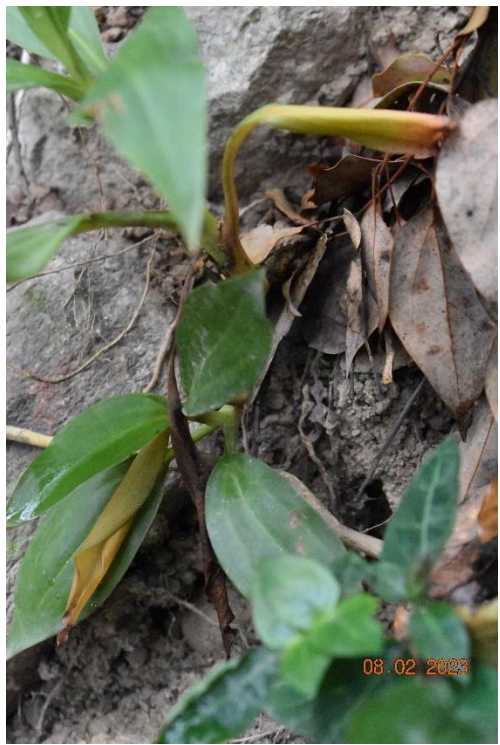
Photo B.3.20: Individual GP-14. Chlorotic leaves.

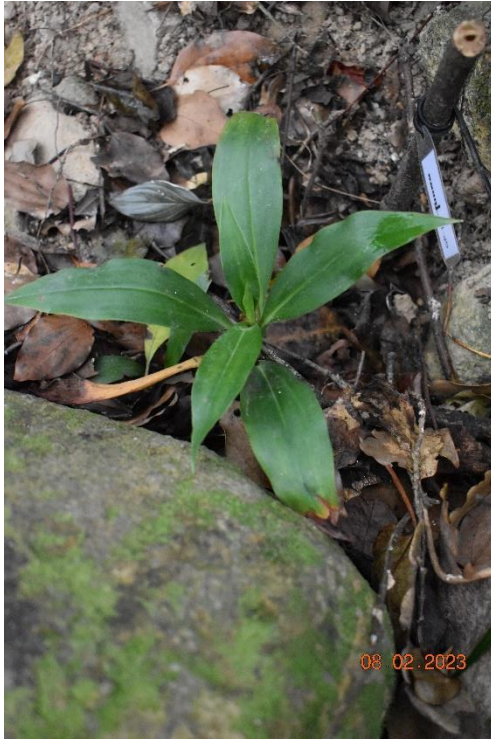
Photo B.3.21: Individual GP-15. Partially chlorotic leaves.

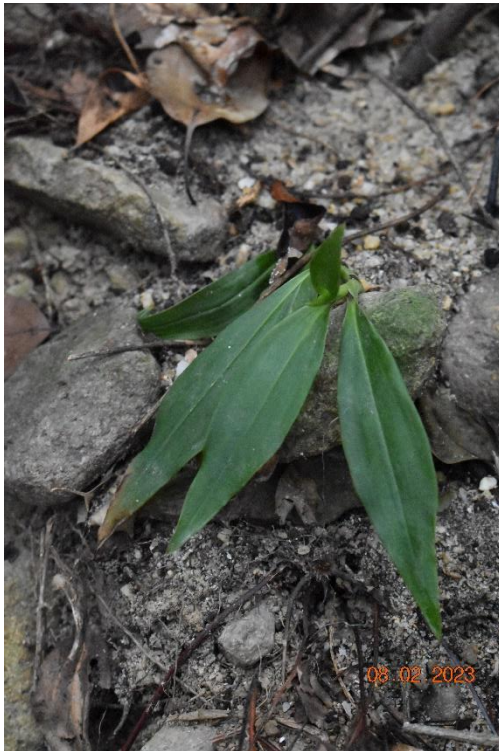
Photo B.3.23: Individual GP-17. Partially wilted leaf.

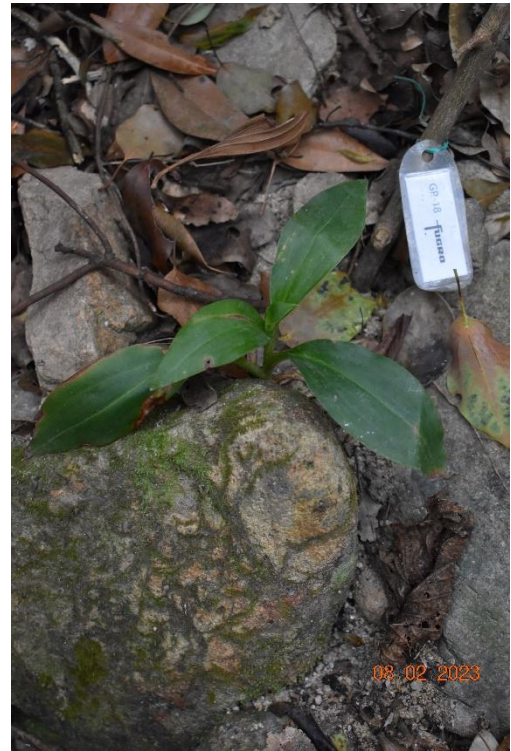
Photo B.3.24: Individual GP-18. Partially wilted leaves.

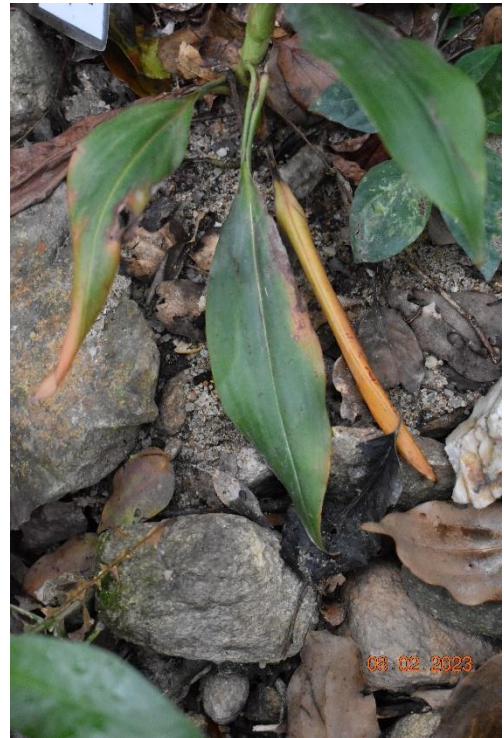
Photo B.3.26: Individual GP-19. Chlorotic and partially wilted leaves.
