7th Post-transplantation Monitoring and Audit Report (24th February 2023)

Northeast New Territories Landfill Extension (NENTX) | Contract No. EP/SP/77/15

0092/22/ED/0334 02 | 1 March 2023

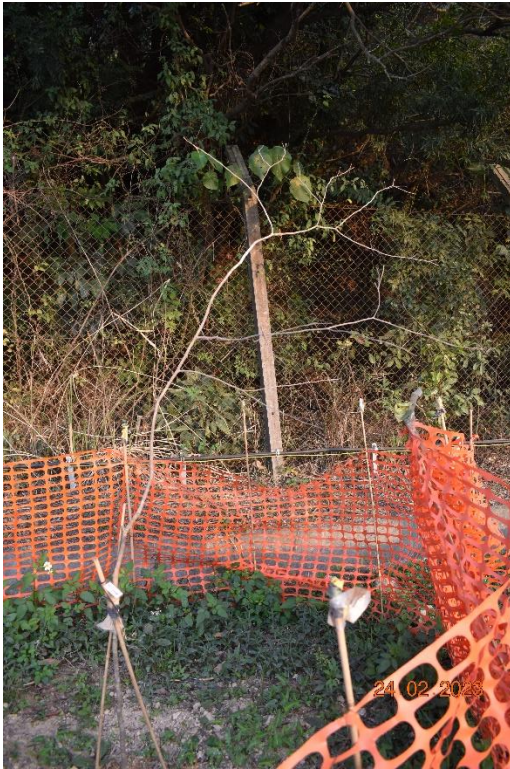
Photo B.1.1 : General view of the transplanted individual AS-03.

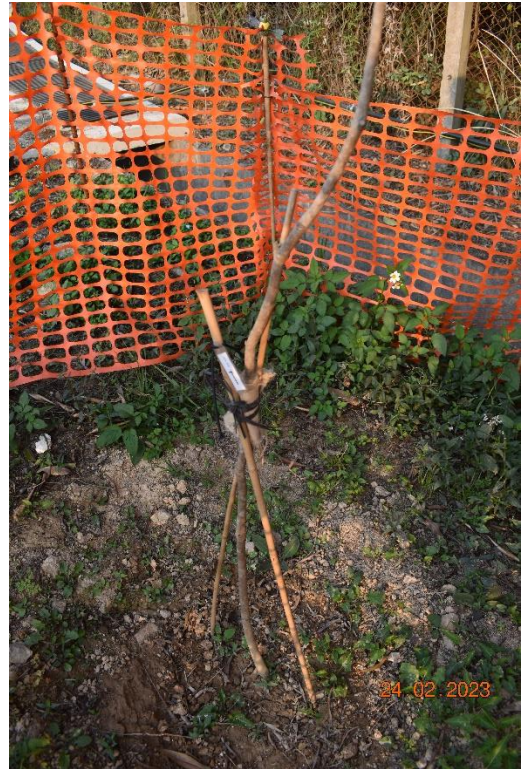
Photo B.1.2 : Stem condition of the transplanted individual AS-03.

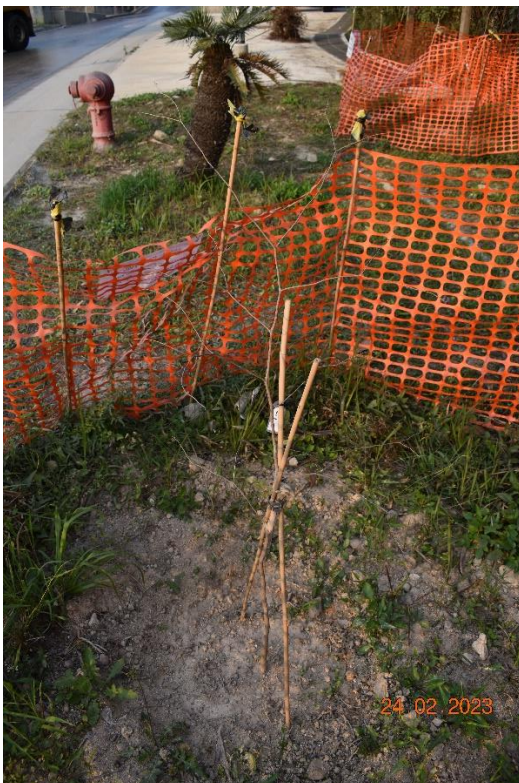
Photo B.1.3 : General view of the transplanted individual AS-02.

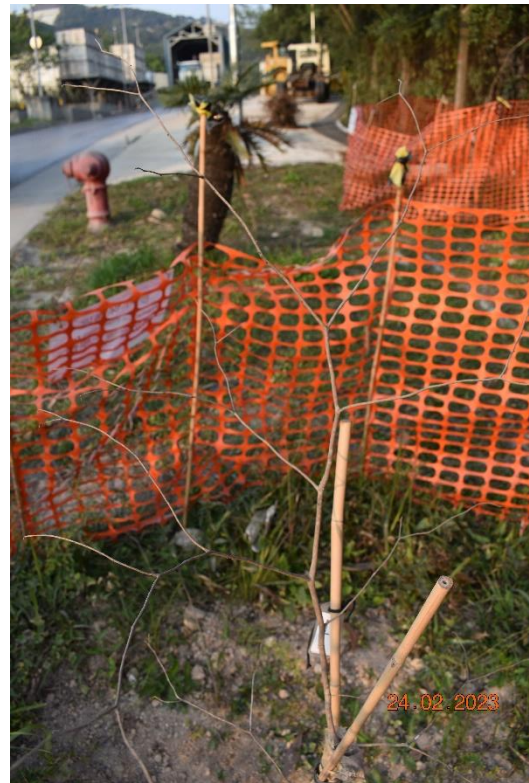
Photo B.1.4 : Branch condition of the transplanted individual AS-02.

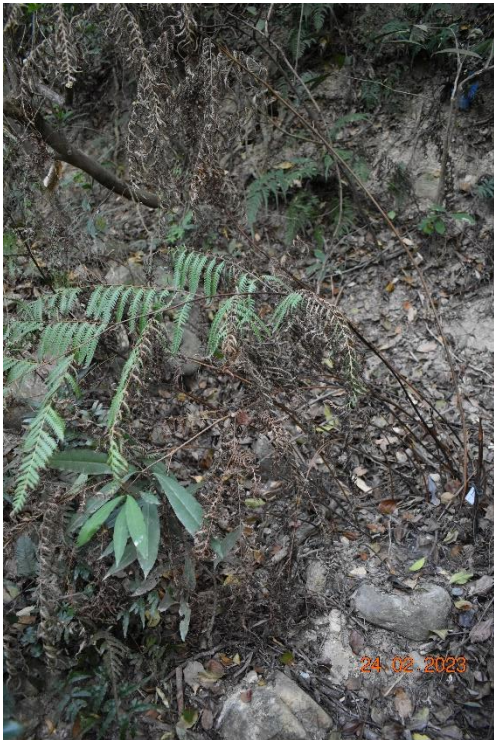
Photo B.2.1. : General view of the transplanted individual CB-01.

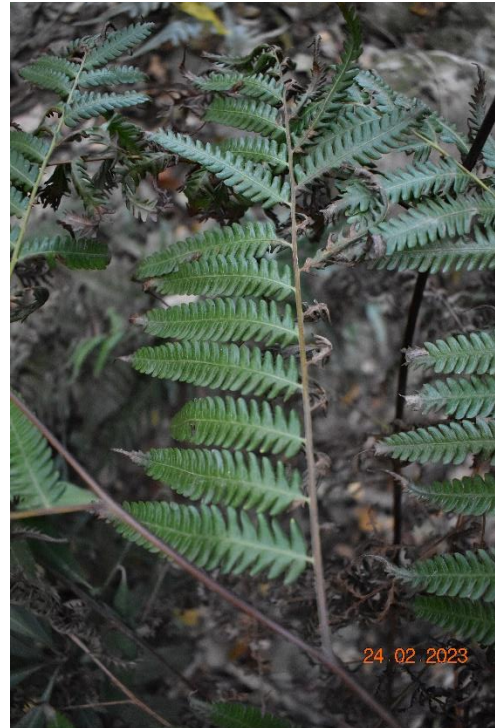
Photo B.2.2. : Leaf condition of the transplanted individual CB-01.

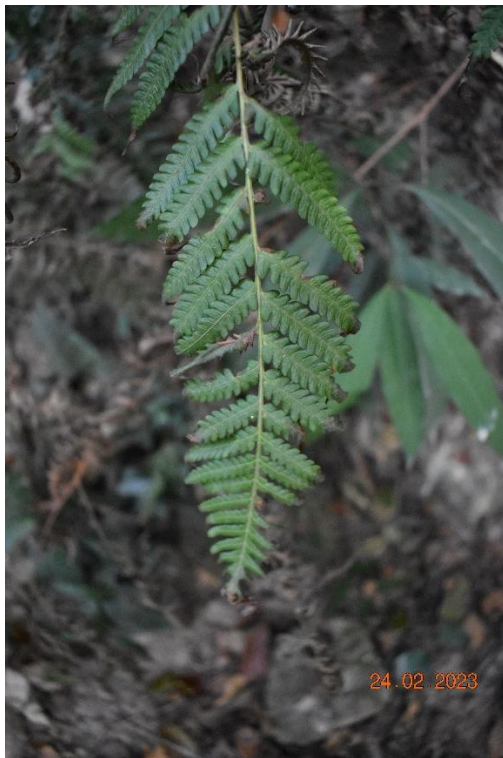
Photo B.2.3. : Leaf condition of the transplanted individual CB-01.

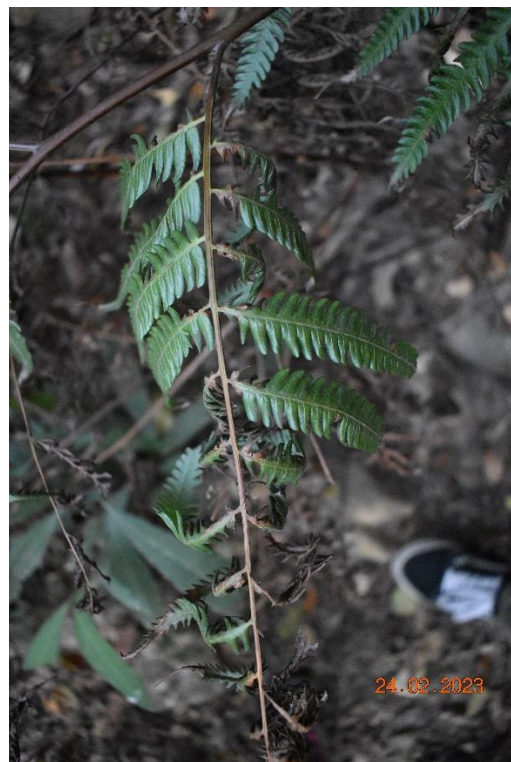
Photo B.2.4. : Stem condition of the transplanted individual CB-01.

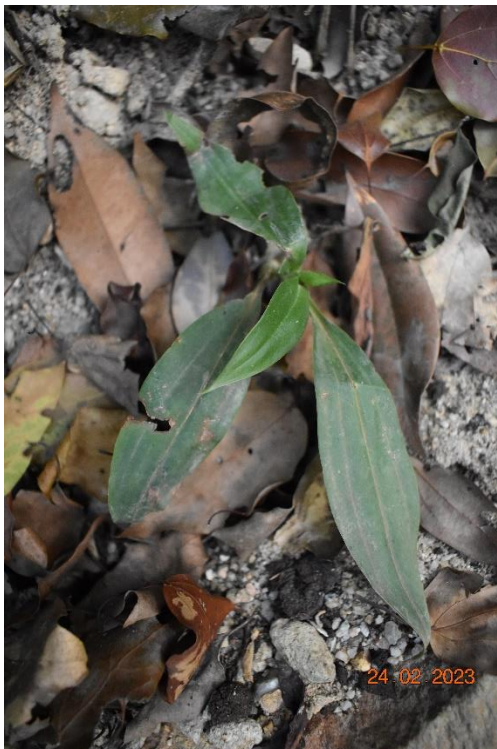
Photo B.3.3: Individual GP-03. Perforated leaves.

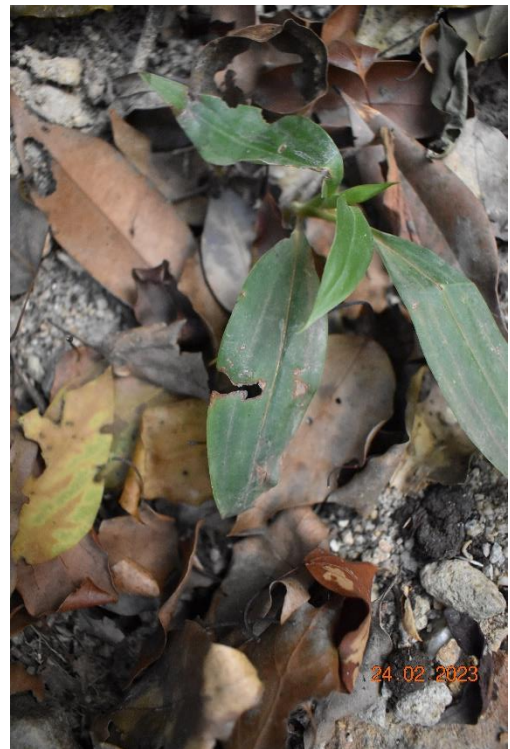
Photo B.3.4: Individual GP-03. Perforated leaves.

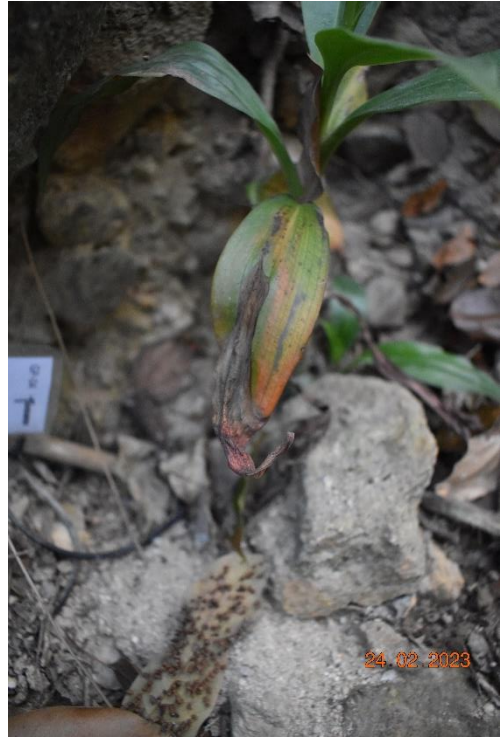
Photo B.3.6: Individual GP-04. Partially wilted leaves.

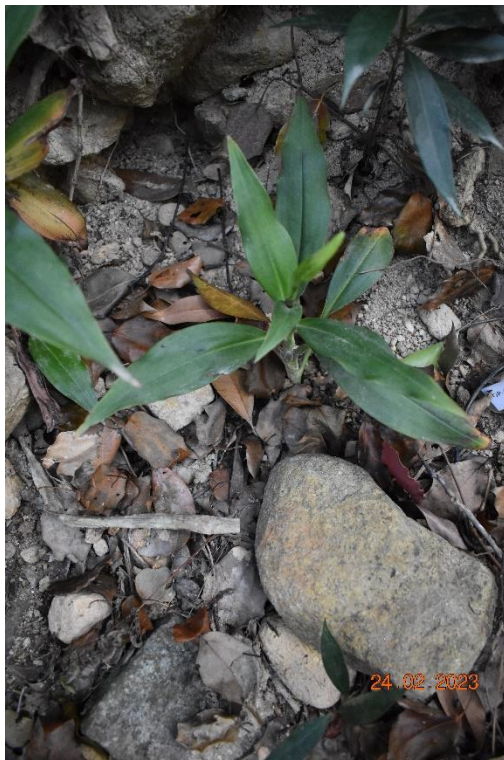
Photo B.3.7: Individual GP-05. Partially wilted leaf.

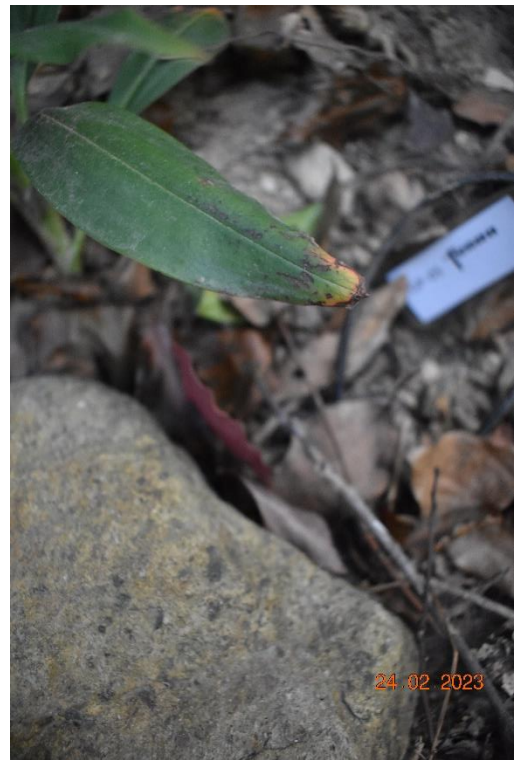
Photo B.3.8: Individual GP-05. Partially wilted leaf.

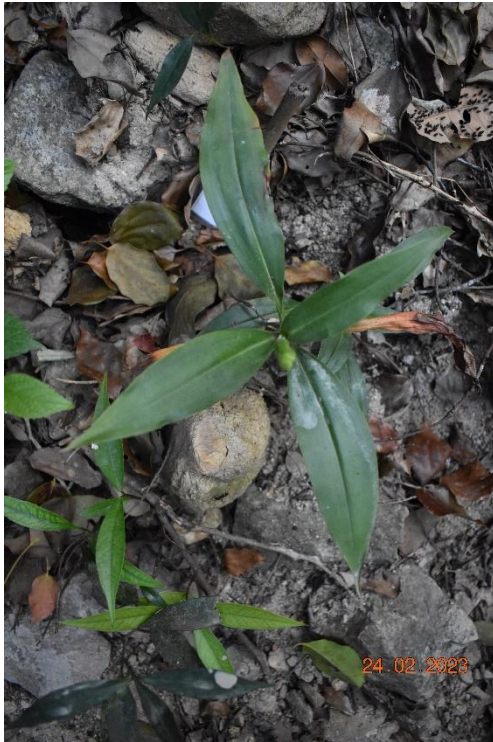
Photo B.3.9: Individual GP-06. Partially wilted leaf.

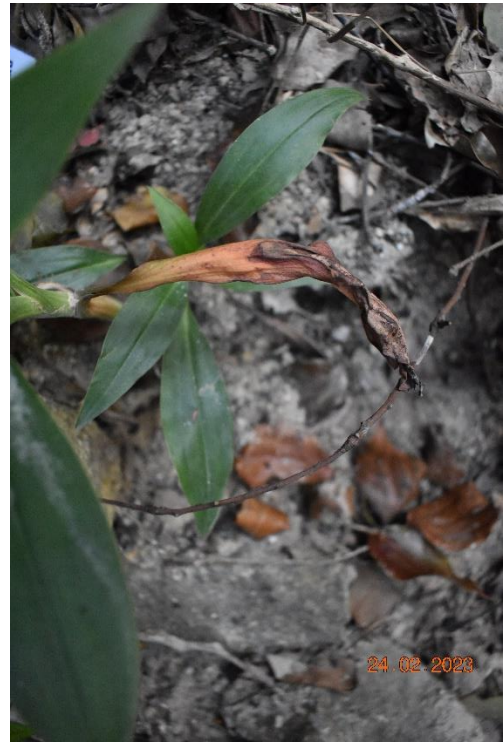
Photo B.3.10: Individual GP-06. Partially wilted leaf.

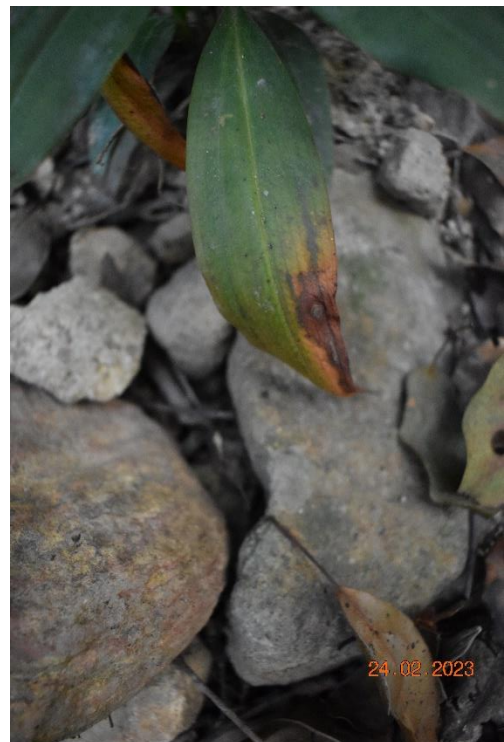
Photo B.3.12: Individual GP-07. Partially wilted leaf.

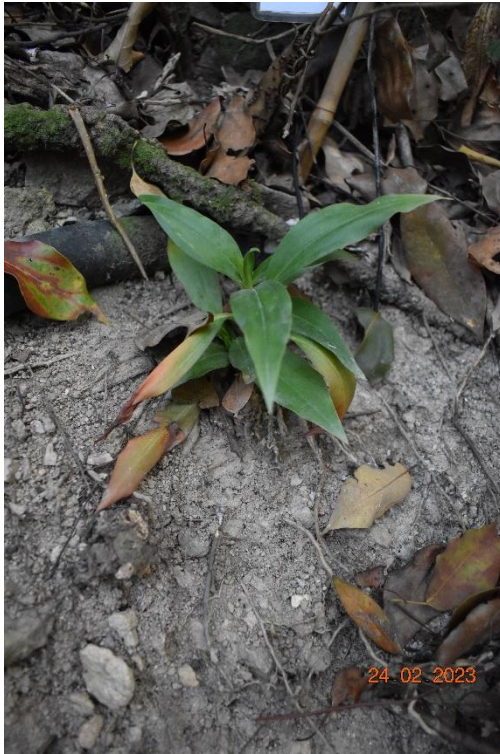
Photo B.3.13: Individual GP-08. Chlorotic leaves.

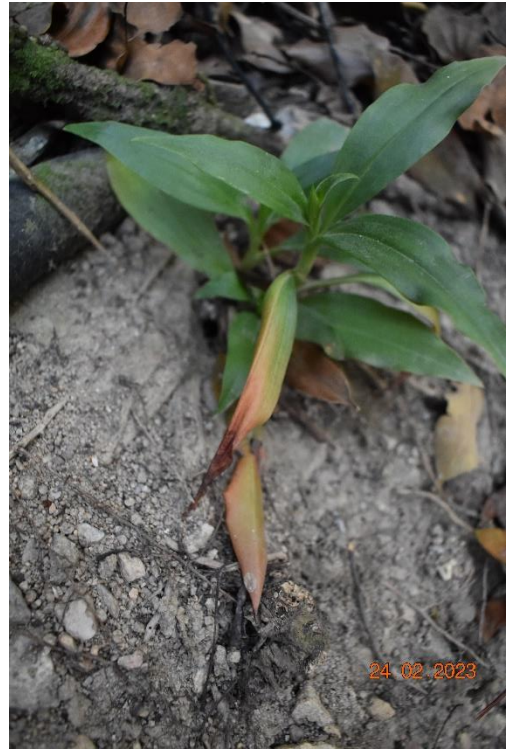
Photo B.3.14: Individual GP-08. Minor chlorotic leaves.

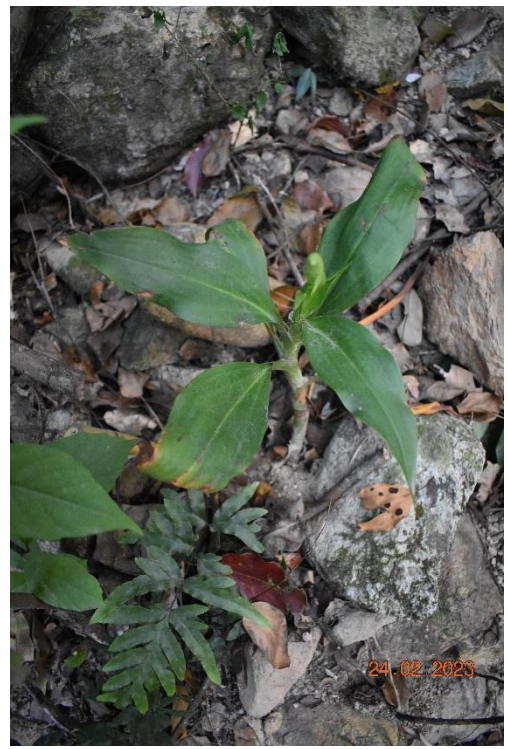
Photo B.3.16: Individual GP-10. Holes in leaves.

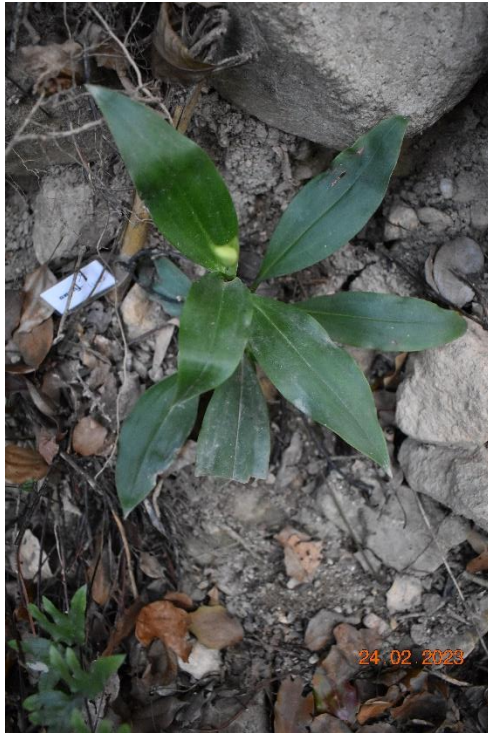
Photo B.3.17: Individual GP-11. Partially wilted leaves.

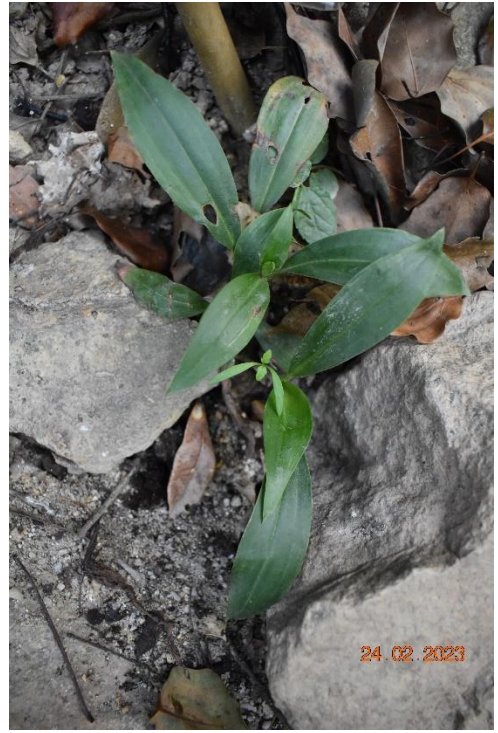
Photo B.3.18: Individual GP-12. Perforated leaves.

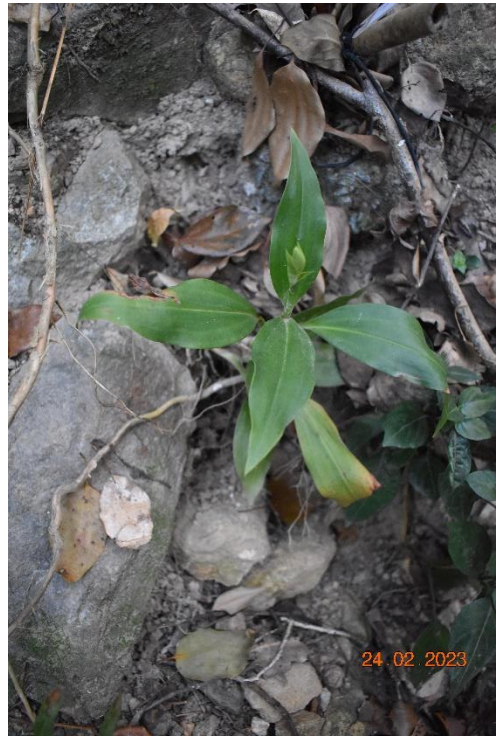
Photo B.3.20: Individual GP-14. Chlorotic leaves.

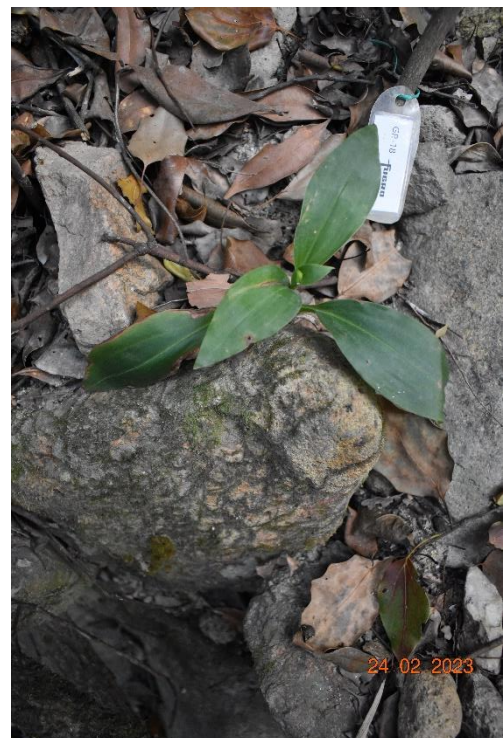
Photo B.3.24: Individual GP-18. Partially wilted leaves.

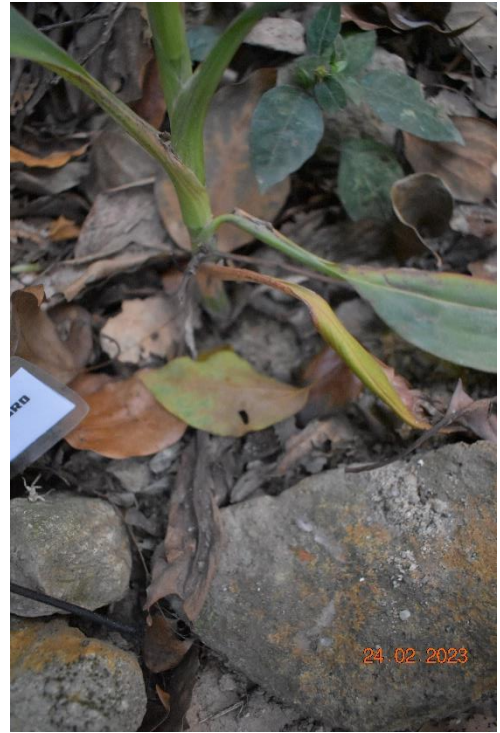
Photo B.3.26: Individual GP-19. Chlorotic leaves.
