8th Post-transplantation Monitoring and Audit Report (20th March 2023)

Northeast New Territories Landfill Extension (NENTX) | Contract No. EP/SP/77/15

0092/22/ED/0351 02 | 27 March 2023

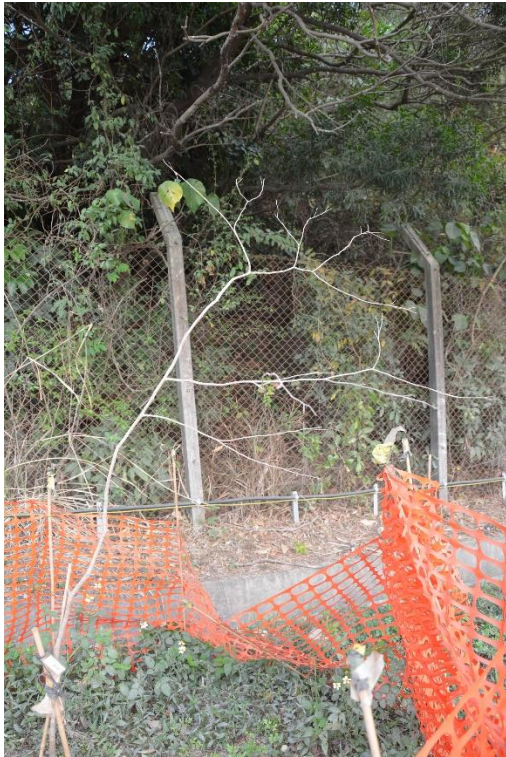
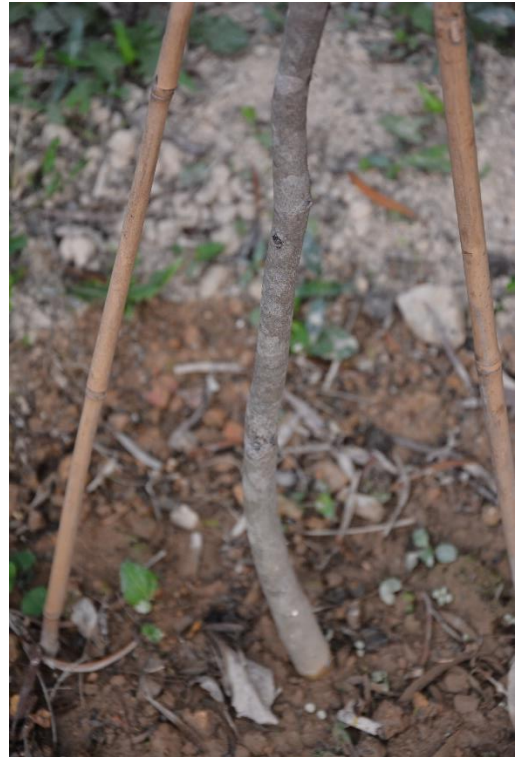
- 2.1.3 The two saplings of the Incense Tree *Aquilaria sinensis* also both demonstrated poor health conditions with die back and fallen leaves.
- 2.1.4 Albeit strict compliance of the transplantation works and post-transplantation maintenance to the approved Transplantation Proposal, transplanted individuals would require time to adapt and establish in the new environment/substrate of the receptor site. Hence, signs of leaf discoloration and/or wilting, dehydration, and even die-off are expected. Thus, succeeding post-transplantation maintenance and monitoring and audit are crucial to assess the progress of recovery and establishment of transplanted individuals in the receptor site.

| Date of Monitoring and Maintenance | Receptor Site | No. | Species | Plant Size Measurements | | | Amenity Value (High/ Medium/ Low) | Form (Good/ Fair/ Poor) | Health Condition (Good/ Fair/ Poor) | Structural Condition (Good/ Fair/ Poor) | Recommendation on Post-Transplantation Maintenance | Key Maintenance Activities Conducted | Remark |
|---|---|---|---|---|---|---|---|---|--|--|--|---|---|
| 20/3/2023 | A | AS03 | A. sinensis | | | 1.75 | | | Poor | | | | No foliage, |

Photo B.1.1 : General view of the transplanted individual AS-03.

Photo B.1.2 : Stem condition of the transplanted individual AS-03.

- The watering frequency for the two saplings of Incense Tree should be maintained at 2-3 times a week. Improve/place organic mulch around the two saplings of Incense Tree to retain soil moisture, protect damaged roots against extreme temperatures, and improve soil quality.
- The watering frequency of the cluster of Lamb of Tartary should be maintained at twice a week. Wilted leaves and stems should be pruned away.
- The watering frequency for all 19 clusters of Bottlebrush Orchid should remain the same. During watering activities, the surrounding dead branches and dry leaves should be removed to ensure no plants are damaged by them.
- Markers should be placed around the Bottlebrush Orchid individuals to prevent people stepping on them by accident.

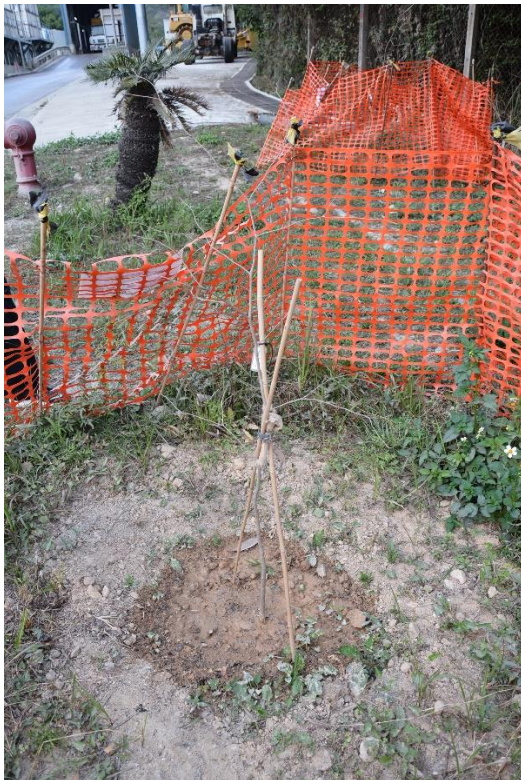
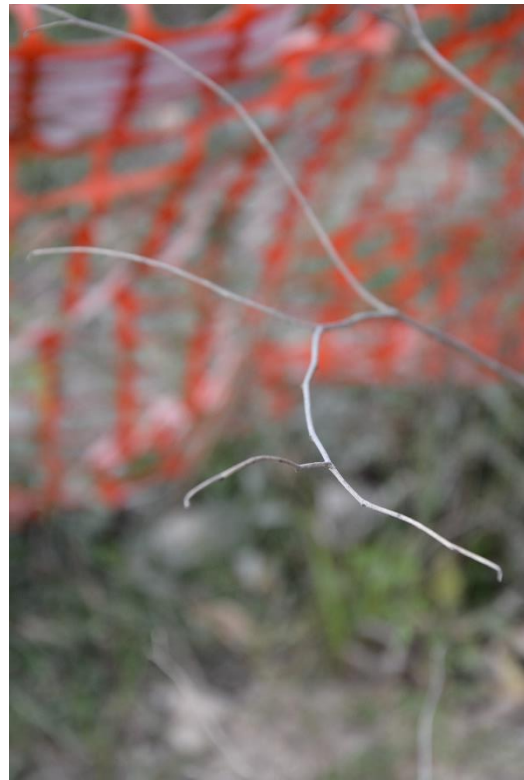
| Date of Monitoring and Maintenance | Receptor Site | No. | Species | Plant Size Measurements | | | Amenity Value (High/ Medium/ Low) | Form (Good/ Fair/ Poor) | Health Condition (Good/ Fair/ Poor) | Structural Condition (Good/ Fair/ Poor) | Recommendation on Post-Transplantation Maintenance | Key Maintenance Activities Conducted | Remark |
|---|---|---|---|---|---|---|---|---|--|--|--|---|---|
| 20/3/2023 | A | AS02 | A. sinensis | | | 1.15 | | | Poor | | | | No foliage |

Photo B.1.3 : General view of the transplanted individual AS-02.

Photo B.1.4 : Branch condition of the transplanted individual AS-02.

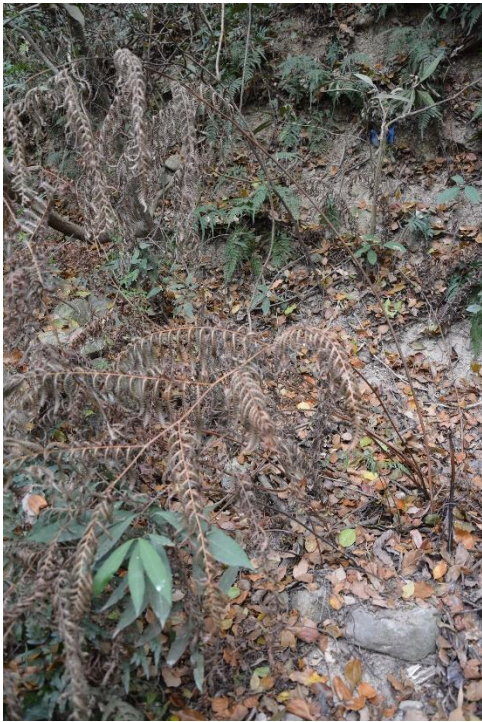
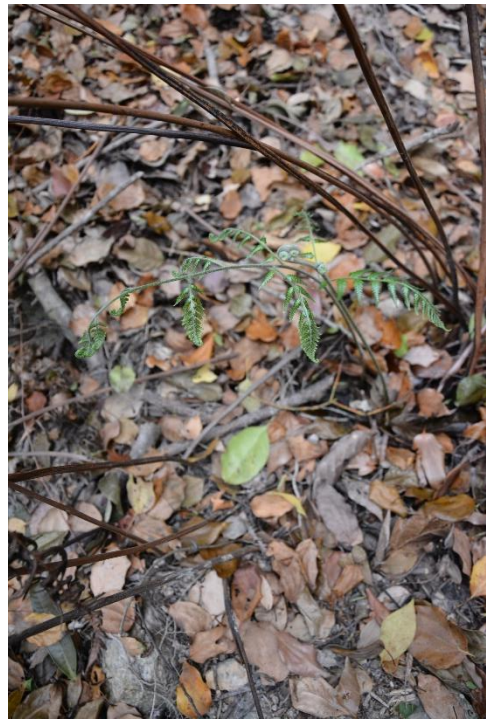
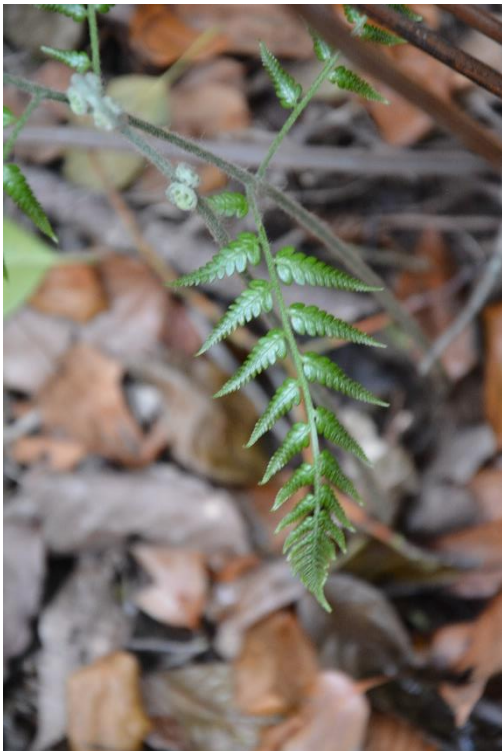
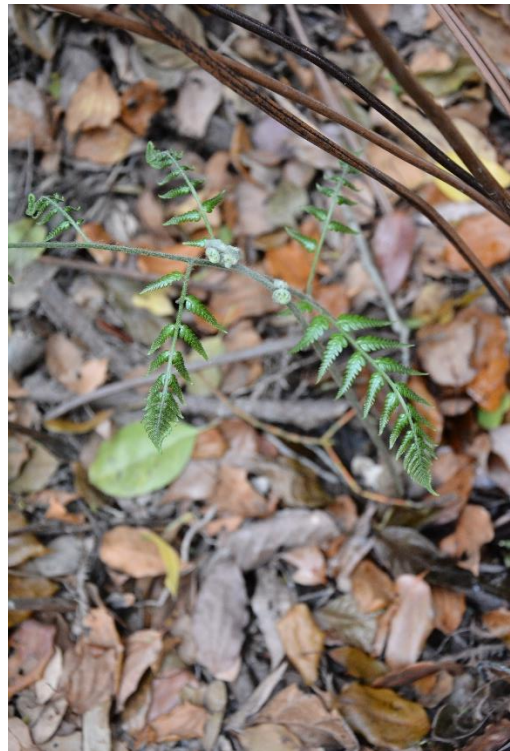
- 2.1.2 The Lamb of Tartary *Cibotium barometz*, however, exhibited discoloration and wilting of leaves. Its stems also showed some decay, but its roots were still in fair condition. The old foliage has wilted but new sprouts have started growing from the roots.

| Date of Monitoring and Maintenance | Receptor Site | No. | Species | Plant Size Measurements | | | Amenity Value (High/ Medium/ Low) | Form (Good/ Fair/ Poor) | Health Condition (Good/ Fair/ Poor) | Structural Condition (Good/ Fair/ Poor) | Recommendation on Post-Transplantation Maintenance | Key Maintenance Activities Conducted | Remark |
|---|---|---|---|---|---|---|---|---|--|--|--|---|---|
| 20/3/2023 | B | CB01 | C. barometz | | | 1.4 | | | Fair | | | | withered leaves, new plants |

Photo B.2.1 : General view of the transplanted individual CB-01.

Photo B.2.2 : New sprouts of the transplanted individual CB-01.

Photo B.2.3 : Leaf condition of the new sprout.

Photo B.2.4 : Leaf condition of the new sprout.

- 4.1.2 It is recommended to pay additional attention to the health conditions of the Lamb of Tartary cluster and the Incense Tree saplings. Moreover, should there be drastic change in the health conditions of these individuals observed during post-transplantation maintenance activities, the Contractor is advised to immediately advise the ecologist to discuss possible remedial actions.

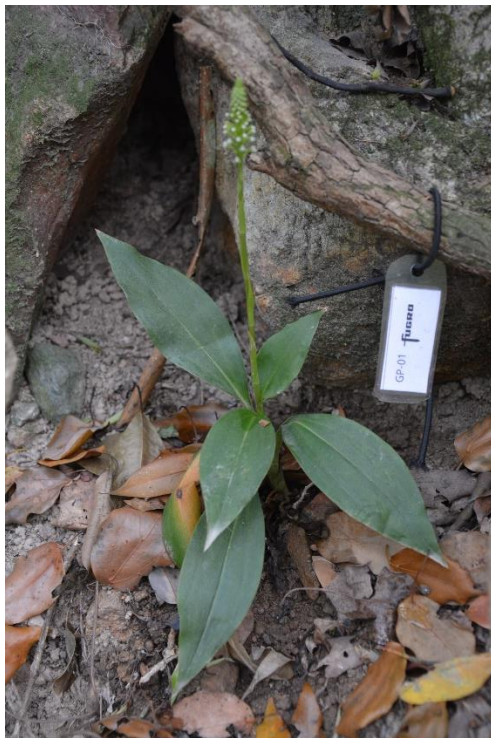
| Date of Monitoring and Maintenance | Receptor Site | No. | Species | Plant Size Measurements | | | Amenity Value (High/ Medium/ Low) | Form (Good/ Fair/ Poor) | Health Condition (Good/ Fair/ Poor) | Structural Condition (Good/ Fair/ Poor) | Recommendation on Post-Transplantation Maintenance | Key Maintenance Activities Conducted | Remark |
|---|---|---|---|---|---|---|---|---|--|--|--|---|---|
| 20/3/2023 | B | GP01 | G. procera | | | 0.2 | | | Fair | | | | Flowering chlorotic leaves |

Photo B.3.1: Individual GP-01. Flowering.

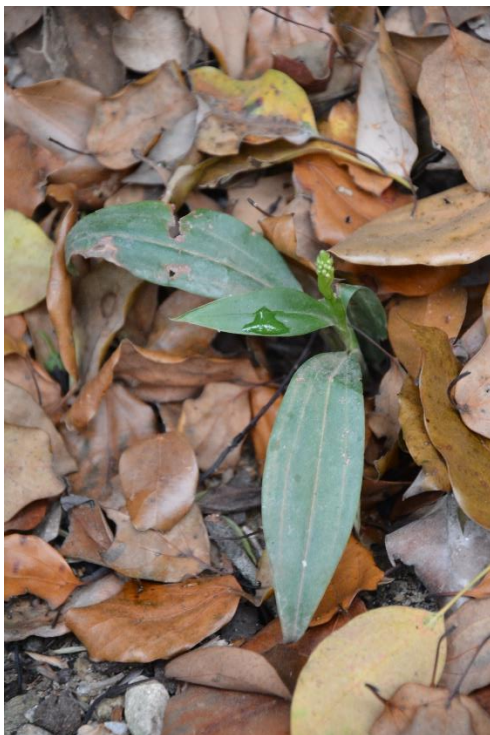
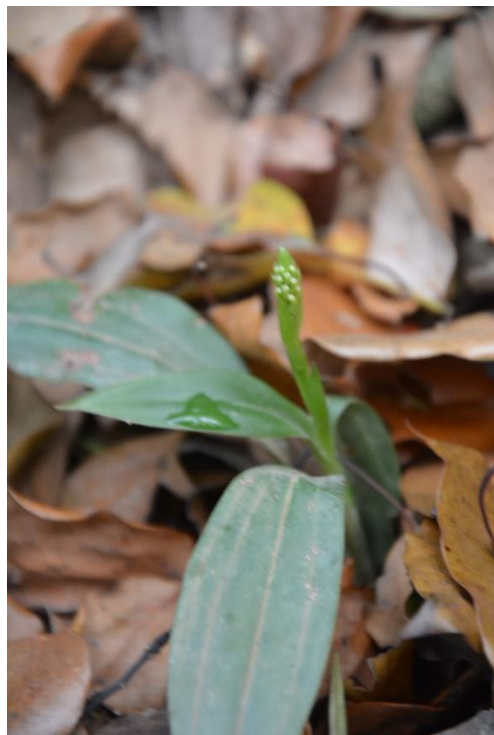
| Date of Monitoring and Maintenance | Receptor Site | No. | Species | Plant Size Measurements | | | Amenity Value (High/ Medium/ Low) | Form (Good/ Fair/ Poor) | Health Condition (Good/ Fair/ Poor) | Structural Condition (Good/ Fair/ Poor) | Recommendation on Post-Transplantation Maintenance | Key Maintenance Activities Conducted | Remark |
|---|---|---|---|---|---|---|---|---|--|--|--|---|---|
| 20/3/2023 | B | GP03 | G. procera | | | 0.08 | | | Fair | | | | beginning to flower holes in leaves |

Photo B.3.3: Individual GP-03. Perforated leaves.

Photo B.3.4: Individual GP-03. Beginning to flower.

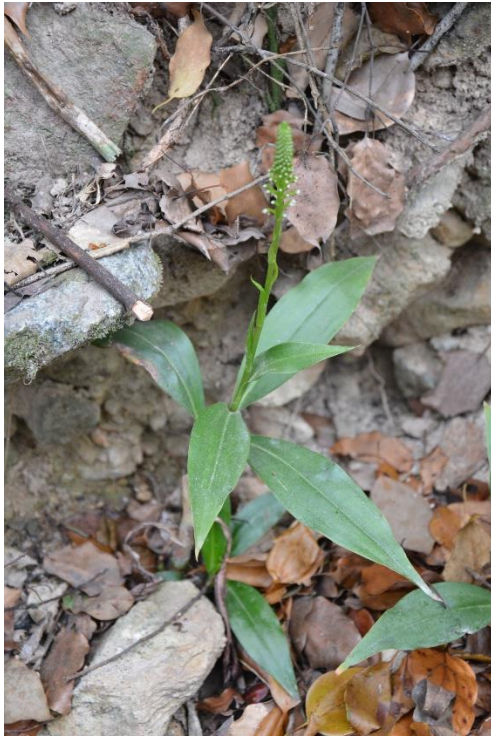
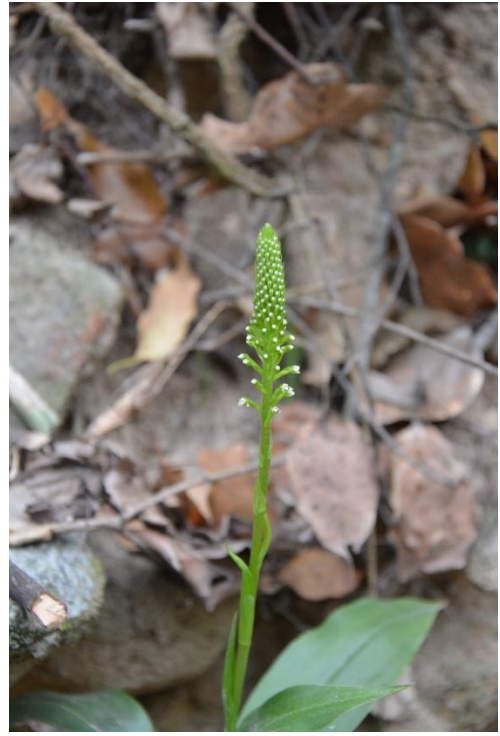
| Date of Monitoring and Maintenance | Receptor Site | No. | Species | Plant Size Measurements | | | Amenity Value (High/ Medium/ Low) | Form (Good/ Fair/ Poor) | Health Condition (Good/ Fair/ Poor) | Structural Condition (Good/ Fair/ Poor) | Recommendation on Post-Transplantation Maintenance | Key Maintenance Activities Conducted | Remark |
|---|---|---|---|---|---|---|---|---|--|--|--|---|---|
| 20/3/2023 | B | GP04 | G. procera | | | 0.3 | | | Fair | | | | Flowering, partially withered leaves |

Photo B.3.6: Individual GP-04. Flowering.

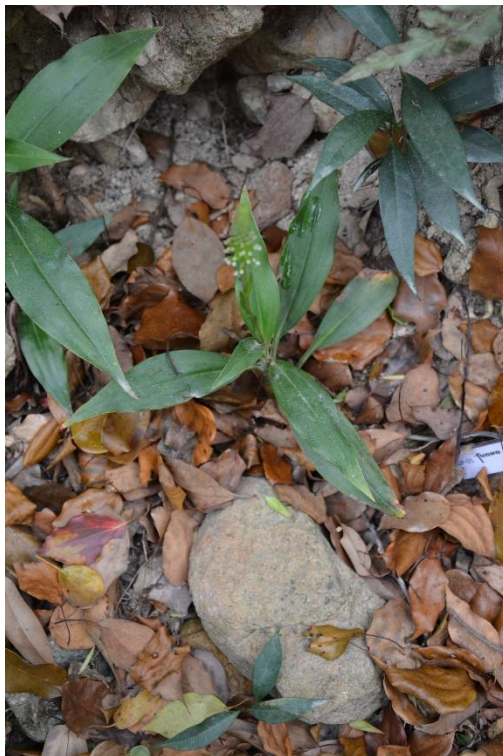
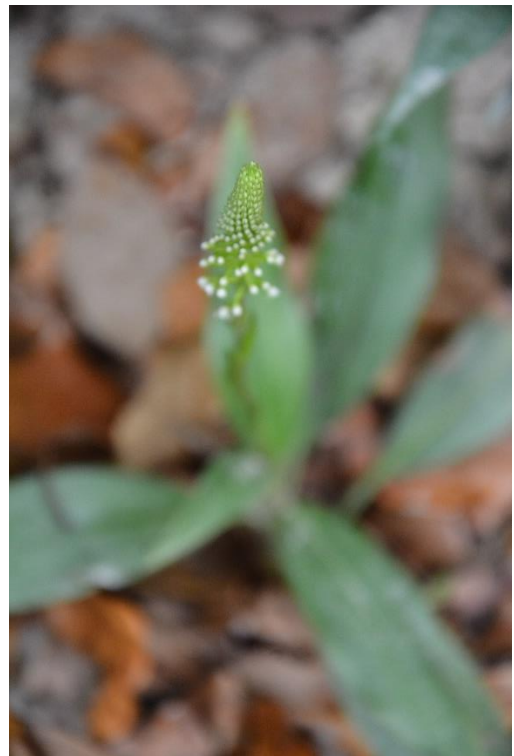
| Date of Monitoring and Maintenance | Receptor Site | No. | Species | Plant Size Measurements | | | Amenity Value (High/ Medium/ Low) | Form (Good/ Fair/ Poor) | Health Condition (Good/ Fair/ Poor) | Structural Condition (Good/ Fair/ Poor) | Recommendation on Post-Transplantation Maintenance | Key Maintenance Activities Conducted | Remark |
|---|---|---|---|---|---|---|---|---|--|--|--|---|---|
| 20/3/2023 | B | GP05 | G. procera | | | 0.21 | | | Fair | | | | Flowering, partially withered leaves |

Photo B.3.8: Individual GP-05. Flowering.

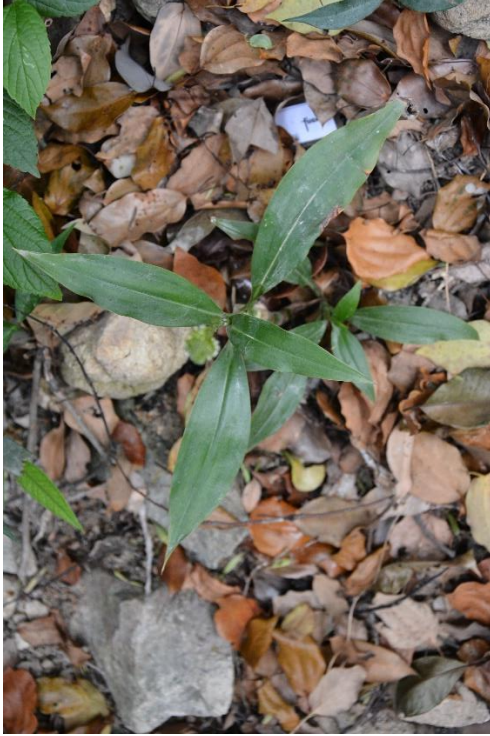
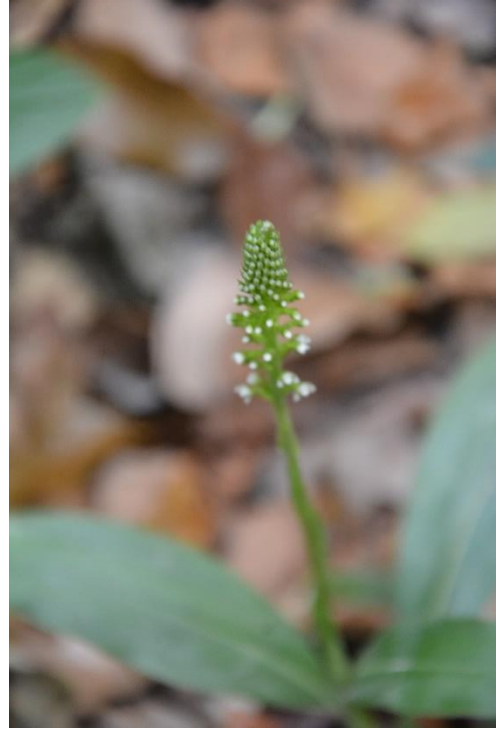
| Date of Monitoring and Maintenance | Receptor Site | No. | Species | Plant Size Measurements | | | Amenity Value (High/ Medium/ Low) | Form (Good/ Fair/ Poor) | Health Condition (Good/ Fair/ Poor) | Structural Condition (Good/ Fair/ Poor) | Recommendation on Post-Transplantation Maintenance | Key Maintenance Activities Conducted | Remark |
|---|---|---|---|---|---|---|---|---|--|--|--|---|---|
| 20/3/2023 | B | GP06 | G. procera | | | 0.2 | | | Fair | | | | Flowering withered leaves |

Photo B.3.10: Individual GP-06. Flowering.

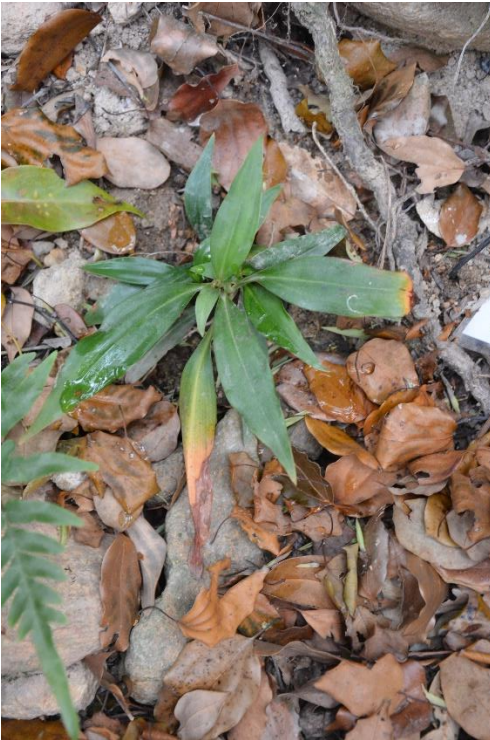
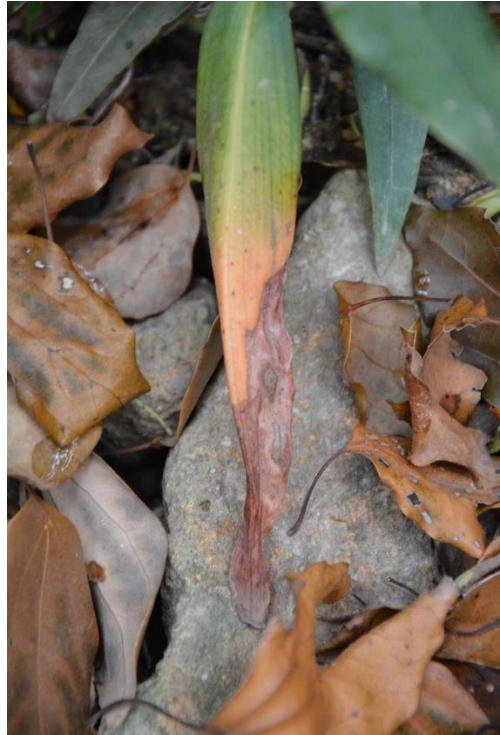
| Date of Monitoring and Maintenance | Receptor Site | No. | Species | Plant Size Measurements | | | Amenity Value (High/ Medium/ Low) | Form (Good/ Fair/ Poor) | Health Condition (Good/ Fair/ Poor) | Structural Condition (Good/ Fair/ Poor) | Recommendation on Post-Transplantation Maintenance | Key Maintenance Activities Conducted | Remark |
|---|---|---|---|---|---|---|---|---|--|--|--|---|---|
| 20/3/2023 | B | GP07 | G. procera | | | 0.13 | | | Fair | | | | chlorotic, leaves partially withered |

Photo B.3.12: Individual GP-07. Partially wilted leaf.

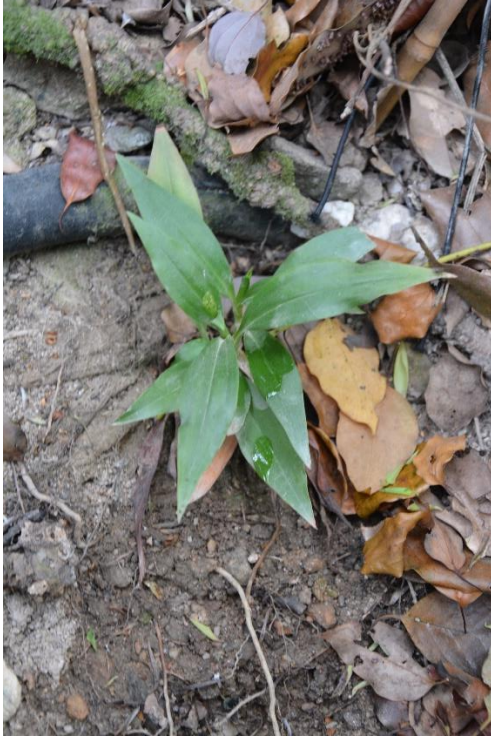
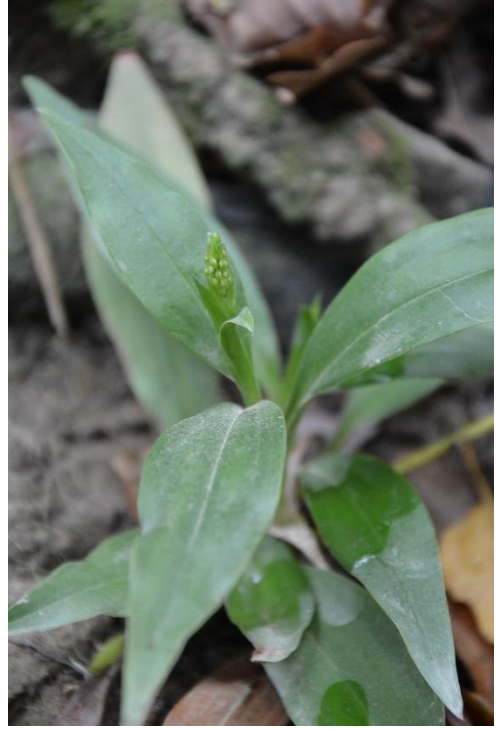
| Date of Monitoring and Maintenance | Receptor Site | No. | Species | Plant Size Measurements | | | Amenity Value (High/ Medium/ Low) | Form (Good/ Fair/ Poor) | Health Condition (Good/ Fair/ Poor) | Structural Condition (Good/ Fair/ Poor) | Recommendation on Post-Transplantation Maintenance | Key Maintenance Activities Conducted | Remark |
|---|---|---|---|---|---|---|---|---|--|--|--|---|---|
| 20/3/2023 | B | GP08 | G. procera | | | 0.12 | | | Fair | | | | Flowering withered leaves |

Photo B.3.14: Individual GP-08. Beginning to flower.

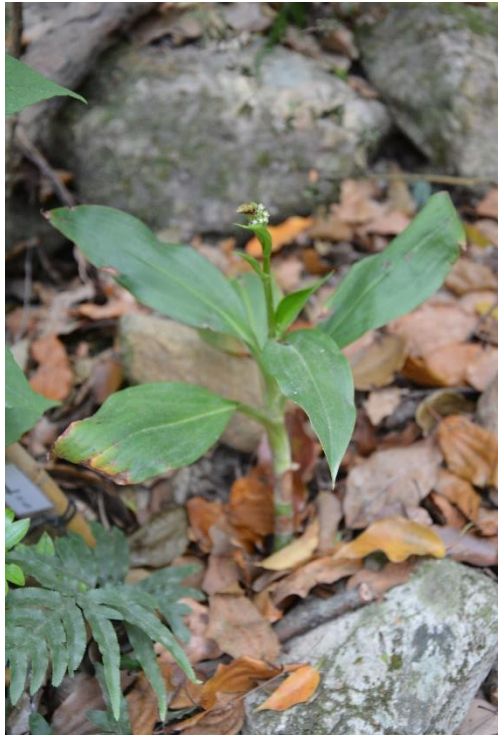
| Date of Monitoring and Maintenance | Receptor Site | No. | Species | Plant Size Measurements | | | Amenity Value (High/ Medium/ Low) | Form (Good/ Fair/ Poor) | Health Condition (Good/ Fair/ Poor) | Structural Condition (Good/ Fair/ Poor) | Recommendation on Post-Transplantation Maintenance | Key Maintenance Activities Conducted | Remark |
|---|---|---|---|---|---|---|---|---|--|--|--|---|---|
| 20/3/2023 | B | GP10 | G. procera | | | 0.25 | | | Fair | | | | Flowering, chlorotic leaves |

Photo B.3.16: Individual GP-10. Flowering.

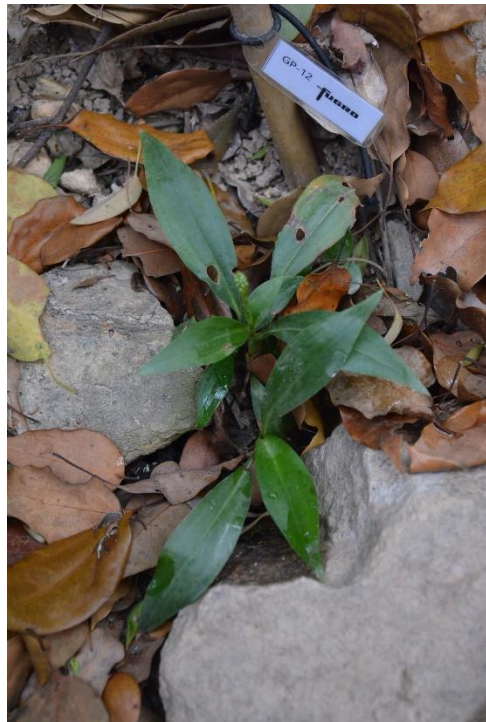
| Date of Monitoring and Maintenance | Receptor Site | No. | Species | Plant Size Measurements | | | Amenity Value (High/ Medium/ Low) | Form (Good/ Fair/ Poor) | Health Condition (Good/ Fair/ Poor) | Structural Condition (Good/ Fair/ Poor) | Recommendation on Post-Transplantation Maintenance | Key Maintenance Activities Conducted | Remark |
|---|---|---|---|---|---|---|---|---|--|--|--|---|---|
| 20/3/2023 | B | GP12 | G. procera | | | 0.08 | | | Fair | | | | Flowering, partially withered leaves |

Photo B.3.19: Individual GP-12. Flowering.

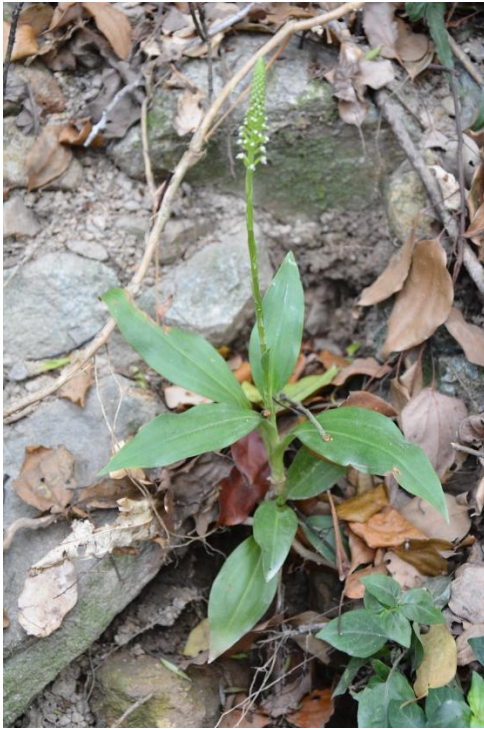
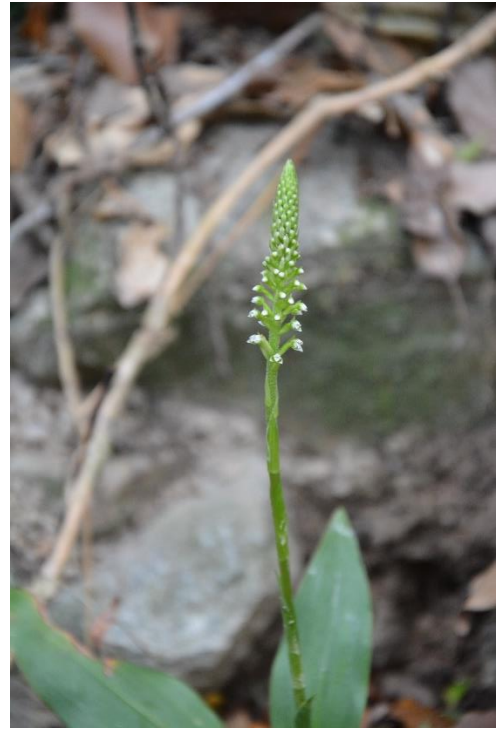
| Date of Monitoring and Maintenance | Receptor Site | No. | Species | Plant Size Measurements | | | Amenity Value (High/ Medium/ Low) | Form (Good/ Fair/ Poor) | Health Condition (Good/ Fair/ Poor) | Structural Condition (Good/ Fair/ Poor) | Recommendation on Post-Transplantation Maintenance | Key Maintenance Activities Conducted | Remark |
|---|---|---|---|---|---|---|---|---|--|--|--|---|---|
| 20/3/2023 | B | GP14 | G. procera | | | 0.18 | | | Fair | | | | Flowering, partially withered leaves |

Photo B.3.22: Individual GP-14. Flowering.

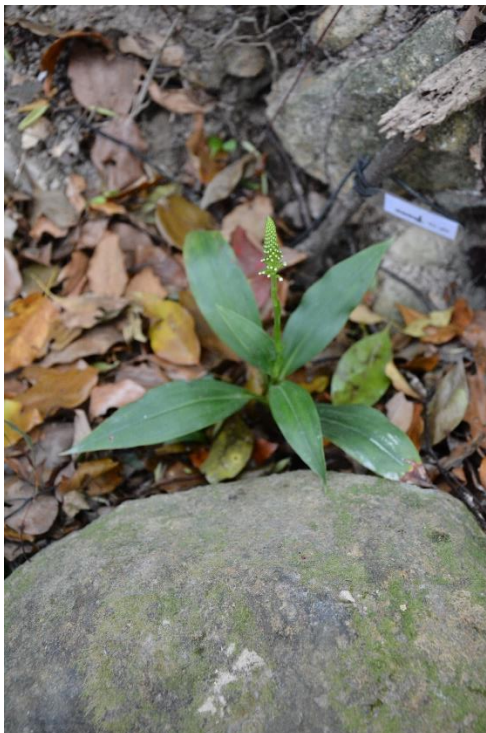
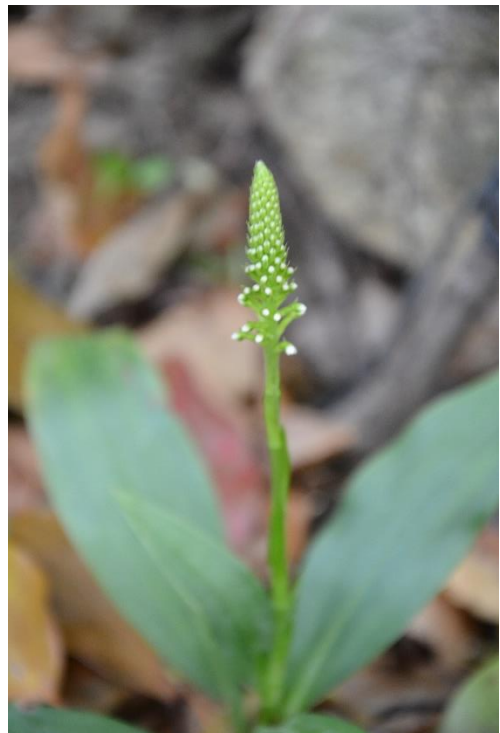
| Date of Monitoring and Maintenance | Receptor Site | No. | Species | Plant Size Measurements | | | Amenity Value (High/ Medium/ Low) | Form (Good/ Fair/ Poor) | Health Condition (Good/ Fair/ Poor) | Structural Condition (Good/ Fair/ Poor) | Recommendation on Post-Transplantation Maintenance | Key Maintenance Activities Conducted | Remark |
|---|---|---|---|---|---|---|---|---|--|--|--|---|---|
| 20/3/2023 | B | GP15 | G. procera | | | 0.15 | | | Fair | | | | Flowering, partially withered leaves |

Photo B.3.24: Individual GP-15. Flowering.

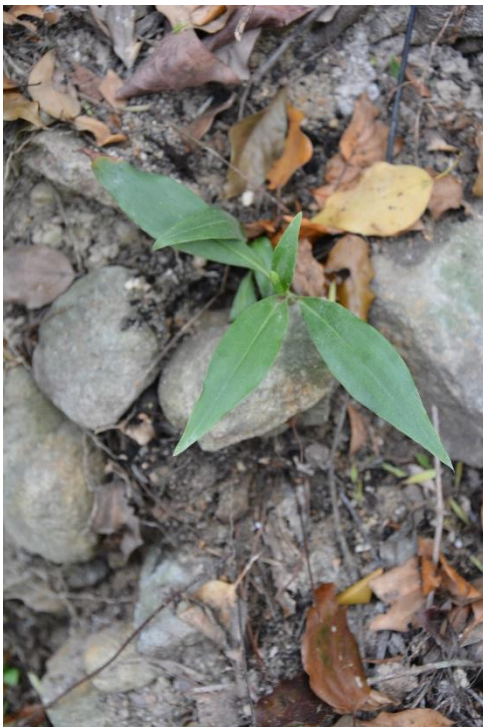
Photo B.3.27: Individual GP-17.

| Date of Monitoring and Maintenance | Receptor Site | No. | Species | Plant Size Measurements | | | Amenity Value (High/ Medium/ Low) | Form (Good/ Fair/ Poor) | Health Condition (Good/ Fair/ Poor) | Structural Condition (Good/ Fair/ Poor) | Recommendation on Post-Transplantation Maintenance | Key Maintenance Activities Conducted | Remark |
|---|---|---|---|---|---|---|---|---|--|--|--|---|---|
| 20/3/2023 | B | GP17 | G. procera | | | 0.10 | | | Fair | | | | partially withered leaves |

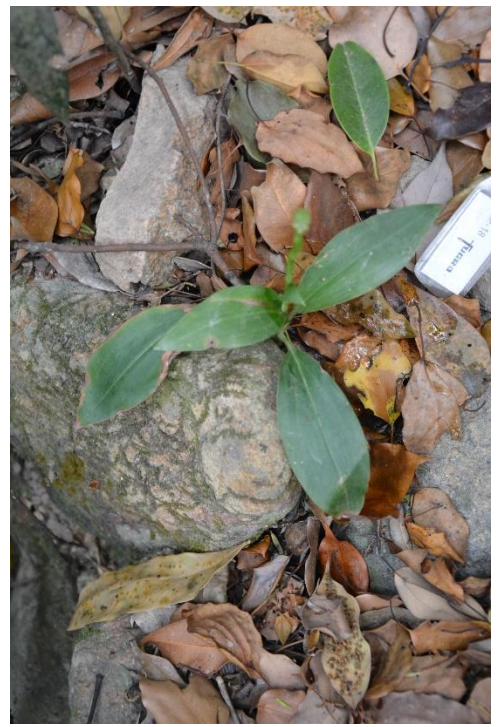
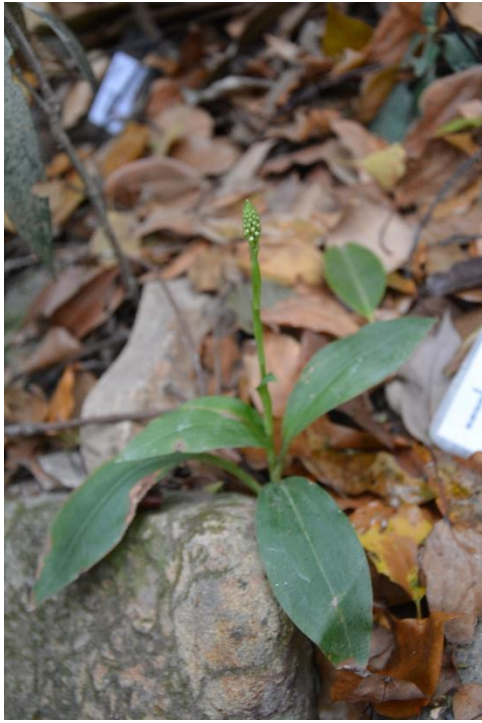
| Date of Monitoring and Maintenance | Receptor Site | No. | Species | Plant Size Measurements | | | Amenity Value (High/ Medium/ Low) | Form (Good/ Fair/ Poor) | Health Condition (Good/ Fair/ Poor) | Structural Condition (Good/ Fair/ Poor) | Recommendation on Post-Transplantation Maintenance | Key Maintenance Activities Conducted | Remark |
|---|---|---|---|---|---|---|---|---|--|--|--|---|---|
| 20/3/2023 | B | GP18 | G. procera | | | 0.11 | | | Fair | | | | beginning to flower partially withered leaves |

Photo B.3.28: Individual GP-18. Flowering.

Photo B.3.29: Individual GP-18. Flowering.

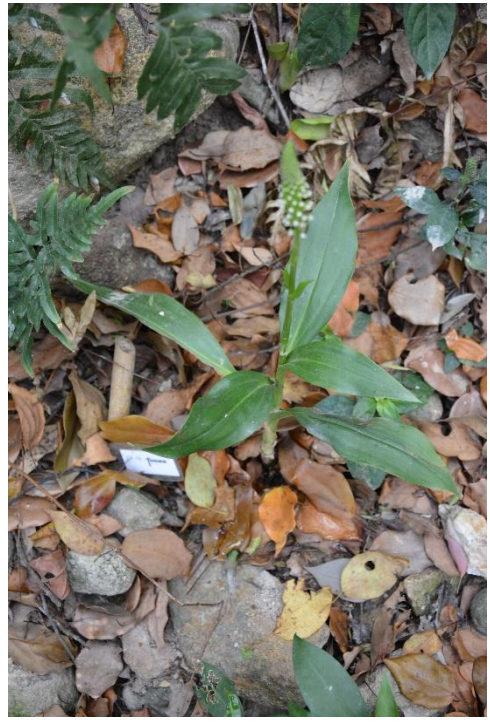
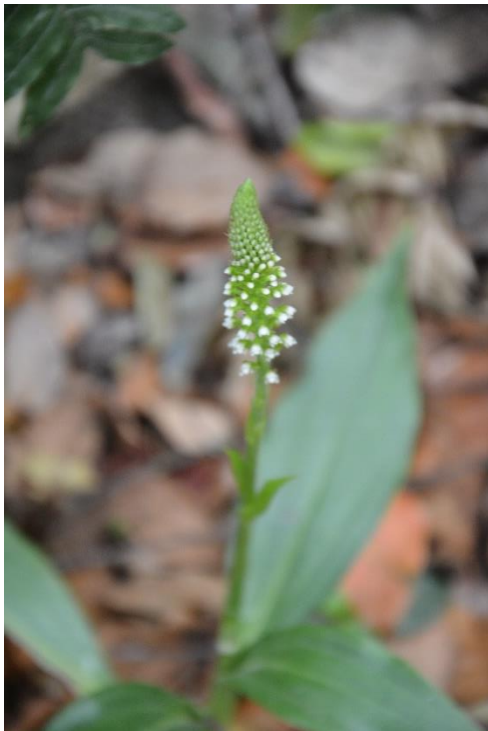
| Date of Monitoring and Maintenance | Receptor Site | No. | Species | Plant Size Measurements | | | Amenity Value (High/ Medium/ Low) | Form (Good/ Fair/ Poor) | Health Condition (Good/ Fair/ Poor) | Structural Condition (Good/ Fair/ Poor) | Recommendation on Post-Transplantation Maintenance | Key Maintenance Activities Conducted | Remark |
|---|---|---|---|---|---|---|---|---|--|--|--|---|---|
| 20/3/2023 | B | GP19 | G. procera | | | 0.22 | | | Fair | | | | Flowering, partially withered leaves |

Photo B.3.30: Individual GP-19. Flowering.

Photo B.3.31: Individual GP-19. Flowering
