9th Post-transplantation Monitoring and Audit Report (21st April 2023)

Northeast New Territories Landfill Extension (NENTX) | Contract No. EP/SP/77/15

0092/22/ED/0365 02 | 24 April 2023

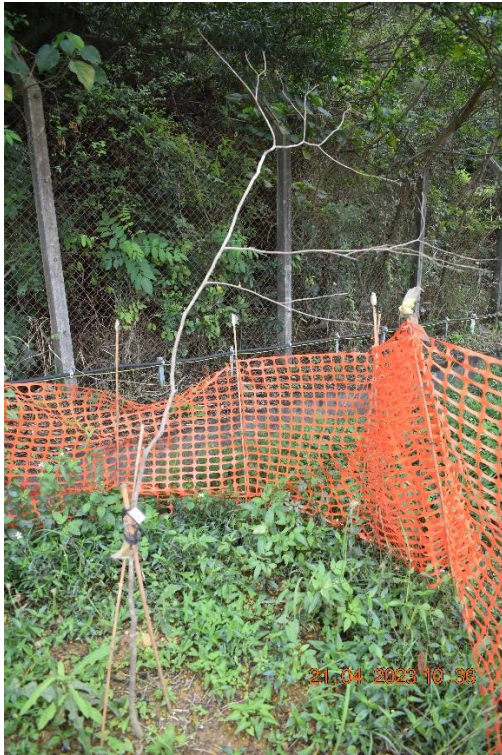
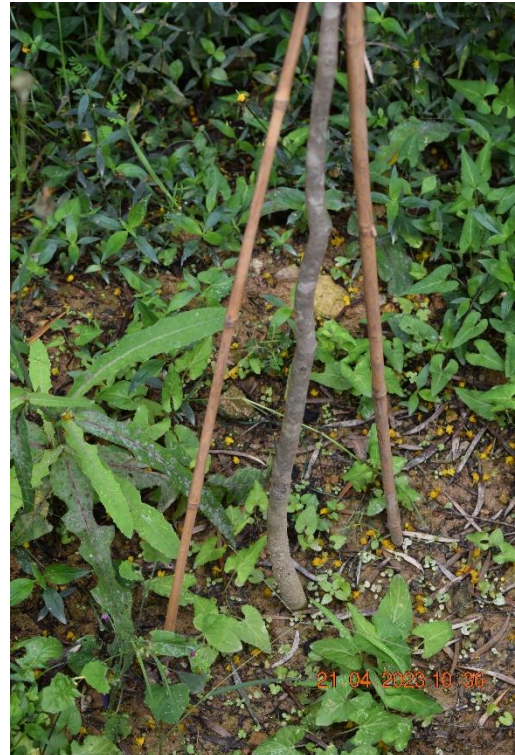
2.1.3 The two saplings of the Incense Tree *Aquilaria sinensis* also both demonstrated poor health conditions with die back and fallen leaves.

Photo B.1.1 : General view of the transplanted individual AS-03.

Photo B.1.2 : Stem condition of the transplanted individual AS-03.

- The watering frequency for the two saplings of Incense Tree should be maintained at 2-3 times a week. Improve/place organic mulch around the two saplings of Incense Tree to retain soil moisture, protect damaged roots against extreme temperatures, and improve soil quality.
- The watering frequency of the cluster of Lamb of Tartary should be maintained at twice a week. Wilted leaves and stems should be pruned away.
- The watering frequency for all 19 clusters of Bottlebrush Orchid should remain the same. During watering activities, the surrounding dead branches and dry leaves should be removed to ensure no plants are damaged by them.
- The Fence of the two Incense Tree saplings should be reinforced.
- Weed around the two Incense Tree saplings should be removed.

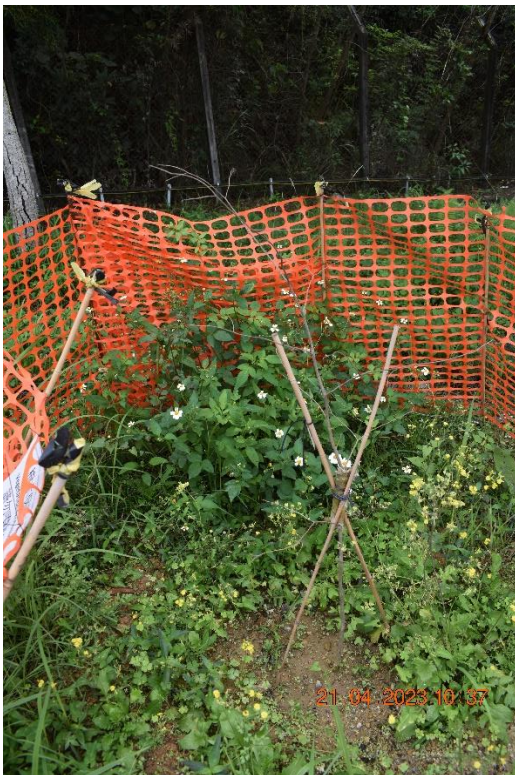
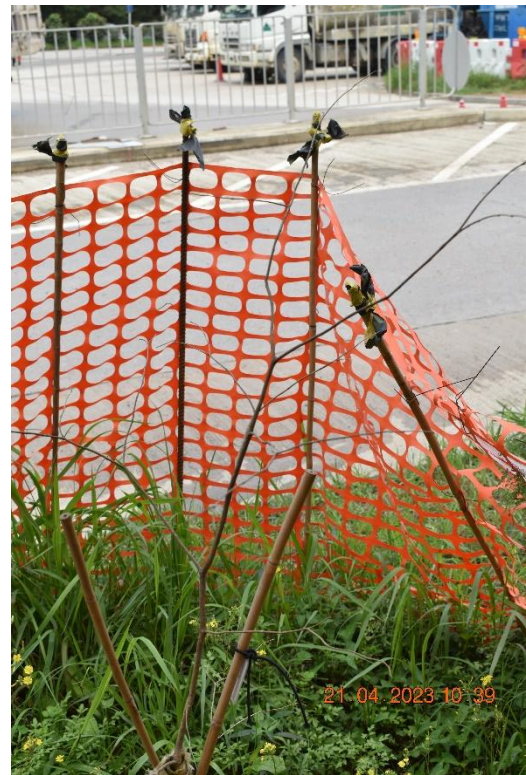
Photo B.1.3 : General view of the transplanted individual AS-02.

Photo B.1.4 : Branch condition of the transplanted individual AS-02.

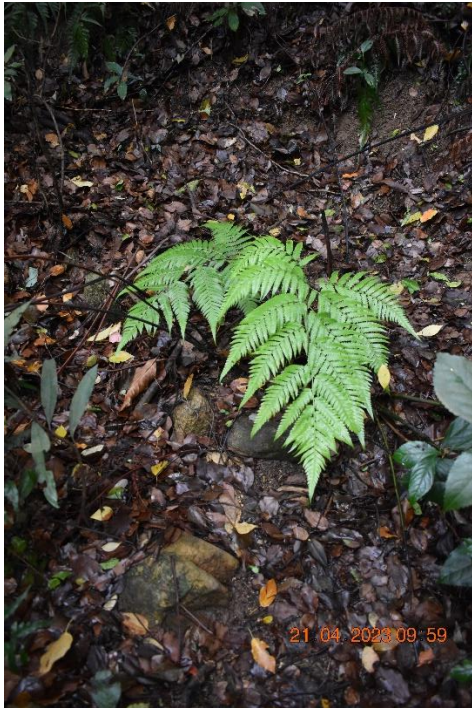
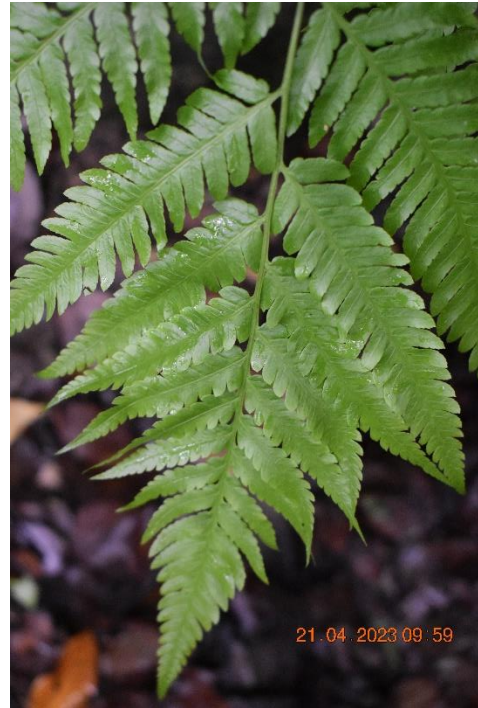
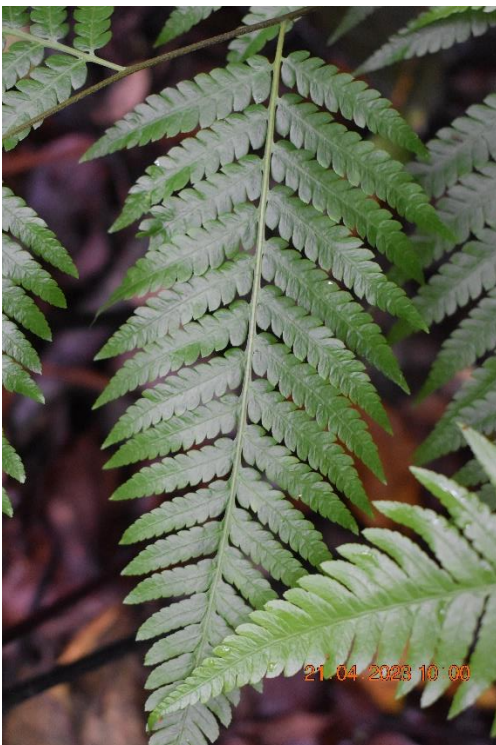
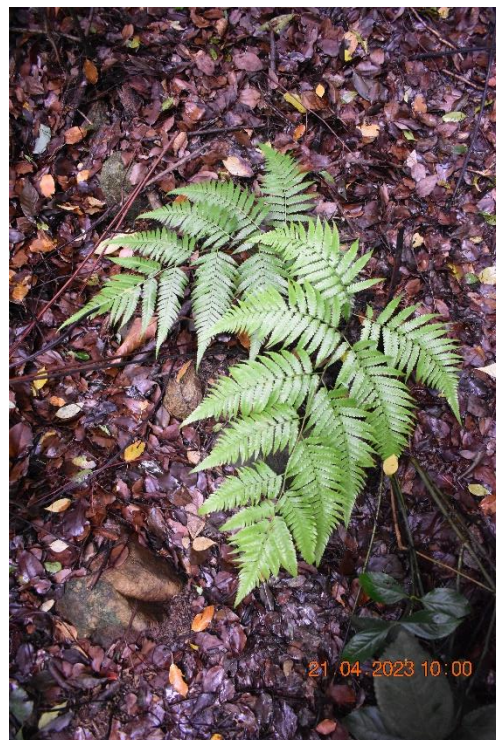
2.1.2 The Lamb of Tartary *Cibotium barometz* is also in fair condition. The old foliage has wilted but new foliage has started growing from the roots. Comparing to the last monitoring, the new foliage is a lot more established and have been growing rapidly.

Photo B.2.1. : General view of the transplanted individual CB-01.

Photo B.2.2. : New foliage of the transplanted individual CB-01.

Photo B.2.3. : Leaf condition of the new foliage.

Photo B.2.4. : General view of the transplanted individual CB-01.

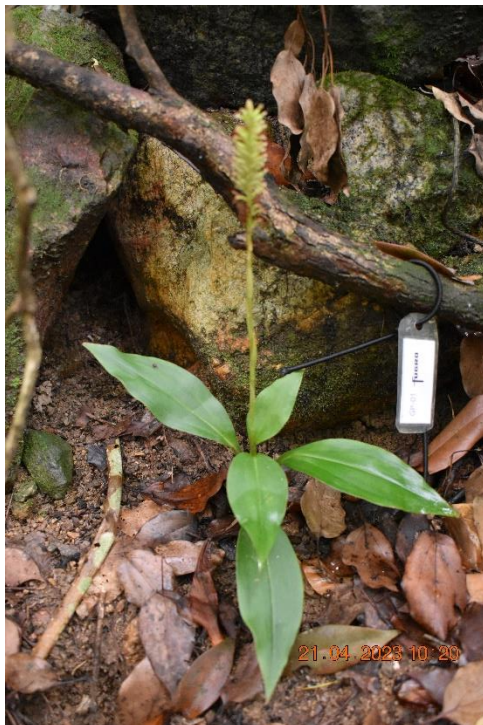
Photo B.3.1: Individual GP-01. Flowering.

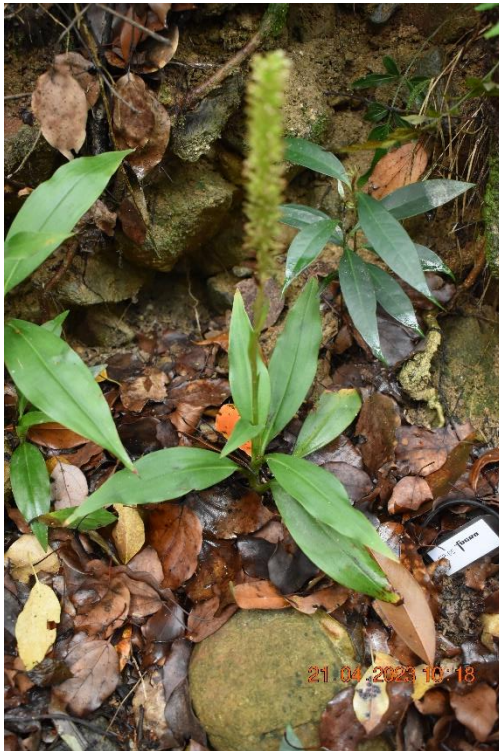
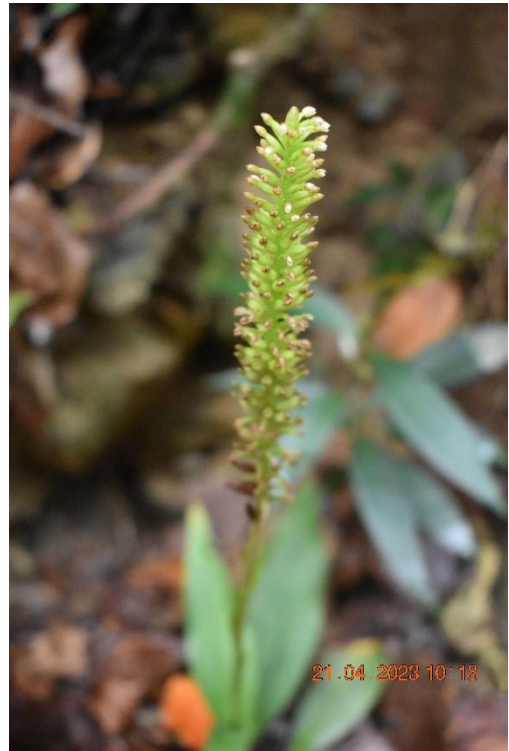
Photo B.3.7: Individual GP-05.

Photo B.3.8: Individual GP-05. Flowering.

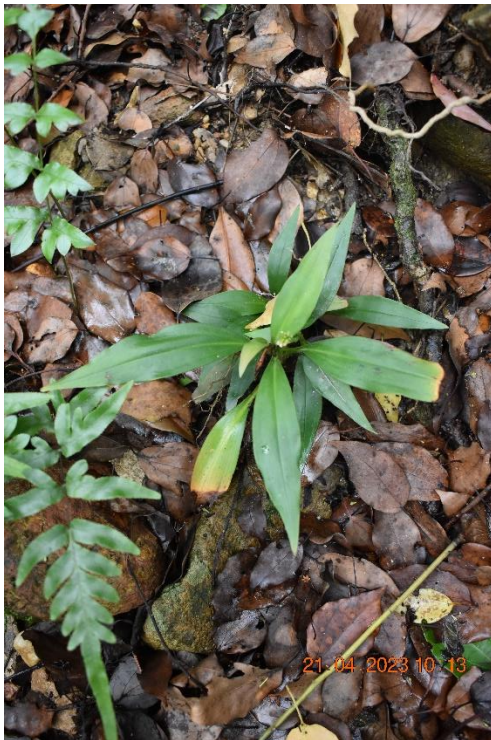
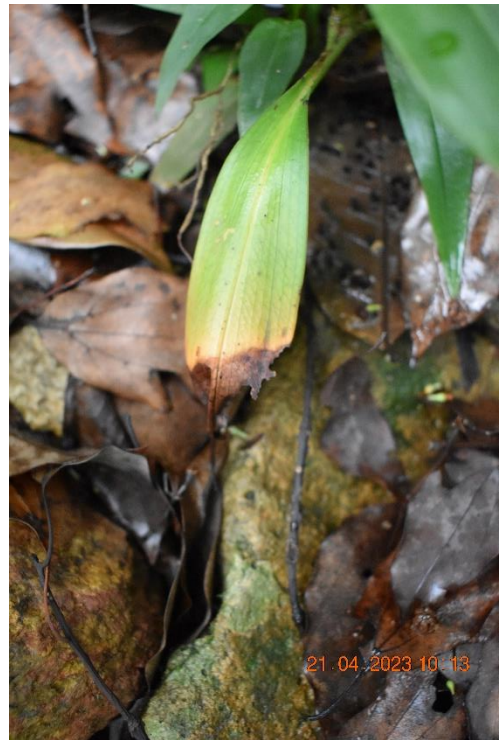
Photo B.3.11: Individual GP-07.

Photo B.3.12: Individual GP-07. Partially wilted leaf.
