10th Post-transplantation Monitoring and Audit Report (12th May 2023)

Northeast New Territories Landfill Extension (NENTX) | Contract No. EP/SP/77/15

0092/22/ED/0372 02 | 15 May 2023

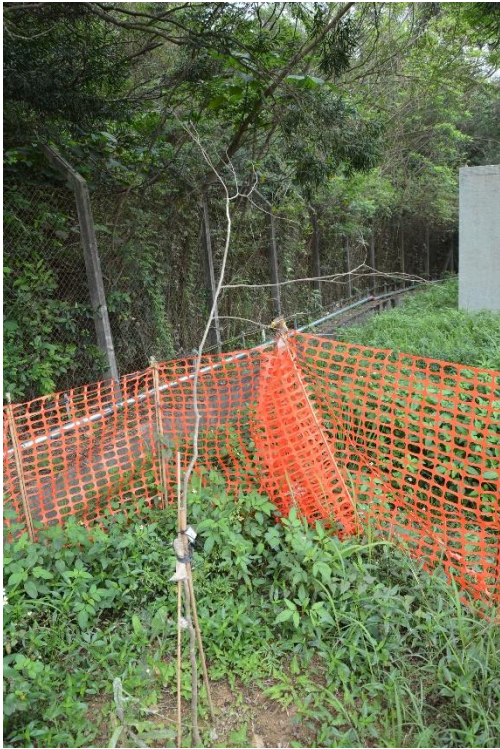
- 2.1.3 The two saplings of the Incense Tree *Aquilaria sinensis* also both demonstrated poor health conditions with die back and fallen leaves.
- 2.1.4 Albeit strict compliance of the transplantation works and post-transplantation maintenance to the approved Transplantation Proposal, transplanted individuals would require time to adapt and establish in the new environment/substrate of the receptor site. Hence, signs of leaf discoloration and/or wilting, dehydration, and even die-off are expected. Thus, succeeding post-transplantation maintenance and monitoring and audit are crucial to assess the progress of recovery and establishment of transplanted individuals in the receptor site.

Photo B.1.1 : General view of the transplanted individual AS-03.

- The watering frequency for the two saplings of Incense Tree should be maintained at 2-3 times a week. Improve/place organic mulch around the two saplings of Incense Tree to retain soil moisture, protect damaged roots against extreme temperatures, and improve soil quality.
- The watering frequency of the cluster of Lamb of Tartary should be maintained at twice a week. Wilted leaves and stems should be pruned away.
- The watering frequency for all 19 clusters of Bottlebrush Orchid should remain the same. During watering activities, the surrounding dead branches and dry leaves should be removed to ensure no plants are damaged by them.
- Weed around the two Incense Tree saplings should be removed.

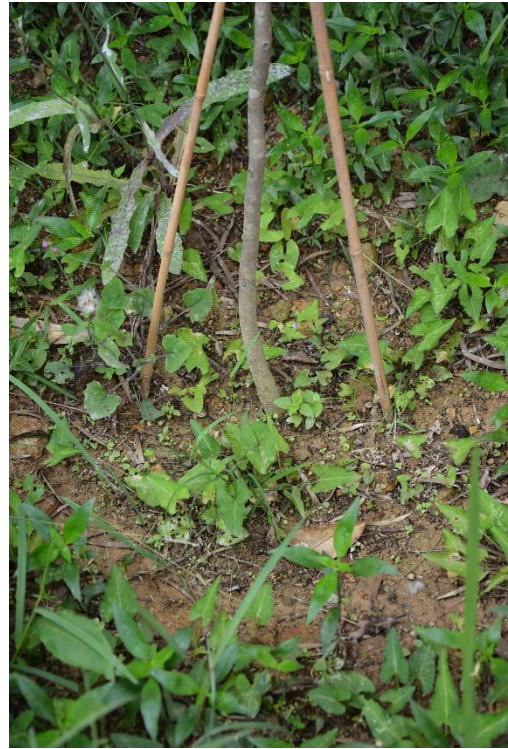
Photo B.1.2 : Stem condition of the transplanted individual AS-03.

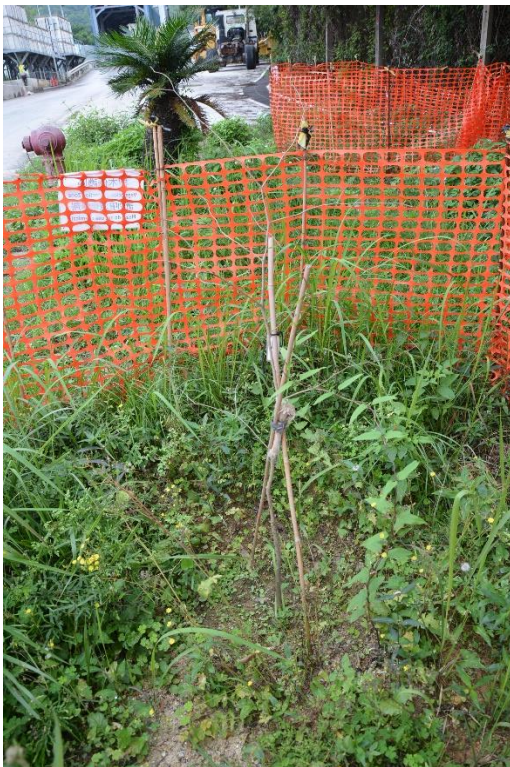
Photo B.1.3 : General view of the transplanted individual AS-02.

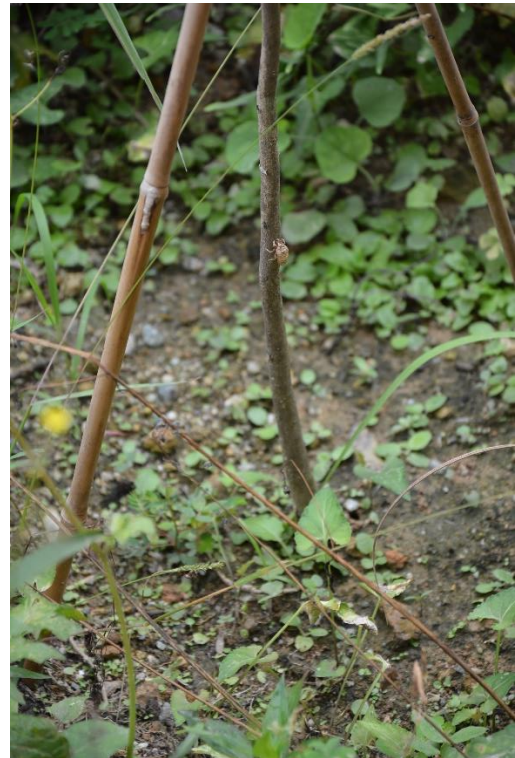
Photo B.1.4 : Stem condition of the transplanted individual AS-02.

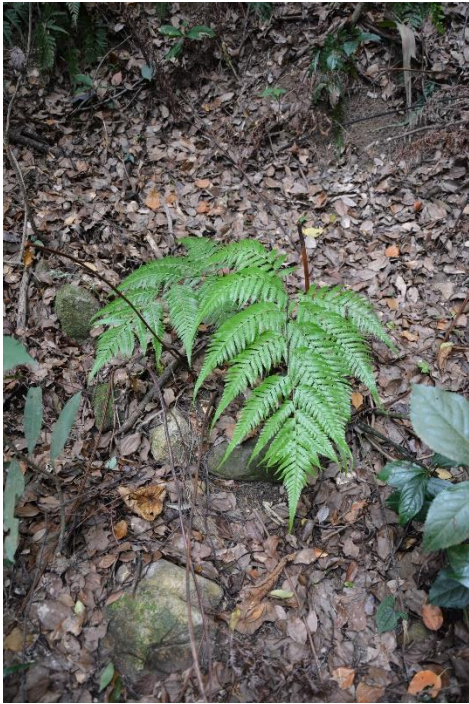
- 2.1.2 The Lamb of Tartary *Cibotium barometz* is now in good condition. The old foliage has wilted but new foliage has started growing from the roots. Comparing to the last monitoring, the new foliage is a lot more established and have been growing steadily.

Photo B.2.1 : General view of the transplanted individual CB-01.

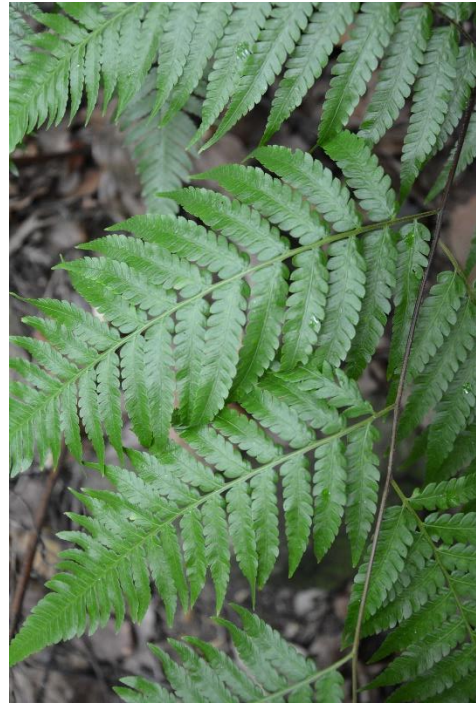
Photo B.2.2 : New foliage of the transplanted individual CB-01.

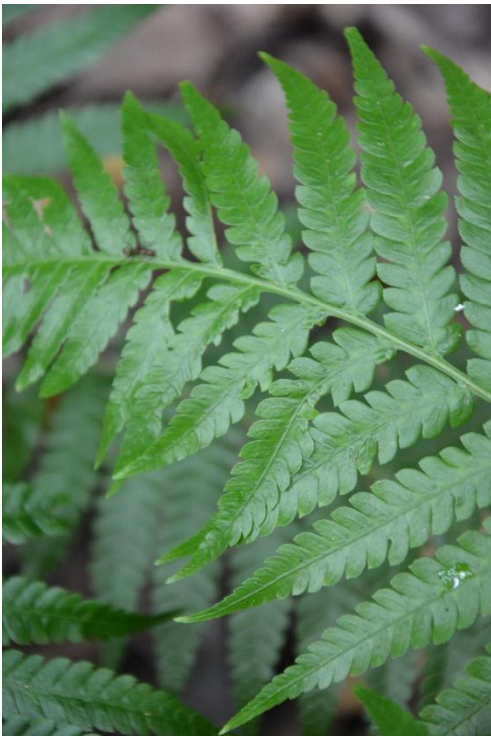
Photo B.2.3 : Leaf condition of the new foliage.

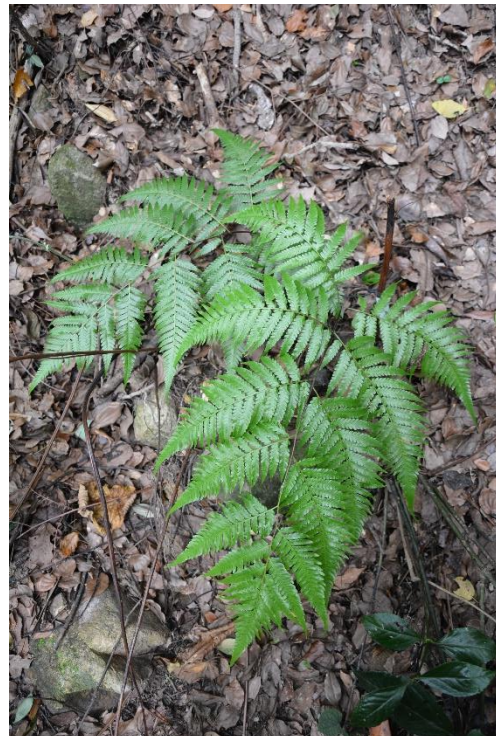
Photo B.2.4 : General view of the transplanted individual CB-01.

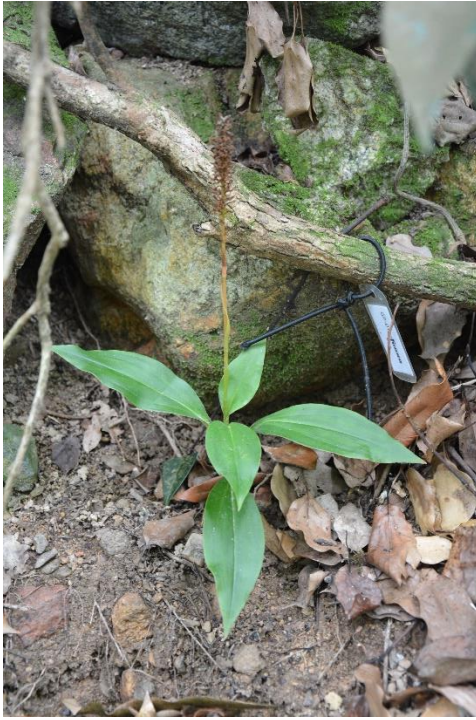
Photo B.3.1: Individual GP-01. Flower withering.

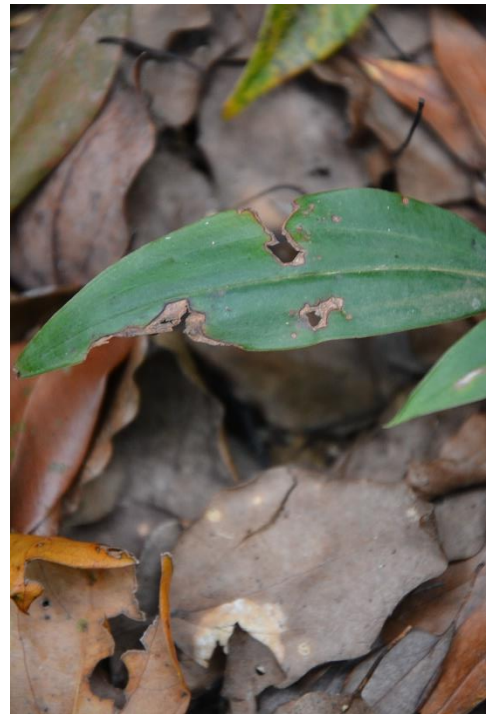
- 2.1.1 The transplanted individuals of the 19 clusters of Bottlebrush Orchid *Goodyera procera* were all in fair to good condition with minor health issues observed in some individuals, i.e., slightly chlorotic leaves and presences of holes in the leaves. Moreover, most individuals have passed the flowering stage.

Photo B.3.4: Individual GP-03. Holes in leaves.

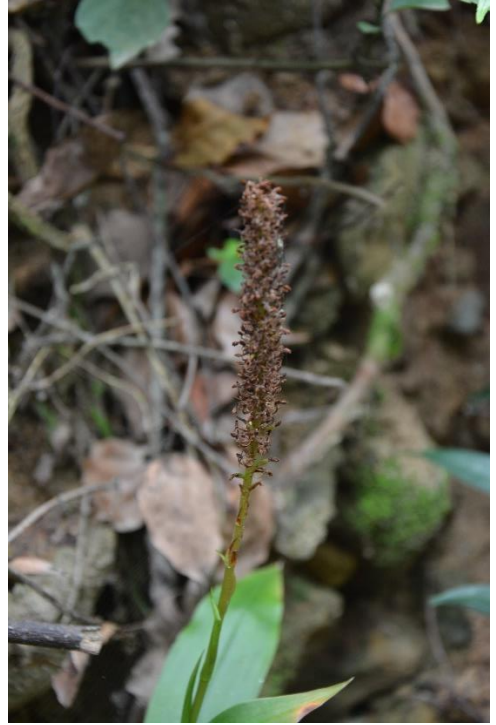
Photo B.3.6: Individual GP-04. Wilted flower.

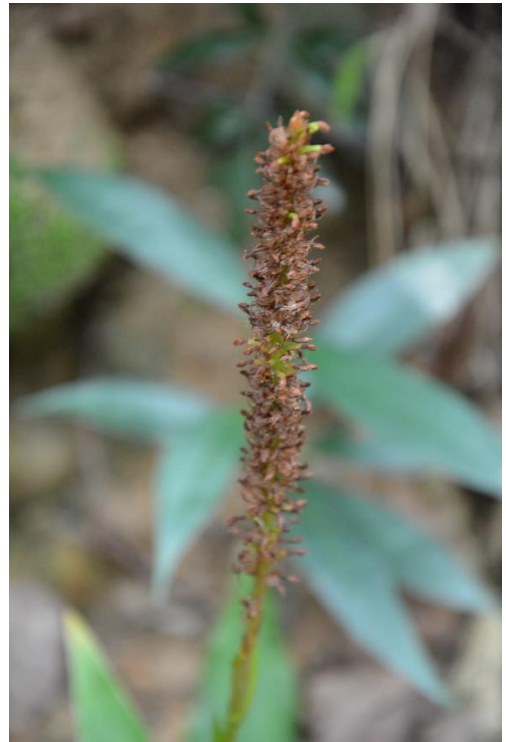
Photo B.3.8: Individual GP-05. Wilted flower.

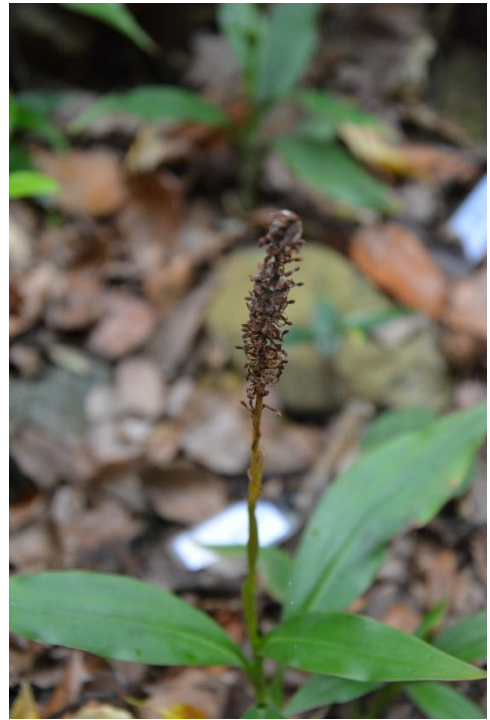
Photo B.3.10: Individual GP-06. Wilted flower.

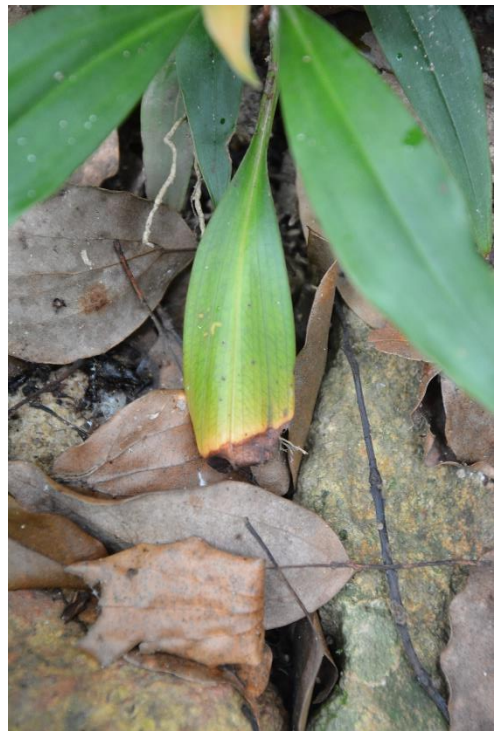
Photo B.3.12: Individual GP-07. Partially wilted leaf.

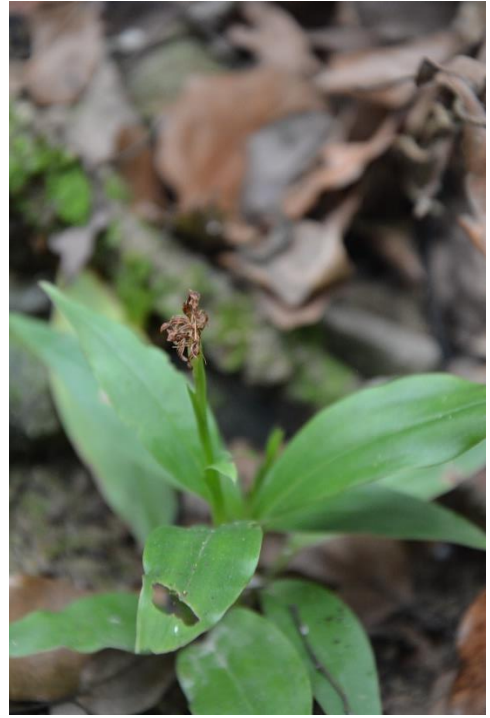
Photo B.3.14: Individual GP-08. Wilted flower.

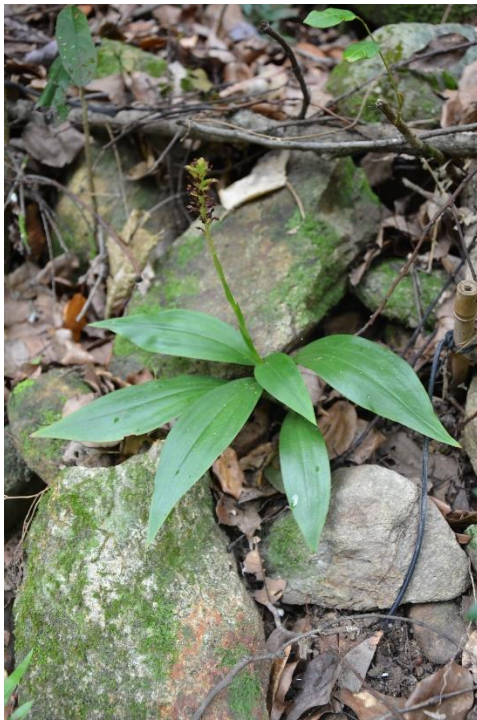
Photo B.3.15: Individual GP-09. Wilting flower.

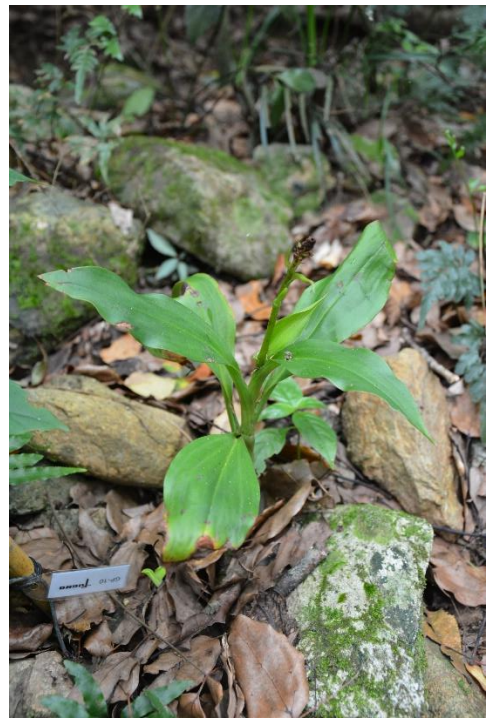
Photo B.3.16: Individual GP-10. Wilted flower.

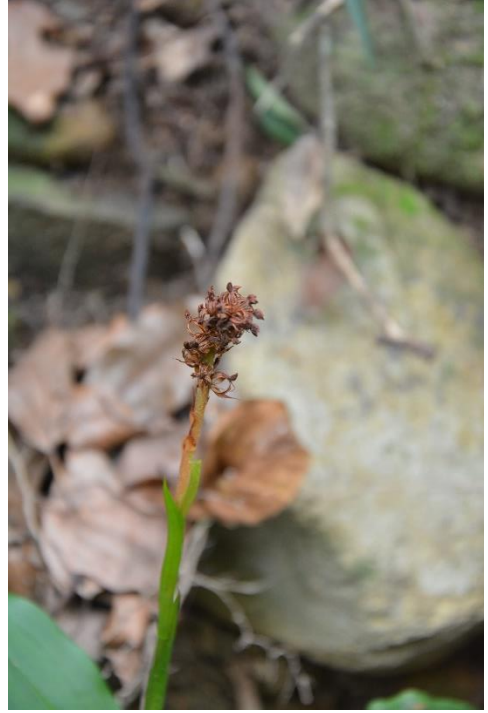
Photo B.3.18: Individual GP-11. Wilted flower.

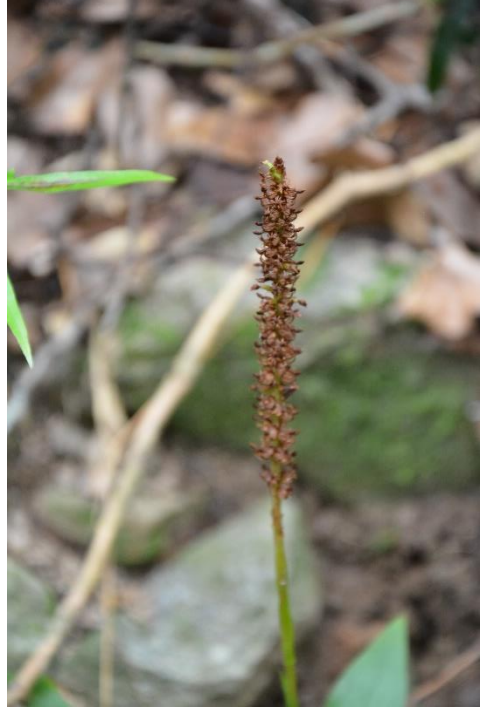
Photo B.3.22: Individual GP-14. Wilted flower.

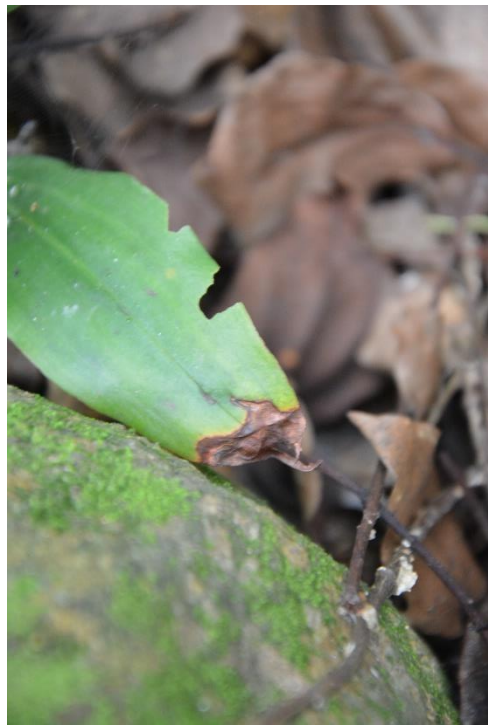
Photo B.3.24: Individual GP-15. Partially wilted leaves.

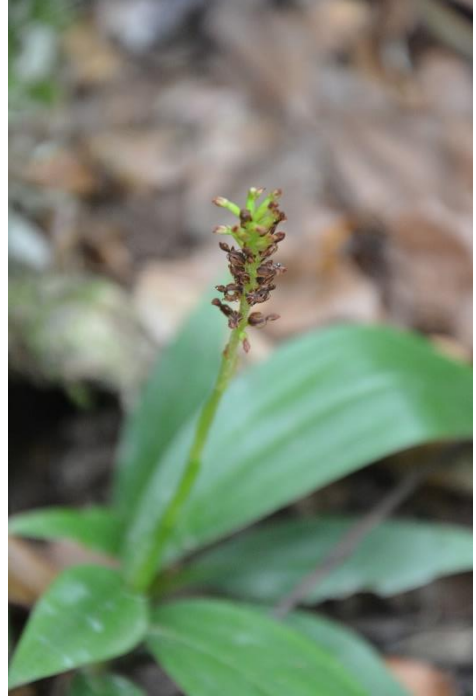
Photo B.3.26: Individual GP-16. Wilted flower.

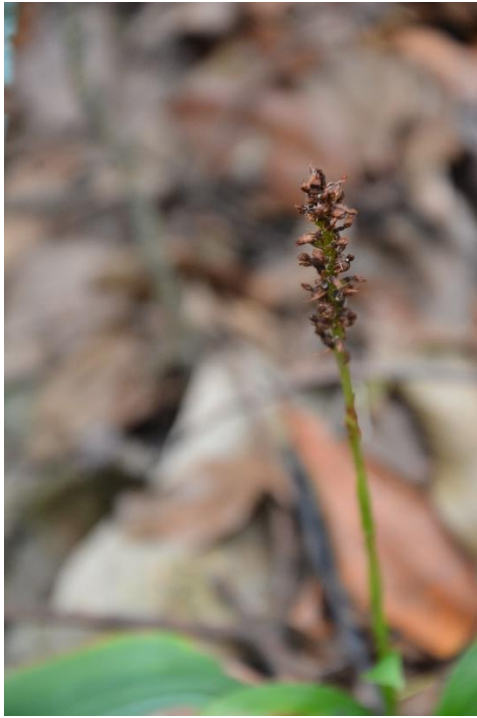
Photo B.3.29: Individual GP-18. Wilted flower.

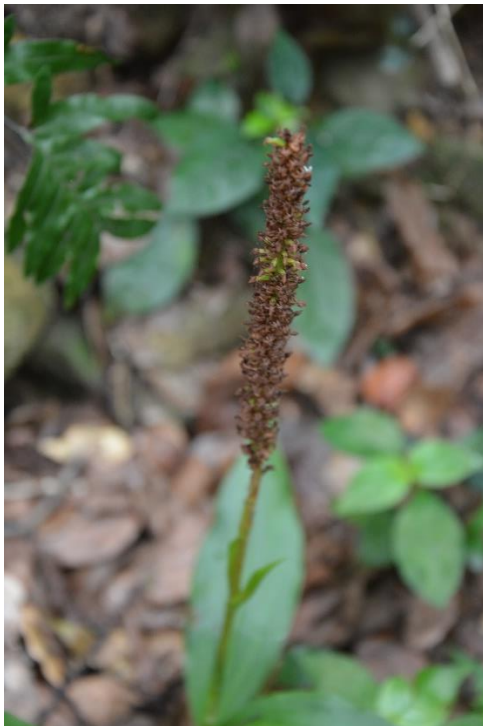
Photo B.3.31: Individual GP-19. Wilted flower.
