11th Post-transplantation Monitoring and Audit Report (16th June 2023)

Northeast New Territories Landfill Extension (NENTX) | Contract No. EP/SP/77/15

0092/22/ED/0385 02 | 23 June 2023

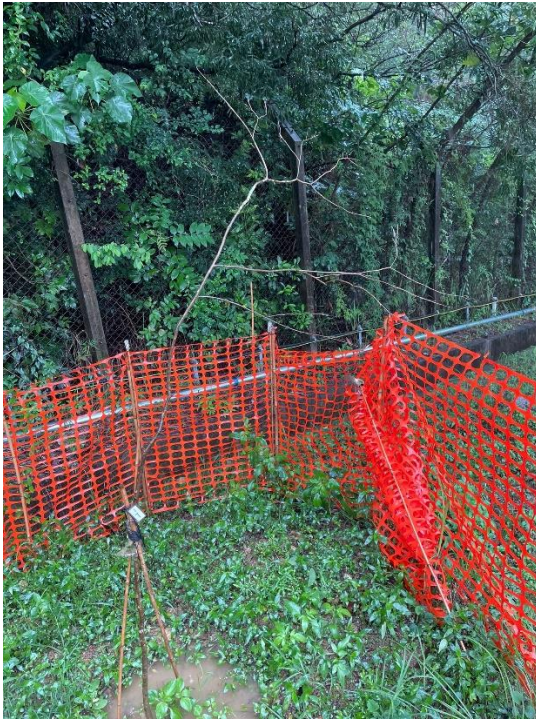
- 2.1.2 The Lamb of Tartary *Cibotium barometz* is in good condition. The new foliage is now very established and have been growing steadily.
- 2.1.3 The two saplings of the Incense Tree *Aquilaria sinensis* both demonstrated poor health conditions with die back and fallen leaves.

Photo B.1.1 : General view of the transplanted individual AS-03.

- The watering frequency for the two saplings of Incense Tree should be maintained at 2-3 times a week. Improve/place organic mulch around the two saplings of Incense Tree to retain soil moisture, protect damaged roots against extreme temperatures, and improve soil quality.
- The watering frequency of the cluster of Lamb of Tartary should be maintained at twice a week. Wilted leaves and stems should be pruned away.
- The watering frequency for all 19 clusters of Bottlebrush Orchid should remain the same. During watering activities, the surrounding dead branches and dry leaves should be removed to ensure no plants are damaged by them.
- Weed around the two Incense Tree saplings should be removed.
- The clusters of Bottlebrush Orchid *Goodyera procera* should be reinforced to prevent them from being washed away by heavy rain.

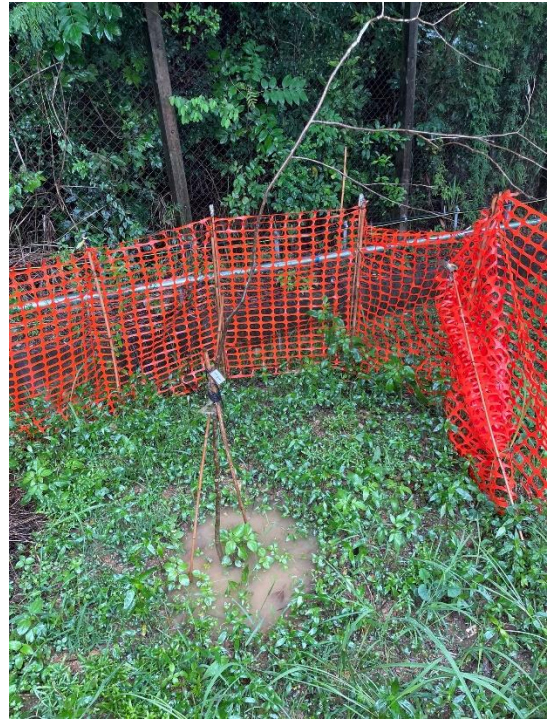
Photo B.1.2 : Stem condition of the transplanted individual AS-03.

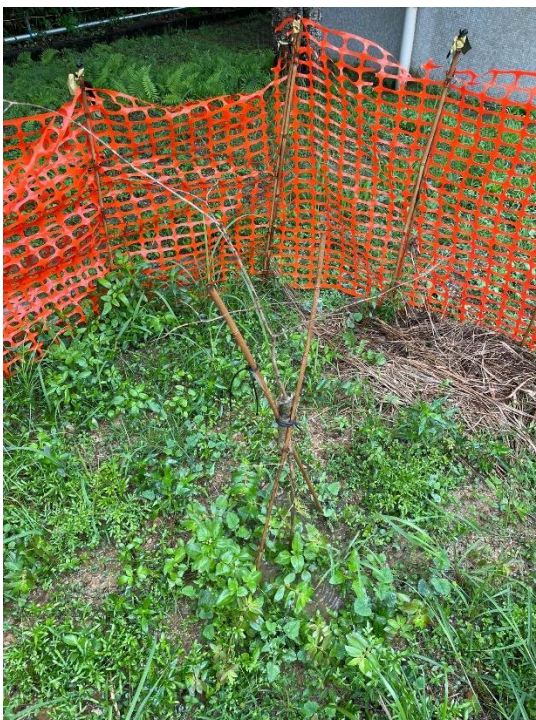
Photo B.1.3 : General view of the transplanted individual AS-02.

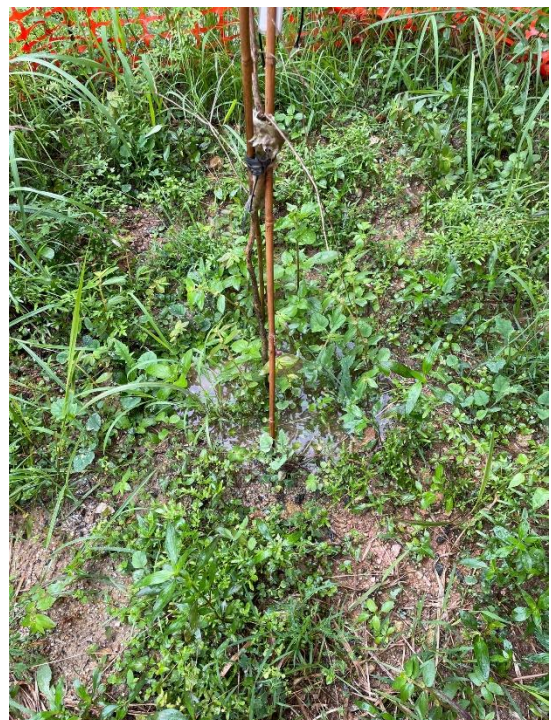
Photo B.1.4 : Stem condition of the transplanted individual AS-02.

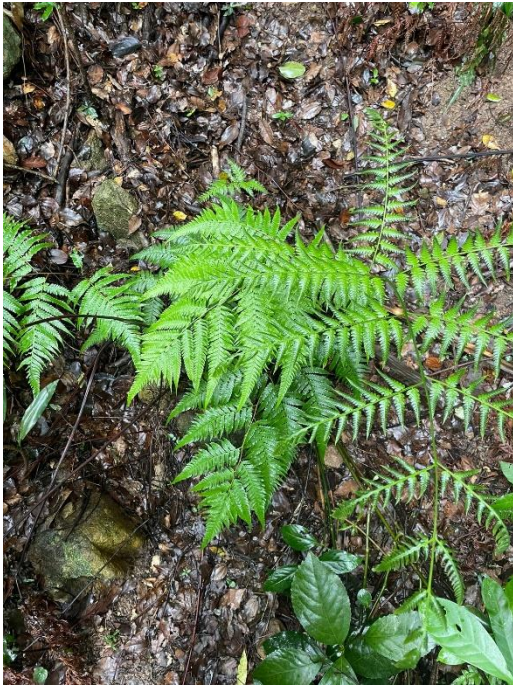
Photo B.2.1 : General view of the transplanted individual CB-01.

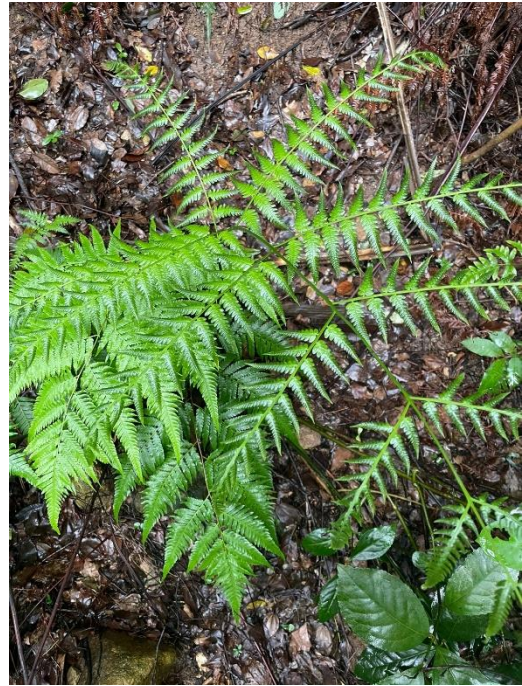
Photo B.2.2 : New foliage of the transplanted individual CB-01.

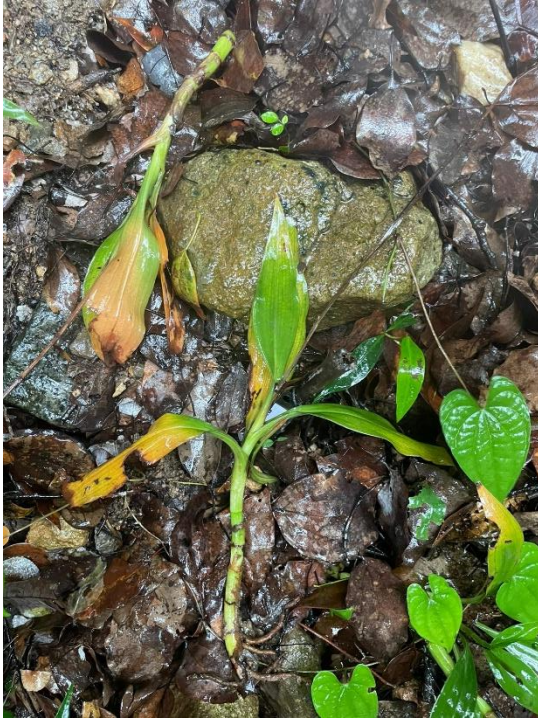
- 2.1.5 The dead or missing individuals of Bottlebrush Orchid *Goodyera procera* could have been a result of wild animal disturbance or heavy rainfall.

| Date of Monitoring and Maintenance | Receptor Site | No. | Species | Plant Size Measurements | | | Amenity Value (High/ Medium/ Low) | Form (Good/ Fair/ Poor) | Health Condition (Good/ Fair/ Poor) | Structural Condition (Good/ Fair/ Poor) | Recommendation on Post-Transplantation Maintenance | Key Maintenance Activities Conducted | Remark |
|---|---|---|---|---|---|---|---|---|--|--|--|---|---|
| 16/6/2023 | B | GP05 | G. procera | | | — | | | dead | | | | dead |

Photo B.3.5: Individual GP-05. Dead.

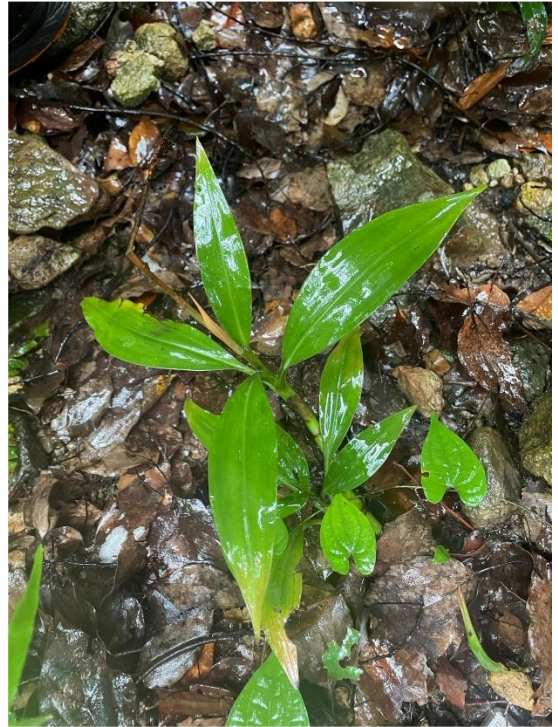
| Date of Monitoring and Maintenance | Receptor Site | No. | Species | Plant Size Measurements | | | Amenity Value (High/ Medium/ Low) | Form (Good/ Fair/ Poor) | Health Condition (Good/ Fair/ Poor) | Structural Condition (Good/ Fair/ Poor) | Recommendation on Post-Transplantation Maintenance | Key Maintenance Activities Conducted | Remark |
|---|---|---|---|---|---|---|---|---|--|--|--|---|---|
| 16/6/2023 | B | GP06 | G. procera | | | 22 | | | fair | | | | chlorotic leaf |

Photo B.3.6: Individual GP-06. Wilted flower.

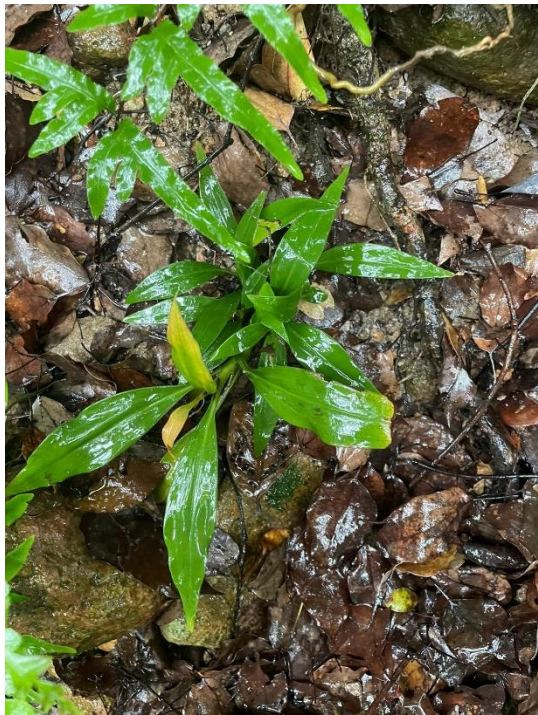
| Date of Monitoring and Maintenance | Receptor Site | No. | Species | Plant Size Measurements | | | Amenity Value (High/ Medium/ Low) | Form (Good/ Fair/ Poor) | Health Condition (Good/ Fair/ Poor) | Structural Condition (Good/ Fair/ Poor) | Recommendation on Post-Transplantation Maintenance | Key Maintenance Activities Conducted | Remark |
|---|---|---|---|---|---|---|---|---|--|--|--|---|---|
| 16/6/2023 | B | GP07 | G. procera | | | 12 | | | fair | | | | chlorotic leaf |

Photo B.3.7: Individual GP-07.

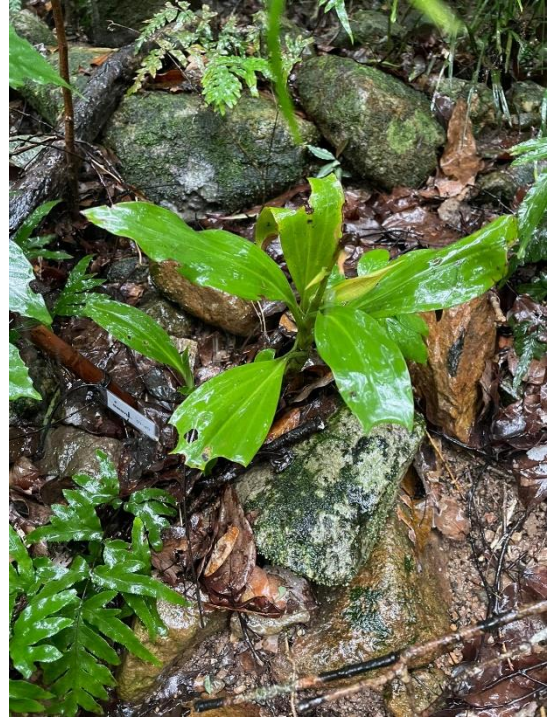
| Date of Monitoring and Maintenance | Receptor Site | No. | Species | Plant Size Measurements | | | Amenity Value (High/ Medium/ Low) | Form (Good/ Fair/ Poor) | Health Condition (Good/ Fair/ Poor) | Structural Condition (Good/ Fair/ Poor) | Recommendation on Post-Transplantation Maintenance | Key Maintenance Activities Conducted | Remark |
|---|---|---|---|---|---|---|---|---|--|--|--|---|---|
| 16/6/2023 | B | GP10 | G. procera | | | 20 | | | fair | | | | chlorotic leaf |

Photo B.3.10: Individual GP-10.

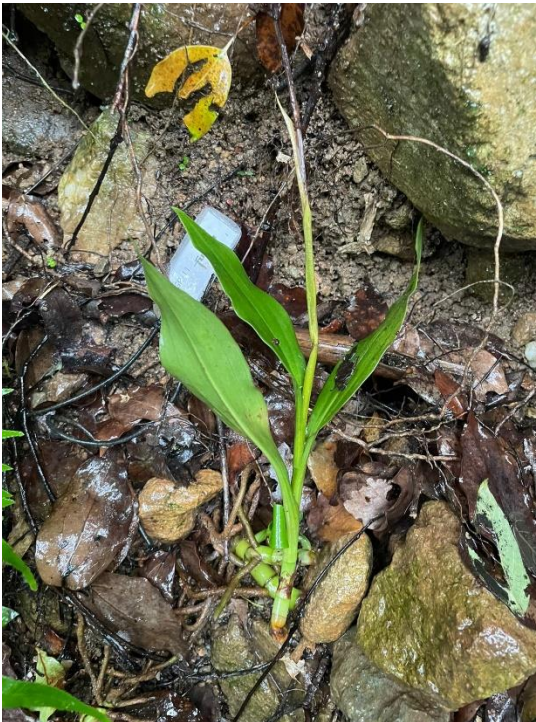
| Date of Monitoring and Maintenance | Receptor Site | No. | Species | Plant Size Measurements | | | Amenity Value (High/ Medium/ Low) | Form (Good/ Fair/ Poor) | Health Condition (Good/ Fair/ Poor) | Structural Condition (Good/ Fair/ Poor) | Recommendation on Post-Transplantation Maintenance | Key Maintenance Activities Conducted | Remark |
|---|---|---|---|---|---|---|---|---|--|--|--|---|---|
| 16/6/2023 | B | GP11 | G. procera | | | — | | | dead | | | | dead |

Photo B.3.11: Individual GP-11. Dead.

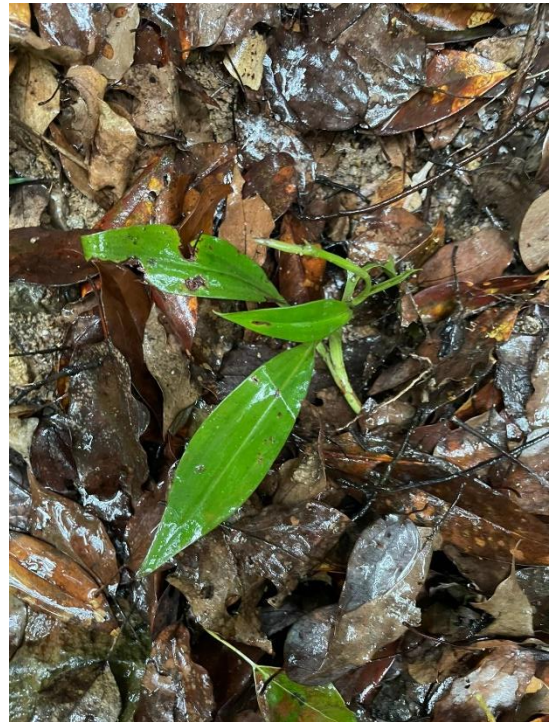
| Date of Monitoring and Maintenance | Receptor Site | No. | Species | Plant Size Measurements | | | Amenity Value (High/ Medium/ Low) | Form (Good/ Fair/ Poor) | Health Condition (Good/ Fair/ Poor) | Structural Condition (Good/ Fair/ Poor) | Recommendation on Post-Transplantation Maintenance | Key Maintenance Activities Conducted | Remark |
|---|---|---|---|---|---|---|---|---|--|--|--|---|---|
| 16/6/2023 | B | GP12 | G. procera | | | 10 | | | fair | | | | partially wilted leaf |

Photo B.3.12: Individual GP-12. Partially wilted leaf.

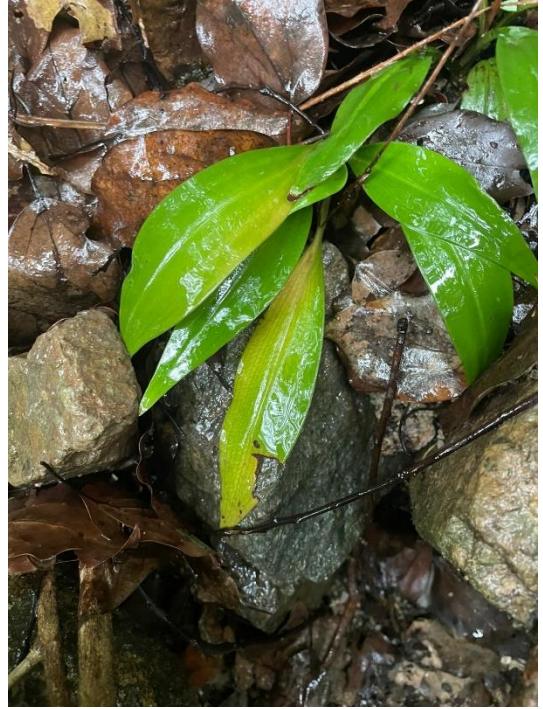
| Date of Monitoring and Maintenance | Receptor Site | No. | Species | Plant Size Measurements | | | Amenity Value (High/ Medium/ Low) | Form (Good/ Fair/ Poor) | Health Condition (Good/ Fair/ Poor) | Structural Condition (Good/ Fair/ Poor) | Recommendation on Post-Transplantation Maintenance | Key Maintenance Activities Conducted | Remark |
|---|---|---|---|---|---|---|---|---|--|--|--|---|---|
| 16/6/2023 | B | GP13 | G. procera | | | 7 | | | fair | | | | chlorotic leaf |

Photo B.3.14: Individual GP-13. Chlorotic leaves.

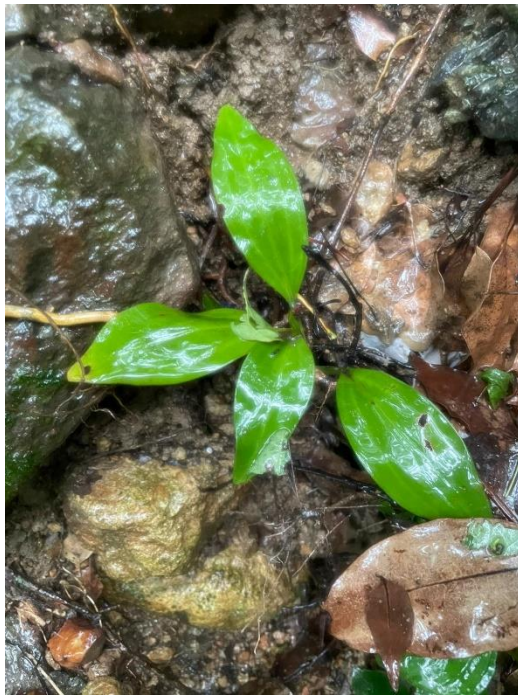
| Date of Monitoring and Maintenance | Receptor Site | No. | Species | Plant Size Measurements | | | Amenity Value (High/ Medium/ Low) | Form (Good/ Fair/ Poor) | Health Condition (Good/ Fair/ Poor) | Structural Condition (Good/ Fair/ Poor) | Recommendation on Post-Transplantation Maintenance | Key Maintenance Activities Conducted | Remark |
|---|---|---|---|---|---|---|---|---|--|--|--|---|---|
| 16/6/2023 | B | GP14 | G. procera | | | 7 | | | fair | | | | chlorotic leaf |

Photo B.3.15: Individual GP-14.

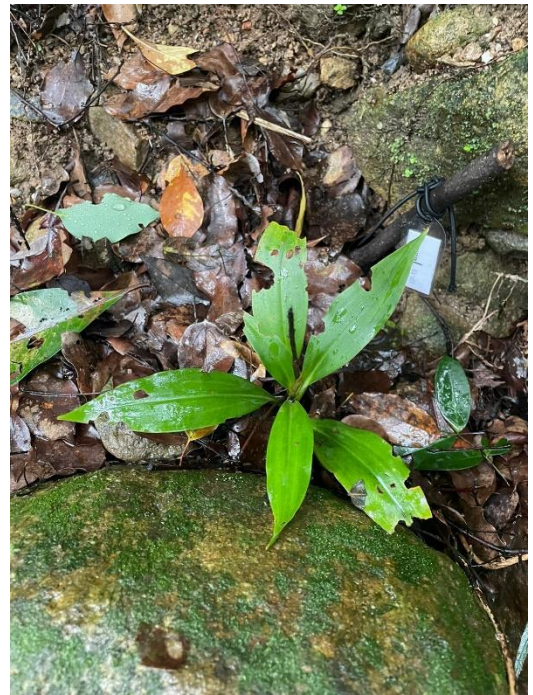
| Date of Monitoring and Maintenance | Receptor Site | No. | Species | Plant Size Measurements | | | Amenity Value (High/ Medium/ Low) | Form (Good/ Fair/ Poor) | Health Condition (Good/ Fair/ Poor) | Structural Condition (Good/ Fair/ Poor) | Recommendation on Post-Transplantation Maintenance | Key Maintenance Activities Conducted | Remark |
|---|---|---|---|---|---|---|---|---|--|--|--|---|---|
| 16/6/2023 | B | GP15 | G. procera | | | 17 | | | fair | | | | hole in leaf |

Photo B.3.16: Individual GP-15.

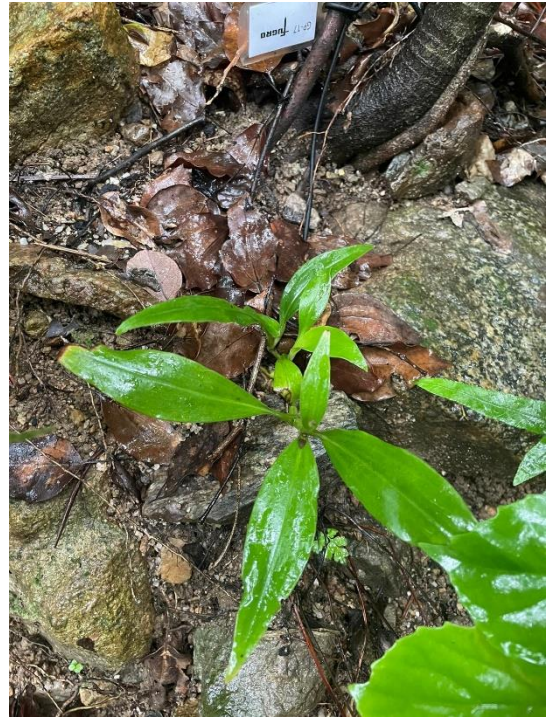
| Date of Monitoring and Maintenance | Receptor Site | No. | Species | Plant Size Measurements | | | Amenity Value (High/ Medium/ Low) | Form (Good/ Fair/ Poor) | Health Condition (Good/ Fair/ Poor) | Structural Condition (Good/ Fair/ Poor) | Recommendation on Post-Transplantation Maintenance | Key Maintenance Activities Conducted | Remark |
|---|---|---|---|---|---|---|---|---|--|--|--|---|---|
| 16/6/2023 | B | GP17 | G. procera | | | 13 | | | fair | | | | chlorotic leaf |

Photo B.3.18: Individual GP-17.

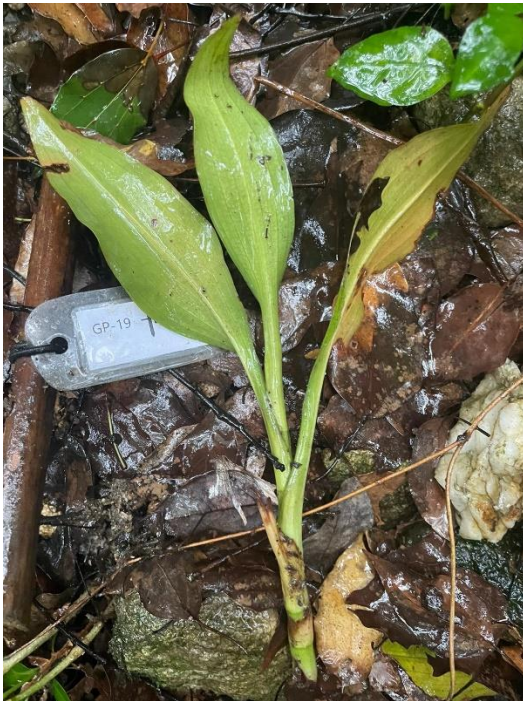
| Date of Monitoring and Maintenance | Receptor Site | No. | Species | Plant Size Measurements | | | Amenity Value (High/ Medium/ Low) | Form (Good/ Fair/ Poor) | Health Condition (Good/ Fair/ Poor) | Structural Condition (Good/ Fair/ Poor) | Recommendation on Post-Transplantation Maintenance | Key Maintenance Activities Conducted | Remark |
|---|---|---|---|---|---|---|---|---|--|--|--|---|---|
| 16/6/2023 | B | GP19 | G. procera | | | — | | | dead | | | | dead |

Photo B.3.19: Individual GP-19. Dead.
