12th Post-transplantation Monitoring and Audit Report (18th July 2023)

Northeast New Territories Landfill Extension (NENTX) | Contract No. EP/SP/77/15

0092/22/ED/0400 02 | 19 July 2023

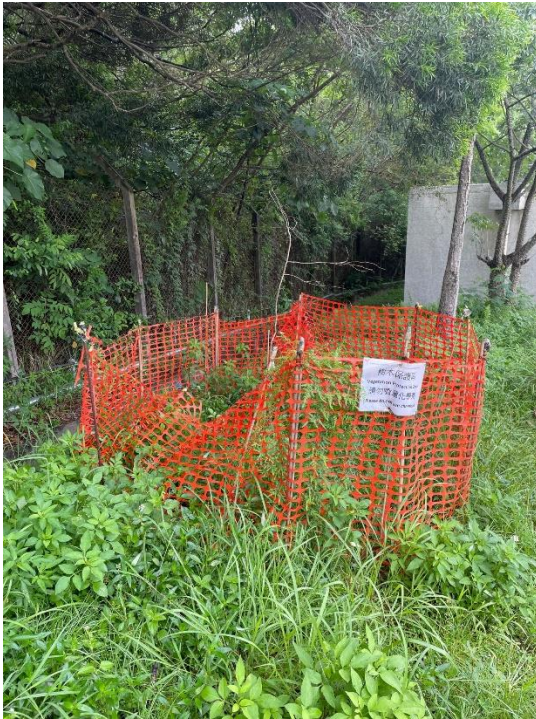
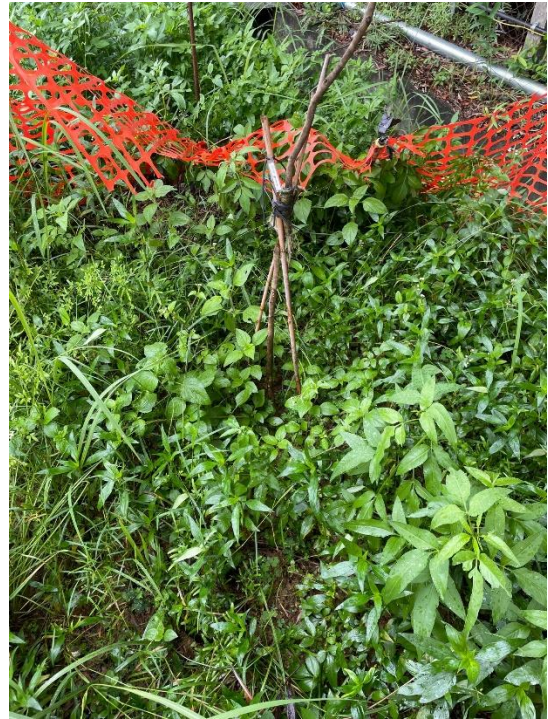
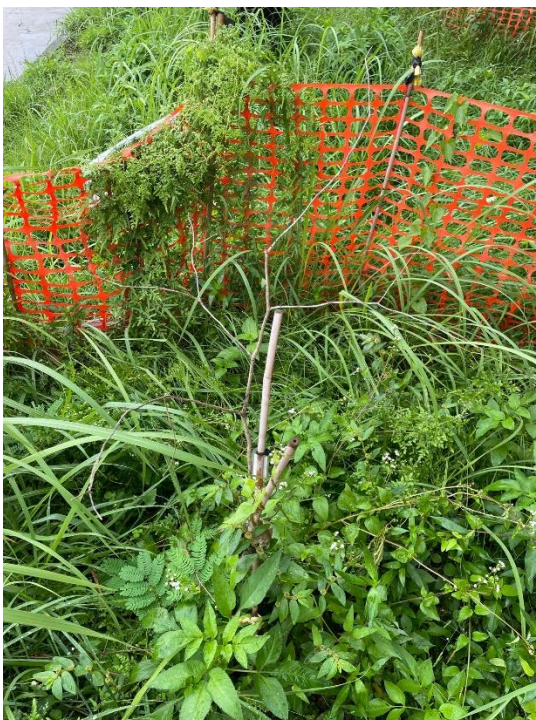
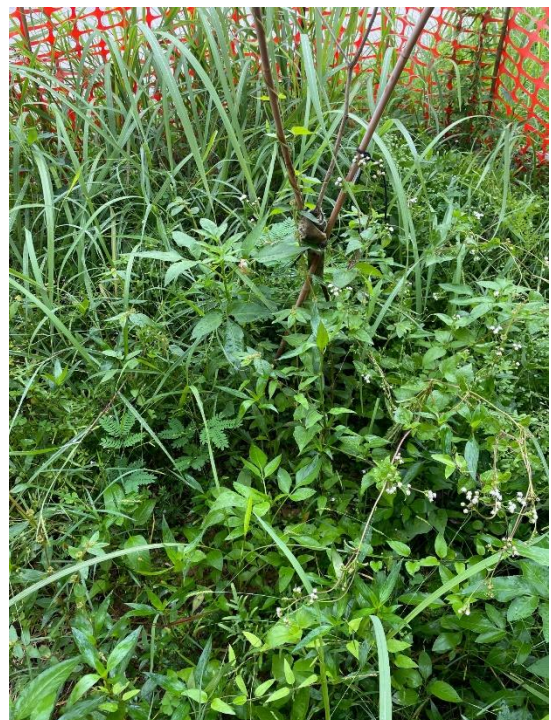
- 2.1.3 The Lamb of Tartary *Cibotium barometz* is in good condition. The new foliage is now very established and have been growing steadily.
- 2.1.4 The two saplings of the Incense Tree *Aquilaria sinensis* both demonstrated poor health conditions with die back and fallen leaves.

Photo B.1.1. : General view of the transplanted individual AS-03.

Photo B.1.2. : Stem condition of the transplanted individual AS-03.

Photo B.1.3. : General view of the transplanted individual AS-02.

Photo B.1.4. : Stem condition of the transplanted individual AS-02.

- The watering frequency for the two saplings of Incense Tree should be maintained at 2-3 times a week. Improve/place organic mulch around the two saplings of Incense Tree to retain soil moisture, protect damaged roots against extreme temperatures, and improve soil quality.
- The watering frequency of the cluster of Lamb of Tartary should be maintained at twice a week.
- The watering frequency for all 19 clusters of Bottlebrush Orchid should remain the same. During watering activities, the surrounding dead branches and dry leaves should be removed to ensure no plants are damaged by them.
- Weed around the two Incense Tree saplings should be removed. Fencing around individual AS-03 should be reinforced.
- The clusters of Bottlebrush Orchid *Goodyera procera* should be reinforced to prevent them from being washed away by heavy rain.

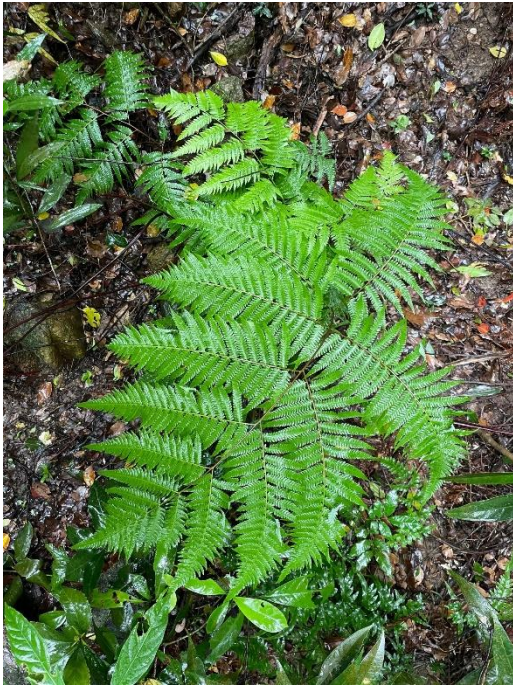
Photo B.2.1 : General view of the transplanted individual CB-01.

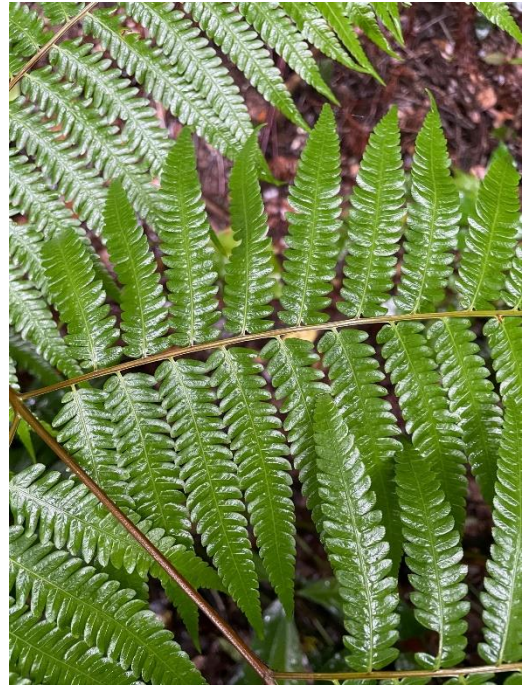
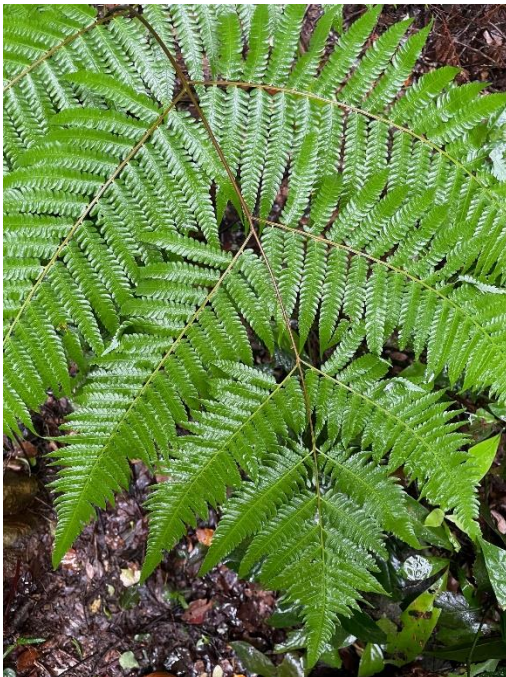
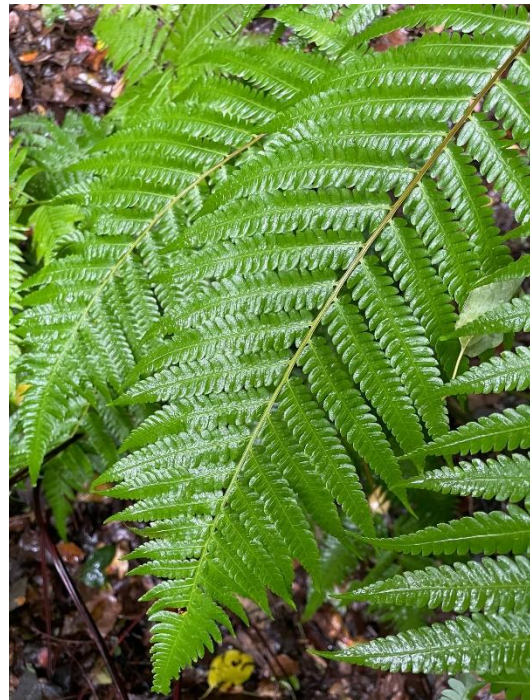
Photo B.2.2 : Leaf condition of the new foliage.

Photo B.2.3 : Leaf condition of the new foliage.

Photo B.2.4 : Leaf condition of the new foliage.

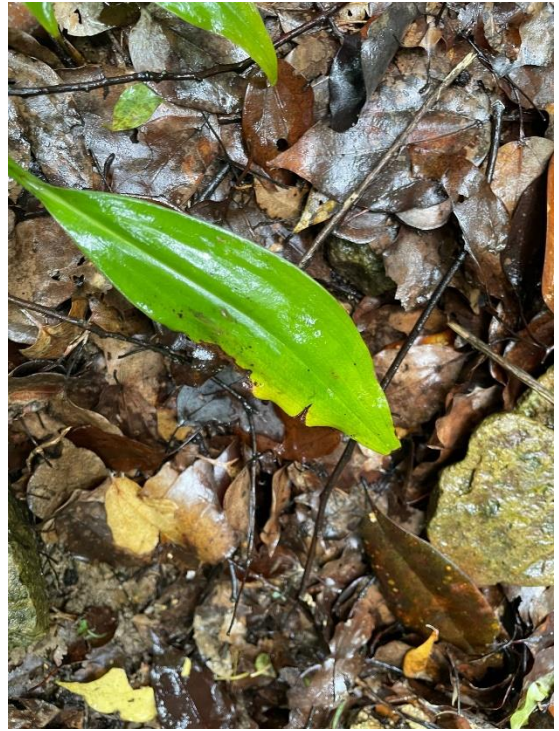
Photo B.3.6: Individual GP-06. Chlorotic leaf.

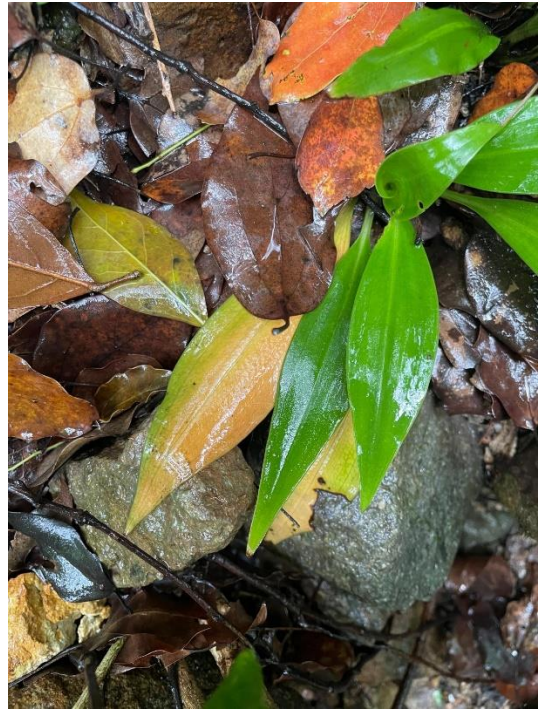
Photo B.3.14: Individual GP-13. Chlorotic leaves.
