13th Post-transplantation Monitoring and Audit Report (11th August 2023)

Northeast New Territories Landfill Extension (NENTX) | Contract No. EP/SP/77/15

0092/22/ED/0423 02 | 14 August 2023

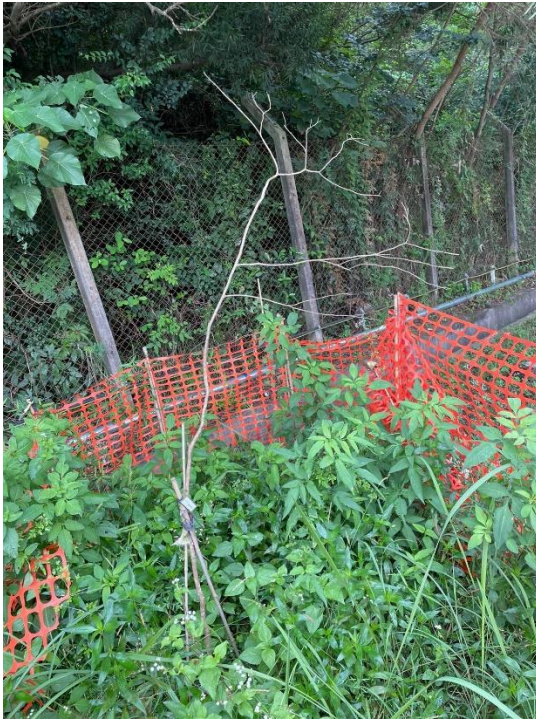
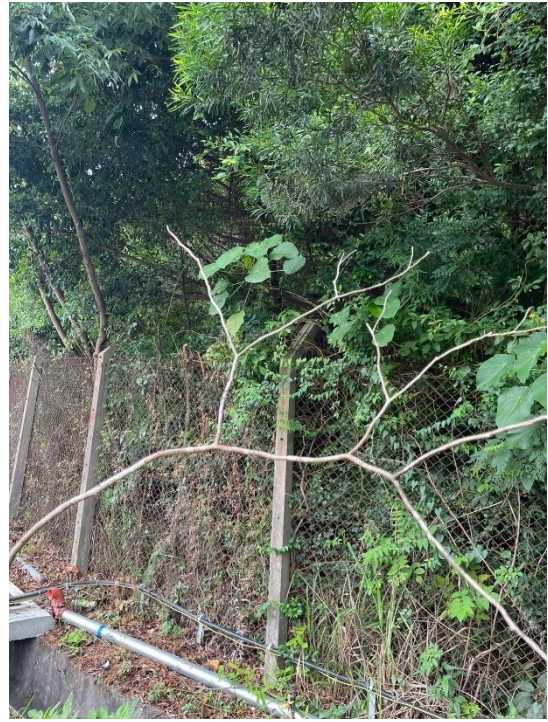
- 2.1.3 The Lamb of Tartary *Cibotium barometz* is in good condition. The new foliage is now very established and have been growing steadily.
- 2.1.4 The two saplings of the Incense Tree *Aquilaria sinensis* both demonstrated poor health conditions with die back and fallen leaves.

Photo B.1.1. : General view of the transplanted individual AS-03.

Photo B.1.2. : Branch condition of the transplanted individual AS-03.

- The watering frequency for the two saplings of Incense Tree should be maintained at 2-3 times a week. Improve/place organic mulch around the two saplings of Incense Tree to retain soil moisture, protect damaged roots against extreme temperatures, and improve soil quality.
- The watering frequency of the cluster of Lamb of Tartary should be maintained at twice a week.
- The watering frequency for all clusters of Bottlebrush Orchid should remain the same. During watering activities, the surrounding dead branches and dry leaves should be removed to ensure no plants are damaged by them.
- Weed around the two Incense Tree saplings should be removed. Fencing around individual AS-03 should be reinforced.

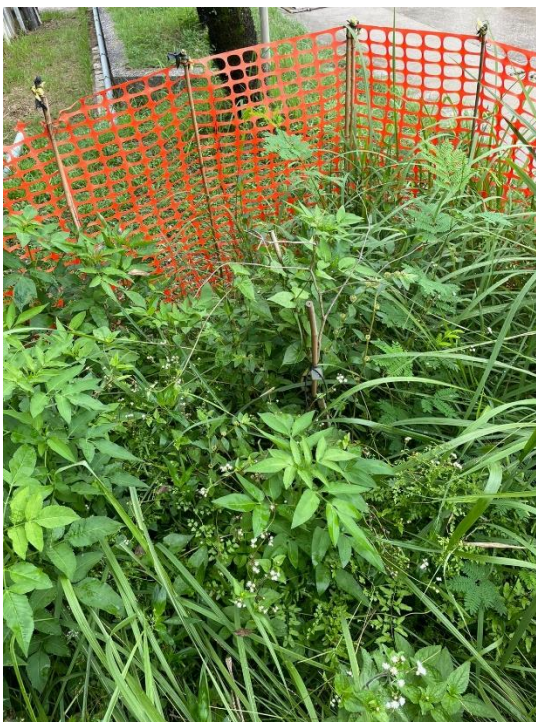
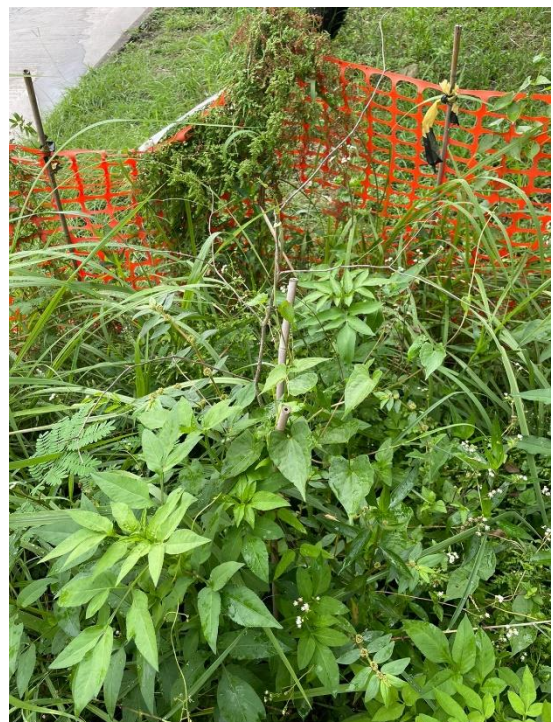
Photo B.1.3. : General view of the transplanted individual AS-02.

Photo B.1.4. : Stem condition of the transplanted individual AS-02.

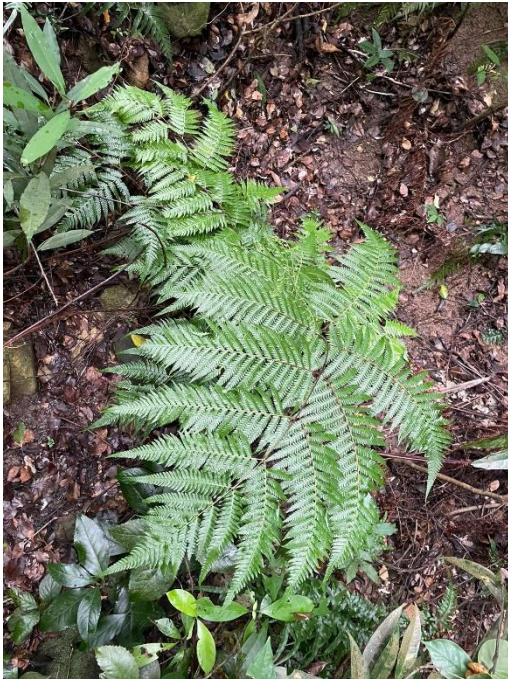
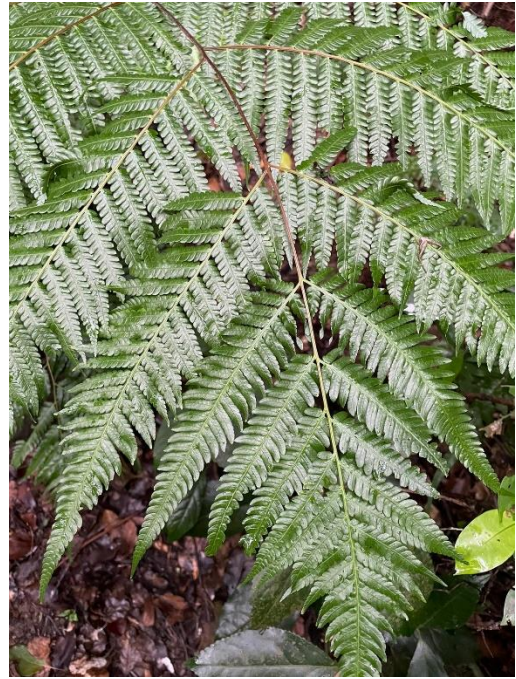
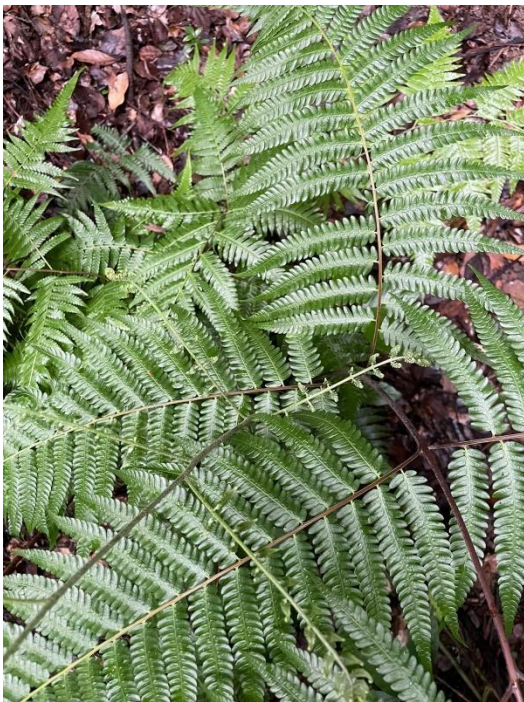
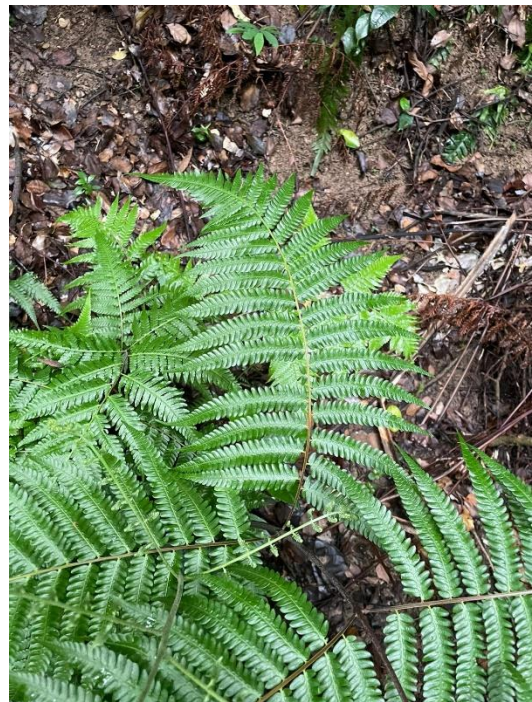
Photo B.2.1. : General view of the transplanted individual CB-01.

Photo B.2.2. : Leaf condition of the new foliage.

Photo B.2.3. : Leaf condition of the new foliage.

Photo B.2.4. : Leaf condition of the new foliage.

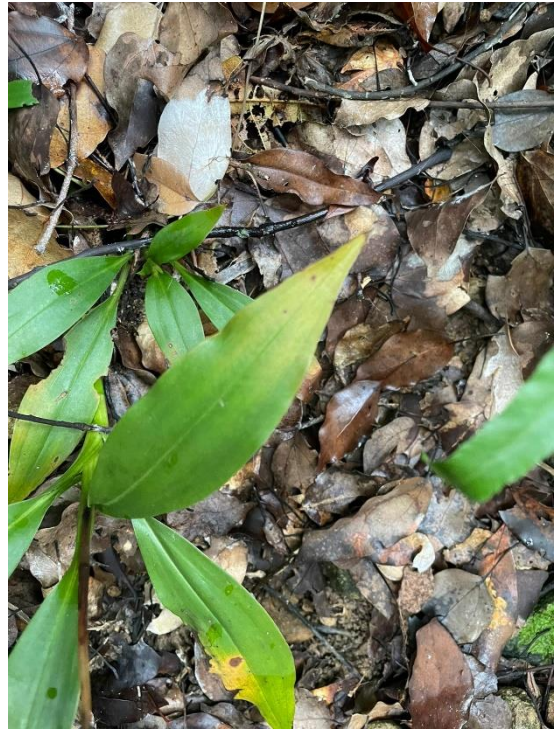
Photo B.3.6: Individual GP-06. Chlorotic leaf.

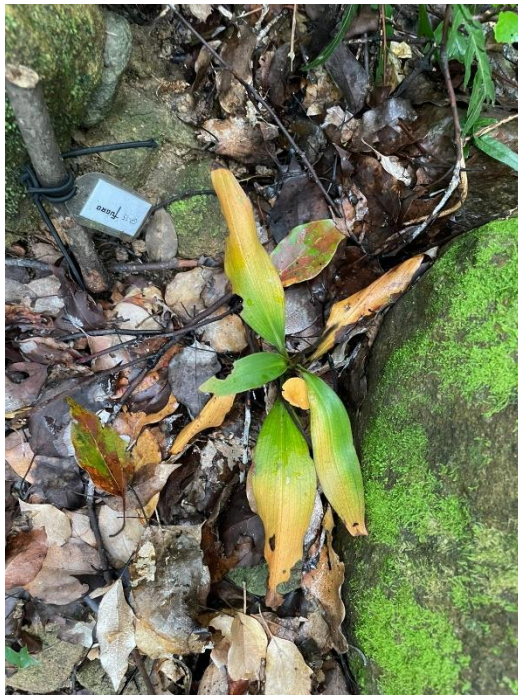
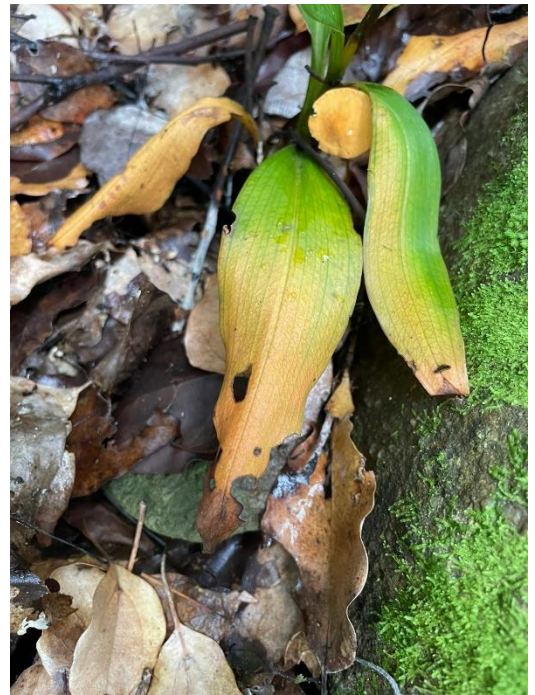
Photo B.3.15: Individual GP-15.

- 2.1.1 The majority of the transplanted individuals of the 19 clusters of Bottlebrush Orchid *Goodyera procera* were in fair to good condition with only minor health issues observed in some individuals, i.e., slightly chlorotic leaves and presences of holes in the leaves. However, one individual (GP15) demonstrated poor health condition. Moreover, following the Tropical Cyclone Talim, which triggered the T8 alert on 17 July 2023 some individuals have gone missing.
