14th Post-transplantation Monitoring and Audit Report (15th September 2023)

Northeast New Territories Landfill Extension (NENTX) | Contract No. EP/SP/77/15

0092/22/ED/0440 01 | 28 September 2023

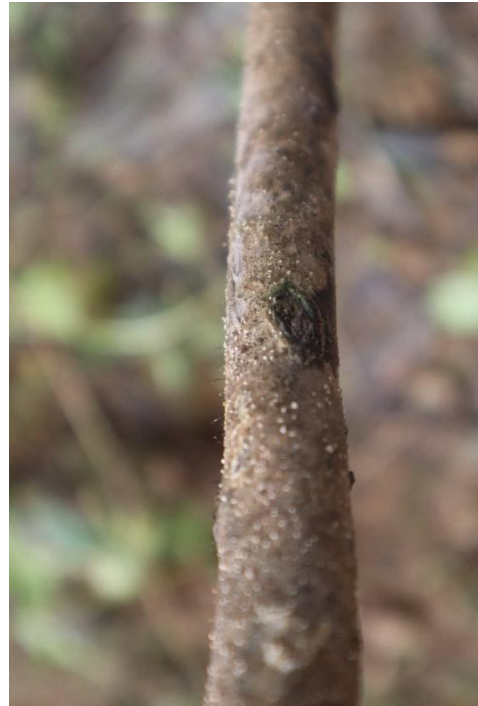
- 2.1.3 The Lamb of Tartary *Cibotium barometz* is in good condition. The new foliage is now very established and have been growing steadily.
- 2.1.4 One saplings of the Incense Tree *Aquilaria sinensis* (AS02) is dead. This could also be due to the recent rainstorm and tropical cyclone. The other (AS03) demonstrated poor health conditions with no foliage and fungi growing.

Photo B.1.2 : Stem condition of the transplanted individual AS-03.

- The watering frequency for the two saplings of Incense Tree should be maintained at 2-3 times a week. Improve/place organic mulch around the two saplings of Incense Tree to retain soil moisture, protect damaged roots against extreme temperatures, and improve soil quality.
- The watering frequency of the cluster of Lamb of Tartary should be maintained at twice a week.
- The watering frequency for all clusters of Bottlebrush Orchid should remain the same. During watering activities, the surrounding dead branches and dry leaves should be removed to ensure no plants are damaged by them.
- Fencing around individual AS-03 should be reinforced.

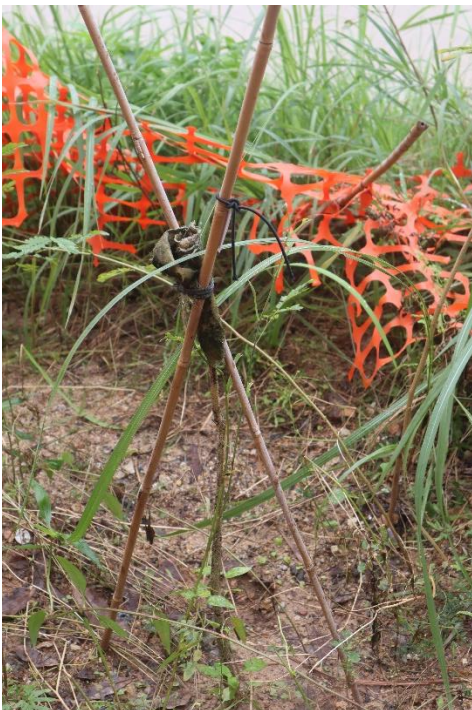
Photo B.1.3 : General view of the transplanted individual AS-02.

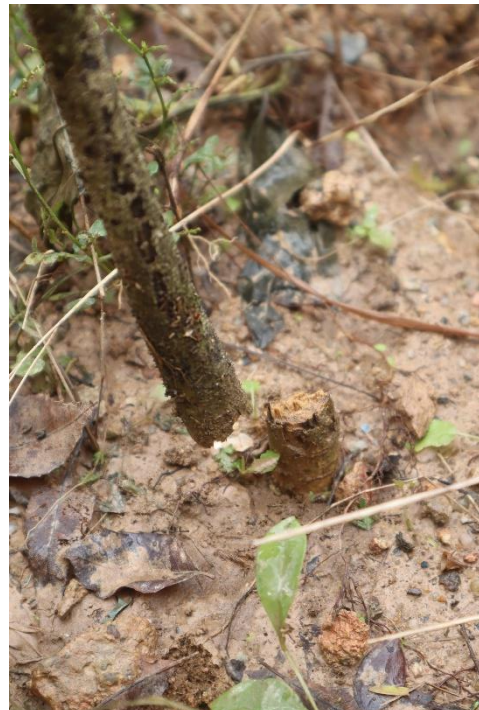
Photo B.1.4 : Broken stem of the transplanted individual AS-02.

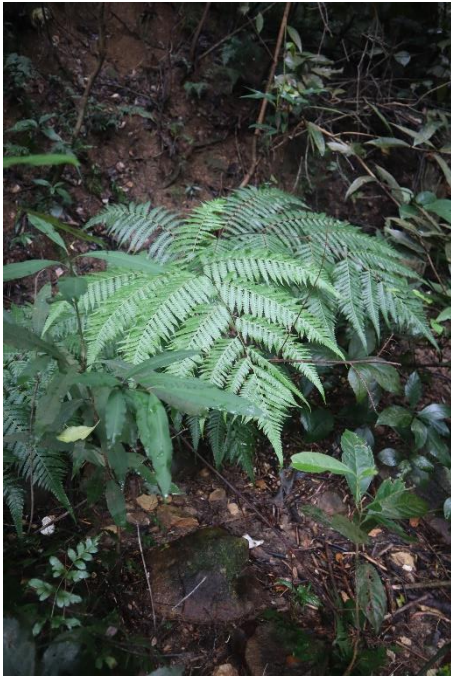
Photo B.2.1 : General view of the transplanted individual CB-01.

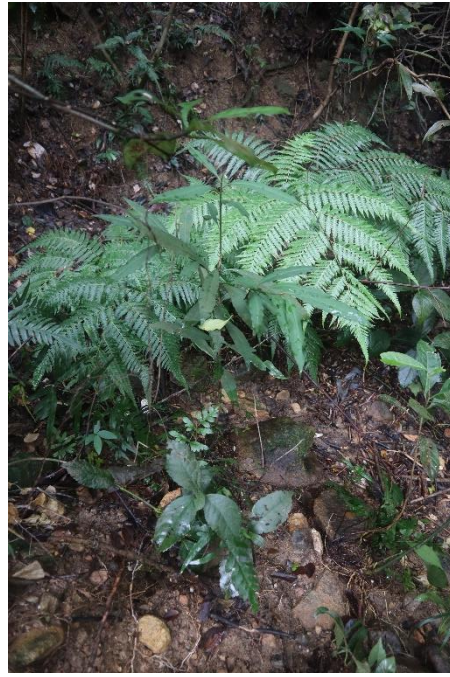
Photo B.2.2 : View of the transplanted individual CB-01.

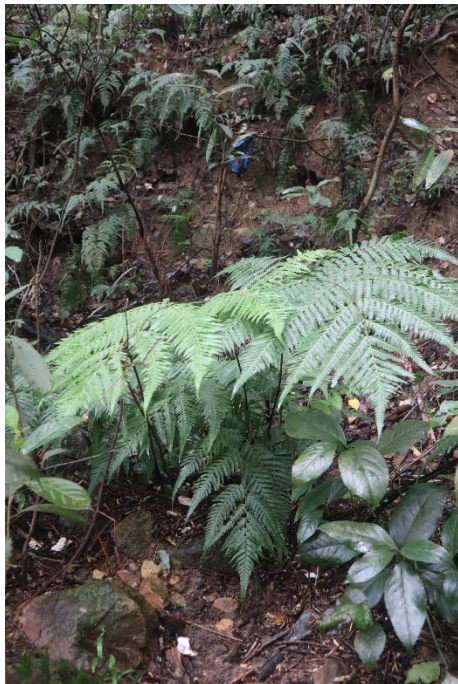
Photo B.2.3 : View of the transplanted individual CB-01.

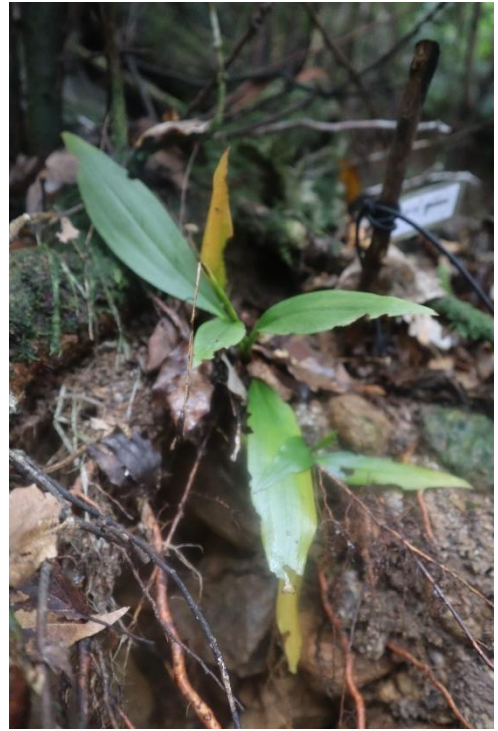
Photo B.3.6: Individual GP-16.

"	B	GP15	"			—		—					"
"	B	GP16	"			13		fair					chlorotic leaves
"	B	GP17	"			9		good					
"	B	GP18	"			—		—					missing
"	B	GP19	"			—		—					missing
