15th Post-transplantation Monitoring and Audit Report (13th October 2023)

Northeast New Territories Landfill Extension (NENTX) | Contract No. EP/SP/77/15

0092/22/ED/0448 02 | 16 October 2023

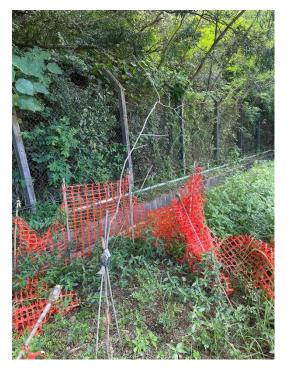
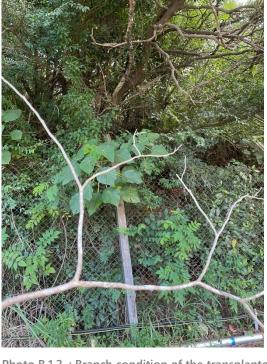
- **2.1.3** The Lamb of Tartary *Cibotium barometz* is in good condition. The new foliage is now very established and have been growing steadily.
- 2.1.4 One saplings of the Incense Tree *Aquilaria sinensis* (AS02) is dead. This could also be due to the recent rainstorm and tropical cyclone. The other (AS03) demonstrated poor health conditions with no foliage and fungi growing.

Photo B.1.1.: General view of the transplanted individual AS-03.

Photo B.1.2.: Branch condition of the transplanted individual AS-03.

- The watering frequency for the two saplings of Incense Tree should be maintained at 2-3 times a week. Improve/place organic mulch around the two saplings of Incense Tree to retain soil moisture, protect damaged roots against extreme temperatures, and improve soil quality.
- The watering frequency of the cluster of Lamb of Tartary should be maintained at twice a week.
- The watering frequency for all clusters of Bottlebrush Orchid should remain the same. During watering activities, the surrounding dead branches and dry leaves should be removed to ensure no plants are damaged by them.

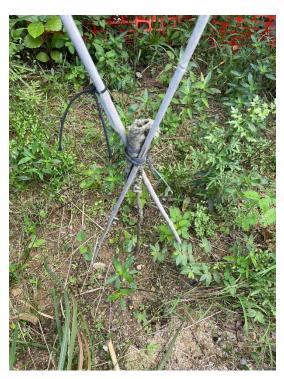
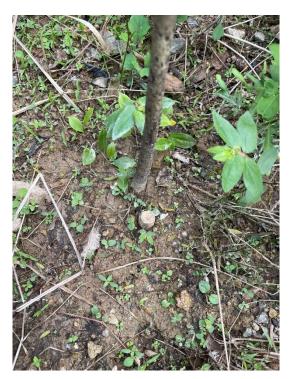
Photo B.1.3.: General view of the transplanted individual AS-02.

Photo B.1.4.: Broken stem of the transplanted individual AS-02.

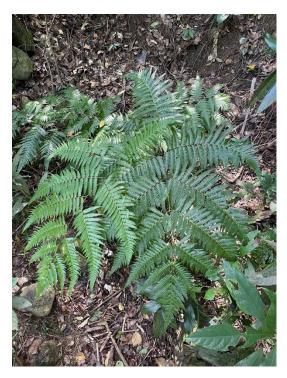
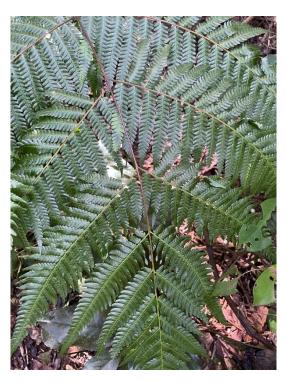
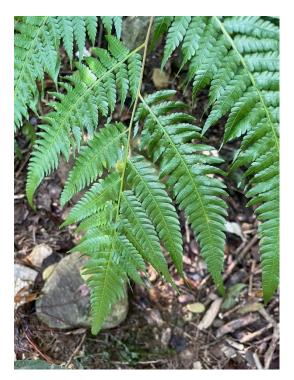
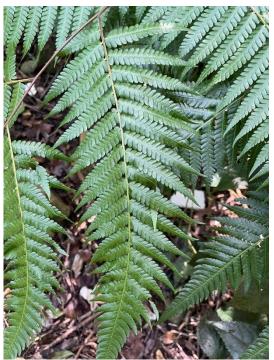
Photo B.2.1.: General view of the transplanted individual CB-01.

Photo B.2.2.: Leaf condition of the transplanted individual CB-01.

Photo B.2.3.: Leaf condition of the transplanted individual CB-01.

Photo B.2.4.: Leaf condition of the transplanted individual CB-01.

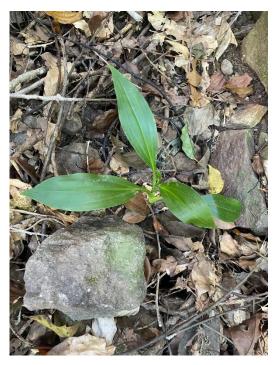
Photo B.3.3: Individual GP-07.

| Date of Monitoring and Maintenance | | No. | Species | Plant Size Measurements | | Amenity Value | Form | Health Condition | Structural Condition | Description 1 | | | |
|---|---|---|---|---|---|---|---|---|---|---|---|---|---|
| 4 | 13 | GPOT | | | | 13 | | | | | | | Chlurotic leave |

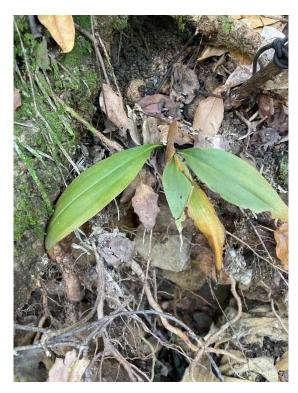
Photo B.3.6: Individual GP-16.

| Date of Monitoring and Maintenance | | No. | Species | Plant Size Measurements | | Amenity Value | Form | Health Condition | Structural Condition | Description 1 | | | |
|---|---|---|---|---|---|---|---|---|---|---|---|---|---|
| | ^ | GP16 | KI VI | | | 14 | | | Pair | | | | chlorotic lean |

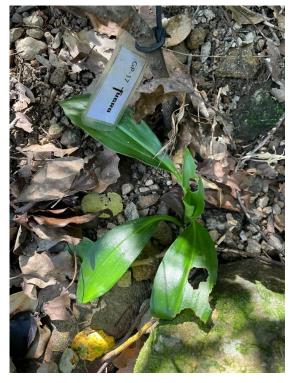
Photo B.3.7: Individual GP-17.

| Date of Monitoring and Maintenance | | No. | Species | Plant Size Measurements | | Amenity Value | Form | Health Condition | Structural Condition | Description 1 | | | |
|---|---|---|---|---|---|---|---|---|---|---|---|---|---|
| */ | _ | 4917 | | | | 8 _ | | | fair | | | | holes on leaves |
