Environmental Permit No. EP-513/2016
Development of Anderson Road Quarry Site –
Road Improvement Works

Transplantation Completion Report

**DEVELOPMENT OF
ANDERSON ROAD QUARRY SITE -
ROAD IMPROVEMENT WORKS**

TRANSPLANTATION COMPLETION REPORT

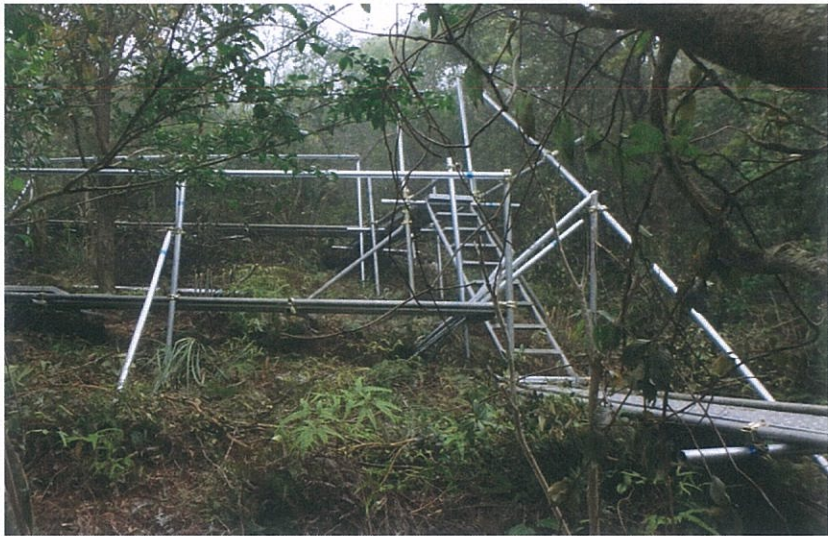
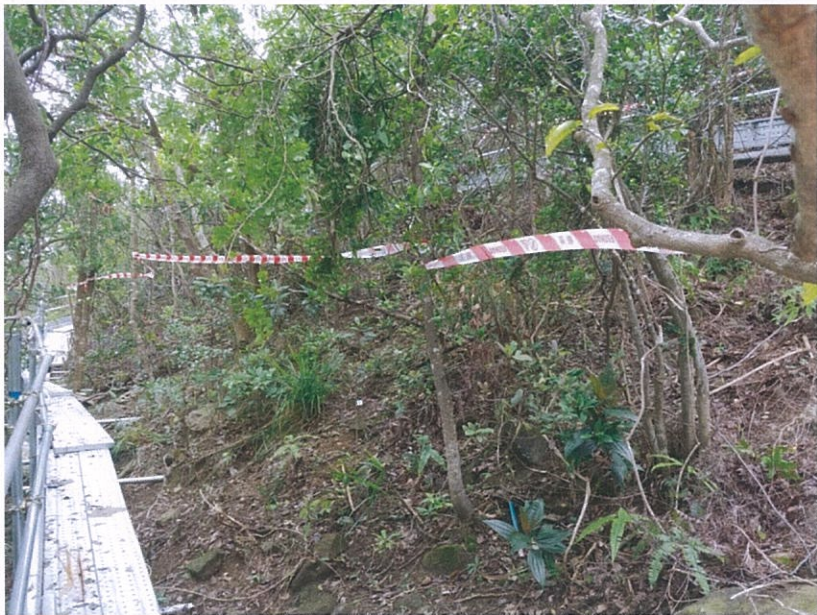
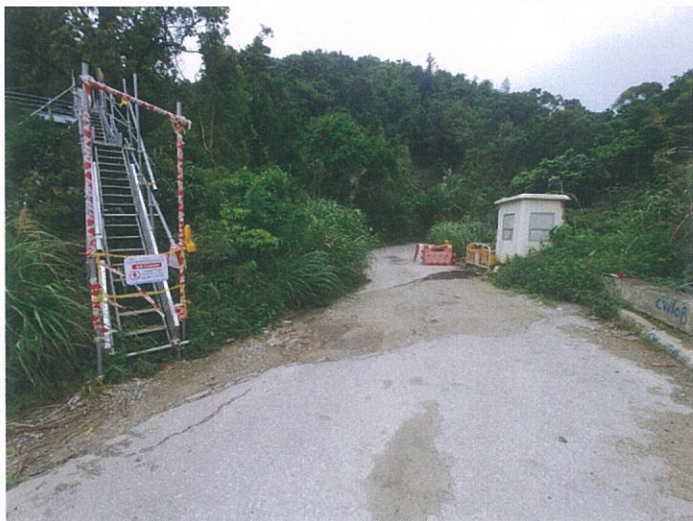
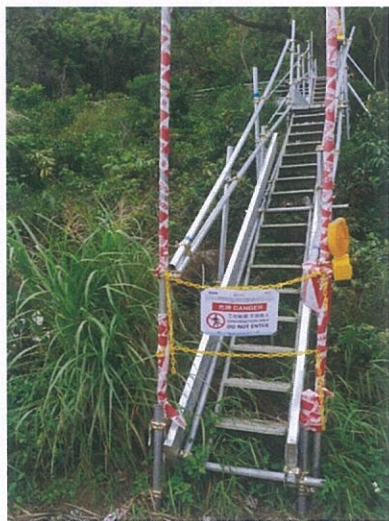
Designed receptor site (RSB as per the transplantation proposal) has received minimum vegetation clearance for building temporary access for the 3-year post-transplantation monitoring and maintenance programme (**Plate 1**). There will be no construction activities at RSB, of which the access is exclusively built for post-transplantation monitoring and maintenance works. Nonetheless, RBS was enclosed with warning tapes. Warning sign was placed at the only entrance against unintentional entry of site staff.

Since RSB is within Project NE/2016/01 which has its security guards and system for the project area. This serves certain protection against potential illegal loggers from entering the area (**Plate 1**).

Plate 1. Vegetation clearance was kept at minimum for building temporary access to the transplantation receptor site.

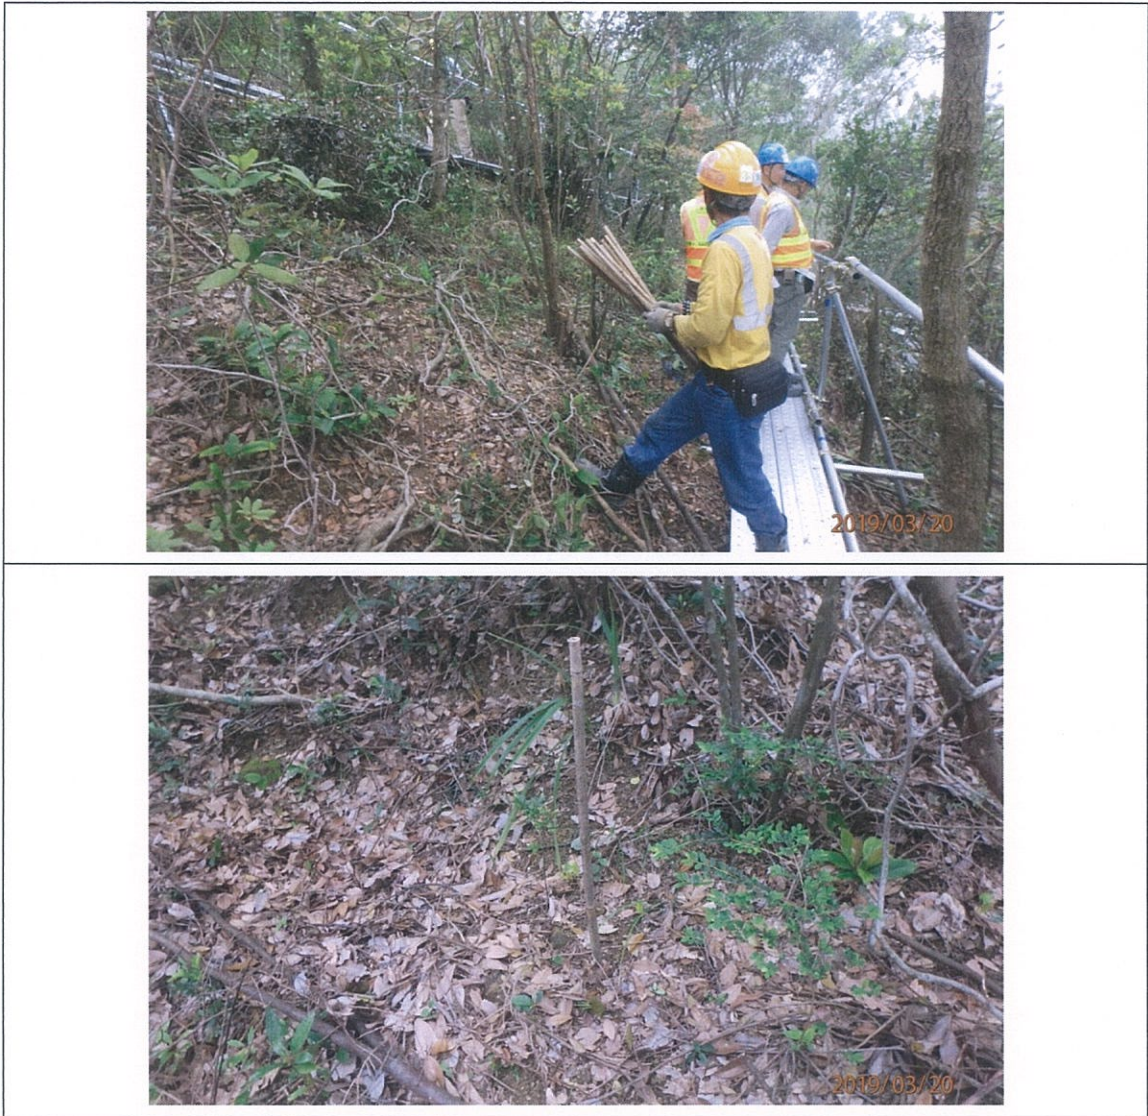
Locations of each planting pit were agreed by the Plant Specialist and the Supervisor of the Contract with adequate spacing for future growth of seedlings. Each pit was marked by a bamboo stick (**Plate 2**). No plant species of conservation importance were detected at the planting area of seedlings.

Plate 2. Each planting pit agreed by the Plant Specialist and the Supervisor of the Contract was marked by a bamboo stick prior to transplantation.

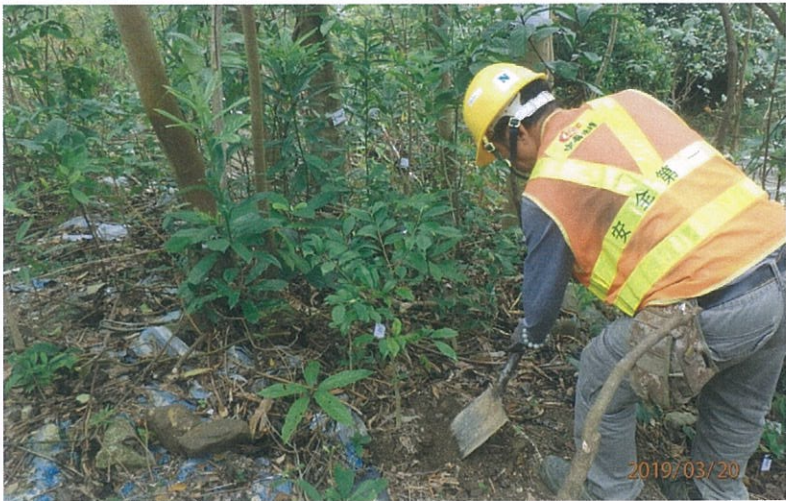
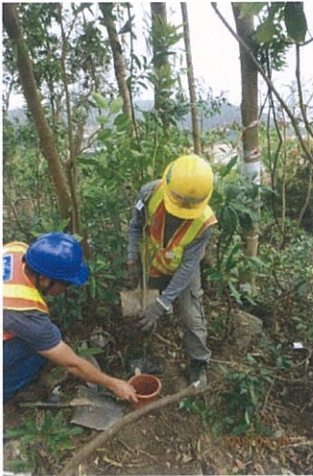
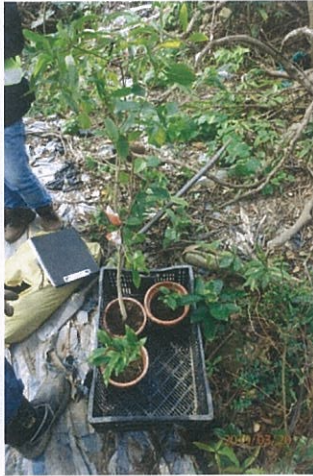
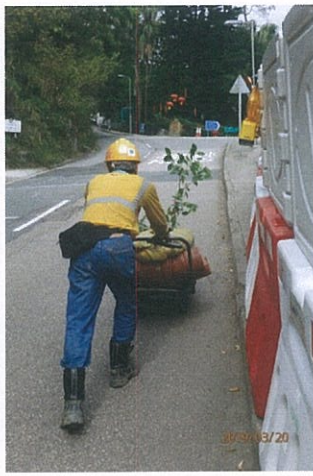
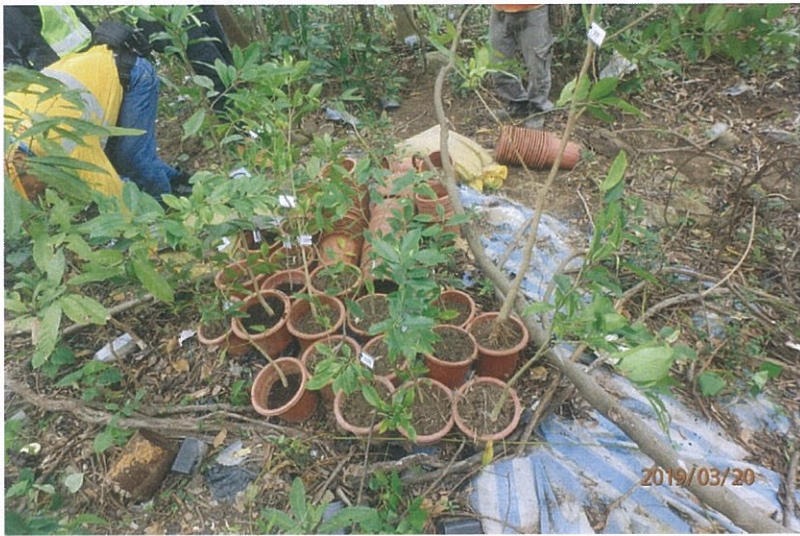
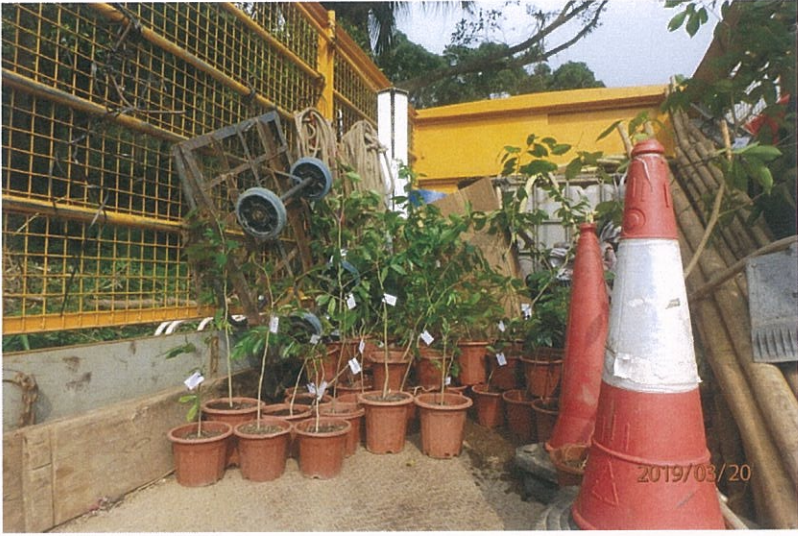
By following the transplantation proposal, all target seedlings were dug up with caution by hand-held shovel by Landscape Specialist Contractor, individually placed upright in pots, counted, irrigated and delivered to the receptor site (**Plate 3**). Meanwhile, planting pits were ready right before transplantation at each marked location. They were optimized at two to three times the width; and same depth of the rootball at the surface wherever practical. All seedlings were transplanted in the pits within two hours of lifting.

Plate 3. All 55 seedlings were dug up with caution by hand-held shovel by Landscape Specialist Contractor, individually placed upright in pots and delivered to the receptor site.

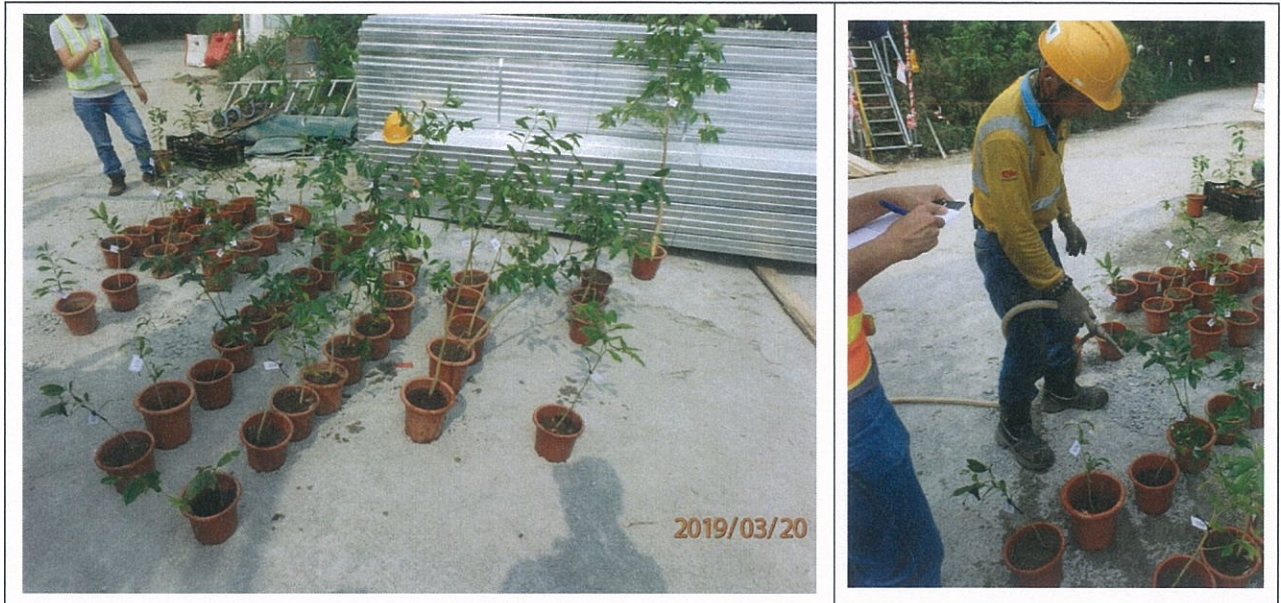
Plate 3 cont'd. All 55 seedlings were counted and irrigated before transplanting to the receptor site.

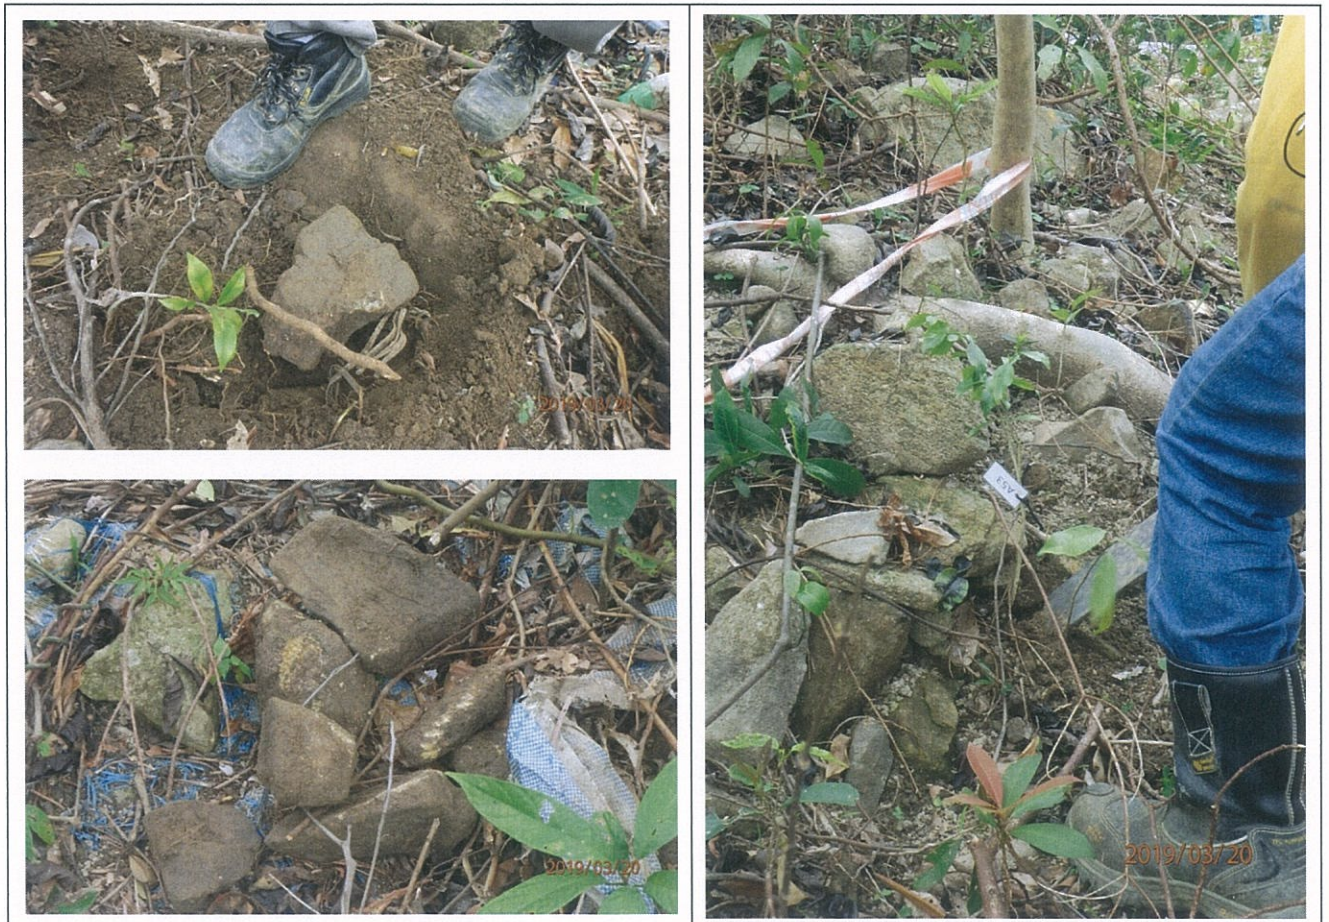
We revealed the original growing site of target seedlings is full of boulders after clearance of dense ground vegetation has been carried out. Rocks/ boulders exposed under a few centimetres of top soil around root zones for some seedlings (**Plate 4**). Some other seedlings were even growing among rock crevices.

Plate 4. Original growing site of target seedlings is full of boulders as revealed by digging up the top soil (left). Some seedlings were even growing among rock crevices (right).
