**Re: Contract No. HY/2009/15  
Central – Wan Chai Bypass – Tunnel (Causeway Bay Typhoon Shelter  
Section)  
Landscape Plan (Rev. 7)**

**Landscape Plan (Revision 7) under FEP-06/364/2009/A for Contract No. HY/2009/15**

**Contract No. HY/2009/15**  
**Central-Wan Chai Bypass – Tunnel (Causeway Bay Typhoon Shelter Section)****Submission of Tree Survey Report - Review of**  
**Existing Trees Proposed to be Felled at Portions IV and XXII**

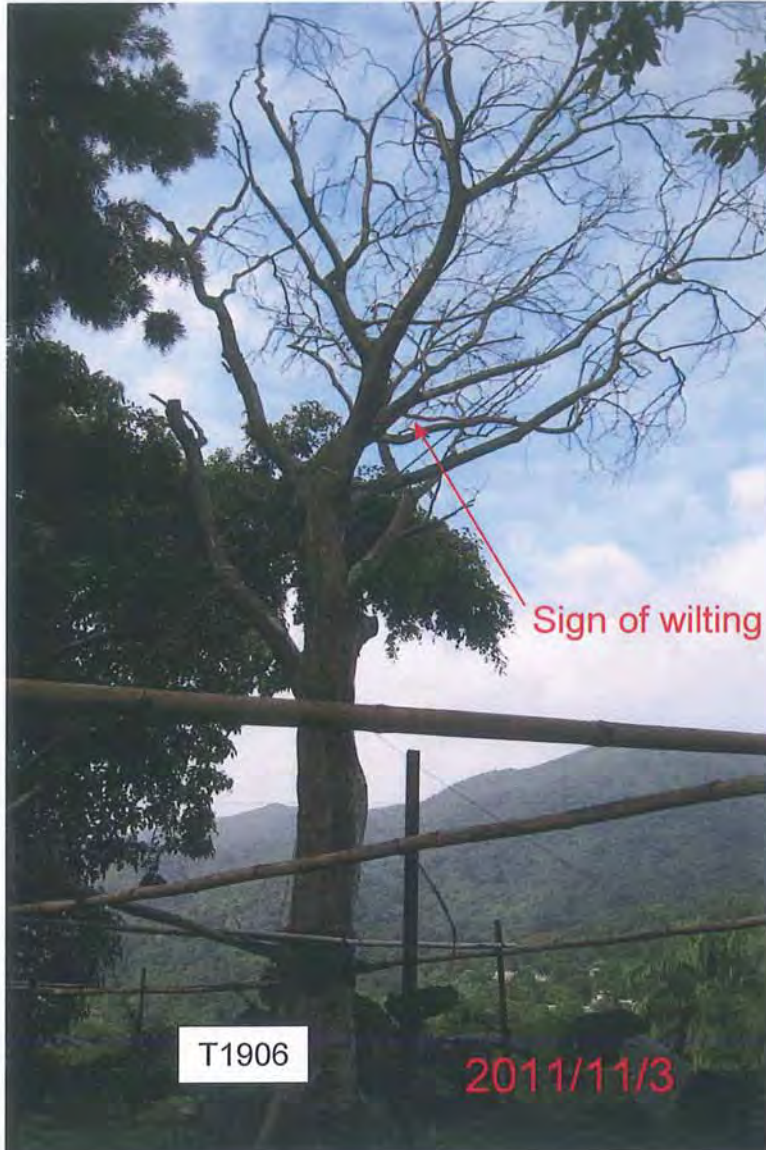
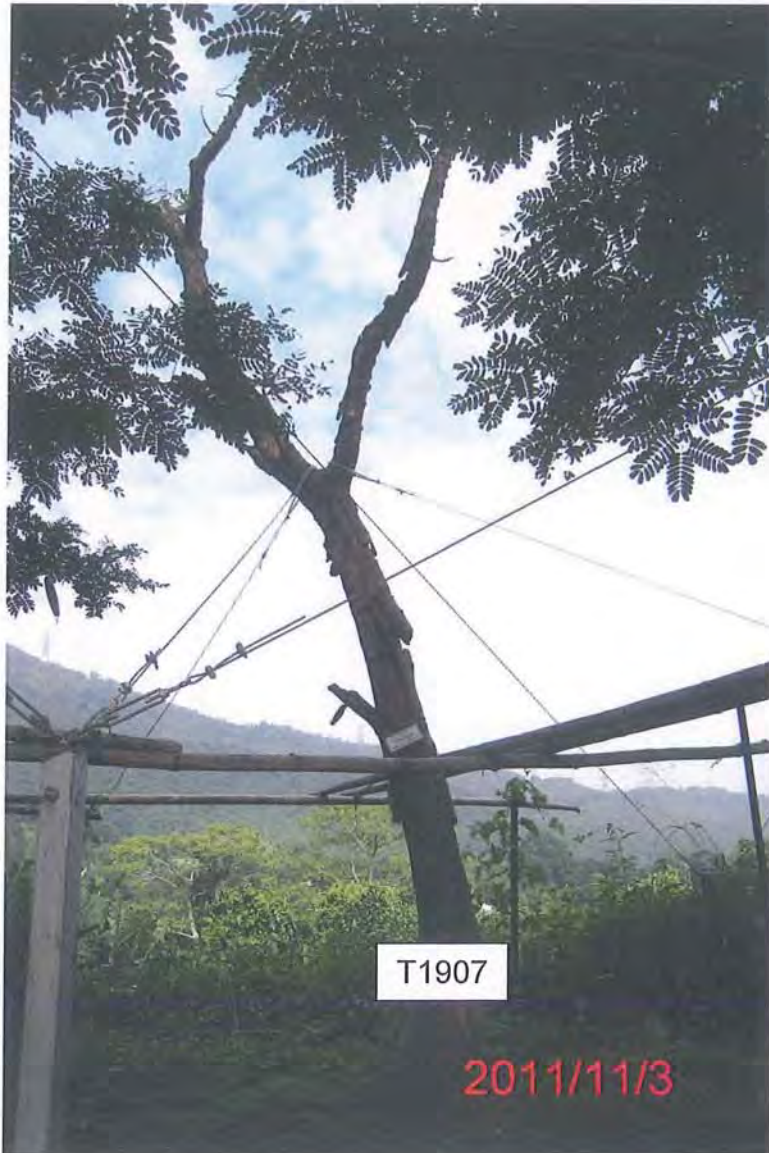
1. The trees grew near the seaside of the rocky embankment of the East Breakwater before they were transplanted. During the transplanting works in early 2011, concrete and rock breaking around their root balls could not be avoided. During the process, we also found that the root balls were not intact attached with soil and hence no pruning works were done for the transplanting. After transplanted to the holding nursery, they intended to grow unhealthily and became weak gradually and died as a consequence.

There were pre-existed conditions that the trees T1906 and T1907 were not suitable for being transplanted that we had pointed out before the execution of such works. Nevertheless, we have made our best endeavors to maintain the trees in healthy conditions during the whole process of the transplanting and in the holding nursery as required under the Contract. Therefore, under such circumstances, it is considered that we are not responsible for remedial works or replacement for the dead trees.

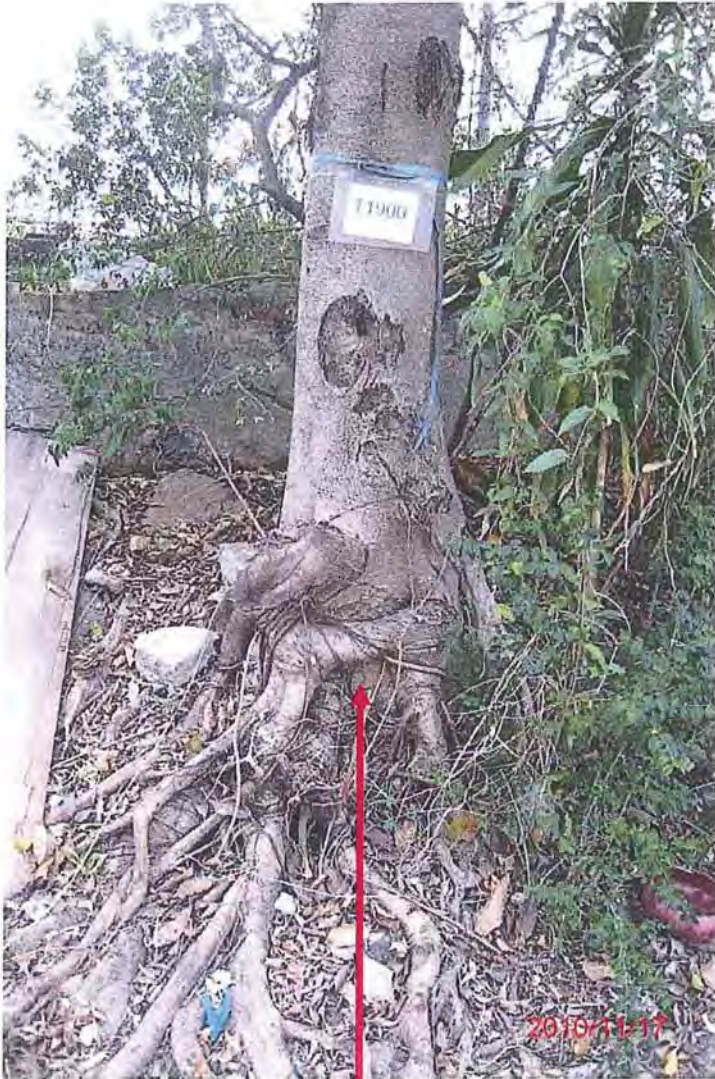
Root system distorted due to confined growing space between rock. Preparation of rootball is unfeasible for survival of transplanting

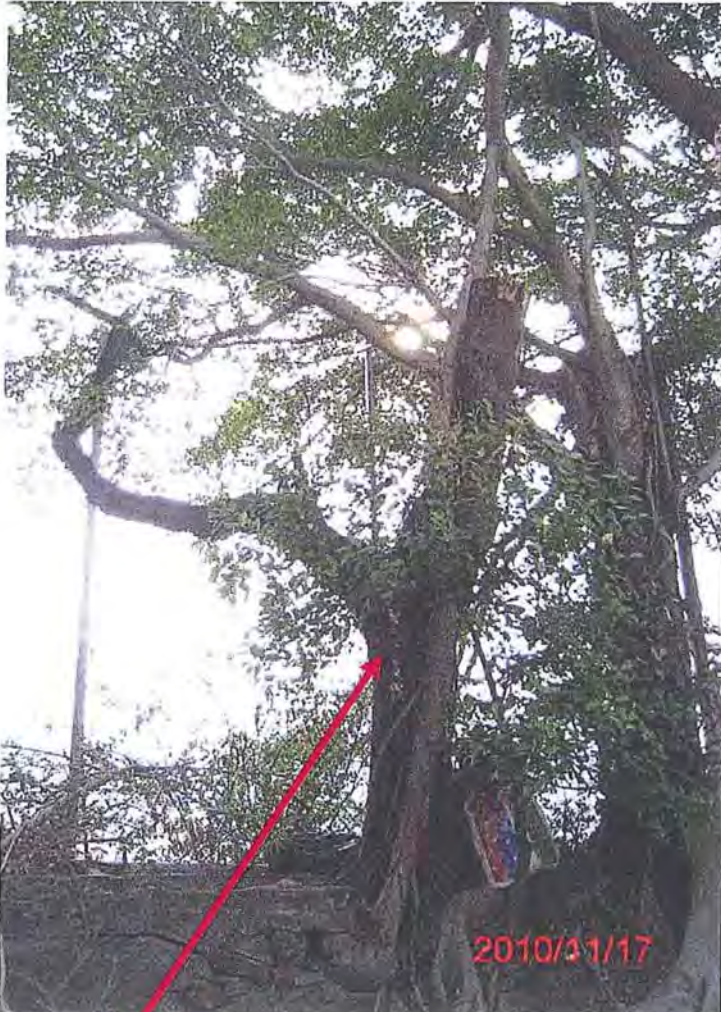
(b) Tree no. T1901 - Ficus benjamina 垂葉榕

Dead tree

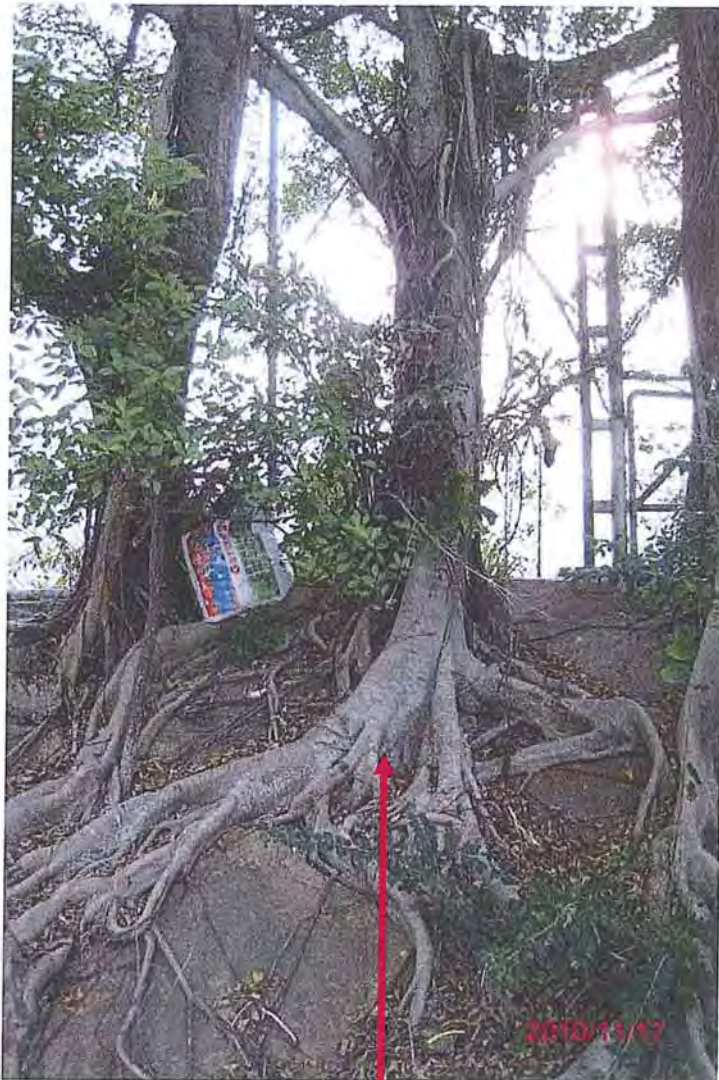
Rootball locates on large boulder at slope and clashing with adjacent roots of trees. Preparation would drastically affect rootball and structural stability

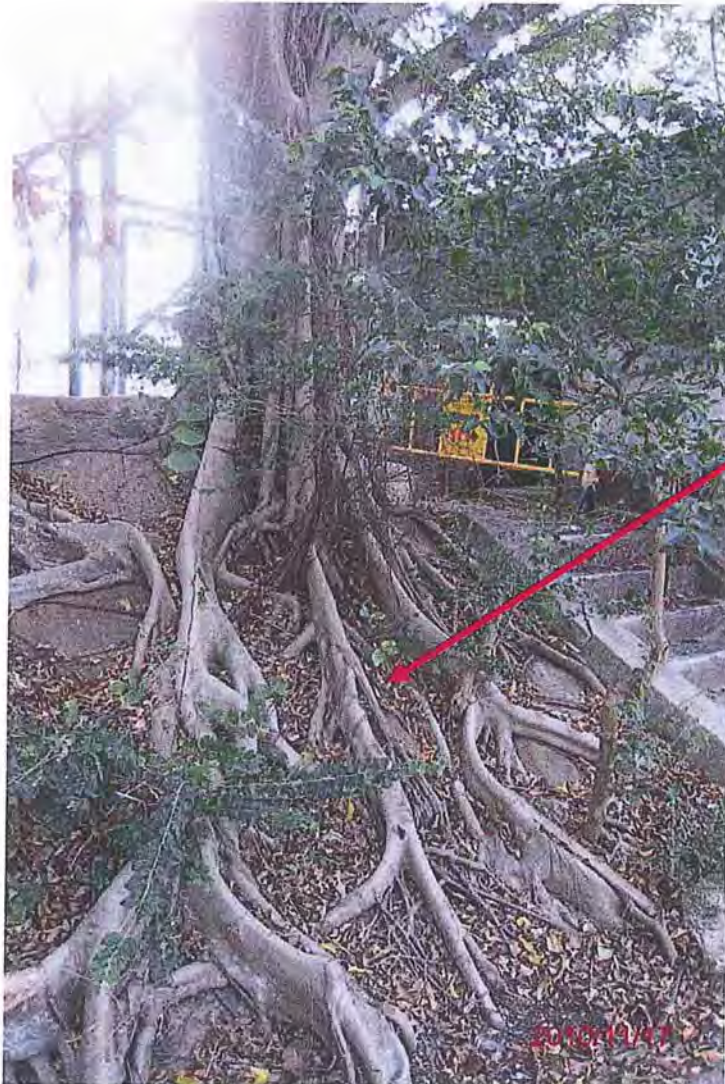
Growing on slope area

Root system distorted due to confined growing space between rock. Preparation of rootball is unfeasible for survival of transplanting.

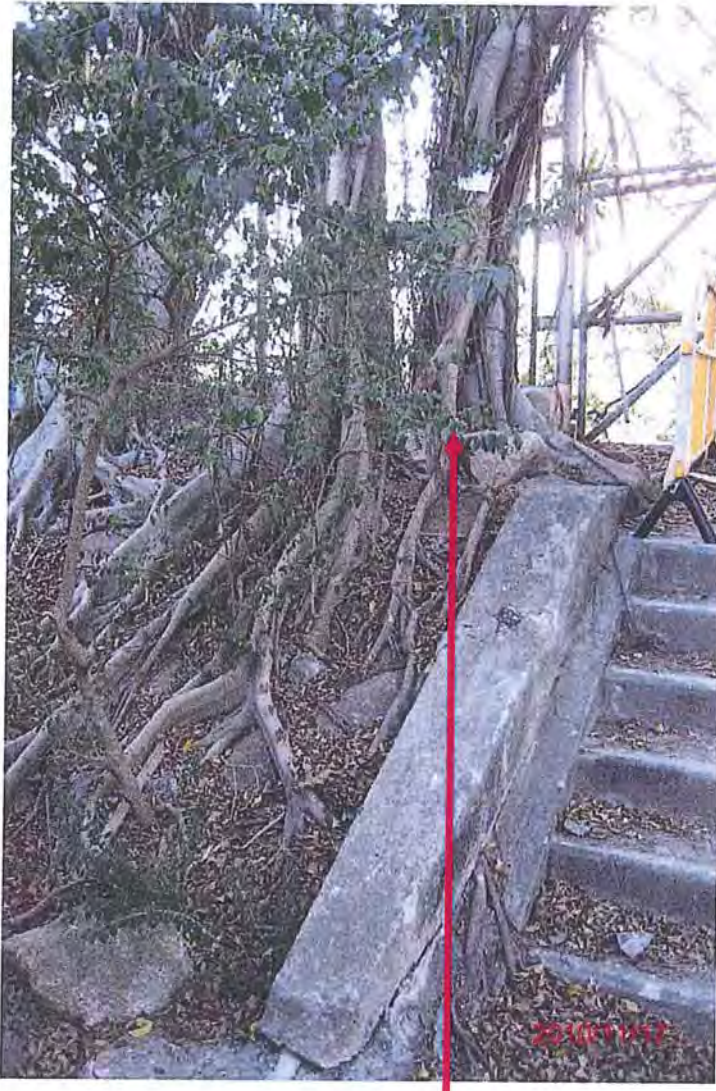
Rootball locates on large boulder at slope and clashes with adjacent roots of trees. Preparation would drastically affect rootball and structural stability

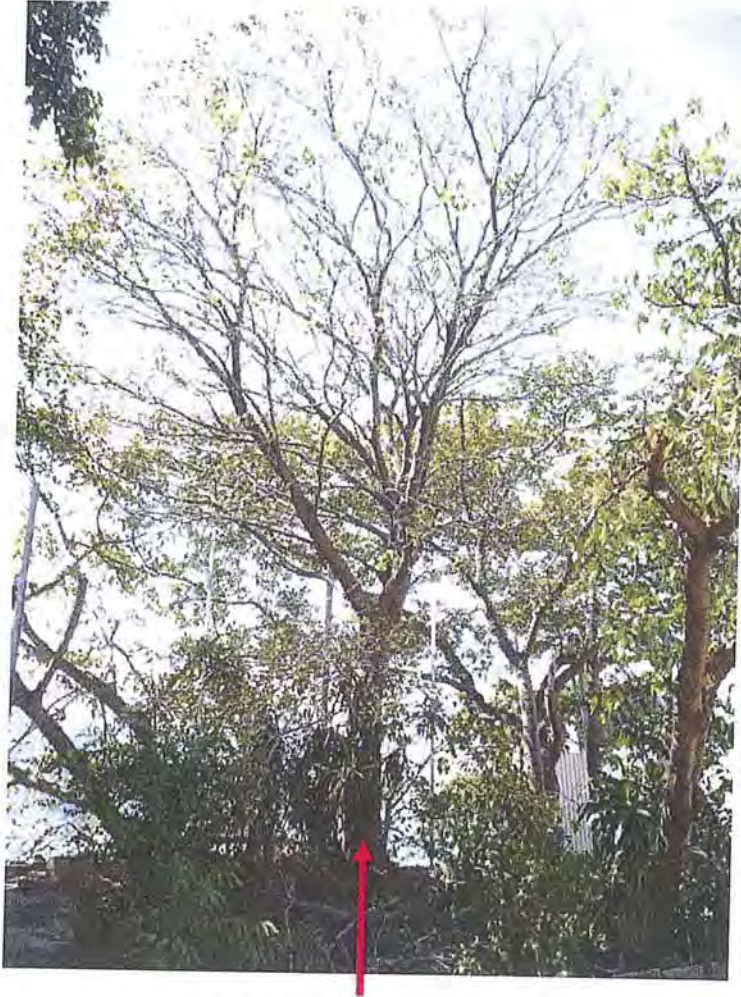
(g) Tree no. T1906 - *Celtis sinensis* 朴樹

Tree locates on uneven levels

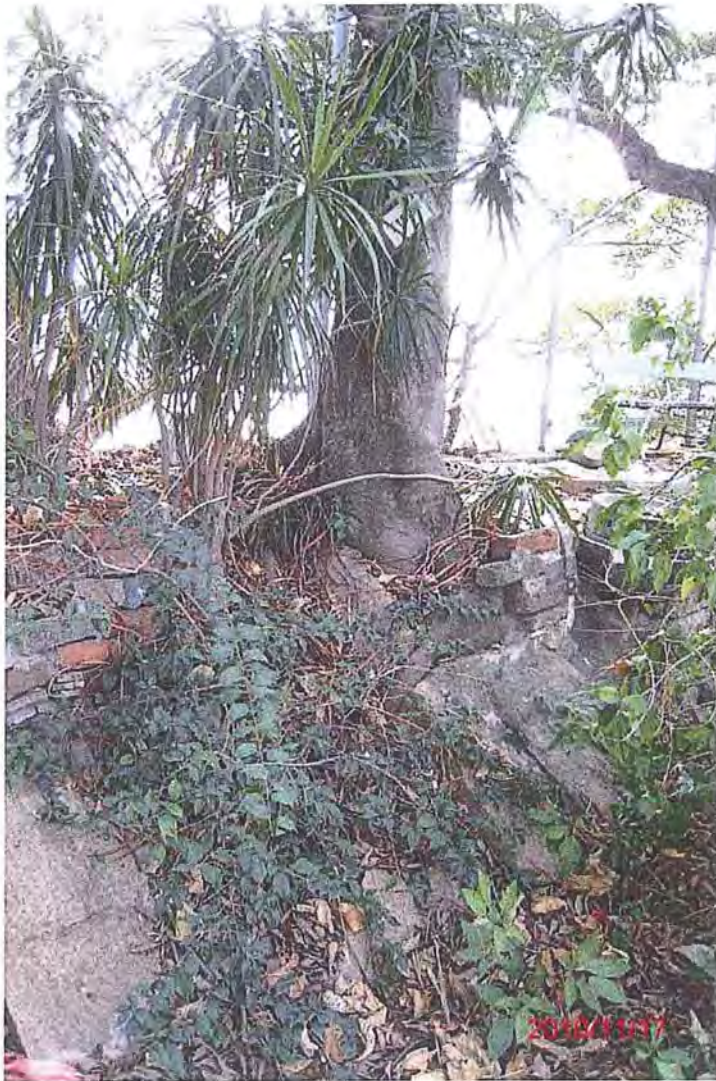
Root system distorted due to confined growing space between rock. Preparation of rootball is unfeasible for survival of transplanting

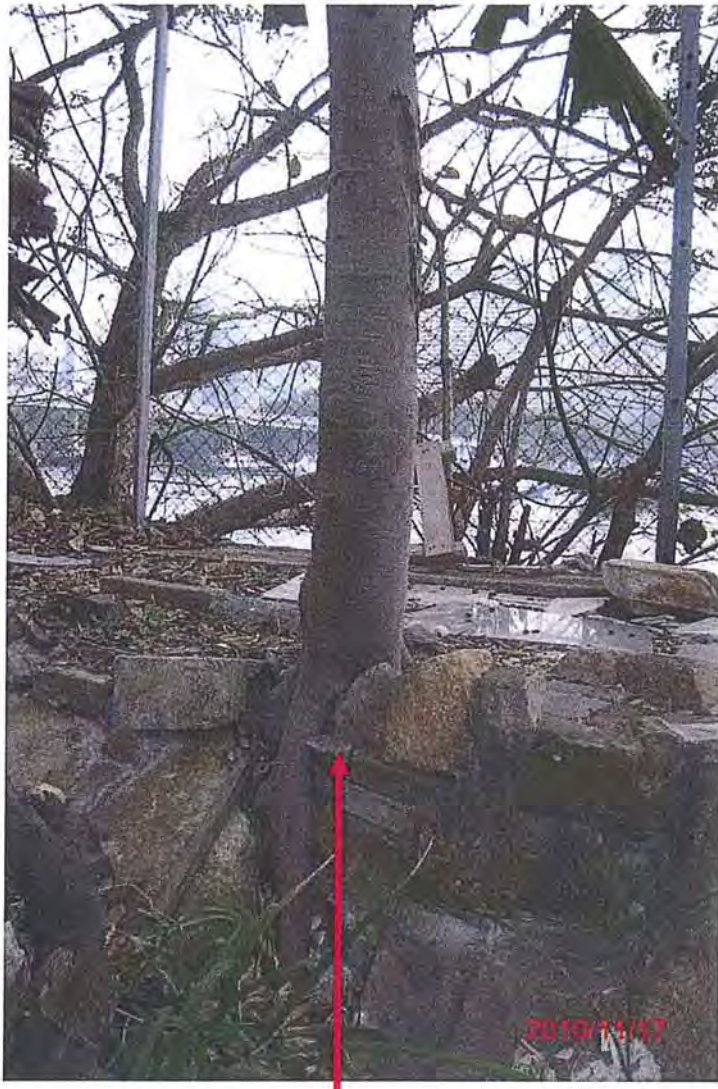
Root system distorted due to rock.  
Limited root system coverage for stability.

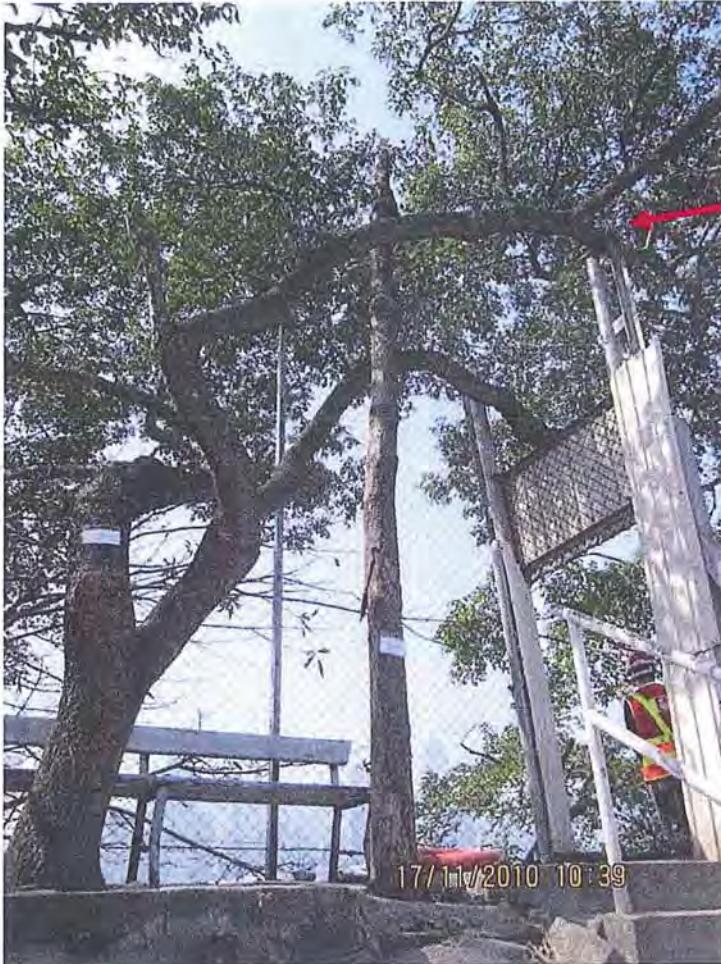
Tree is leaning using adjacent steel as support for main canopy

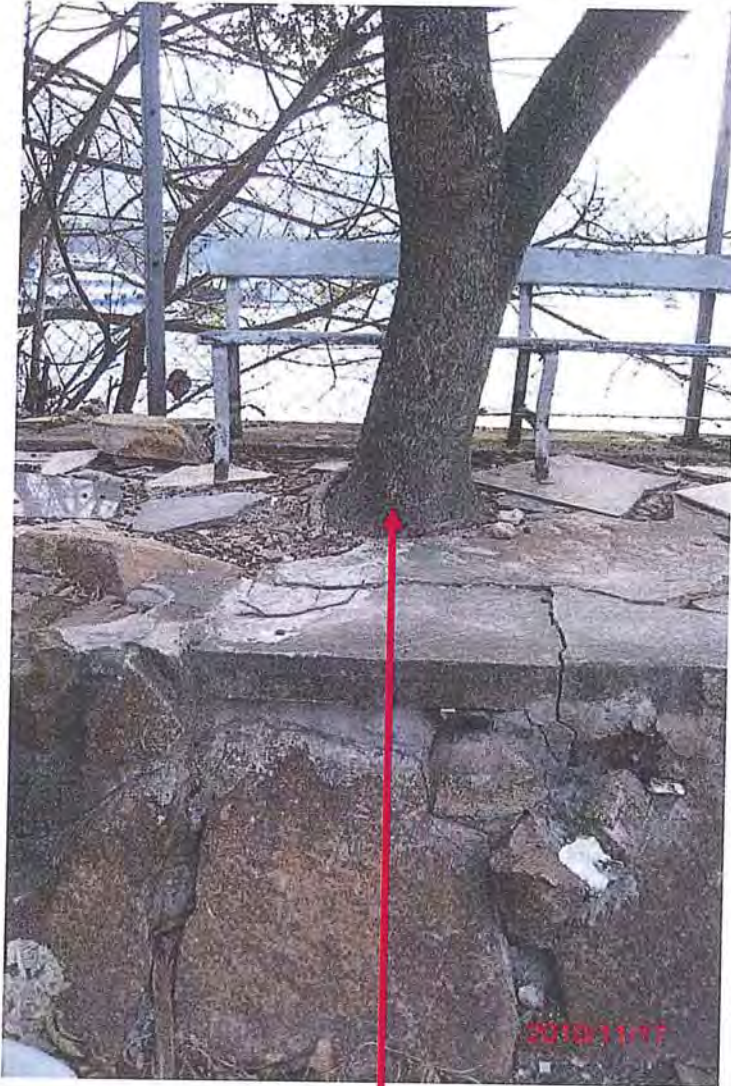
Rootball locates in rocks.  
Limited area due to rock and adjacent slope profile.  
Root system distorted within ground profile.

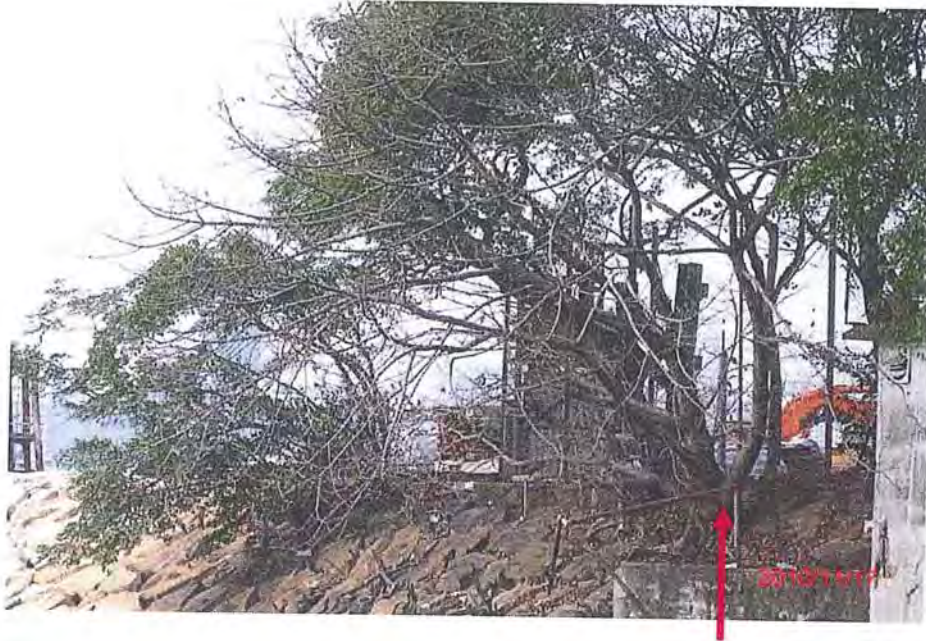
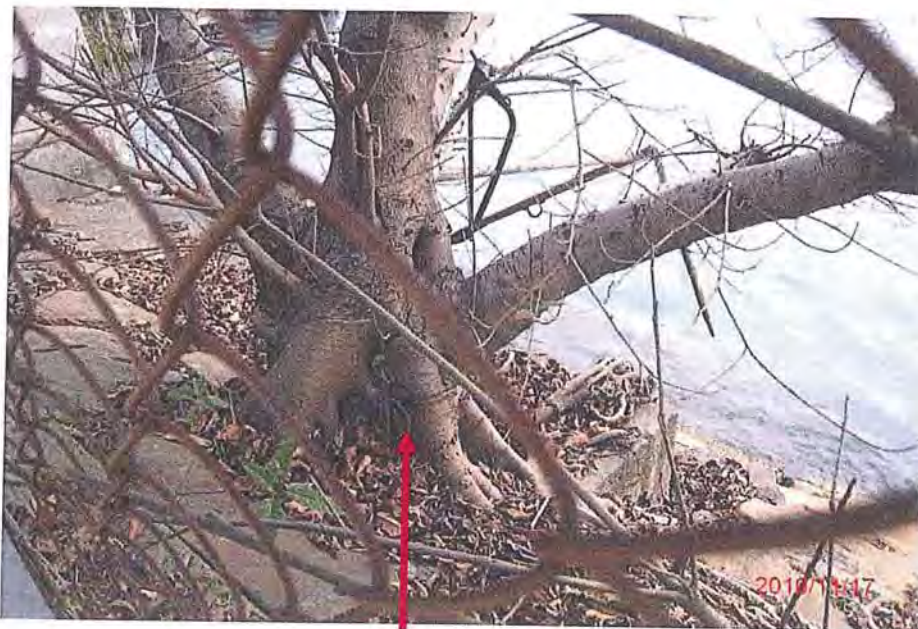
(k) Tree no. T1910 - *Ficus virens* 大葉榕, 黃葛樹

Distored rootball grows in 45 degree rock slope

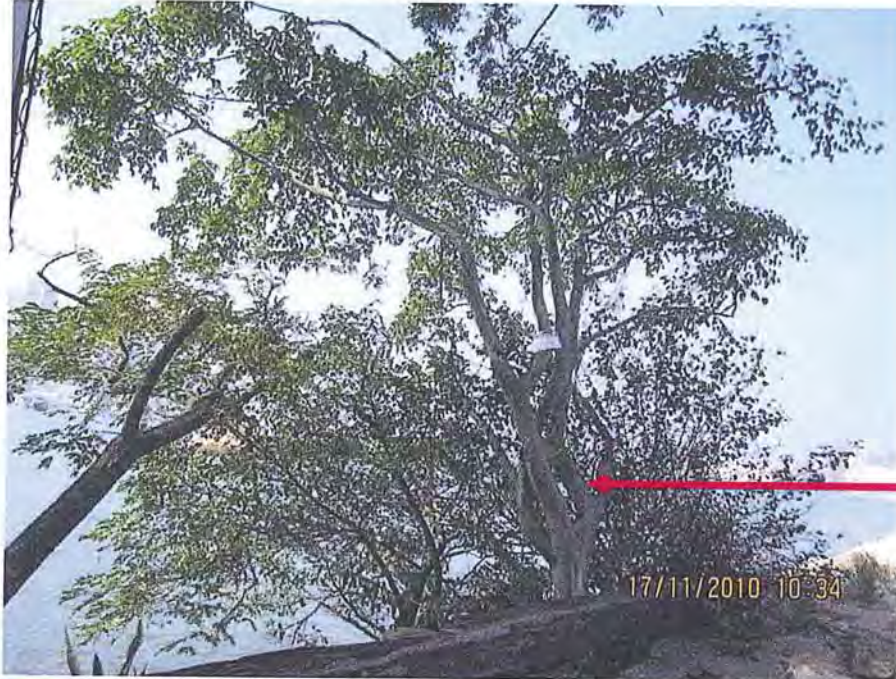
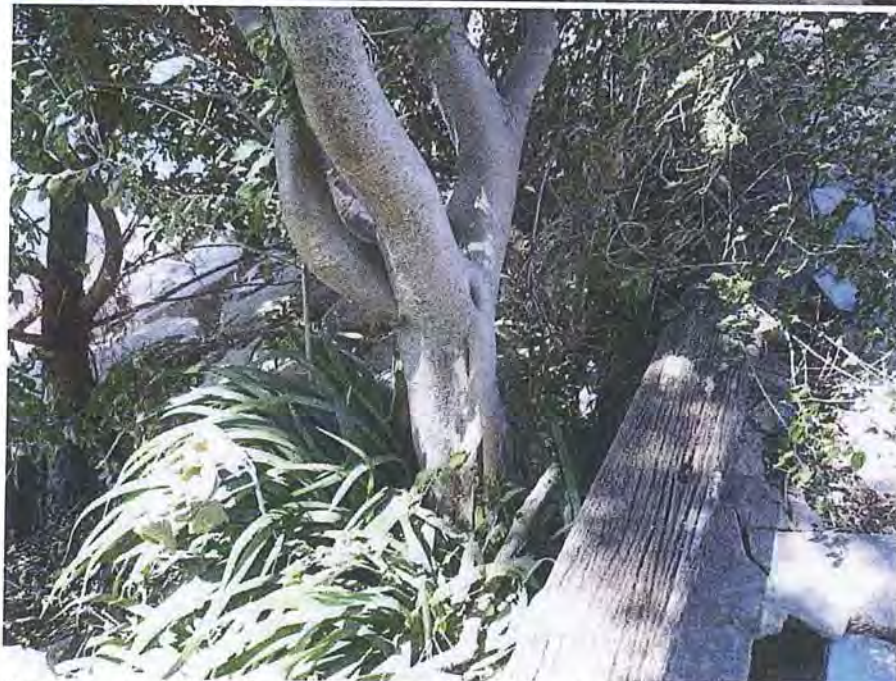
(m) Tree no. T1912 - Ficus benjamina 垂葉榕

Root system distorted due to confined growing space between rocks.  
Preparation of rootball is unfeasible for survival of transplanting.

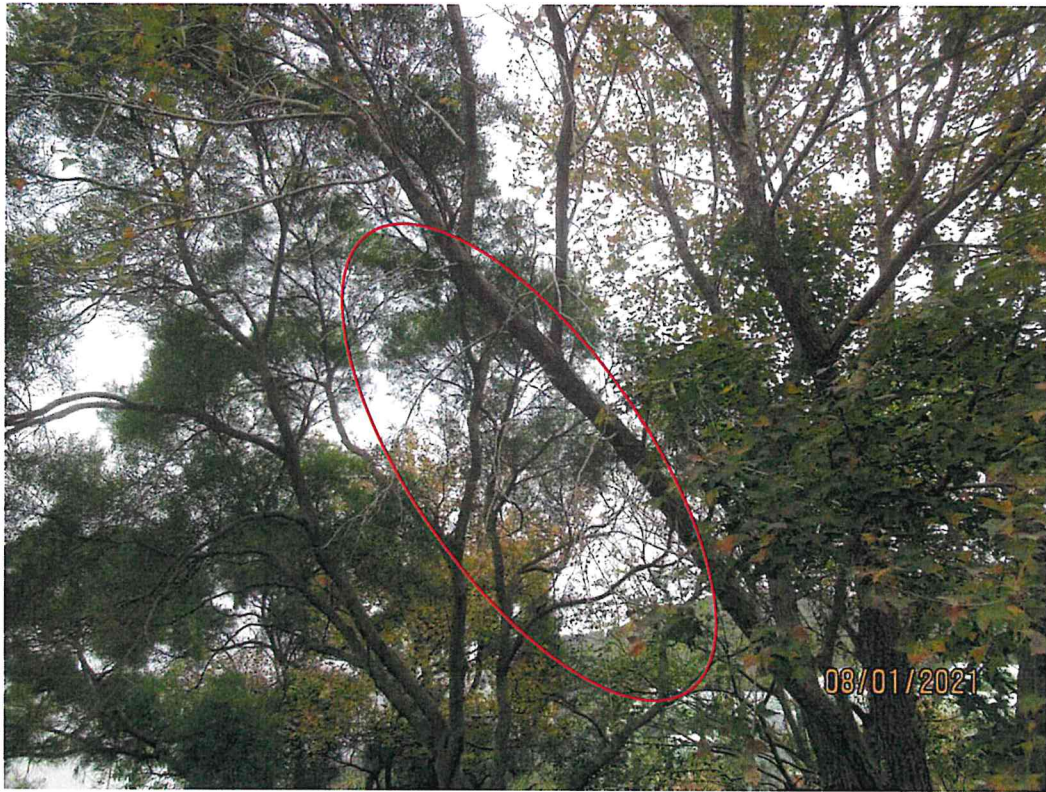
T009: Minor dead twigs are recommended to be removed.

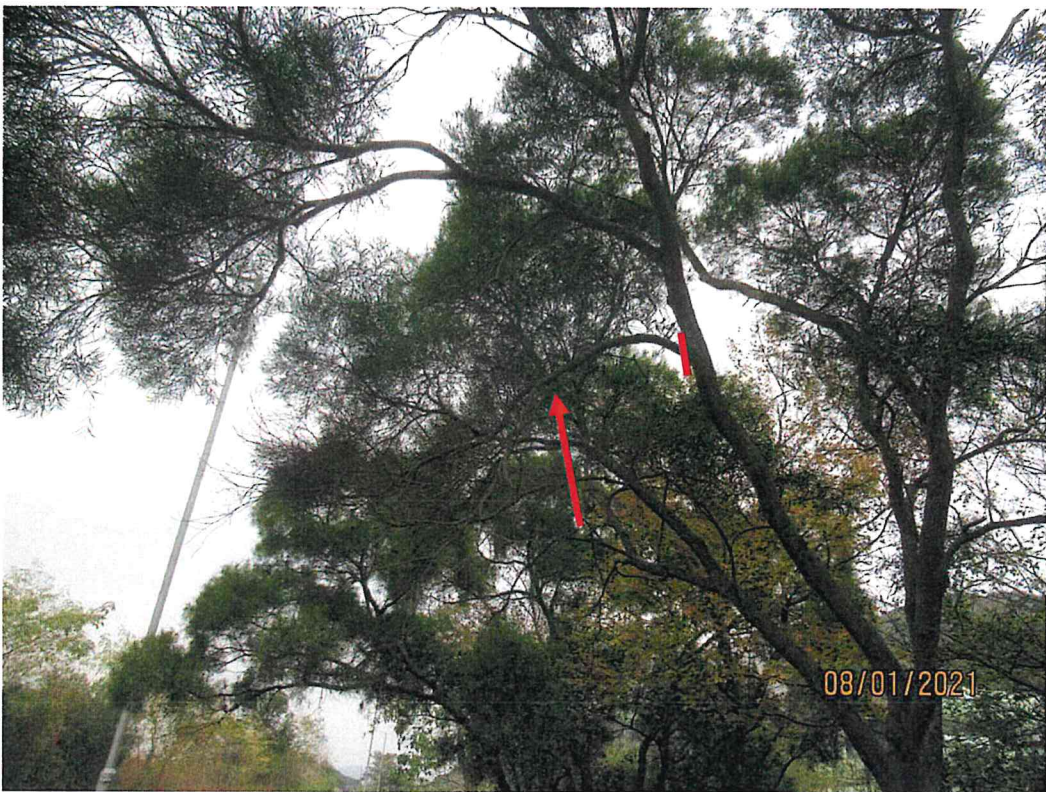
T010: Dead branch is recommended to be removed.

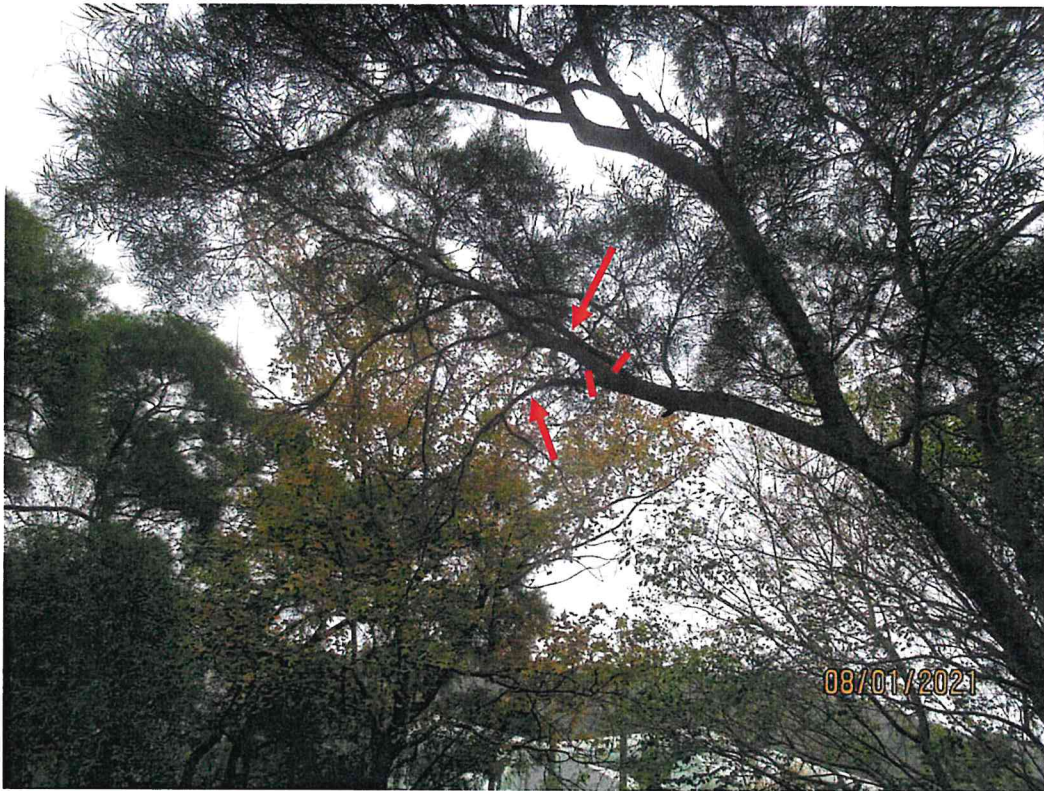
T10: Dead branches are recommended to be removed.

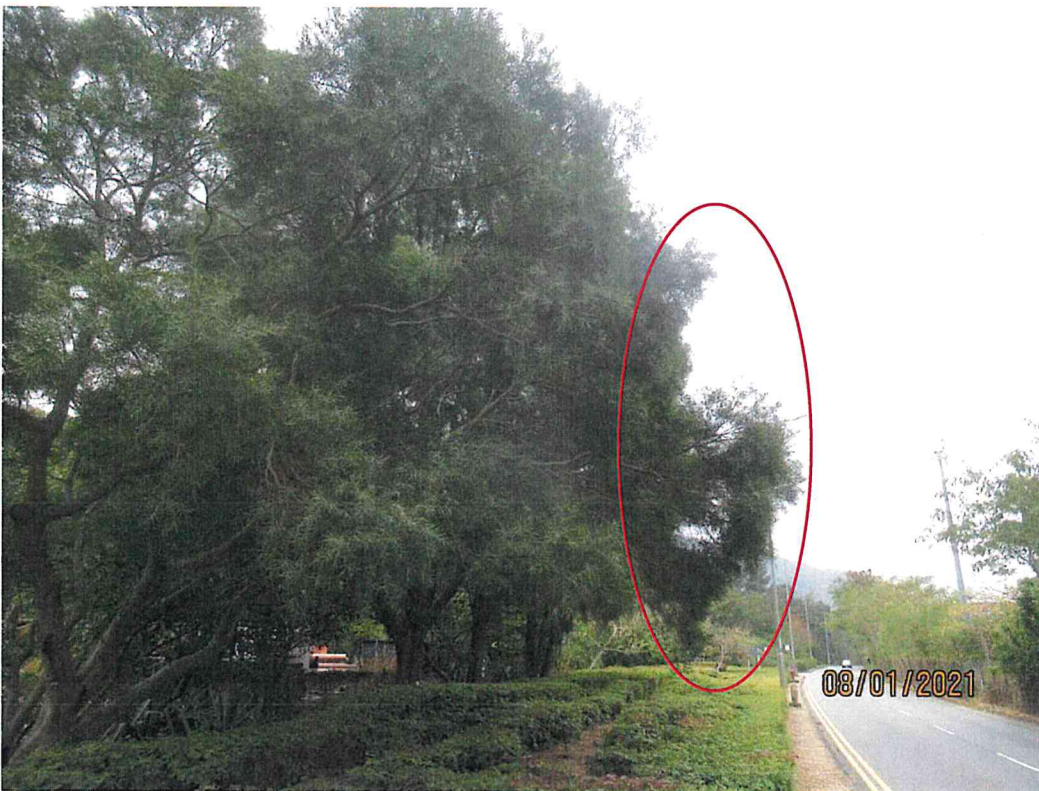
T012: Branch reduction away from the traffic is recommended.
