CEDD Contract No.CV/2007/05
Demolition of Kennedy Town Incineration Plant and
Abattoir

Condition Survey Report for Cracks / Damages
Identified on Existing Ground Slab

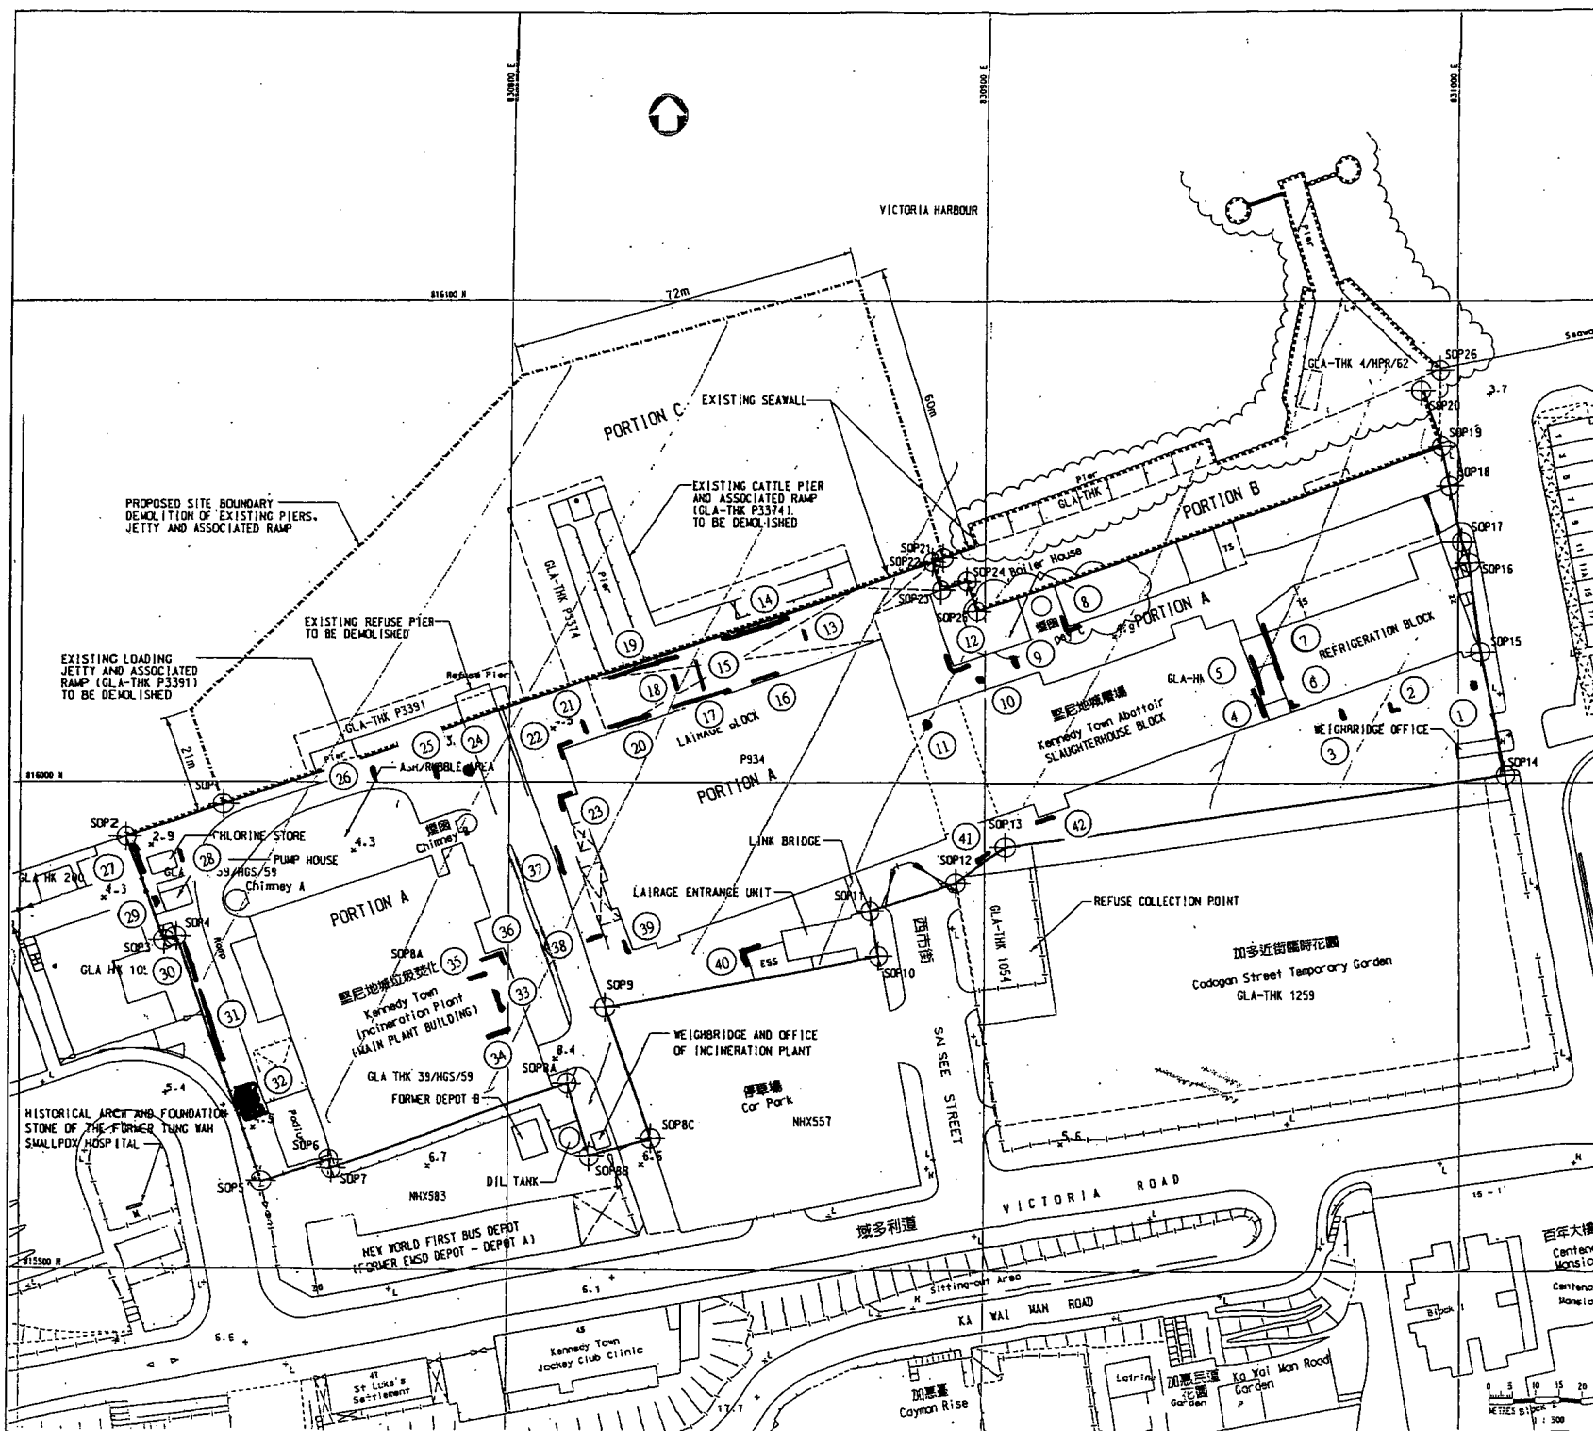
Layout Plan for Cracks / Damages on Existing Ground Slab

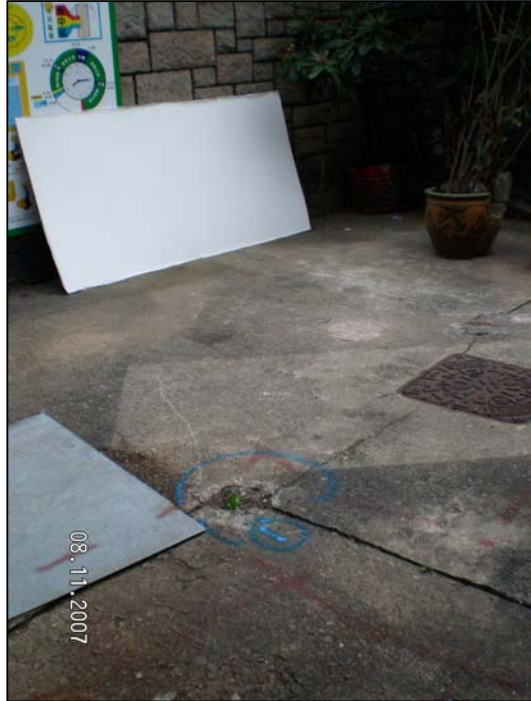
Contract No. CV/2007/05
Demolition of Kennedy Town Incineration Plant and Abattoir
Initial Cracks Record Photos of the Site
Photos Taken on 8 November 2007

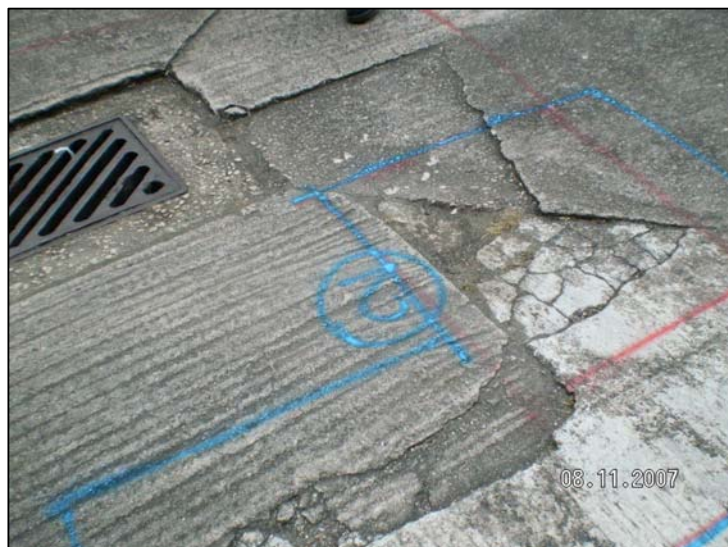
Cracked / Damaged concrete ground slab between refrigeration block
and weighbridge office at Portion A

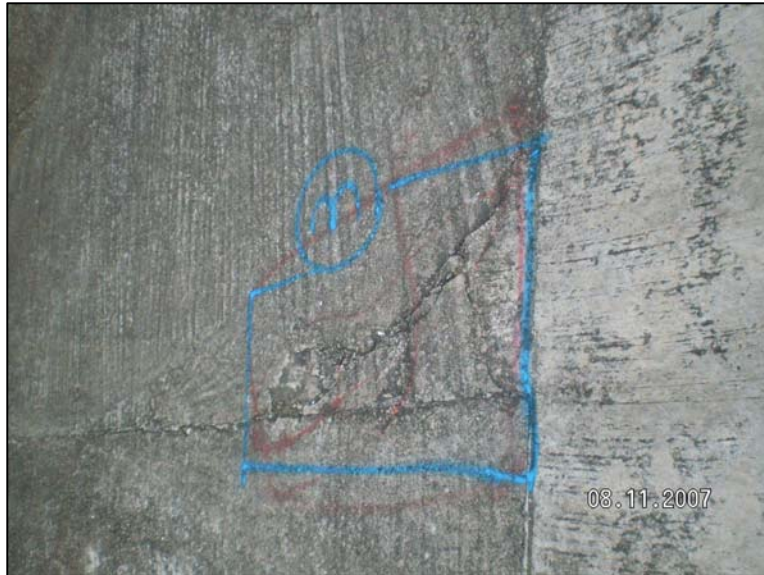
Contract No. CV/2007/05
Demolition of Kennedy Town Incineration Plant and Abattoir
Initial Cracks Record Photos of the Site
Photos Taken on 8 November 2007

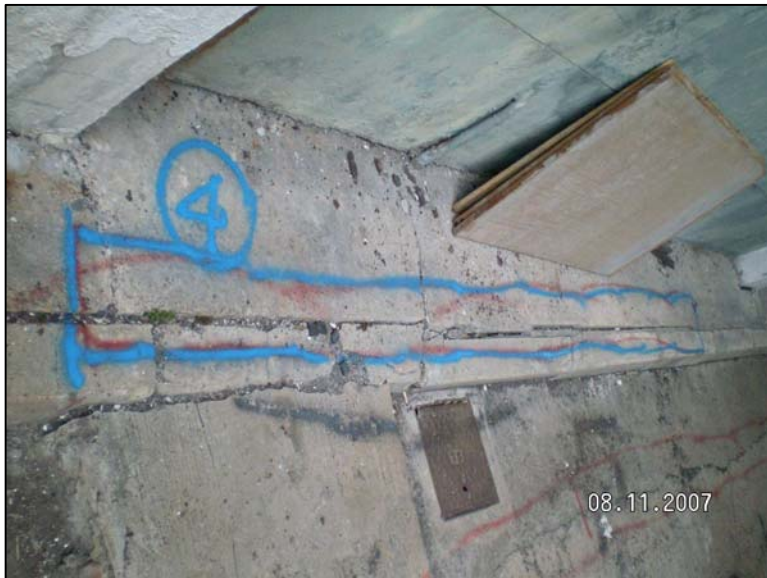
Cracked / Damaged concrete ground slab outside refrigeration block
at Portion A

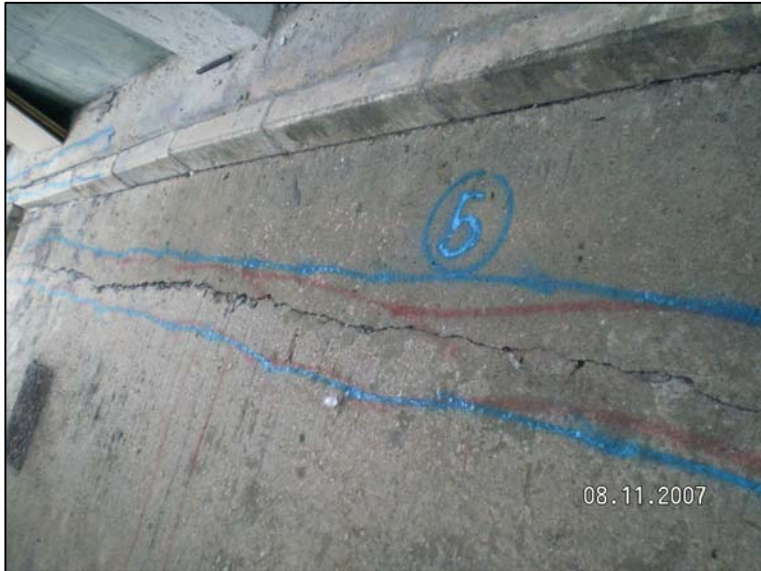
Contract No. CV/2007/05
Demolition of Kennedy Town Incineration Plant and Abattoir
Initial Cracks Record Photos of the Site
Photos Taken on 8 November 2007

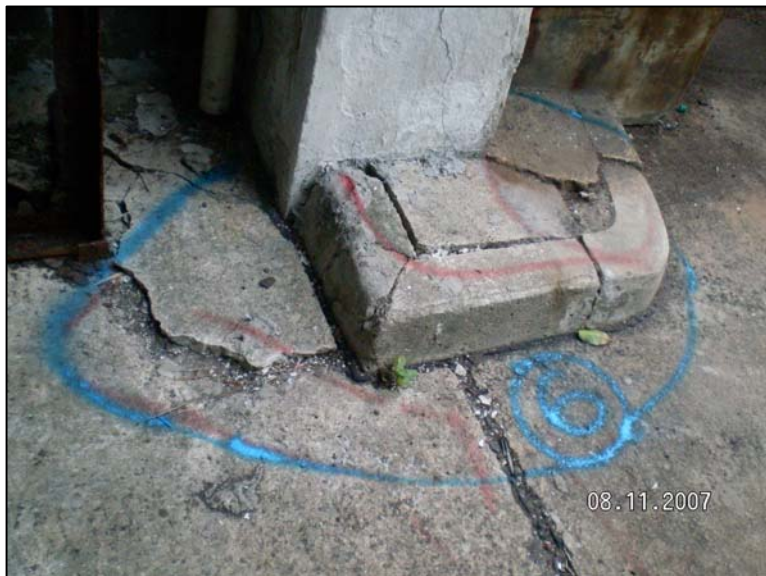
Cracked / Damaged concrete road slab between refrigeration block
and Kennedy Town abattoir slaughterhouse block at Portion A

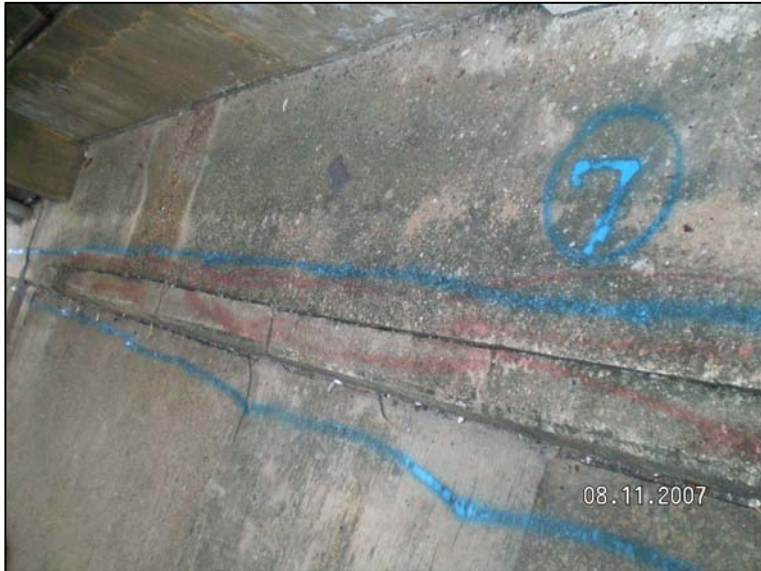
Contract No. CV/2007/05
Demolition of Kennedy Town Incineration Plant and Abattoir
Initial Cracks Record Photos of the Site
Photos Taken on 8 November 2007

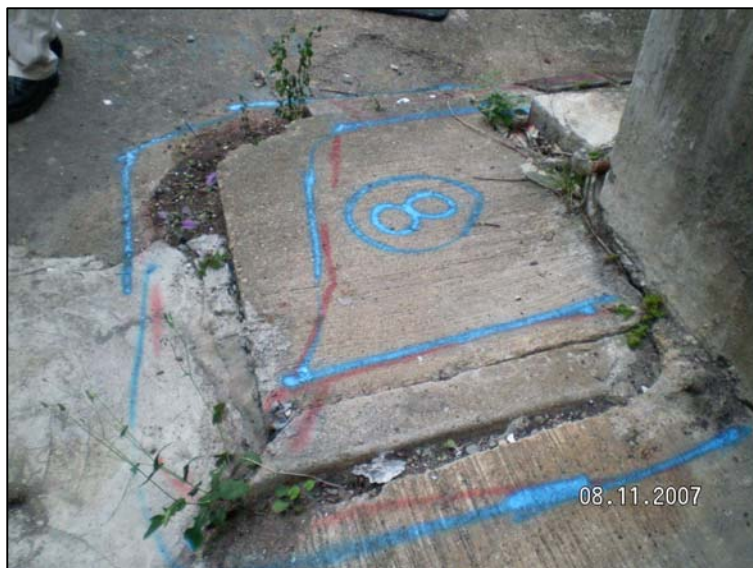
Cracked / Damaged concrete road kerb between refrigeration block
and Kennedy Town abattoir slaughterhouse block at Portion A

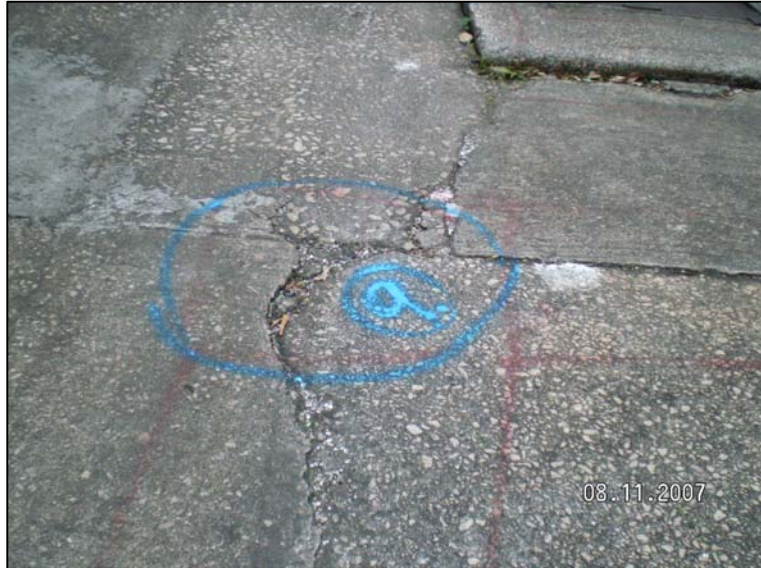
Contract No. CV/2007/05
Demolition of Kennedy Town Incineration Plant and Abattoir
Initial Cracks Record Photos of the Site
Photos Taken on 8 November 2007

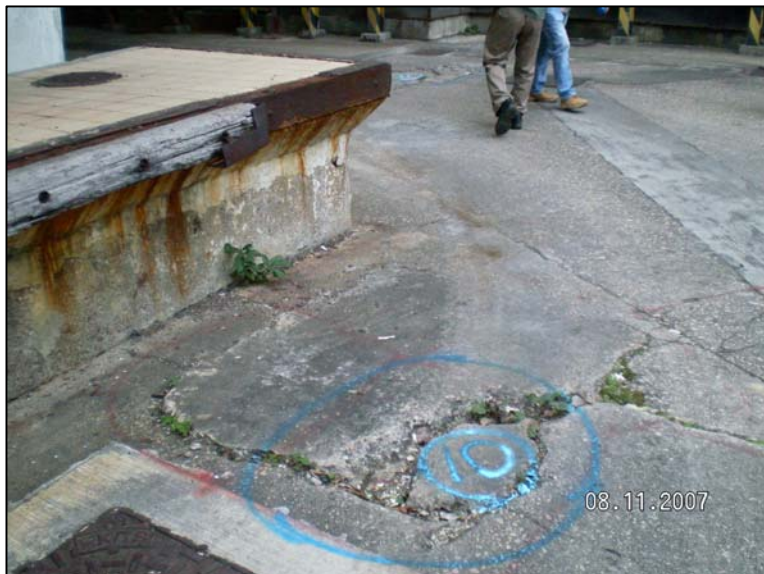
Cracked / Damaged concrete ground slab between E&M Services
Dept. and Kennedy Town abattoir slaughterhouse block at Portion A

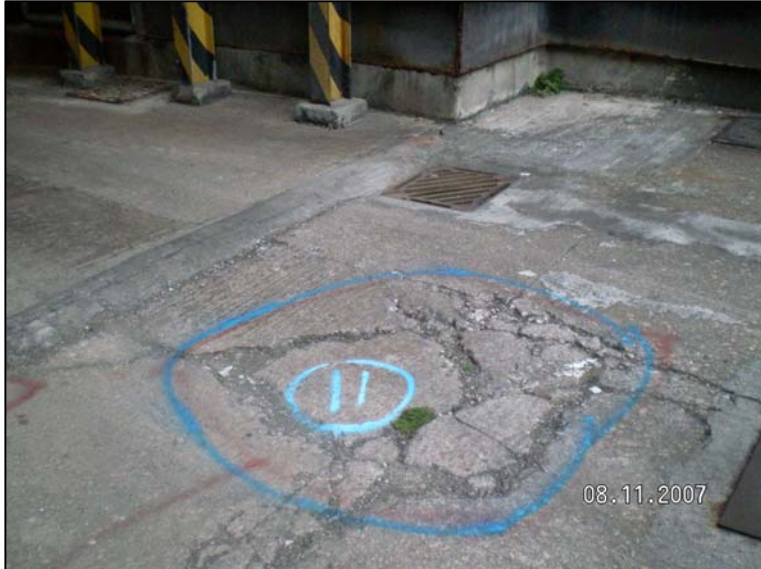
Contract No. CV/2007/05
Demolition of Kennedy Town Incineration Plant and Abattoir
Initial Cracks Record Photos of the Site
Photos Taken on 8 November 2007

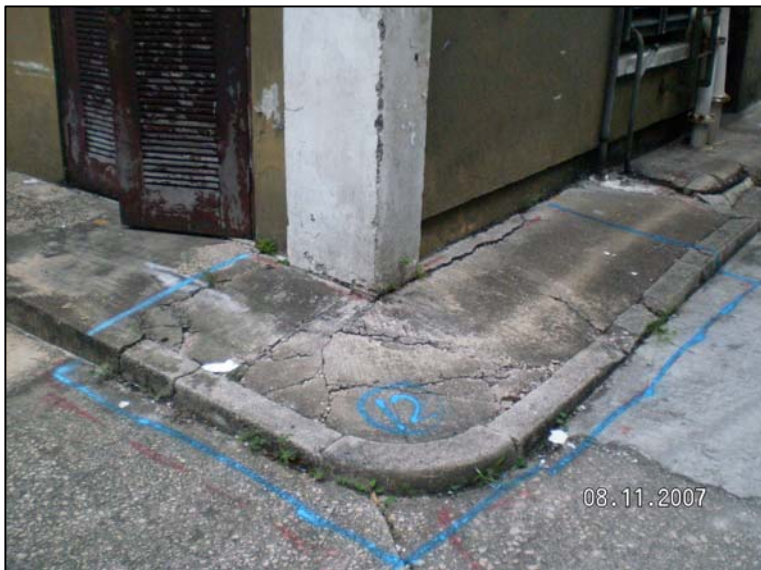
Cracked / Damaged concrete ground slab between lairage block and
Kennedy Town abattoir slaughterhouse block at Portion A

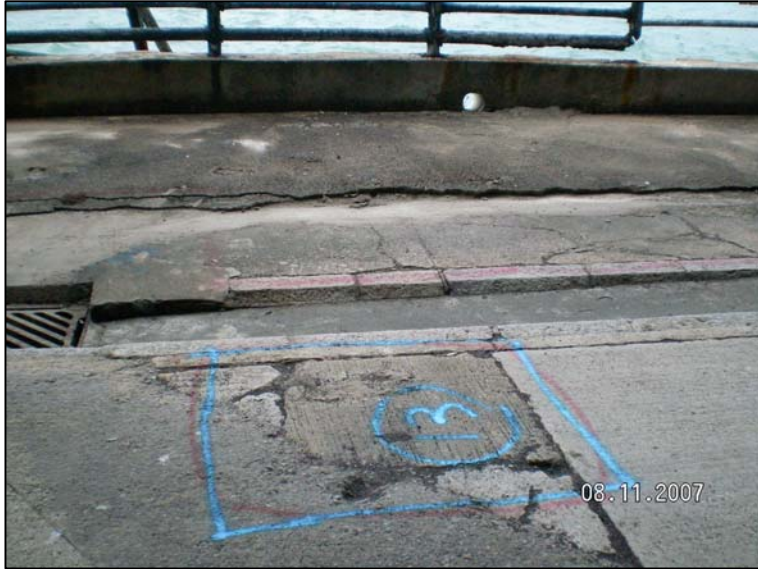
Contract No. CV/2007/05
Demolition of Kennedy Town Incineration Plant and Abattoir
Initial Cracks Record Photos of the Site
Photos Taken on 8 November 2007

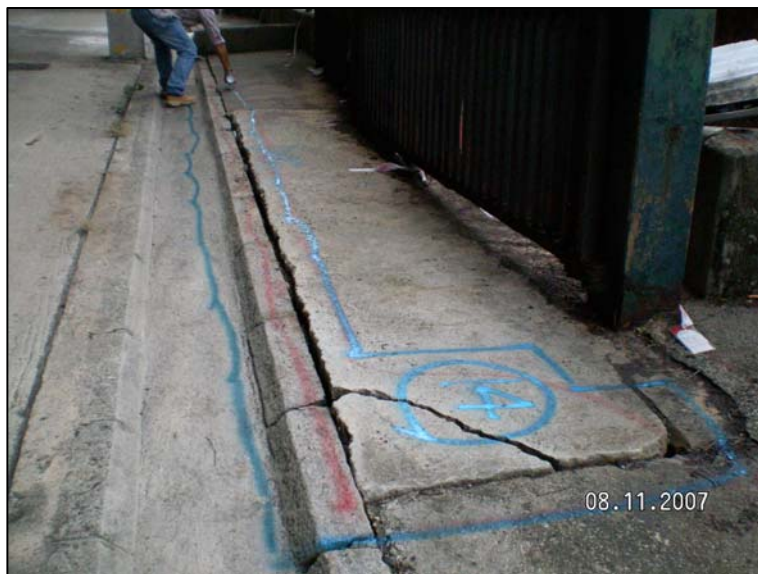
Cracked / Damaged concrete ground slab under steel shed
at Portion A

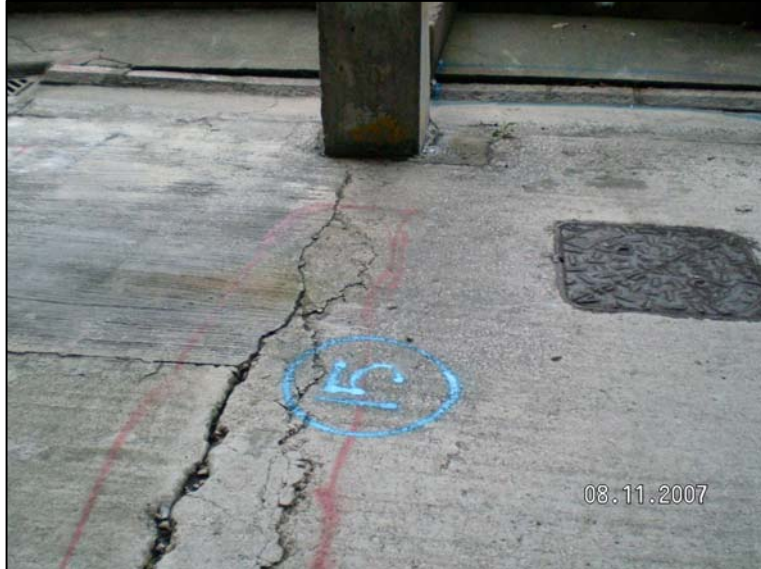
Contract No. CV/2007/05
Demolition of Kennedy Town Incineration Plant and Abattoir
Initial Cracks Record Photos of the Site
Photos Taken on 8 November 2007

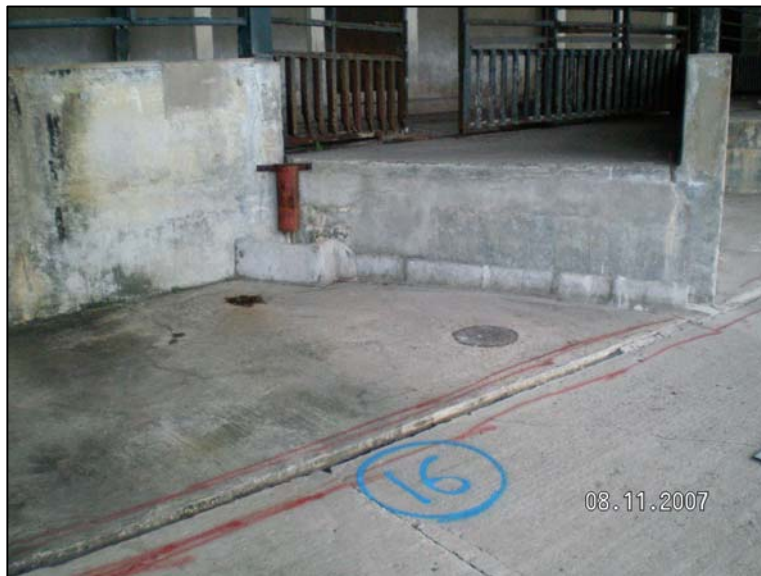
Cracked / Damaged concrete ground slab under steel shed at Portion A

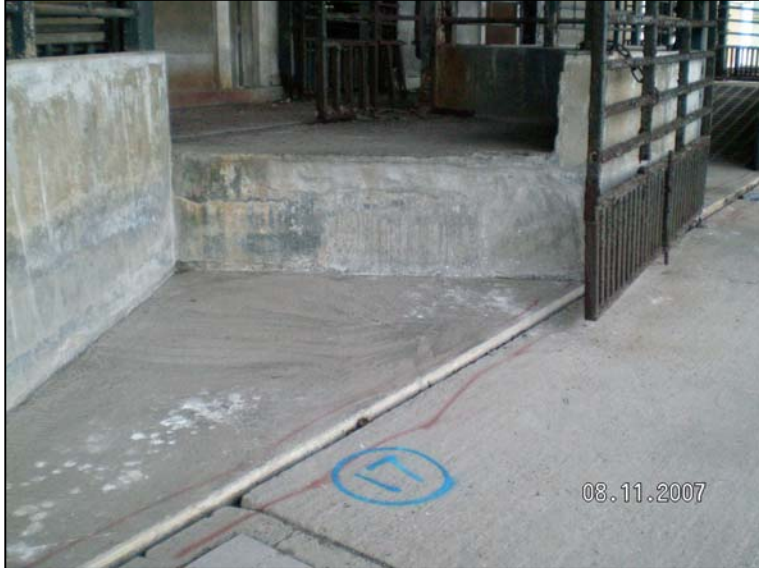
Contract No. CV/2007/05
Demolition of Kennedy Town Incineration Plant and Abattoir
Initial Cracks Record Photos of the Site
Photos Taken on 8 November 2007

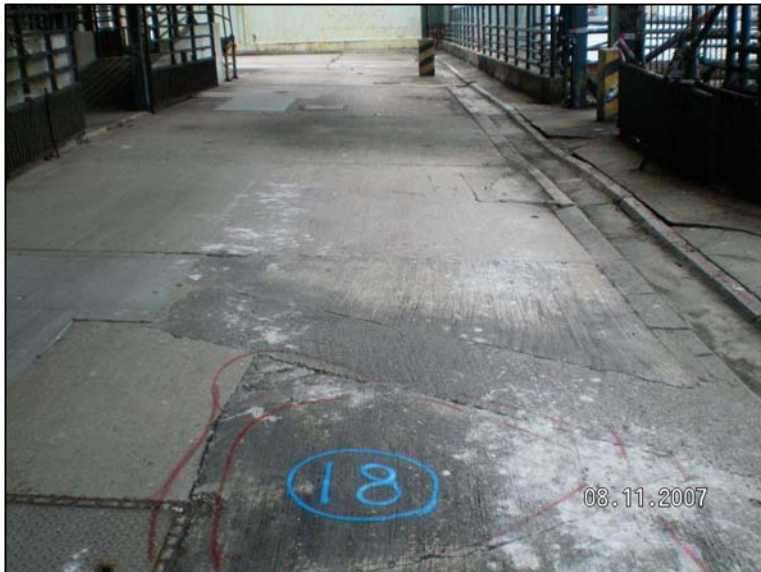
Cracked / Damaged concrete ground slab under steel shed
at Portion A

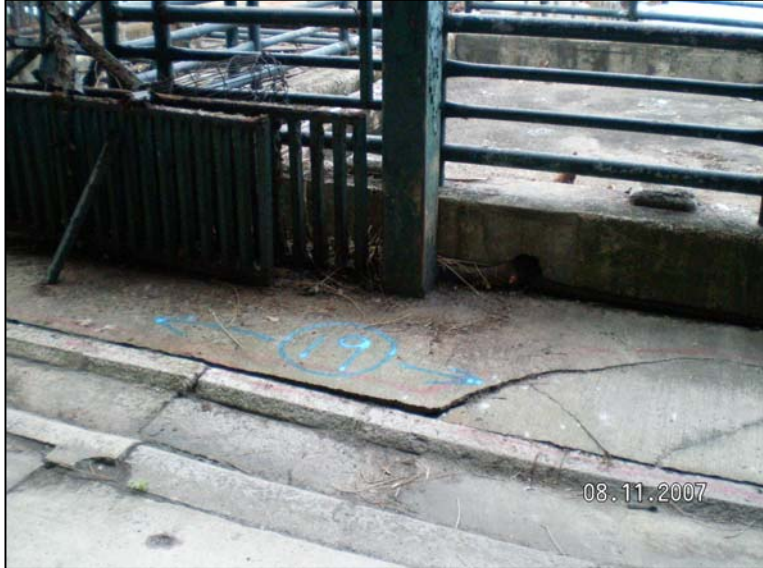
Contract No. CV/2007/05
Demolition of Kennedy Town Incineration Plant and Abattoir
Initial Cracks Record Photos of the Site
Photos Taken on 8 November 2007

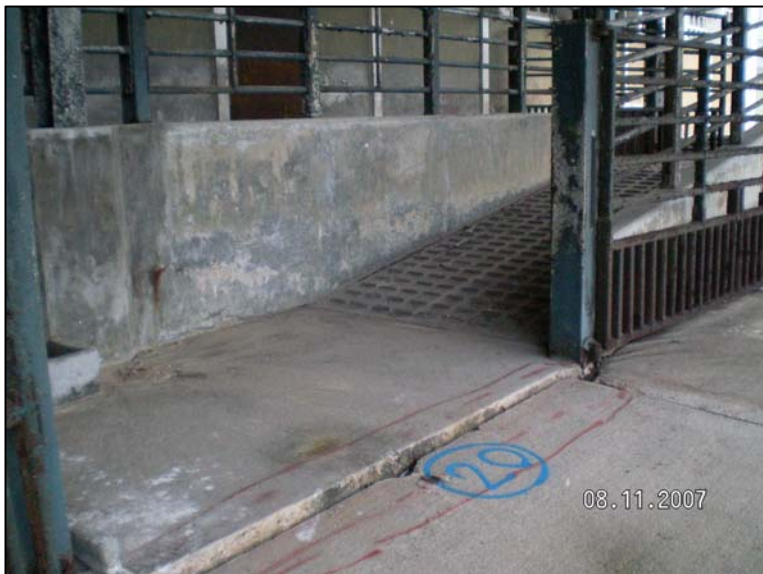
Cracked / Damaged concrete ground slab under steel shed
at Portion A

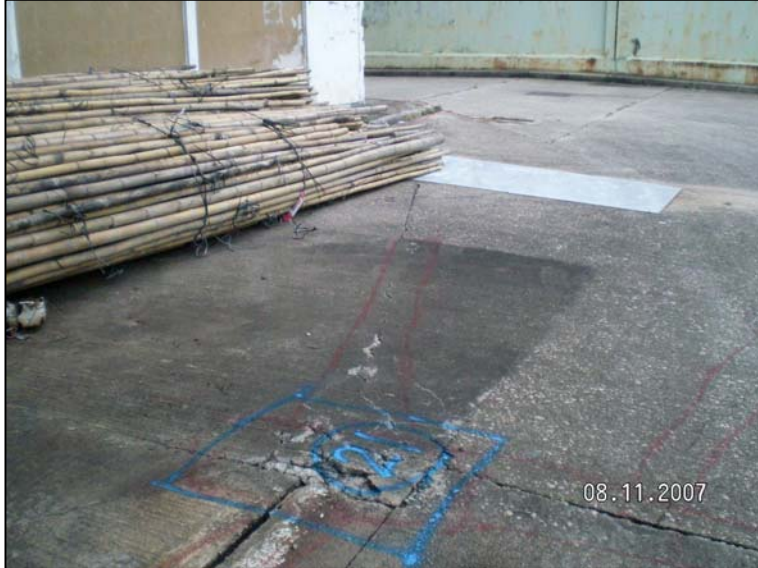
Contract No. CV/2007/05
Demolition of Kennedy Town Incineration Plant and Abattoir
Initial Cracks Record Photos of the Site
Photos Taken on 8 November 2007

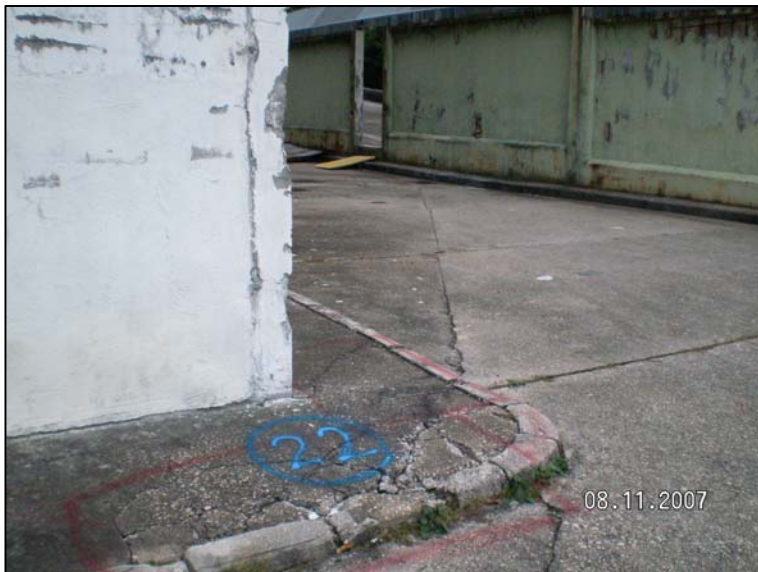
Cracked / Damaged concrete ground slab outside lairage block
and steel shed at Portion A

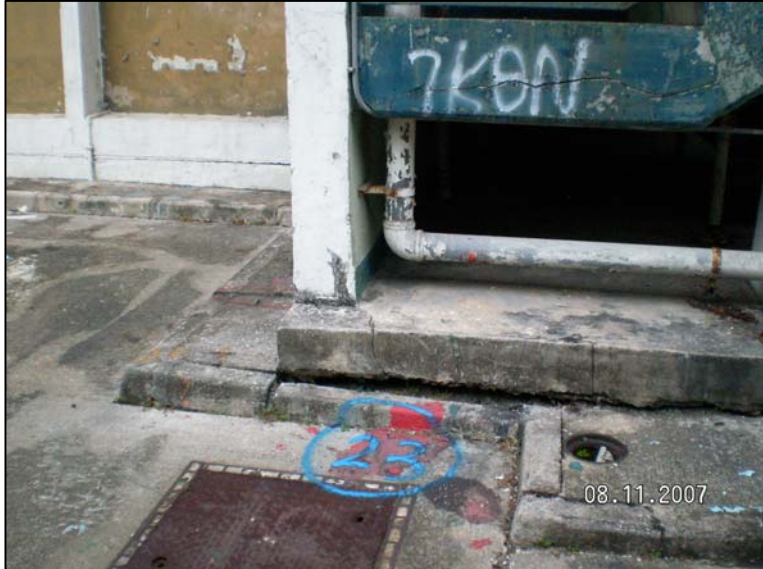
Contract No. CV/2007/05
Demolition of Kennedy Town Incineration Plant and Abattoir
Initial Cracks Record Photos of the Site
Photos Taken on 8 November 2007

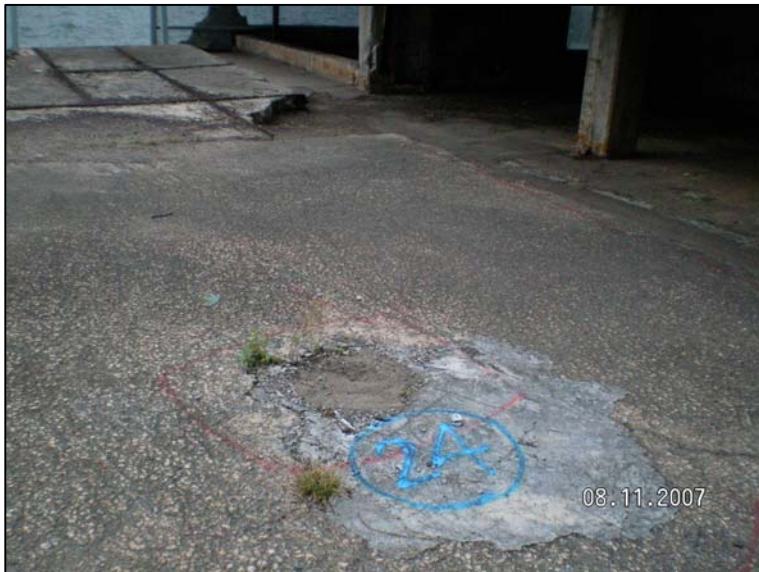
Cracked / Damaged concrete ground slab and kerb outside
lairage block and ramp at Portion A

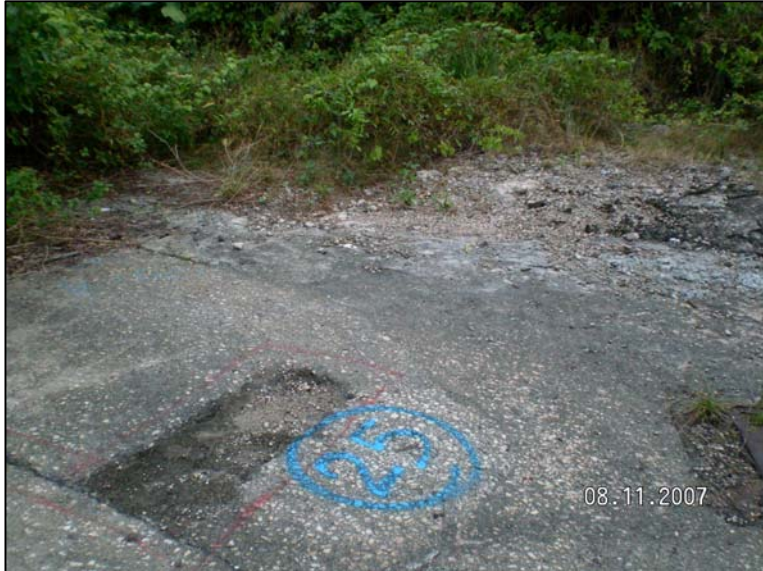
Contract No. CV/2007/05
Demolition of Kennedy Town Incineration Plant and Abattoir
Initial Cracks Record Photos of the Site
Photos Taken on 8 November 2007

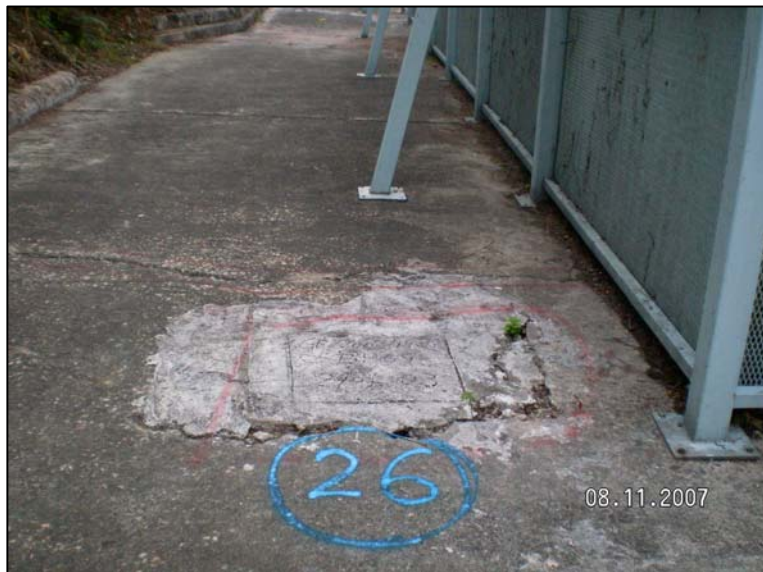
Cracked / Damaged road slab between Chimney B and ramp
at Portion A

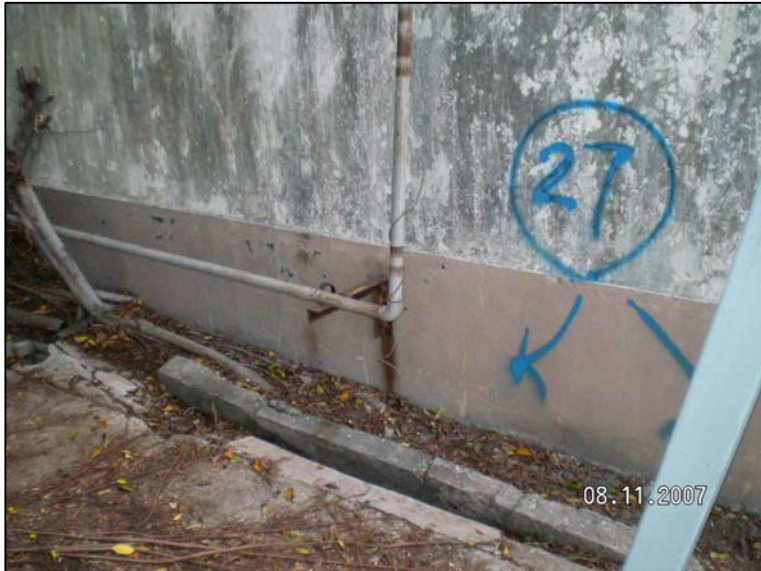
Contract No. CV/2007/05
Demolition of Kennedy Town Incineration Plant and Abattoir
Initial Cracks Record Photos of the Site
Photos Taken on 8 November 2007

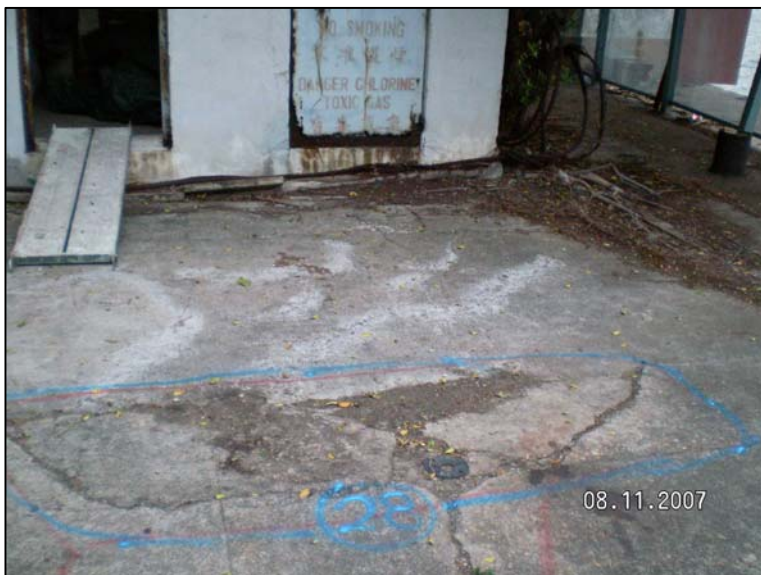
Cracked / Damaged concrete U-channel and slab between the
external wall and chlorine store at Portion A

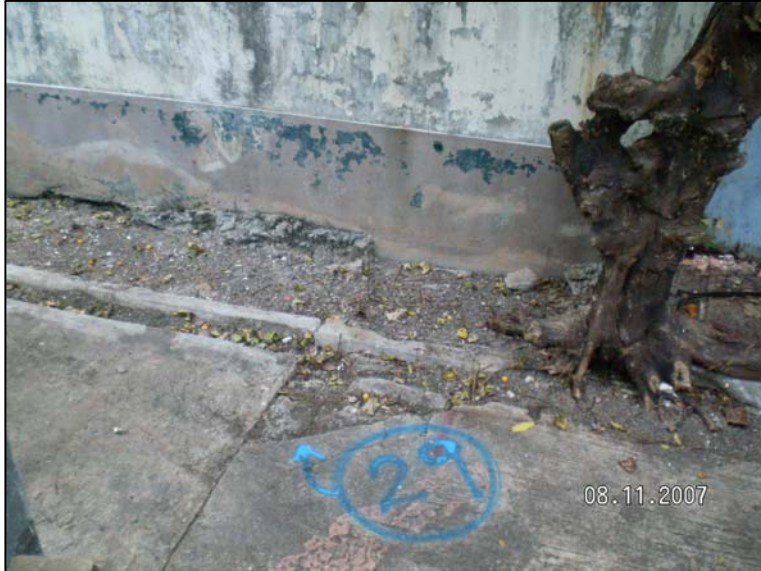
Contract No. CV/2007/05
Demolition of Kennedy Town Incineration Plant and Abattoir
Initial Cracks Record Photos of the Site
Photos Taken on 8 November 2007

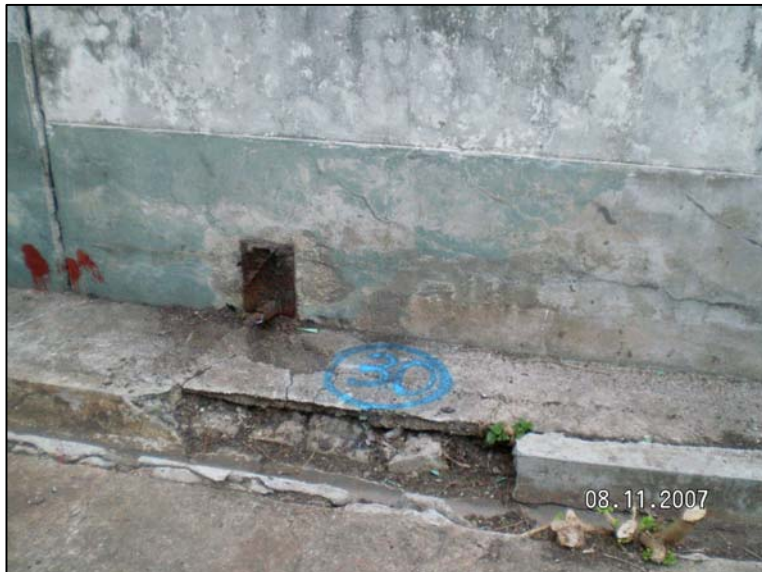
Cracked / Damaged concrete ground slab outside pump house
at Portion A

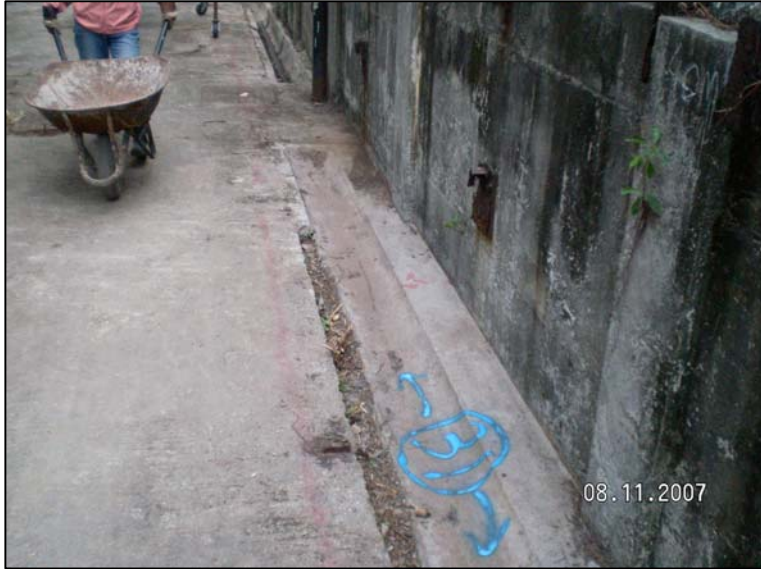
Contract No. CV/2007/05
Demolition of Kennedy Town Incineration Plant and Abattoir
Initial Cracks Record Photos of the Site
Photos Taken on 8 November 2007

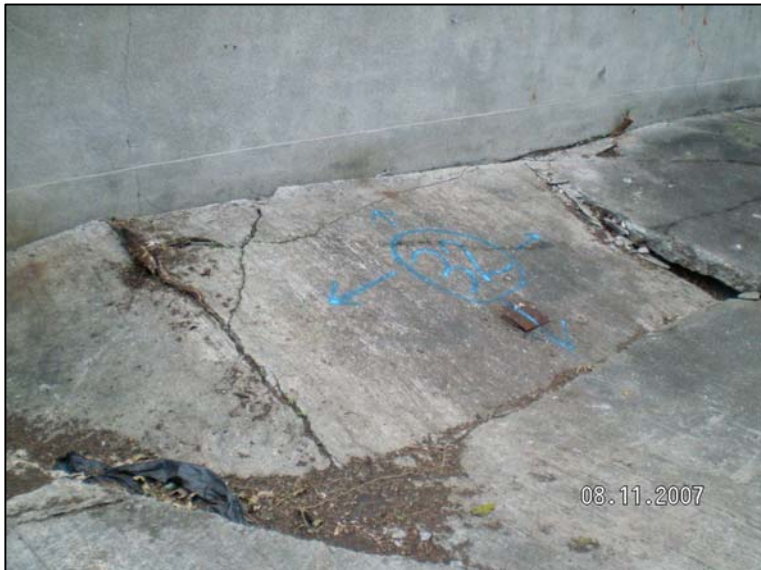
Cracked / Damaged concrete U-channel between the external wall and Kennedy Town incineration plant (main plant building) at Portion A

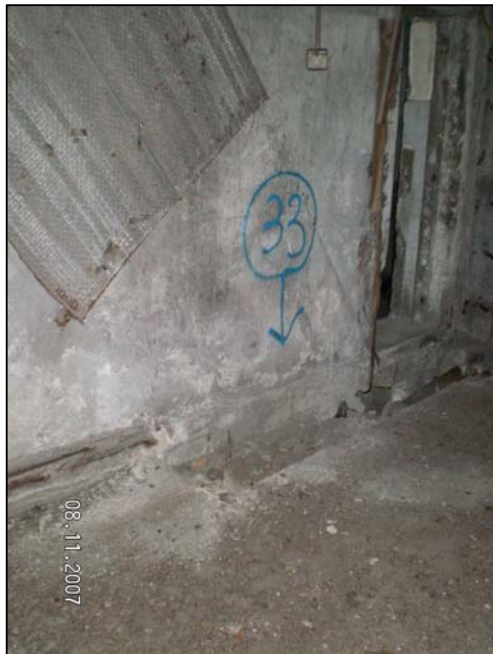
Contract No. CV/2007/05
Demolition of Kennedy Town Incineration Plant and Abattoir
Initial Cracks Record Photos of the Site
Photos Taken on 8 November 2007

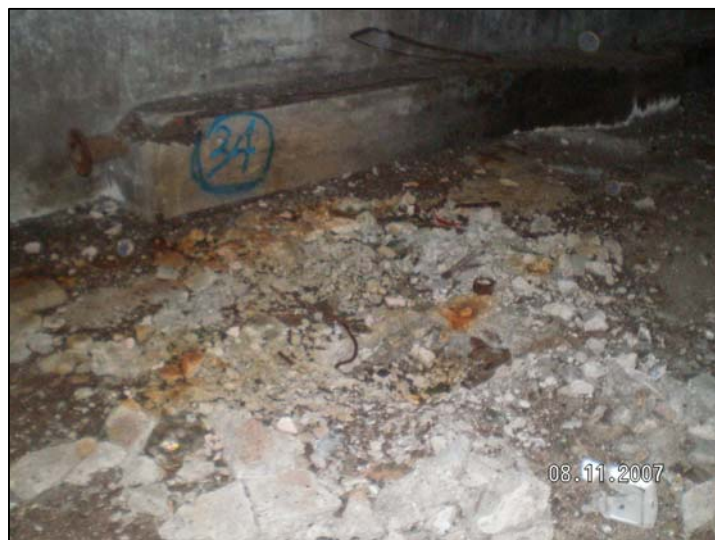
Cracked / Damaged concrete ground slab inside the Kennedy Town incineration plant (main plant building) at Portion A

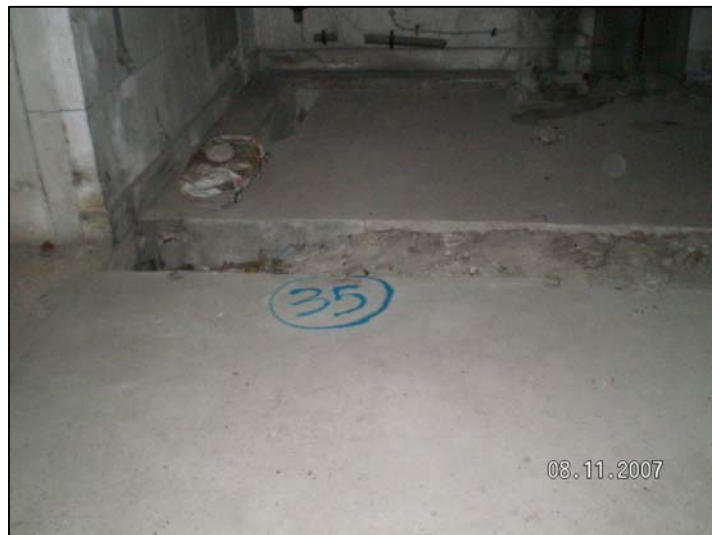
Contract No. CV/2007/05
Demolition of Kennedy Town Incineration Plant and Abattoir
Initial Cracks Record Photos of the Site
Photos Taken on 8 November 2007

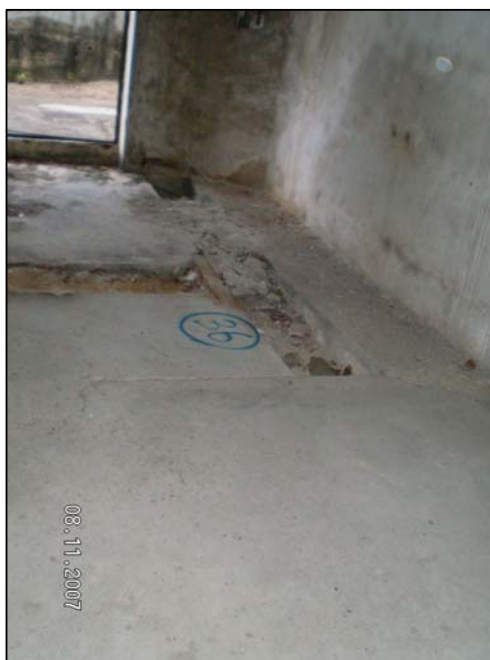
Cracked / Broken concrete ground slab inside the Kennedy Town incineration plant (main plant building) at Portion A

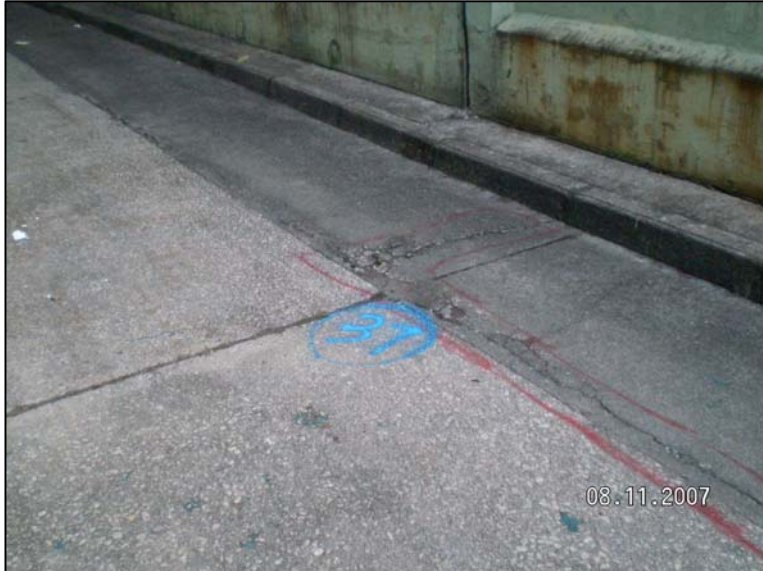
Contract No. CV/2007/05
Demolition of Kennedy Town Incineration Plant and Abattoir
Initial Cracks Record Photos of the Site
Photos Taken on 8 November 2007

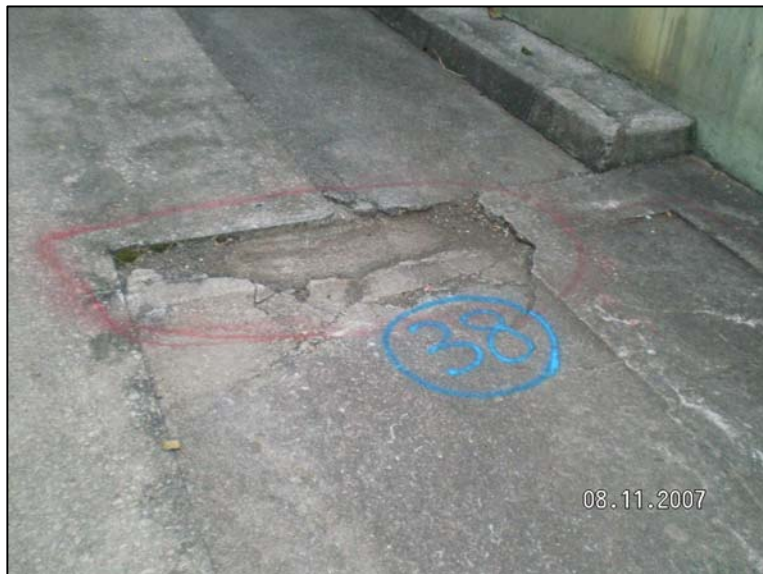
Cracked / Damaged road slab between the external wall and
lairage block at Portion A

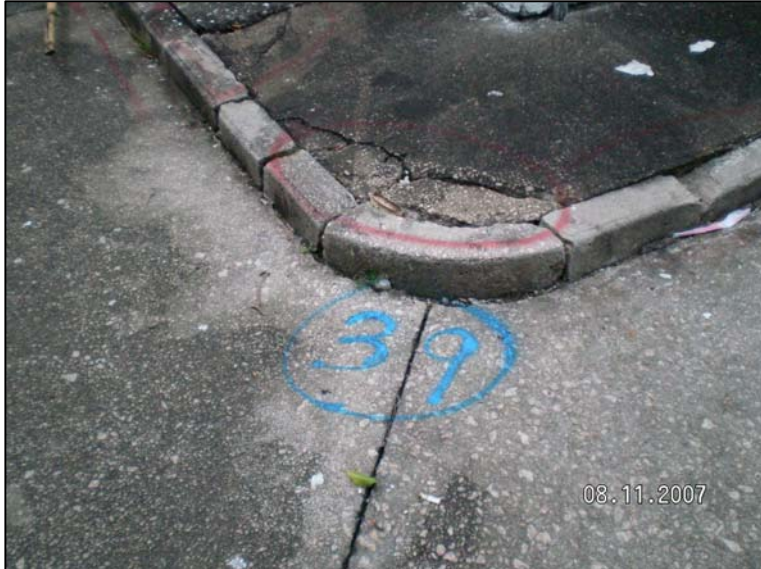
Contract No. CV/2007/05
Demolition of Kennedy Town Incineration Plant and Abattoir
Initial Cracks Record Photos of the Site
Photos Taken on 8 November 2007

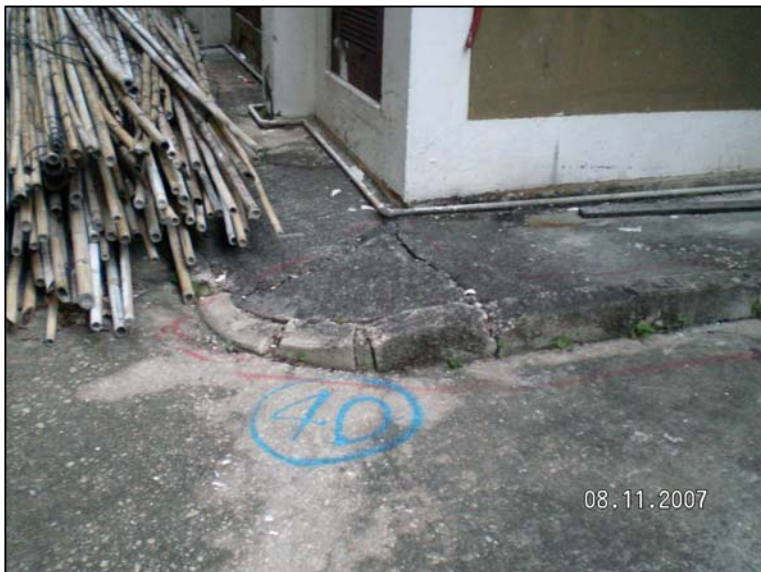
Cracked / Damaged concrete ground slab and kerb between the
external wall and lairage block at Portion A

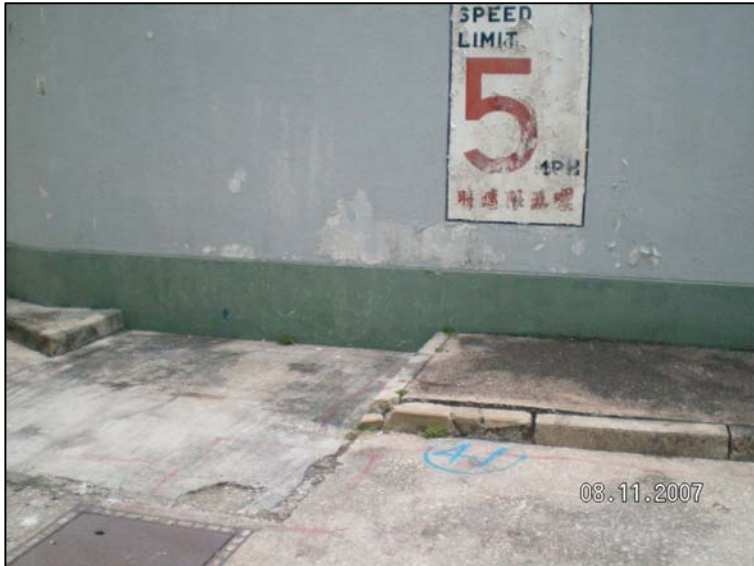
Contract No. CV/2007/05
Demolition of Kennedy Town Incineration Plant and Abattoir
Initial Cracks Record Photos of the Site
Photos Taken on 8 November 2007

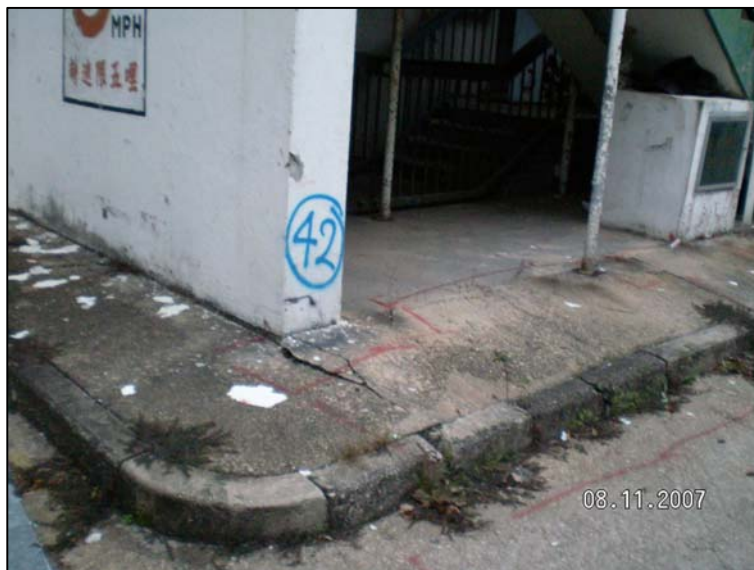
Cracked / Damaged concrete ground slab and kerb between the external wall and Kennedy Town abattoir slaughterhouse block at Portion A
