Contract No. HY/2011/03

Hong Kong-Zhuhai-Macao Bridge Hong Kong Link Road Section between Scenic Hill and Hong Kong Boundary Crossing Facilities

Monthly EM&A Report No.90 (March 2020)

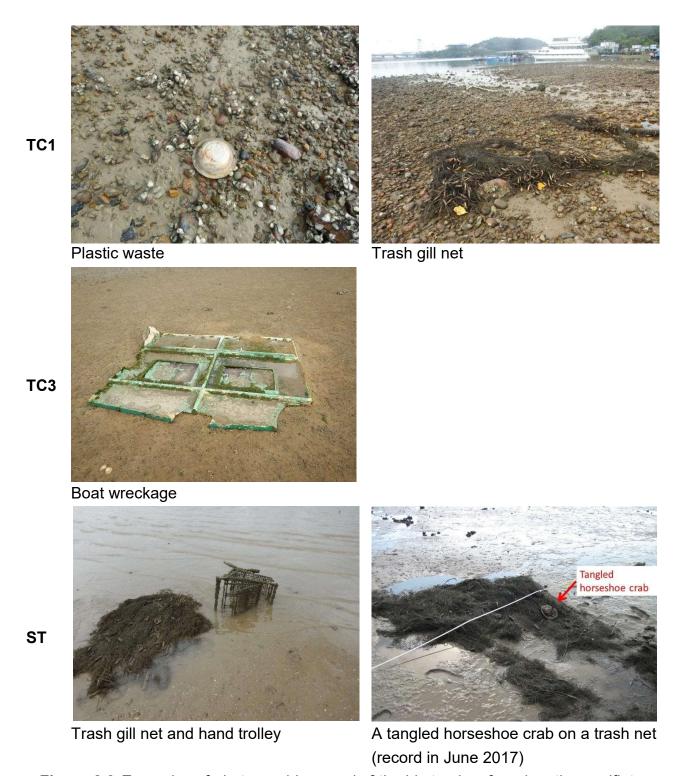
- 6.3.2 Since the field survey of June 2016, increasing number of trashes and even big trashes (**Figure 2.3 of Appendix I**) were found in every sampling zone. It raised a concern about the solid waste dumping and current-driven waste issues in Tung Chung Wan. Respective measures (e.g. manual clean-up) should be implemented by responsible governmental agency units.

Figure 2.3 Examples of photographic record of the big trashes found on the mudflat.
