Ocean Park Tai Shue Wan Water World Project

Operation Phase Monthly EM&A Report
May 2022

June 2022

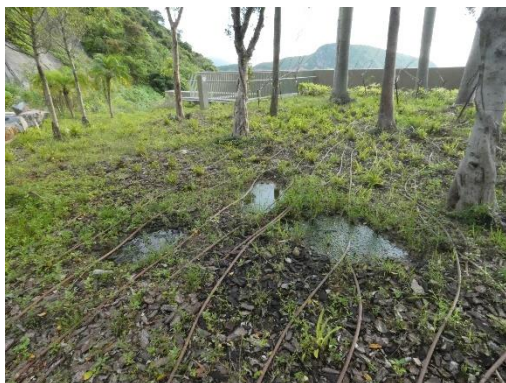
Figure 2.1 Diggings left by wild boar in EEA

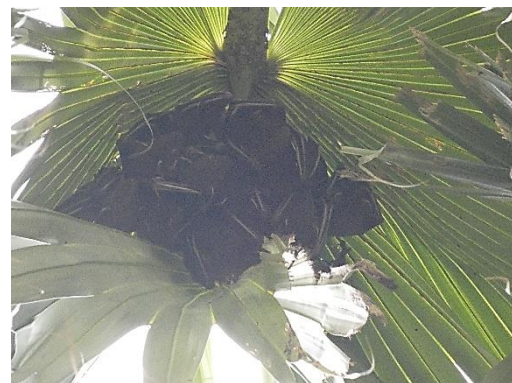
Figure 2.2 Short-nosed Fruit Bat roosting on frond of Chinese Fan-palm

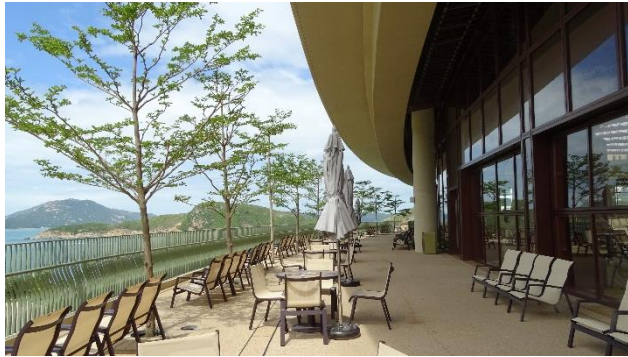
OP01 Sensitive Design and Disposition – Color palette of the design was mostly in subdued tones. Floor and walls were painted with non-reflective finishing.

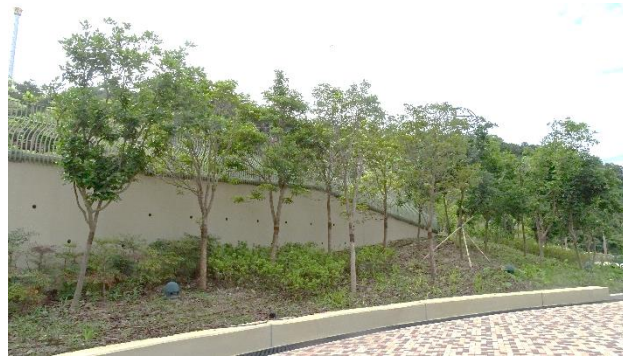
OP02 Compensatory Tree Planting – General view of whip trees newly planted.

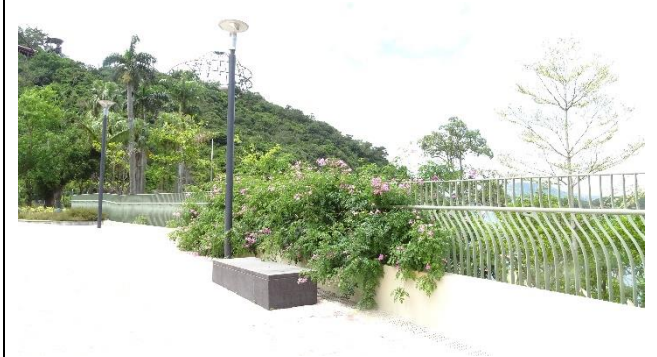
OP03 Enhancement Planting – Additional trees and shrubs were planted along the pedestrian walkway.

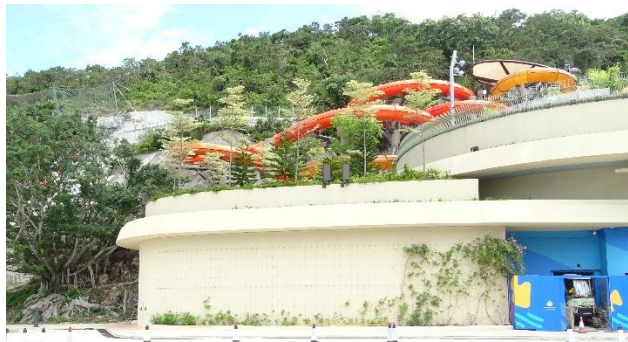
The removal of tree saplings of invasive species on the green roof floor was hindered by the lack of safe access. Removal of such invasive species is recommended to avoid further spreading once safety access is available.

OP04 Green Roofs and Vertical Greening – General view of green roof and vertical green in establishment.

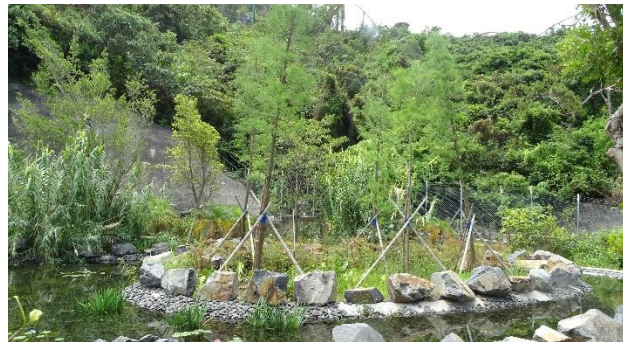
OP05 Re-provision of Flamingo Pond – General view

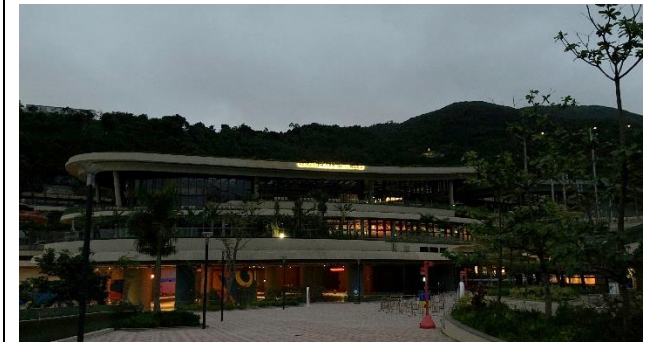
OP06 Responsive Lighting Design – General view of lighting design with appropriate level of lighting to reduce potential impact
