## **Appendix 11.4**

### **Marine Geophysical Survey**

## **Appendix 11.4 - MARINE GEOPHYSICAL SURVEY**

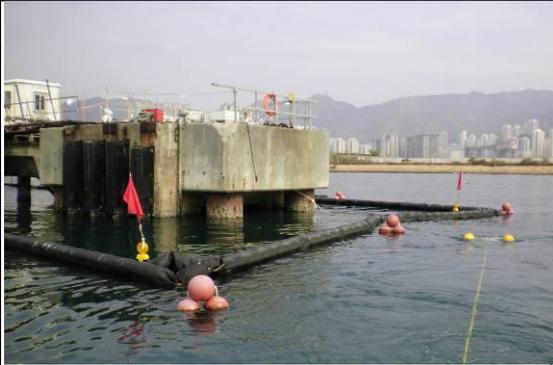
There is a drilling platform working for the same project in the vicinity of the survey area and a disused fuel dolphin connecting to the former airport runway within the survey area.

The disused fuel dolphin is enclosed by its safety protection

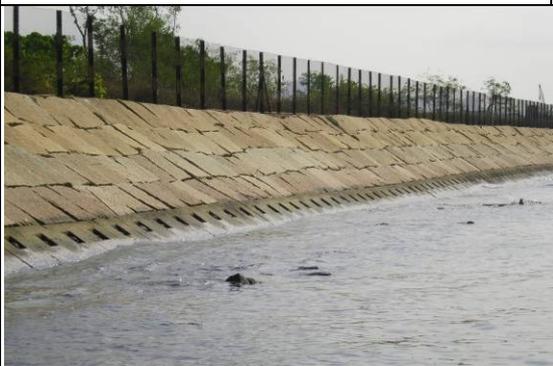
Boulders near seawall of Kai Tak

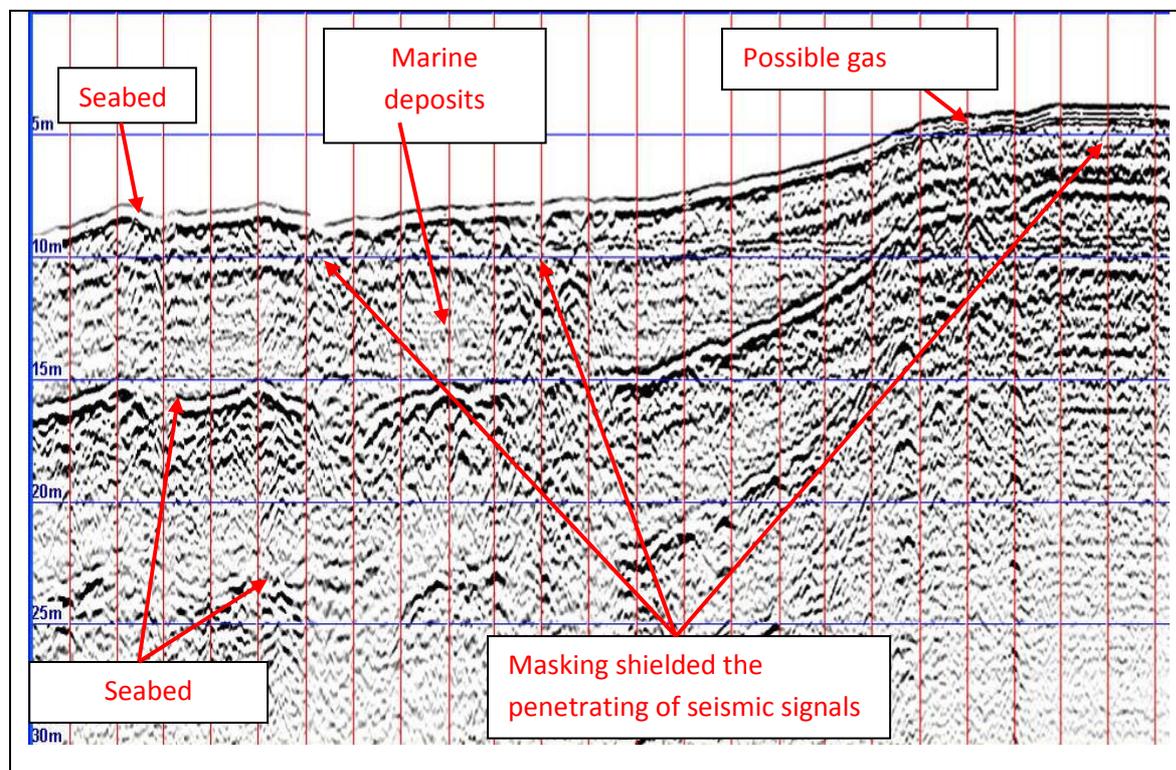
Seismic data showed that the survey area was covered by marine deposits which was identifiable on seismic records as a clear conformable horizon. However, the area was heavily masked as expected which blocked the interpretation work for sub bottom geology. Masking is probably caused by the presence of organic materials on the seabed (e.g. discharge from the water outfall) and the gas bubbles so generated absorb the seismic energy, thereby preventing reflections from deeper horizons.

In addition, the very shallow water in the survey area produced multiples that could not be removed by the processing. Consequently, interpretation of seismic profiles below the first seabed multiple was severely reduced.

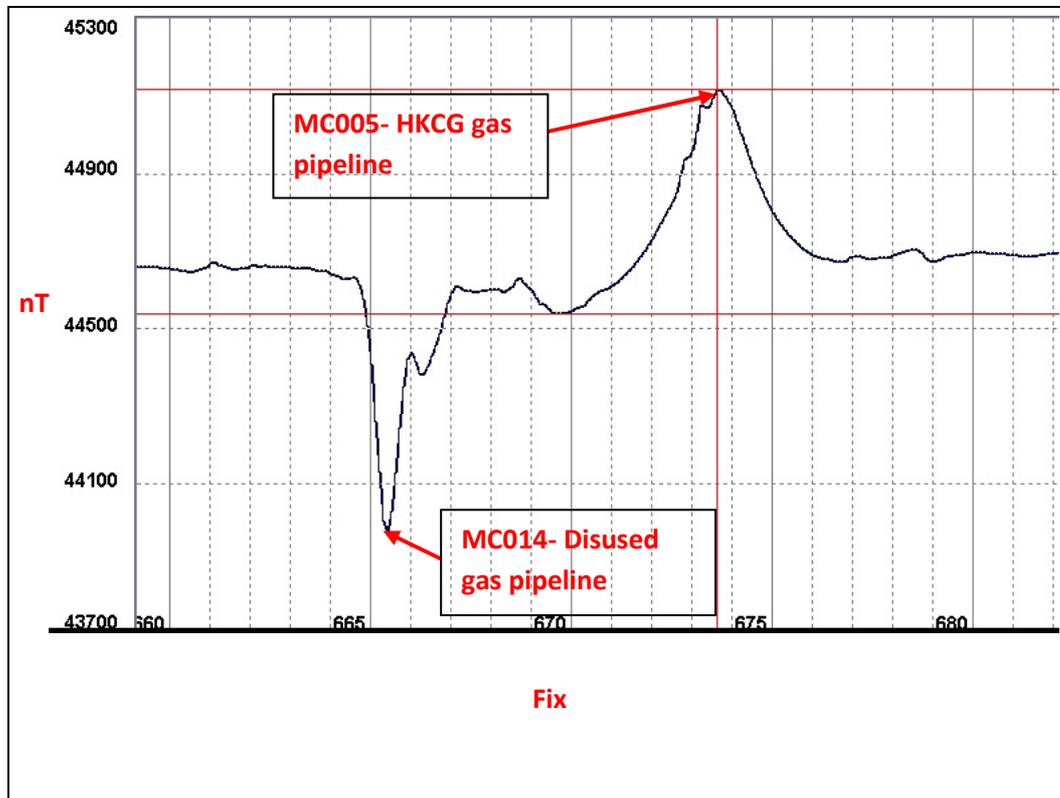
The alignment of the existing pipelines was successfully detected by the magnetometer except the area close to the disused fuel dolphin. The disused fuel dolphin generates strong magnetic anomalies which confused the anomalies from the pipeline.

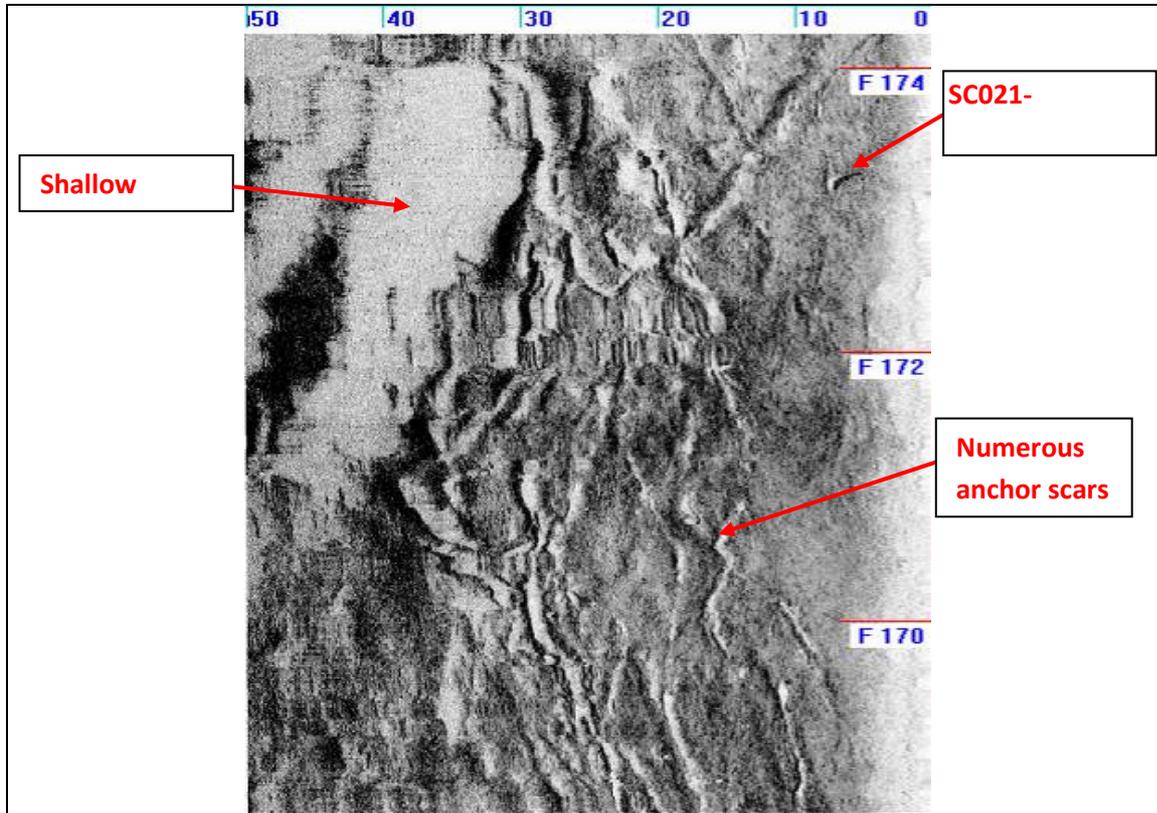
A total of 39 sonar contacts were located. Eight of these were identified as tyres and one as a marker buoy sinker. The remaining 30 need diver inspection to assess their archaeological value.

A total of 18 magnetic contacts were recorded. Of these, 12 are connected to disused gas pipelines and 6 are unknown. The other six will require diver inspection to assess their archaeological value.

Anchor scars were observed on soft seabed sediments as barges, ferries and other commercial boats anchor there.
