Appendix 16.9: Diver Survey Results

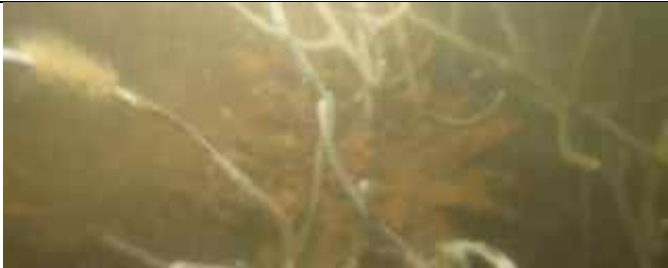
Sonar Contact (SC) Magnetic Contact (MC) Number	Easting	Northing	Description	Underwater Photograph or retrieved object at the surface
SC013	807181.5	821044.2	Modern metal debris

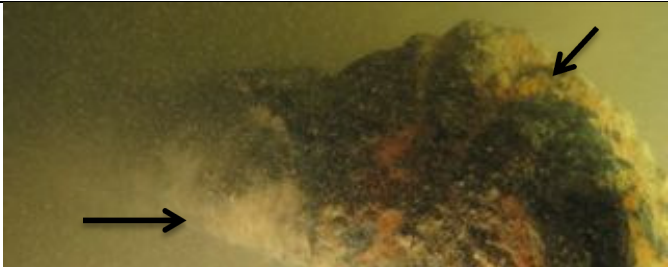
MC005	807178.0	821053.1	Corroded metal bar

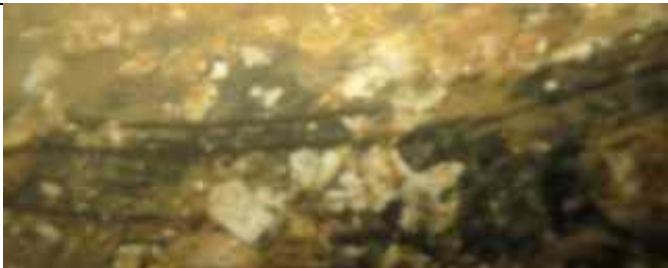
MC008	807179.8	821044.4	Metal bar with marine growth

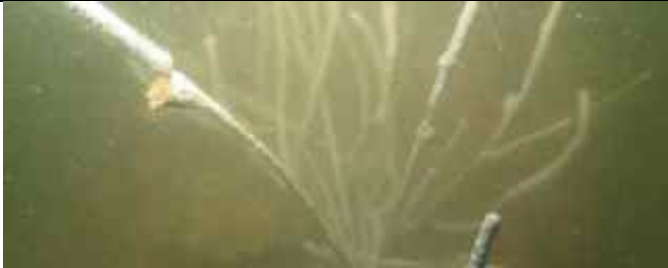
Sonar Contact (SC) Magnetic Contact (MC) Number	Easting	Northing	Description	Underwater Photograph or retrieved object at the surface
MC009	807180.1	821047.1	Modern metal wire

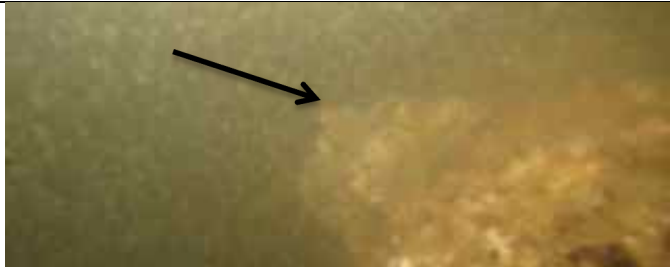
MC014	807179.3	821042.4	Concrete blocks with marine growth

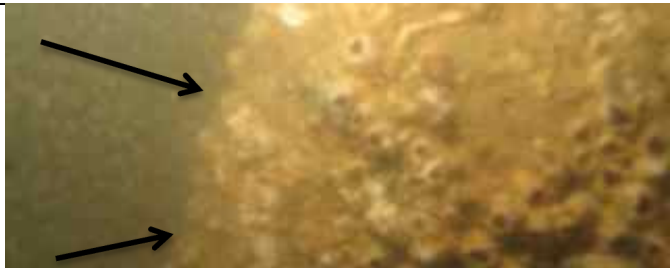
MC015	807167.4	821035.9	Concrete blocks with marine growth

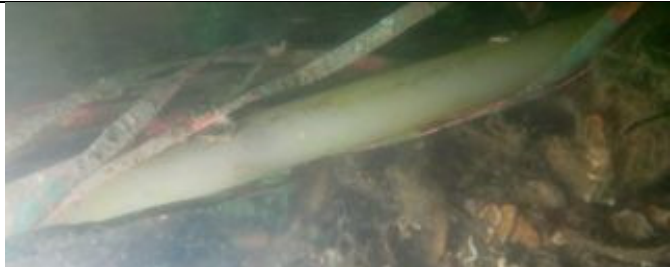
SC014	807202.9	821101.7	Metal pole and numerous plastic attachments

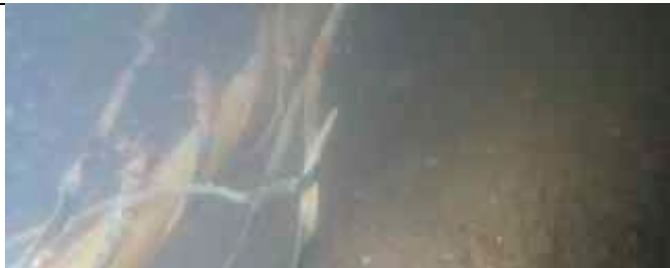
MC018	807188.0	821101.9	Plastic pole with plastic attachments and wire

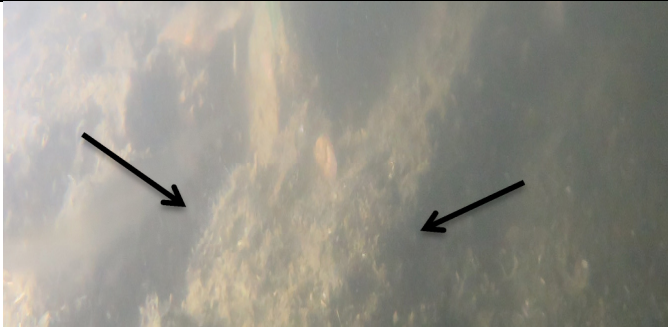
Sonar Contact (SC) Magnetic Contact (MC) Number	Easting	Northing	Description	Underwater Photograph or retrieved object at the surface
SC017	807656.2	821200.3	Modern debris

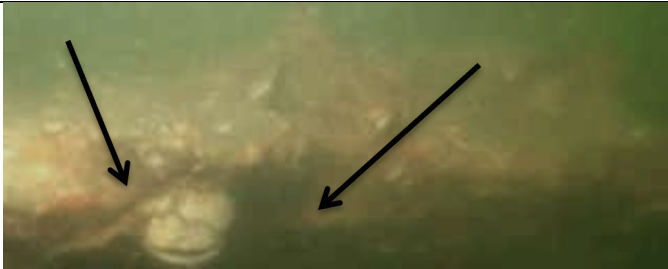
MC019	807631.6	821197.0	Construction debris

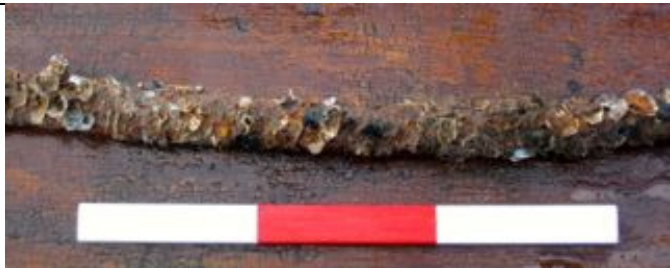
SC021	807087.7	820607.3	Modern rebar with marine growth

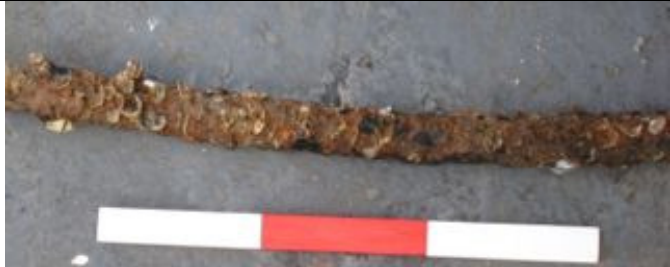
Sonar Contact (SC) Magnetic Contact (MC) Number	Easting	Northing	Description	Underwater Photograph or retrieved object at the surface
MC168	807088.9	820611.9	Modern rebar with marine growth

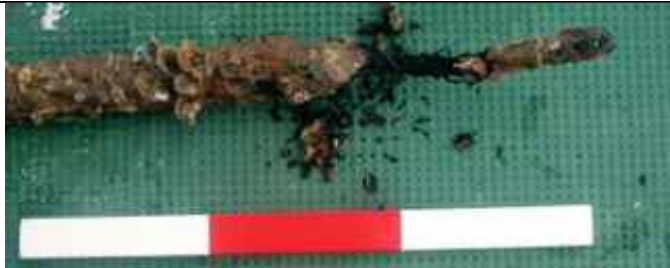
MC169	807070.2	820606.5	Metal wire encrusted with marine growth

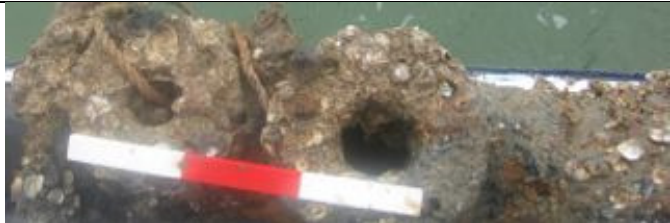
Sonar Contact (SC) Magnetic Contact (MC) Number	Easting	Northing	Description	Underwater Photograph or retrieved object at the surface
SC023	806992.1	820326.4	Metal pipe with twin flanges

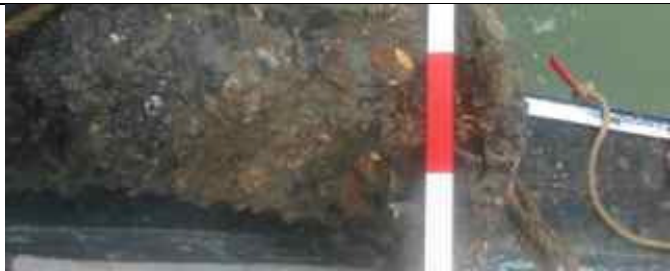
MC069	806991.0	820305.2	Metal pipe heavily encrusted with marine growth

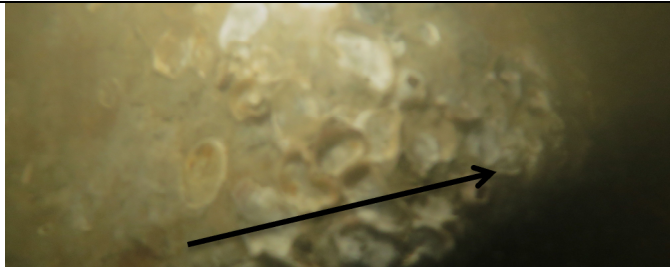
SC029	805329.9	819119.8	Concrete block with marine growth
